*RE: Cultural Resource Study Letter Report for Parcel 100-36-041 at 617 West Tombstone Avenue, City of Flagstaff, Coconino County, Arizona (PZ-23-00173; LA Neal Consulting, LLC Project No. 1091-23)*

### Property Description/Architecture

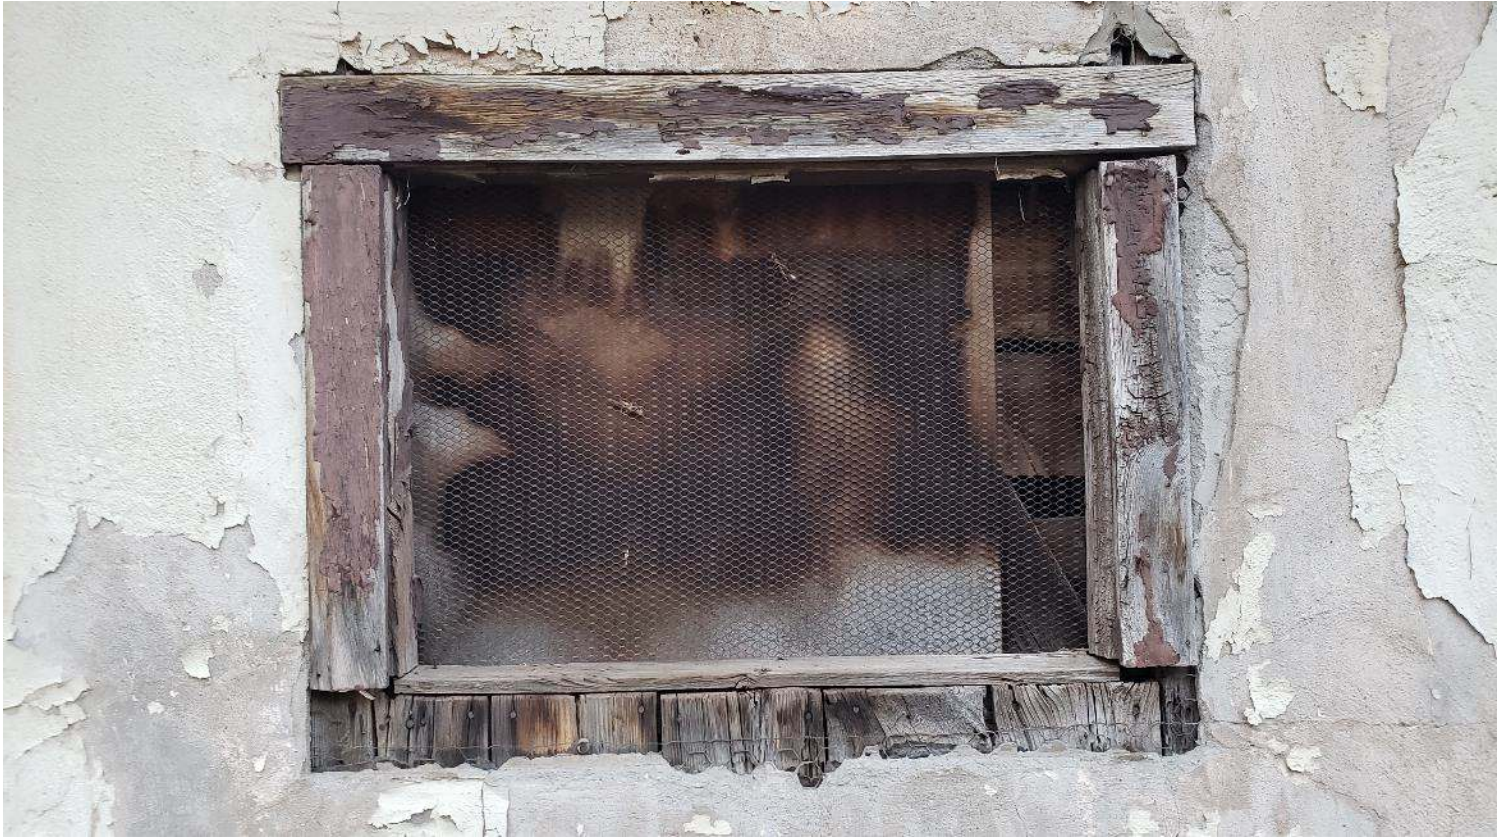
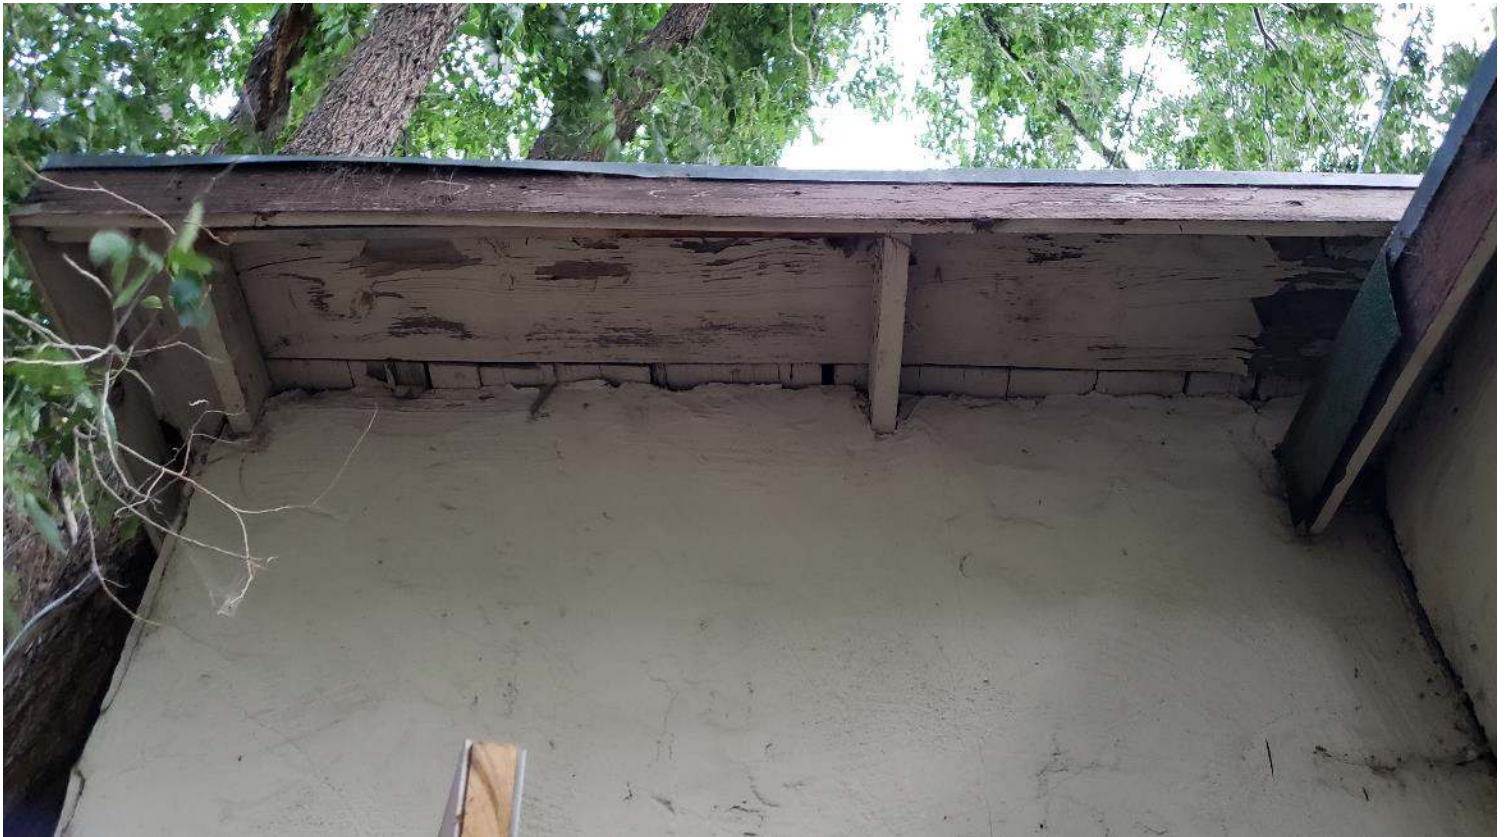
Photos 61–62. 617 W Tombstone workshop screened window in S façade (top) and eave over building's S half N façade entry (at NE corner of S half) facing up/S (bottom).

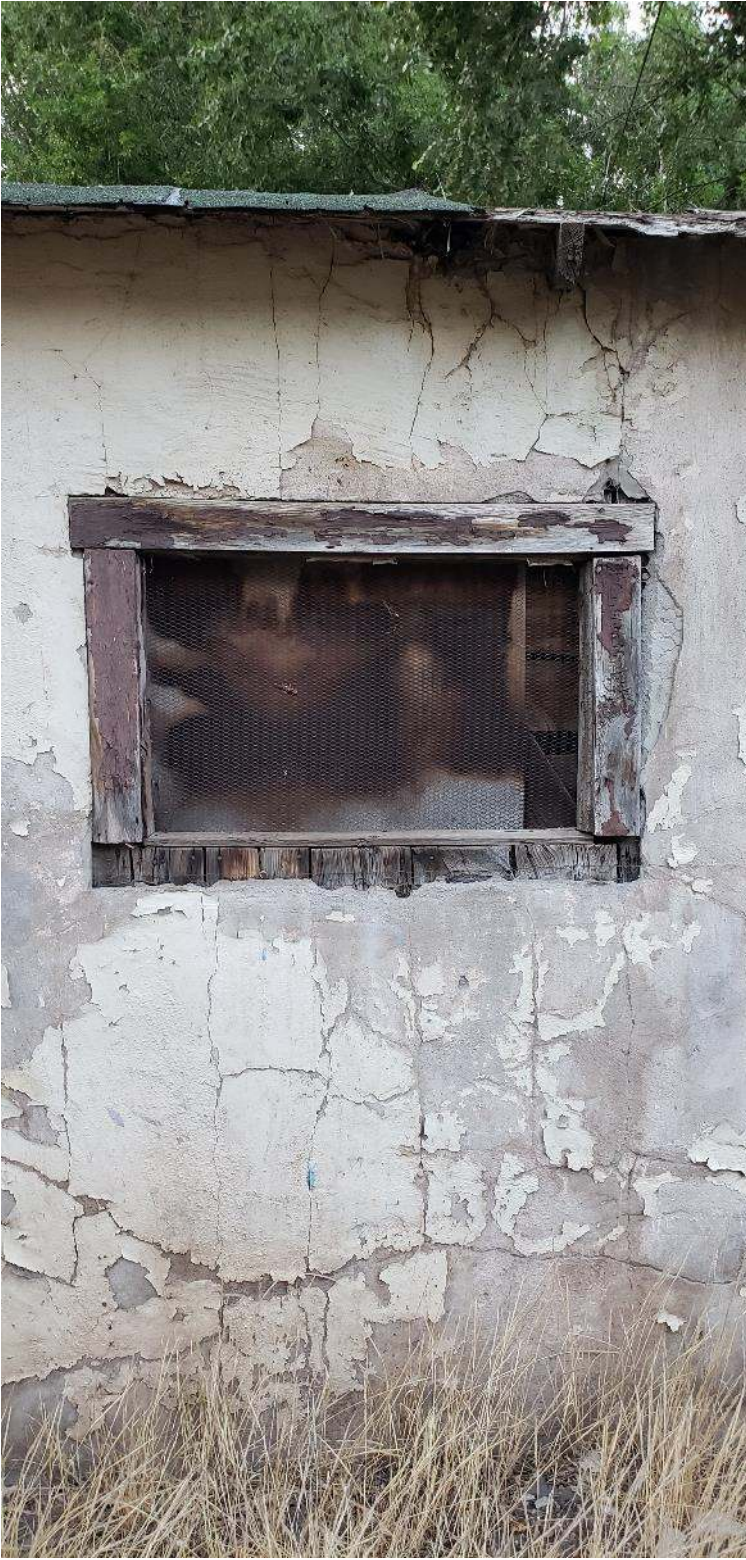
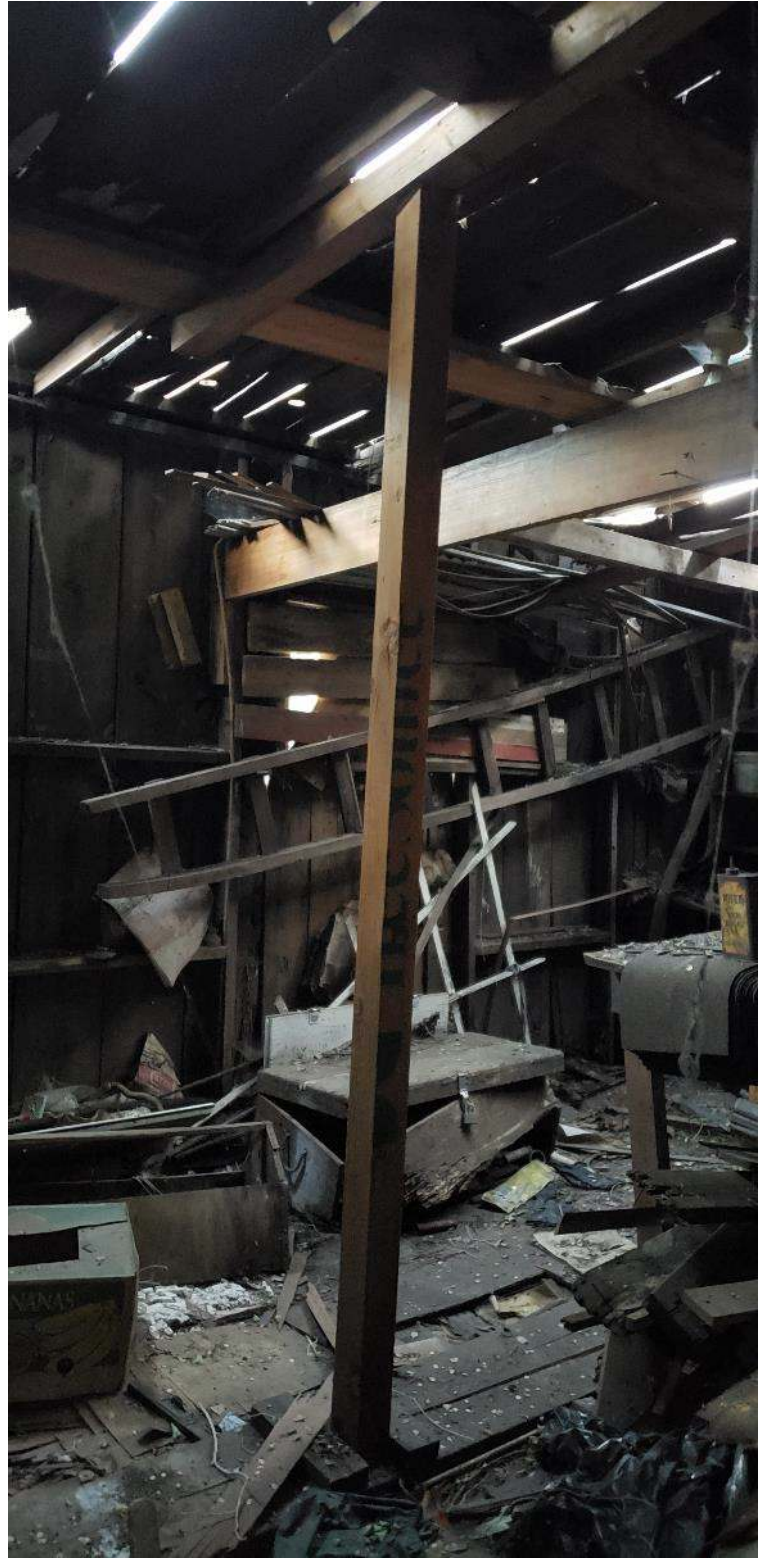
Photos 63–64. 617 W Tombstone workshop screened window and roof edge detail in S façade (left) and building's S half interior from entry at NE corner facing SW (right).

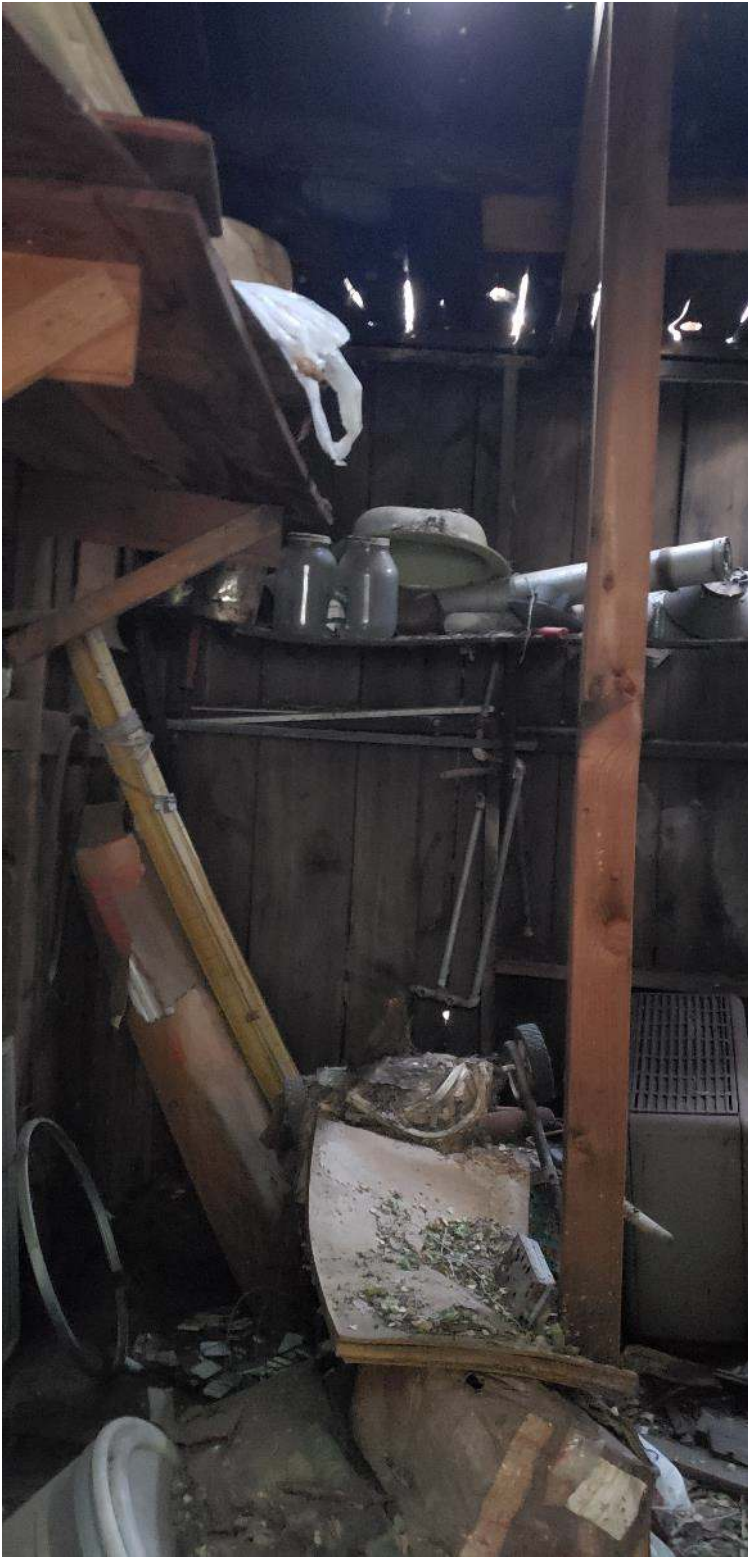
Photos 65–66. 617 W Tombstone workshop S half interior facing S at NE corner entry (left) and WSW from entry (bottom).

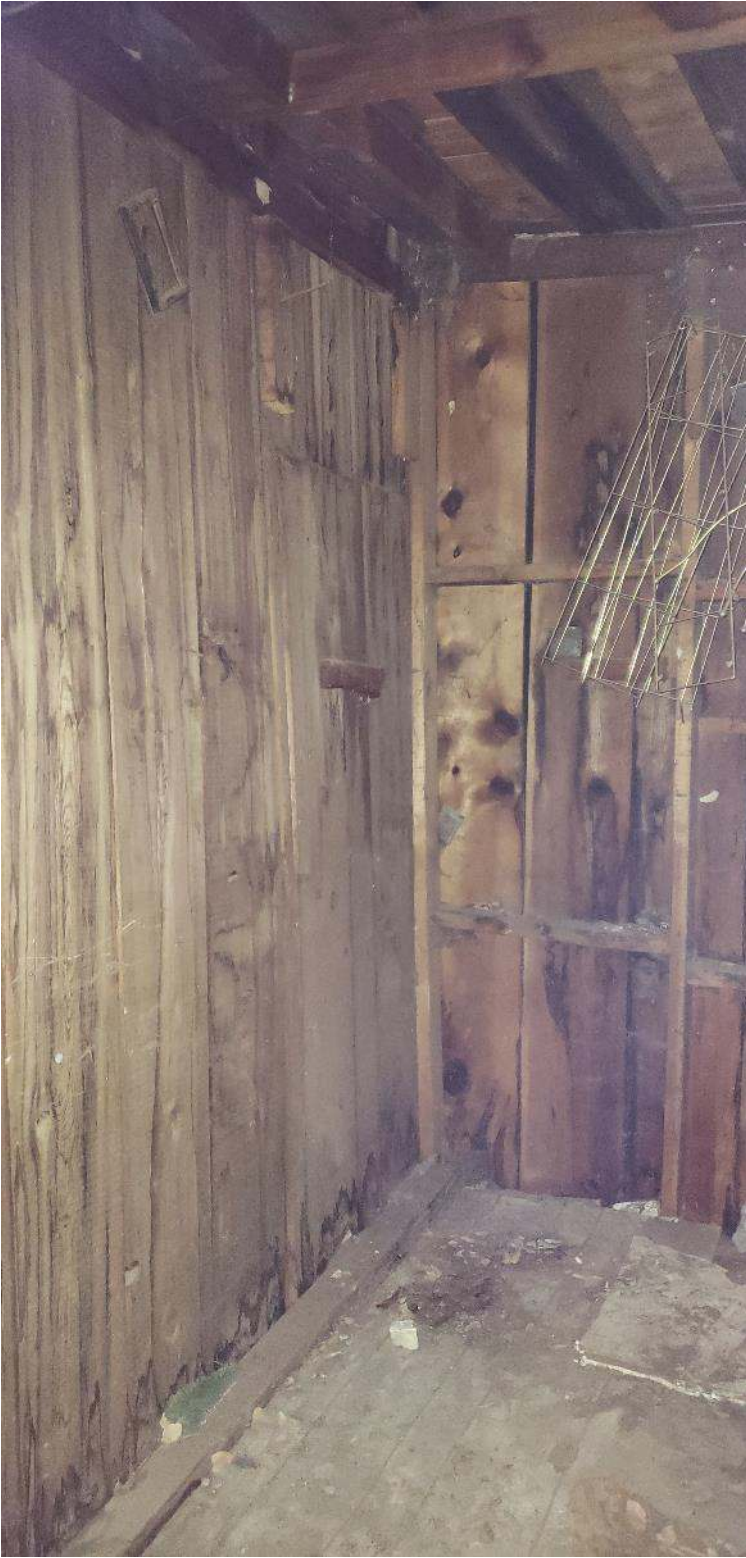
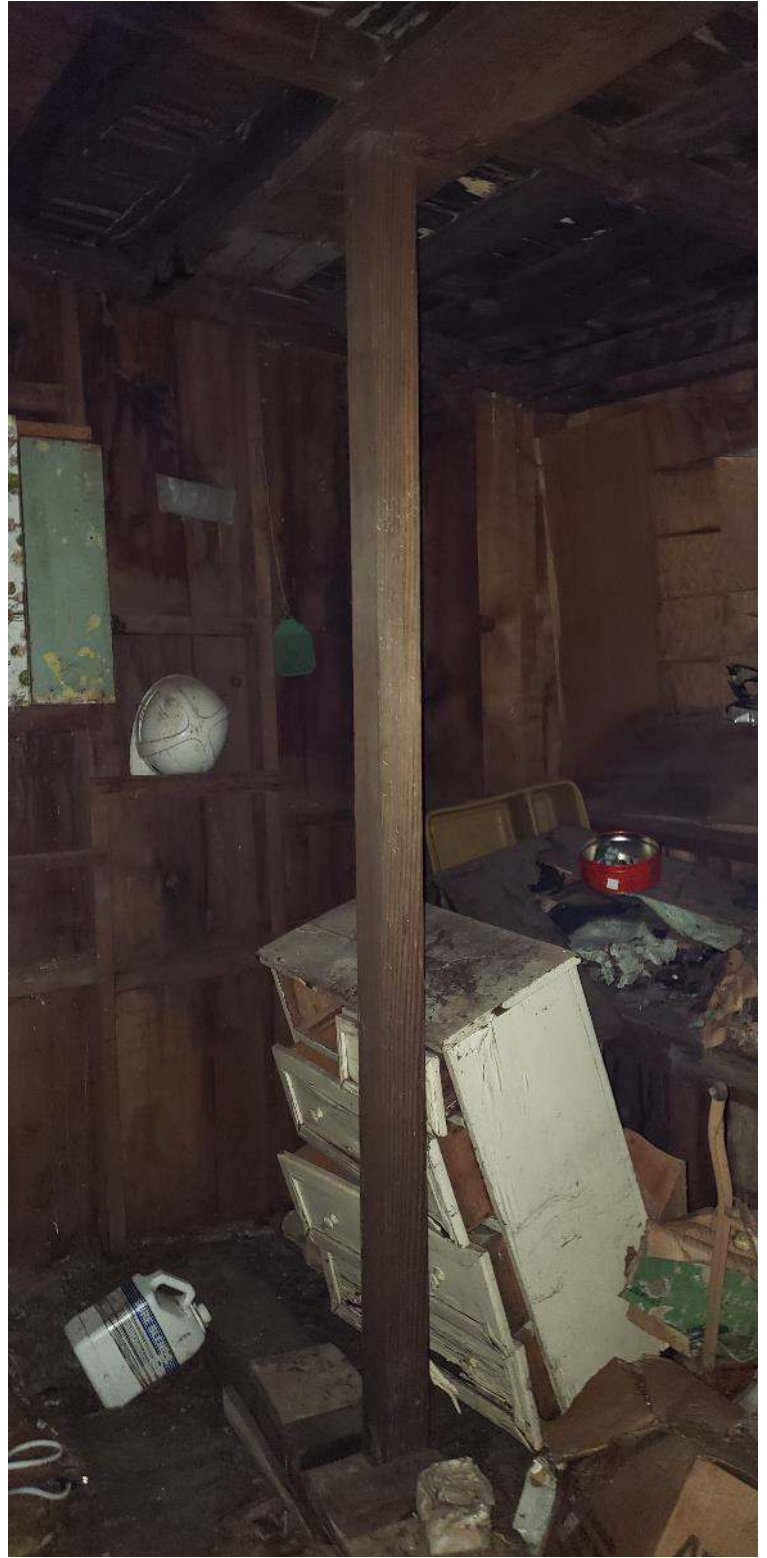
Photos 67–68. 617 W Tombstone workshop N half interior facing WSW from E entry (left) and WNW from entry (bottom).
