**CITY OF FLAGSTAFF HERITAGE PRESERVATION COMMISSION  
STAFF REPORT**

**CERTIFICATE OF APPROPRIATENESS**  
**PZ-24-00183**  
**104 E Route 66**

This is a request for a Certificate of Appropriateness for stone repair, new canopy posts, and repair of the existing canopy at 104 E Route 66 Lumberjack Pizza (APN 101-21-011). The property is in the Downtown Historic Overlay District and the Central Business zoning district. The building was constructed in 1881 and the façade modified in 1916. The date of the installation of the canopy is unknown but is likely more than 50 years old.

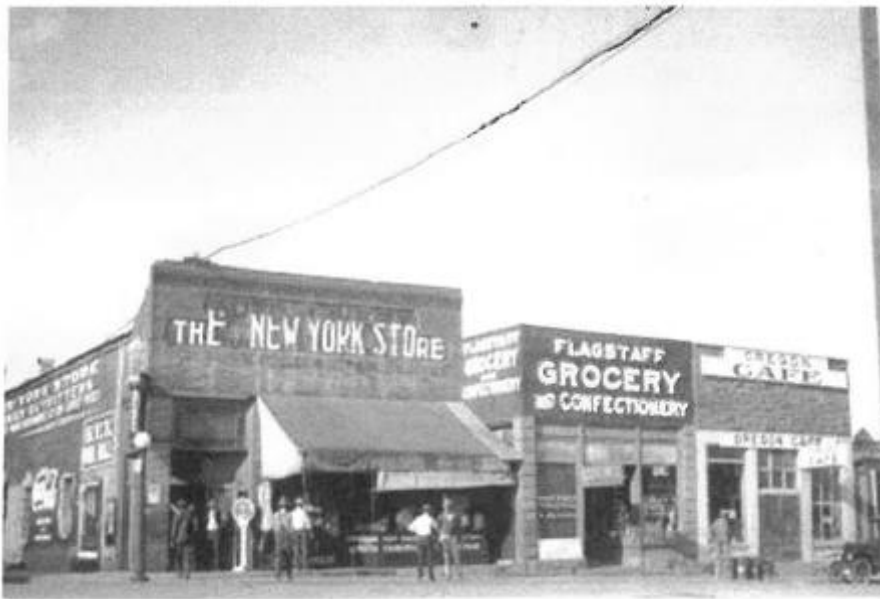
The proposed storefront rehabilitation submission solves damage to a façade's sidewalk roof component and enhances the general appearance of the façade. This historic façade also had an awning or canopy as seen in the photo below.

The proposed repairs add to but do not alter the original size and shape of opening and the wall at the sidewalk edge. There are no proposed changes to the door style. The change in style to the canopy posts will increase visibility for pedestrians and will make the façade material from the 1916 improvements more visible. There is a minor change in the style to achieve these objectives. The steel corbel and small decorative bands and curves will add some detail that is not inconsistent with other shapes and features on the street. The stone on the façade and much of the canopy will be preserved.
