Phase 1 Historic Resource Study for 19 West Birch Avenue in Flagstaff

Prepared for
Capri, Inc.

Cornerstone Environmental Report No. CEC 25-105

April 25, 2025 (Revised May 5, 2025)

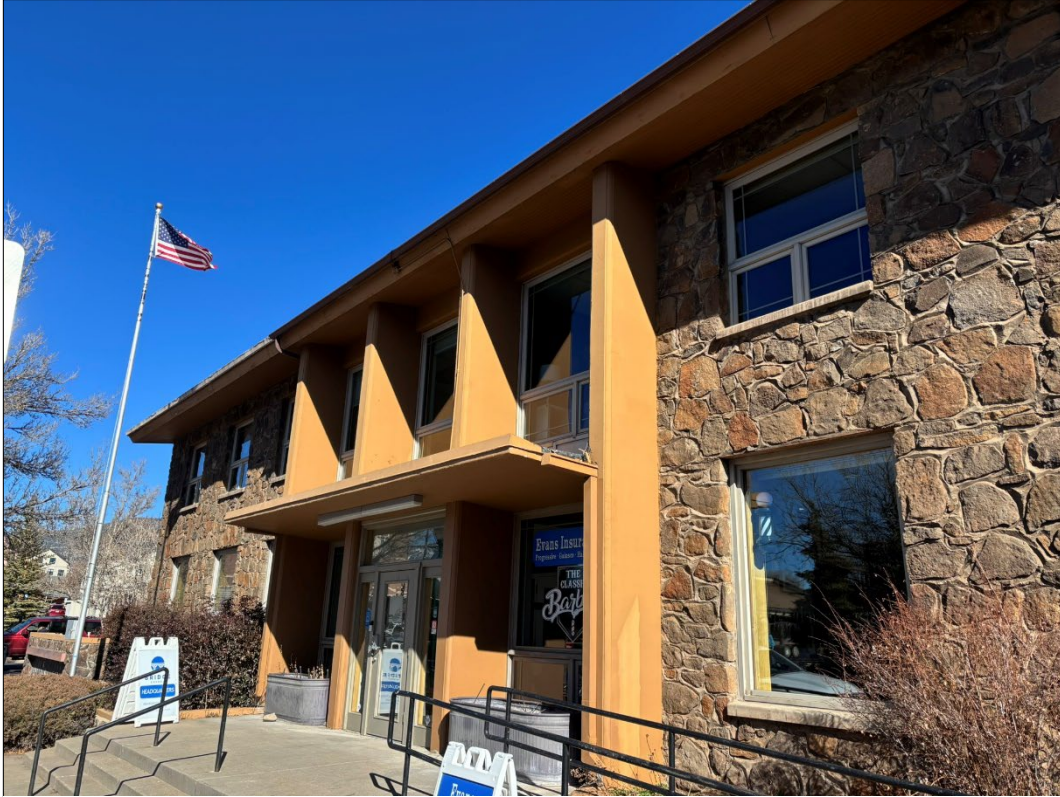
Photograph 1. East facing photograph of the west face of the building, showing the entrance to what was once City Hall.

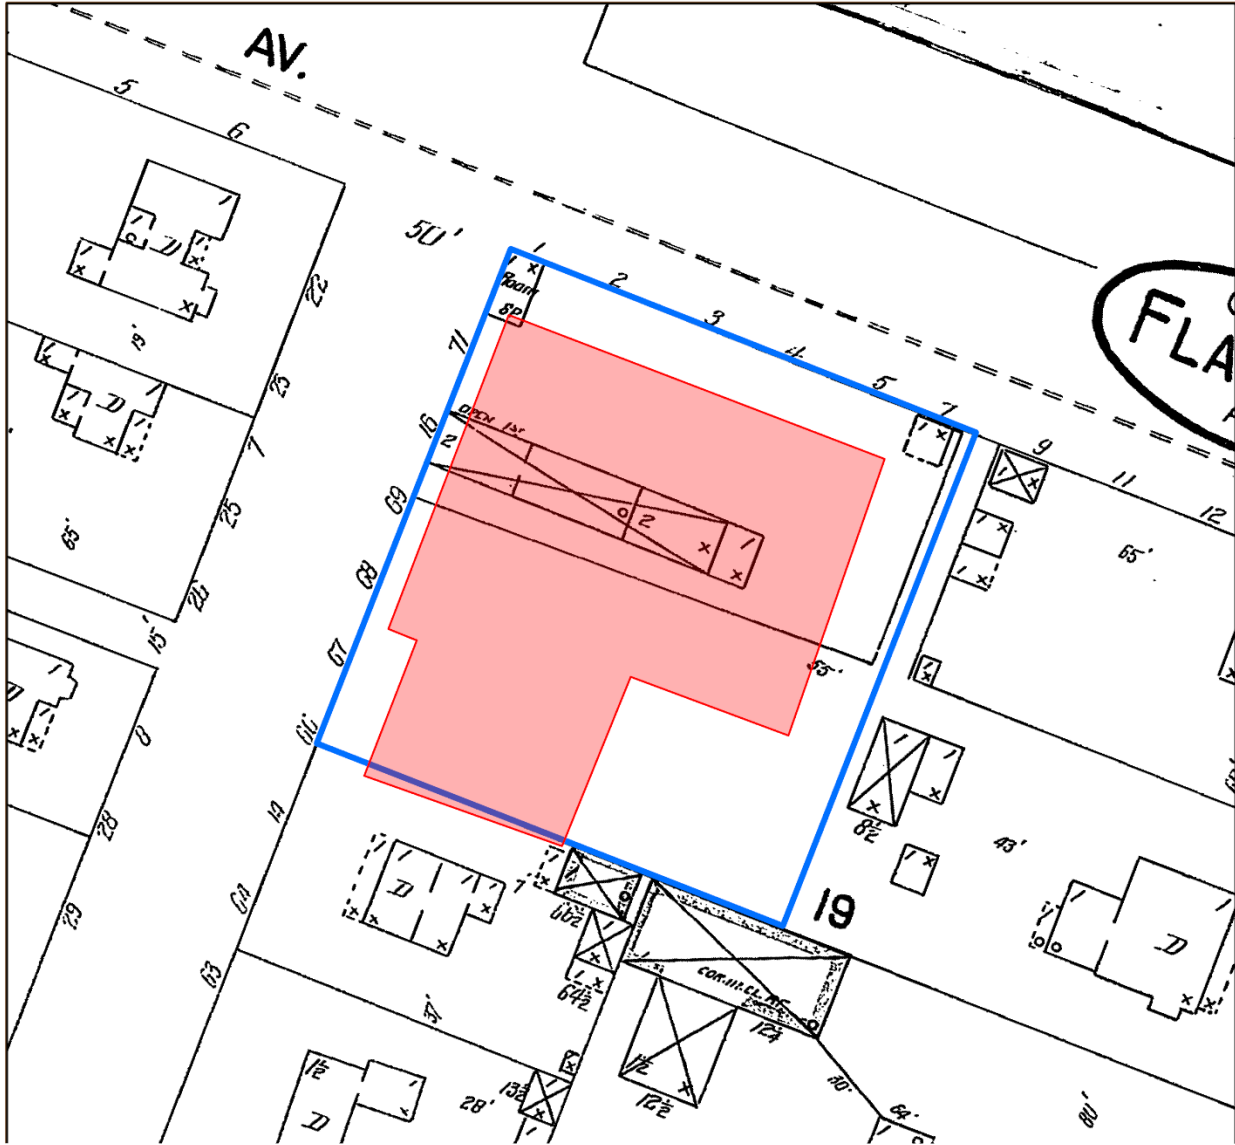
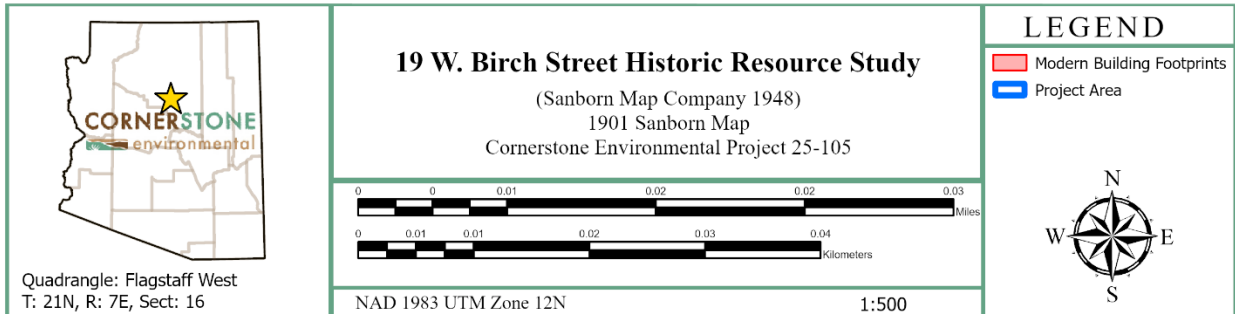
Figure 11. 1901 Sanborn map showing a horse stable, a one room structure, and a small outbuilding on the property.

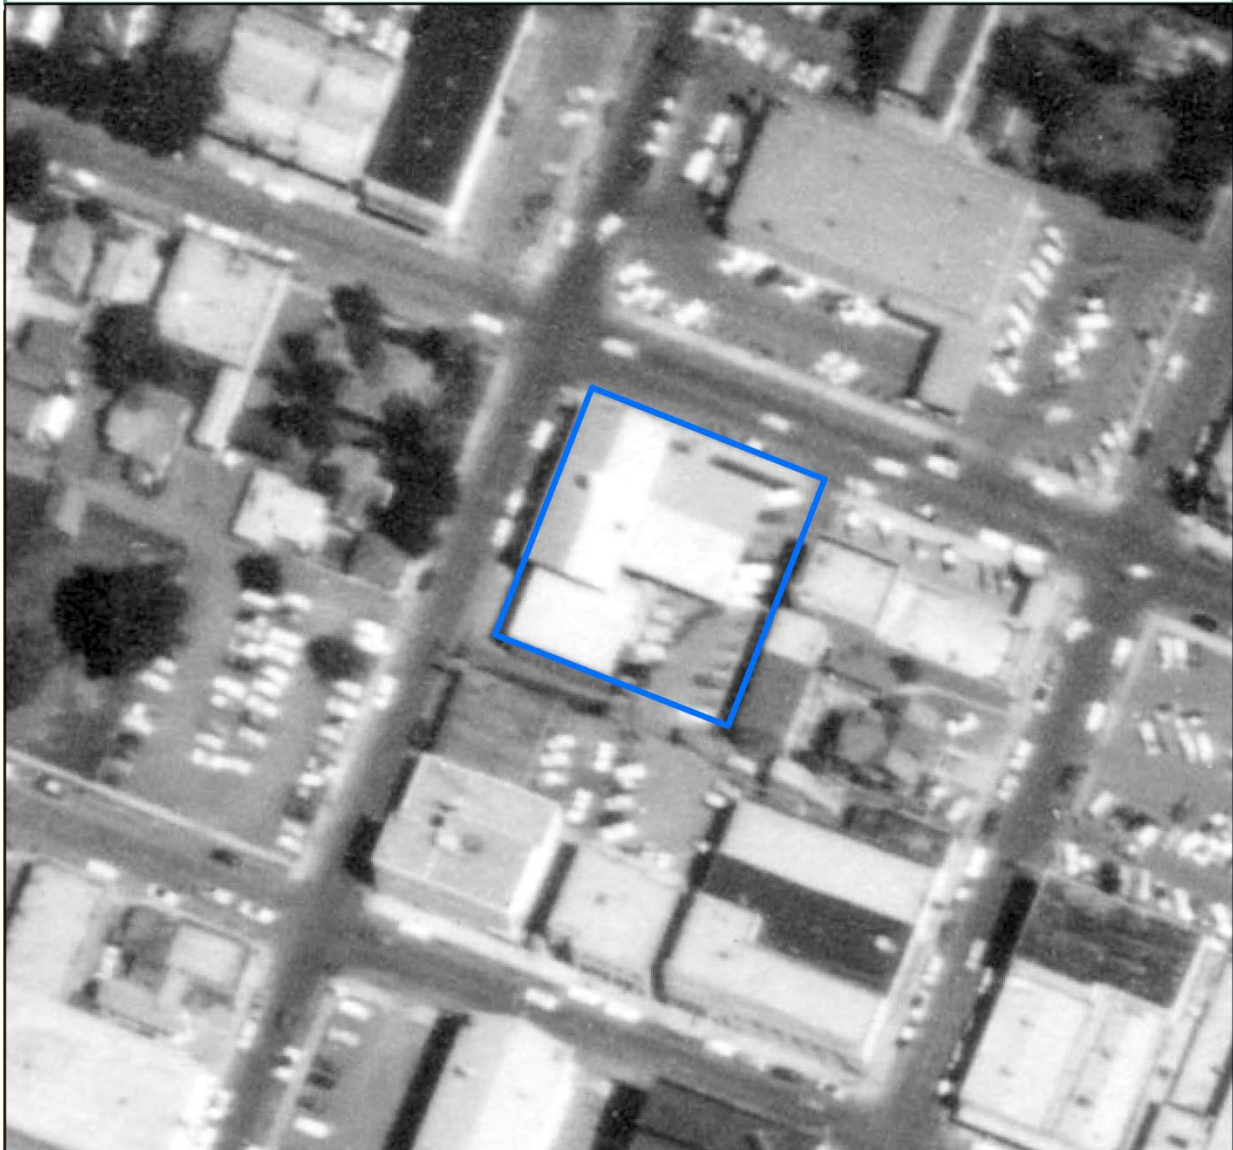
Figure 15. Historic aerial imagery from 1959 showing the project area and studied building.

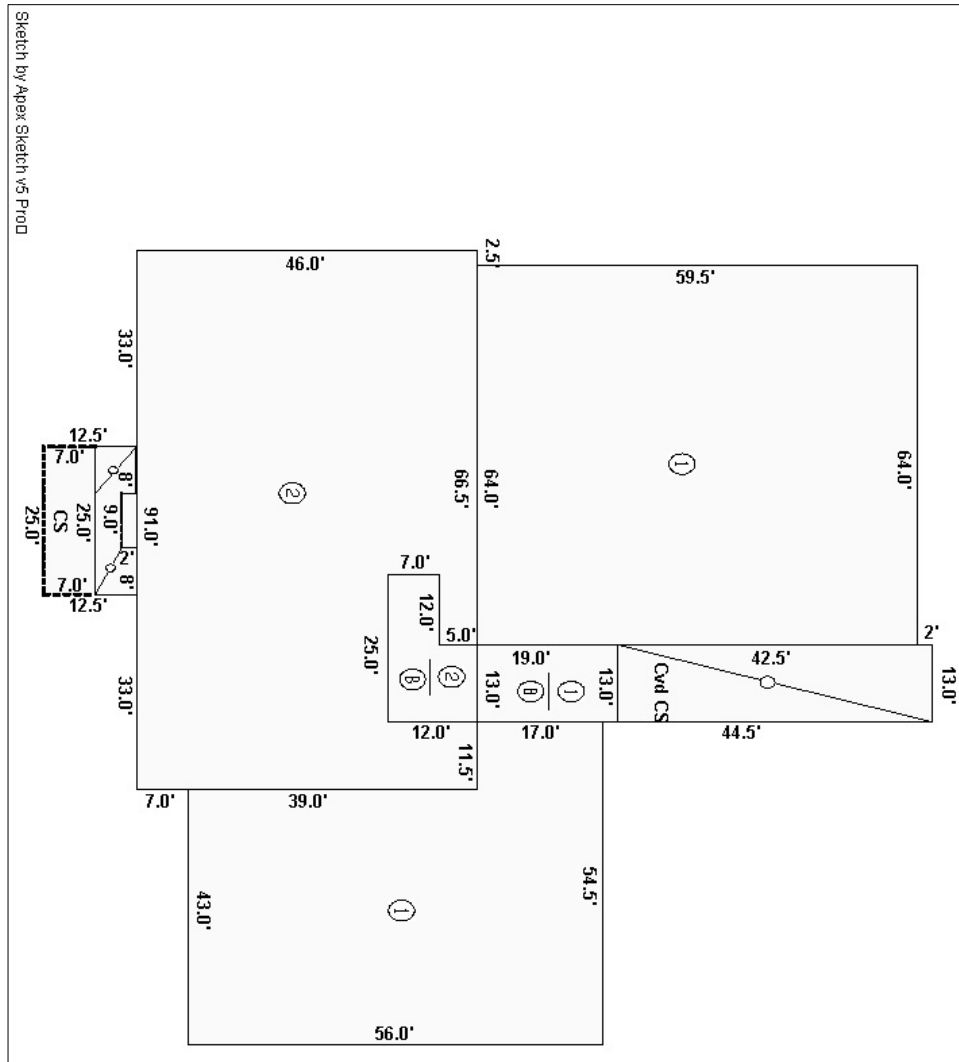
The City Hall building as it exists today consists of one central section and two wings, with a partial second story and partial basement (Figure 16). The construction combines elements of the International Style architectural movement, seen with the use of ribbon windows and volumetric floor design, with elements of a more local, unofficial Flagstaff style, as evidenced by the Malpais basalt used in the structure façades.

Figure 16. Plan view sketch map from the County Assessor's Office of the first floor of the studied building, with north oriented towards the top of the page.

The City Hall was housed in the central portion of the building, the Flagstaff Police Department was housed in the eastern wing, and the Flagstaff Fire Department was housed in the southern wing. Based off the County Assessor's Office floorplan sketch, the City Hall portion of the building measures 46 feet (ft)

by 91 ft, the fire department measures 56 ft by 54.5 ft at its maximum width and the police department portion measures 64 ft by 59.5 ft. A complete second story is present in the central portion of the building and approximately matches the dimensions of the first floor. The dimensions of the basement are approximately 29 ft by 25 ft and it is roughly L-shaped.

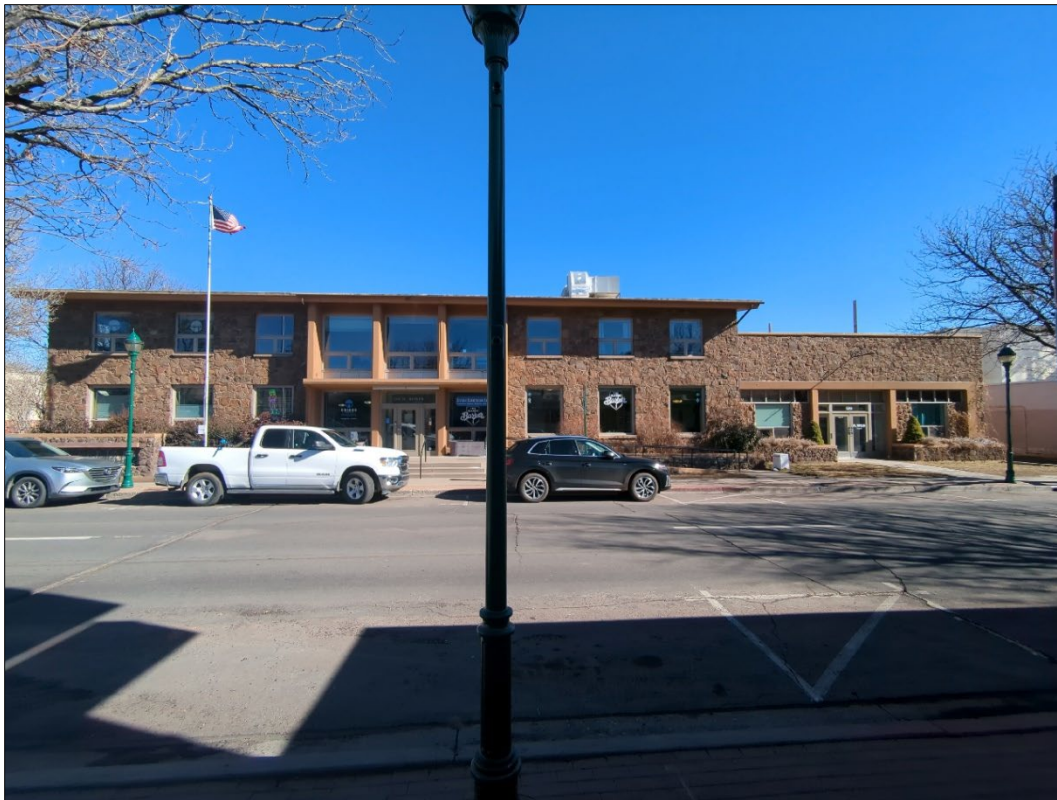
The exterior of the central section of the building, which was formerly City Hall, consists of a Malpais basalt façade (Photograph 2). Twelve three-part float glass windows are present on the west-facing northern and southern sides of the elevation, with six windows on the first floor and six windows on the second floor. Three larger three-part float glass windows are present on the west facing portion of the second floor. A glass doored entryway, with a cantilevered canopy and two adjacent three-part float glass windows form the main entrance into the building on the west face. A set of three concrete steps and a ramp with metal pipe railings lead up to the entryway. The north facing elevation of the central section consists of dual Malpais basalt and corrugated sheet metal façade with 10 float glass windows, five on the first floor and a matching five on the second floor (Photograph 3). The southern facing elevation is adjoined to the fire department wing and is Malpais basalt. Malpais basalt planters are present at the base

Photograph 2. West elevation of the studied building at 19 W Birch Ave, the City Hall and fire department portions of the building are visible.

of the north, west, and south facing façade. A modern Malpais basalt signage structure is present on the property off the northwest corner of the building. The roof of the central portion is slightly slanted, forming an open gable roof.

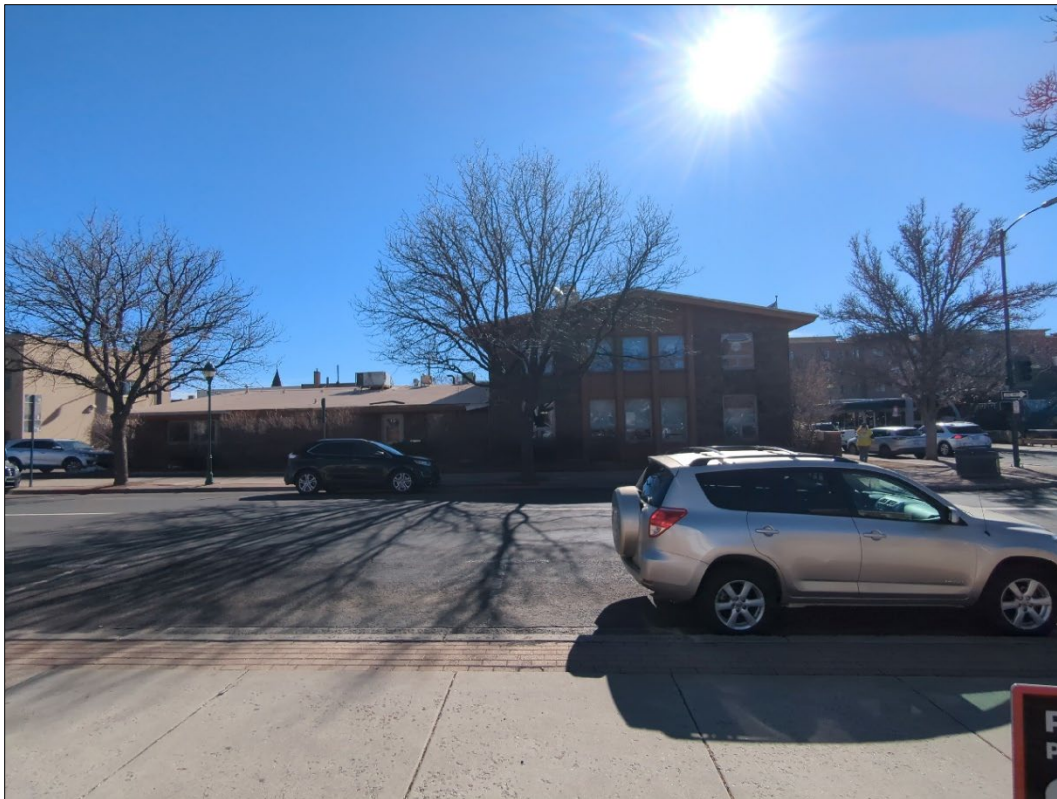
Photograph 3. North elevation of 19 W. Birch Ave, showing the north entryway into the building.

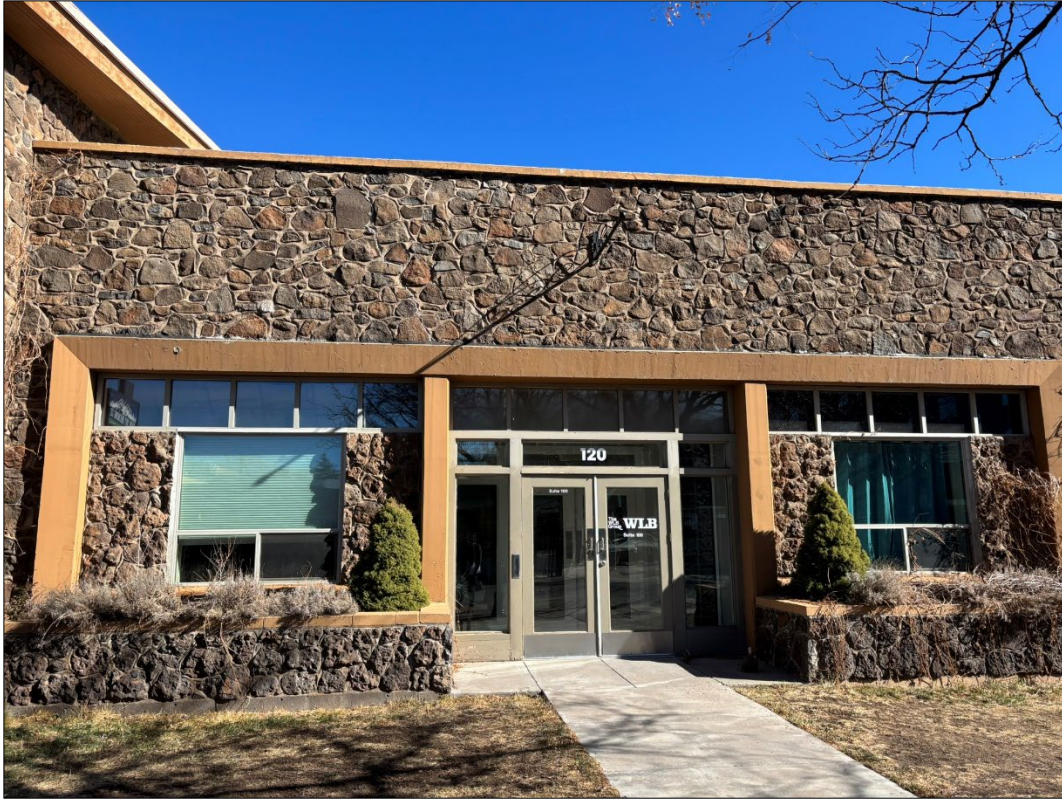
The exterior of the southern section of the building, which formerly housed the fire department, consists of Malpais basalt façade which is present on all exterior sides of the section. The section has a slightly slanted shed style roof, which slopes down to the east. The western façade exhibits three float glass ribbon windows running horizontally north-south across the façade, just above a glass door entryway. Two three-part float glass windows are present on either side of the entry way, and the entire assemblage of ribbon windows, entrance, and float glass windows are framed by horizontal and vertical metal beams, which have been painted light brown. The framing elements are likely original to when it was a three-bay garage for the fire department, are modern and a result of it being converted to an office space. Two Malpais basalt planters, on each side of the entry way, are present (Photograph 4). The south facing façade contains a metal security door leading into the building, and three two-party wired safety glass windows spaced evenly along the façade (Photograph 5). The east facing façade has three two-part wired safety glass windows, and an inset doorway leading into the building.

Photograph 4. East facing photograph showing the entryway to southern portion of the building which once housed the fire department.

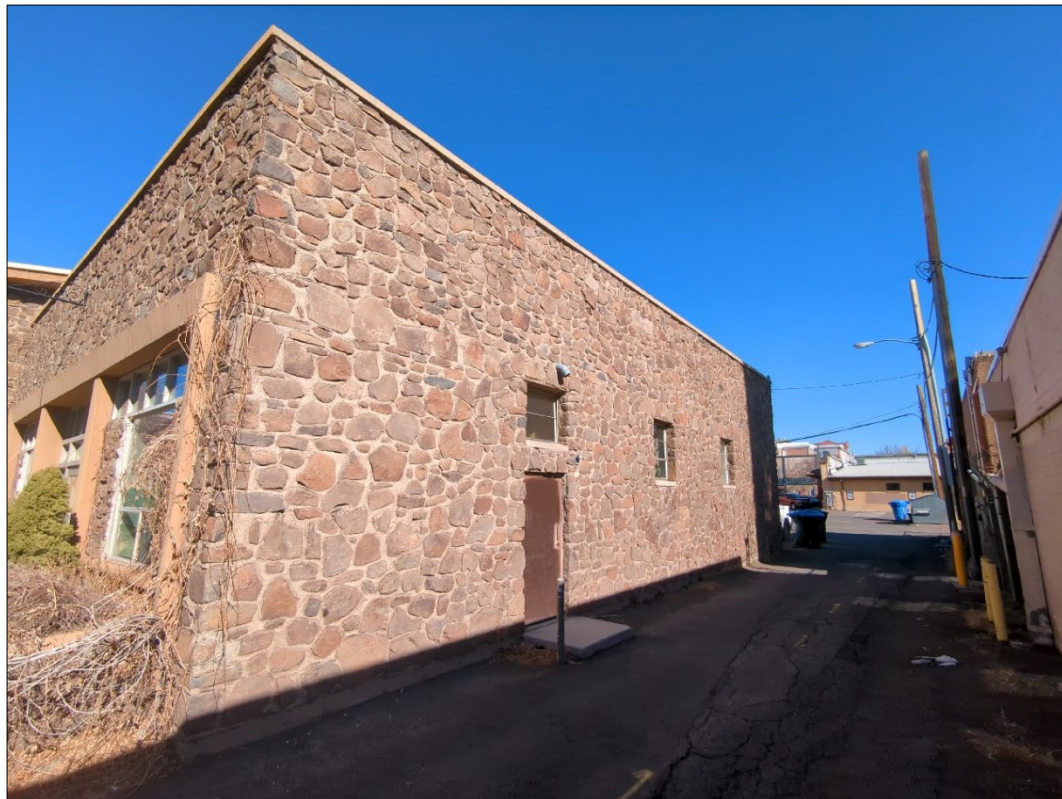
Photograph 5. South facing exterior of the former fire department, which exits into an alleyway.

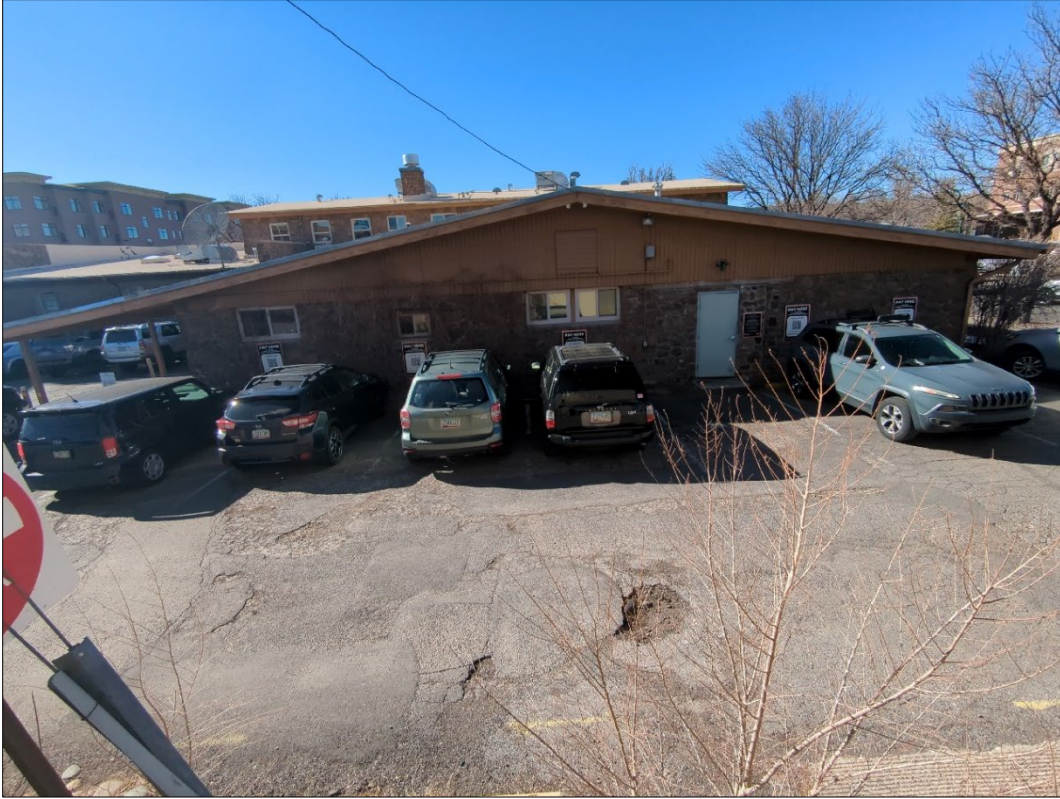
The exterior of the eastern portion of the building, which formerly housed the police department and jail, consists of a Malpais basalt façade with the east facing side featuring a façade of tan painted corrugated sheet metal underneath the eave of the roof. This section has a slightly gabled roof, sloping down to the north and south. The northern elevation exhibits a glass door entryway into the building, with a two-part float glass window to the right of the entrance. An east-west ribbon window is present along the easternmost side of the northern elevation. The east facing elevation consists of a metal door entryway, a pair of adjoining two-part float glass windows, and two separate two-part float glass windows (Photograph 6). Modern parking signage is affixed to the Malpais basalt façade, and some electrical wiring fixtures are present along both the façade and corrugated sheet metal. The south-facing portion of this section has an extension of the gabled roof which forms an overhang which is supported by four metal beams with concrete footers (Photograph 7). A wooden entry door is present near the western extent of the elevation, with a series of concrete steps and metal railings leading to the entry way. To the west of the entryway is a wired safety glass window, and to the east is a set of three evenly spaced float glass windows.

Photograph 6. East elevation of 19 W Birch Ave, showing the east facade of the former police station.

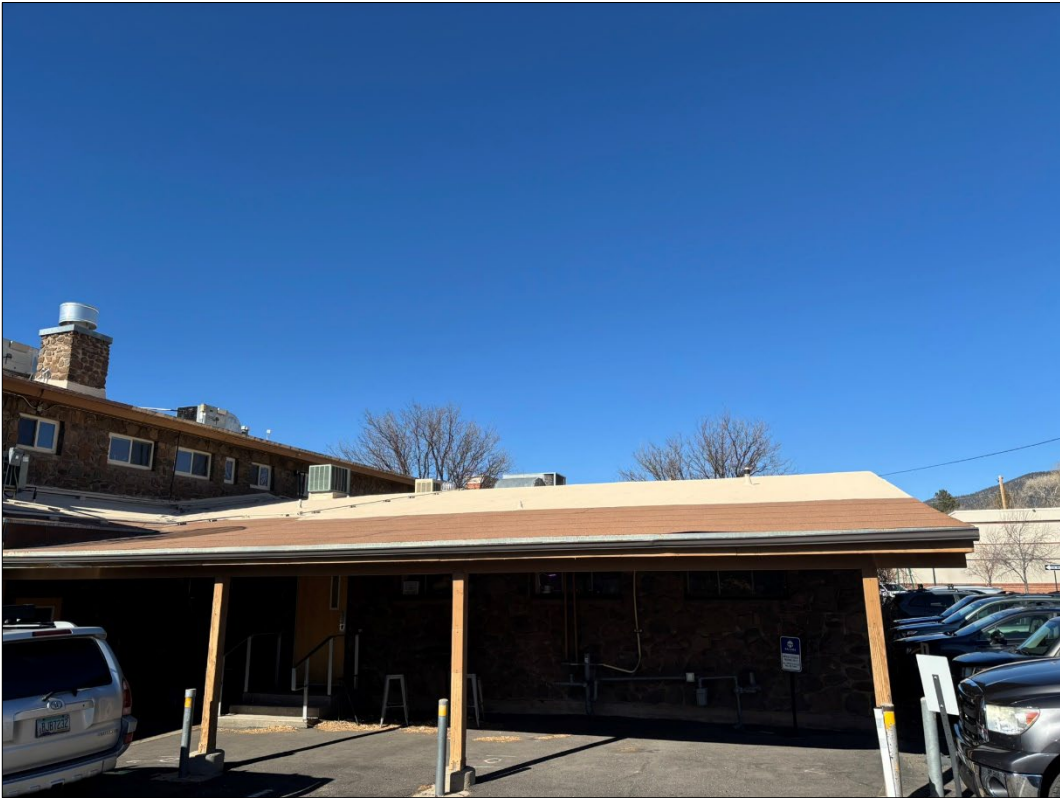
Photograph 7. South facing façade of the former fire department, showing the extension of the roof which forms a canopy.

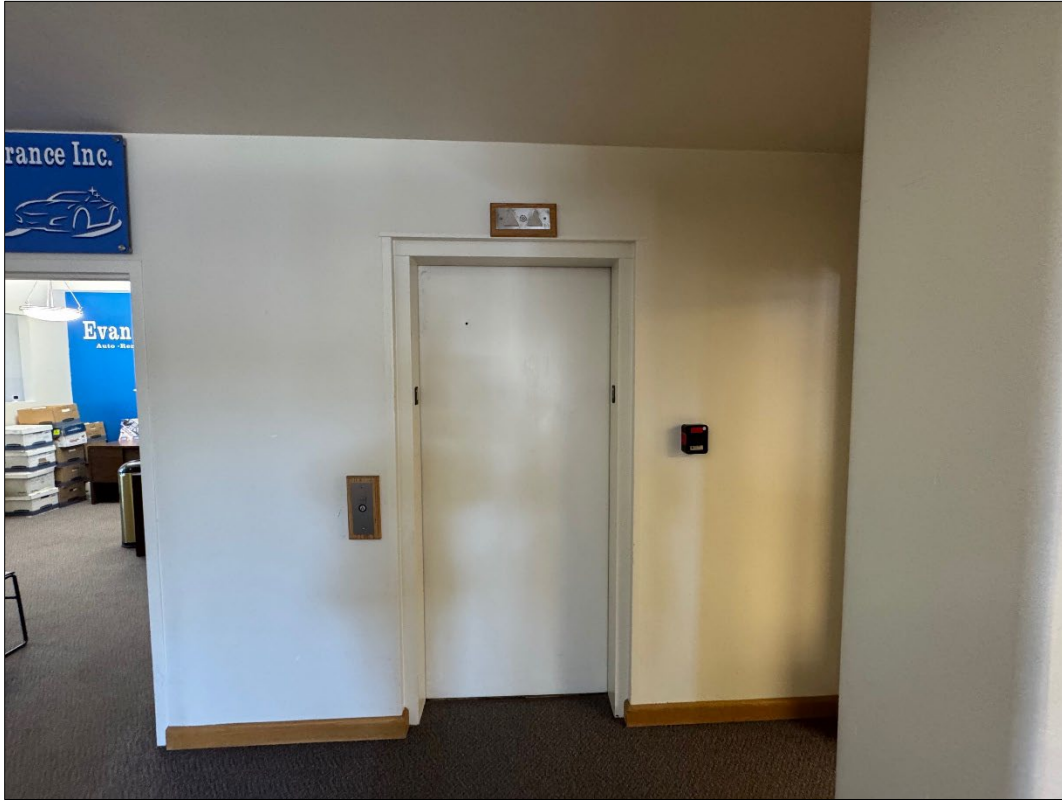
Photograph 8. Elevator in the central area of the building connecting to the second floor.

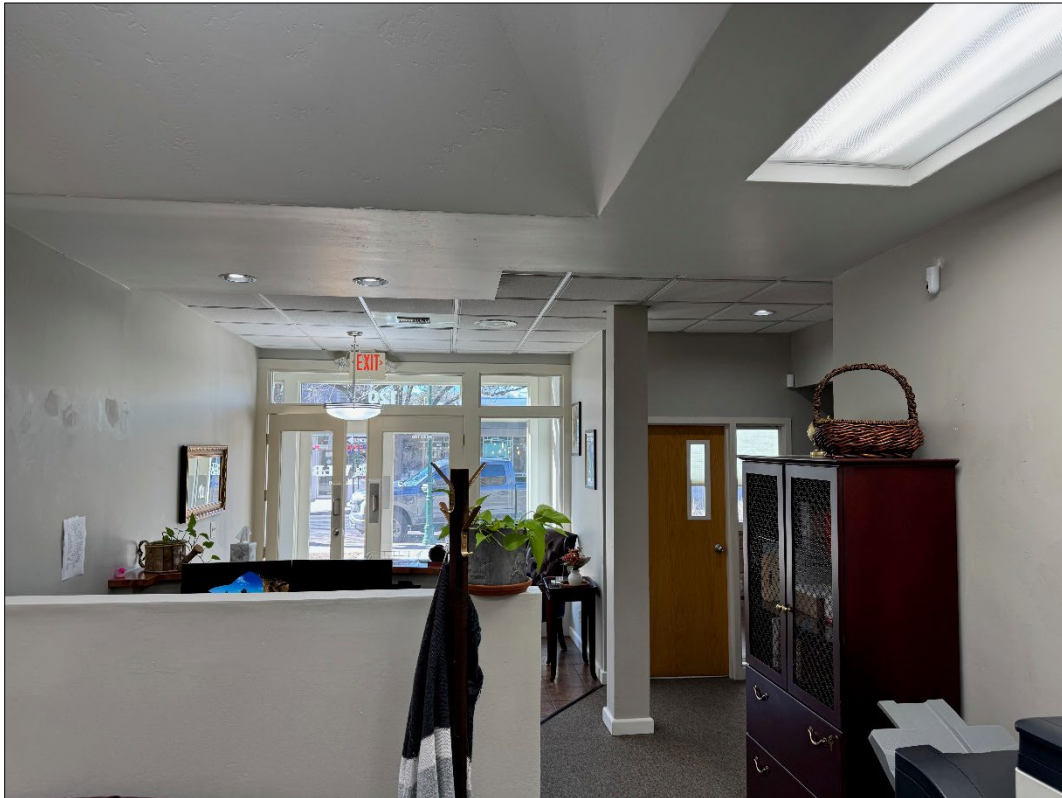
The southern wing which previously housed the fire department has undergone significant remodeling and is currently the office of an engineering firm. The garage bay doors and garage area have been removed or otherwise remodeled to an extent where no evidence of the existence of the garage area remains in either the exterior or interior of the building, apart from the framing of the garage bays (Photograph 9). All interior areas of this wing have been remodeled and modernized with modern office fixtures and furniture, and the wing no longer retains any elements which point to the wing's previous life as Flagstaff's Fire Department.

Photograph 9. The entryway and lobby of the engineering firm which occupies what would have once been the fire department garage, facing west through what was formerly a garage bay door.

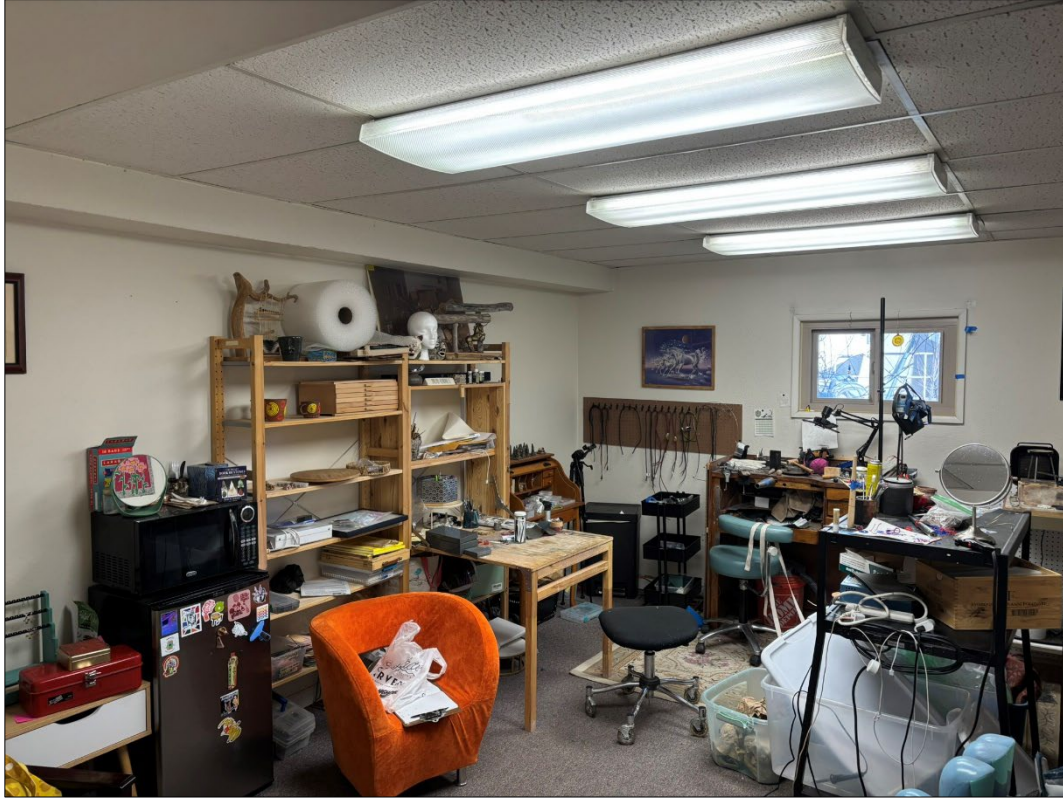
Photograph 10. A room in the former police department, which is now used as a metalsmith workshop, facing east.

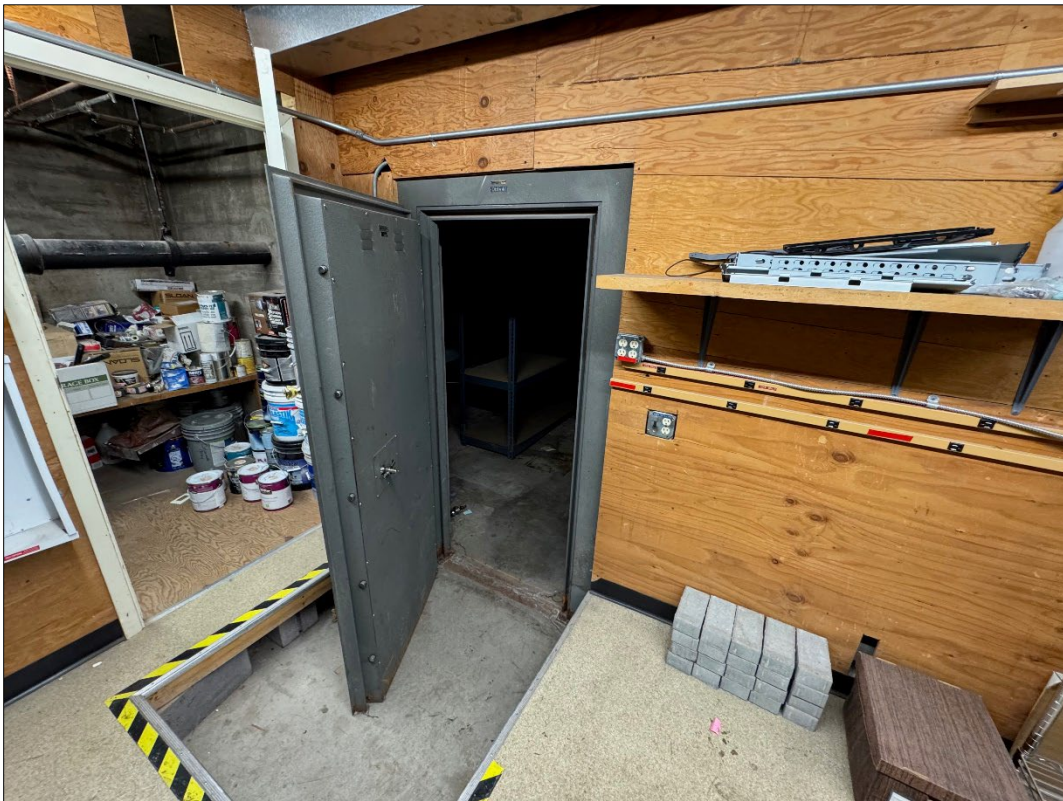
Photograph 11. The basement vault room which was once used to hold city records and receipts.

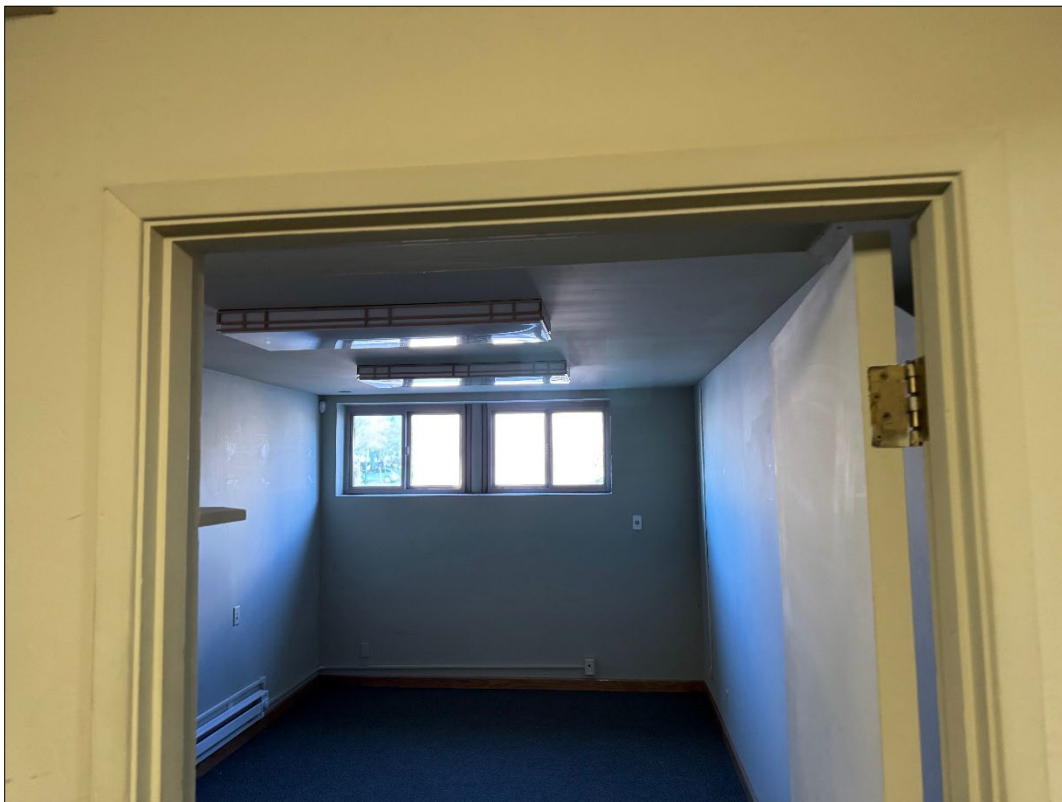
The windows, doors, and ceiling light fixtures in all areas of the building appear to have been updated during the remodeling efforts, and a birch wood trim is present throughout the structure, possibly a decorative feature inspired by the street the building is located on (Photograph 12). A variety of window types are present in the building. Exterior windows, particularly on the facing west side of the building, are in ribbons, a common feature of International Style architecture. The exterior windows appear to have been replaced at some point and have modern fixtures and frames. Interior windows, such as those present in the office spaces of the building, are a mix of common float glass windows, and wired safety glass windows. While the wired safety glass windows would make sense in the context of a fire department and police facility, the windows are a common fire resistance safety installation and are present in areas that would have been heavily remodeled and are likely later additions to the structure. No exterior signage for the civic departments remains on the property.

Photograph 12. One of the former jail cells in the former police department. The decorative overhead light fixtures are a modern addition and have a birch wood trim.

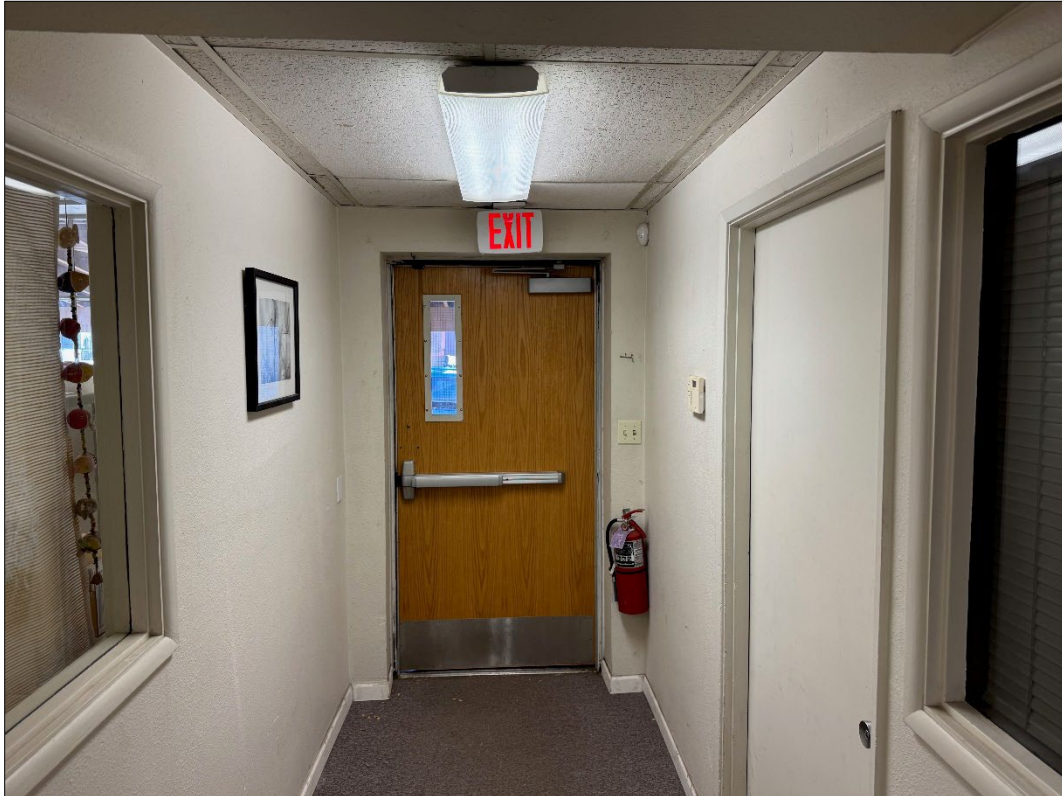
Doors appear to be modern steel frame doors (Photograph 13). The southwestern section of the building, where the fire department was once housed, has had modern glass doors installed in two sets along the west side of the building, forming a small vestibule before entering the building proper. Ceiling light fixtures commonly feature a white plastic case with a wooden “lace” matching the birch trim found throughout the building and are present in rooms, such as the jail cell, where they are out of place given the original purpose of the room. Wooden railings have been constructed around the stairwells and appear mismatched to the stairway itself. The railings were likely installed to be compliant with updated safety codes.

Photograph 13. South facing photograph showing the south entrance to the former police department.
