**PHASE 1 CULTURAL RESOURCE STUDY FOR PARCEL 100-37-016B AT 205
SOUTH PARK STREET / 405 WEST TUCSON AVENUE, FLAGSTAFF,
COCONINO COUNTY, ARIZONA**

City of Flagstaff Community Development Division Project No. PZ-25-00111
LA Neal Consulting Project and Report No. 1106-25

September 8, 2025 (revised)

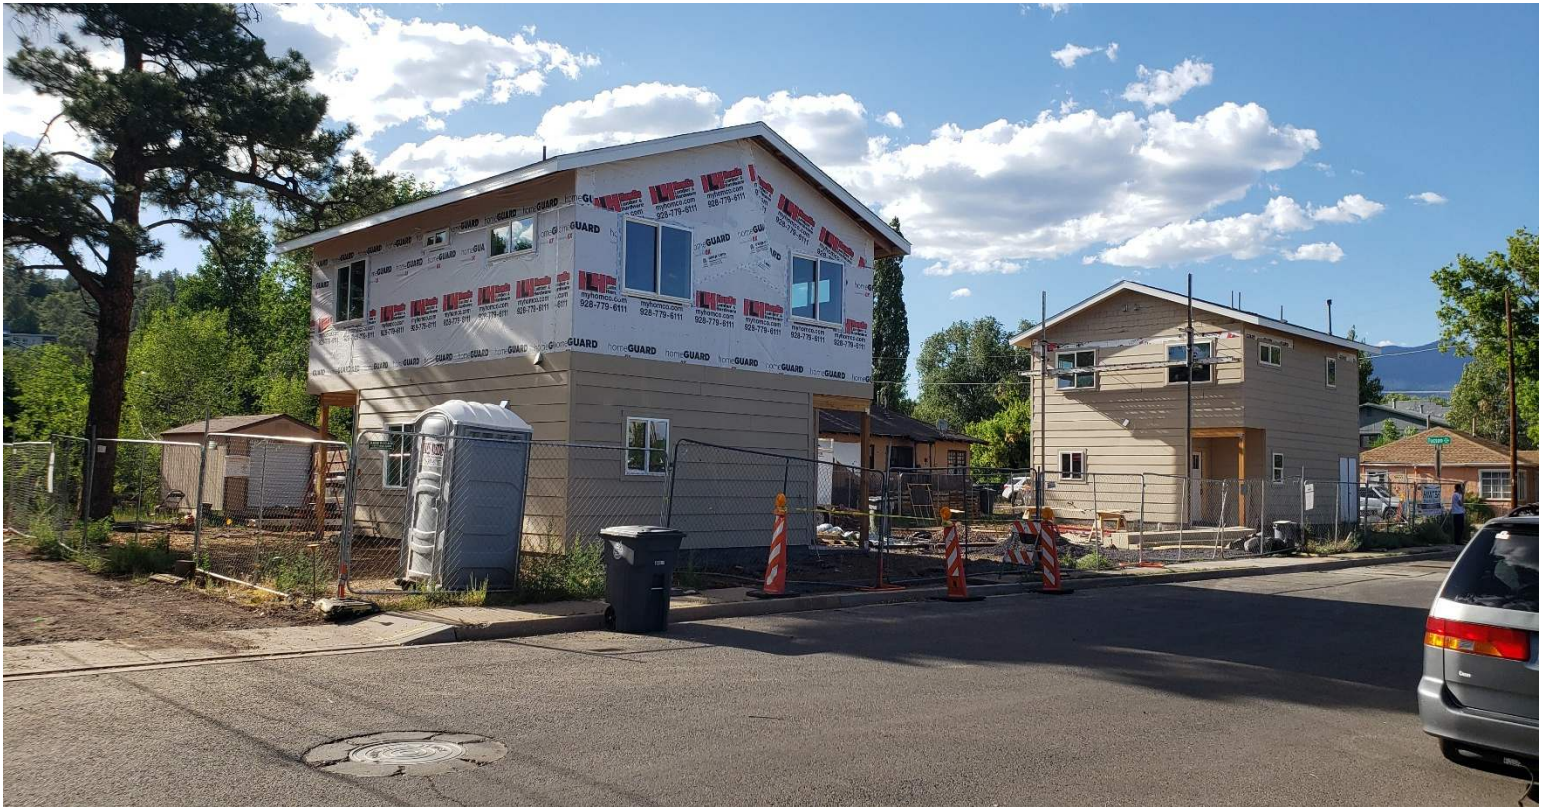
Interiorly, the walls consist of modern (post-1950) gypsum board (drywall), the floor is OSB sheathing, and the wiring (plastic-sheathed Romex) and plumbing (ABS fittings, ductile iron pipe, and plastic tubing for water delivery) are all modern (see Photo 5). Fiberglass insulation was also present in the walls, possibly added when the drywall replaced earlier wood composite or plaster.

Photos 5–6. 205 S Park St interior wall showing modern dimensional lumber and sheetrock where ca. 2015 plumbing repair was made (*top*) and 205 S Park St location to NW showing new house construction with 407 W Tucson in background between two new structures and 407 W Tucson outbuilding in left background (*bottom*, also 123 S Park St house in far-right background).
