**PHASE 1 CULTURAL RESOURCE STUDY FOR PARCEL 100-37-016B AT 205
SOUTH PARK STREET / 405 WEST TUCSON AVENUE, FLAGSTAFF,
COCONINO COUNTY, ARIZONA**

September 22, 2025 (Final)

City of Flagstaff Community Development Division Project No. PZ-25-00111
LA Neal Consulting Project and Report No. 1106-25

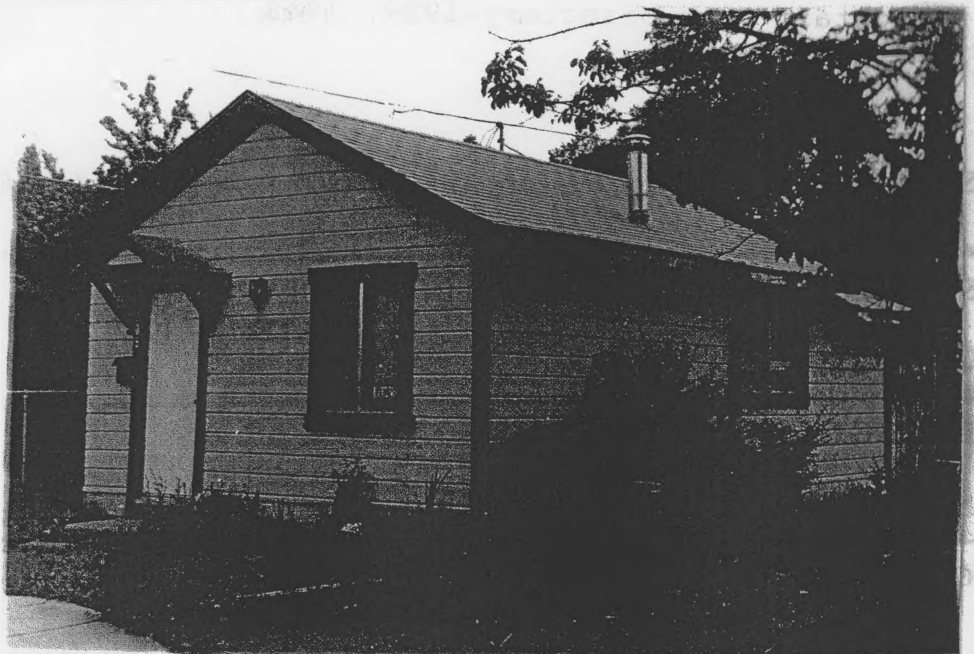
SKETCH MAP

ADDITIONAL DESCRIPTION / ANALYSIS:

Retains sufficient integrity to convey its historic identity.

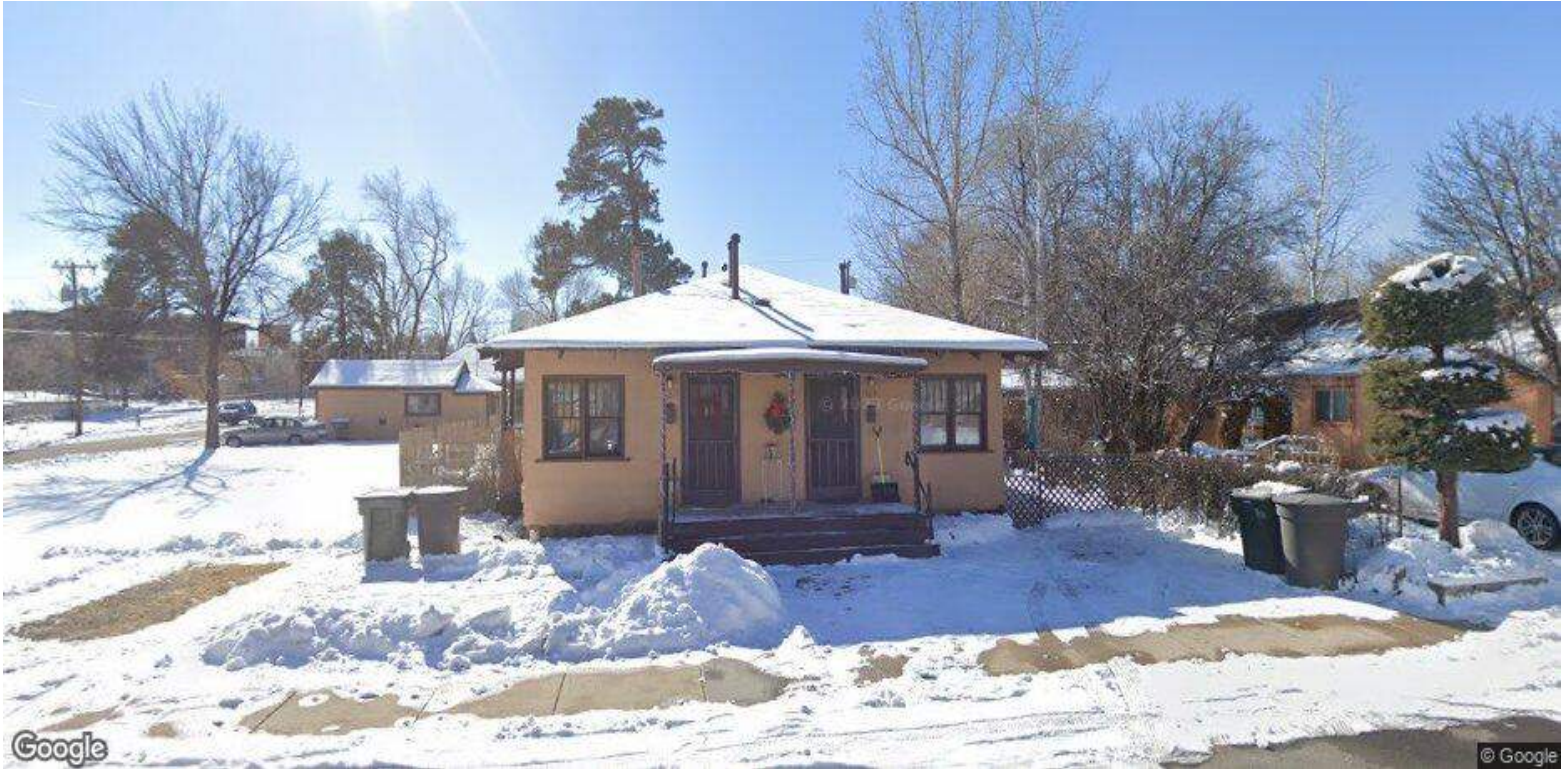
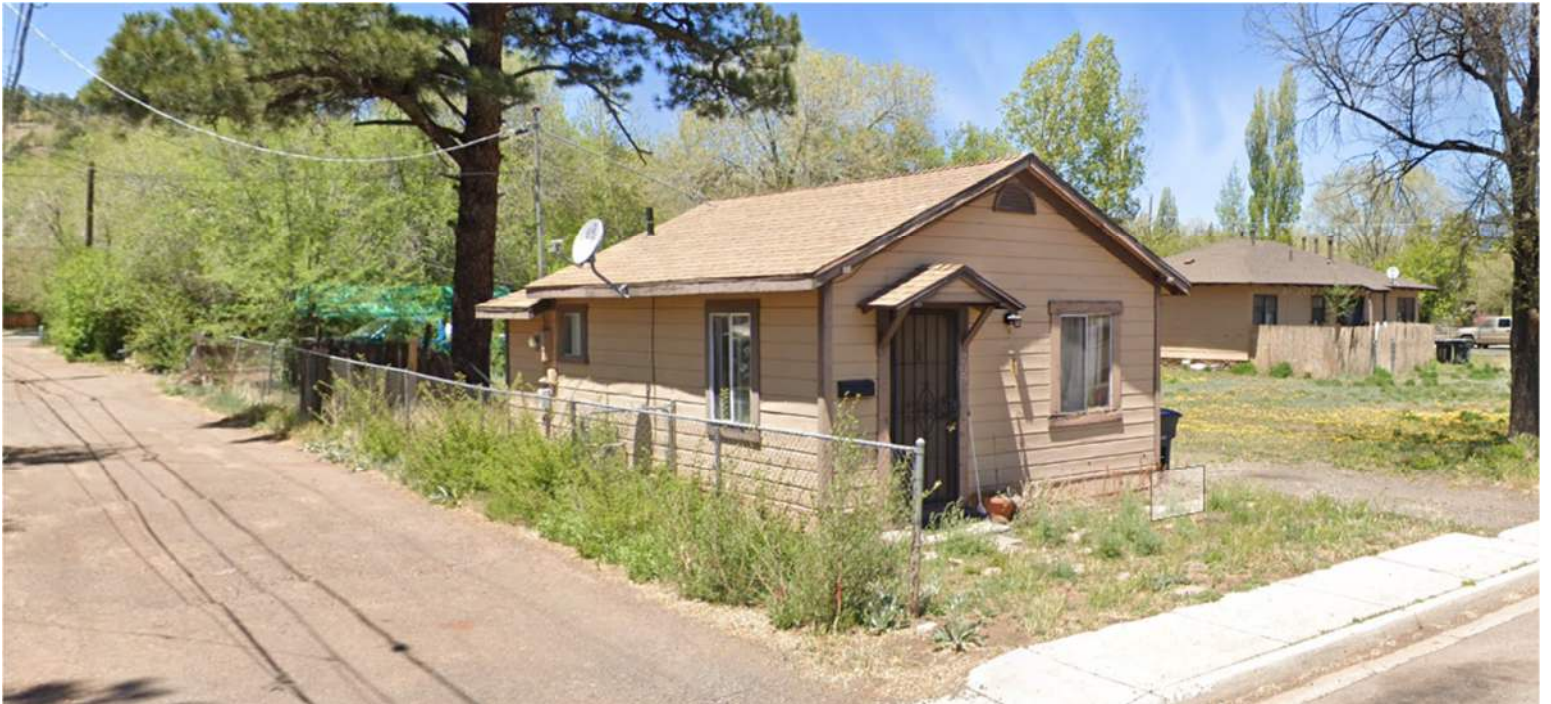
Photos 1–2. 205 S Park St house in left background and facing 405/407 W Tucson Ave from N side of Tucson to SSW (*top*) and front/E and S façades to NW from Park St with 407 W Tucson in right background (*bottom*).

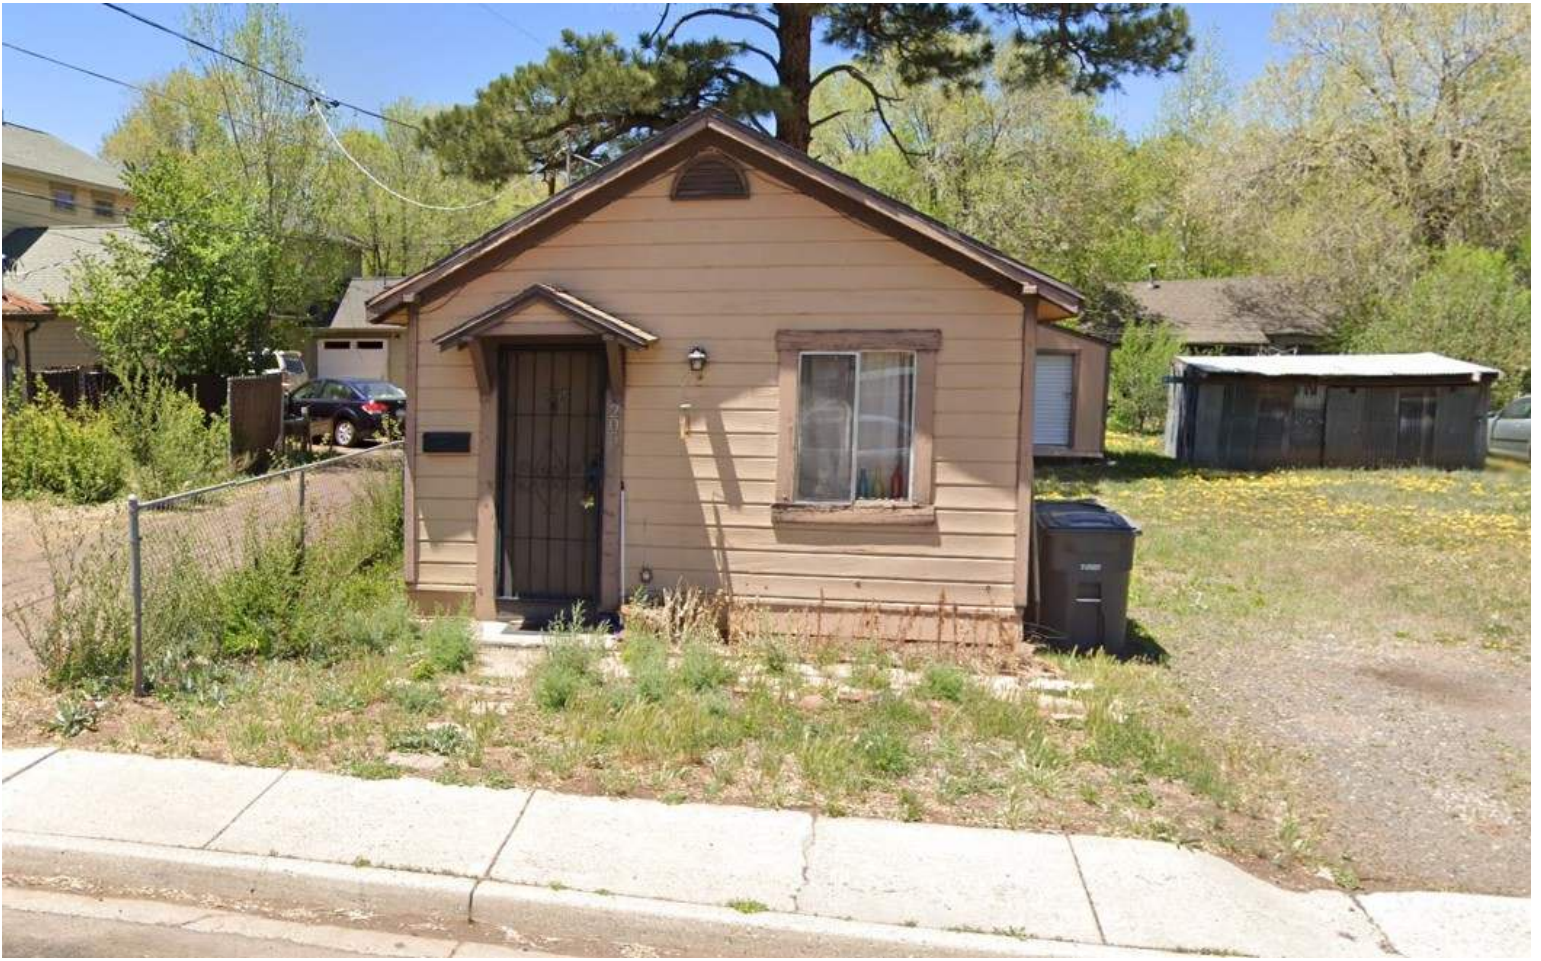
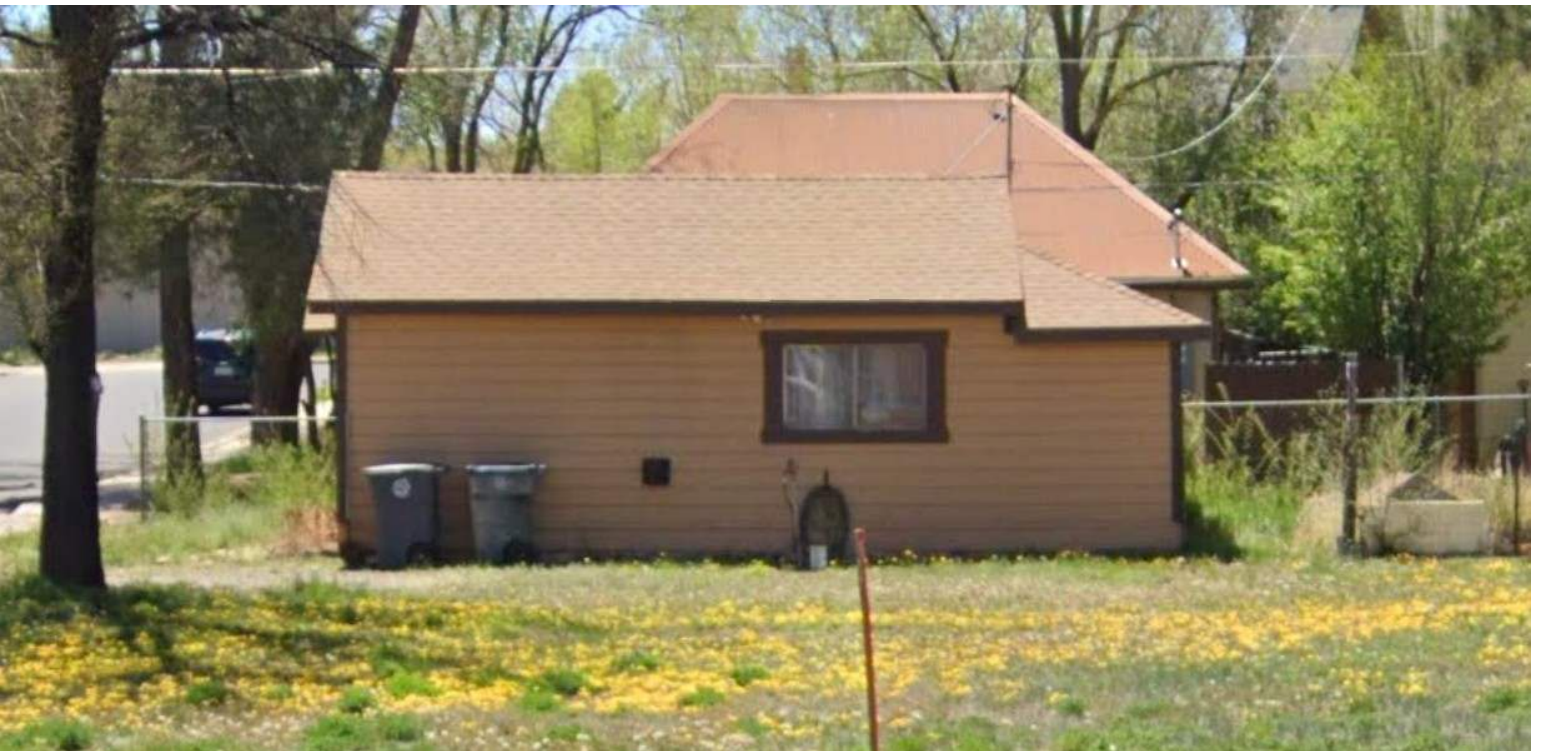
Photos 3–4. 205 S Park St front/E façade to W from Park St with 407 W Tucson outbuildings in right background (*top*) and N façade to S from 405 W Tucson lot with 215 S Park St house behind 205 S Park (*bottom*).

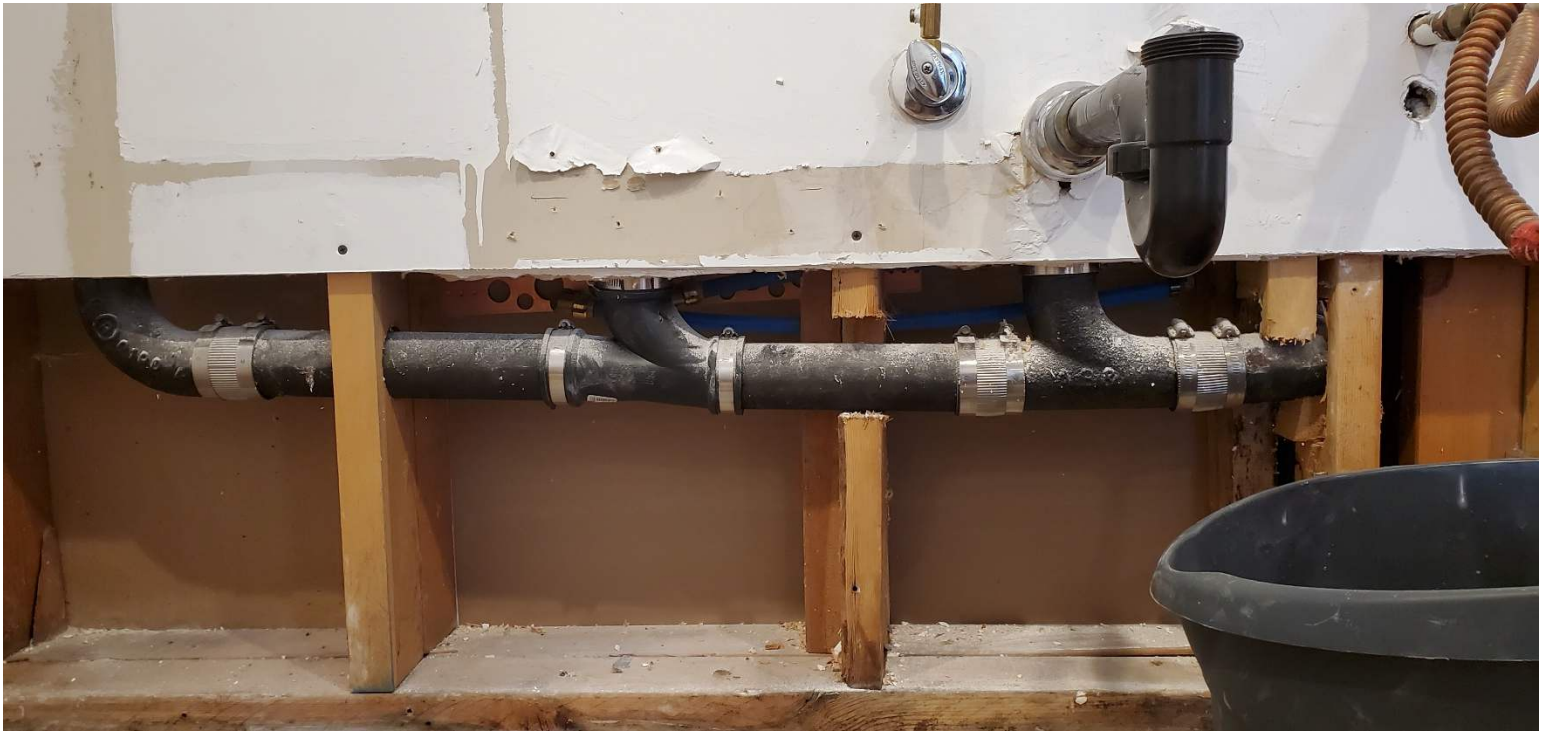
Photos 5–6. 205 S Park St interior wall showing modern dimensional lumber and sheetrock where ca. 2015 plumbing repair was made (top) and 205 S Park St location to NW showing new house construction with 407 W Tucson in background between two new structures and 407 W Tucson outbuilding in left background (bottom, also 123 S Park St house in far-right background).

Interiorly, the walls consisted of modern (post-1950) gypsum board (drywall), the floor was OSB sheathing, and the wiring (plastic-sheathed Romex) and plumbing (ABS fittings, ductile iron pipe, and plastic tubing for water delivery) were all modern (see Photo 5). Fiberglass insulation was also present in the walls, possibly added when the drywall replaced earlier wood composite or plaster.
