# Inner Basin Roadway & Critical Water Infrastructure

6 October 2026

# Update

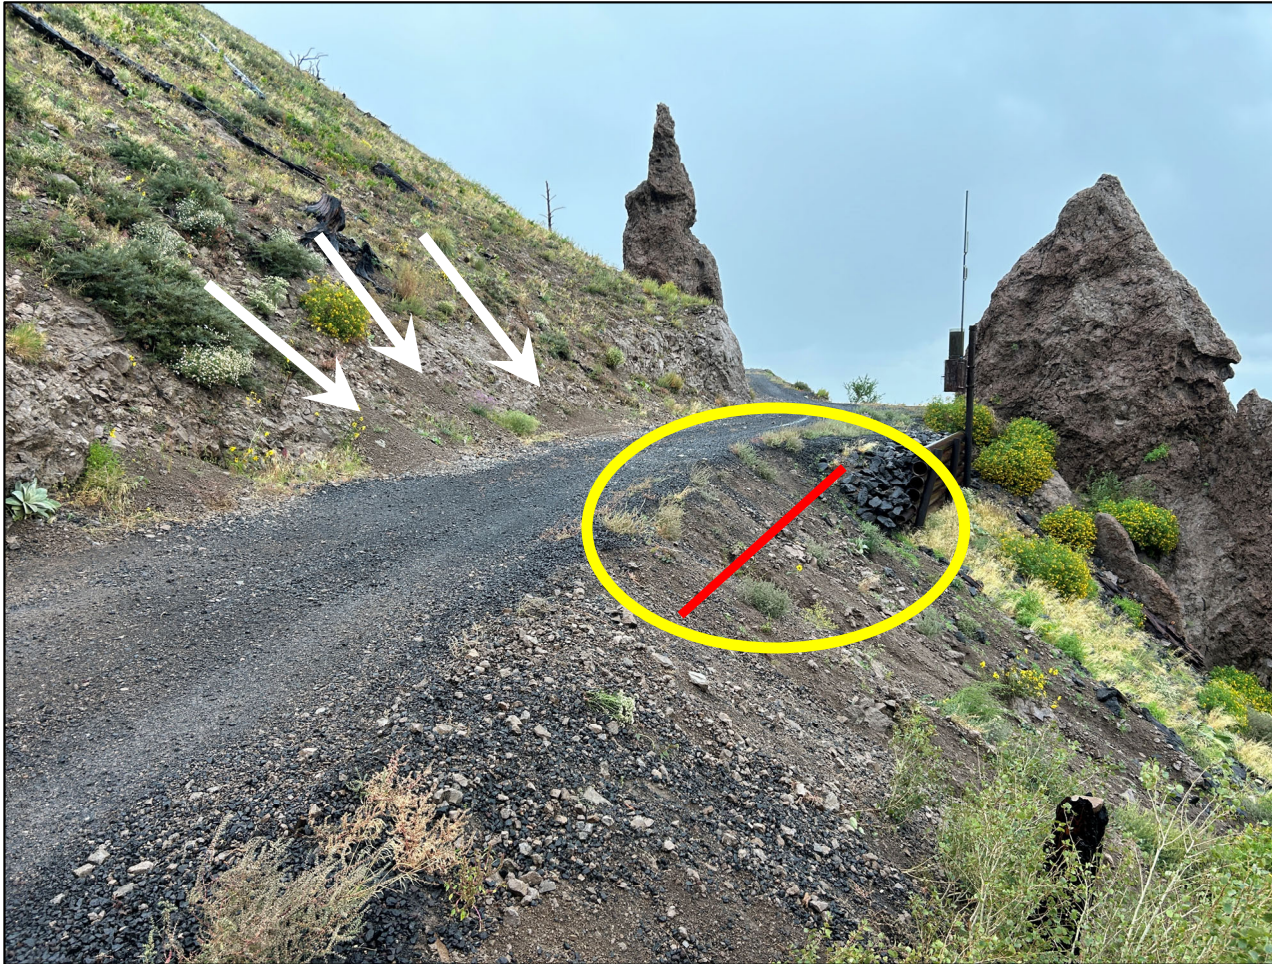
## SITE 18B

- Hillside has eroded right to left in yellow circle (from red line)
- Hillside on left side is bedrock and cannot be cut
- White arrows show soil deposition

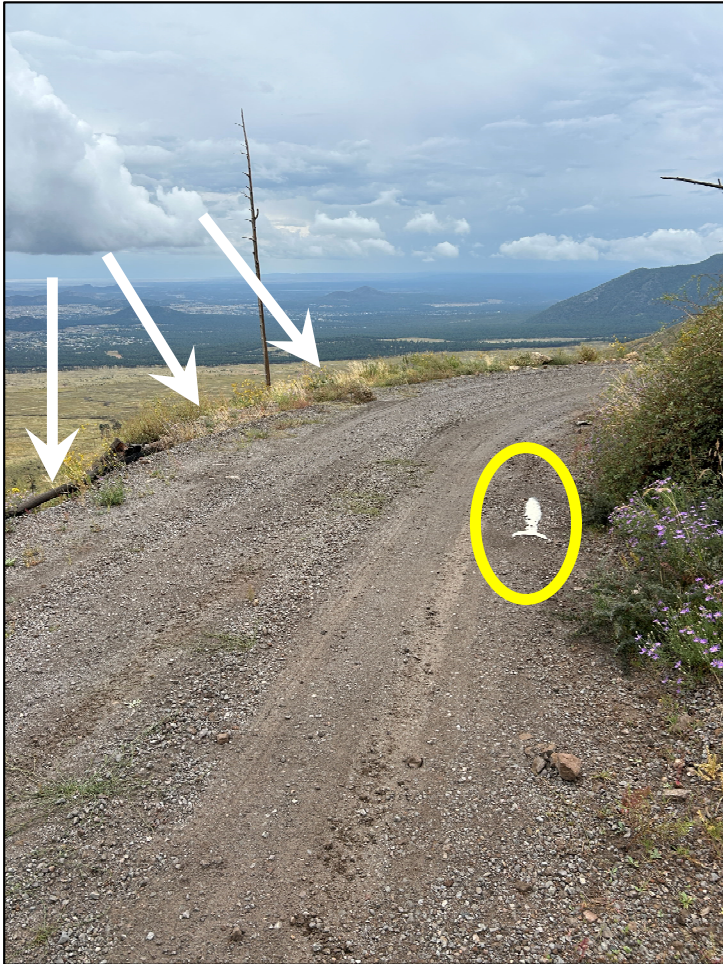
## SITE 3.1

- Waterline and bells are exposed (yellow)
- Gabions on the outside road edge (white)
- Bring in roadway aggregate to increase coverage on waterline

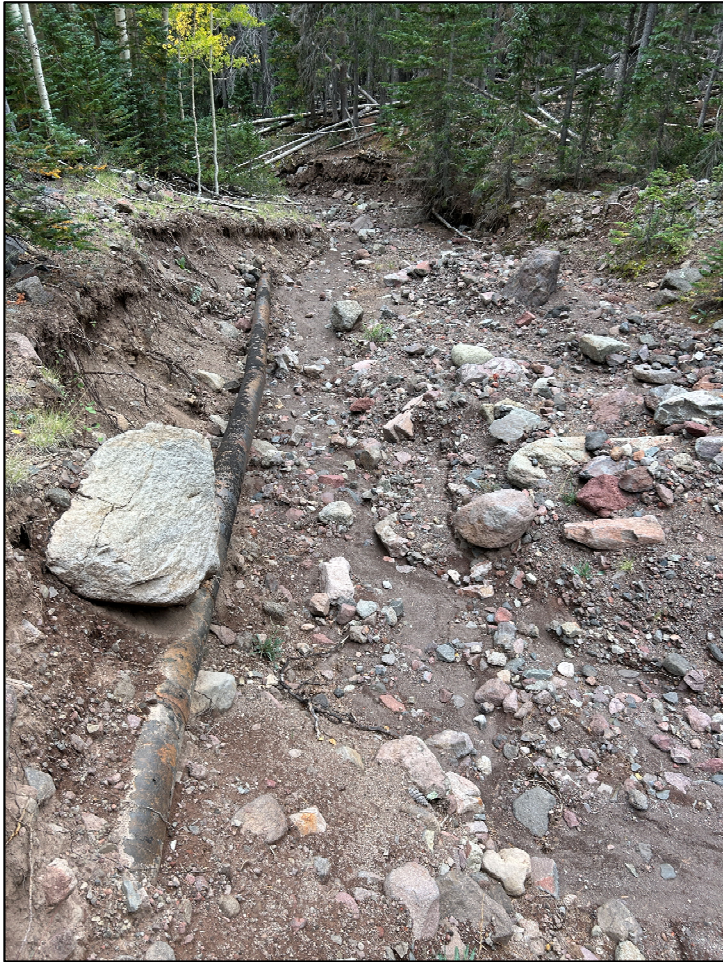
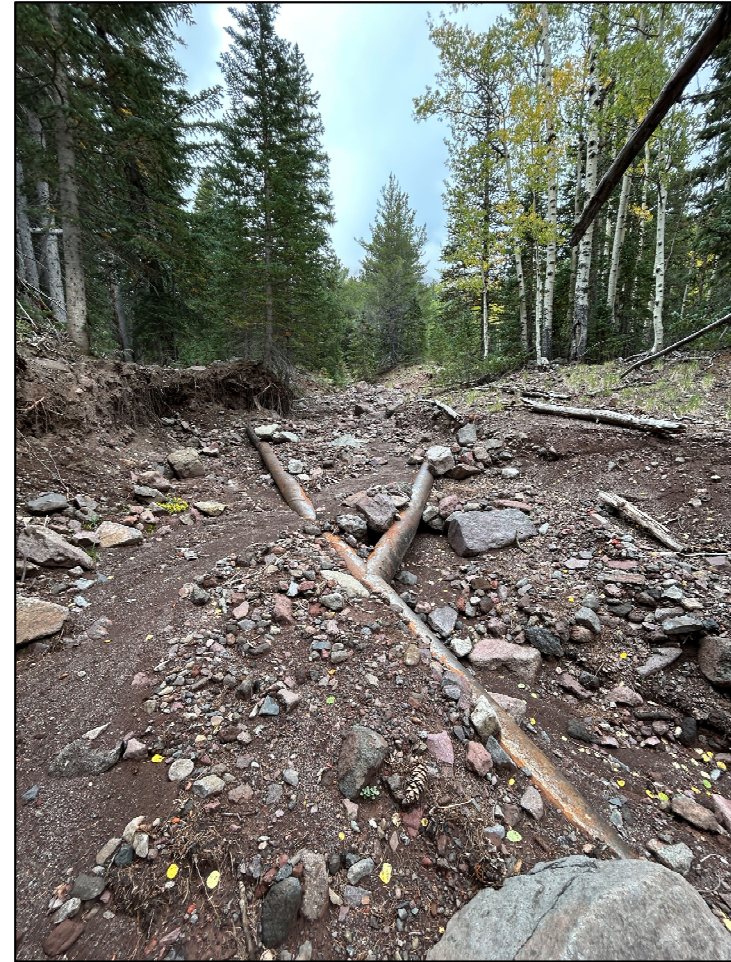
# Pipeline Armoring

- **Exposed Pipeline**
- **In Drainage Way**
- **Reinforced Concrete Encasement**
