# Water Main Break Repair - Jan 2026

- Water main failed on Tuesday, Jan. 20 in the evening.
- Flagstaff Police Department and Flagstaff Fire Department immediately responded to the emergency, securing the roadway and reducing the impact to vehicular and pedestrian traffic.
- Flagstaff Water Services crews immediately responded to isolate the water main and perform excavation work.

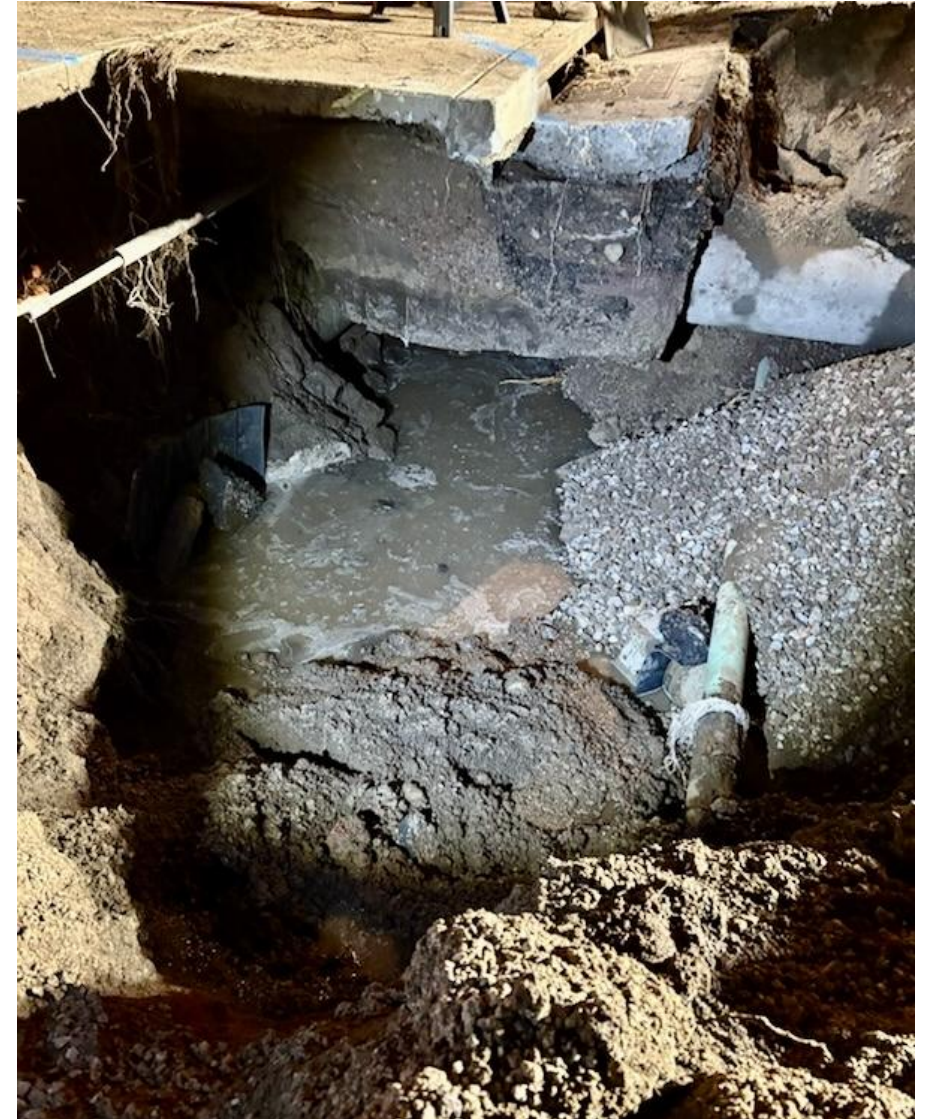
Photo of water main break taken at 1:15 a.m. Wednesday morning.

- JOC Eagle Mountain mobilized very next day
- Placement of utilities (natural gas, fiber optic, irrigation) and a stormwater collection basin delayed repair
- Water restored to surrounding properties on Wednesday at 10:00 p.m. after City crews completed installation of a 12” water valve
- The repair was complete by the following Monday, and traffic was restored on Huntington Drive. Flagstaff Public Works will oversee backfilling, paving, and sidewalk repair.

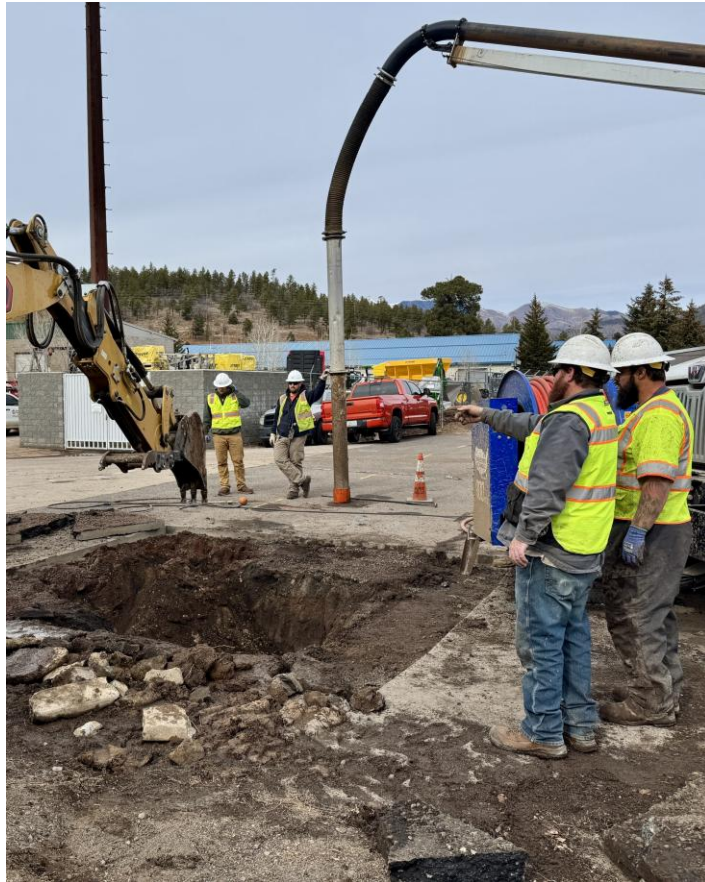
Wednesday: City Water Services crews prepare a 2<sup>nd</sup> site to install valve that returns flow to remaining properties.

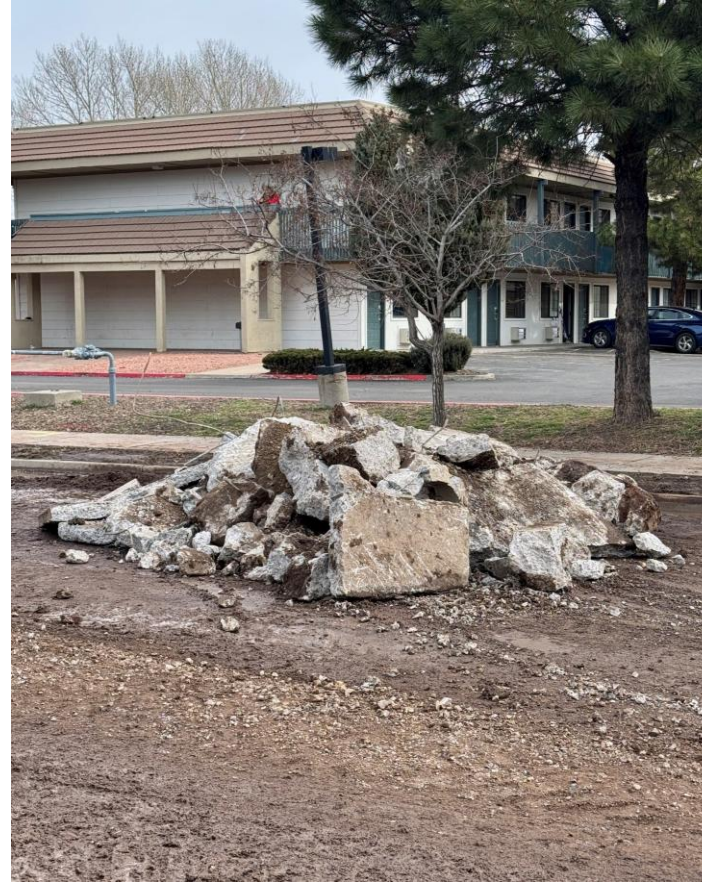
Wednesday: Debris of the stormwater collection basin that had to be removed before water main could be repaired.

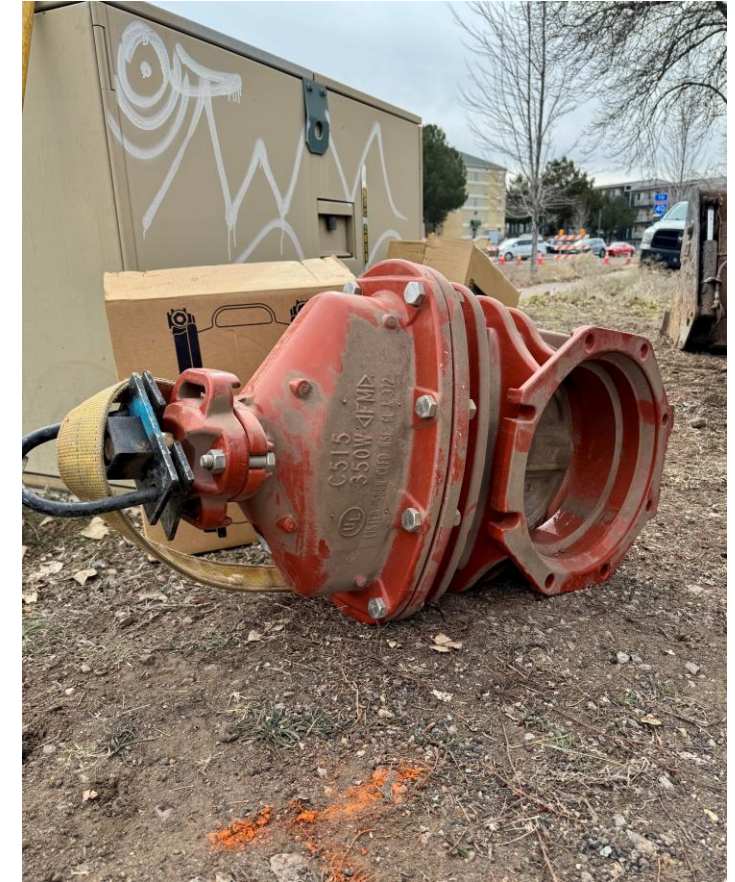
Wednesday: Valve waiting to be installed restores water to affected customers while also isolating the break location for repair.

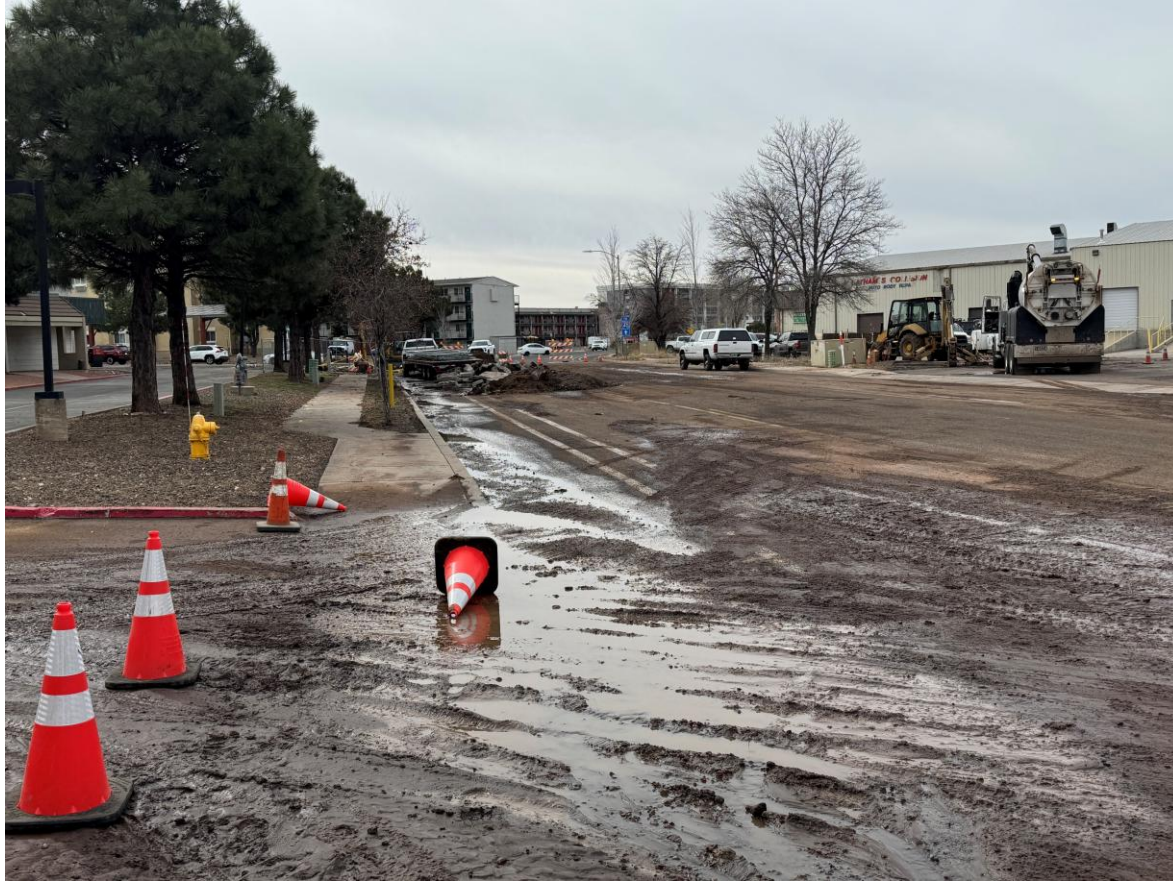
Wednesday: Vantage point of two sites from 50 yards away shows extent of impact.

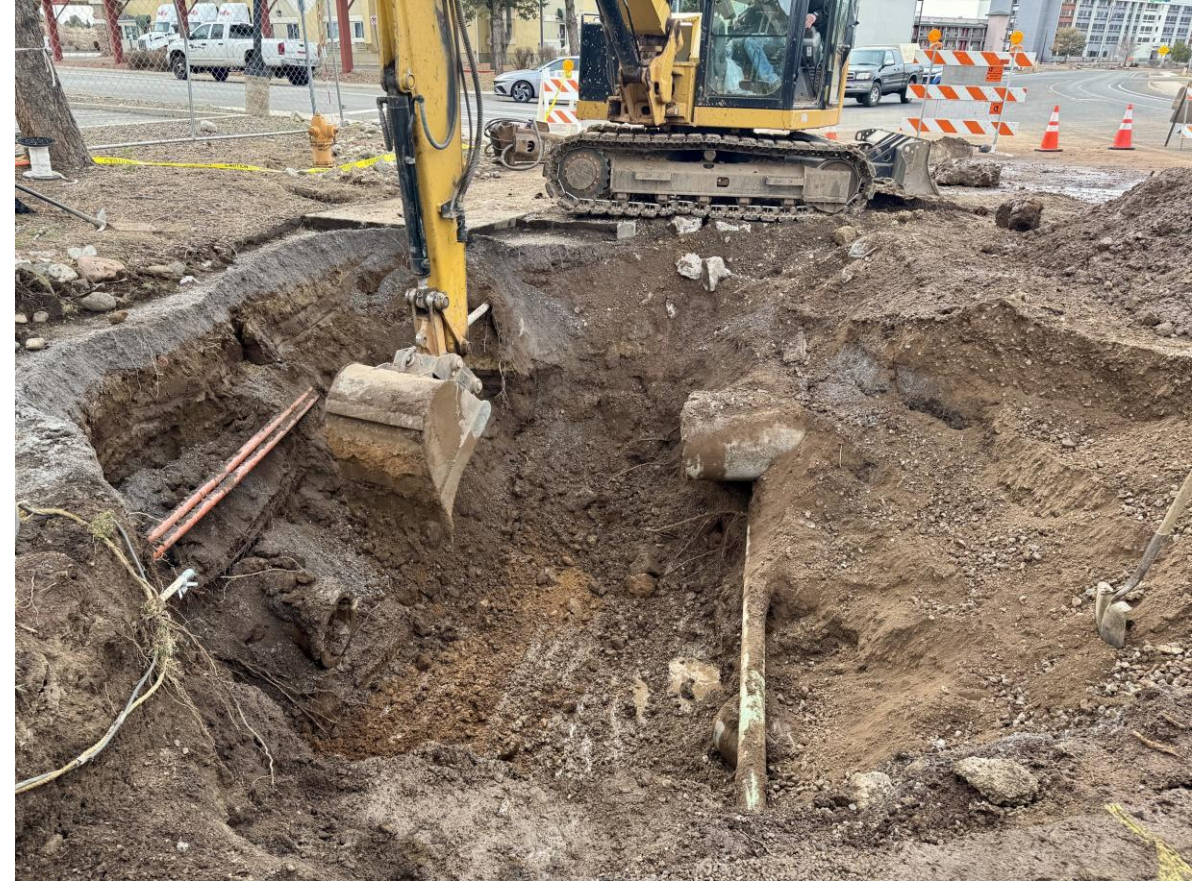
Wednesday: Site of main break shows proximity of utilities to water main, including natural gas directly above and to the right, and fiber optics and irrigation above and to the left.
