*RE: Cultural Resource Study Letter Report for Parcel 100-31-013 at 814 West Coconino Avenue, City of Flagstaff, Coconino County, Arizona (PZ-26-00040; LA Neal Consulting, LLC Project No. 1110-25)*

### Property Description/Architecture

## Summary and Determination of Effects

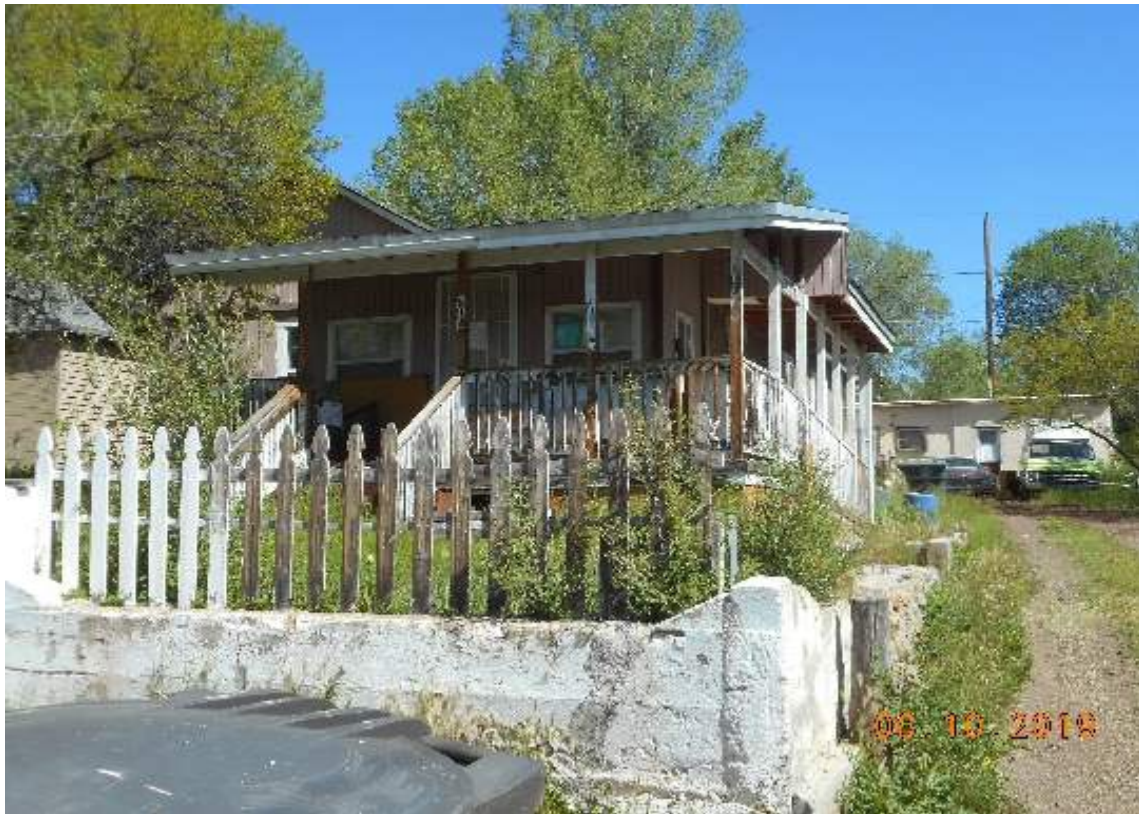
Photos 3–4. 814 W Coconino Ave overview (2019) from Coconino Ave to NNW (top, subject building is ADU at rear of lot behind/N of the main house) and dated October 2025 (bottom).

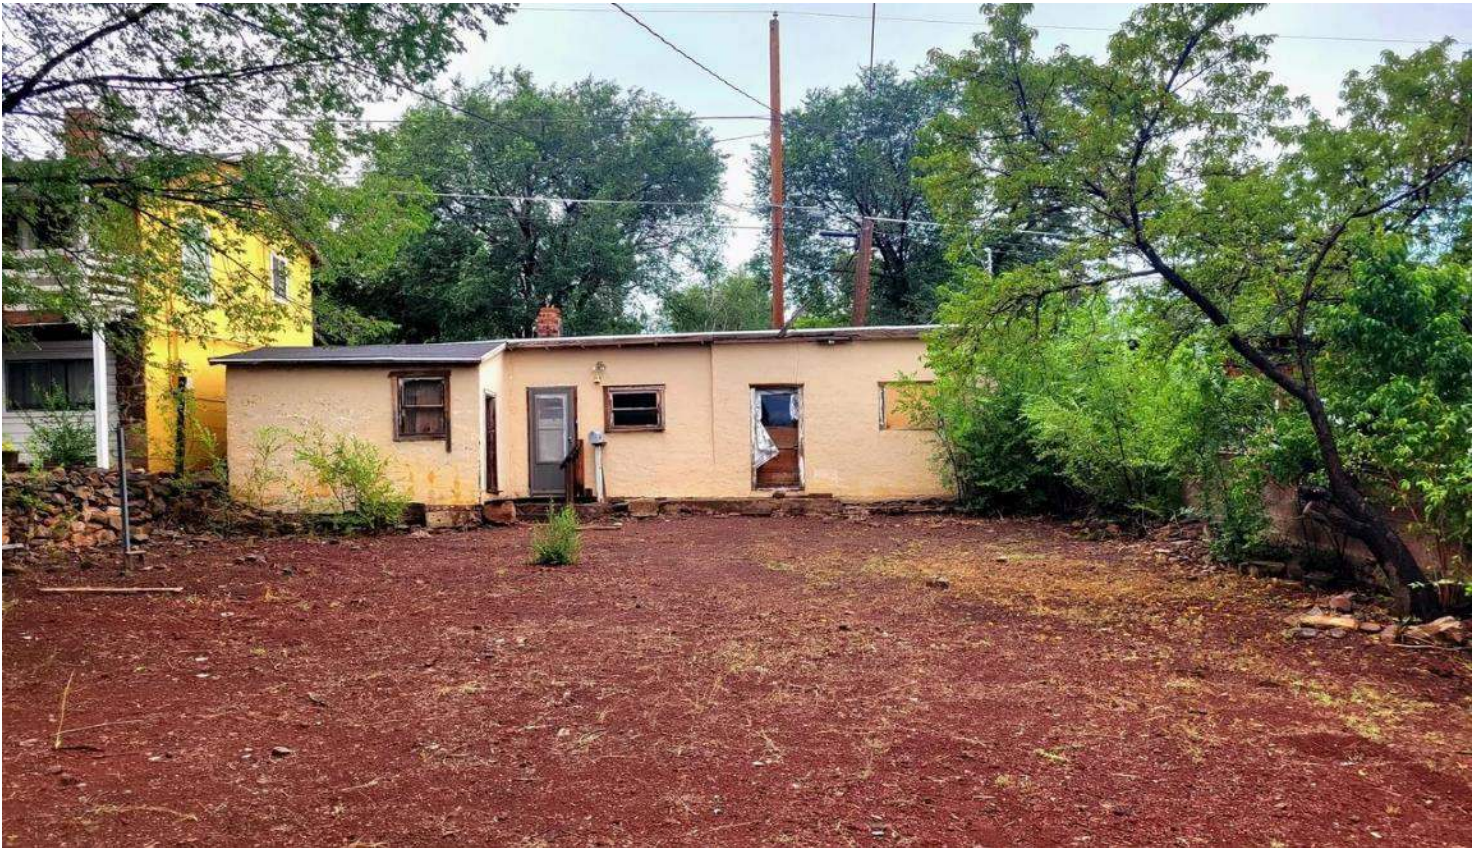
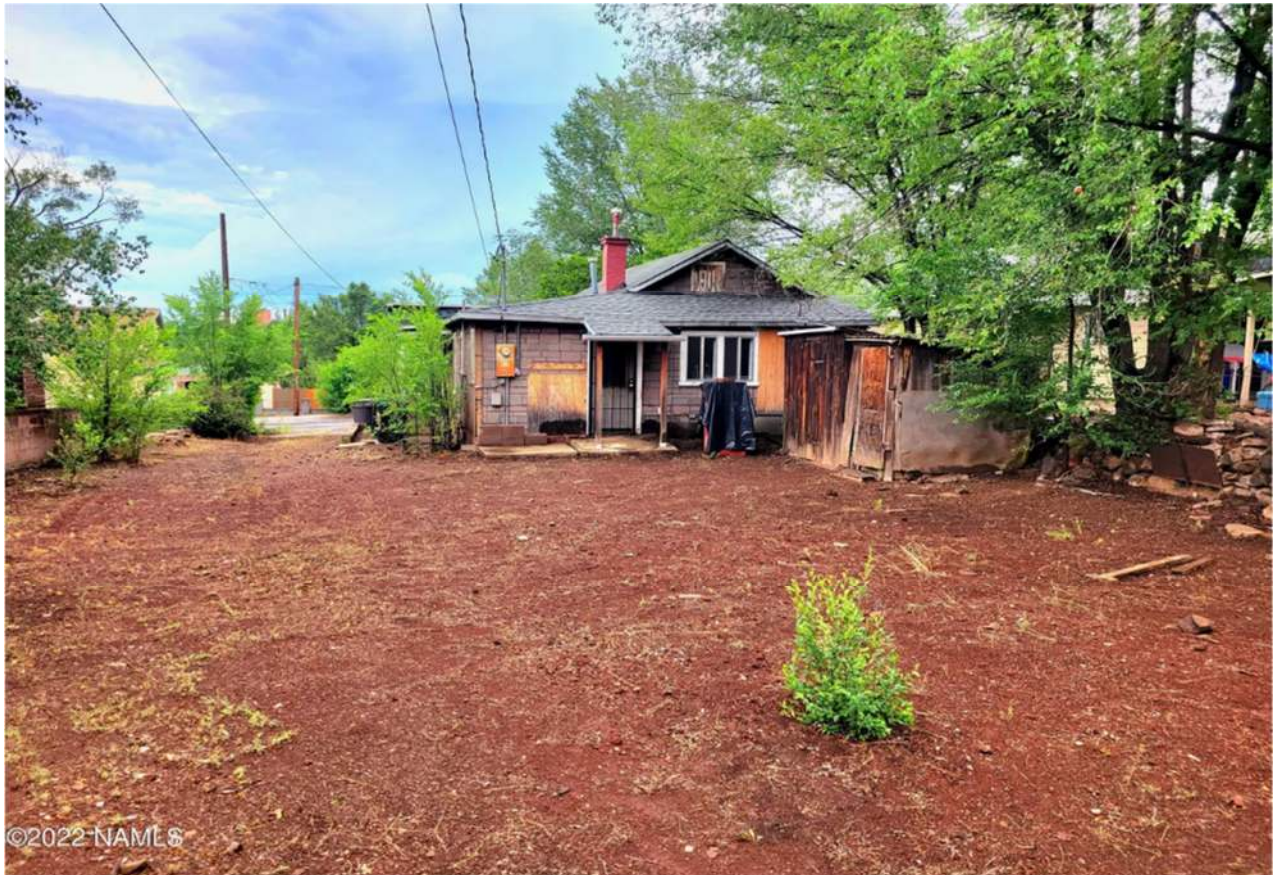
The property at **814 W Coconino Ave** (Block 1K, Parcel 100-31-013, Lots 8 & 9) consists of a currently inhabited one-story, five-room, modest shotgun-style house fronting Coconino Avenue to the south and an uninhabited ADU at the rear of the lot on an alley (*Appendix B, Photos 1–6*). The 606-square foot ADU is a one-story, L-shaped (modified rectangular), shed-style, five-room dwelling with the long axis oriented east-west parallel to Coconino Avenue to the south and an alley to the north. The ADU has a livable area of 606 square feet, sits on a 0.16-acre lot, and the main portion measures 42 feet E-W × 12.5 feet N-S (*Appendix A, Figure 4, building plan sketch*). The ADU has a low-pitch shed roof sloped to the north and south-sloped low-pitch roof over the front room extension on the southwest corner (*Photos 7–8*). The building's front/south wall is 10 feet high, and the rear/north wall is 7 feet 4 inches. Deeper eaves are present on the south and north sides of the house with shallow eaves on the east and west façades (*Photos 9–10*). There are no gutters installed on the house. Asphalt shingles over 1 × 6-inch wood planking make up the roof; the planking is exposed in some of the eaves. The house foundation is a combination of a one-course, undressed rock footer embedded into the ground, observable on the

Photos 5–6. 814 W Coconino Ave ADU overview dated 2022 to NNW (top) and view to S from ADU to main house dated 2022 (bottom).

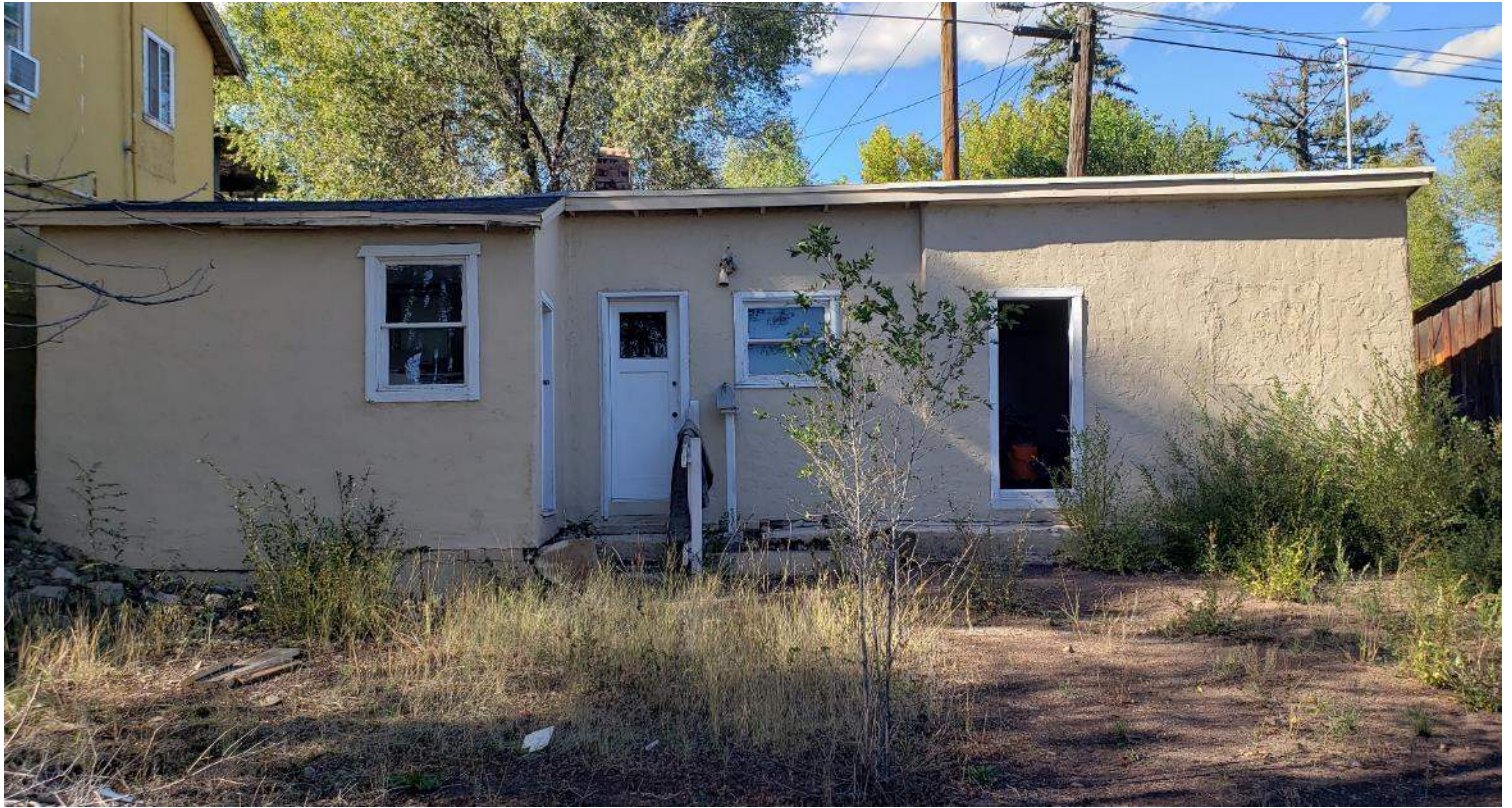
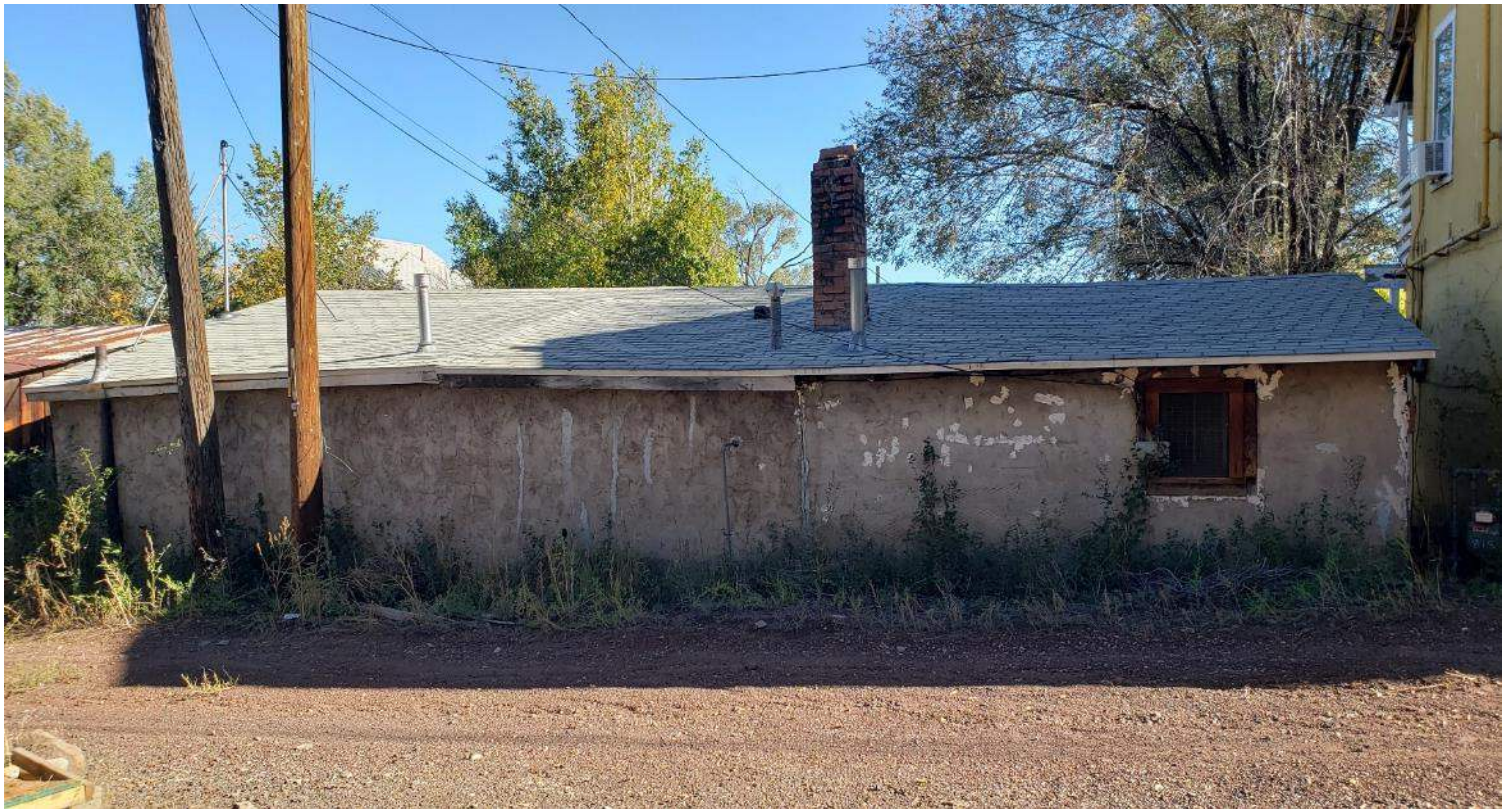
north façade, and a 1-foot-high footer wall of stone and cement along the south façade. Along a portion of the south façade is also a 1-foot-high concrete slab measuring 20¼ feet L x 3 feet W. It has a rubble core and concrete form border with the concrete slab atop this foundation.

The exterior walls are painted cement stucco over horizontal wood planking (1 x 3½" and 1 x 4") and vertical wood framing, with 4 x 4-inch wood posts at the corners (*Photo 11*). The front of the building has two entrances, one into the living room currently without a door and the other into the kitchen with a single-panel, single fixed-window wood door (see *Photo 7*). There is a third exterior entrance into the southwest-corner room that is not accessible from inside the structure. There are windows of varied styles and sizes on the south, north, and east façades (see *Photos 7–10*). All windows are wood-framed with two double-hung windows (36" W x 30" H in kitchen) in the south wall; a metal grate-covered, 2 x 2-foot, 4-paneled glass, hinged window in the northwest wall; and one window in the east wall (the bathroom) measuring 24" W x 30" H with opaque plexiglass on the interior and wire mesh on the exterior. A fifth window opening was filled and stuccoed in recent years in the southeast wall where the tub/shower is located on the interior (see *Photos 5 & 7*). Modifications have been made and amenities added through time, possibly to convert what may have originated as a storage/work shed to a dwelling. The exterior does reflect the recorded 1925 construction date, meaning the structure was likely built at the same time as the main house, but the interior is equally reflective of the 1950s and beyond. Because the southwest corner room has no interior access and different, newer interior treatments from the rest of the structure, it is suspected to have been added or enclosed at some point after the initial construction.

Photos 7–8. 814 W Coconino Ave ADU front/S facade to NNW (top) and back/N façade to SSE (bottom).

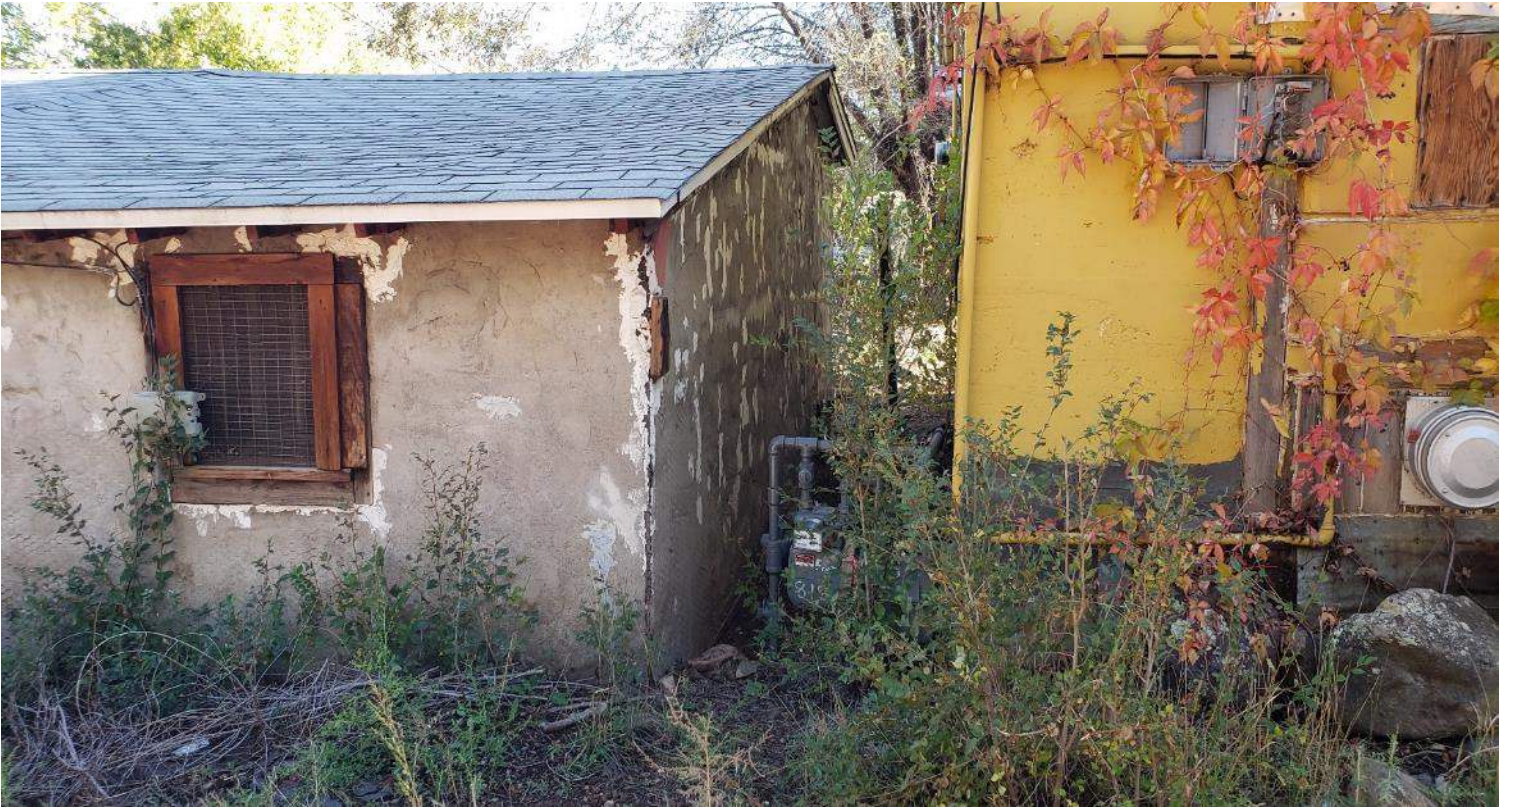
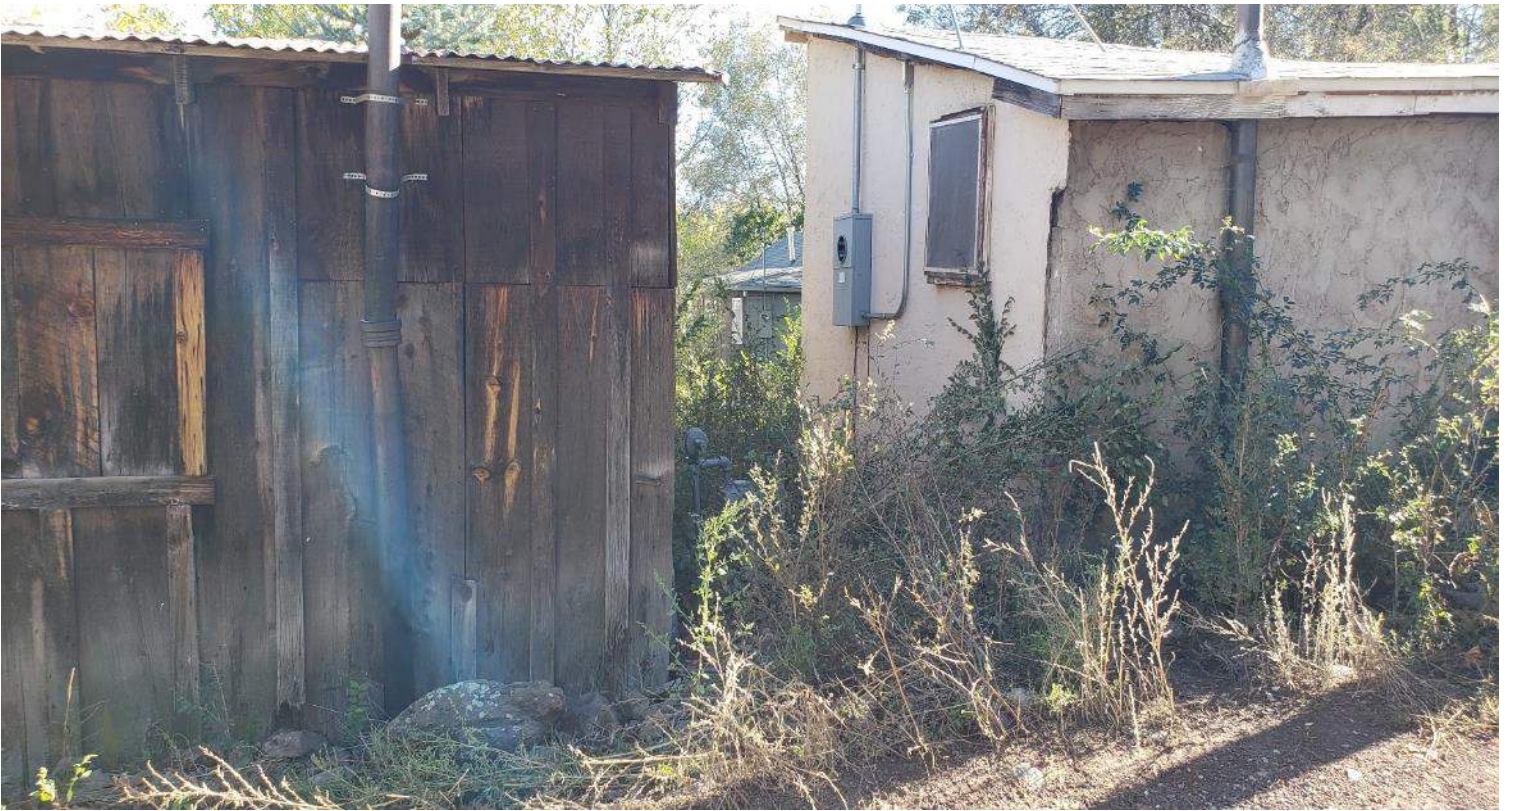
Photos 9–10. 814 W Coconino Ave ADU W façade/NW corner to SE (top) and E façade/NE corner to SW (bottom).

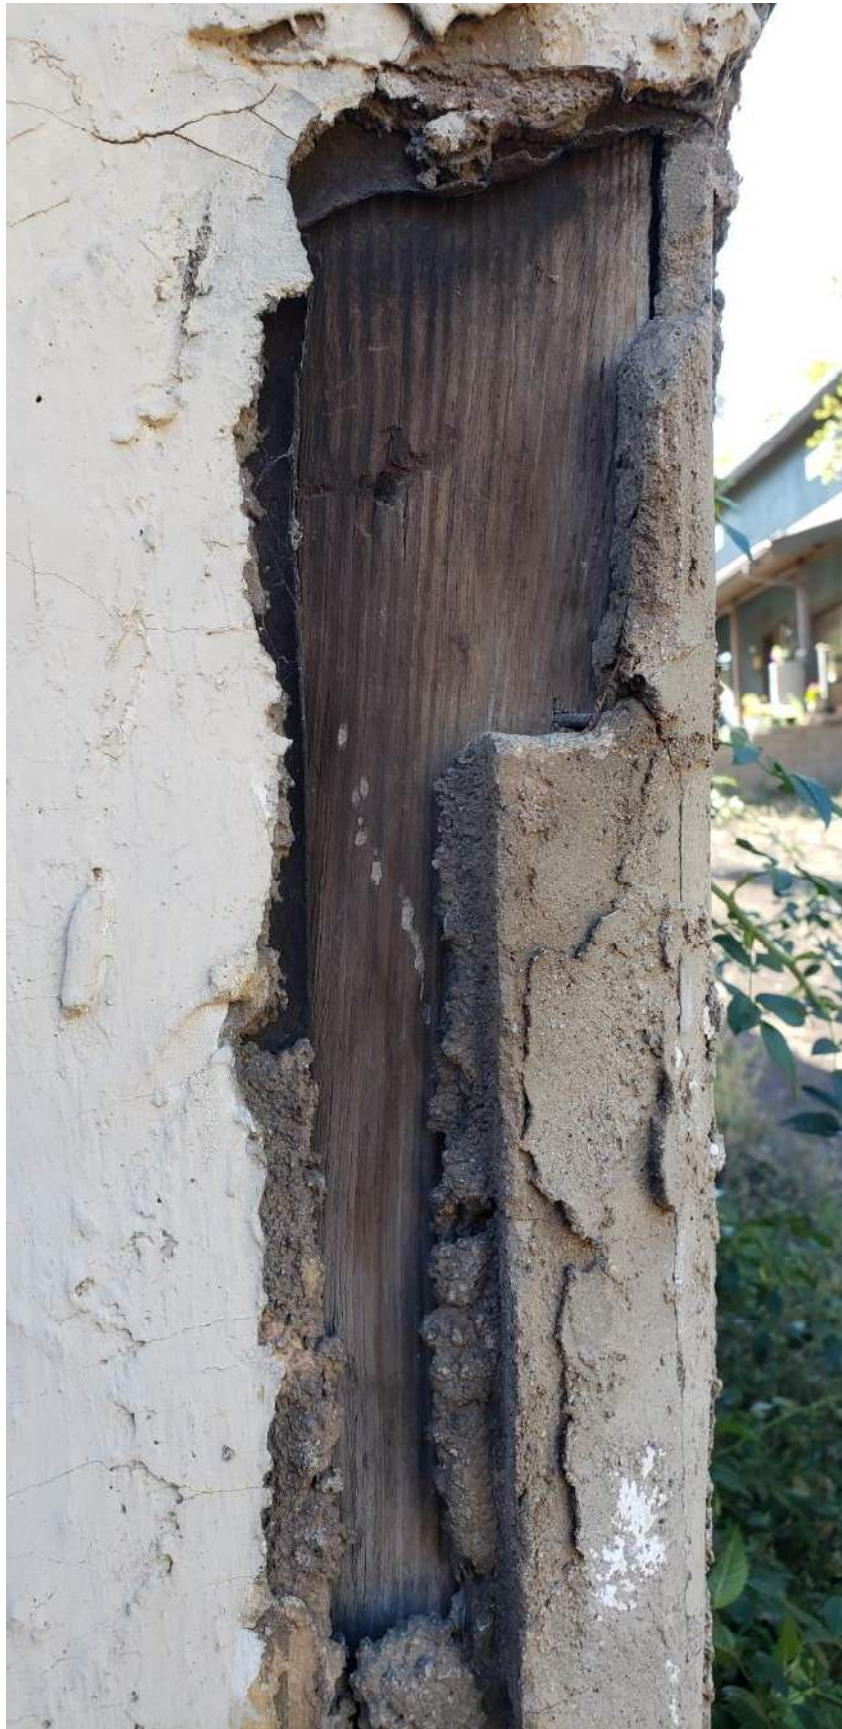
Photo 11. 814 W Coconino Ave ADU NE corner detail.

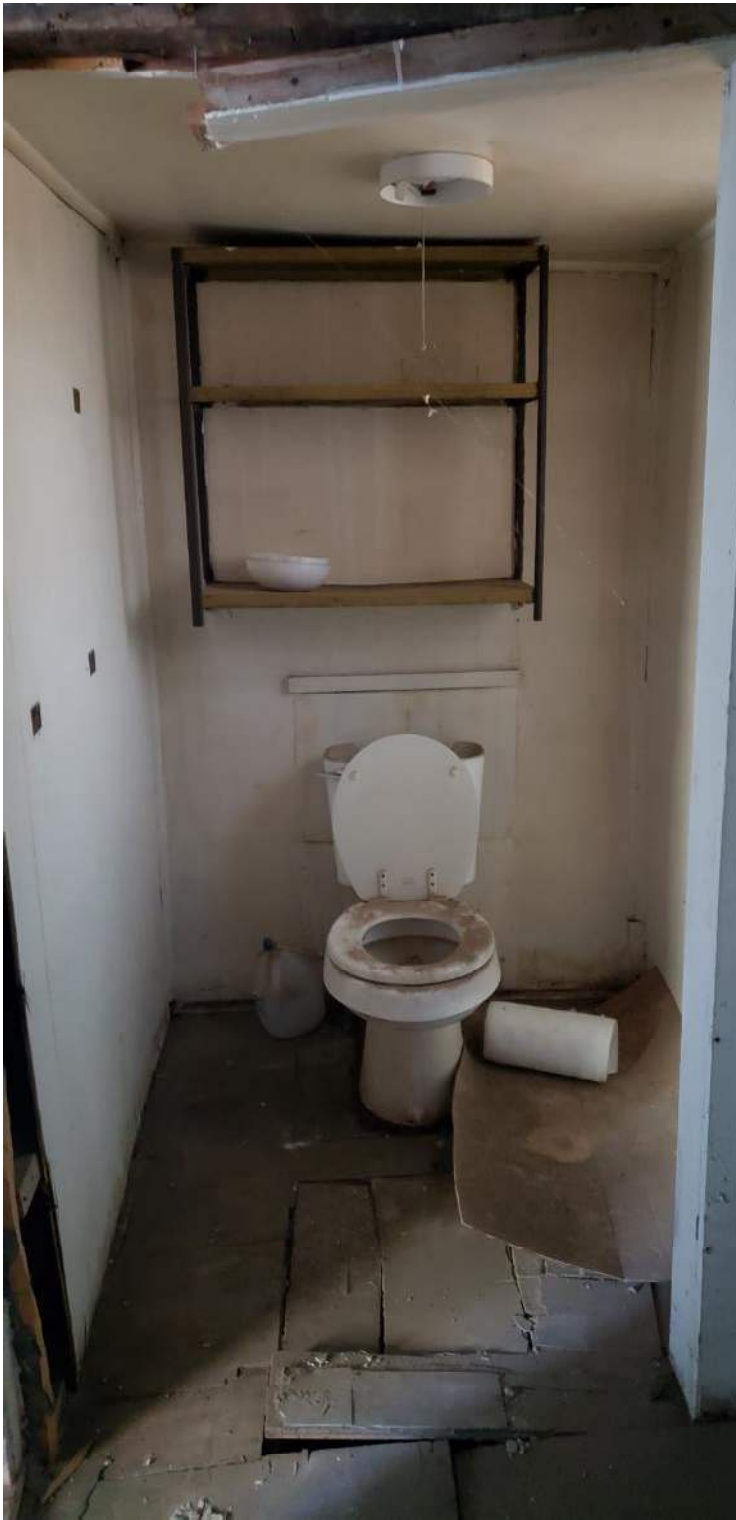
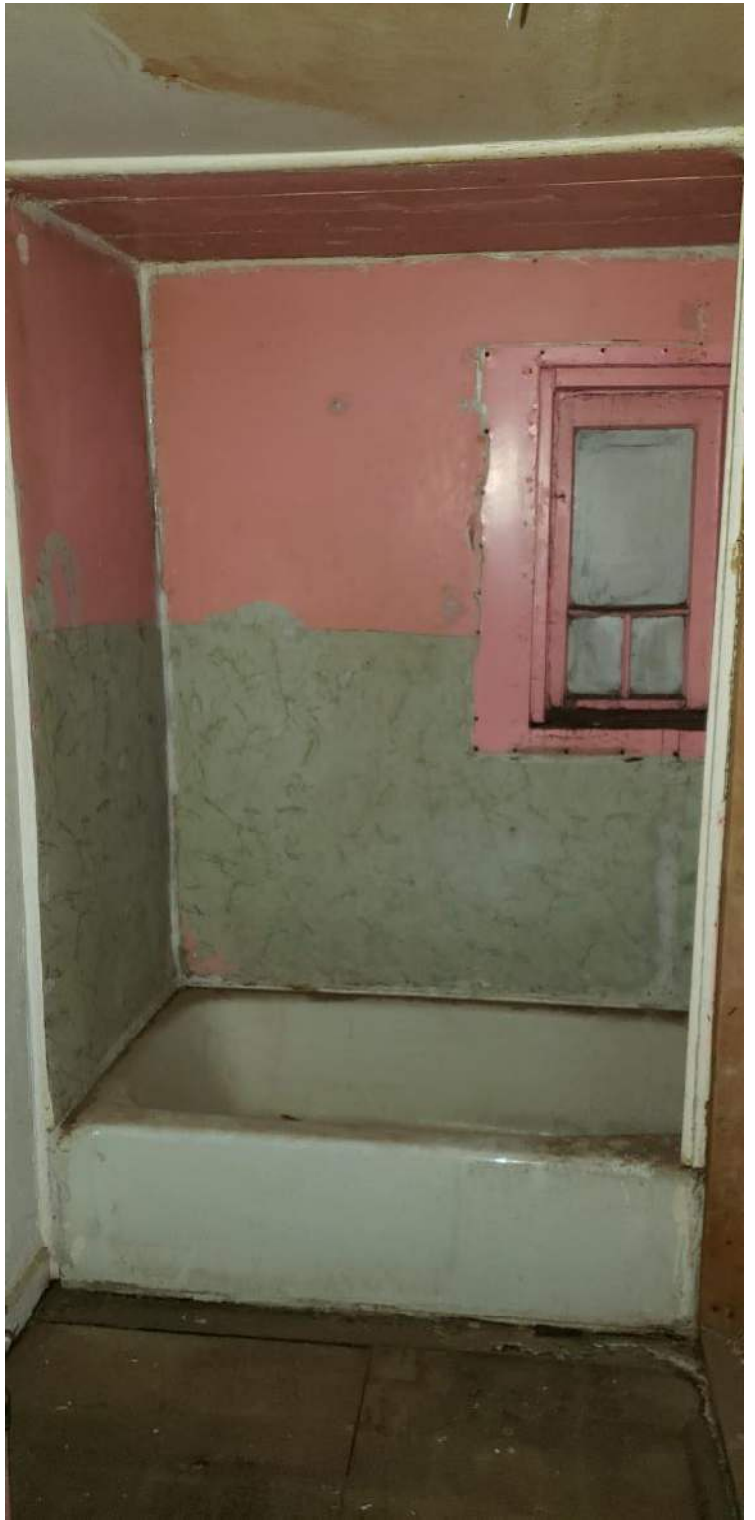
The interior, moving east to west, has a bathroom (*Photos 12–14*), living room (*Photos 15–18*), kitchen (*Photos 19–21*), bedroom with closet (*Photos 22–25*), and southwest corner utility room (possibly used as a bedroom at some point, *Photos 26–27*). The most recent heat sources are free-standing gas stoves in the northwest corners of the bedroom and living room. It is also obvious that the brick chimney that projects outward from the shared bedroom/kitchen wall once served to vent presumably wood-burning stoves in both rooms. No fixed heat source was specified on the 1966–1980s Residential Property Record Card. The ceilings and underlying interior walls are plastered with fabricated wood paneling and drywall introduced over the plaster and replacing it in some rooms. A patch of wall in the bathroom where a sink was once installed shows the paint history of white over beige over pink over dark green (see *Photo 14*), and a swirled green formica-like composite laminate was installed in the lower tub/shower area of the bathroom (see *Photo 13*). The floors are wood, including ¾-inch tongue-and-groove planking (3¼" and 6¼" wide), covered with carpet and linoleum. The bathroom floor likely had an overlayment treatment but is currently bare wood planking. Overall, the interior treatments and materials are mostly indicative of the ca. 1950s and later remodeling, but the structure's origins are apparent when one pulls away the layers. The house is in poor structural condition and is of low architectural interest in general and within the context of Flagstaff's history. The building was identified as consisting of three rooms of minimal construction quality in the late 1960s per the Residential Property Record Card, but by 1980 the grade was listed as good. This notation would indicate improvements were made to garner this ranking. The dwelling has fallen back into disrepair to the point that it is not structurally sound enough to be occupied and is considered unsafe and uninsurable.

Photos 12–13. 814 W Coconino Ave ADU bathroom toilet in NE corner of building (left) and tub in SE corner (right).

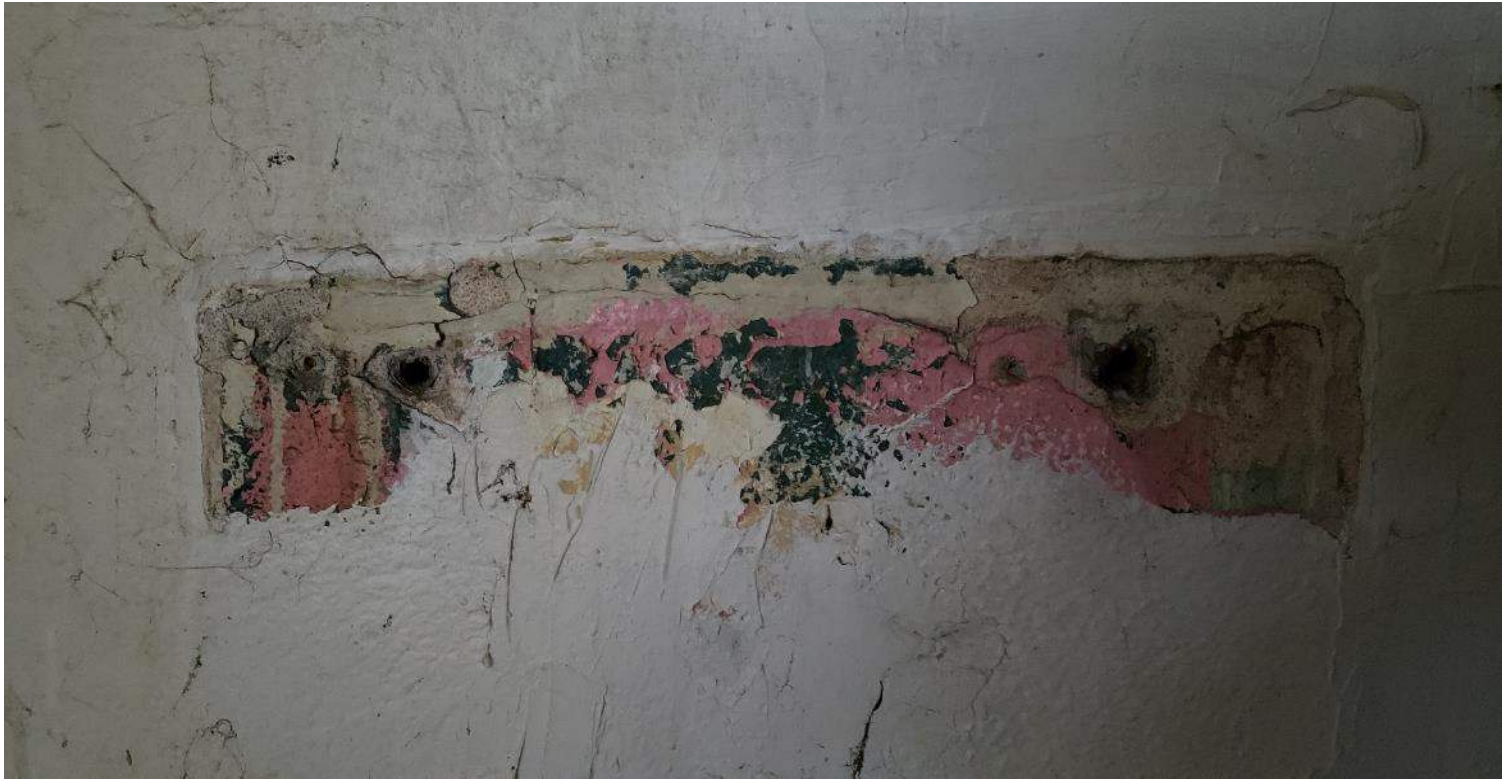
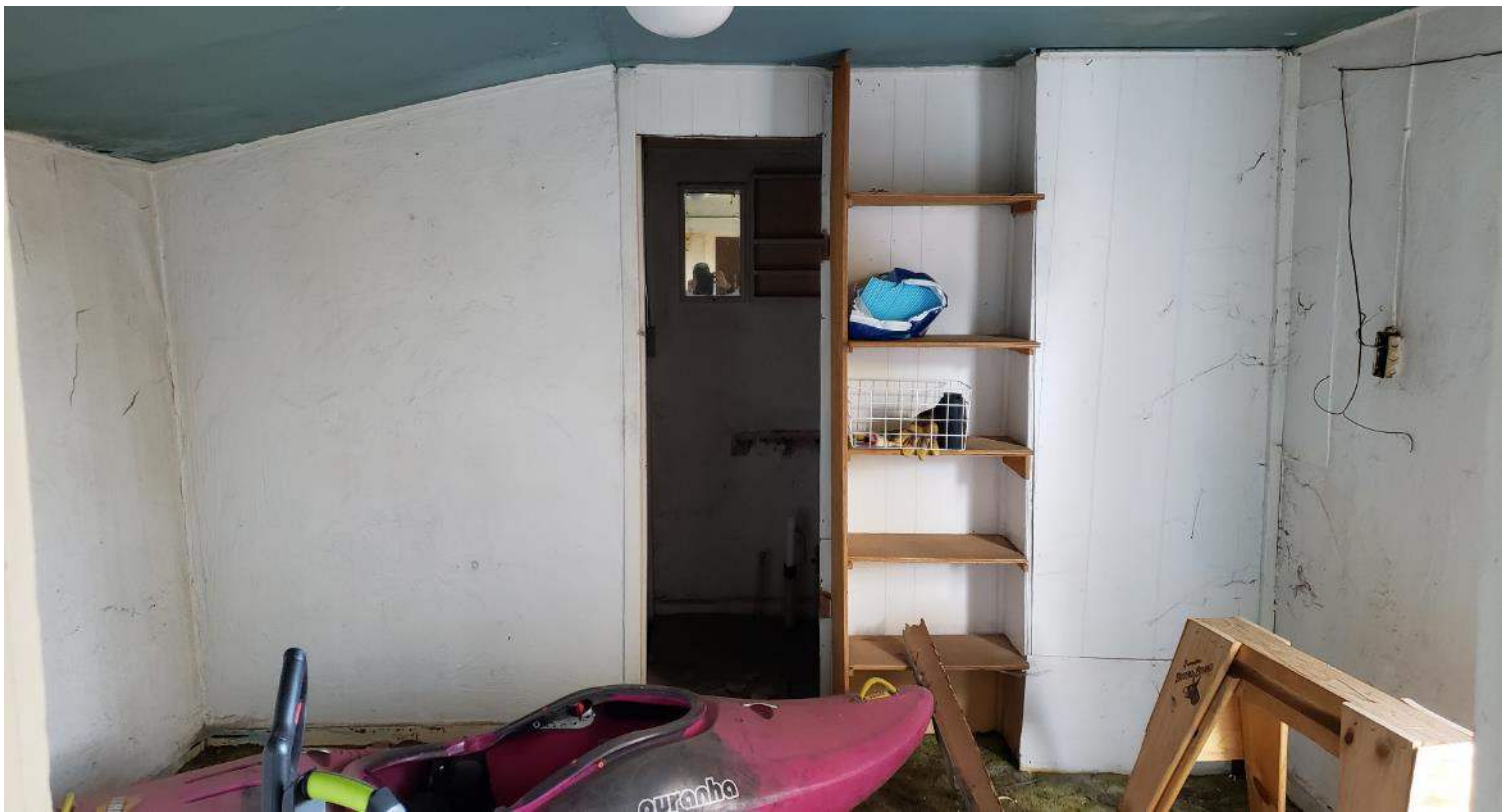
Photos 14–15. 814 W Coconino Ave ADU bathroom E wall paint treatments over time (top) and living room E½ to E with door to bathroom in background (bottom).

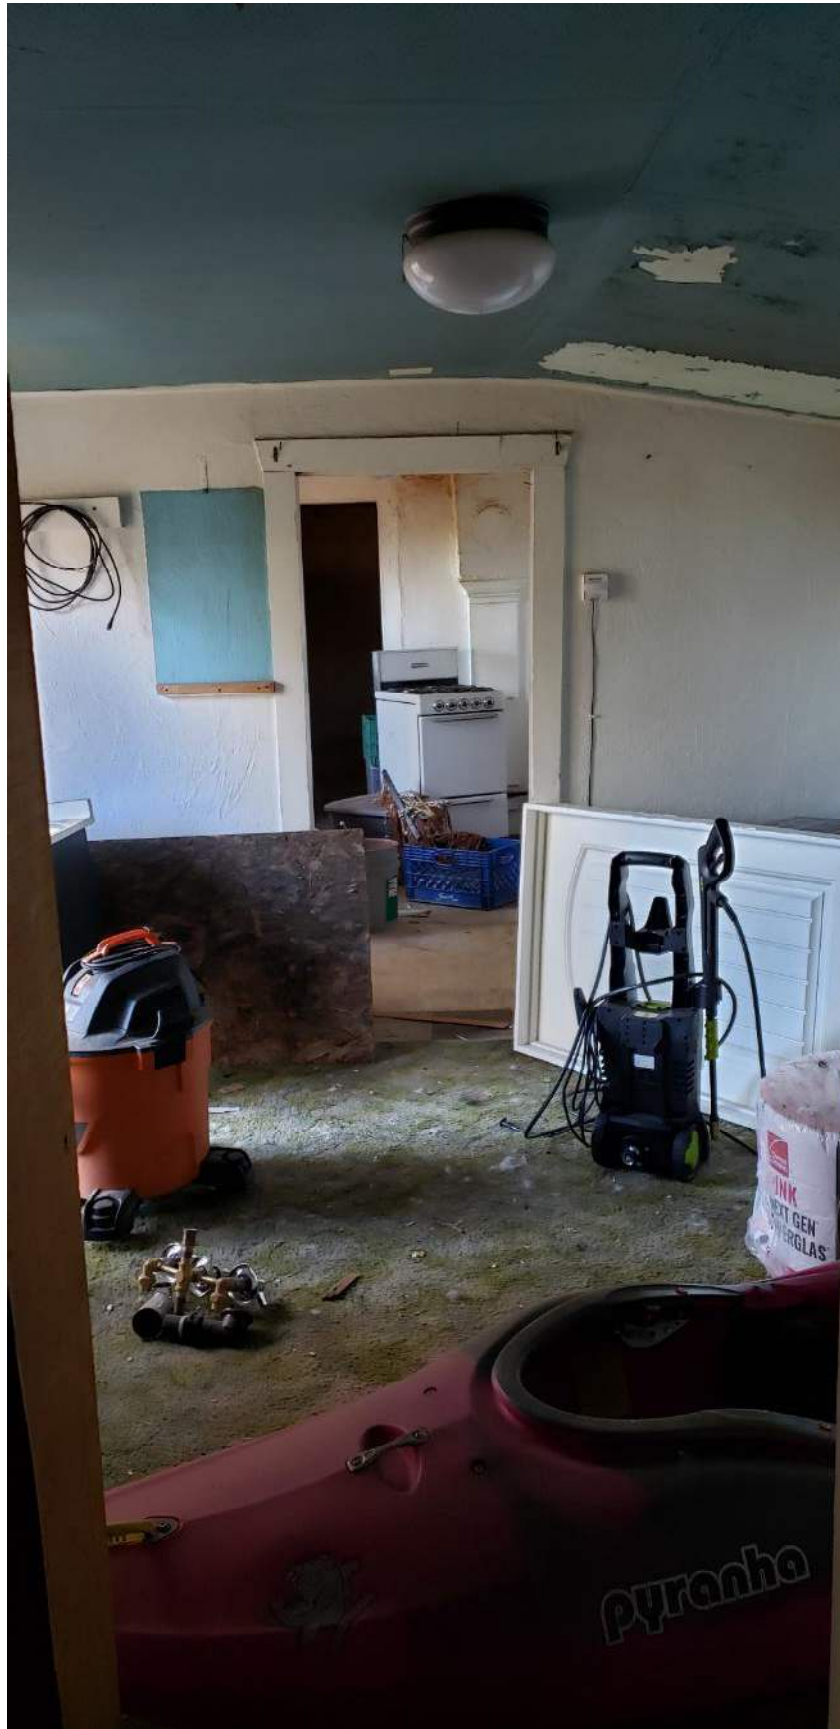
Photo 16. 814 W Coconino Ave ADU living room and kitchen beyond to W from within bathroom.

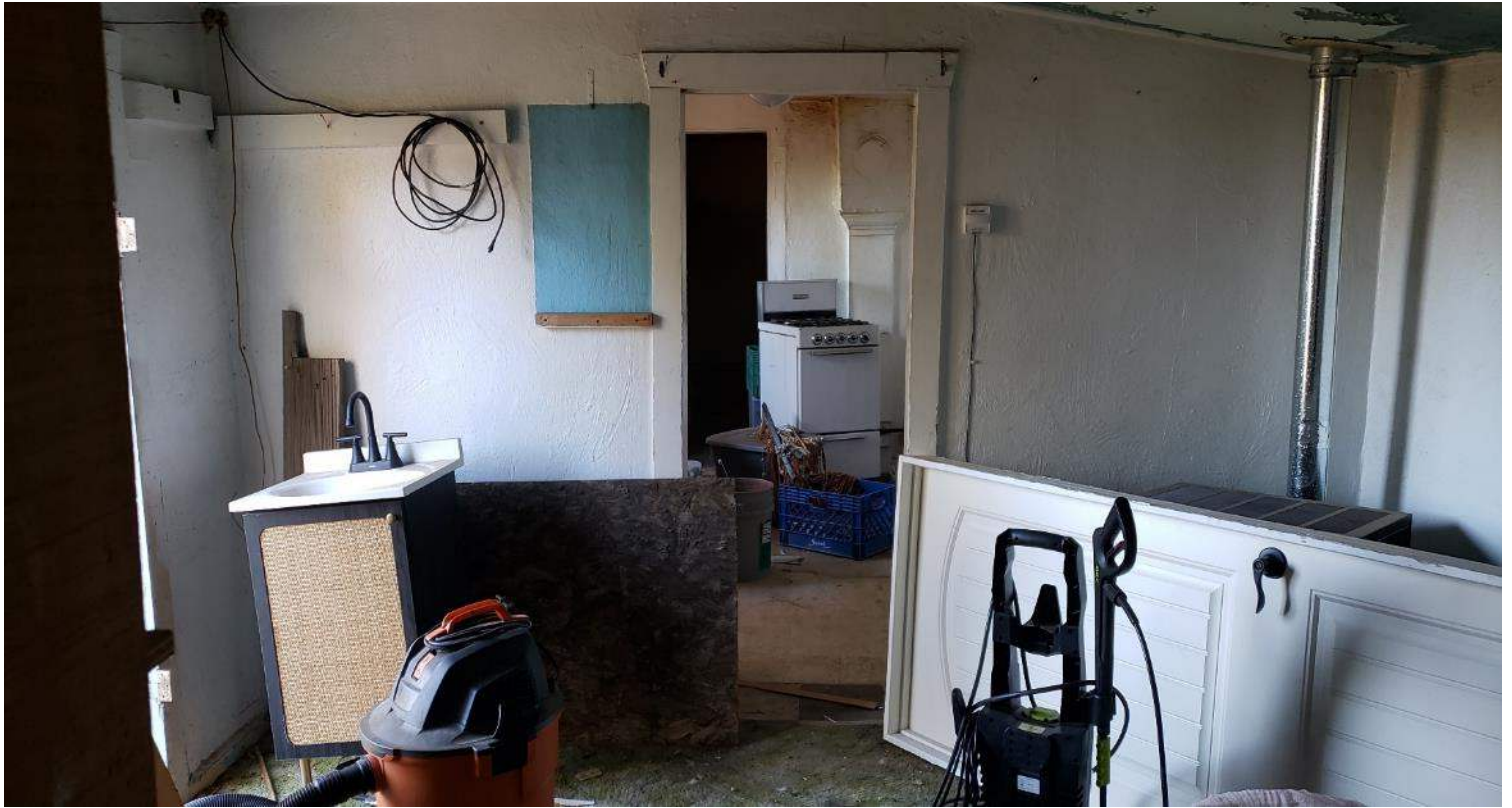
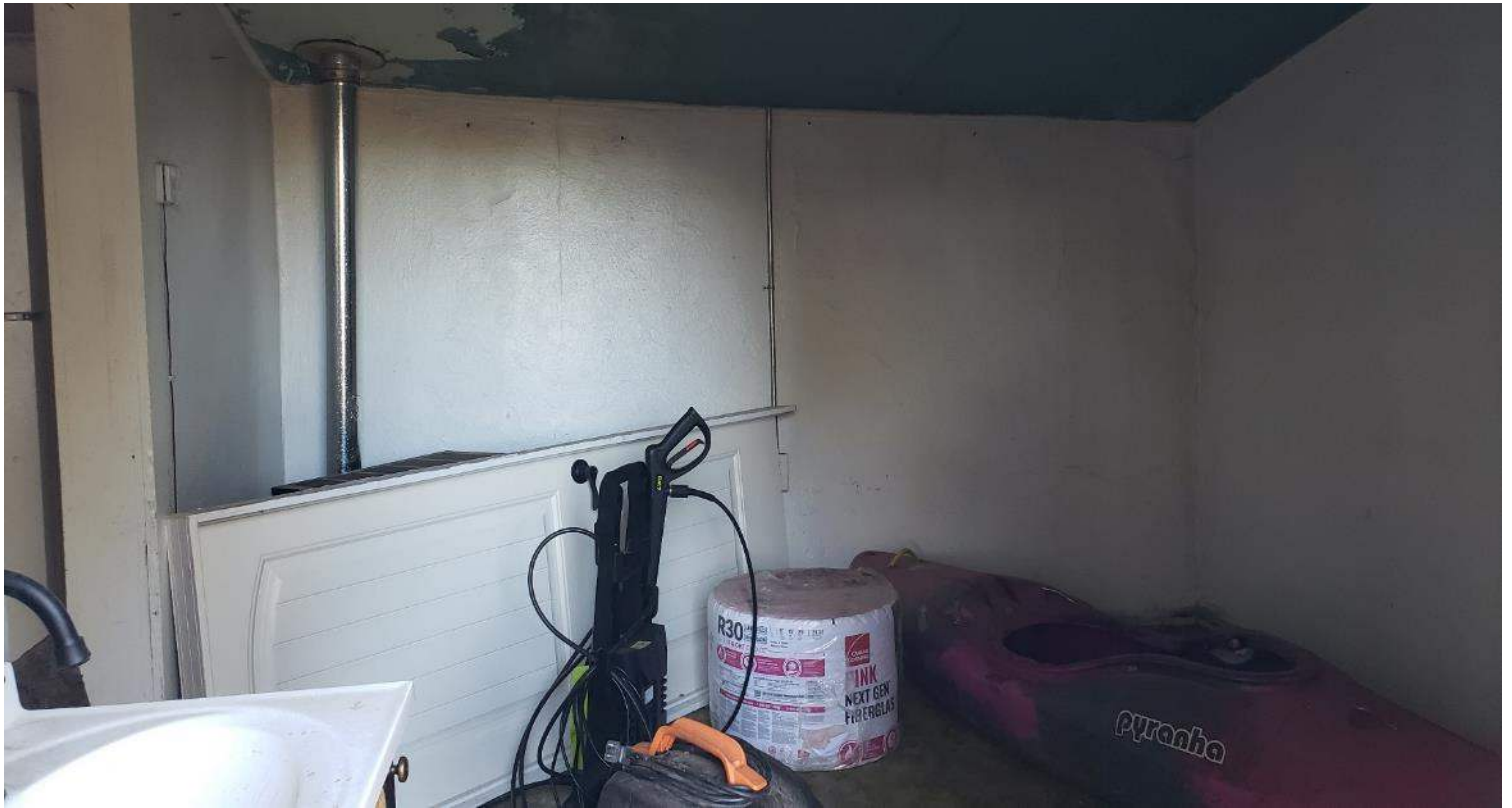
Photos 17–18. 814 W Coconino Ave ADU living room W½ to W with kitchen in background (top) and living room to N from front door (bottom).

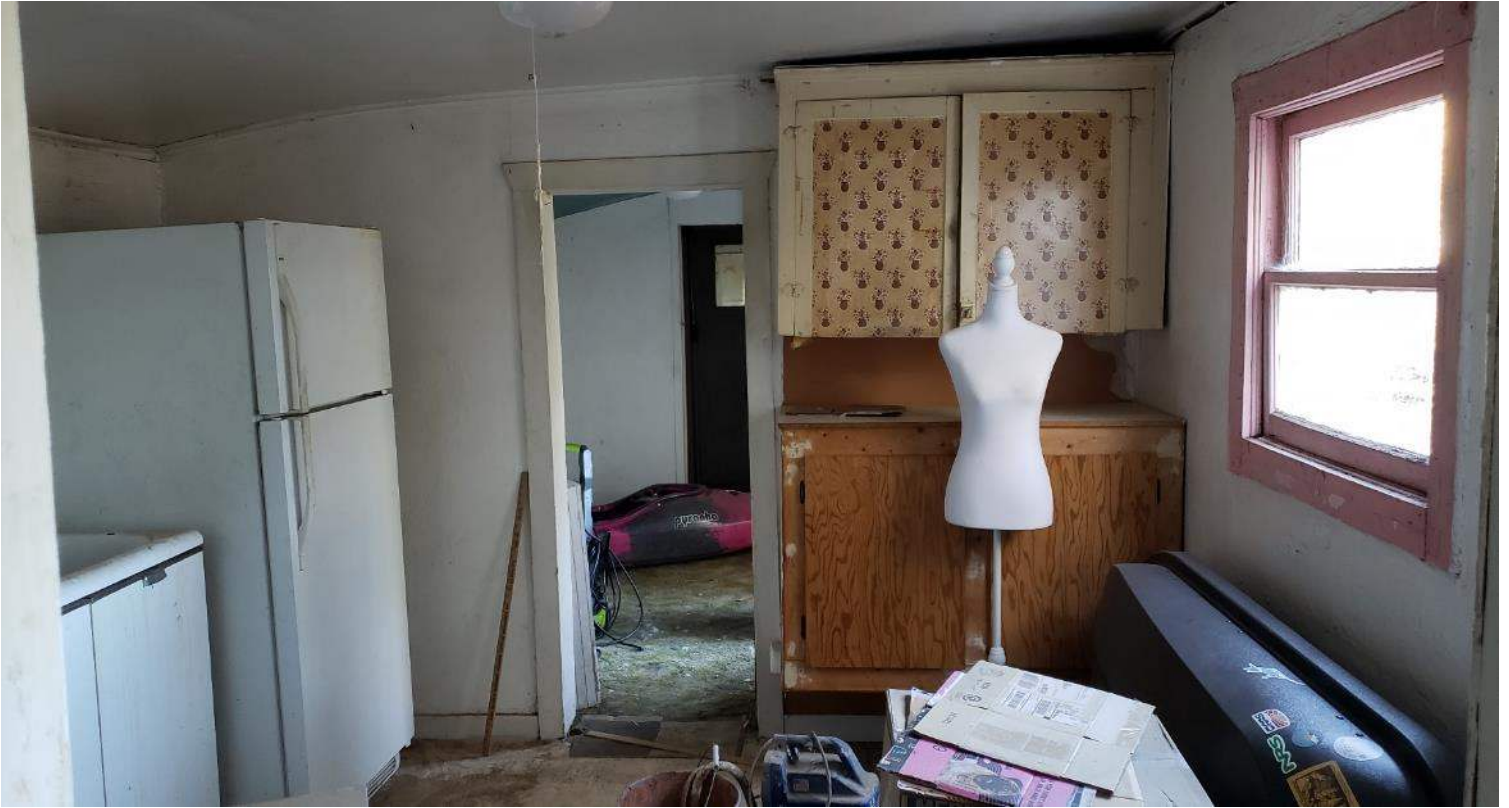
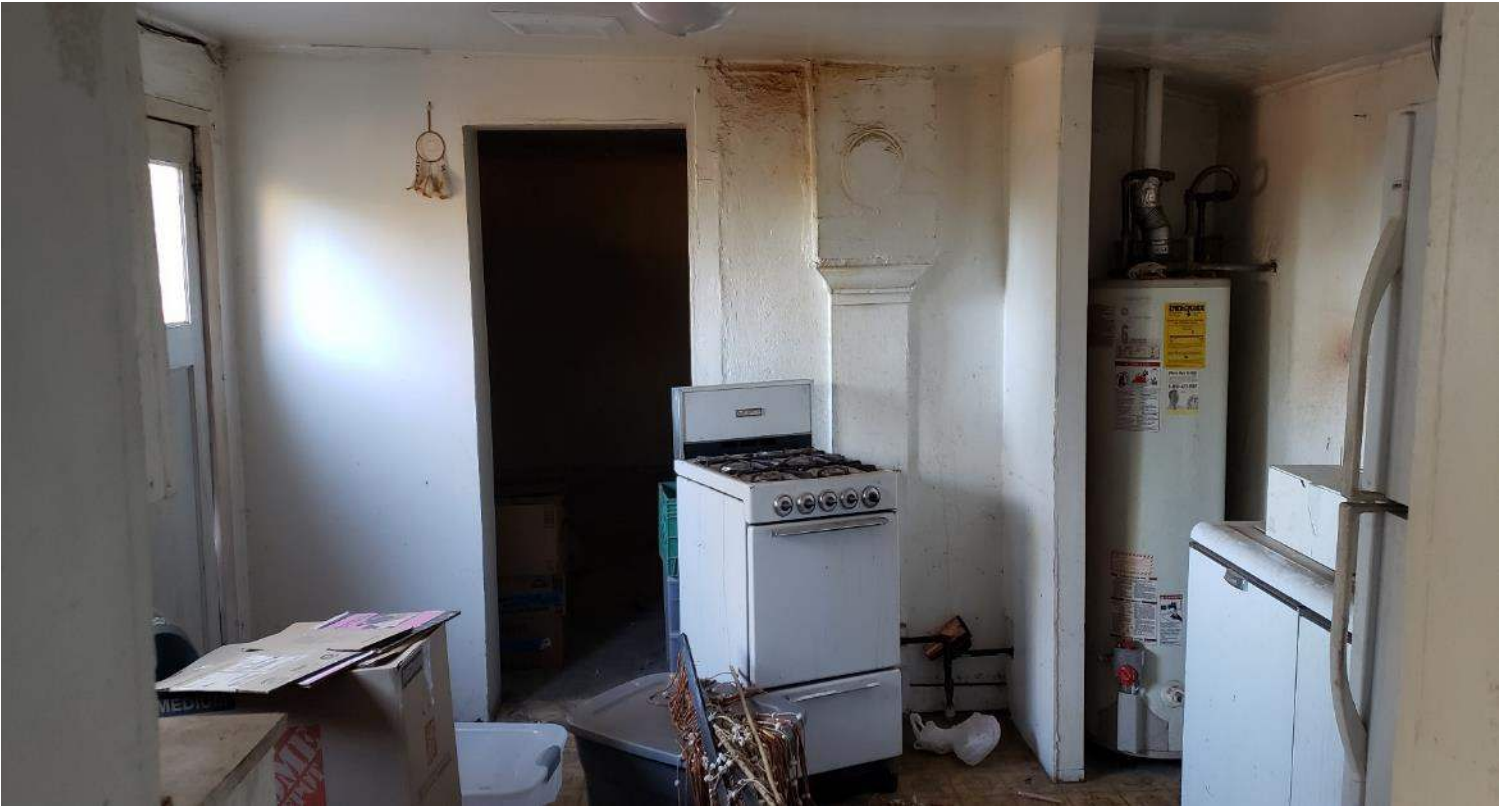
Photos 19–20. 814 W Coconino Ave ADU kitchen E½ to E with living room in background (top) and kitchen W½ to W from living room doorway (bottom).
