*RE: Cultural Resource Study Letter Report for Parcel 100-31-013 at 814 West Coconino Avenue, City of Flagstaff, Coconino County, Arizona (PZ-26-00040; LA Neal Consulting, LLC Project No. 1110-25)*

### Property Description/Architecture

## Summary and Determination of Effects

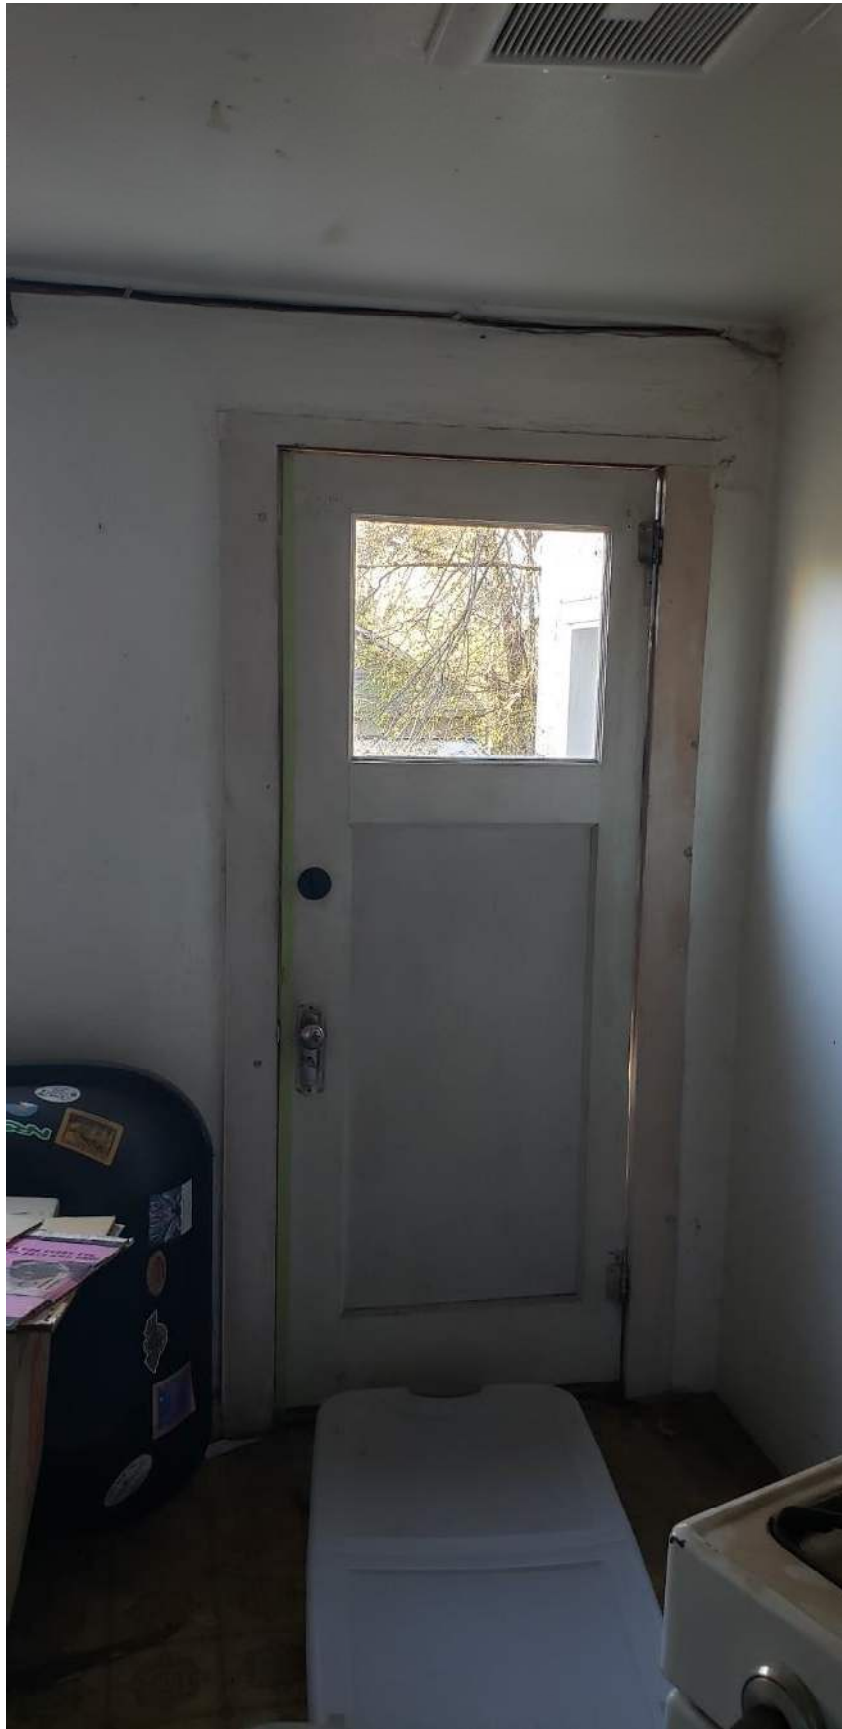
The interior, moving east to west, has a bathroom (*Photos 12–14*), living room (*Photos 15–18*), kitchen (*Photos 19–21*), bedroom with closet (*Photos 22–25*), and southwest corner utility room (possibly used as a bedroom at some point, *Photos 26–27*). The most recent heat sources are free-standing gas stoves in the northwest corners of the bedroom and living room. It is also obvious that the brick chimney that projects outward from the shared bedroom/kitchen wall once served to vent presumably wood-burning stoves in both rooms. No fixed heat source was specified on the 1966–1980s Residential Property Record Card. The ceilings and underlying interior walls are plastered with fabricated wood paneling and drywall introduced over the plaster and replacing it in some rooms. A patch of wall in the bathroom where a sink was once installed shows the paint history of white over beige over pink over dark green (see *Photo 14*), and a swirled green formica-like composite laminate was installed in the lower tub/shower area of the bathroom (see *Photo 13*). The floors are wood, including ¾-inch tongue-and-groove planking (3¼" and 6¼" wide), covered with carpet and linoleum. The bathroom floor likely had an overlayment treatment but is currently bare wood planking. Overall, the interior treatments and materials are mostly indicative of the ca. 1950s and later remodeling, but the structure's origins are apparent when one pulls away the layers. The house is in poor structural condition and is of low architectural interest in general and within the context of Flagstaff's history. The building was identified as consisting of three rooms of minimal construction quality in the late 1960s per the Residential Property Record Card, but by 1980 the grade was listed as good. This notation would indicate improvements were made to garner this ranking. The dwelling has fallen back into disrepair to the point that it is not structurally sound enough to be occupied and is considered unsafe and uninsurable.

Photo 21. 814 W Coconino Ave ADU front/kitchen door to S.

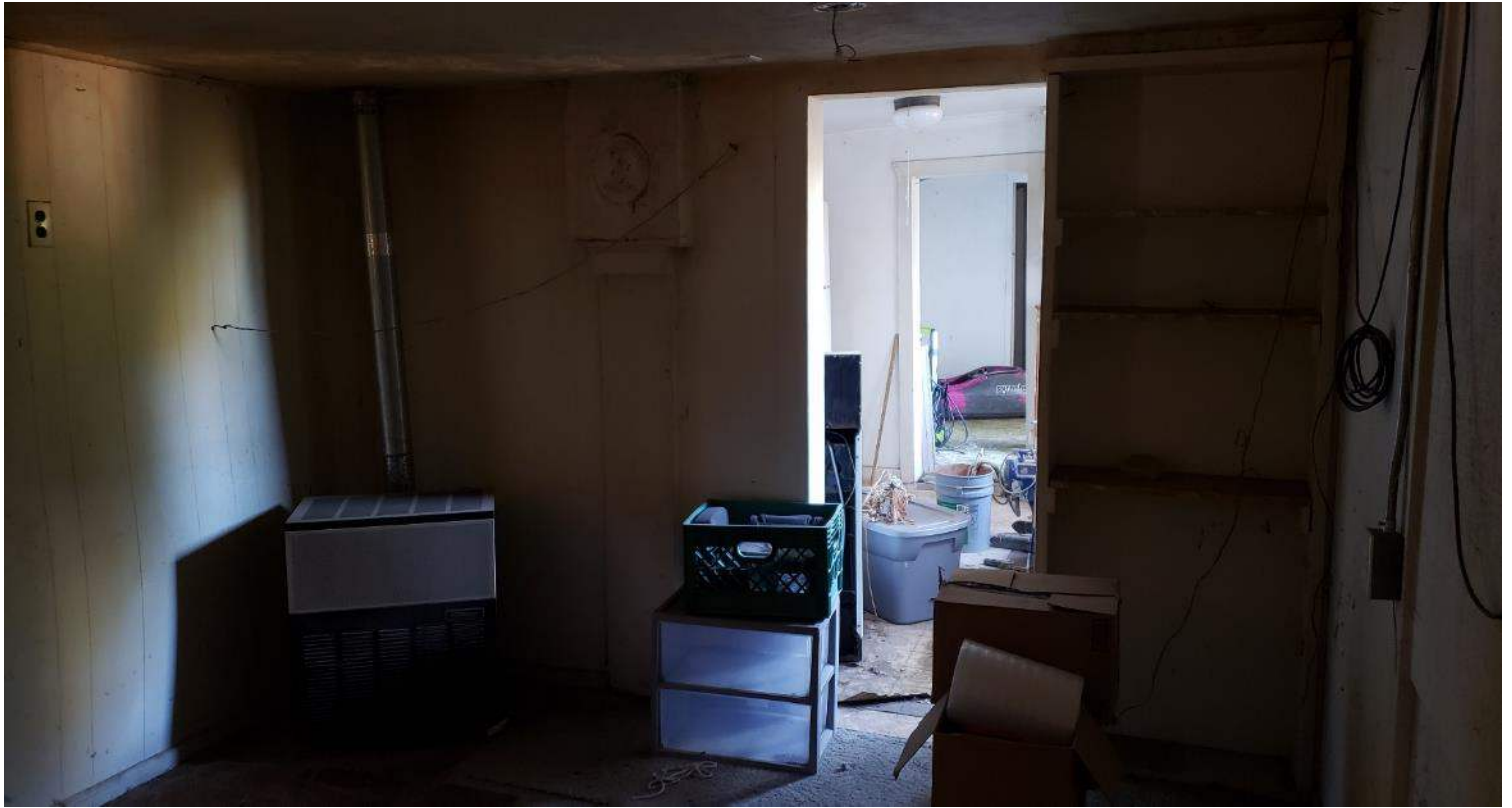
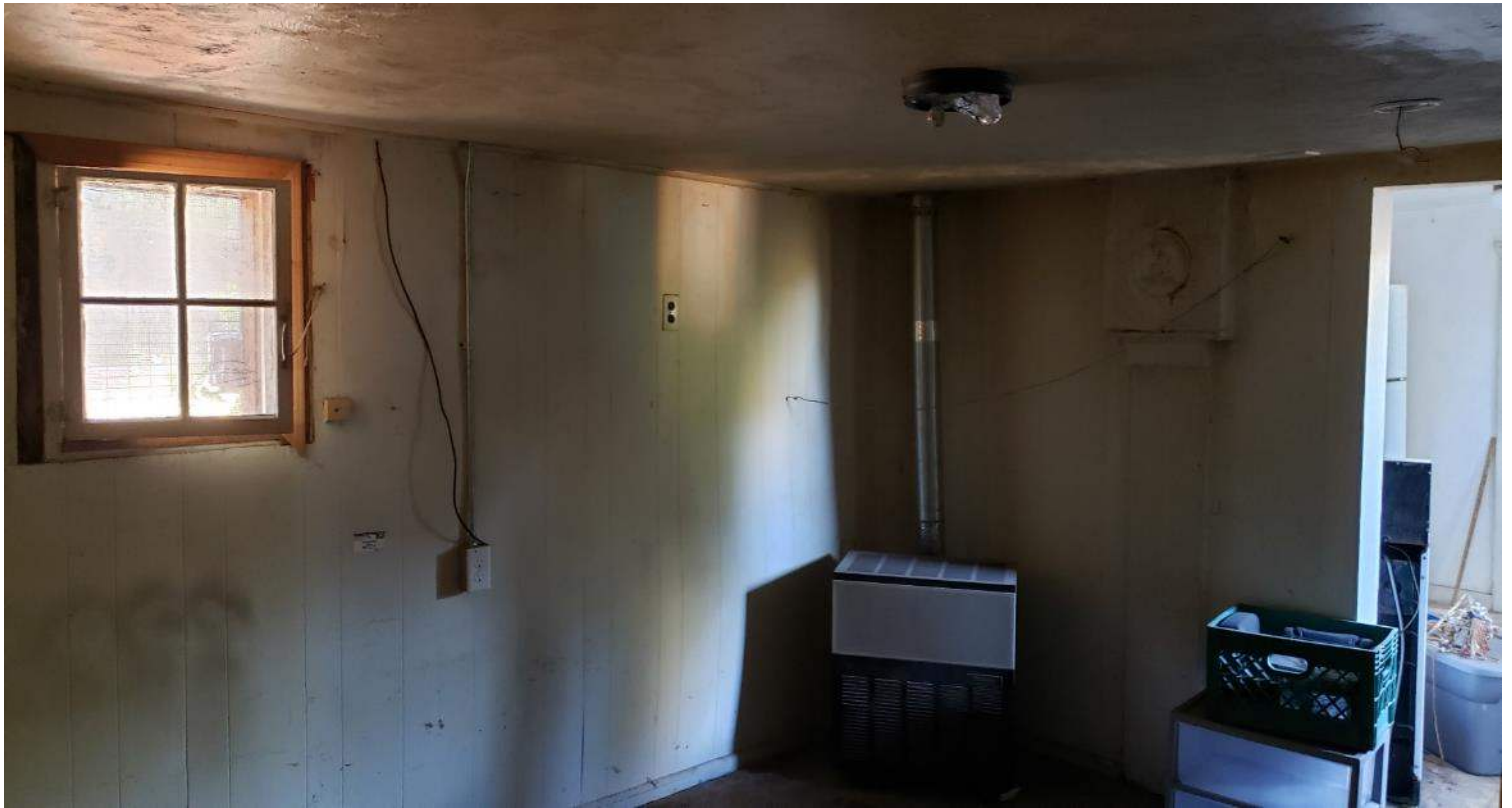
Photos 22–23. 814 W Coconino Ave ADU bedroom E½ to ENE at W end of building looking through to kitchen and living room (top) and bedroom NE corner to NE (bottom).

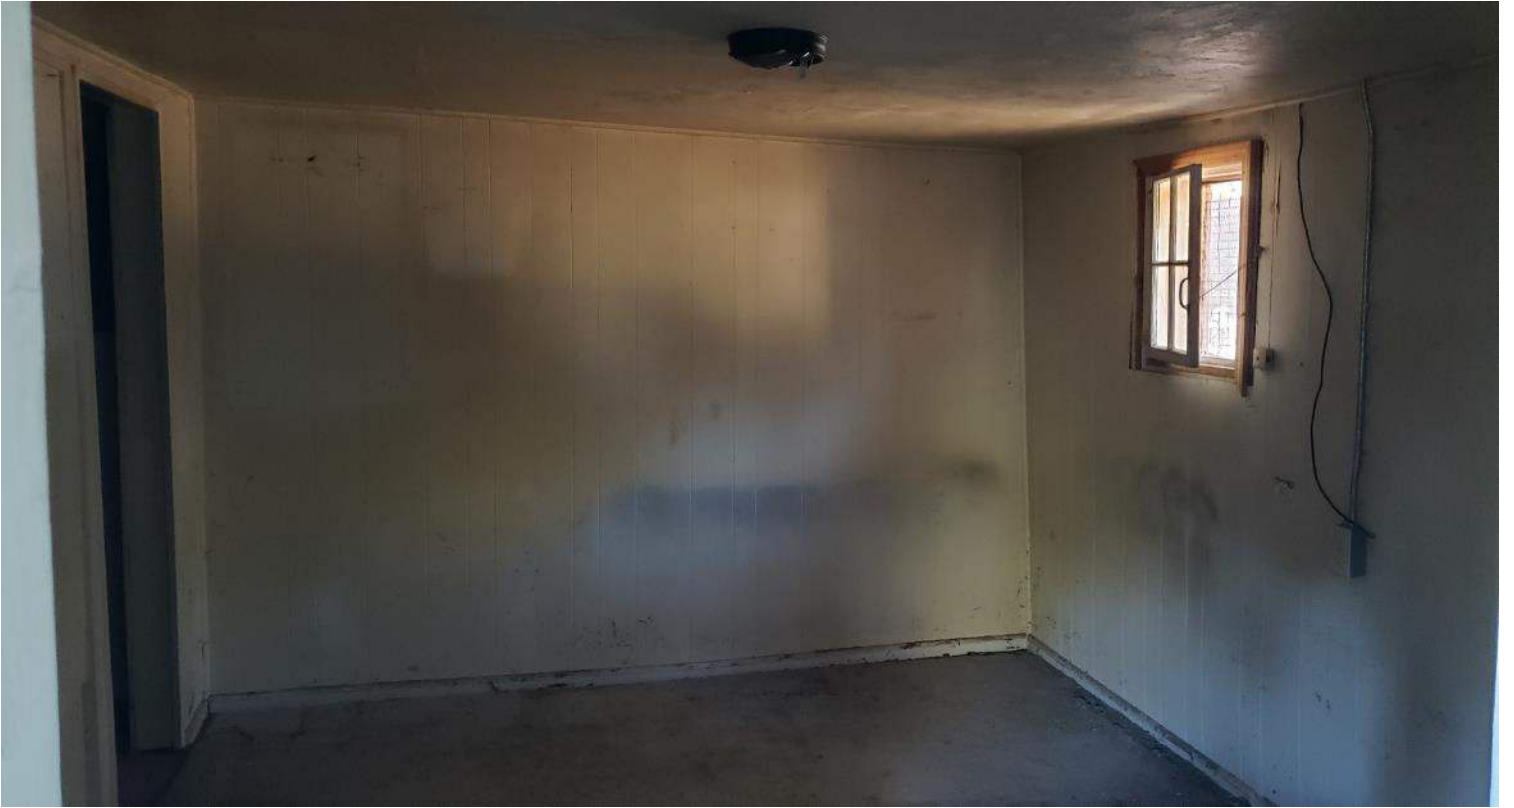
Photo 24. 814 W Coconino Ave ADU bedroom W $\frac{1}{2}$  to WNW with closet opening to the left.

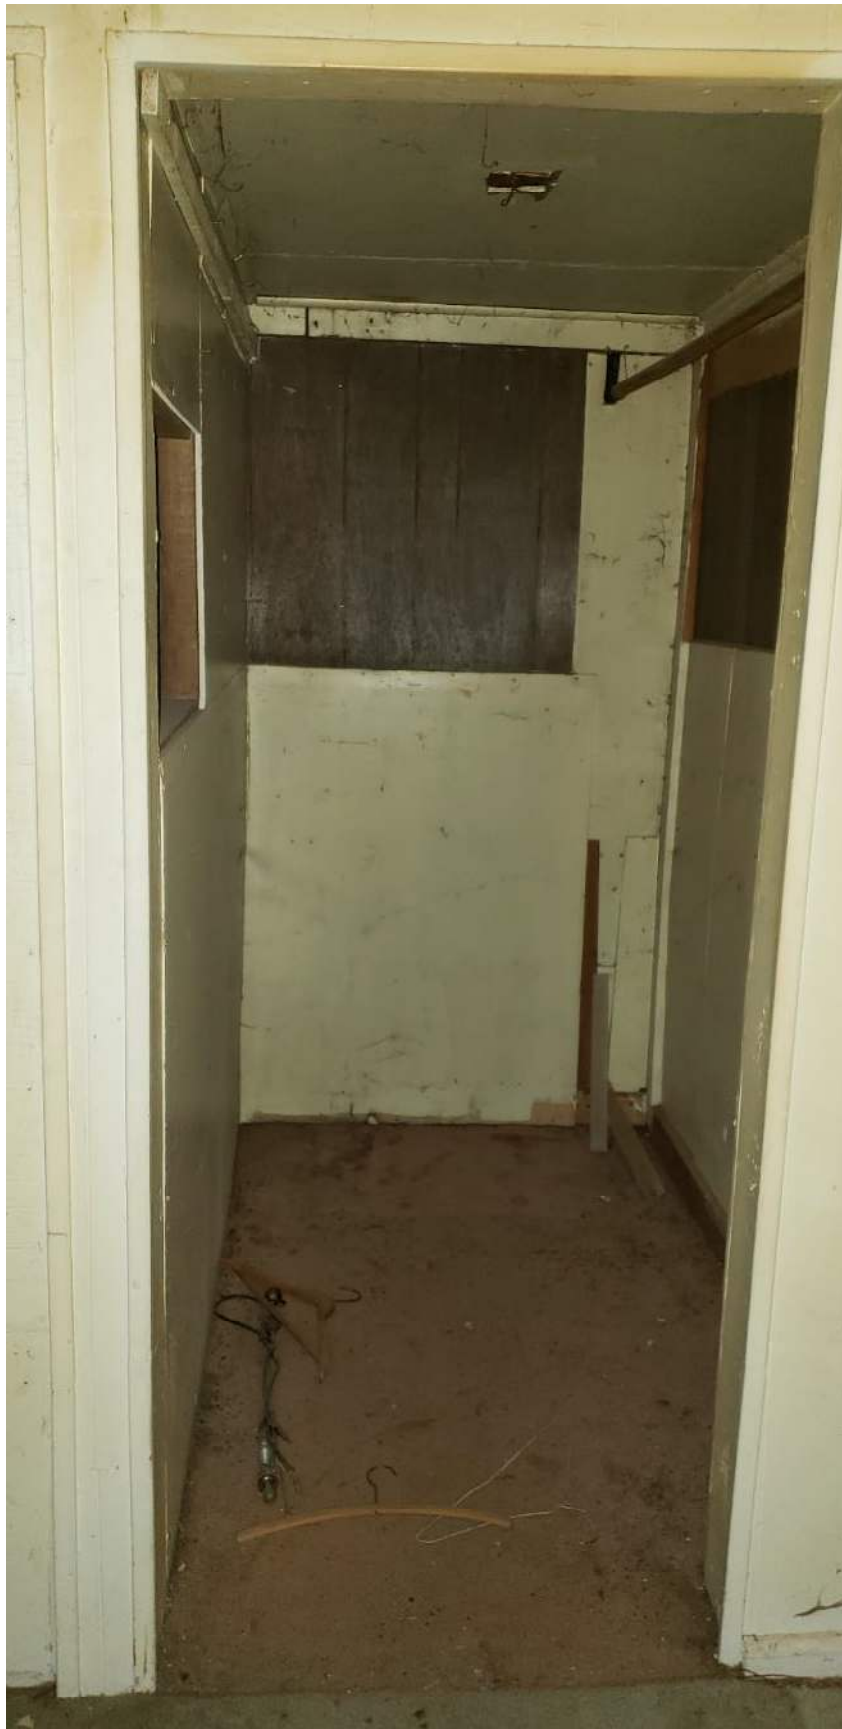
Photo 25. 814 W Coconino Ave ADU closet off bedroom's SW corner to S.

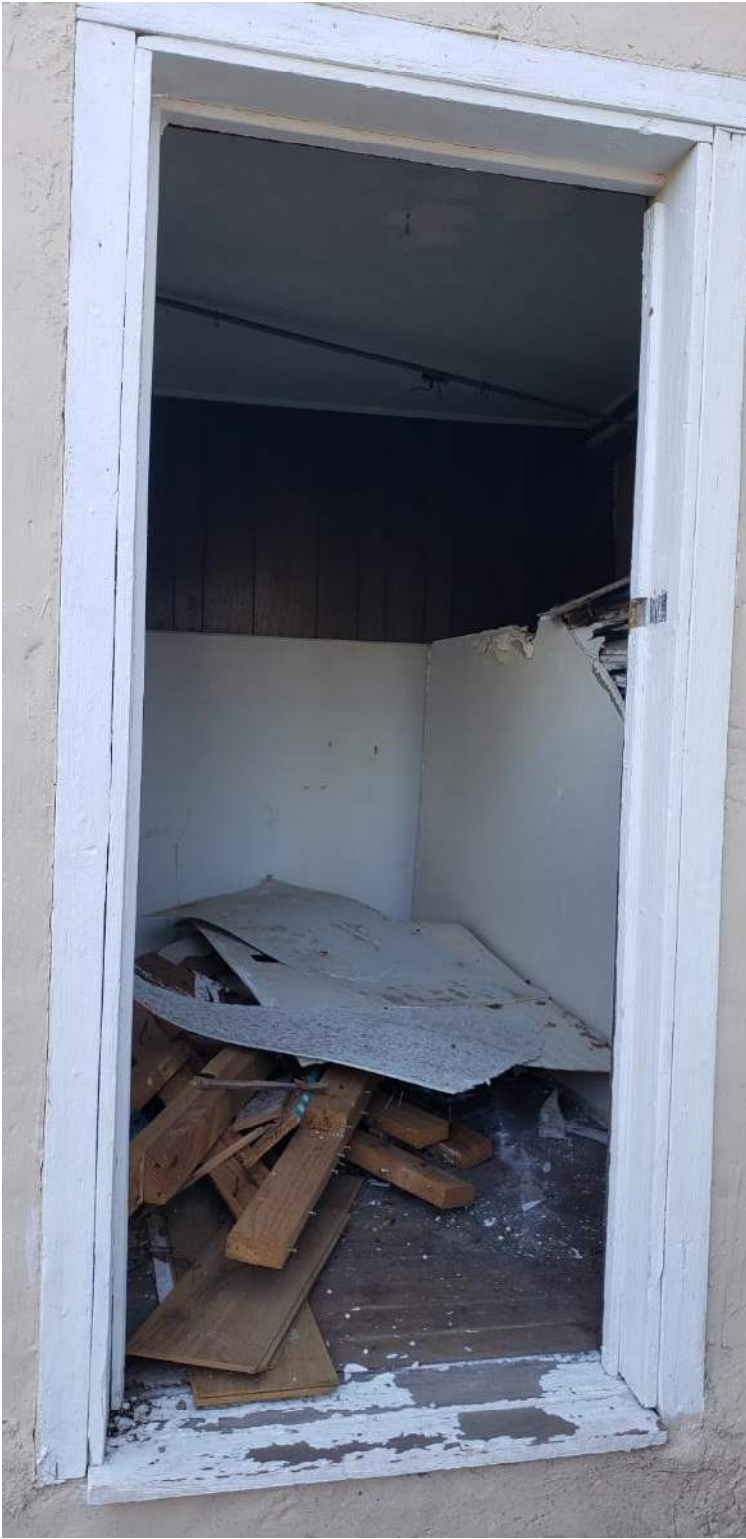
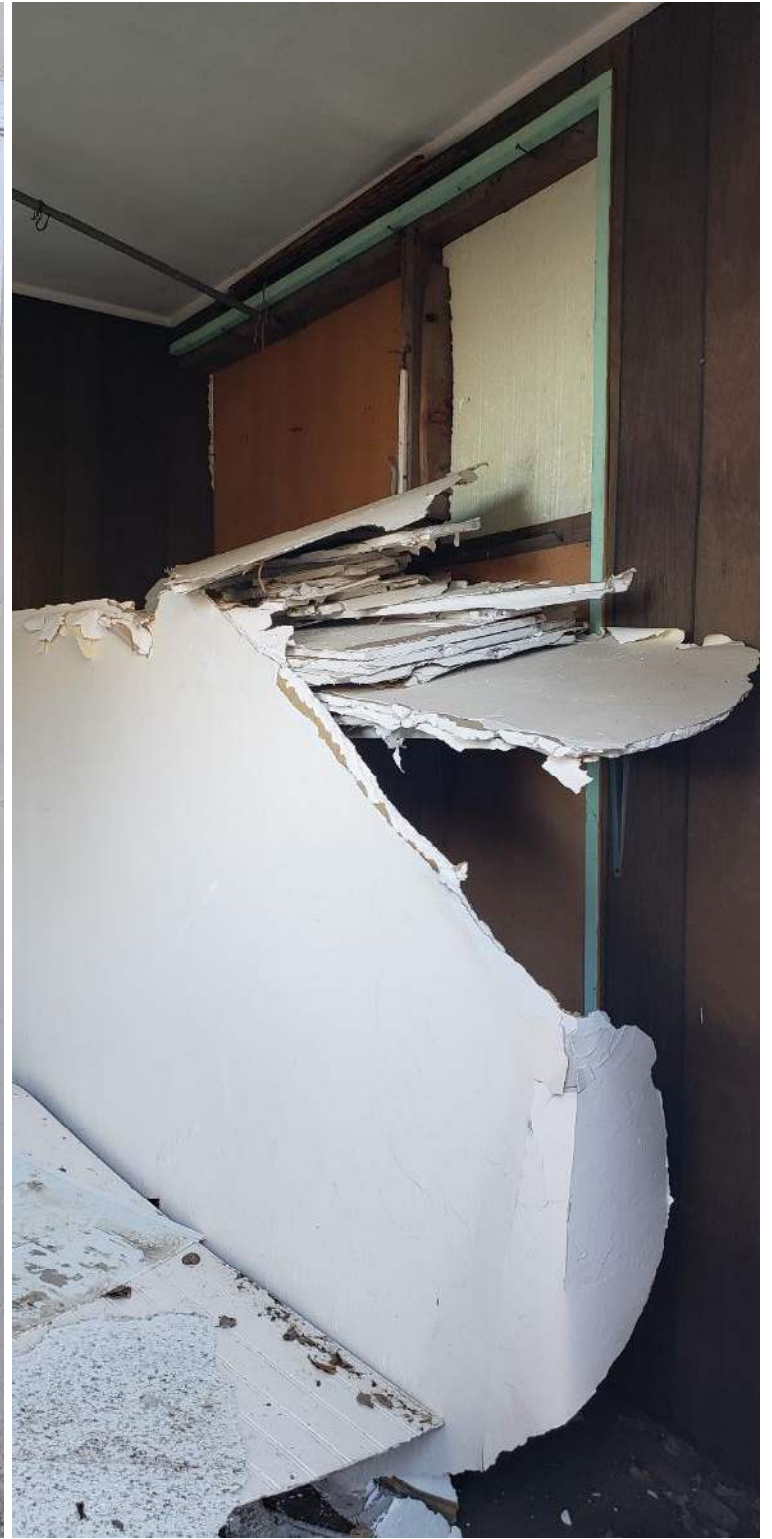
Photos 26–27. 814 W Coconino Ave ADU utility room to WNW off building's SW corner (top) and to NW from exterior doorway (bottom).
