ENVIRONMENTAL SITE ASSESSMENT

Indian River Drive Properties:

Fort Pierce, Florida

DLS Environmental Services, Inc.
1901 SW Yellowtail Avenue
Port St. Lucie, Florida 34953
(772)215-3997

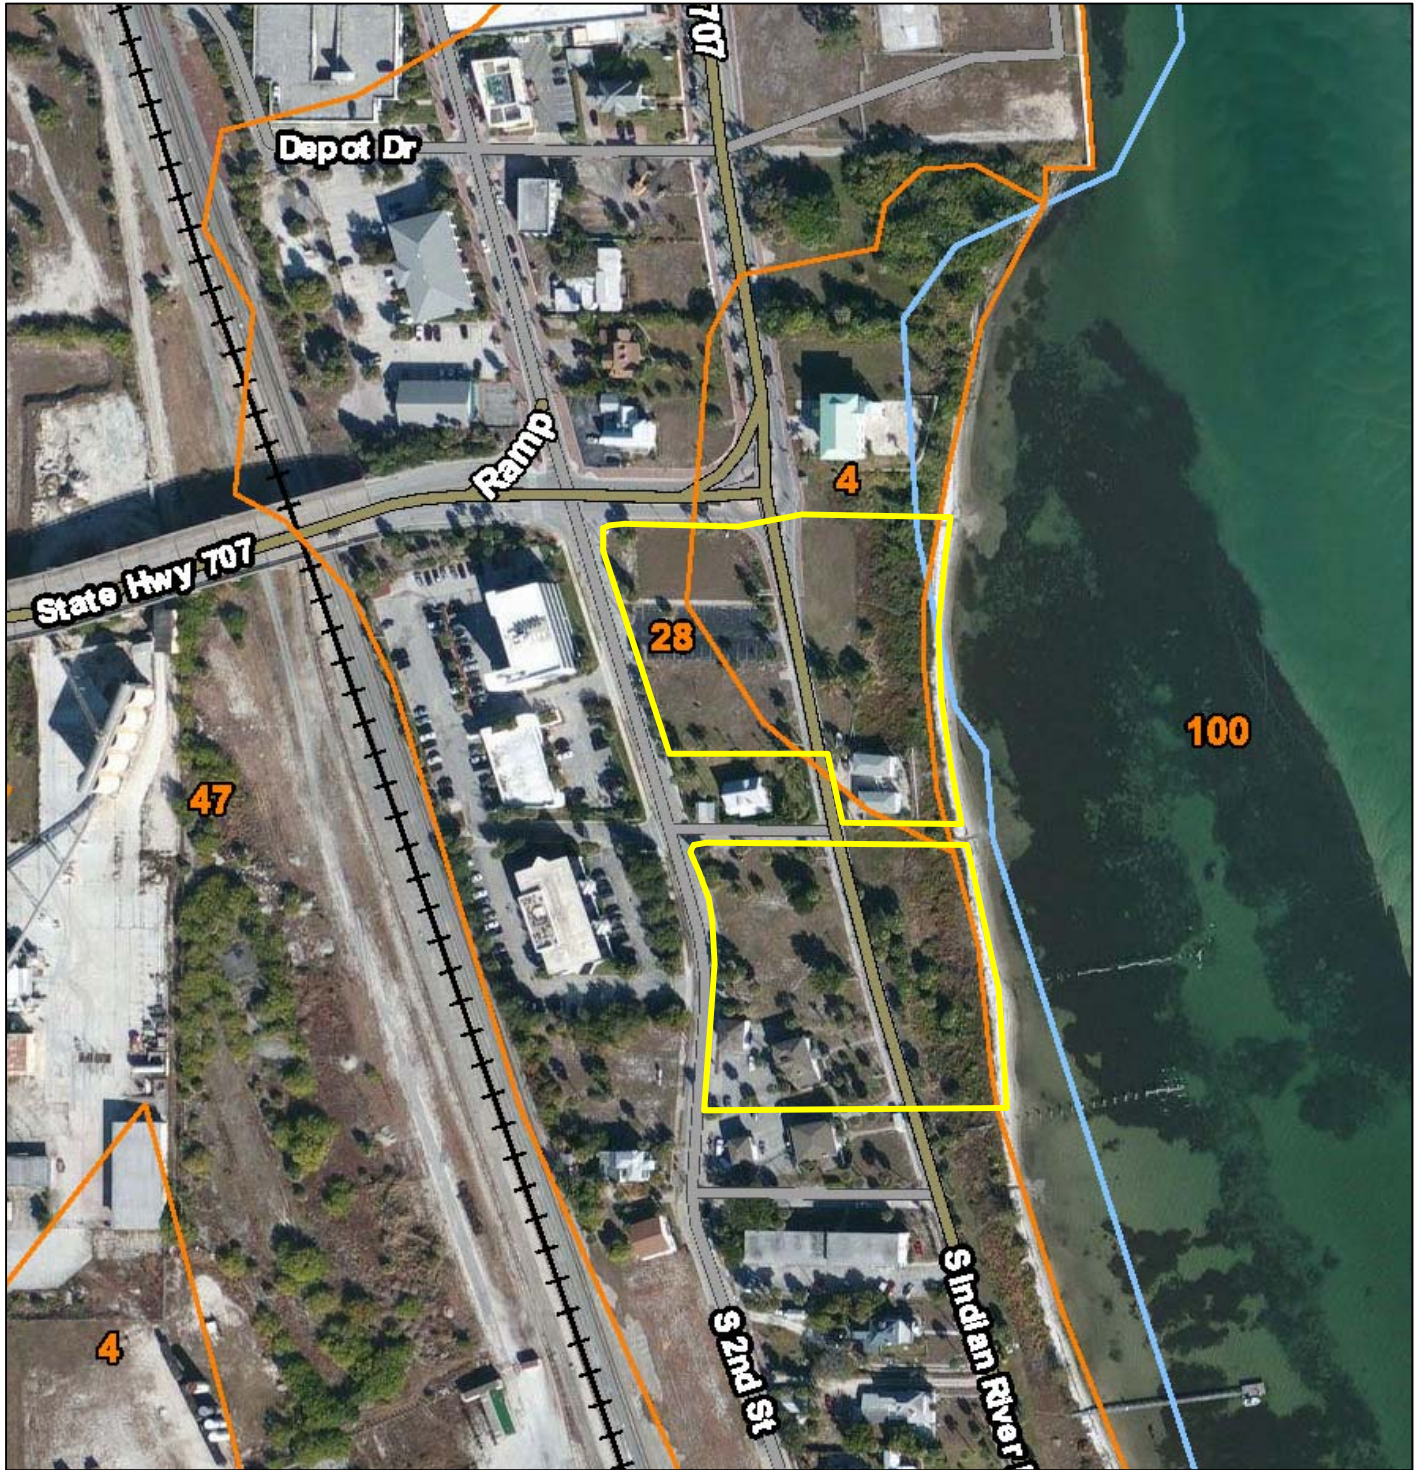
FIGURE 2

SOILS:
 ARENTS, 0 TO 5 PERCENT SLOPES (4)
 PAOLA SAND (28)

Soils Map

Project soils were mapped according to the *Soil Survey of St. Lucie County Area, Florida*, March 1981, United States Department of Agriculture, Soil Conservation Service. A copy of the Soil Survey Map depicting the project boundaries and soil type(s) is included as **Figure 2**. The project site contained two soil mapping units. A general description of the soil types are as follows:

Arents, 0 to 5 percent slopes (4)

This soil consists of soil material dug from several areas that have different kinds of soil. It is used to fill such areas as low sloughs, marshes, shallow depressions, and swamps above their natural ground levels. Depth of fill material ranges from about 20 to 50 inches. Several kinds of mineral soils underlie the fill material. The water table in this Arents soil is between depths of 20 and 50 inches most of the year.

Paola Sand (28)

This nearly level to sloping soil is excessively drained. It is on high dune-like ridges and in undulating areas. Slopes are smooth to convex or concave. Included in this mapping layer of Paola soil are small areas of Astatula, St. Lucie, and Welaka Variant soils. This soil does not have a water table within a depth of 80 inches, and usually it is not within a depth of 120 inches annually and permeability is very rapid. Typical natural vegetative associations include sand pine, scrub live oak, rosemary, and cabbage palms.

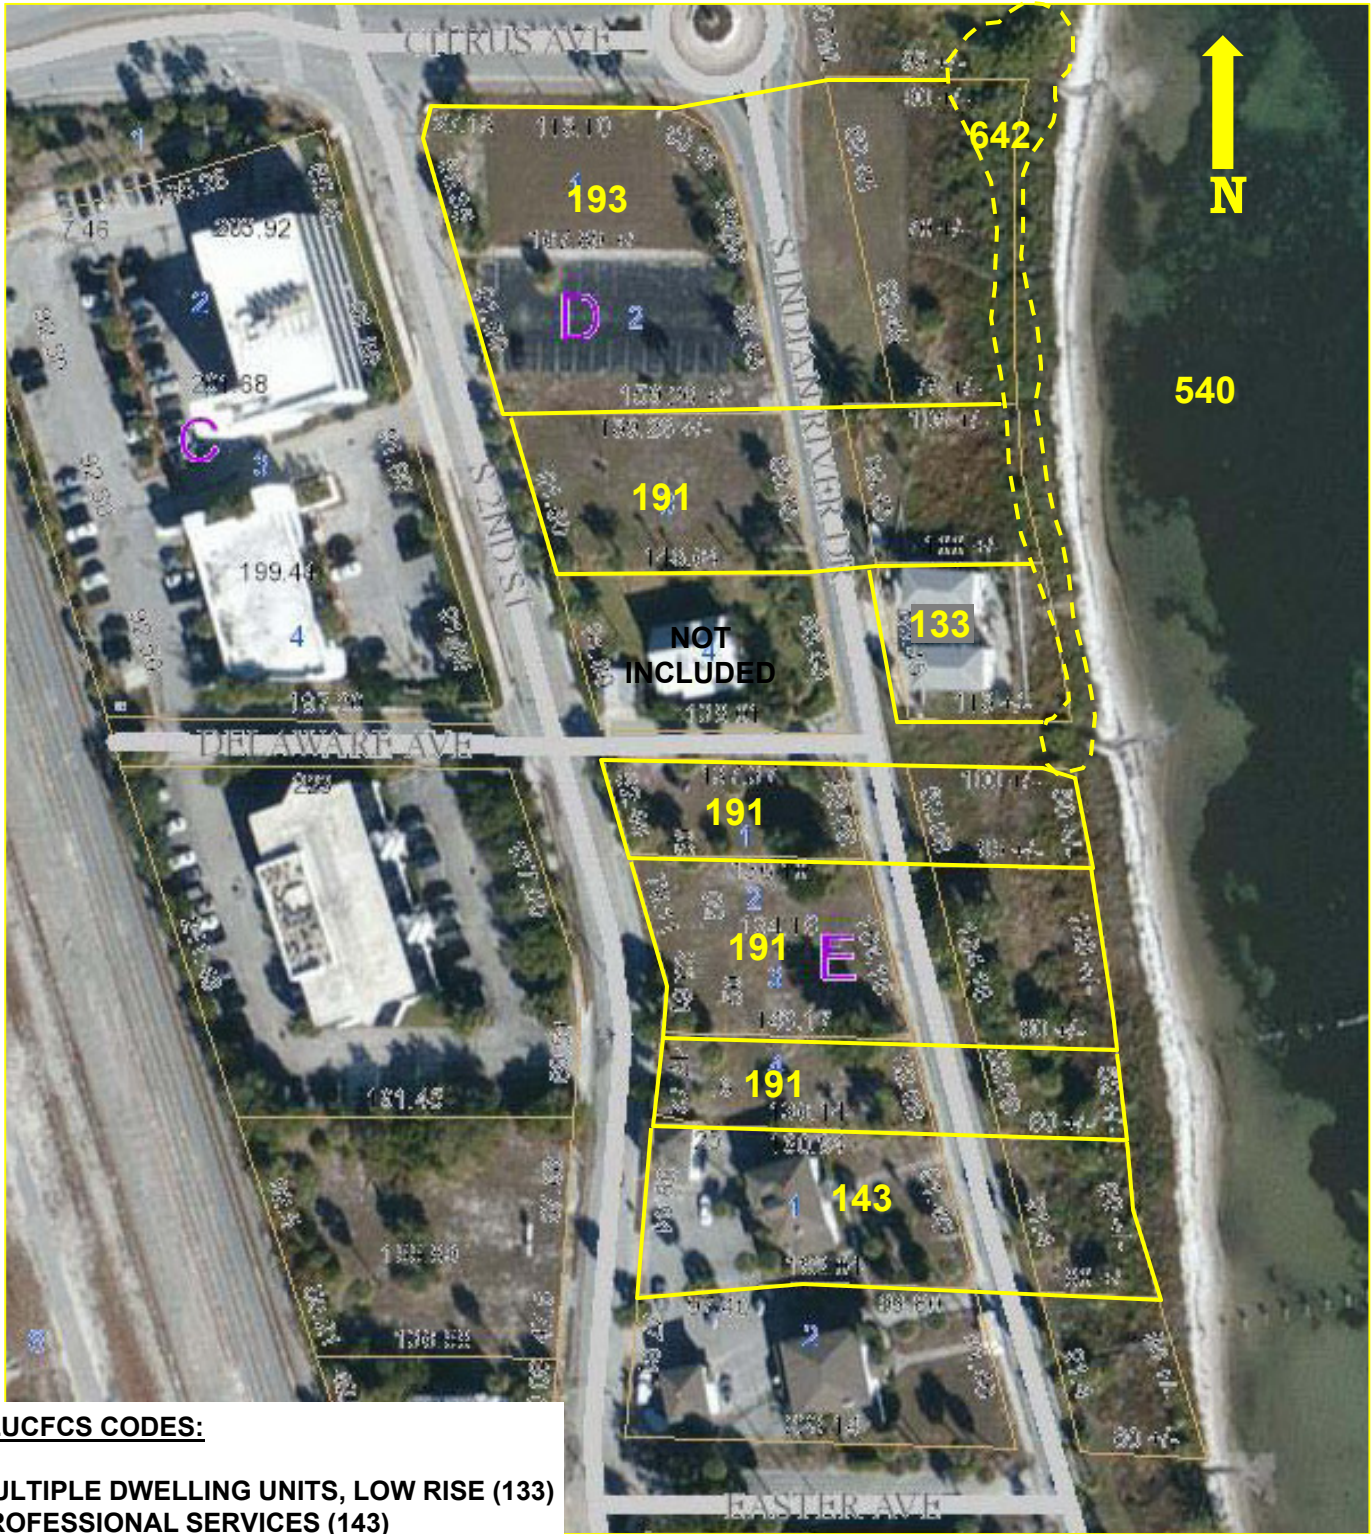
FIGURE 3

- MULTIPLE DWELLING UNITS, LOW RISE (133)
- PROFESSIONAL SERVICES (143)
- UNDEVELOPED LAND IN URBAN AREAS (191)
- URBAN LAND IN TRANSITION (193)
- SALTWATER MARSHES (642)
- BAYS AND ESTUARIES (540)

FLUCFCS Map

The FLUCFCS map is depicted as **Figure 3** and contained the following community designations:

- **133 – Multiple dwelling units, low rise**
This property is currently a 4-unit apartment complex. There is a narrow strip of wetlands adjacent to the shoreline associated with this property which has been assigned a different FLUCFCS number appropriate to that community.
- **143 – Professional services**
This property is currently a mixed use with a residence and an attorney’s office.

- **191 – Undeveloped land in urban areas**
It appears that the majority of the properties involved in this environmental assessment would fall into this category since there are no structures on most of them. The only remaining vegetation on these vacant parcels is mowed ground cover and some cabbage palms.
- **193 – Urban land in transition**
This property contains an asphalt parking lot however the future use is unknown.
- **642 – Saltwater marshes**
A narrow strip of property adjacent to the shoreline on the northern parcels contained cordgrass (*Spartina alterniflora*), three-square (*Scirpus americanus*), and salt grass (*Distichlis spicata*).
- **540 – Bays and estuaries**
The properties involved in this site assessment all have frontage on the Indian River. This location of the Indian River does support seagrasses.

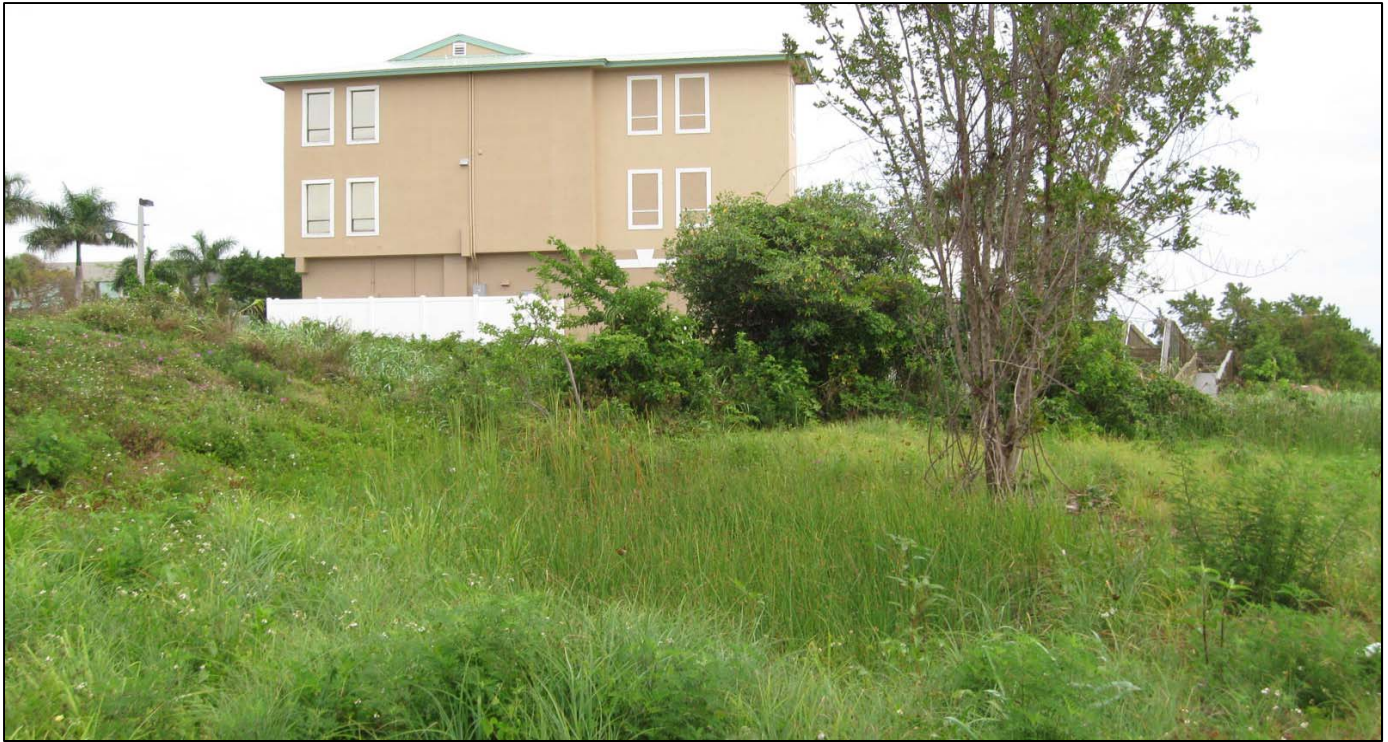
Photo looking north at wetland area in the northeast corner of 401 S. Indian River Drive.
Mangroves in the background are off-site.

The project site was reviewed for potential wetlands based upon the methodologies identified in Chapter 62-340, Florida Administrative Code which consists of reviewing the area for vegetation, soils, and hydrologic indicators. Based upon this review, a strip of wetlands was identified adjacent to the shoreline on the northern parcels identified in this site assessment.

Any impacts to the wetland area or any proposed docking facilities would require authorizations from both the Florida Department of Environmental Protection and the U.S. Army Corps of Engineers regardless of the land use assigned to the properties.

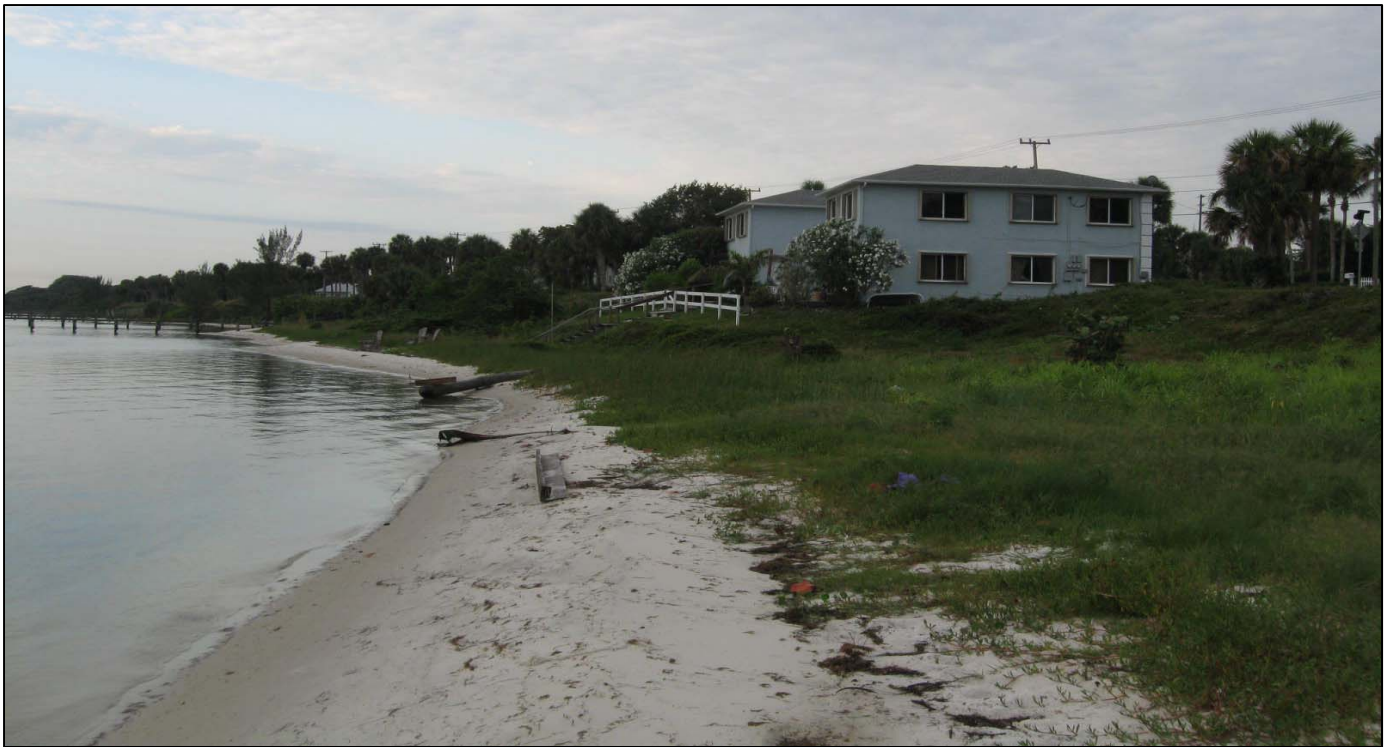
Photo looking south at strip of wetlands along shoreline of 401, 411, and 426 S. Indian River Drive.

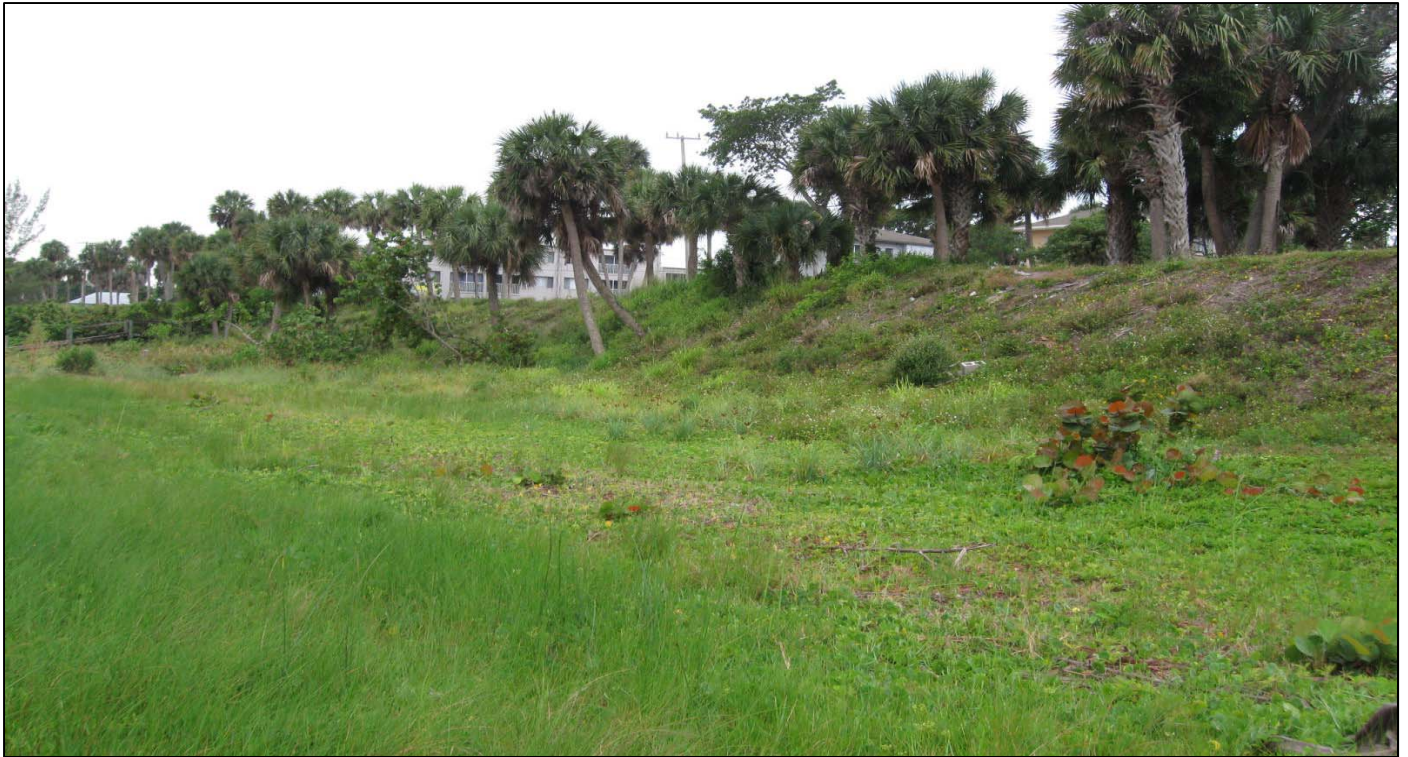
Photo looking south along area on east side of Indian River Drive for 500, 507, 509, and 519 S. Indian River Drive.

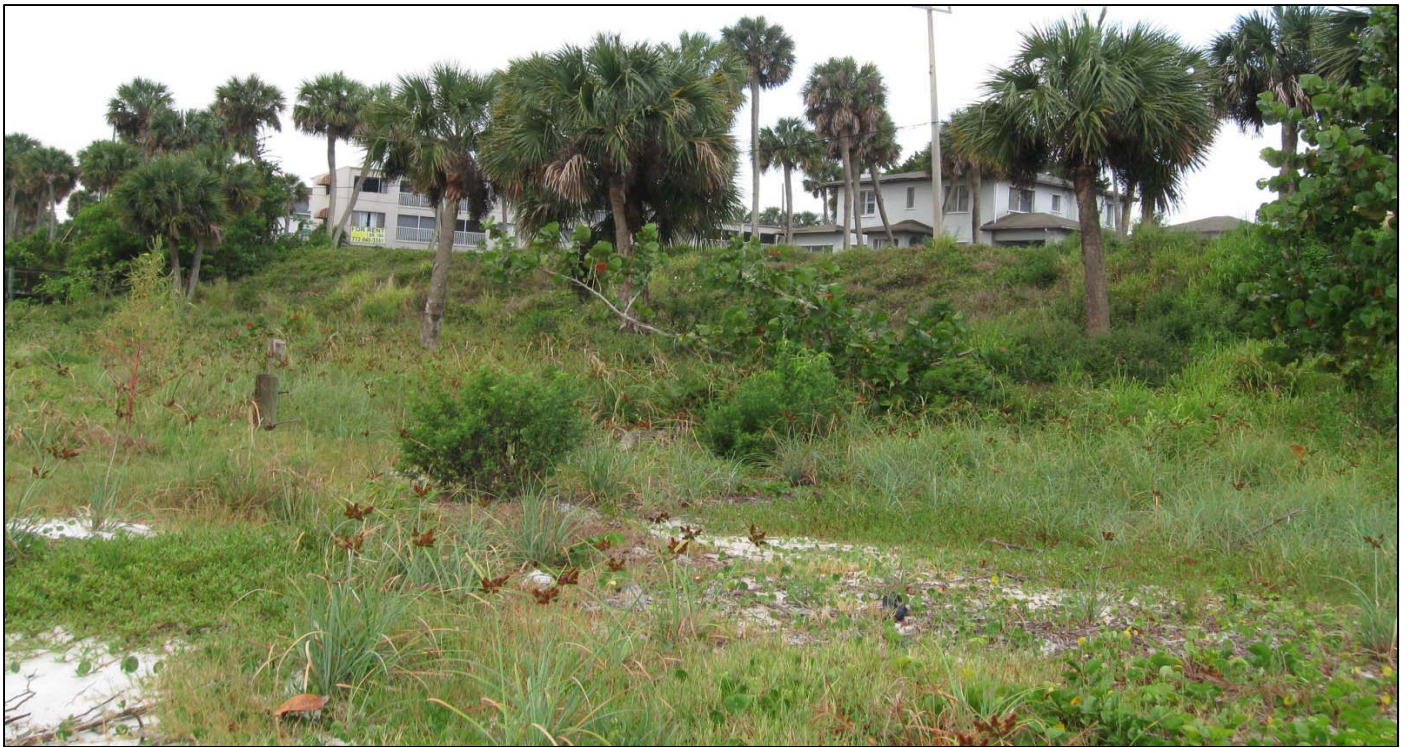
Photo showing bank and existing vegetation associated with 507, 509, and 519 S. Indian River Drive.

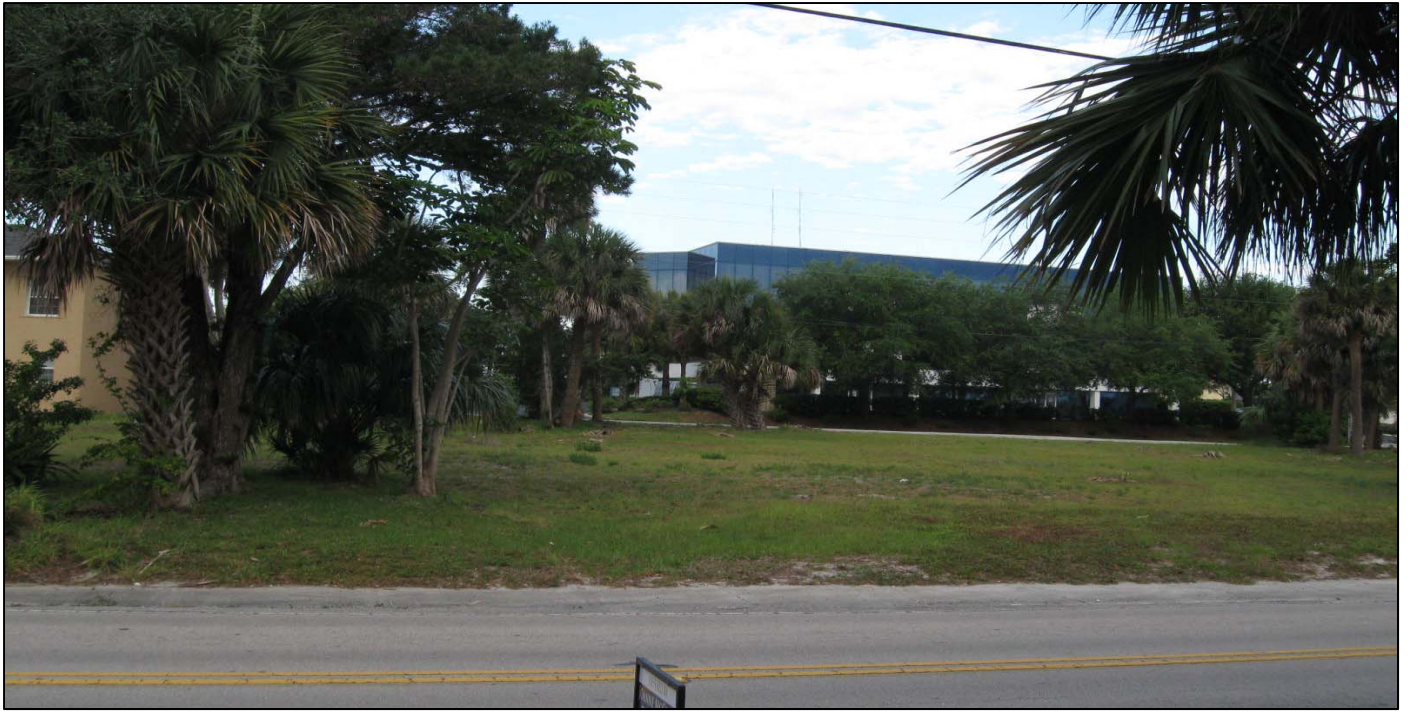
Photo looking at vacant parcels 500, 507, and 509 S. Indian River Drive.

Based upon a review of aerials from 2000, all of the currently vacant properties within the project area had structures at that time. The majority of these structures appear to be residential except for the parcel at the southwest corner of Citrus and Indian River Drive. It appears that these structures were removed between 2007 and 2011 and the properties remain vacant.

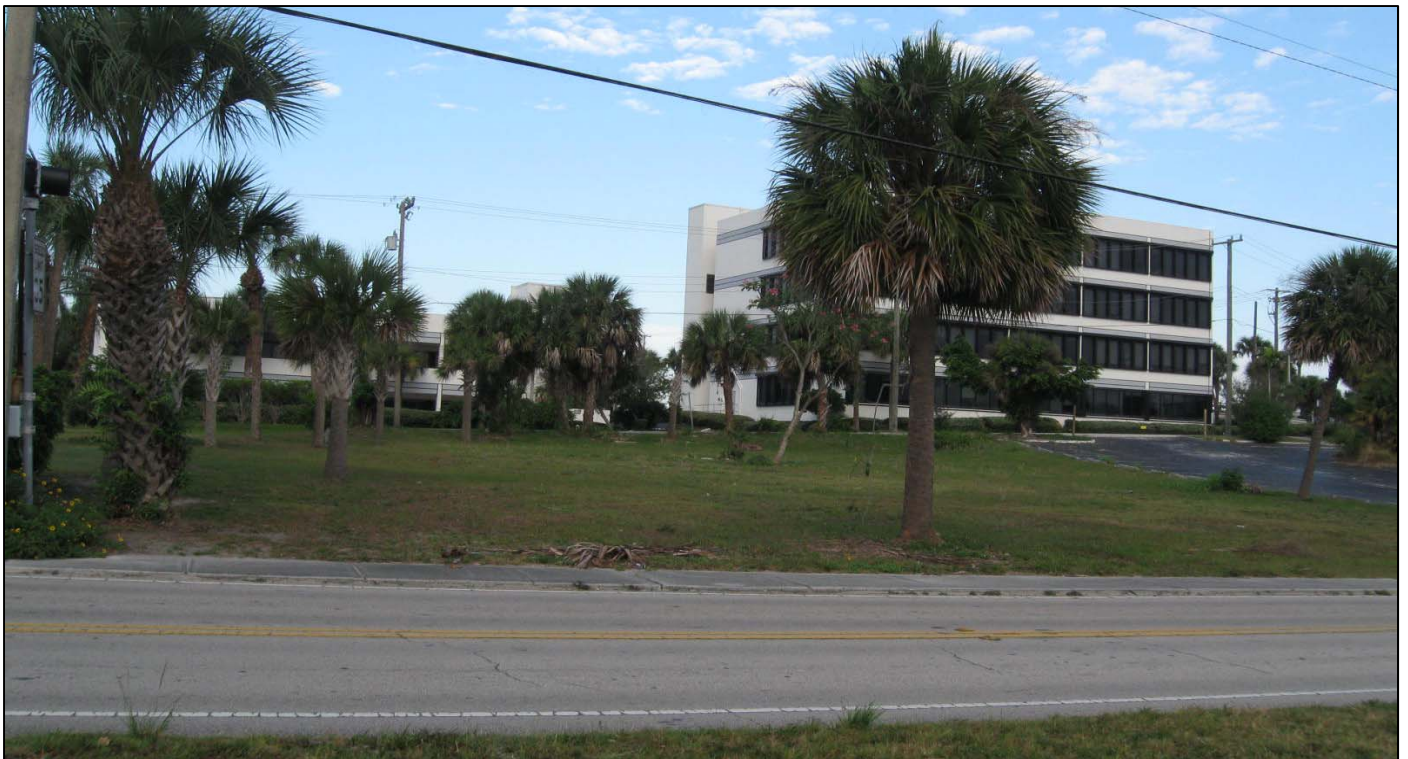
Photo looking at vacant parcel with parking area at 401 S. Indian River Drive.
