FT. PIERCE PRECAST & CONCRETE FACILITY

ENVIRONMENTAL IMPACT REPORT

August 2016

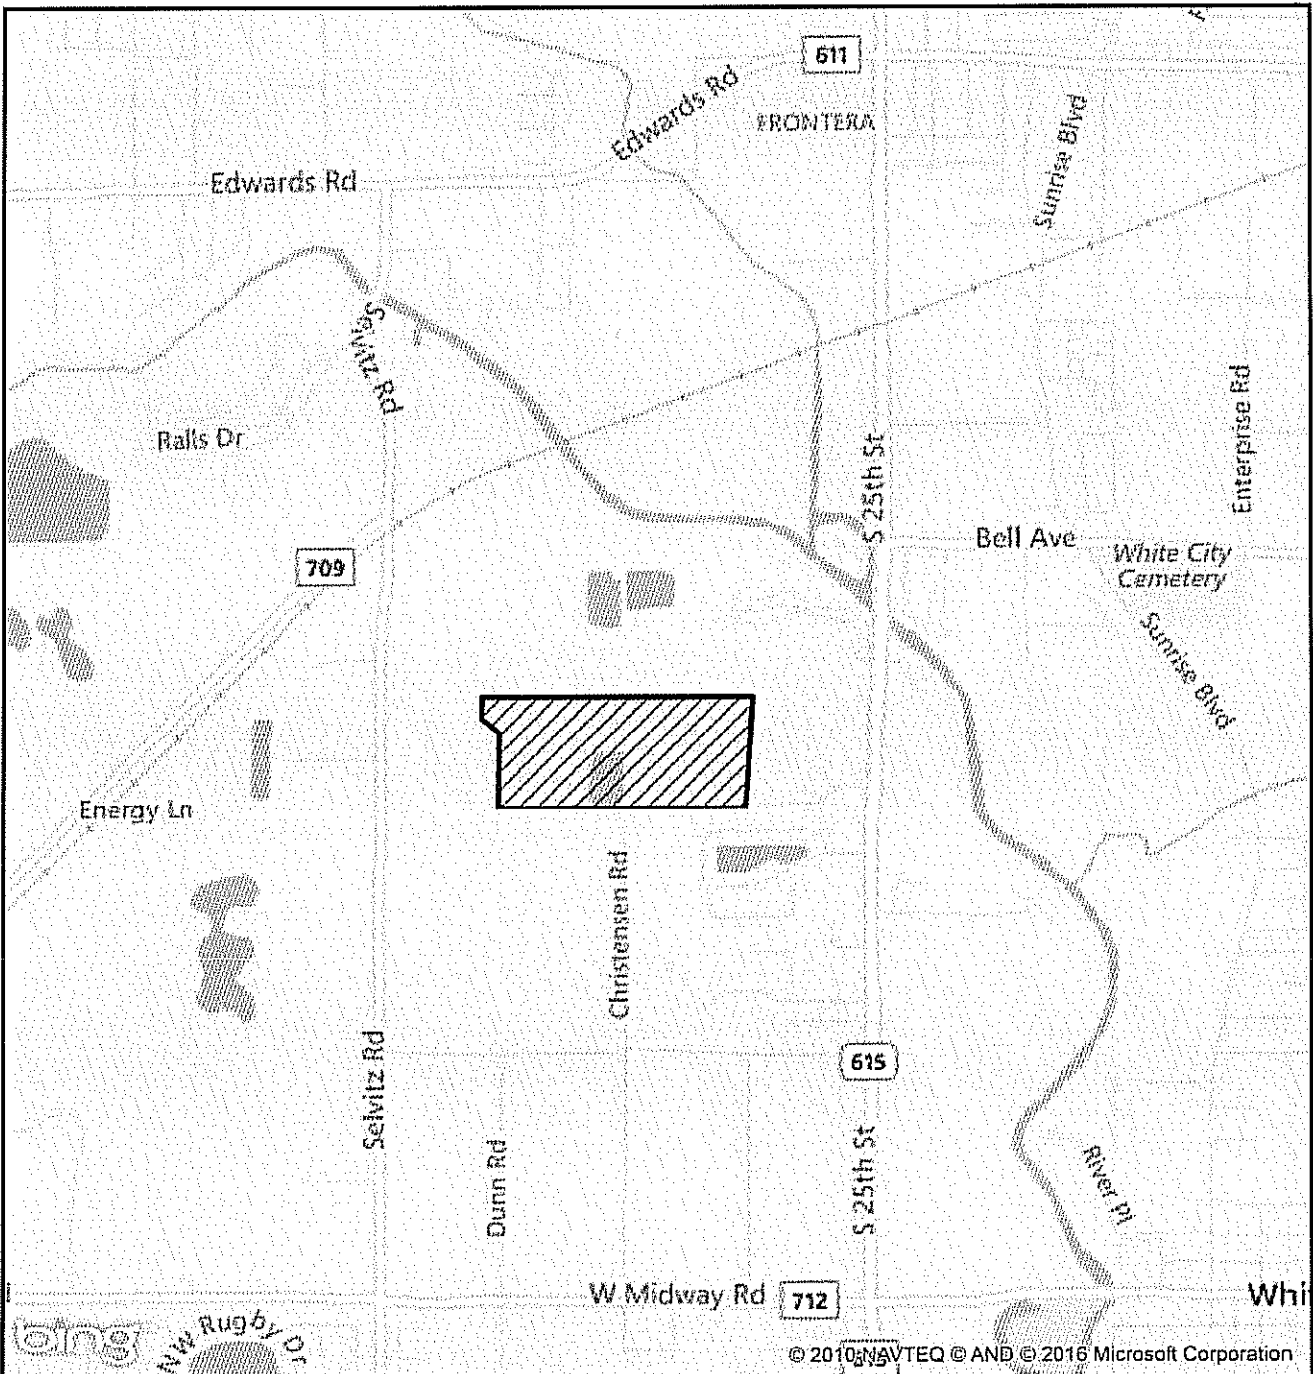
1. SOILS REPORT

A soils map obtained from the USDA Web Soil Survey and with the property boundary is attached in Appendix A of this report. According to the soil map, seven soil types are found on the subject property. The description of these soils, in their natural state, according to the St. Lucie County Soil Survey is provided below:

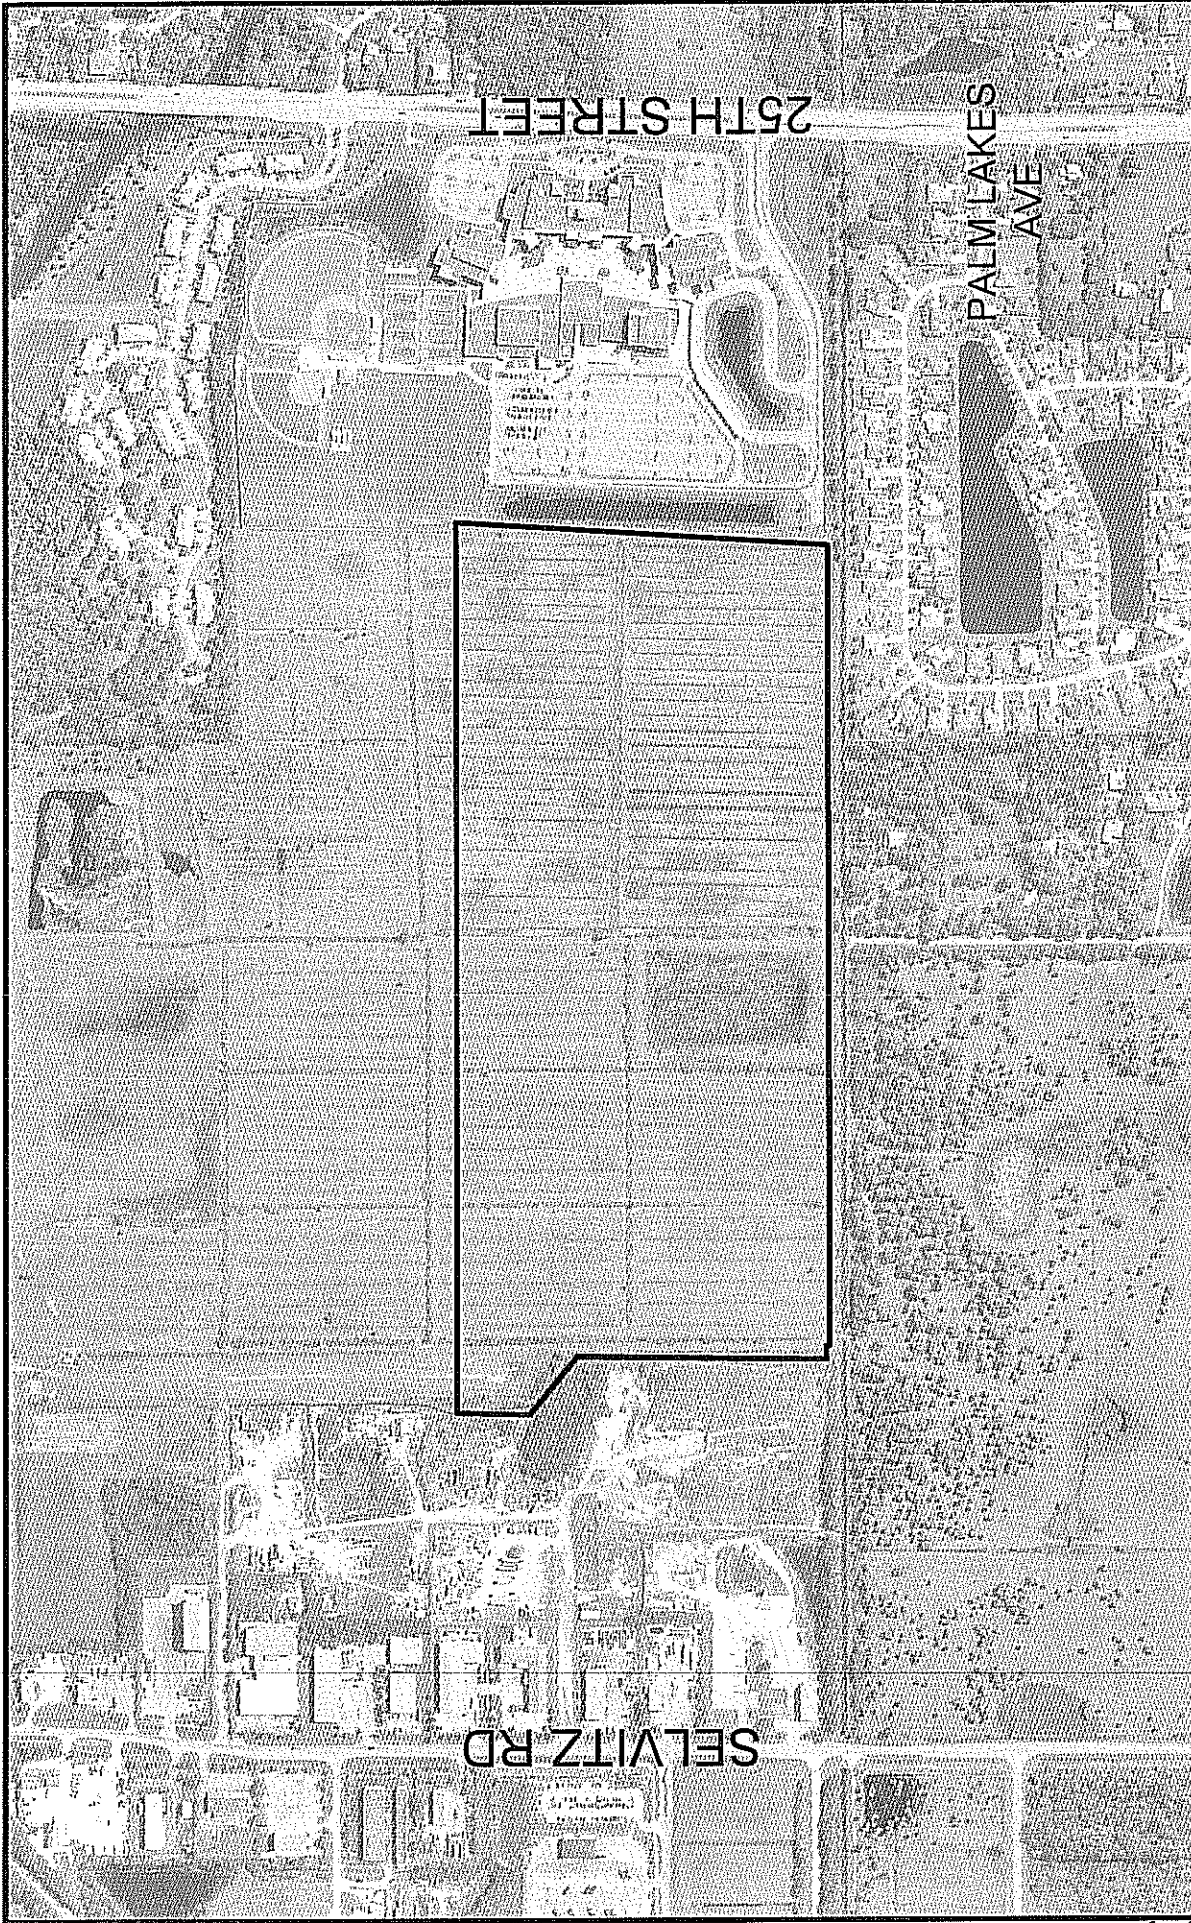
AUG 20 16
FIGURE
3

DOT AERIALS DATED 2016

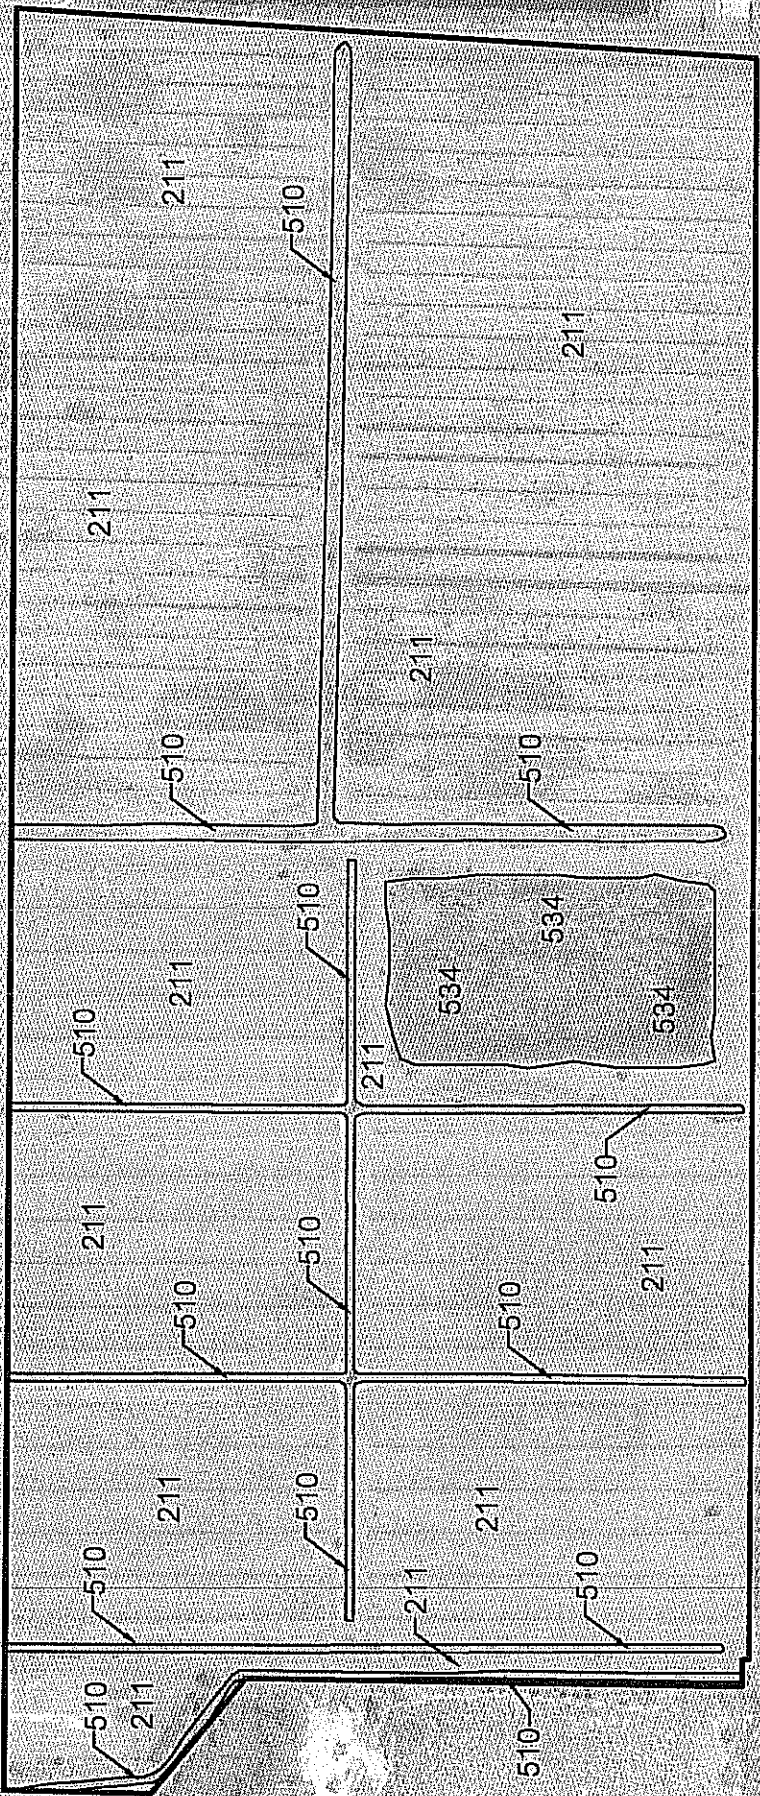
AUG 2016
FIGURE 4

- 211 - IMPROVED PASTURE (68.1± AC)
 - 510 - DITCHES (3.2± AC)
 - 534 - RESERVOIRS LESS THAN 10 ACRES (3.7± AC)
- TOTAL SITE (75.0± AC)**

There are three different FLUCFCS classifications currently present on the site including improved pasture (211), the ditches that network throughout the site are classified as streams and waterways (510), and the water retention basin is categorized as a reservoir less than 10 acres (534).

A land cover map of the observed community types is included as Figure 3 in the appendix of this report. The land cover types observed on the property are described as follows:

211 Improved Pasture – 68.1 ± acres

510 Ditches – 3.2 ± acres

A system of drainage ditches extends throughout the property. The ditches are approximately 10-15 feet wide and are typically vegetated with scattered Carolina willow (*Salix caroliniana*), primrose willow (*Ludwigia peruviana*), Caesar weed (*Urena lobata*), cattail (*Typha* spp.), swamp fern (*Blechnum serrulatum*), Brazilian pepper and Old-world climbing fern (*Lygodium microphyllum*). Some of these ditches are connected and extend beyond the limits of the property. The sides of the ditches have steep slopes with no littoral shelves.

534 Reservoir less than 10 acres – 3.7 ± acres

A water retention basin is located within the central-southern half of the property. The reservoir is surrounded by an earthen levee and contains surface water. Vegetation within the reservoir consists of jointed spike rush (*Eleocharis interstincta*), soft rush (*Juncus effusus*), flat sedges (*Cyperus* spp.), dropseed grass (*Sporobolus* spp.), wax myrtle (*Myrica cerifera*), guinea grass and primrose willow.

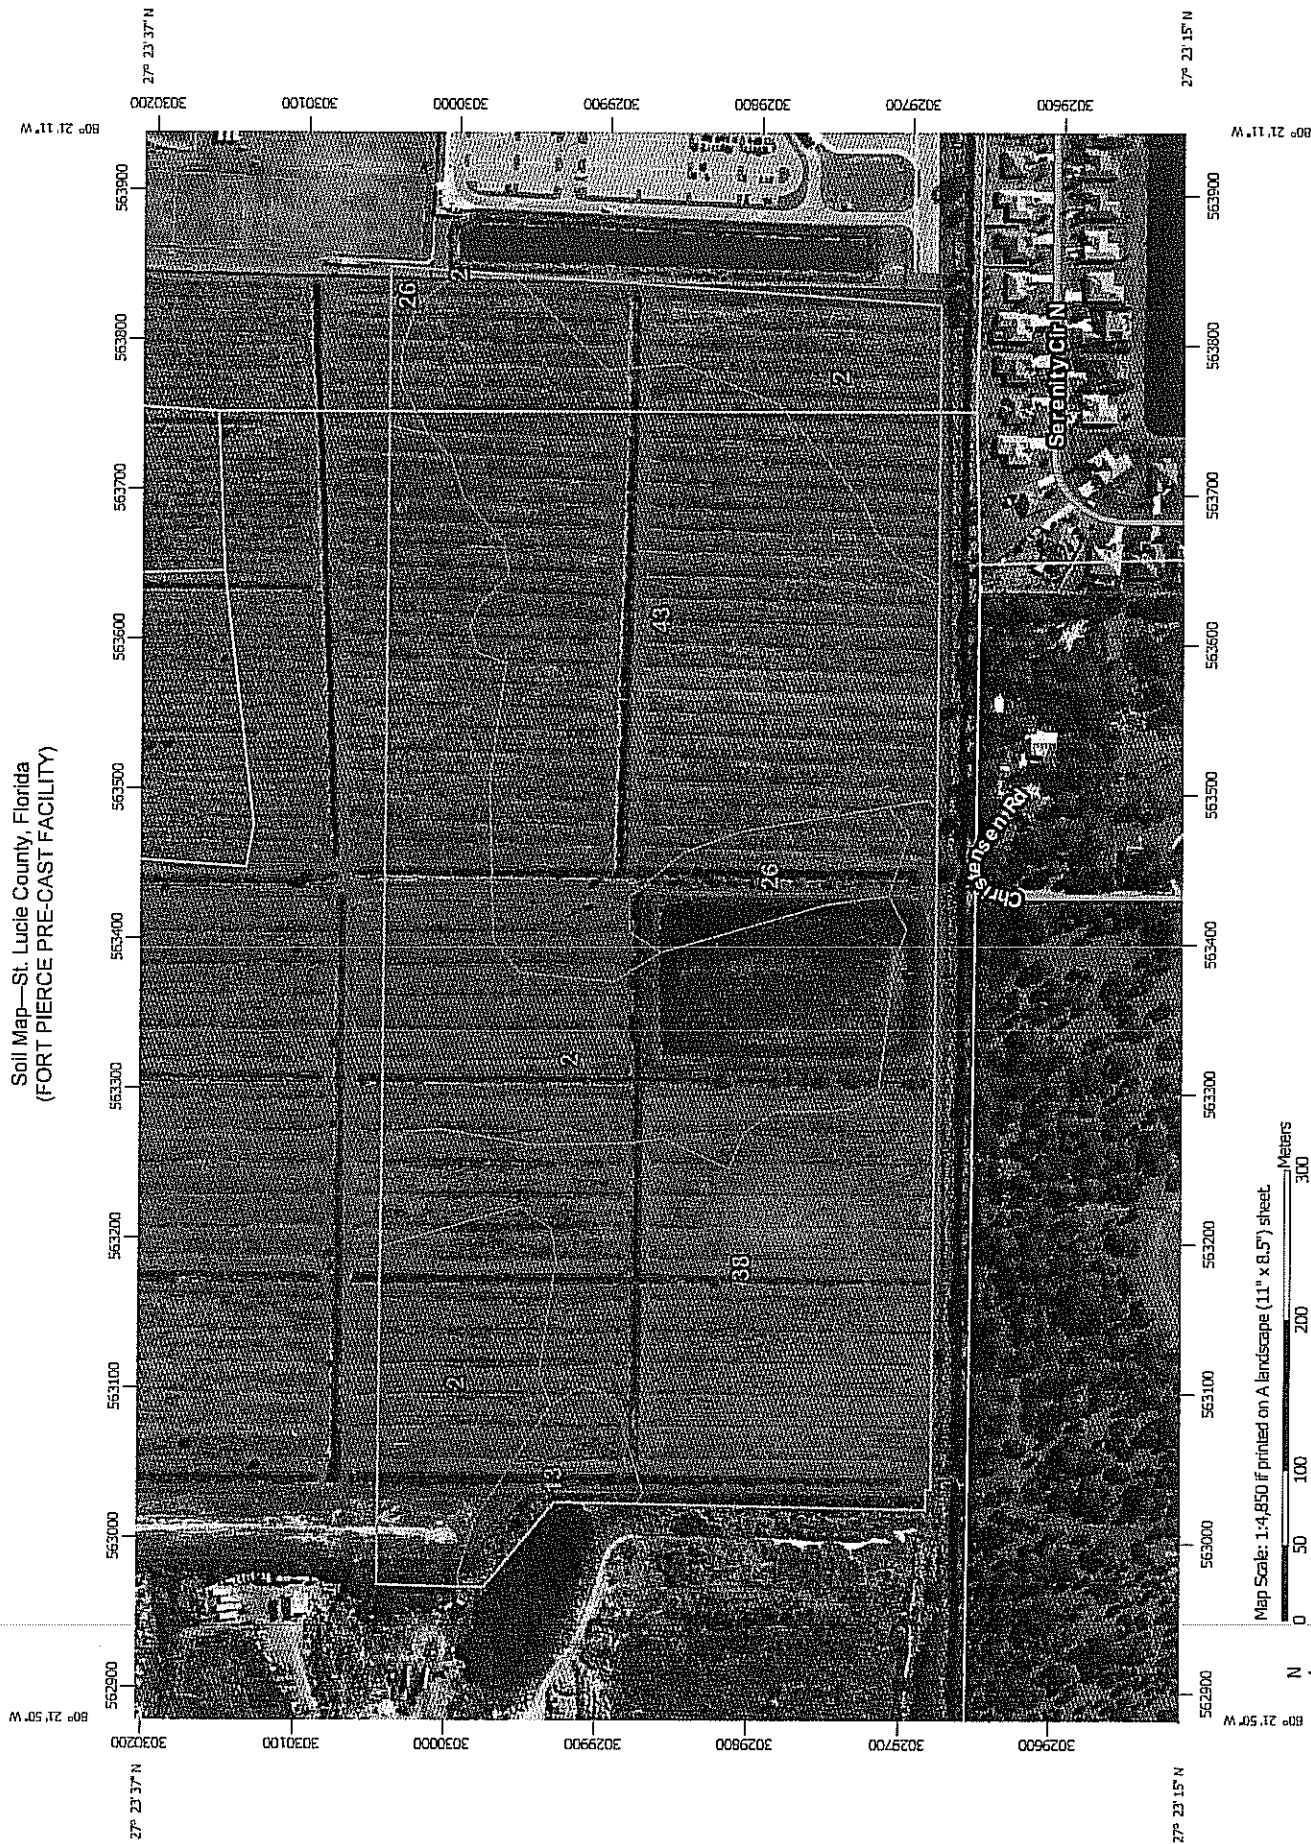
Soil Map—St. Lucie County, Florida
(FORT PIERCE PRE-CAST FACILITY)

St. Lucie County, Florida (FL111)			
Map Unit Symbol	Map Unit Name	Acres in AOI	Percent of AOI
2	Ankona and Farnton sands	27.6	36.9%
13	Floridana sand, depressional	1.7	2.3%
26	Oldsmar sand, depressional	3.0	4.0%
38	Riviera fine sand, 0 to 2 percent slopes	18.0	23.9%
43	Susanna and Wauchula sands	24.7	32.8%
Totals for Area of Interest		75.0	100.0%
