# HISTORIC PRESERVATION BOARD

## BOARD AGENDA

Historic Preservation Board Regular Meeting - Monday, January 27, 2020 - 6:00 p.m.  
City Hall - City Commission Chambers, 100 North U.S. #1, Fort Pierce, Florida

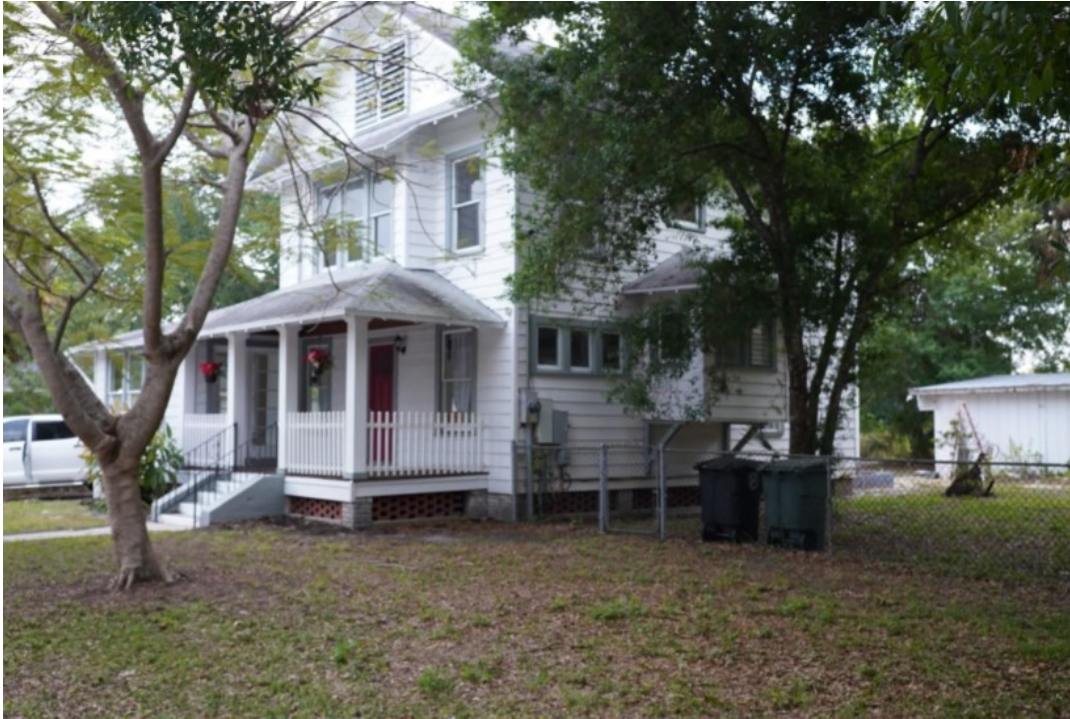
The applicant is requesting approval to demolish the subject residence and shed. The application indicates long term neglect has resulted in termite damage to foundations, floors and rafters.

Existing residence located at 1009 Delaware Avenue

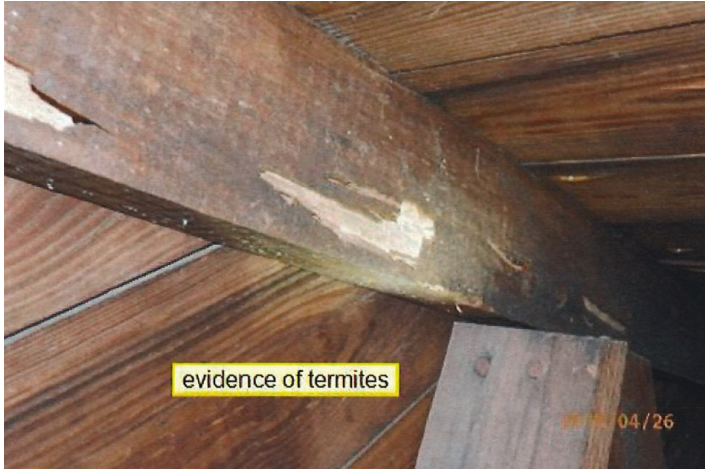
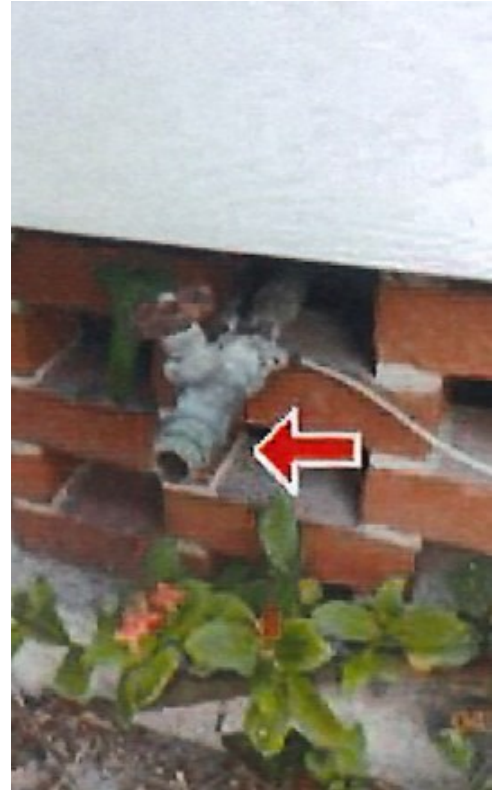
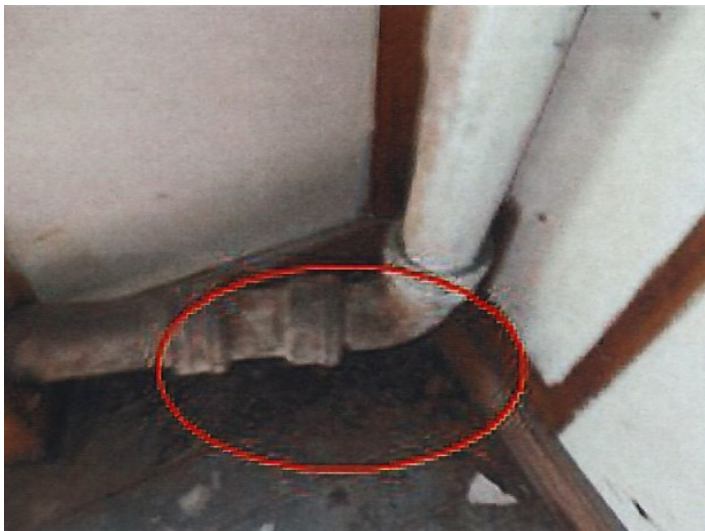
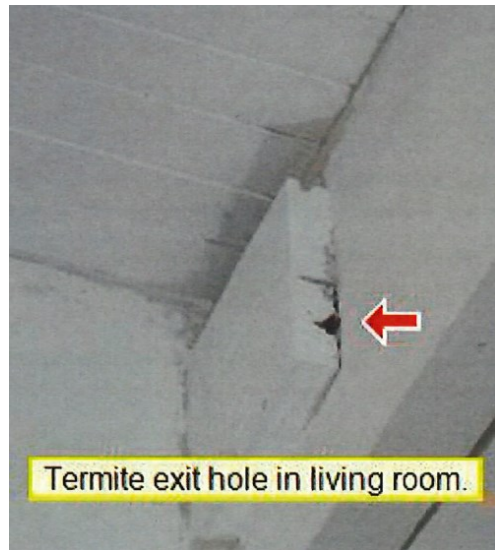
Interior damage pictures provided by the applicant

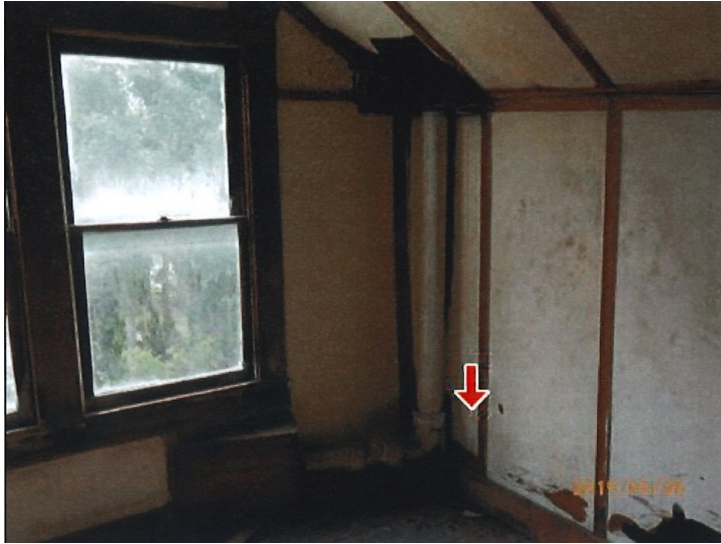
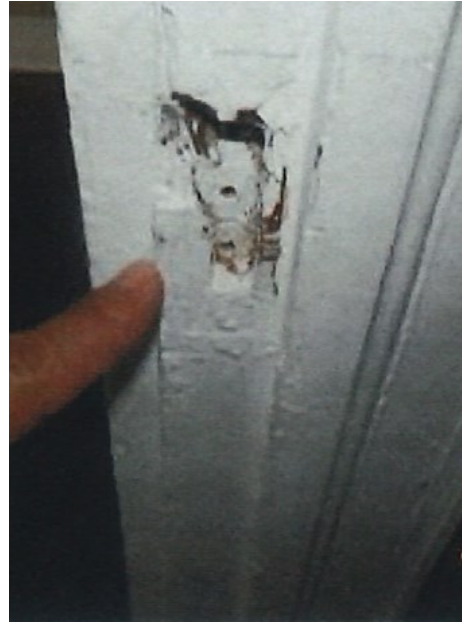
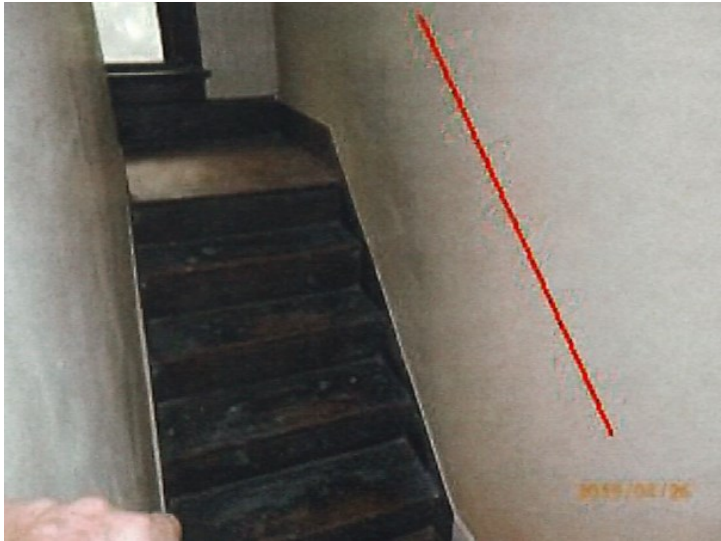
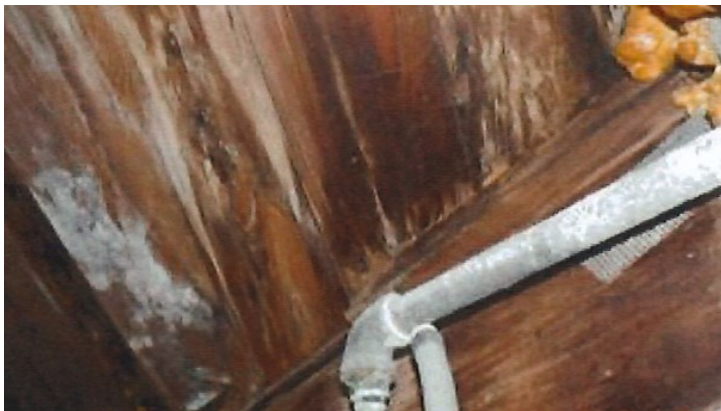
Interior damage—pictures provided by the applicant

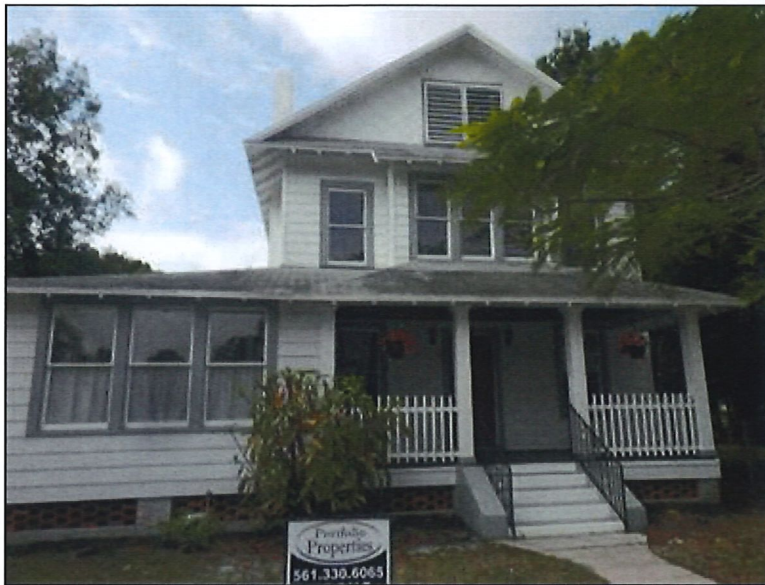
1.0

The 3 tab fiberglass roof was installed in 2004 with a permit. The roof is in poor condition. A 3 tab roof usually lasts a bout 15 years. It needs to be replaced.

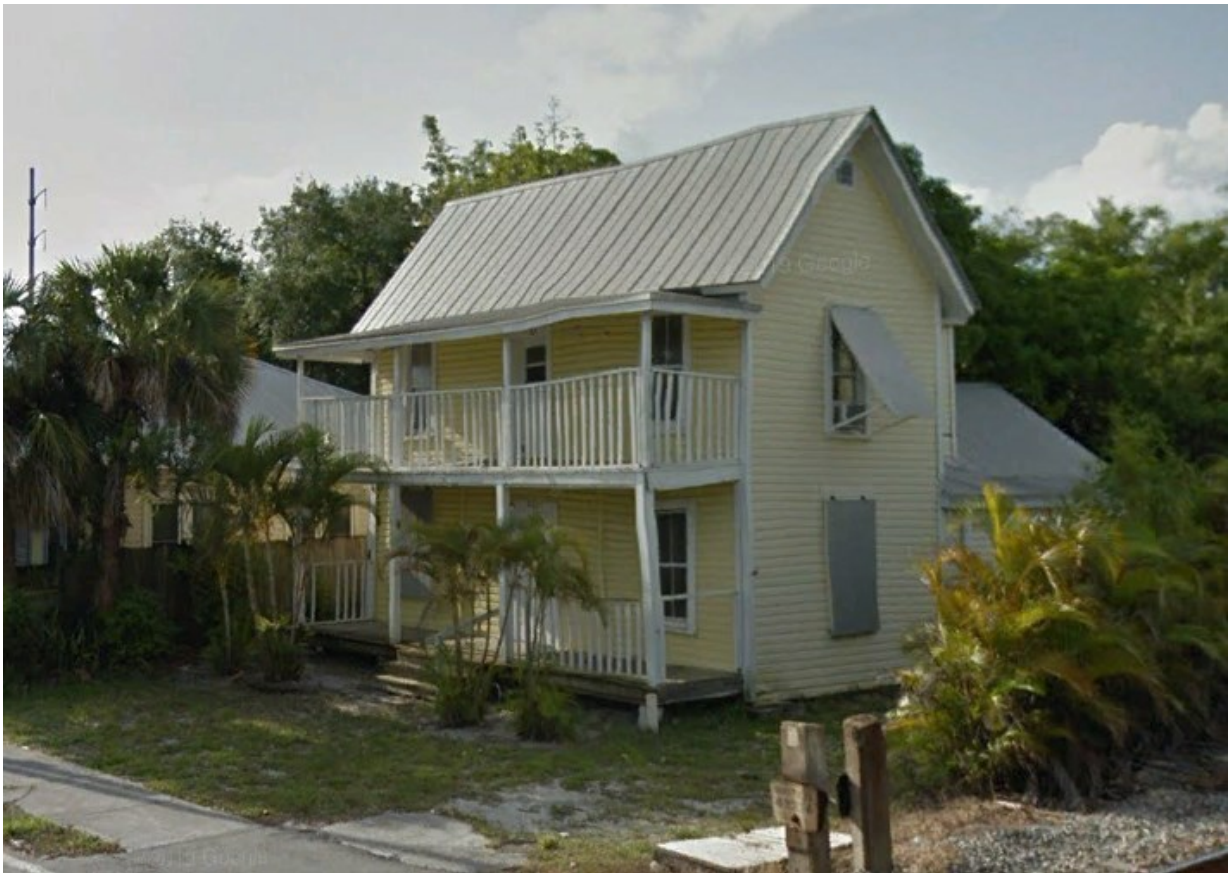
Current Building Conditions

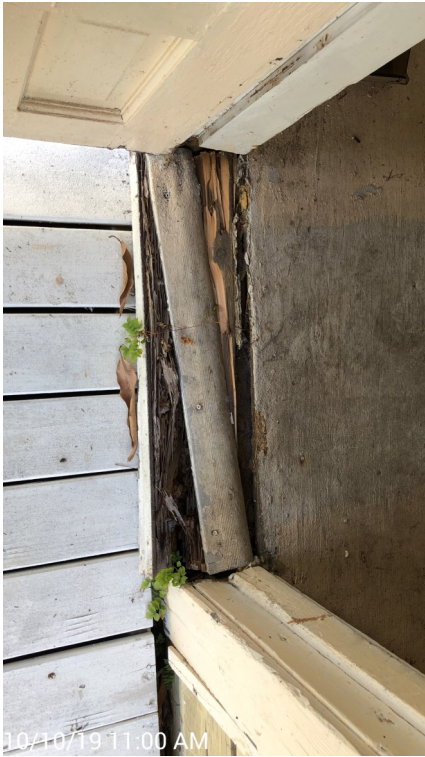
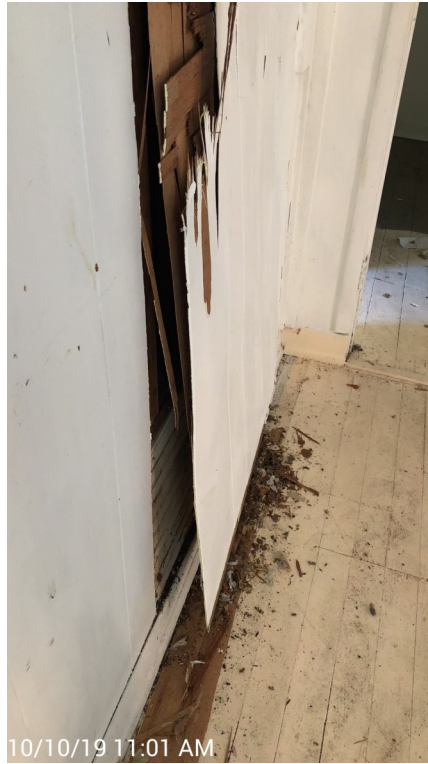
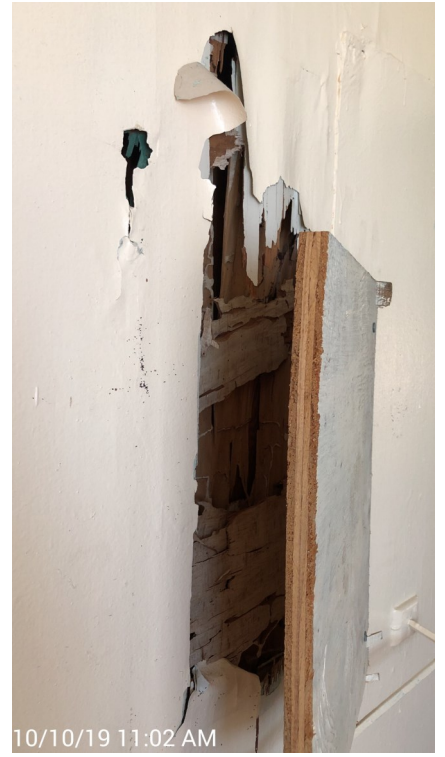
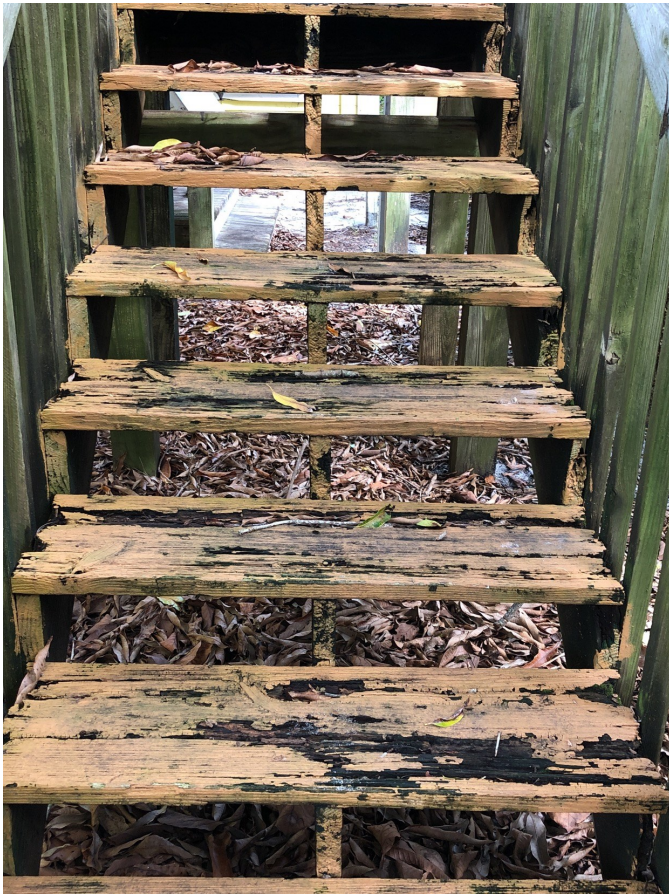
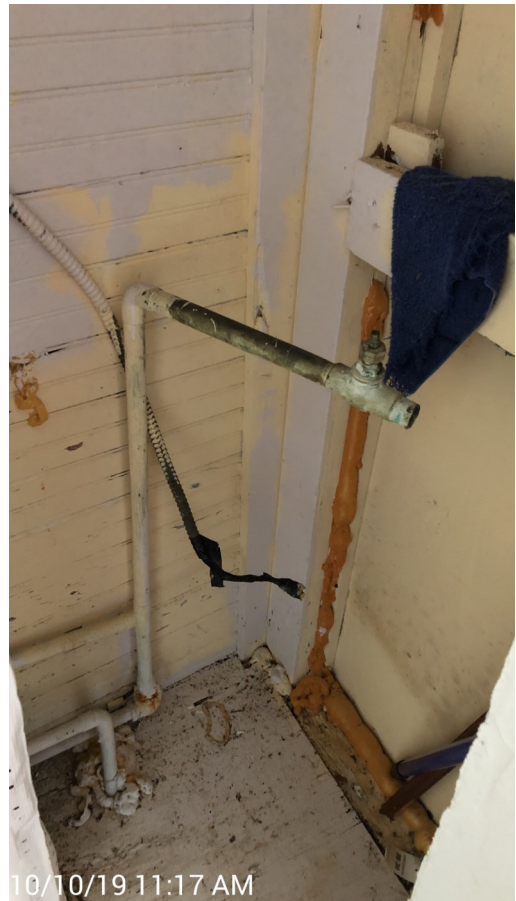
- The structure in its current state is damaged, dilapidated, potential dangerous and unsafe for occupancy.
- All or part of building contains structural members that have evidence of deterioration and at present is not recommended to be capable to support nominal loads and load effects.
- Building lacks adequate ventilation, sanitary facilities, heat and illumination.

Damaged elements — pictures provided by the Building Department Coordinator

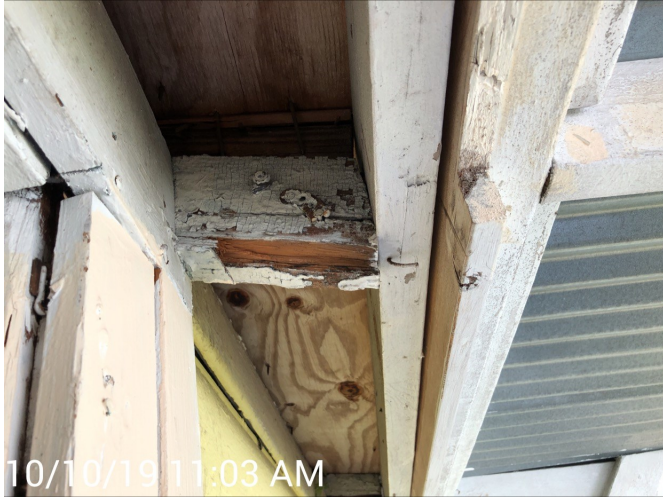
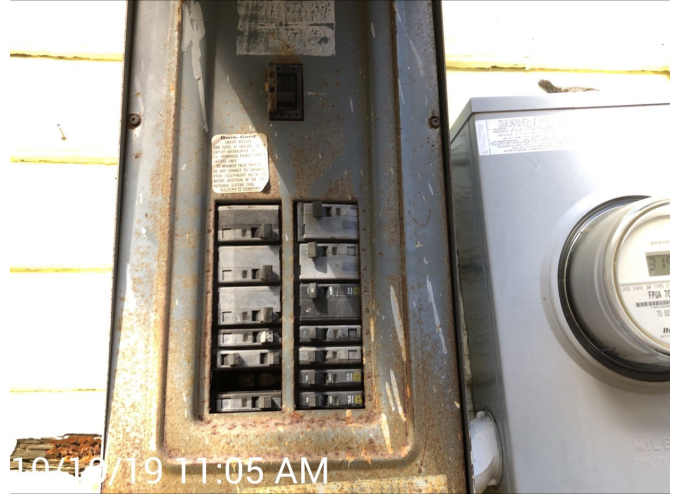
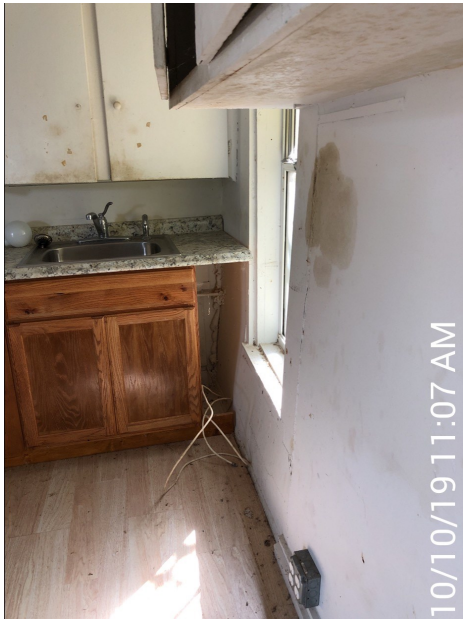
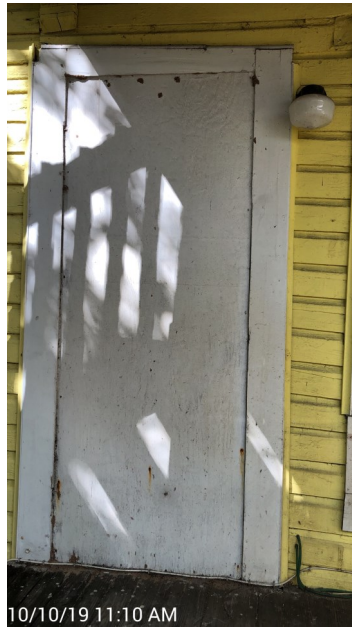
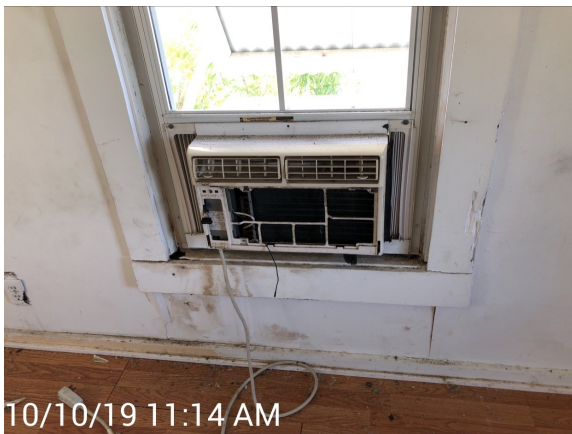
Exterior and interior damage— pictures provided by the Building Department Coordinator
