DR. MARTIN LUTHER KING, JR. COMMEMORATIVE COMMITTEE

HISTORIC LINCOLN THEATER

1132 Avenue D,
FT. Pierce, FL 34950

HISTORY OF LINCOLN THEATER
EXISTING CONDITIONS
PROPOSED MASTER PLAN
HISTORIC PRESERVATION STANDARDS
PROJECT ESTIMATE / BUDGET

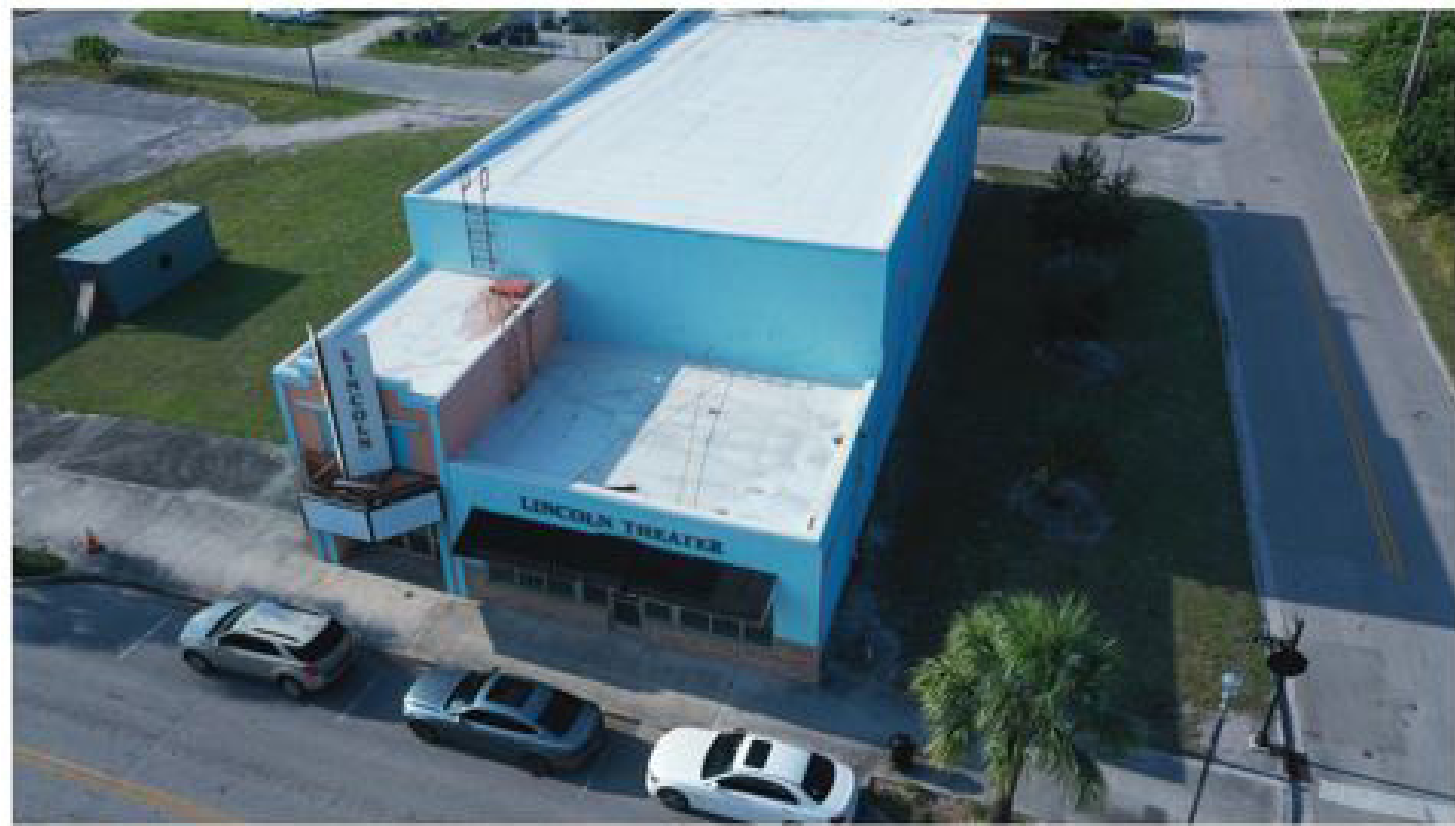
Existing South Facade (South Aerial)

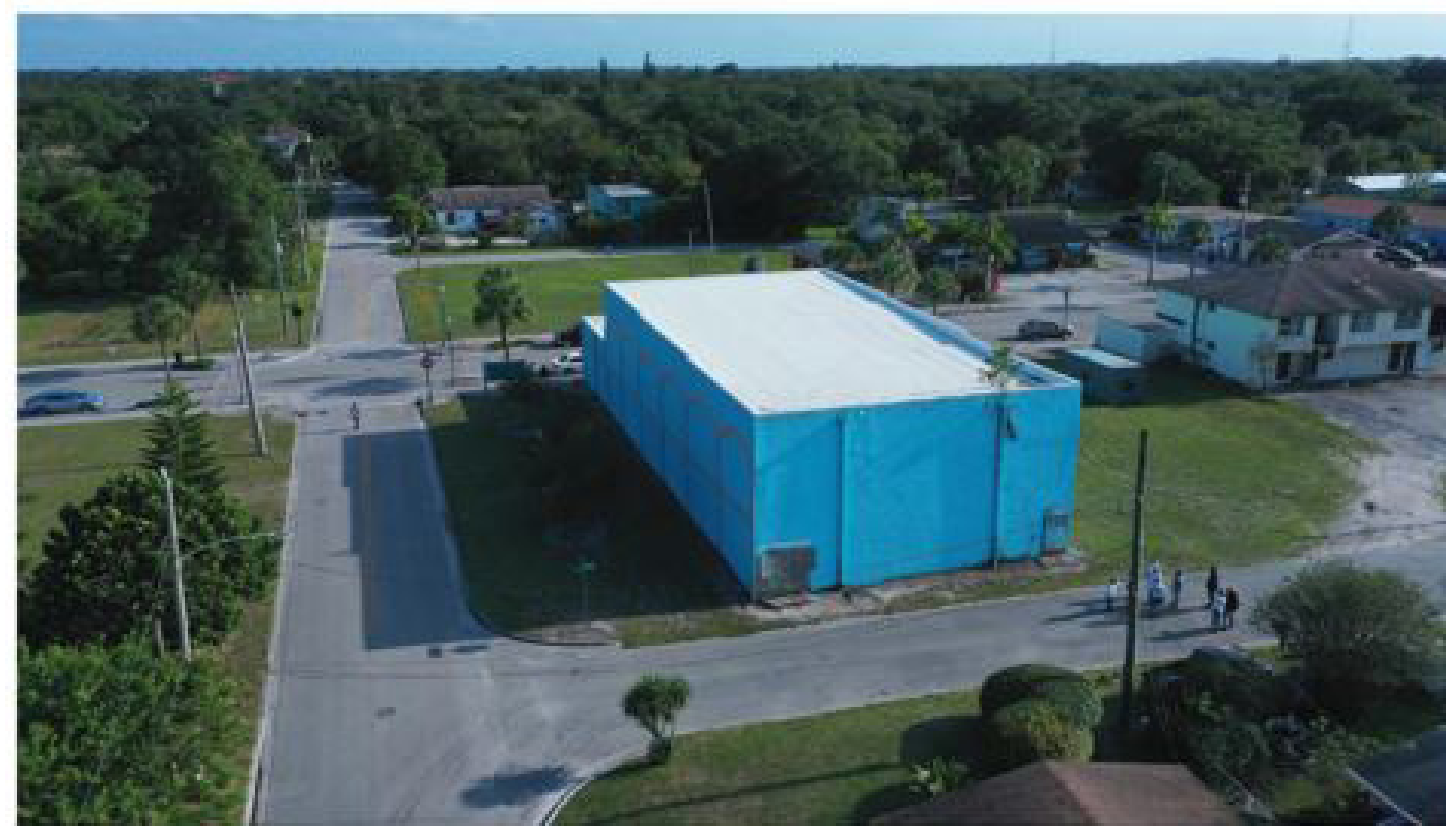
Existing North Facade (Rear)

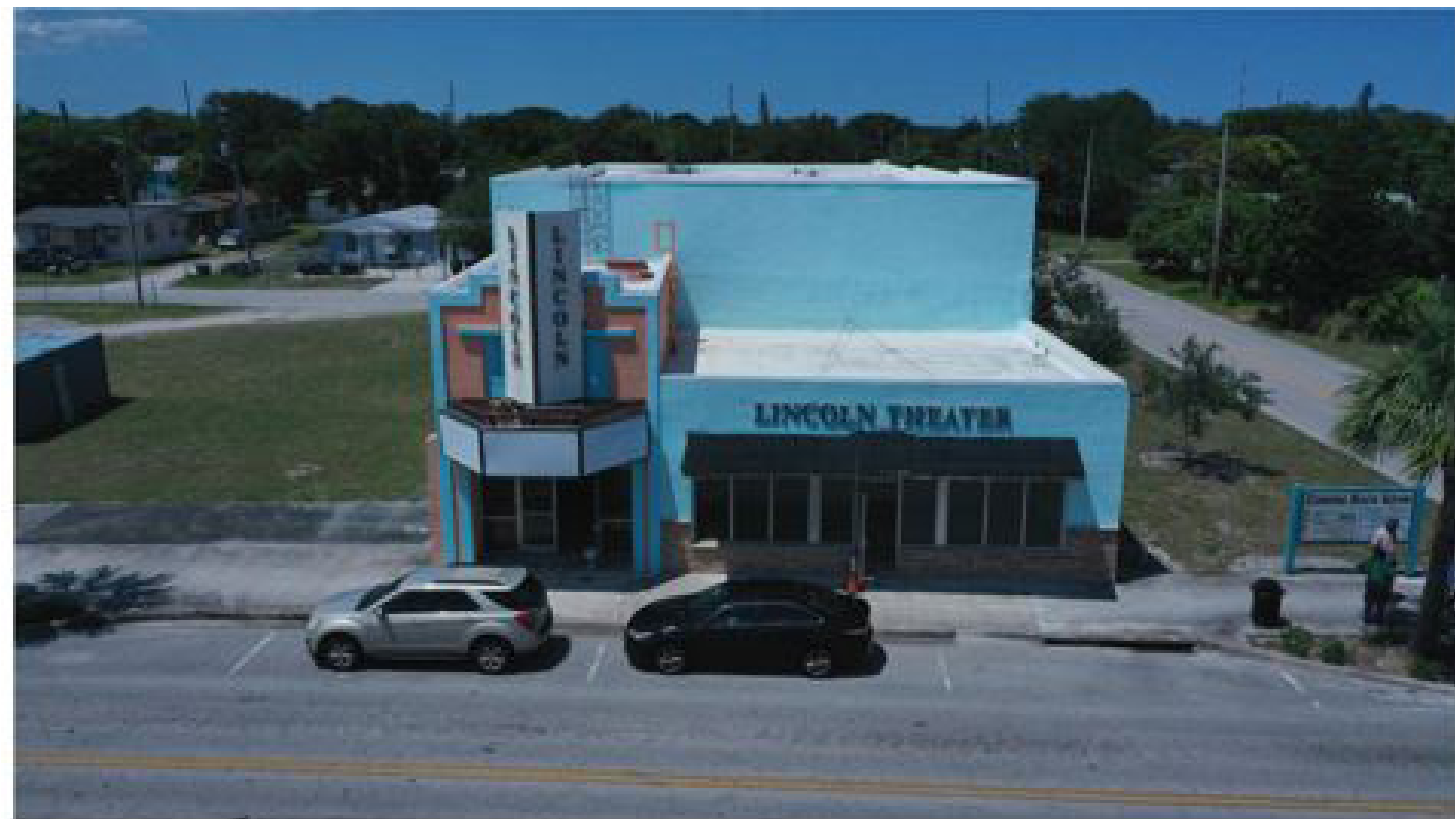
Existing South Facade (Front)

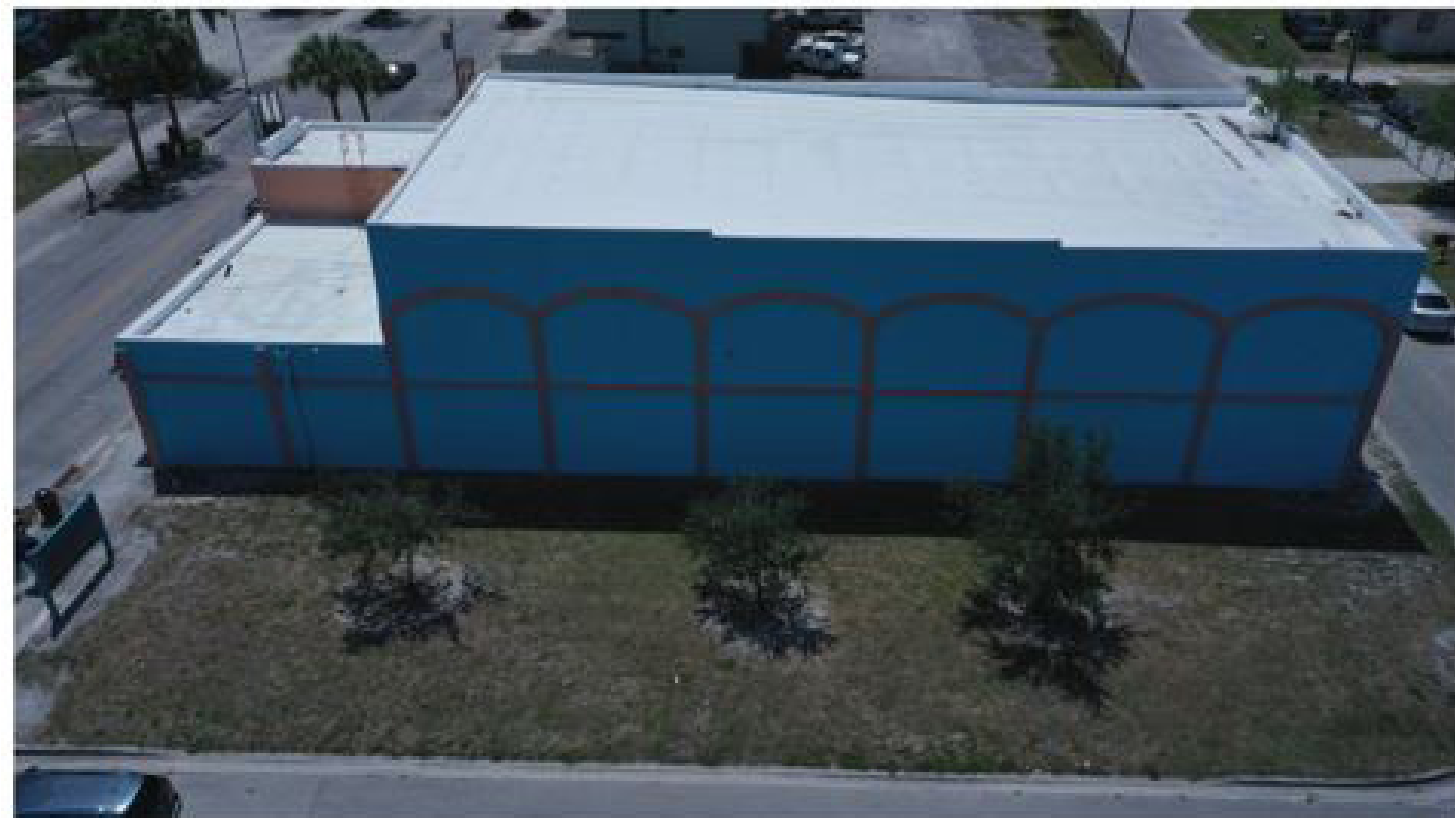
Existing Facade (East)

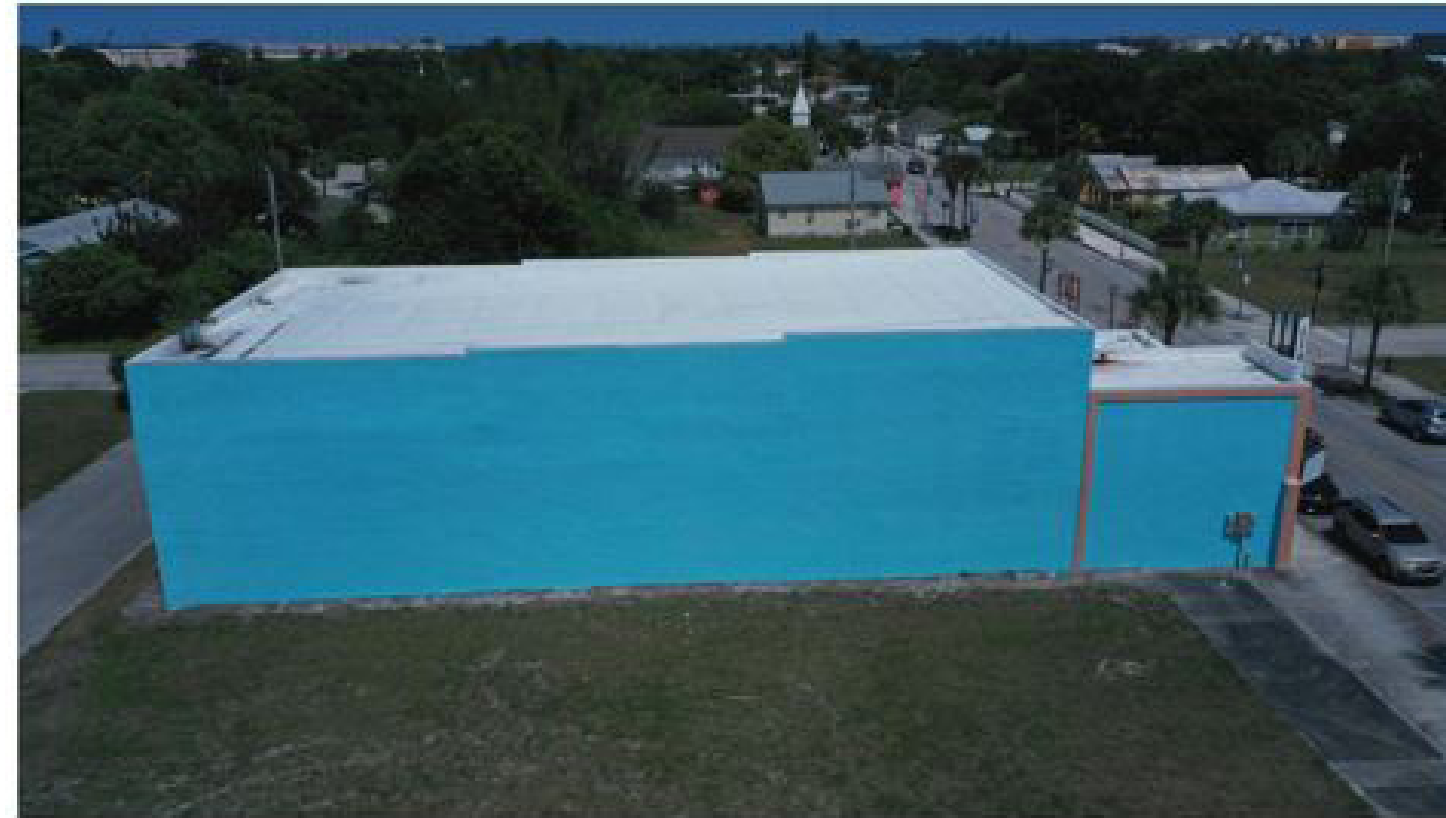
Existing Facade (West)

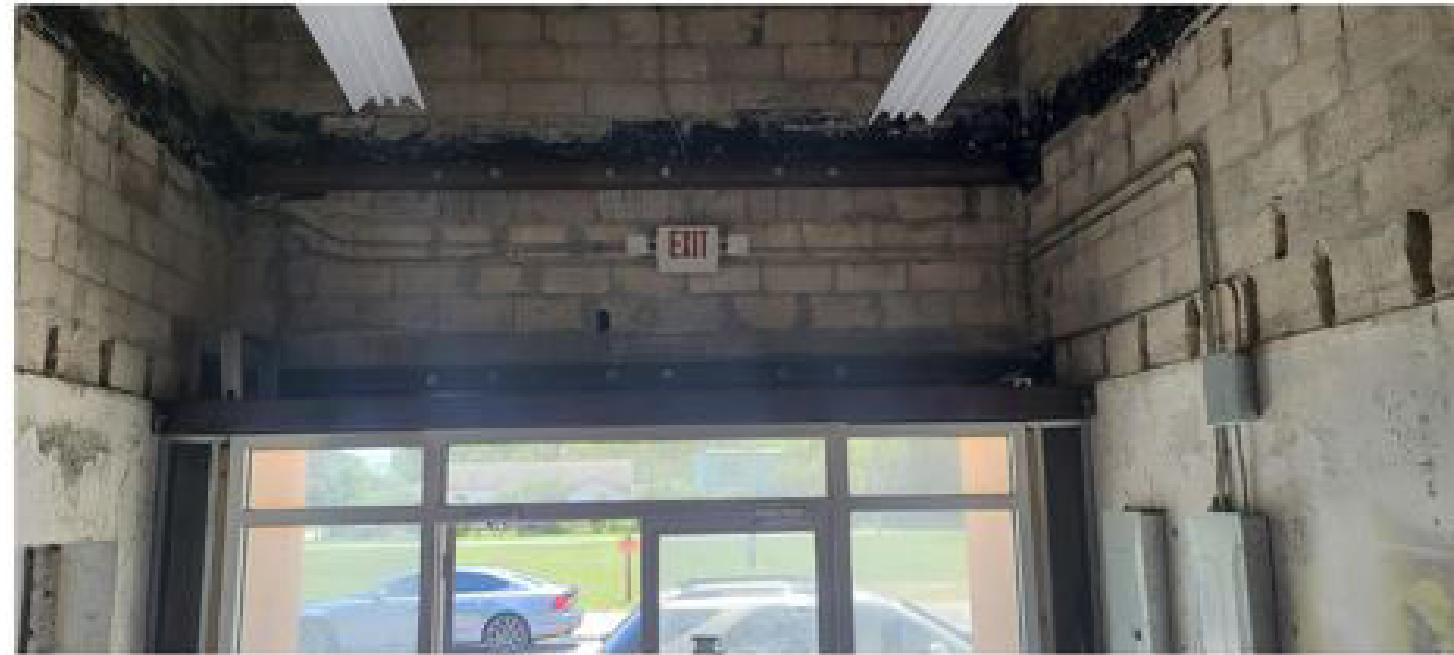
Existing Lobby Storefront

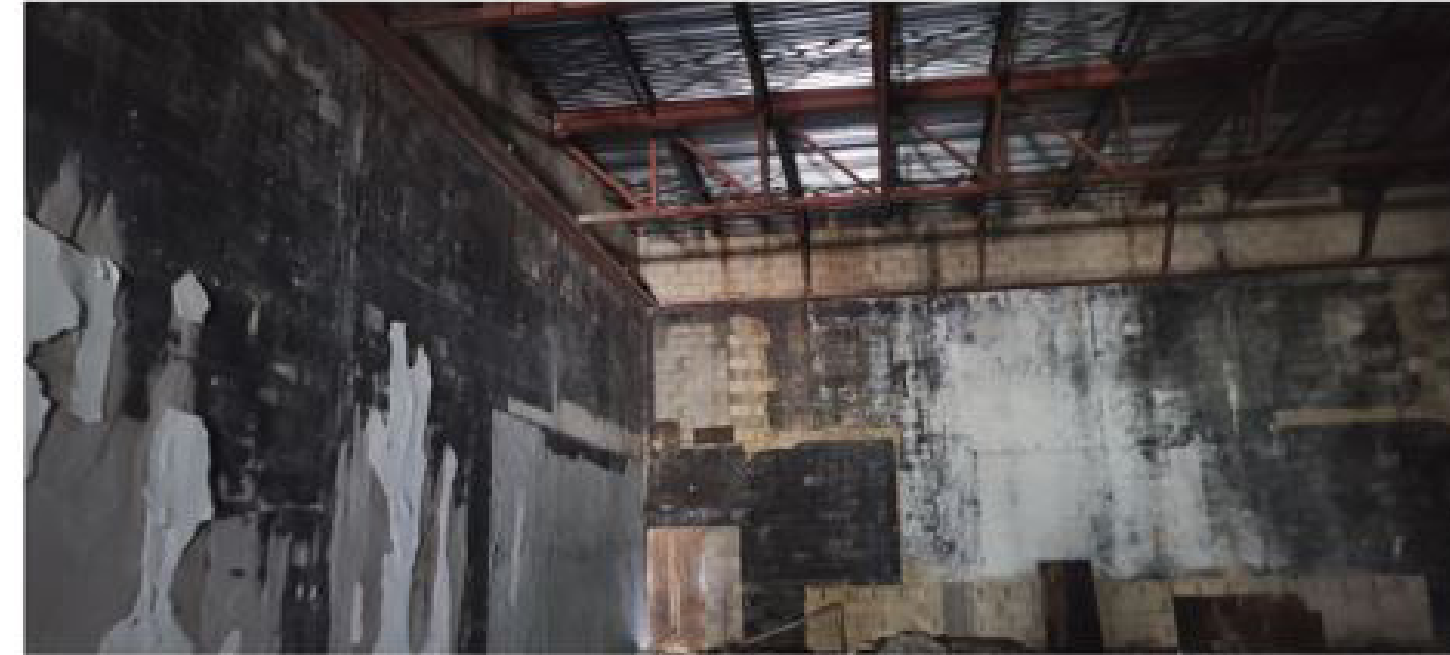
Existing Wall Conditions With Roof Structure

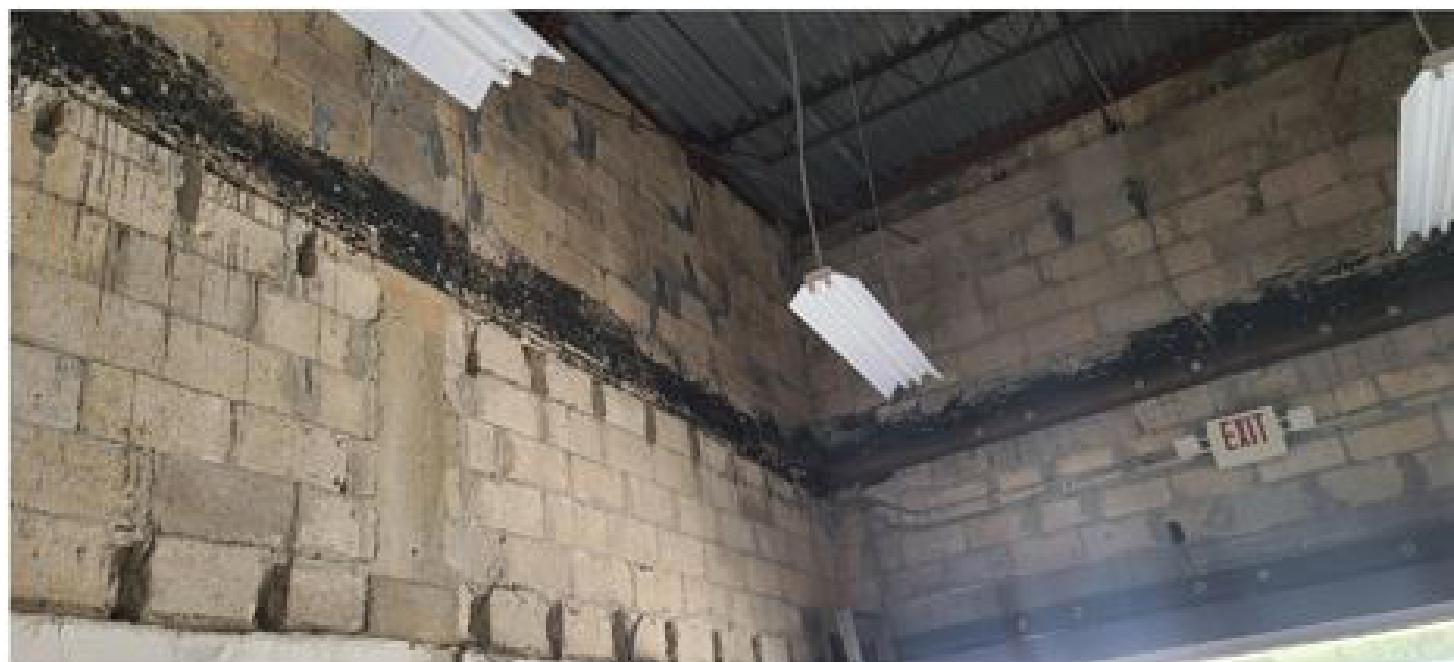
Existing Wall Conditions

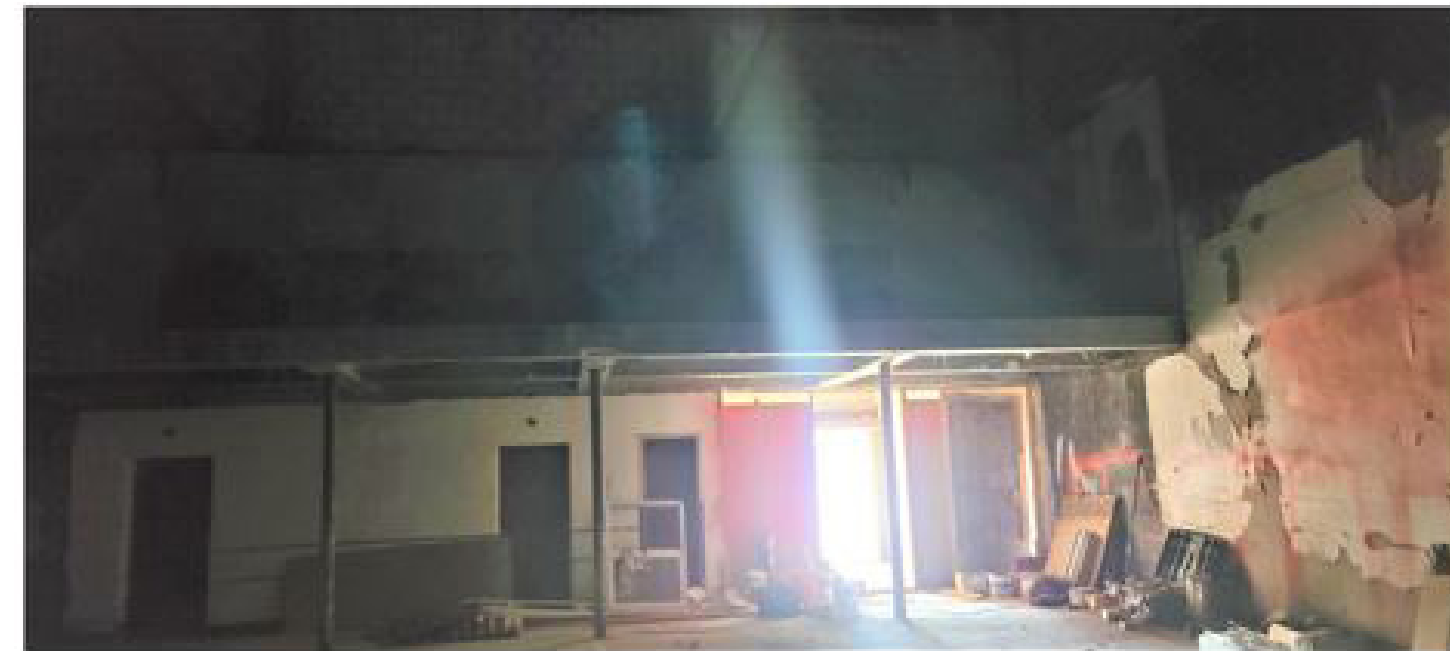
Existing Column Structure with Views of Main Entrance and Bathrooms

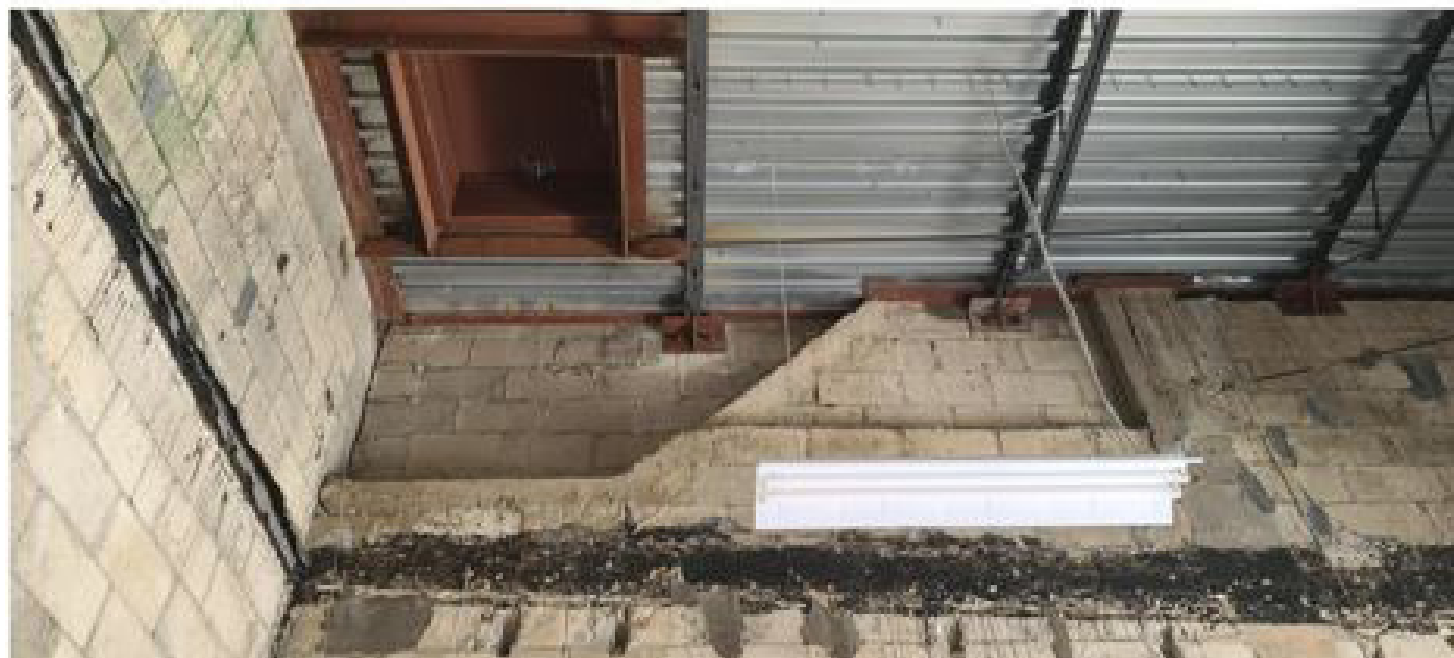
Existing Lobby Roof Structure (Looking at the Gorter)

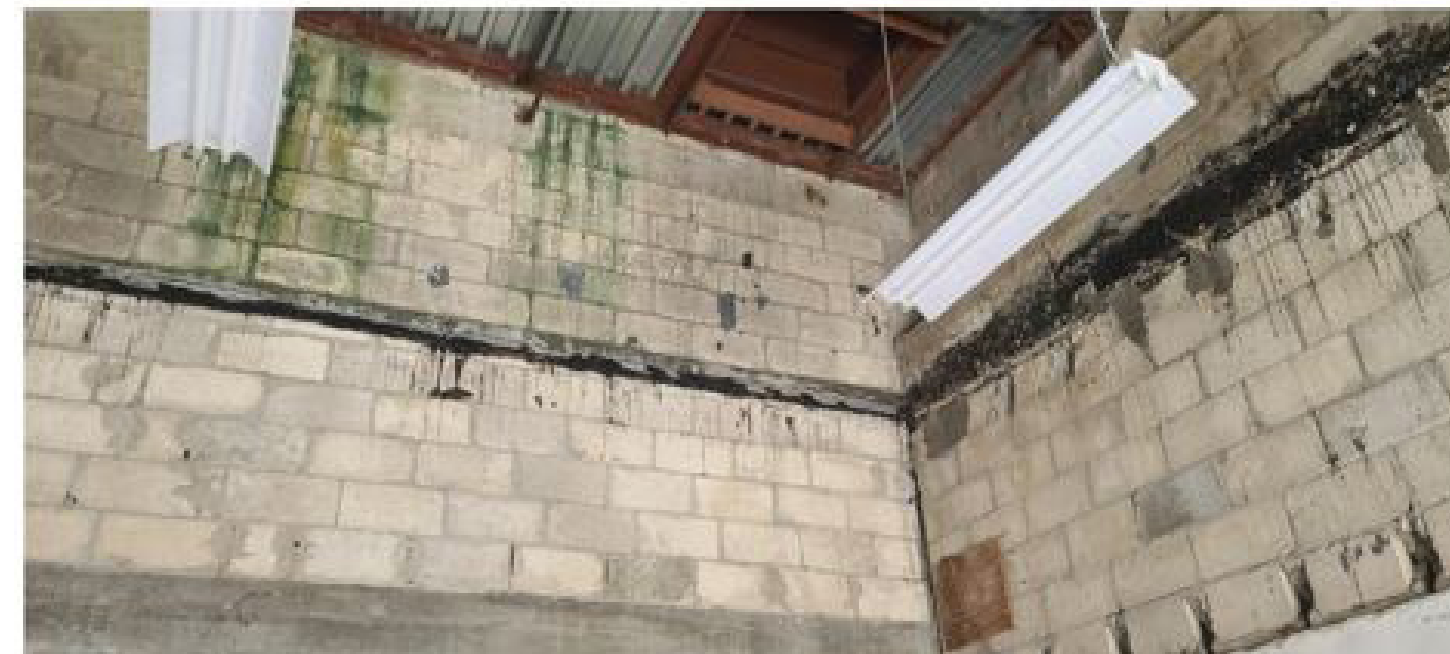
Existing Lobby Wall Condition

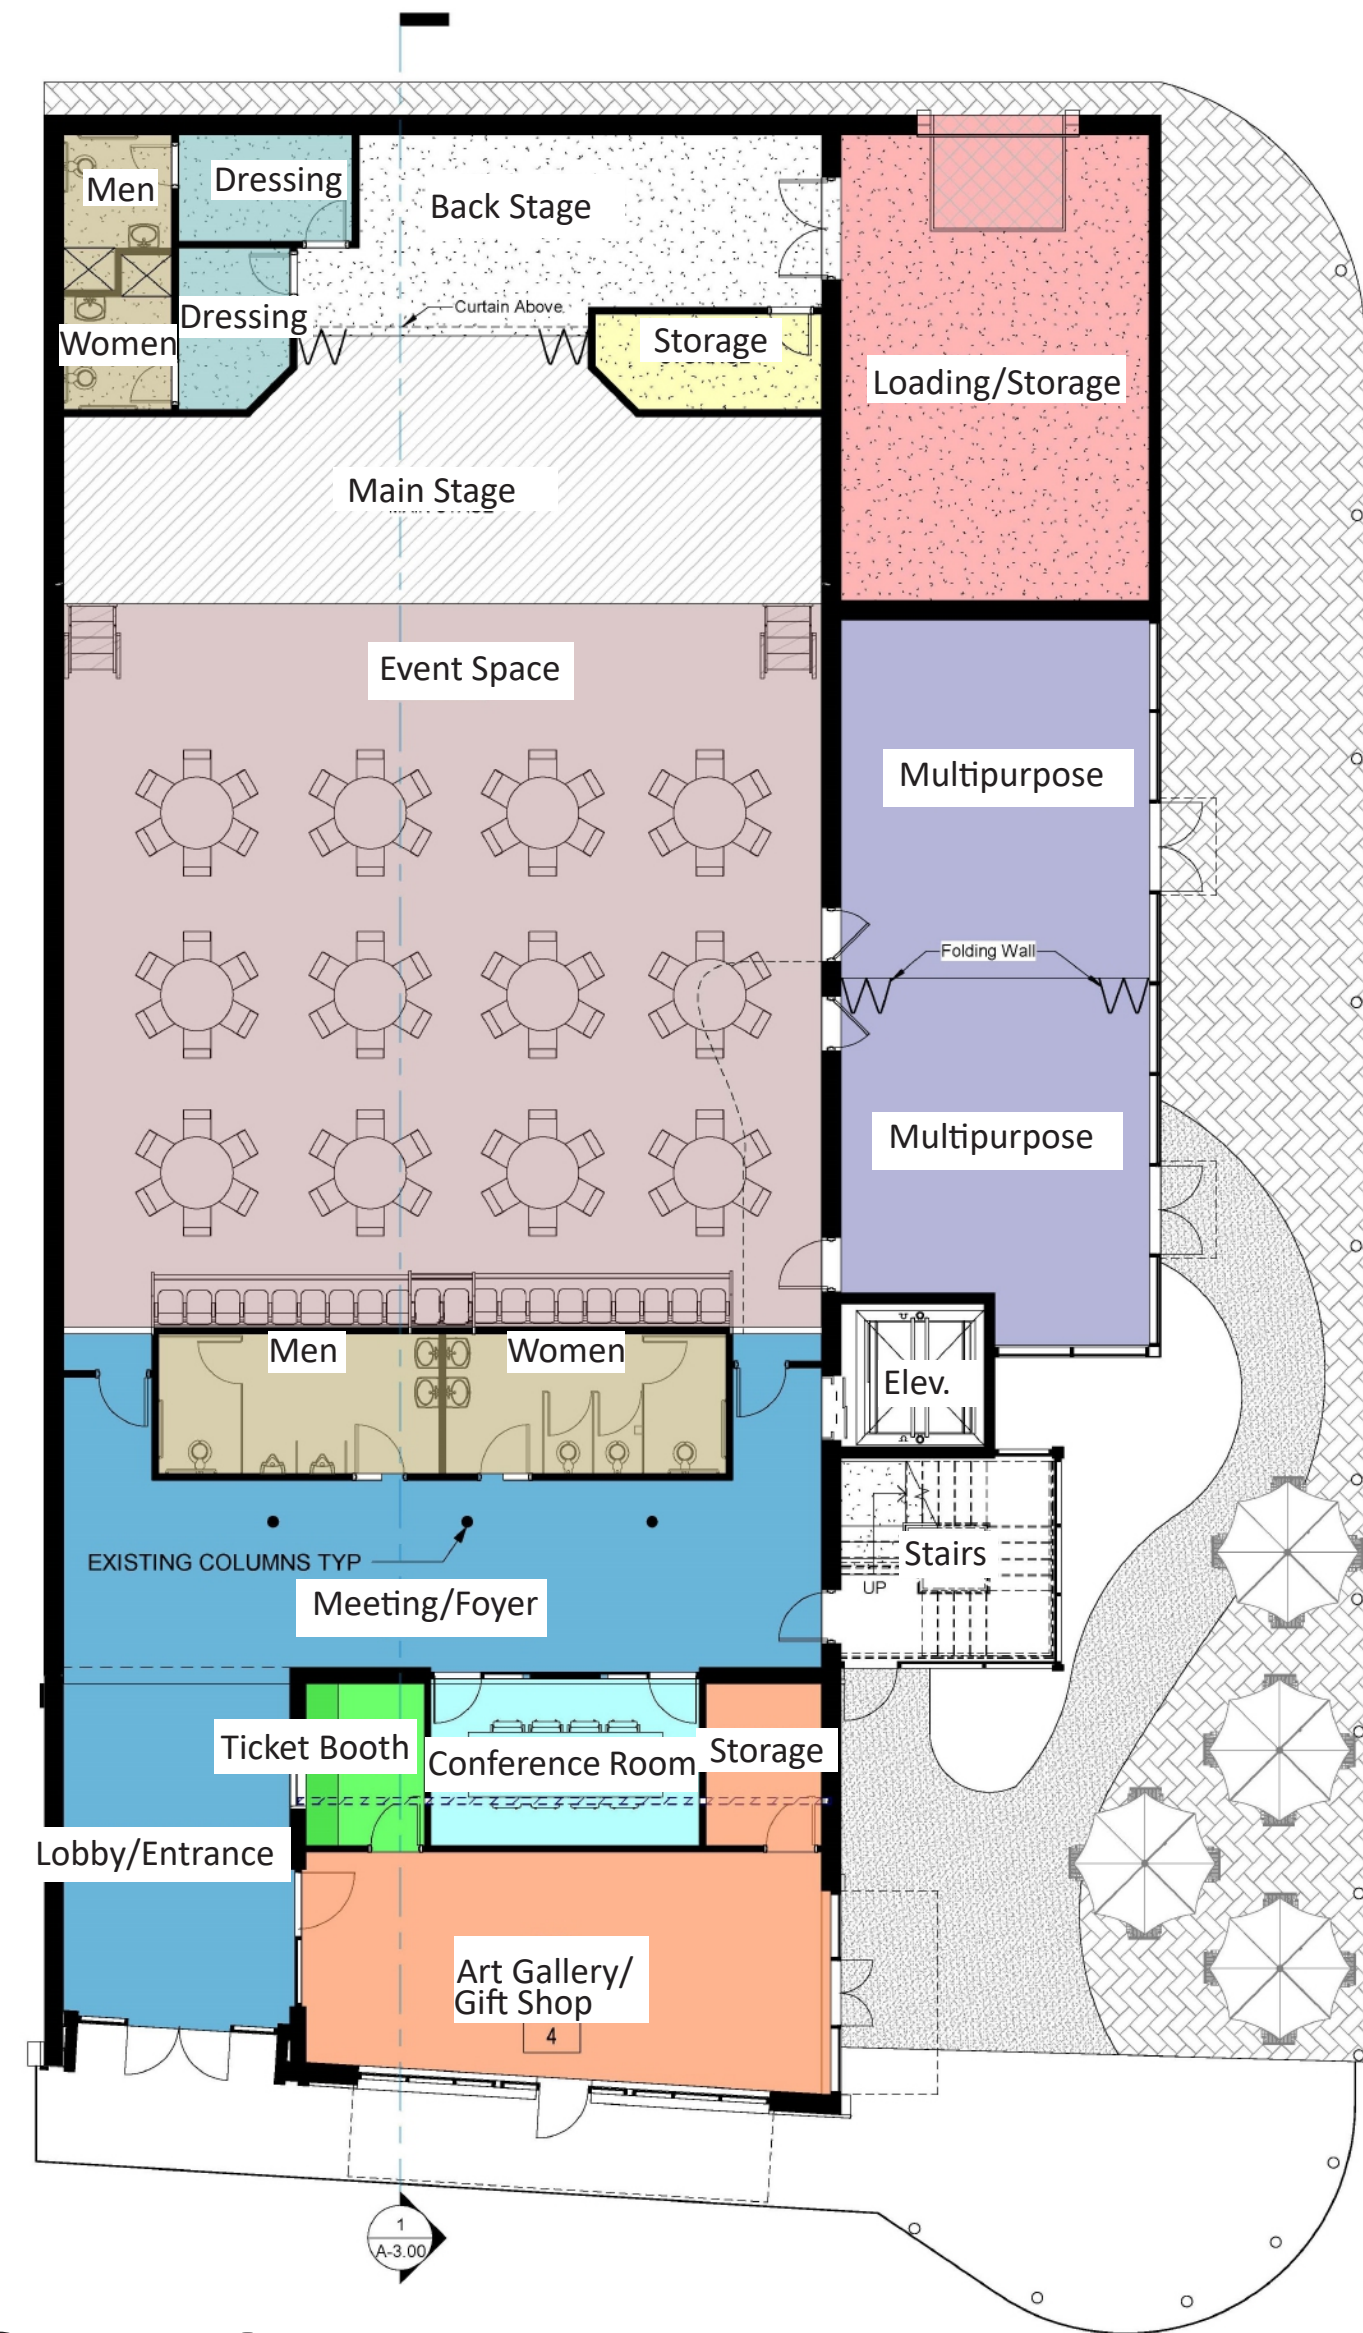
SEAT COUNT 72 / EVENT SPACE /
WEDDINGS / BANQUETS

SEAT COUNT 188 / LECTURE /
FILM PRESENTATIONS / EVENT SPACE

OF AUDITORIUM SEATS: 188

OF BANQUETS: 72

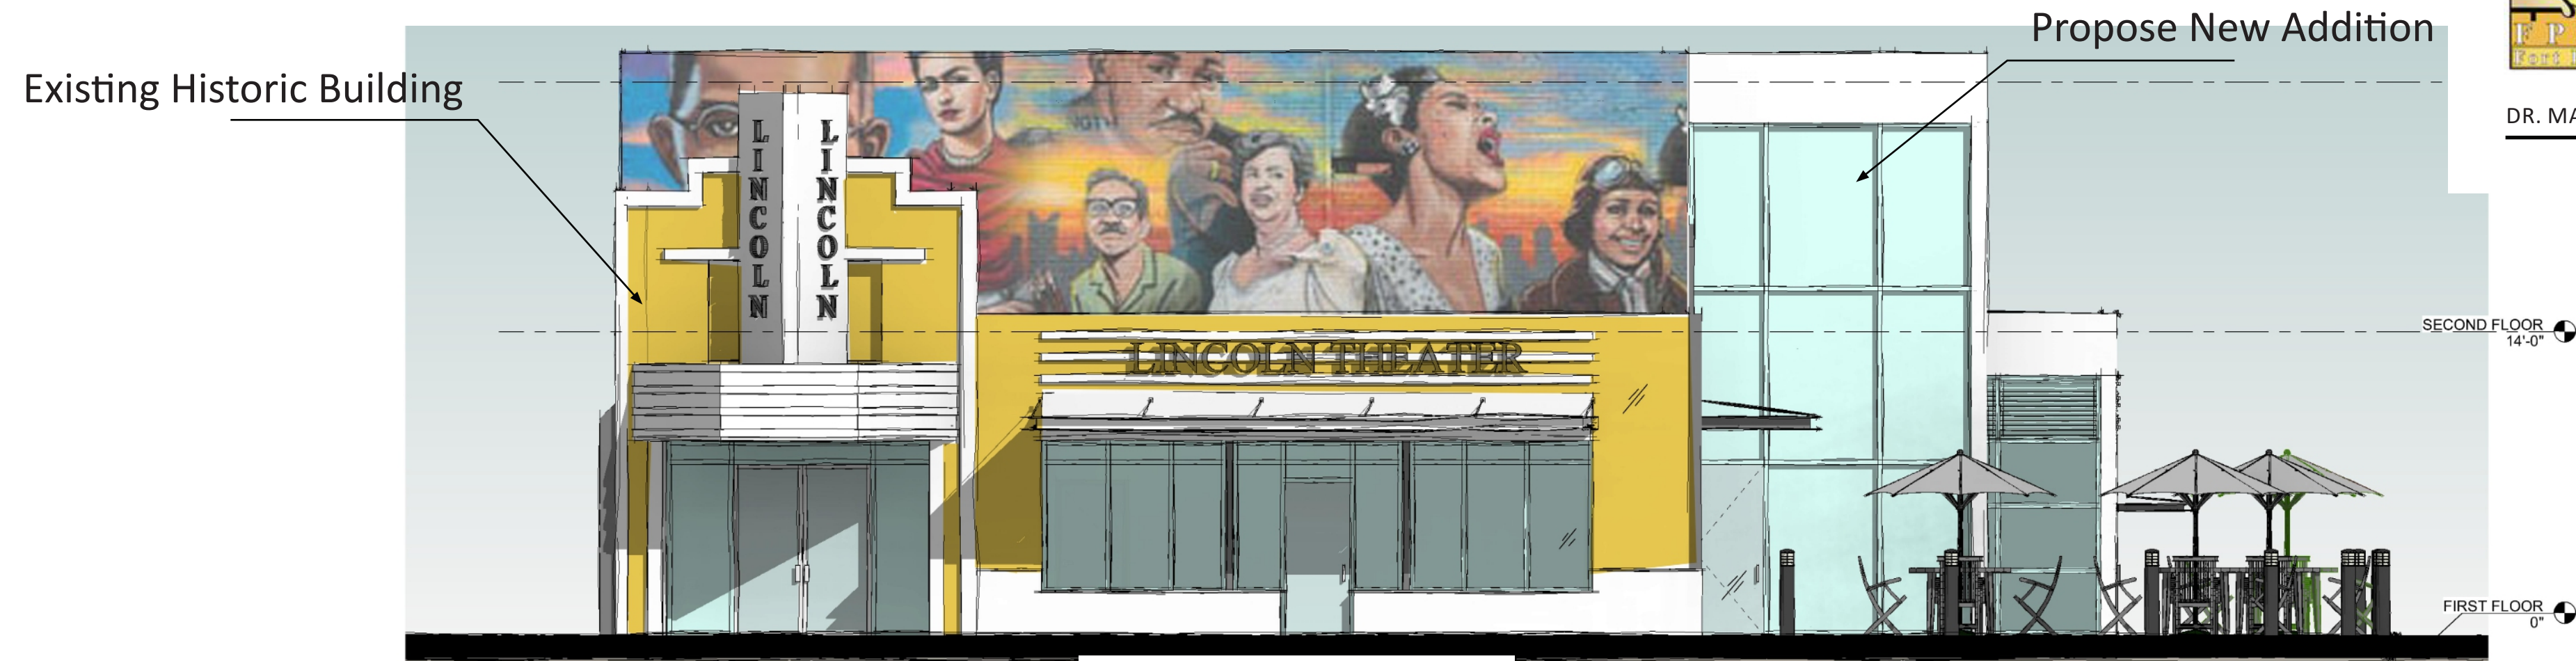
Proposed South Elevation (Front)

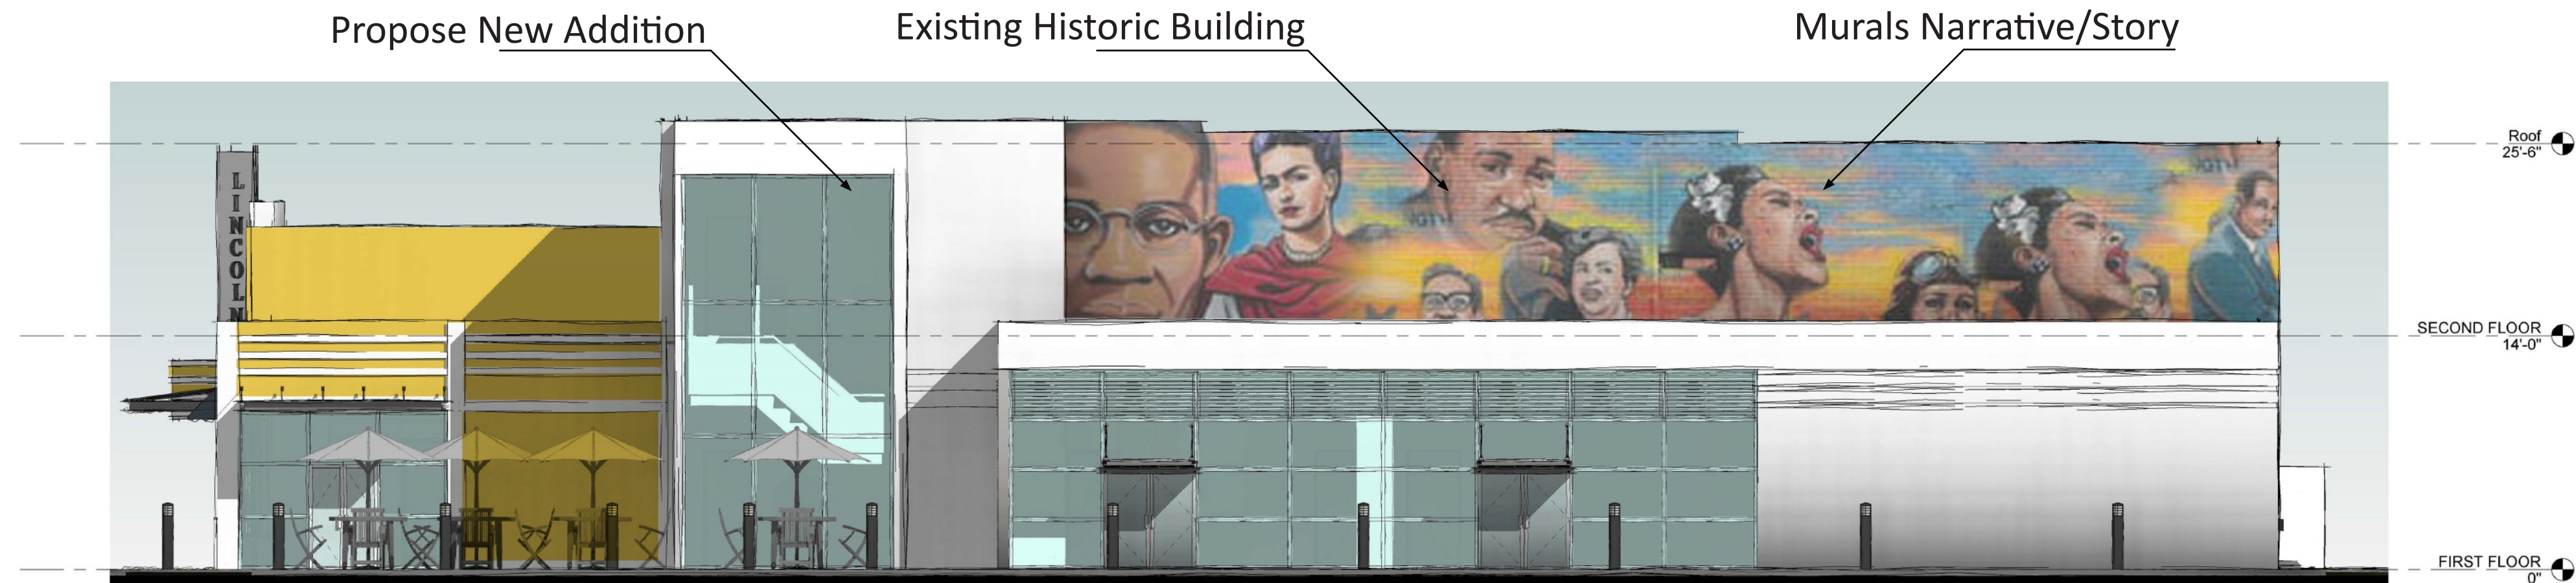
Proposed East Elevation (Side View)

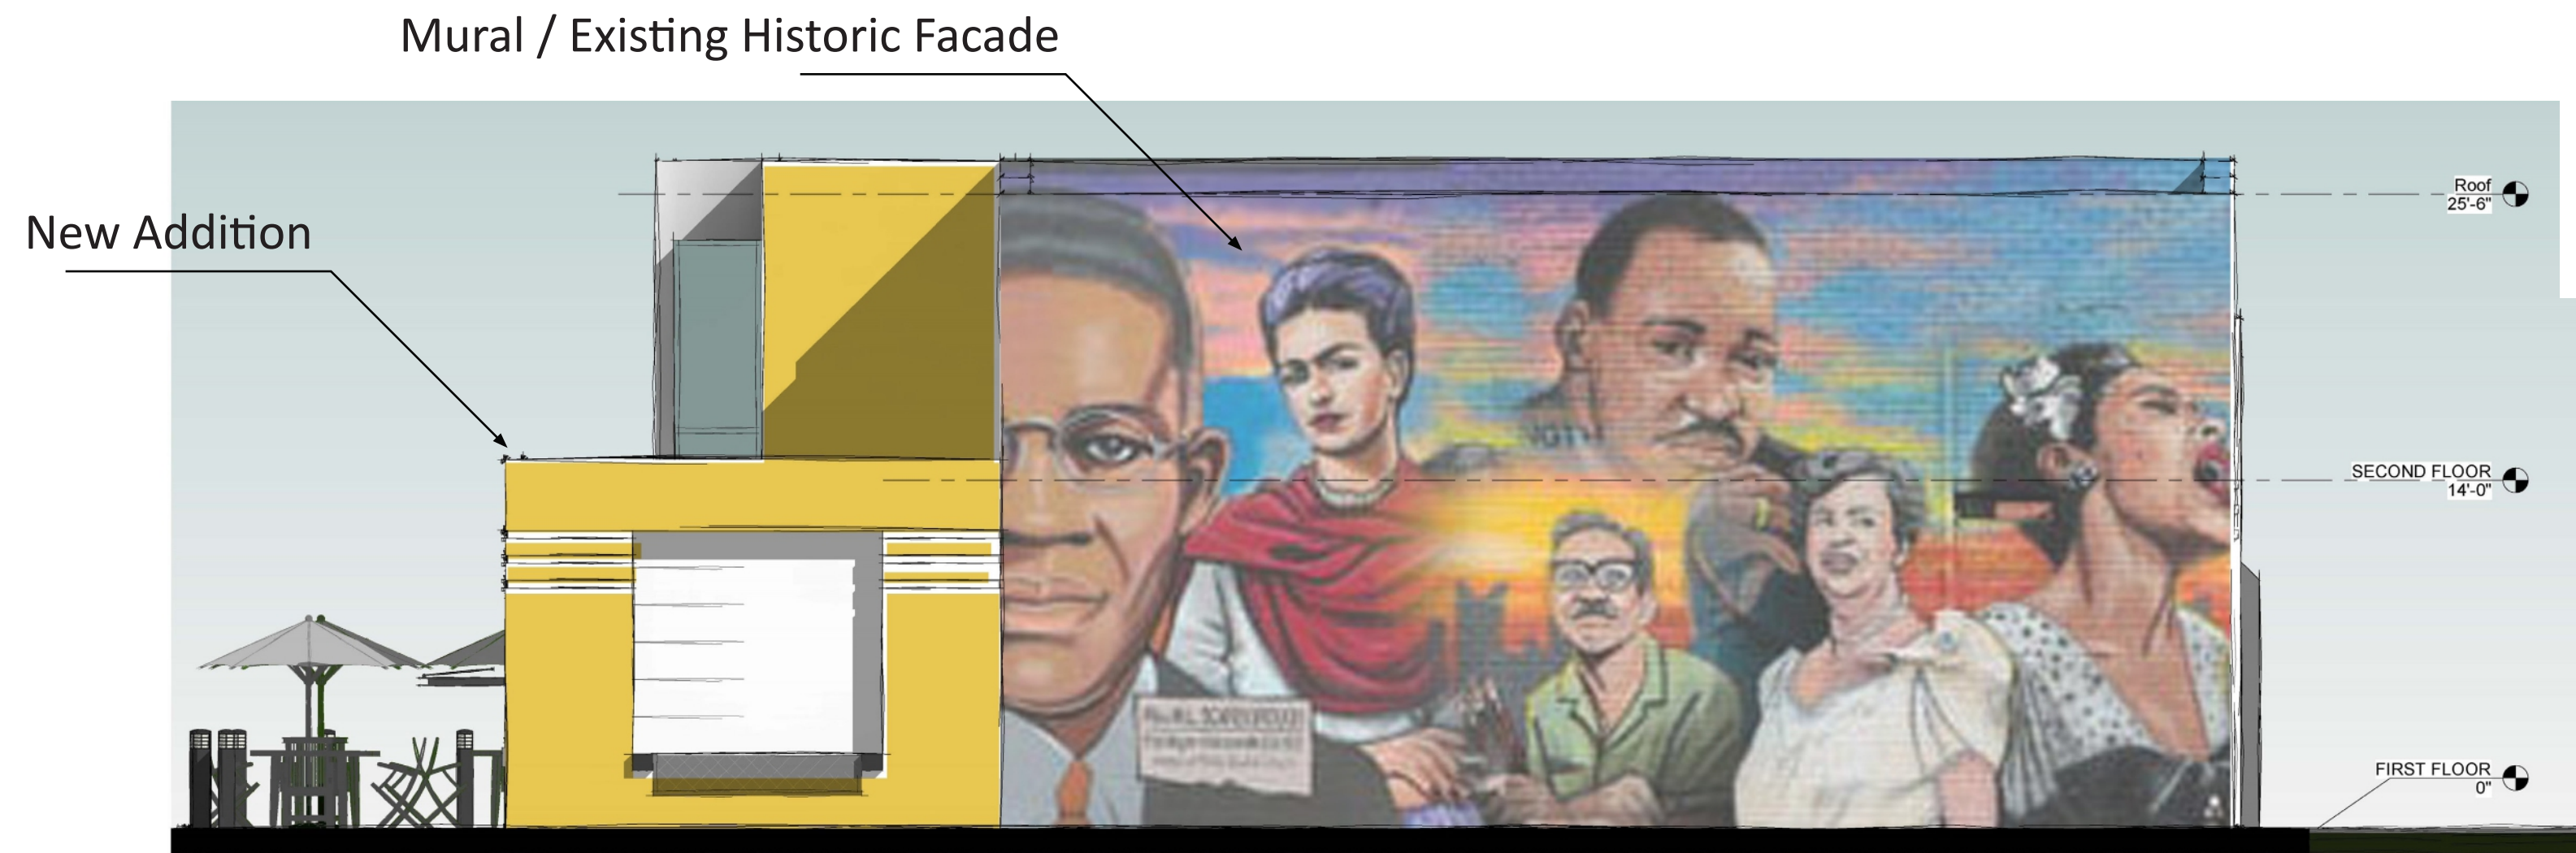
Proposed North Elevation (Rear)

Mural / Existing Historic Facade

Existing Historic Building

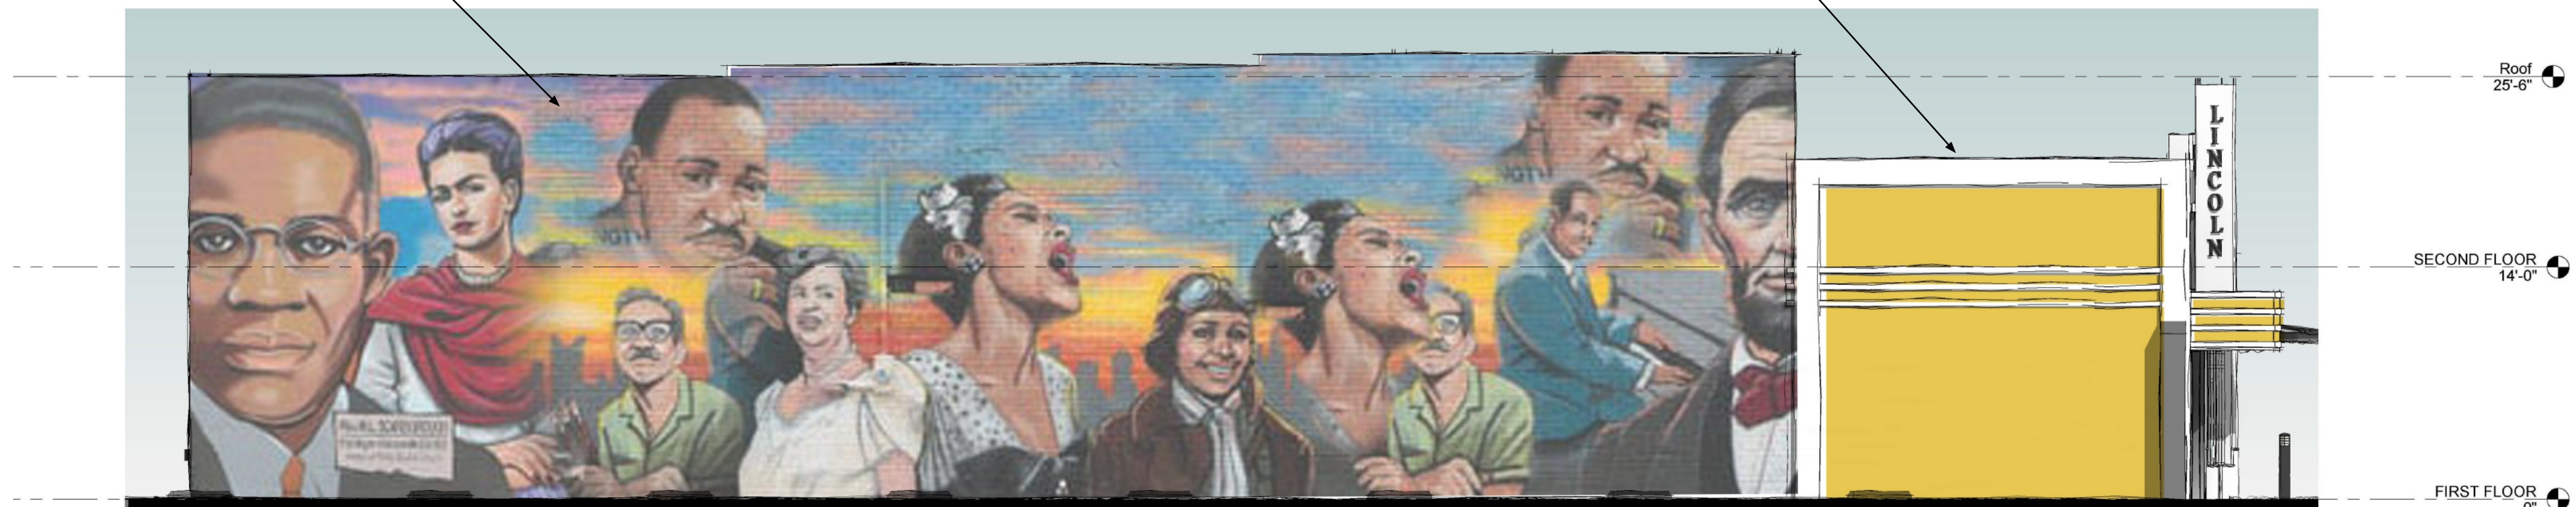
Proposed West Elevation (Side View)

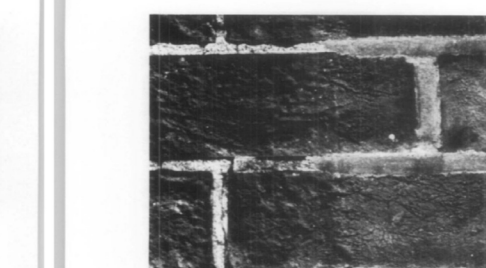
Abrasive Cleaning of Wood. This wooden window sill, molding and paneling have been sandblasted to remove layers of paint in the rehabilitation of this commercial building. Not only is some paint still embedded in cracks and crevices of the woodwork, but more important, grit blasting has actually eroded the summer wood, an effect raising the grain, and resulting in a rough surface.

Abrading the Surface without Removing the Paint. Even though the entire outer surface layer of the brick has been sandblasted off, spots of paint still cling to the masonry. Sandblasting or other similarly abrasive methods are not always a successful means of removing paint.
