# 906 DELAWARE AVENUE

CERTIFICATE OF APPROPRIATENESS: APPLICATION SUPPLEMENT

January 24, 2022

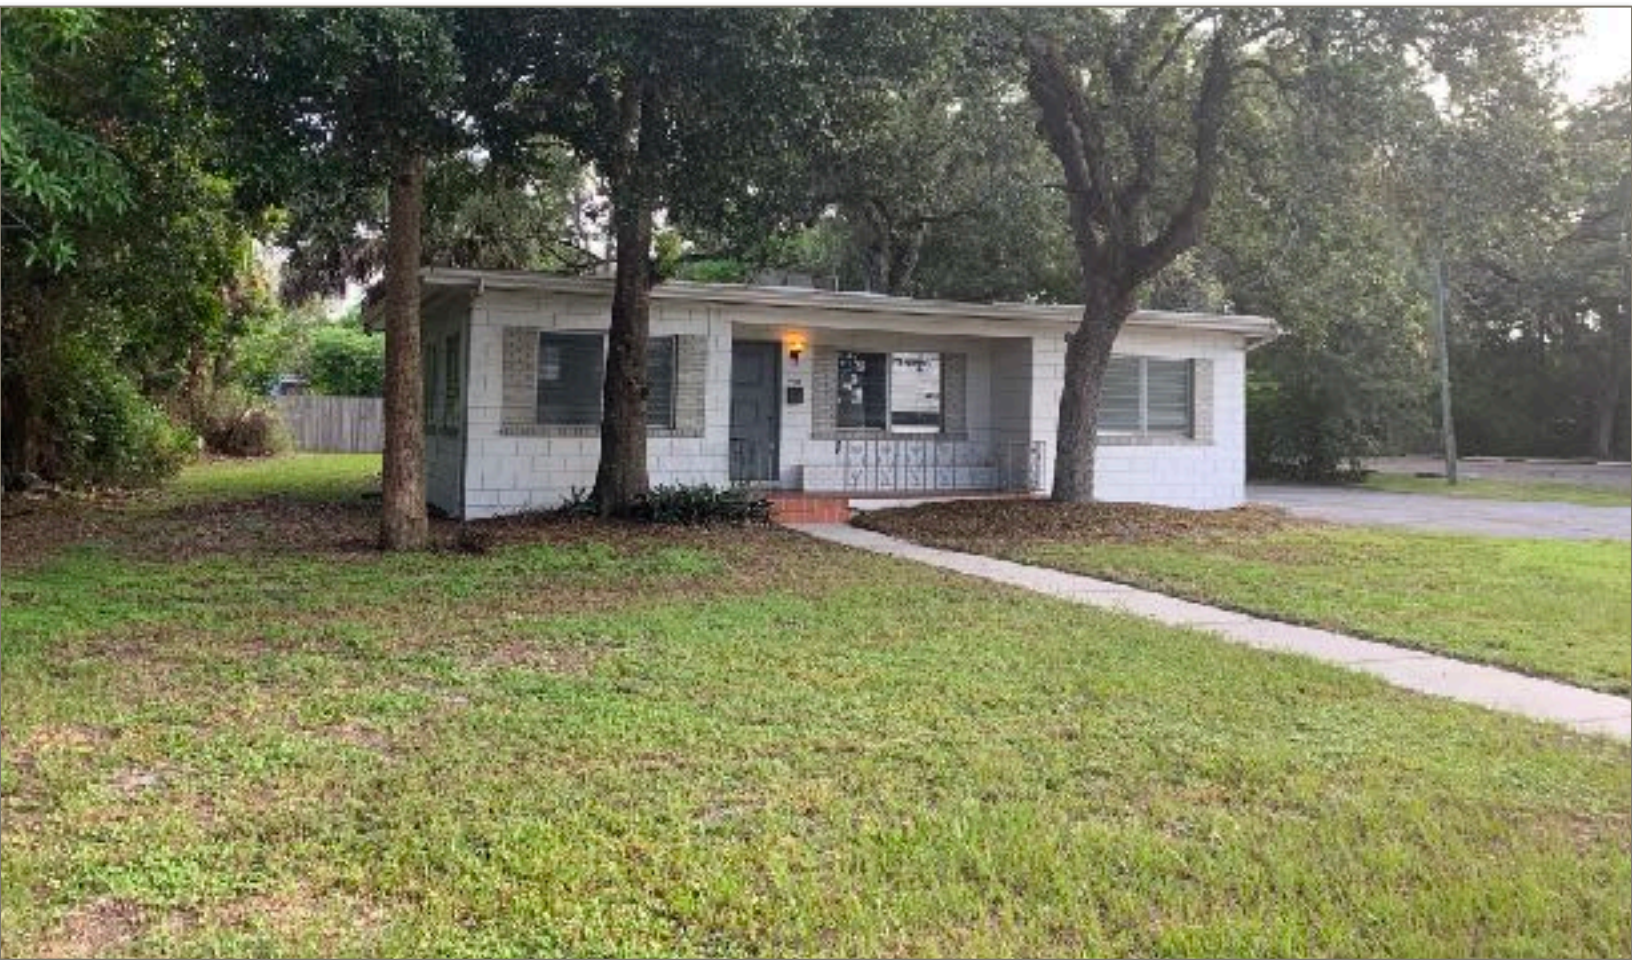
## 906 DELAWARE AVENUE: SEPTEMBER 2021

906 Delaware Avenue is a non-contributing structure in the Sample Oaks Historic District. Built in 1954, the architectural design is mid-century modern, and outside the period of significance for the District. The mid-century modern exterior design elements of the structure include struck block wall fabric, flat roof, horizontal window orientation, an integrated brick planter on the shallow front porch, and parking in the front of the building.

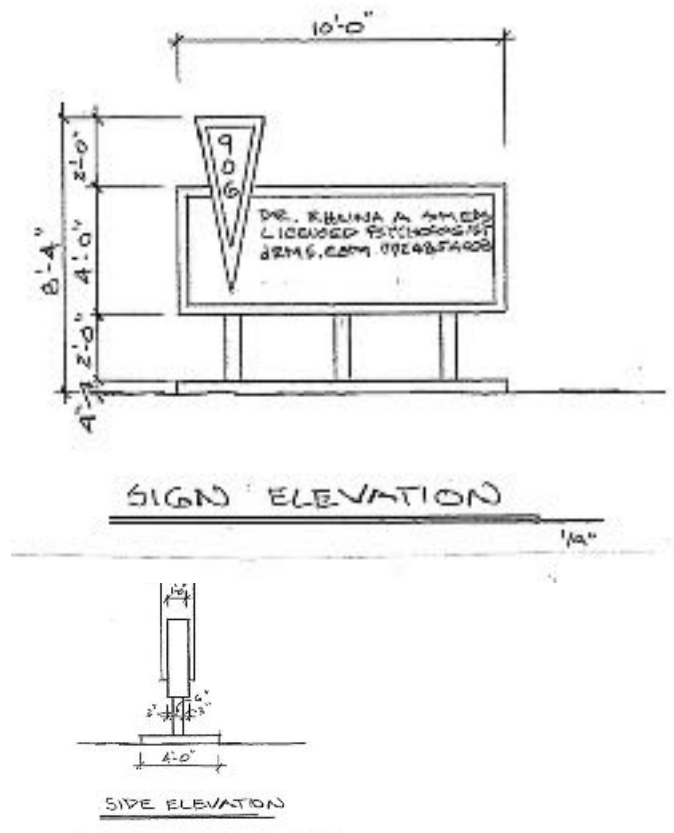
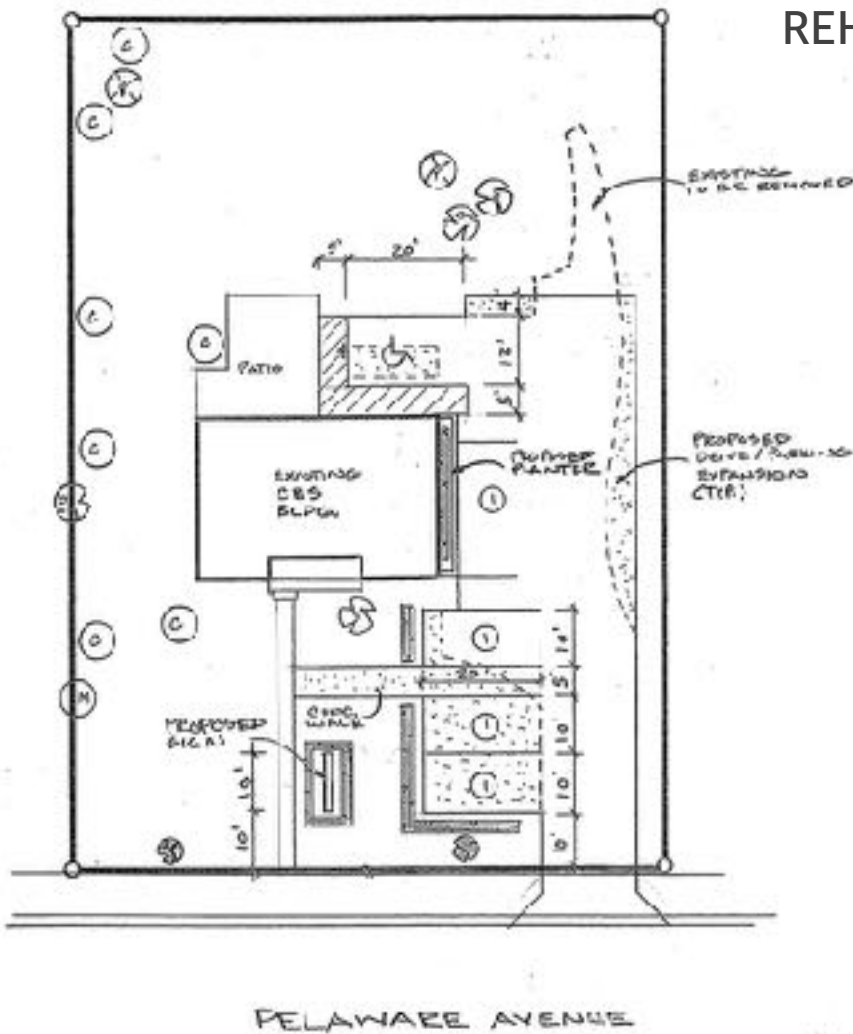
## MONUMENT SIGN

This professional office will require a monument sign in keeping with the site's architectural design. A custom sign has been designed with a nod to midcentury geometric shapes, and will be constructed of concrete and stainless steel (or aluminum).

Lighting of the sign will be ground uplights, not backlit.

These colors will also be incorporated into the monument sign, in addition to stainless steel, and deep gray letters.

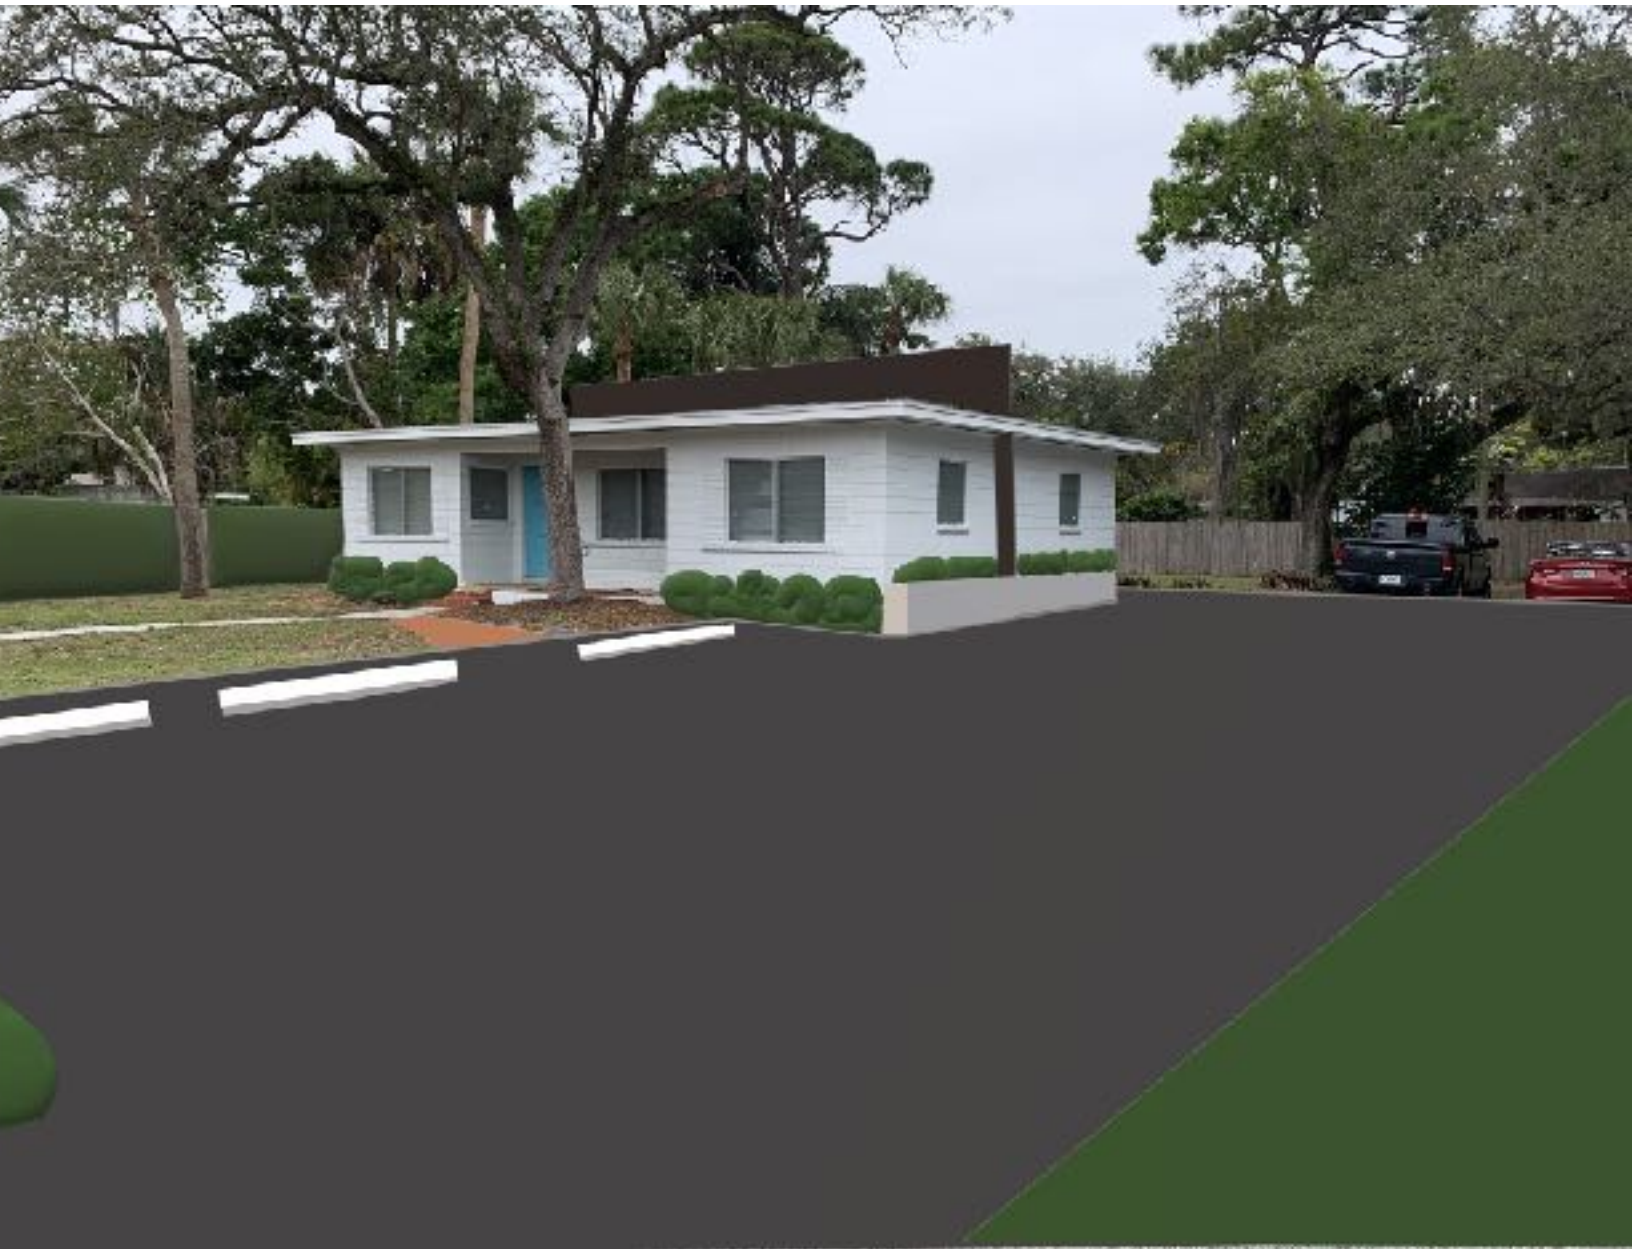
PROPOSED SITE IMPROVEMENTS  
1"=20'

1. Parking: Removal of uneven millings and replace with either asphalt or pavers (depending on grant funding availability) to meet code and ADA accessibility requirements. Install landscaping per code around parking area. Parking improvements to be installed in same area as originally used. The midcentury modern period idealized the auto, and began placing parking in front of the building. This design reflects that history. Stormwater retention will be integrated into the parking design.
2. Monument Sign: A custom built concrete and steel monument sign will be constructed in a midcentury modern design.
3. Western Boundary fence and hedge: Screen the residential use to the west with a 6' tall wooden shadowbox privacy fence and hedge. At the front facade, the fence will drop to 4' in height in a modern horizontal pine design.

## SITE PLAN
