**Reference:** **Environmental Assessment**  
3240 S 25<sup>th</sup> Street  
Fort Pierce, FL 34981  
Parcel ID: 2428-232-0001-000-0

## ENVIRONMENTAL ASSESSMENT

3240 S 25th Street  
Fort Pierce, FL 34981  
Parcel ID:  
**2428-232-0001-000-0**

Date: March 25, 2025  
Project # 25-188

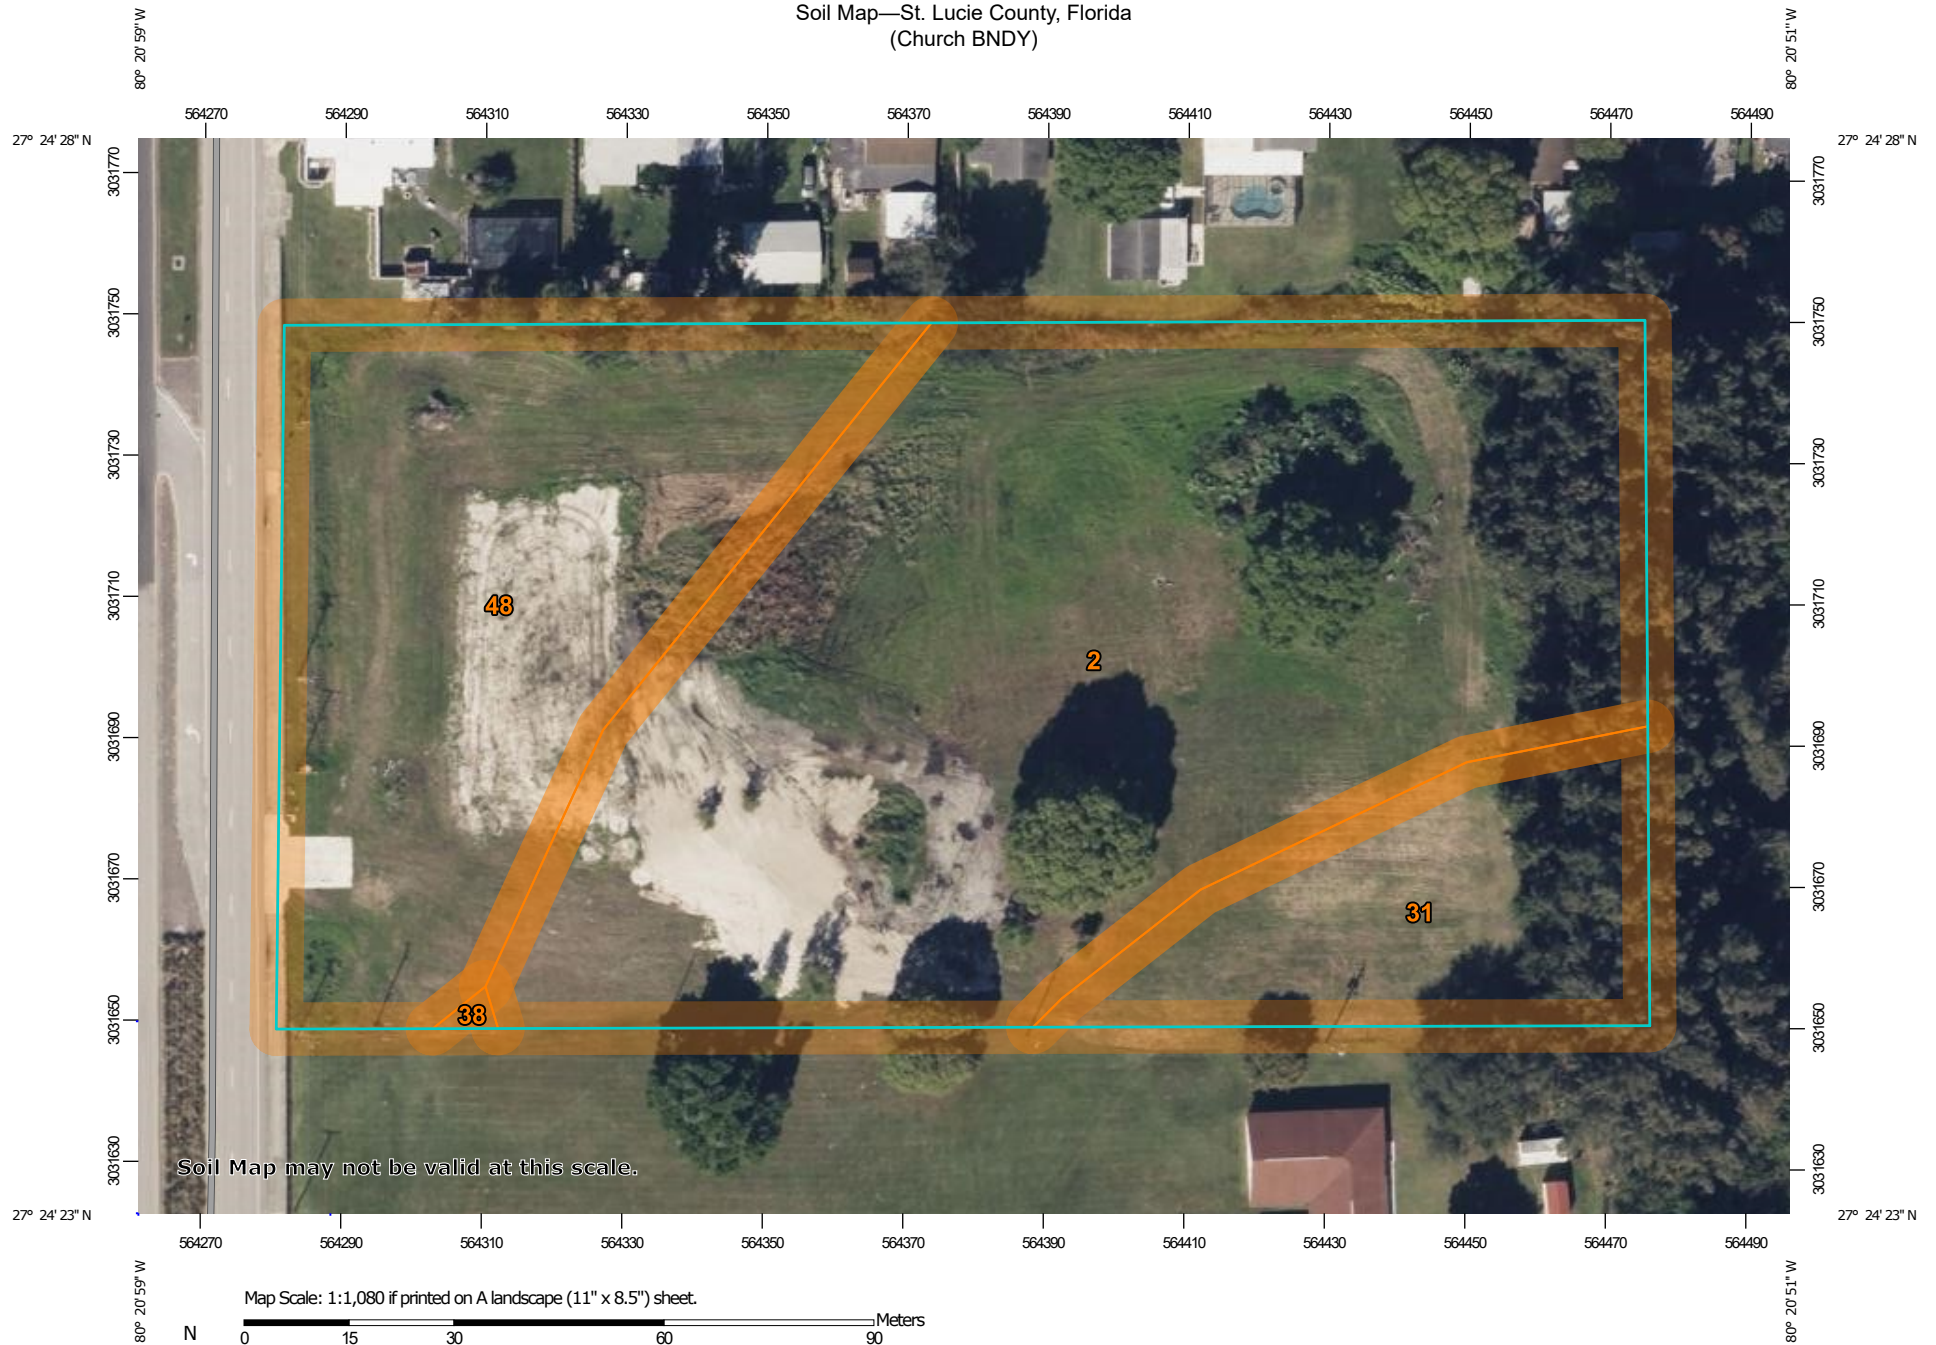
Soil Map—St. Lucie County, Florida  
(Church BNDY)

Based on a review of the U.S. Department of Agriculture (USDA) Web Soil Survey the site is composed of the following soil series:

**Ankona and Farnton sands-** The Ankona and Farnton series consist of very deep, very poorly drained, slowly permeable soils. These sands formed in sandy and loamy marine sediments. A water table is within depths of 6 to 18 inches for 1 to 4 months, primarily in the winter and early spring and it is at depths of 18 to 40 inches for 6 months or more during the rest of the year in most years. Ankona and Farnton soils are found in broad flats and depressional areas. Typical vegetation consists of longleaf pine, slash pine, saw palmetto, wax myrtle, gallberry, fetterbush, creeping bluestem, chalky bluestem, lopsided Indian grass, low panicums and pineland threeawn. Depressional areas are dominated by marsh vegetation consisting of maidencane, cutgrass, sand cordgrass, and St. John's wort.

**Riviera fine sand-** This poorly drained, nearly level soil is found in hammocks and along drainage ways. The surface layer is dark gray brown fine sand about 5 inches thick. The soil has a water table at a depth of less than 10 inches for 2 to 4 months in most years and at a depth of 10 to 30 inches for most of the rest of the year. Permeability is rapid in the surface and subsurface layers and is slow to very slow in the subsoil, and rapid in the substratum. Natural vegetation includes cabbage palms and scattered longleaf pine and slash pine and an understory of wax myrtle and saw palmetto. The most common native grasses are pineland threeawn and blue maidencane. Broom sedges, creeping bluestem, paspalum, sand cordgrass and panicums are typical grasses for this soil.

**Wabasso sand-** This soil is a nearly level, poorly drained soil in broad open areas of the flatwoods. The surface layer is sand about 8 inches thick. The upper 4 inches is black and the lower 4 inches is dark grey. The water table is typically at a depth of less than 10 inches for 1 to 4 months during the wet season, and at a depth of 10 to 40 inches for 6 to 9 months in most years. Natural vegetation is slash pine, cabbage palm, saw palmetto, running oak, inkberry and fetterbush. Common grasses are threeawn and bluestem. The soil has severe limitations for cultivated crops and citrus due to wetness. The soil has high potential for dwellings without basements, small commercial buildings, local roads and streets.
