PULTE GROUP

CORNERSTONE

Environmental Assessment Report

August 2024

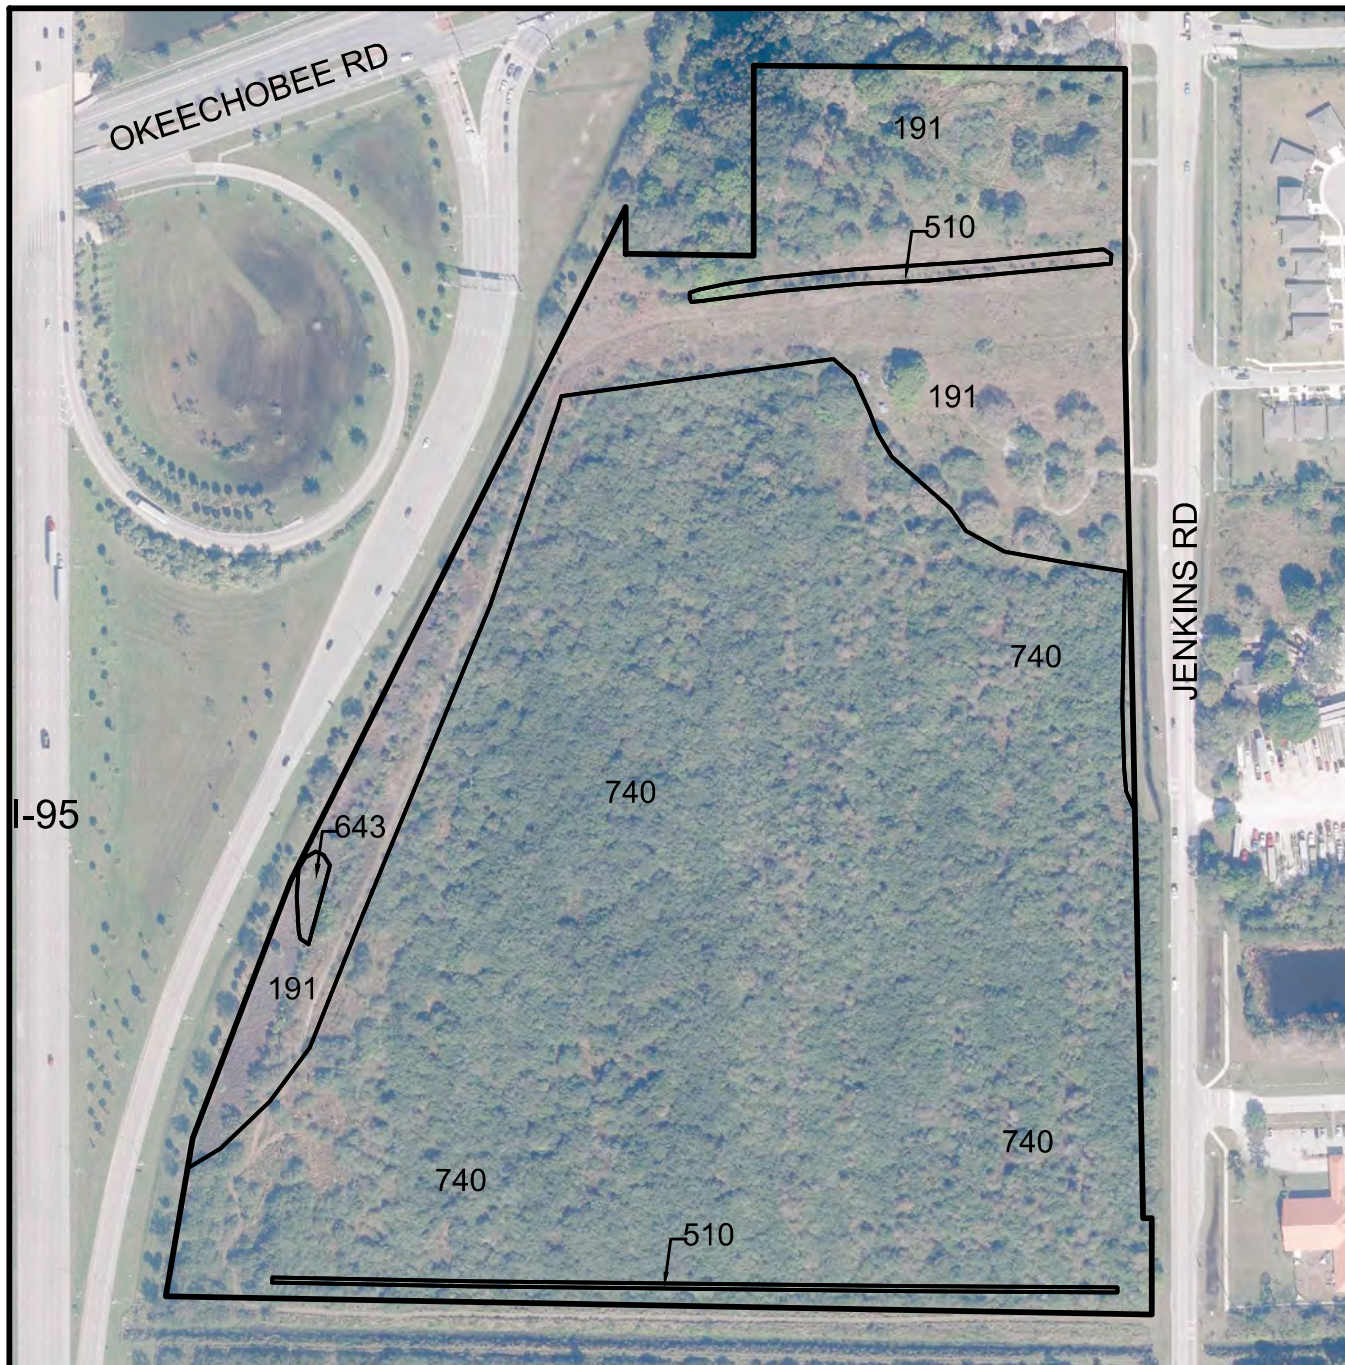
AUG 2024
FIGURE
4

- 191 - UNDEVELOPED LAND WITHIN URBAN AREAS (12.4± AC)
- 510 - DITCH (0.6± AC)
- 643 - WET PRAIRIE (0.1± AC)
- 740 - DISTURBED LANDS (36.8± AC)
- TOTAL SITE (49.9± AC)

FLUCFCS

This land cover is located within the northern and western portions of the property. The vegetation assemblage within these areas is dominated by non-native invasive species, ruderal weeds, and non-native pasture grasses. Vegetation includes Brazilian pepper, Australian pine, guava, smut grass, cogon grass, guinea grass, Caesar weed, and castor bean. Scattered occurrences of native laurel oak, slash pine, cabbage palm, and wax myrtle are also present.

The property contains two man-made ditches that were created in support of the former agricultural practices on the property. The northern of the two ditches is shallow and is vegetated predominantly with non-native invasive species including torpedo grass, limpo grass, Peruvian primrose willow, and Caesar weed. Scattered occurrences of native species including broomsedge, spadeleaf and pennywort are also present. The southern ditch, located near the southern property boundary is a deep, steep sided ditch that contains scattered occurrences of non-native invasive Peruvian primrose willow and native Carolina willow.

There is one area located near the western property boundary that meets the criteria to be considered a wet prairie wetland. Vegetative cover in this area includes native grape vine, Virginia chain fern, and broomsedge, and non-native invasive old-world climbing fern and Peruvian primrose willow.

This is the predominant land cover type on the subject property, and was previously improved for agricultural use. The vegetation assemblage is currently dominated by non-native invasive Brazilian pepper with scattered occurrences of native laurel oak, cabbage palm, and wax myrtle.

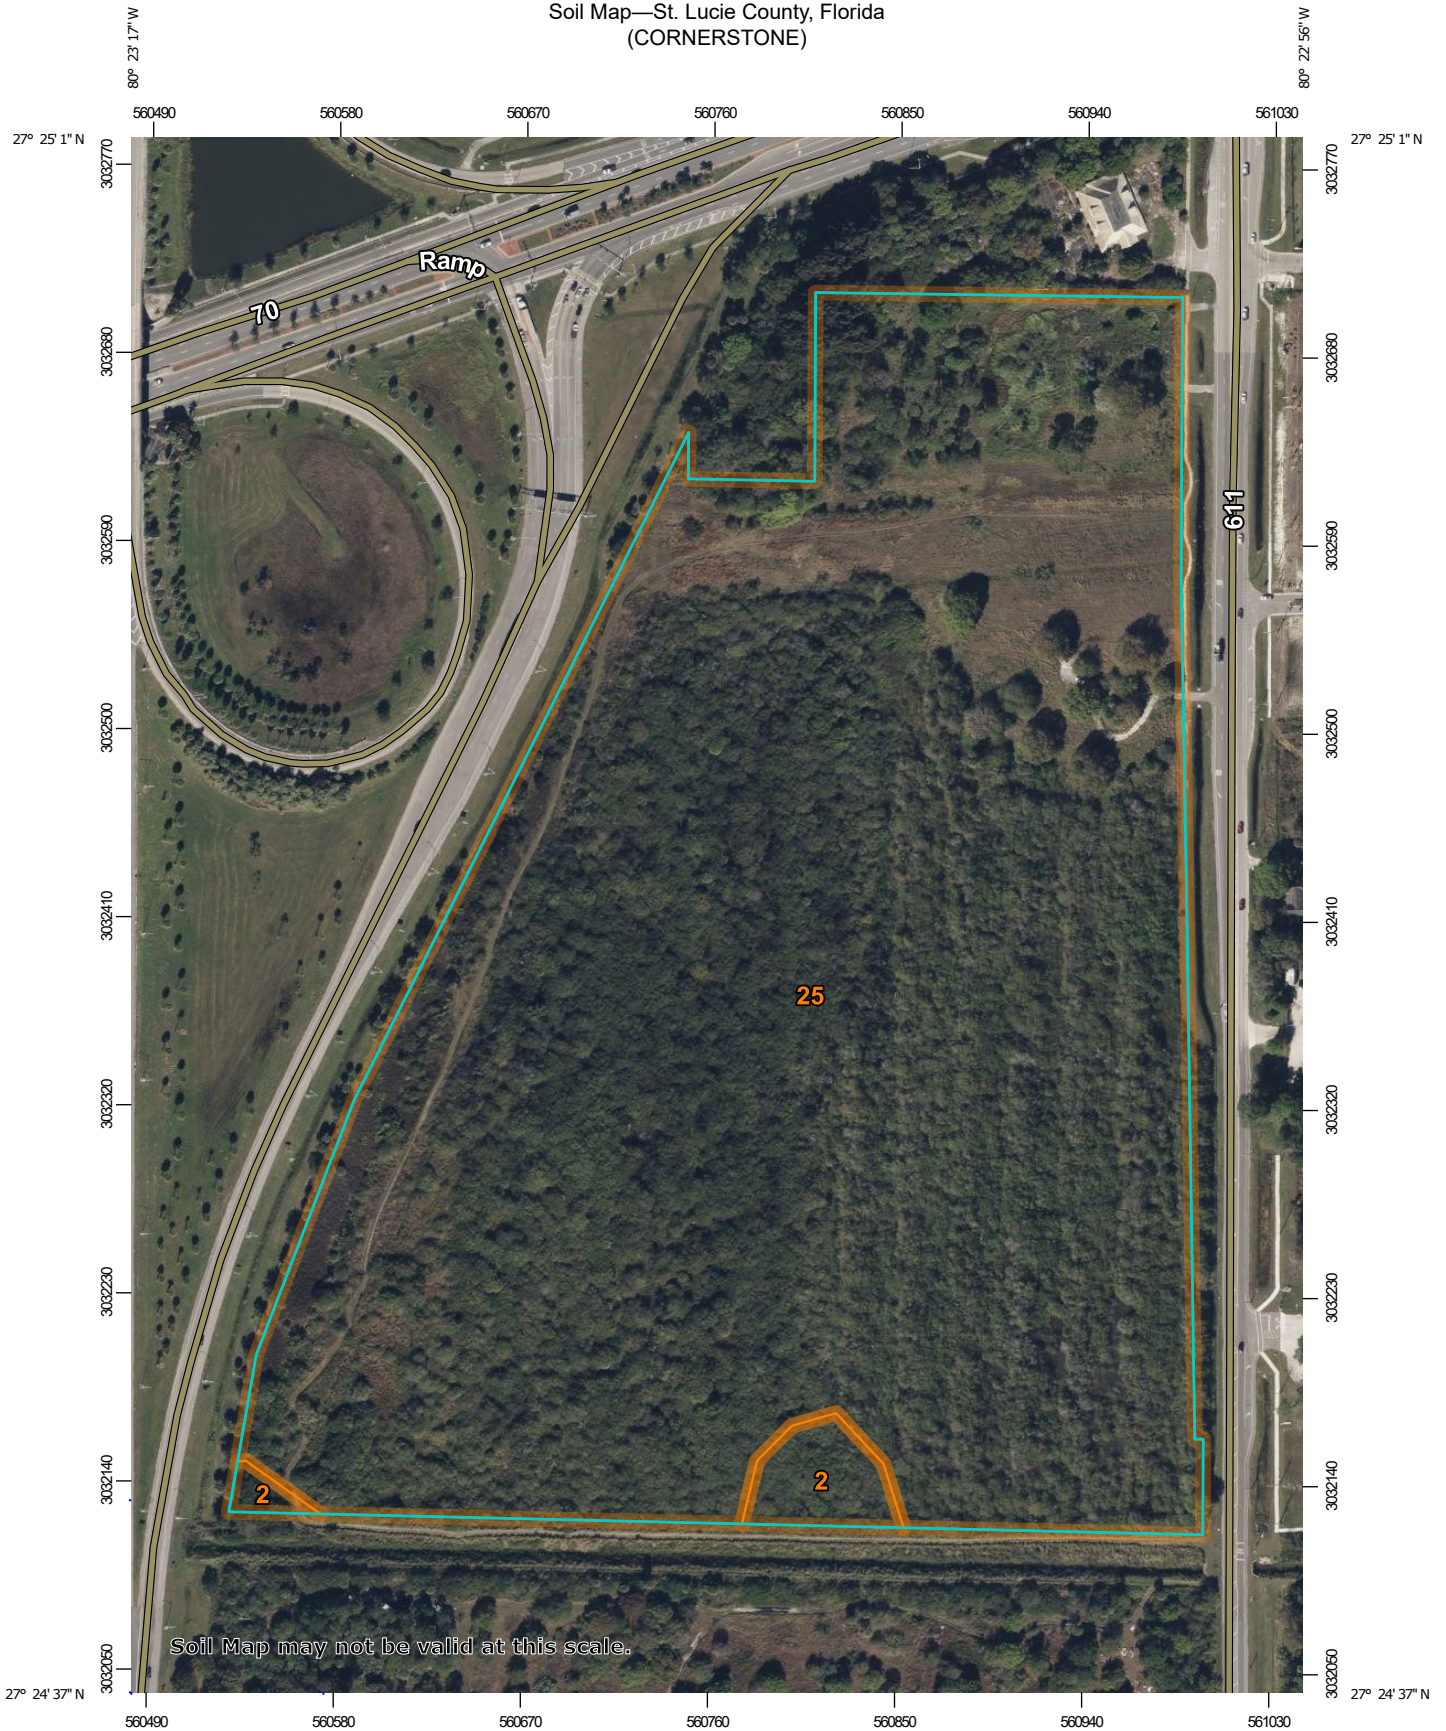
Soil Map—St. Lucie County, Florida
(CORNERSTONE)

Map Unit Symbol	Map Unit Name	Acres in AOI	Percent of AOI
2	Ankona and Farnton sands	0.9	1.8%
25	Nettles and Oldsmar sands	49.0	98.2%
Totals for Area of Interest		49.9	100.0%

A Custom Soil Resource Report for the subject property is provided in the Appendix. This report, prepared by the United States Department of Agriculture (USDA) Natural Resource Conservation Service (NRCS) provides descriptions of the soil types within the Cornerstone property along with acreage summaries, soil limitation information, and recommended soil treatments for various proposed land uses.
