# **ENVIRONMENTAL ASSESSMENT REPORT**

**Gordy Road  
FORT PIERCE, FL**

***PREPARED BY:***  
**WGI, INC.**  
**2035 VISTA PARKWAY**  
**WEST PALM BEACH, FL 33411**  
**561-687-2220**

**DECEMBER 1, 2025**

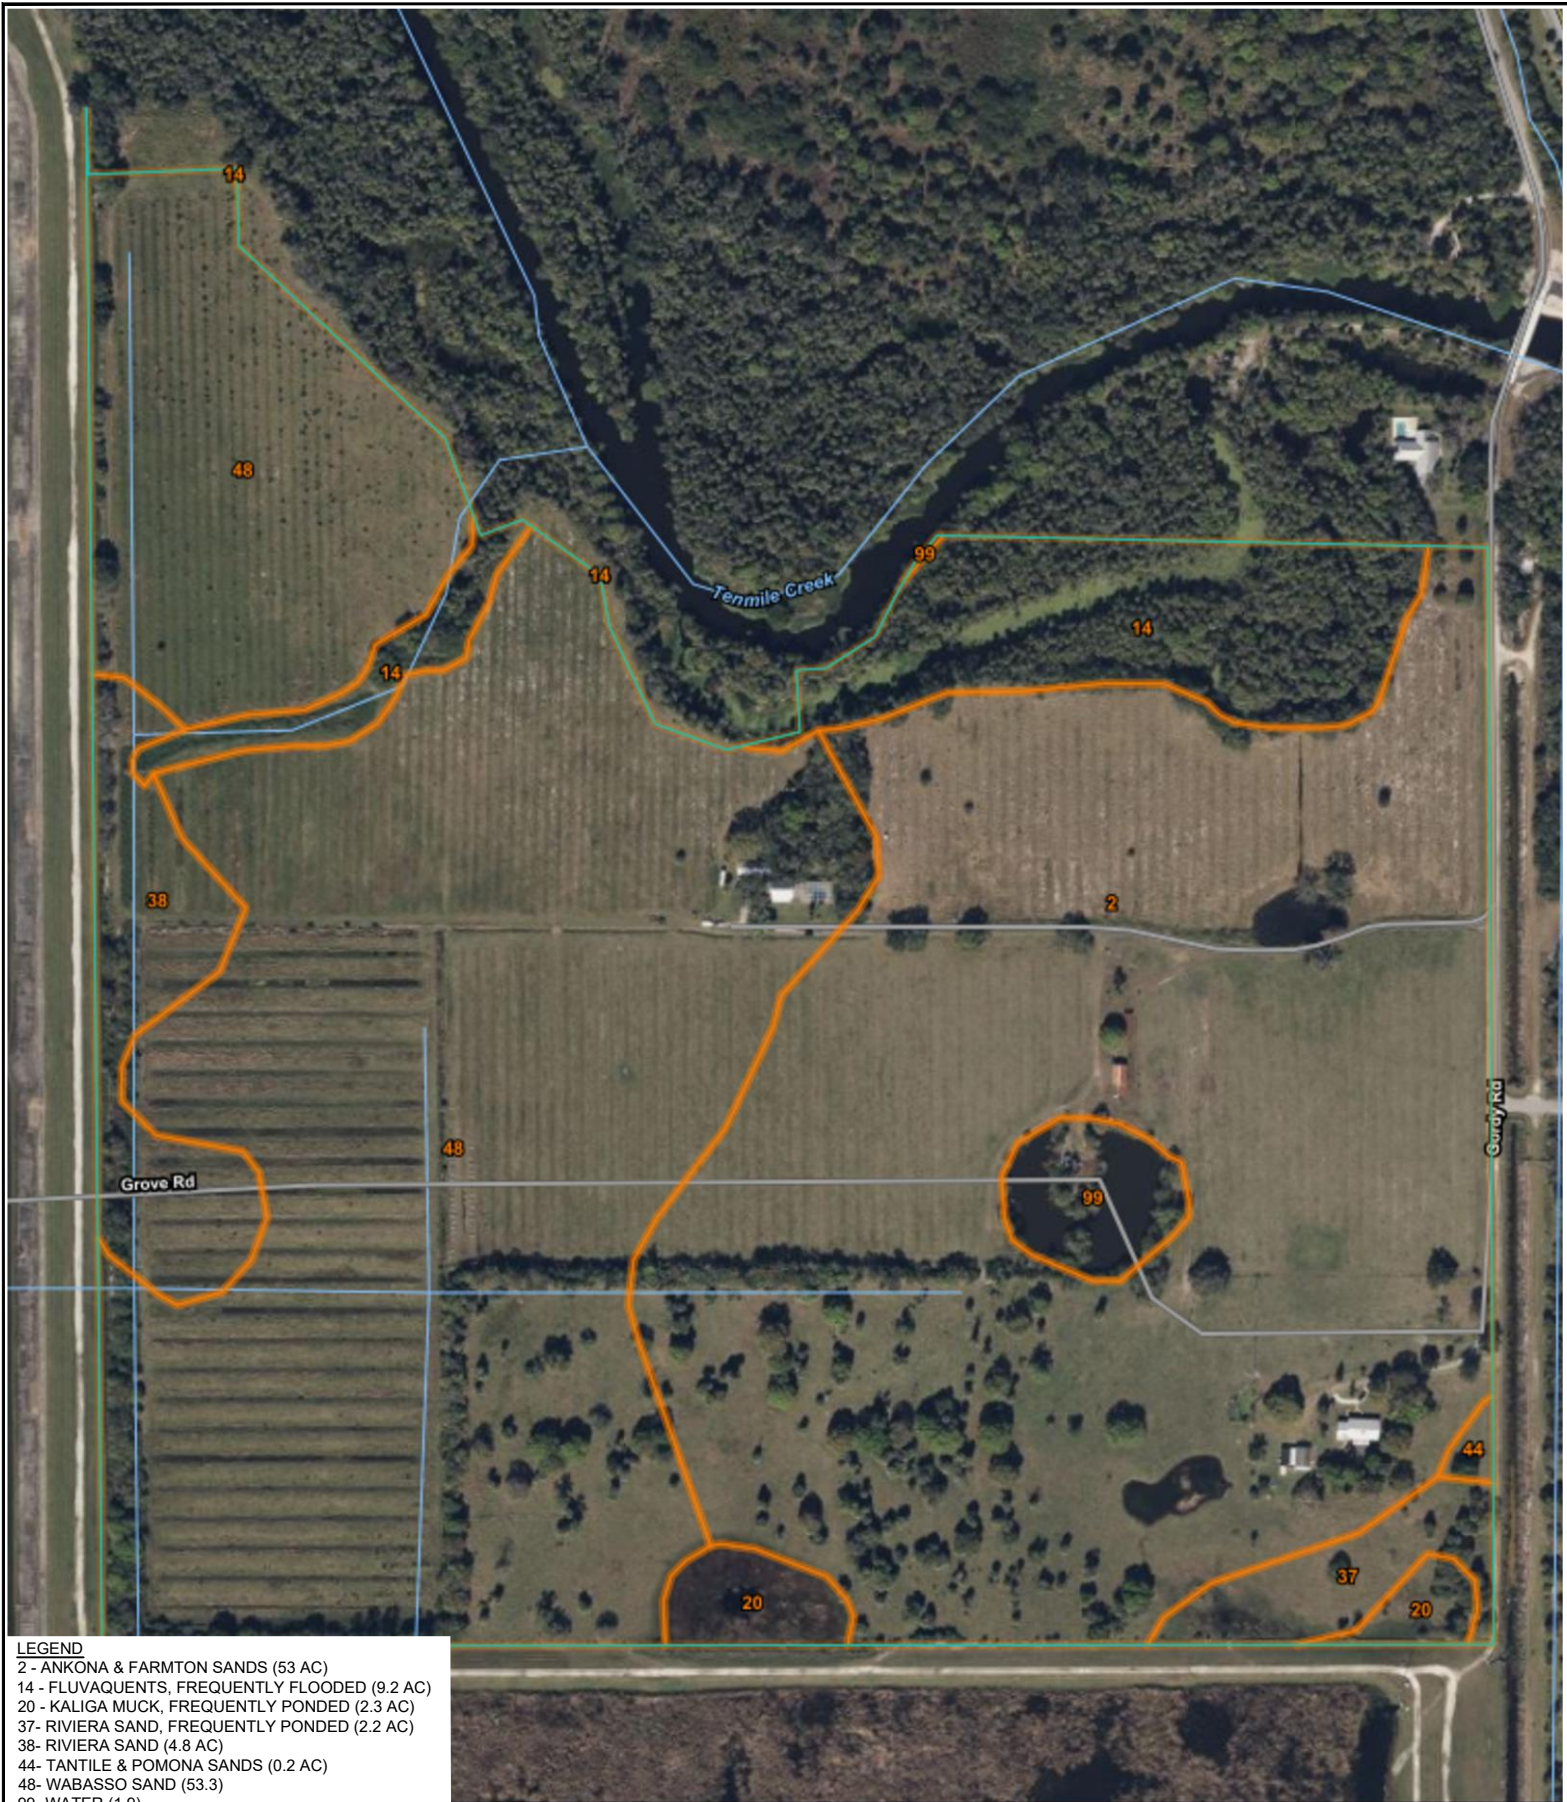
## SOIL SURVEY MAP EXHIBIT B

Based upon the USDA NRCS Soil Survey for St. Lucie County, Florida, seven soil types are mapped within the property. A soil map is included as **Exhibit B**. Listed below are each of the soil types found within the property and a general description of the characteristics of each soil type.

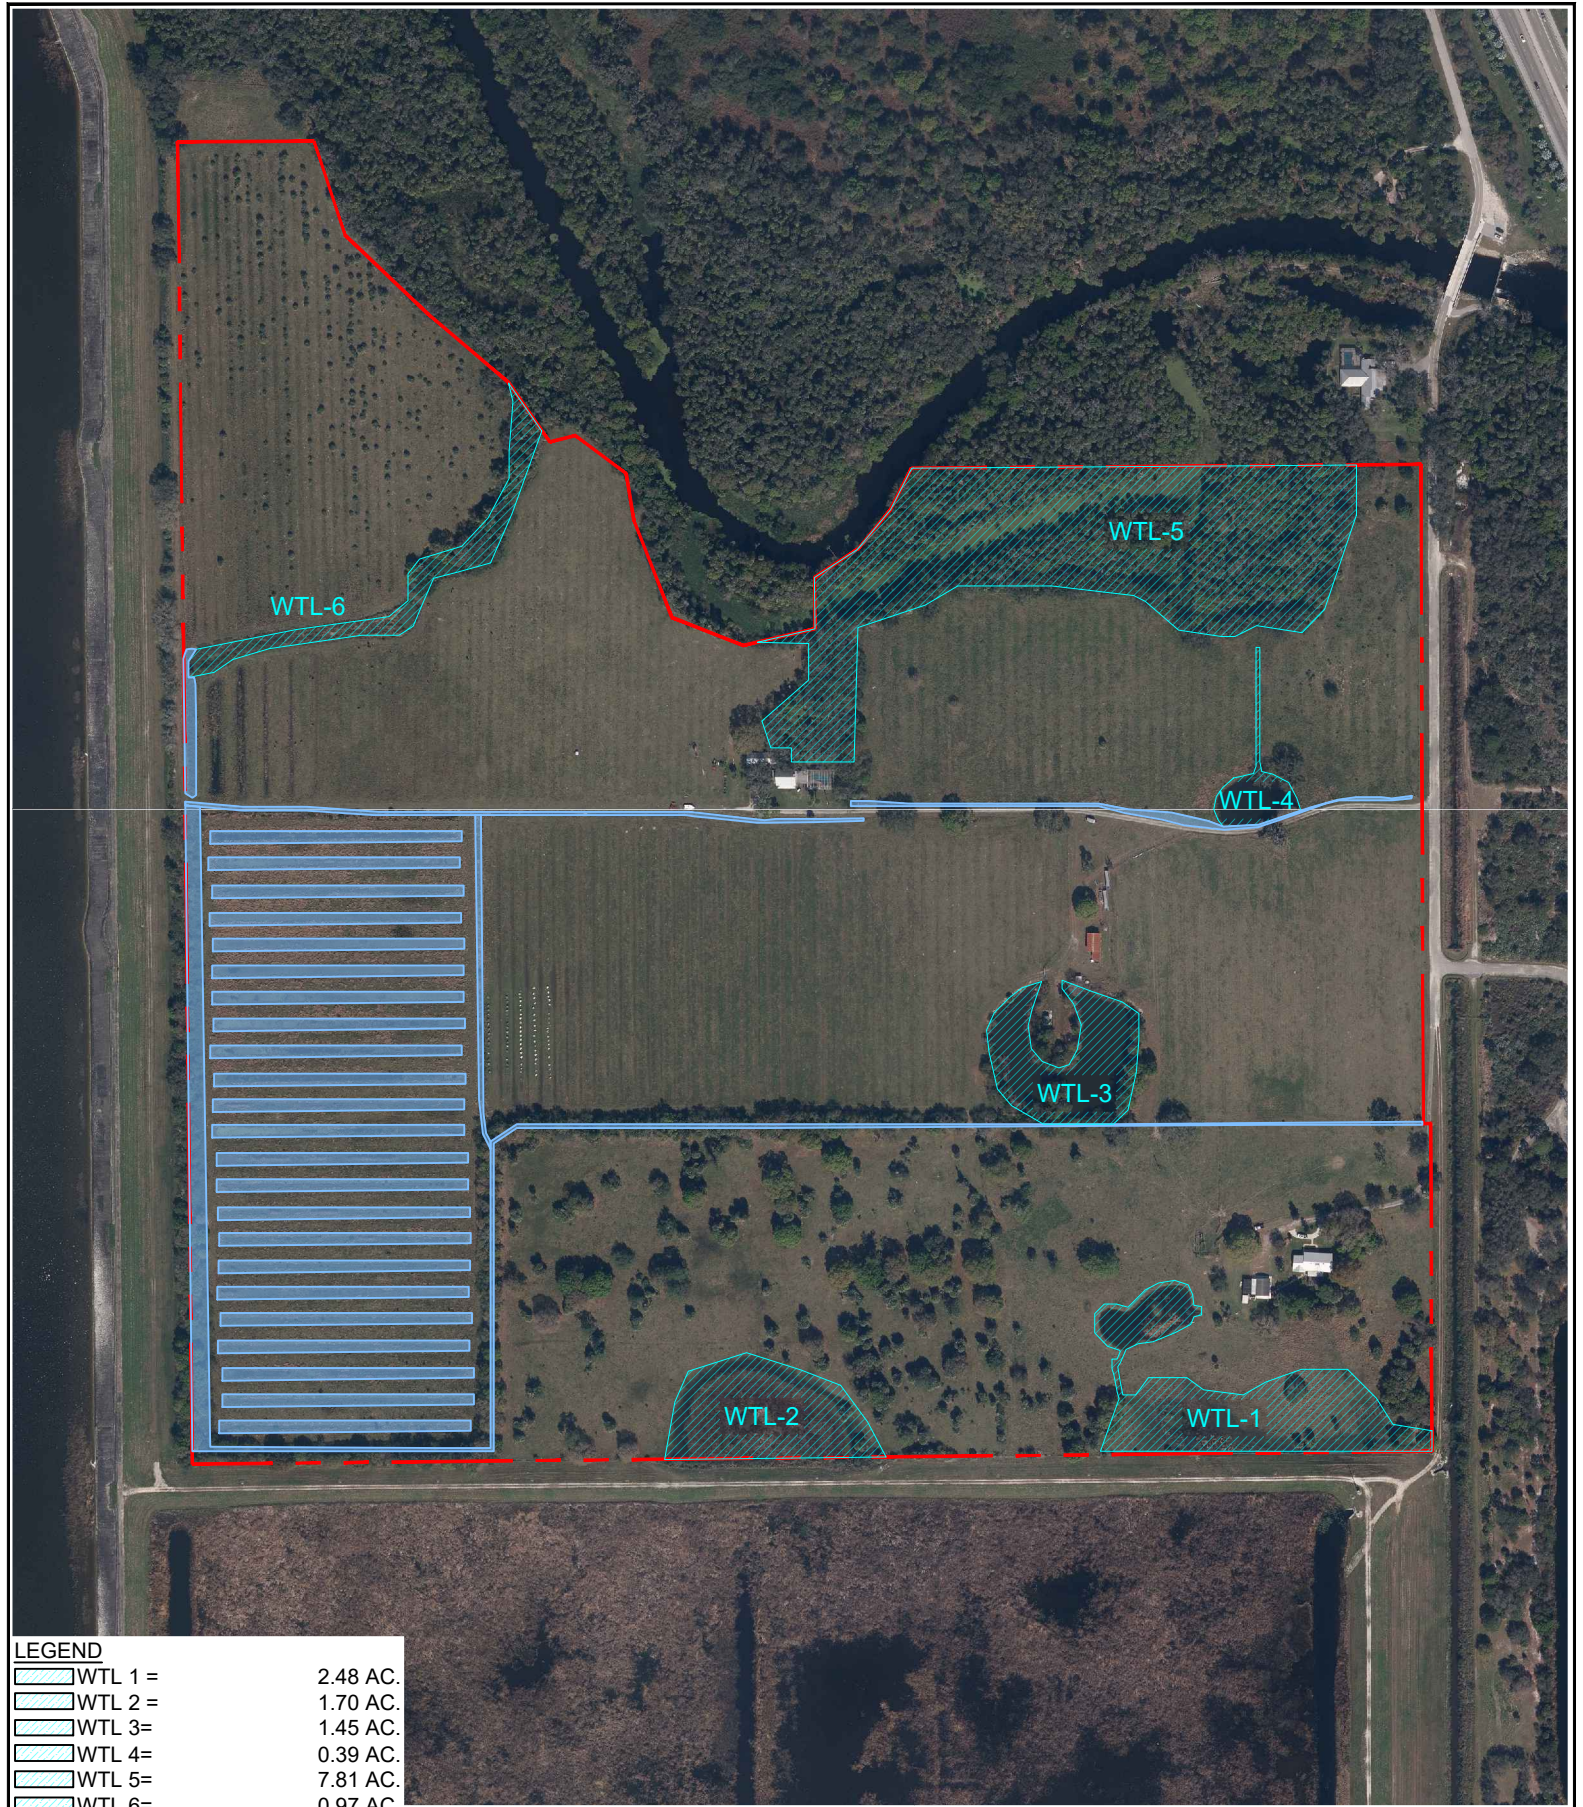
## WETLAND BOUNDARY MAP EXHIBIT D

Delineation of wetlands regulated by the South Florida Water Management District (SFWMD) is done according to Chapter 62-340 Florida Administrative Code (F.A.C.), Delineation of the Landward Extent of Wetlands and Surface Waters. The *Florida Wetlands Delineation Manual* (Gilbert et al., 1995) serves as a guide to Chapter 62-340. The United States Army Corps of Engineers (USACE) will delineate federal jurisdictional wetlands according to 40 CFR Part 120, the Waters of the United States (WOTUS) rule. The USACE 1987 Wetland Delineation Manual serves as a guide to 40 CFR Part 120. In this evaluation, WGI used the intent and methodology of the manual to form the opinion that wetlands are located within the boundaries of the subject property. The wetland communities listed below were observed within the subject property. A wetland boundary map is included as **Exhibit D**.

It is WGI's opinion that there are approximately 14.8 acres of herbaceous and forested wetlands, and 8.83 acres of surface waters, on the subject property. Wetlands 3 and 4 are historic wetlands that were dredged and are now being used as irrigation/drainage ponds. It is WGI's opinion that the regulatory agencies may consider these areas wetlands and not "other surface waters" due to their historic wetland status. WGI's opinion is based on preliminary reconnaissance only; WGI has not conducted official wetland delineation services for this site. Furthermore, wetland boundaries can only be verified by state and/or federal regulatory agency involvement. The State of Florida Department of Environmental Protection (FDEP) has established the Environmental Resource Program (ERP) under Chapter 62-330, F.A.C. that governs the "construction, alteration, operation, maintenance, repair, abandonment, and removal of stormwater management systems, dams, impoundments, reservoirs, appurtenant works, and works (including docks, piers, structures, dredging, and filling located in, on or over wetlands or other surface waters, as defined and delineated in chapter 62-340, F.A.C.)". The FDEP has delegated authority for certain ERP activities to the South Florida Water Management District (SFWMD).

SFWMD individual permit and likely a USACE individual permit. WGI recommends that an approved jurisdictional determination from USACE be submitted as early as possible in the development process as USACE currently has a lengthy processing time (approximately 12-18 months) for 404 program related requests. Both agencies (SFWMD and USACE) require avoidance and minimization of impacts to wetlands prior to considering mitigation for impacting wetlands. The agencies may require some portion of the wetland to be preserved and enhanced unless there is adequate justification for impacting. Preservation of the wetland will require a conservation easement and preserve area management plan that will require maintenance of the wetland in perpetuity. Any impacts to the wetland will require compensatory mitigation. The preferred method of mitigation under federal regulations is via the purchase of mitigation credits from an approved mitigation bank that services the project area.

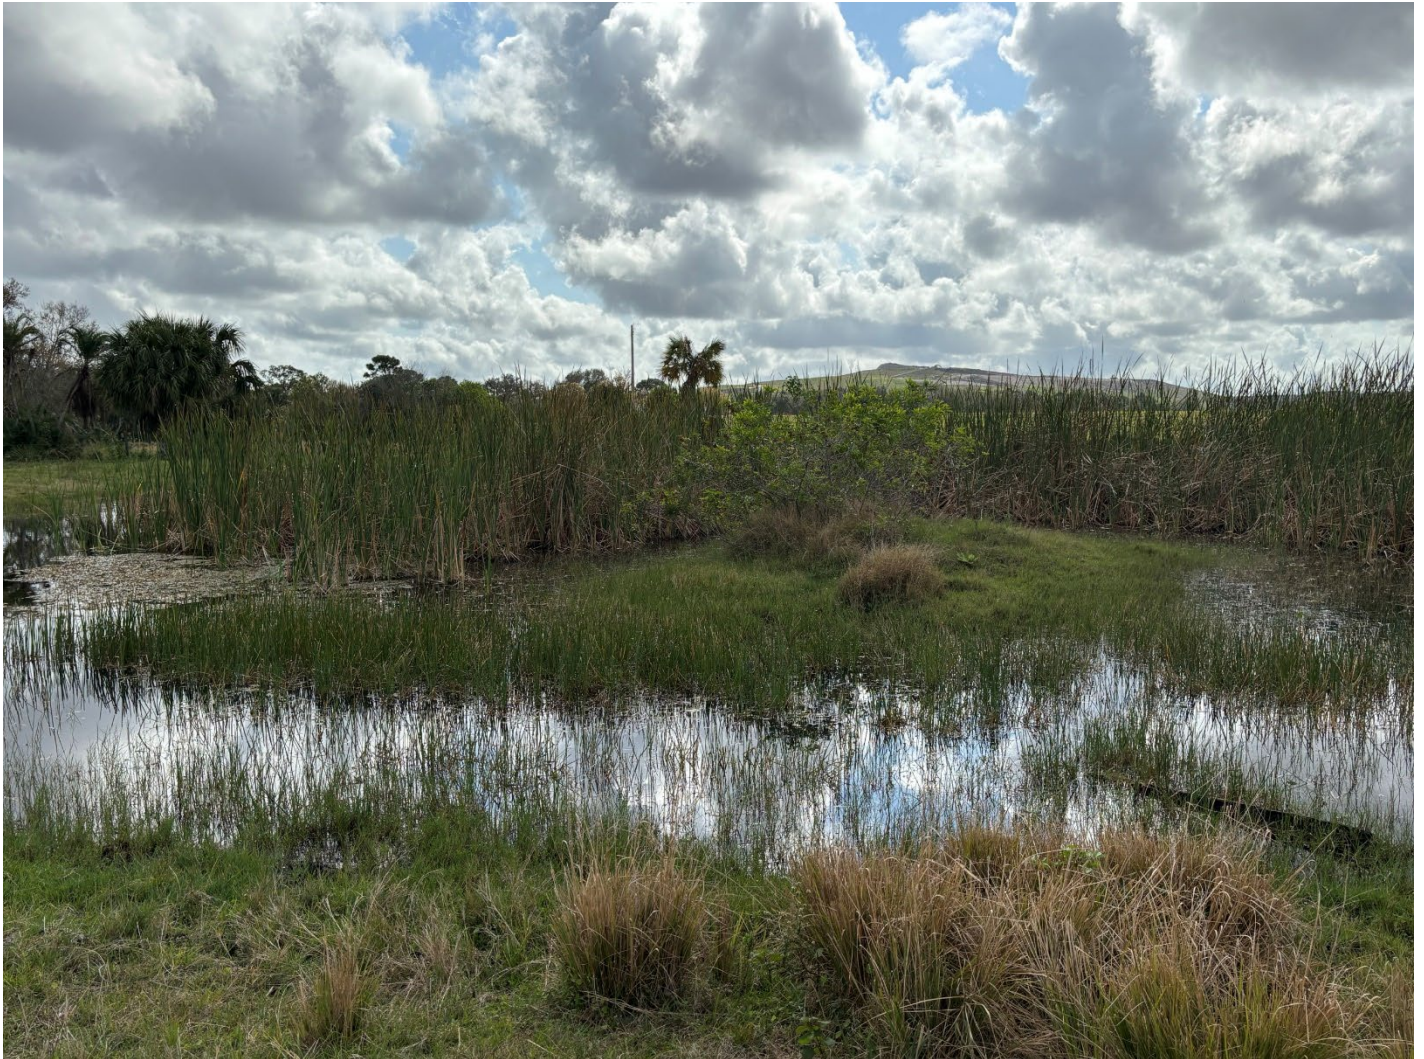
Photo Number: 1	View of one of the southern wetlands on the subject property that is possibly suitable foraging and nesting habitat for sandhill cranes.
Photo date: 2/03/2025	
Direction: S

- **Florida Sandhill Crane**
  - To avoid the need for an FWC take permit, activities should not impact natural wetlands when there are active nests. A 400-foot buffer must be maintained around active nests. If eggs or flightless young are present, land use conversion within 1,500 feet of the nest should be avoided until they reach sustained flight, typically at 70 days old.

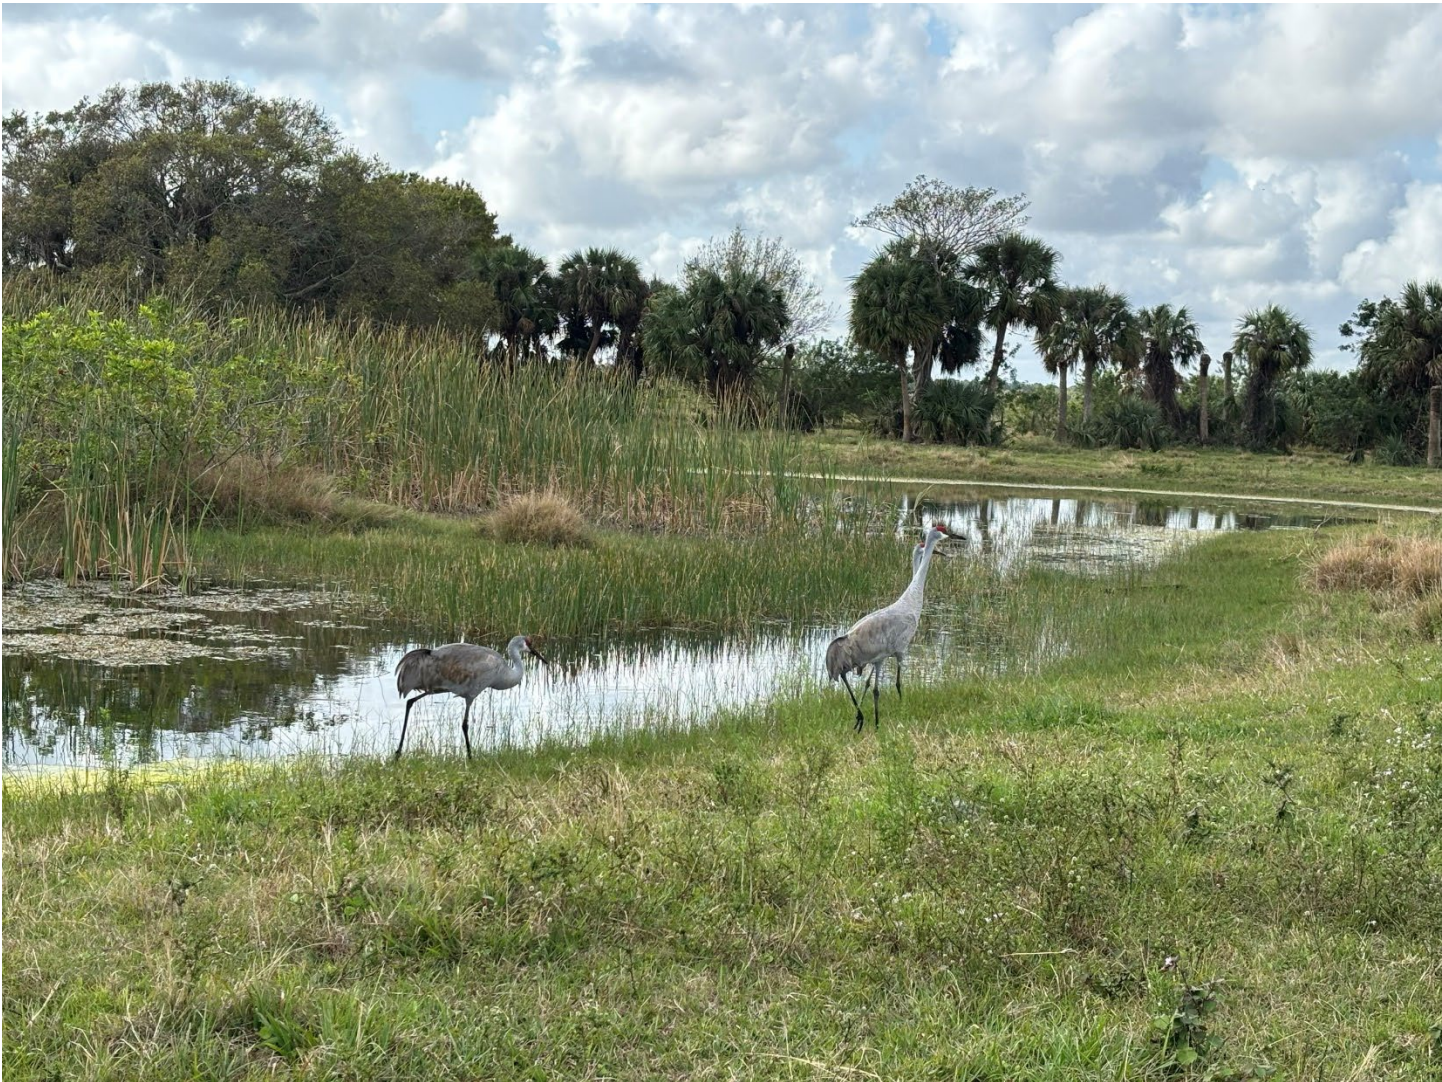
Photo Number: 2
Photo date: 2/03/2025
Direction: S

On February 3, 2025, sandhill cranes and potential nesting habitat were observed on the subject property. **Florida sandhill cranes (*Grus canadensis pratensis*)**, along with their active nests, eggs, and young, are protected under the Federal Migratory Bird Treaty Act, as well as state regulations Rule 68A-16.001 and Rule 68A-4.001, F.A.C. Sandhill crane nesting season occurs between January and May, with nests typically found in seasonally flooded emergent wetlands such as freshwater marshes. The site may provide foraging habitat for Florida sandhill cranes, while the wetlands in the southeastern portion of the property could serve as potential nesting areas. The Florida Fish and Wildlife Conservation Commission (FWC) recommends conducting nesting surveys before any construction activities, particularly during the breeding season from December through August. Since Florida sandhill cranes do not reuse the same nesting sites annually, surveys may need to be conducted each year if construction is ongoing. If active nests are identified onsite, the Species Conservation Measures and Permitting Guidelines advise establishing a 400-foot buffer around the nest to minimize human disturbance. Pre-construction surveys should be conducted within 30 days of project initiation and must include either one aerial survey or two ground surveys. To avoid the need for an FWC take permit, activities should not impact natural wetlands used by sandhill cranes for breeding, feeding, or sheltering. A 400-foot buffer must be maintained around active nests, and if flightless young are present, land use conversion within 1,500 feet of the nest should be avoided until they are capable of sustained flight, typically within 70 days of hatching.

View of the southern wetland and Sandhill Cranes.

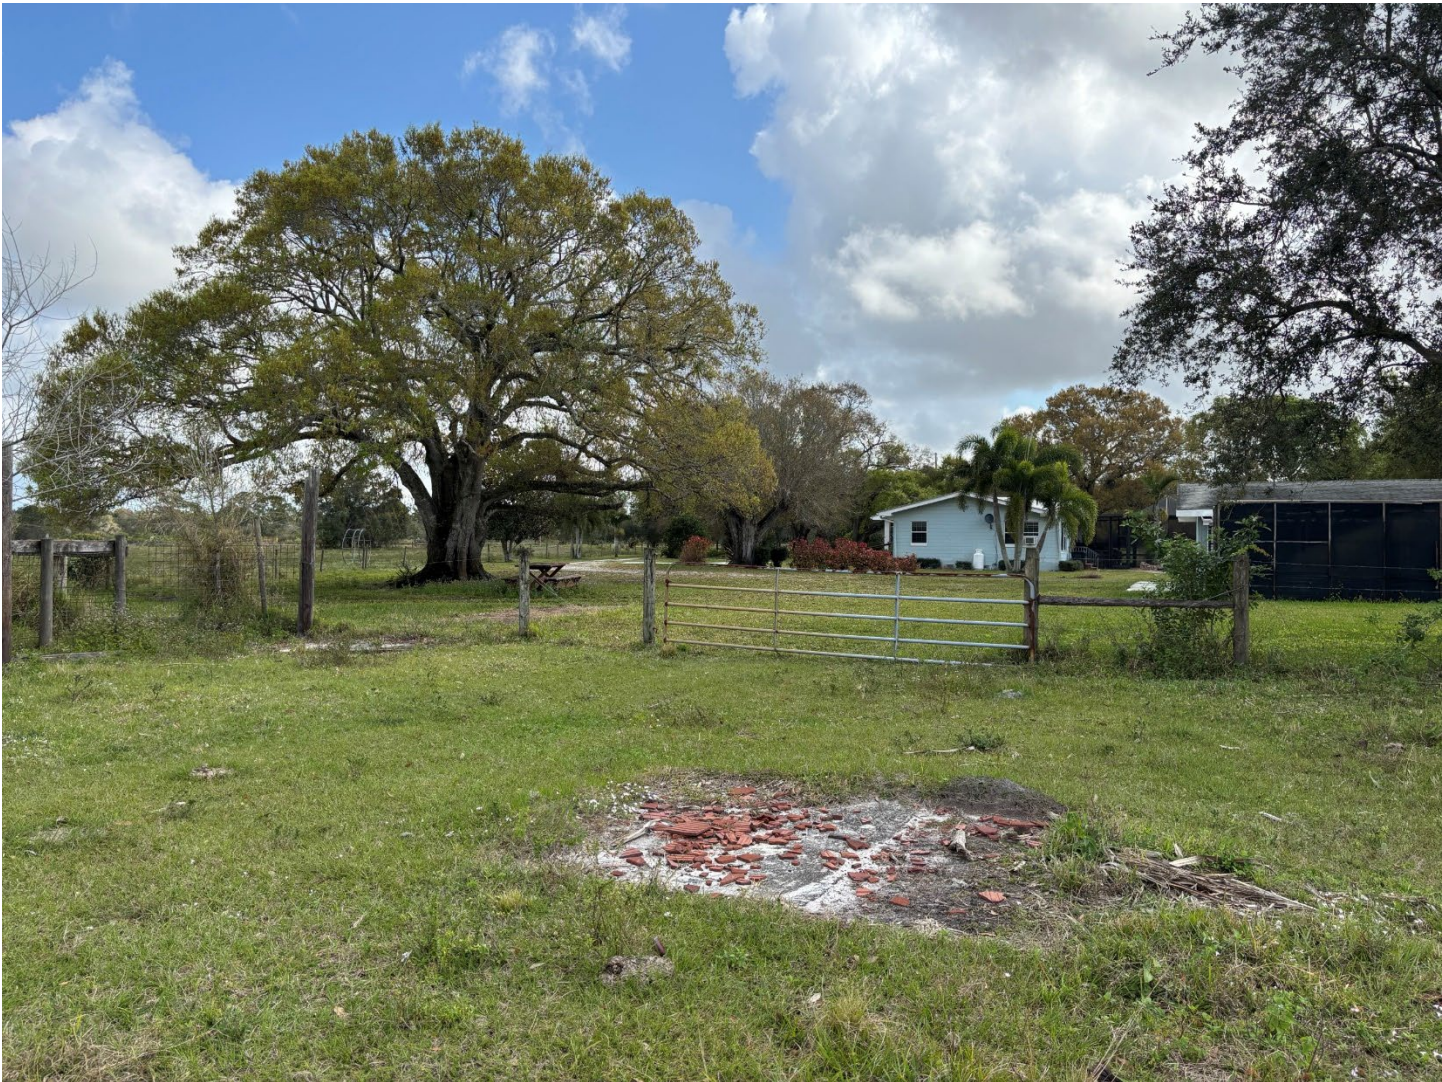
Photo Number: 3	View of the southern residential area with some large specimen oaks.
Photo date: 2/03/2025	
Direction: NE

Mitigation for trees is not necessary if at least 25% of the site's upland habitat is preserved. A tree survey and removal permit are required. Mitigation is required for the removal of any native tree at least 14 inches DBH, except palms, which must have a minimum clear trunk of ten feet. If trees are to be mitigated on-site the mitigation plan must include: replacement trees (preserved, relocated, or newly planted) of the same or another native species. Replacement trees must exceed minimum landscape requirements and be at least 12 feet tall and 2½ inches DBH, except palms, which must have a ten-foot clear trunk. Trees must be replaced at a ratio of one inch DBH for each inch removed, with palm trees preserved or relocated counting one-for-one towards mitigation.

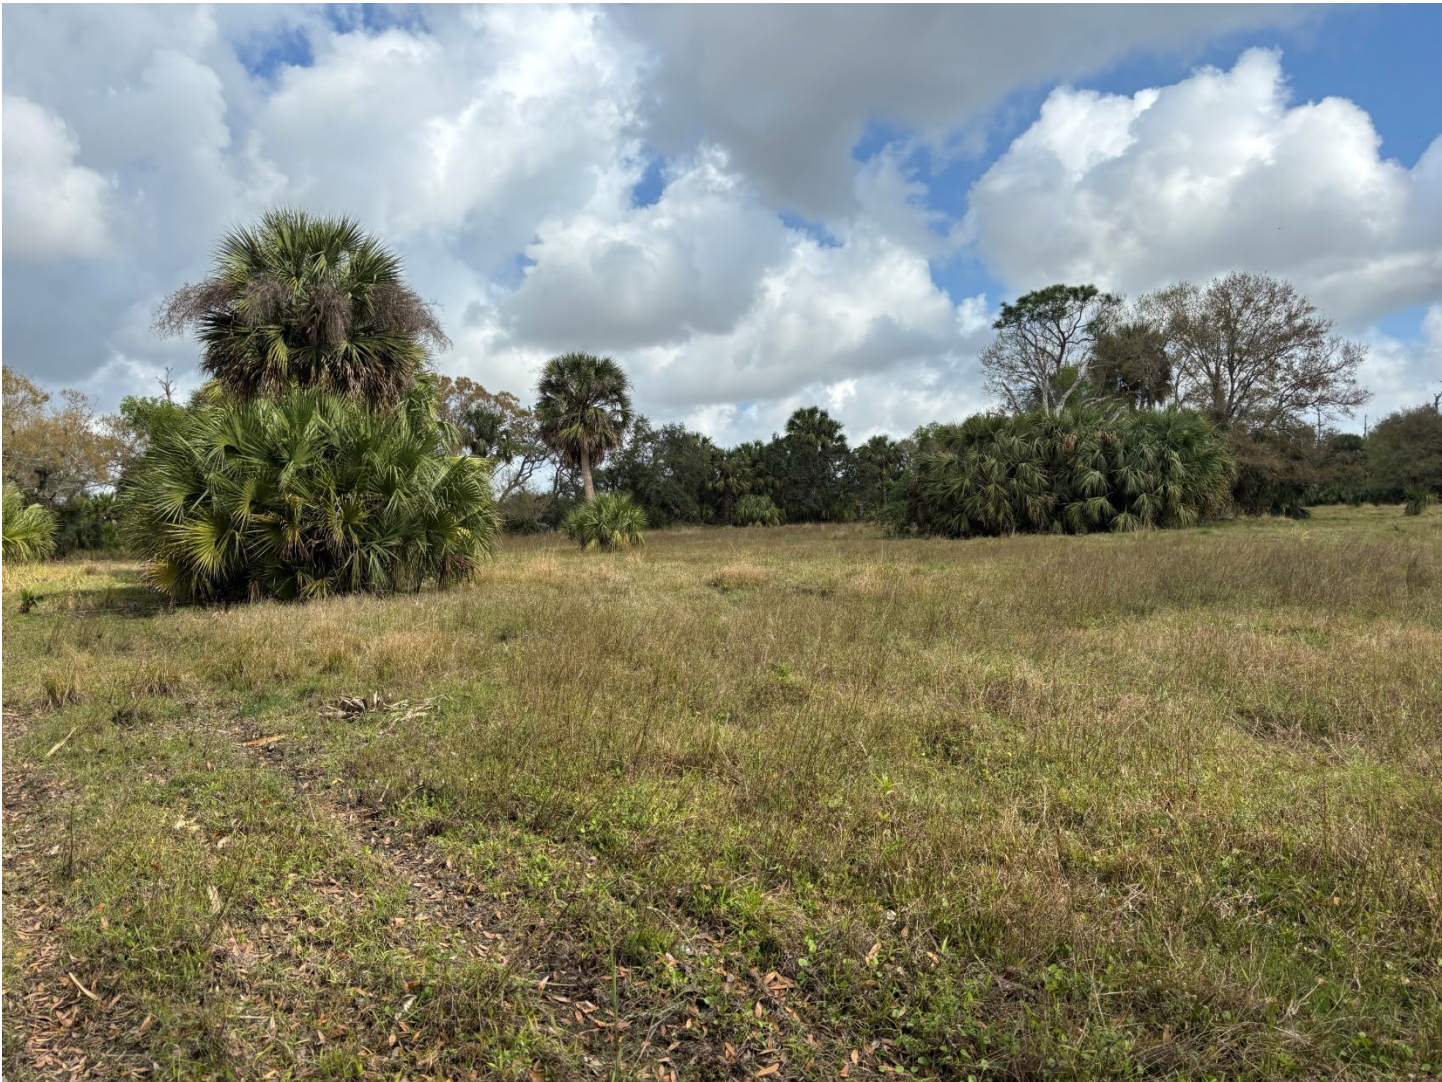
Photo Number: 4
Photo date: 2/03/2025
Direction: W

The subject property is located within the USFWS Consultation Area for the federally threatened **Audubon's crested caracara (*Caracara cheriway*)**, which is protected under the federal Migratory Bird Treaty Act (MBTA). Caracara habitat includes wet prairies, wooded areas with saw palmetto, cypress, scrub oaks, and pastures. It is WGI's opinion that suitable habitat is present on the subject property. No Audubon's crested caracara were observed during the site visit.

View of the cattle pasture showcasing possible Audubon Crested Caracara habitat.

require a survey to determine if the property contains nests or is used for foraging. Survey protocol requires monitoring the entire subject property plus a 1,500-meter radius buffer around the subject property. Monitoring must be done at a certain time of year (from January to April) so caracaras should be considered in project scheduling.

- If a survey is requested by the USFWS, it may be more efficient to assume the presence of the caracara, in which case an Incidental Take Permit (ITP) may be required along with the preparation of a Habitat Conservation Plan.

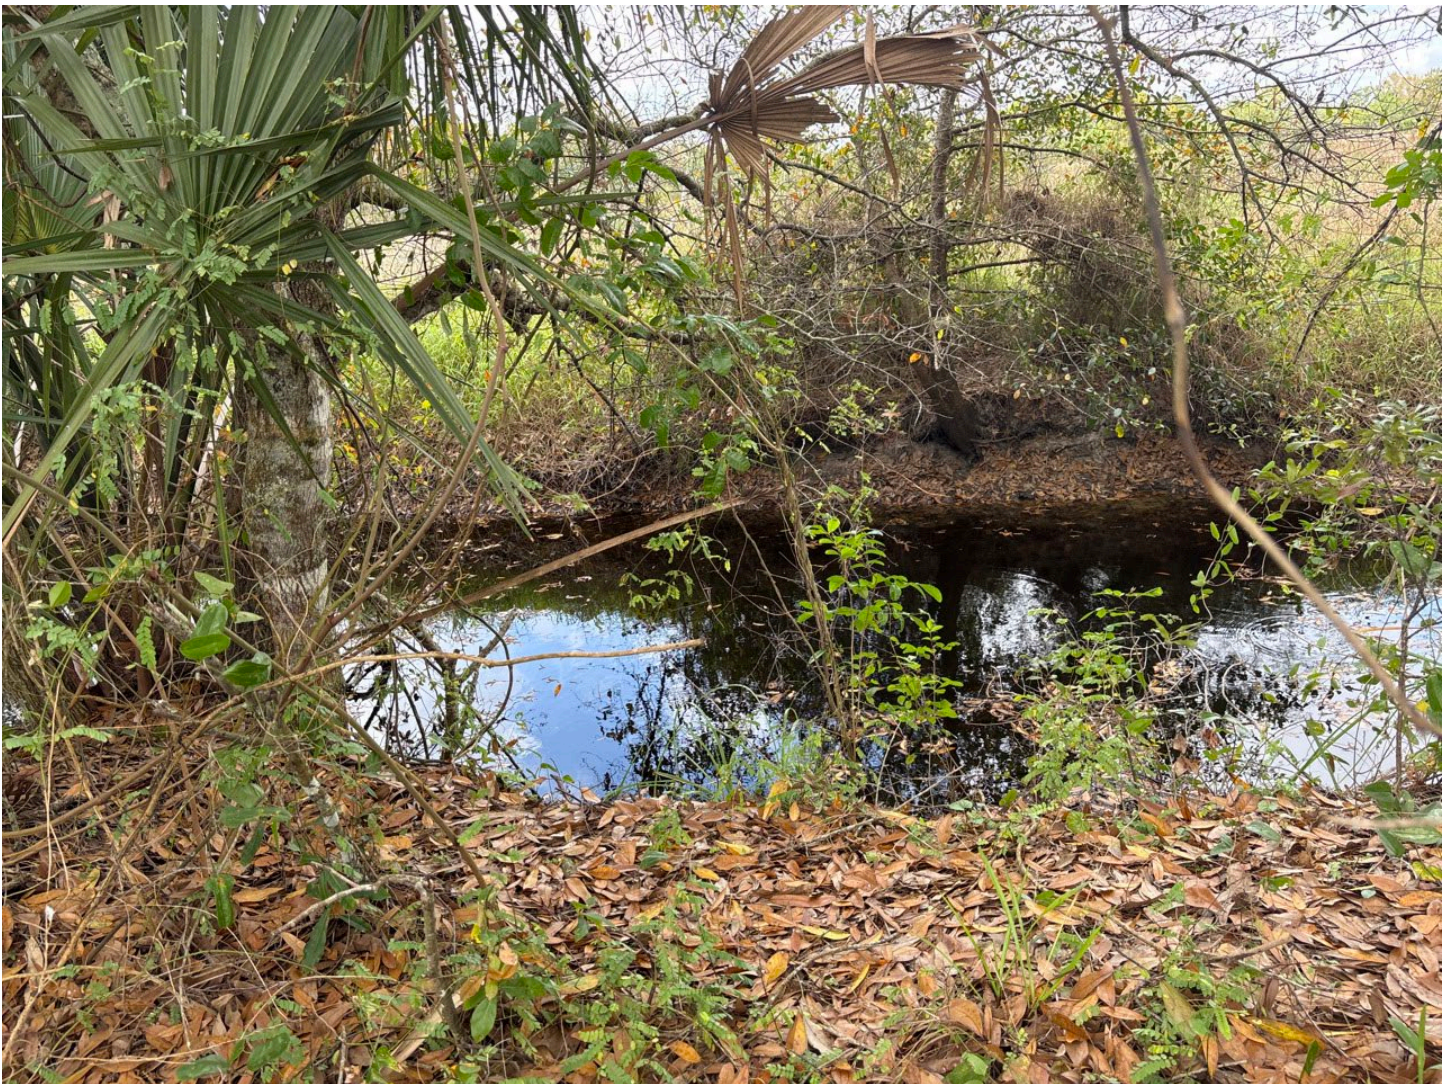
Photo Number: 5
Photo date: 2/03/2025
Direction: W

This category includes rivers, creeks, canals, and other linear water bodies. There are drainage ditches and creeks on the subject property from agricultural use that are connected to offsite canals via culverts.

View of one of the drainage ditches that flows into an offsite canal.

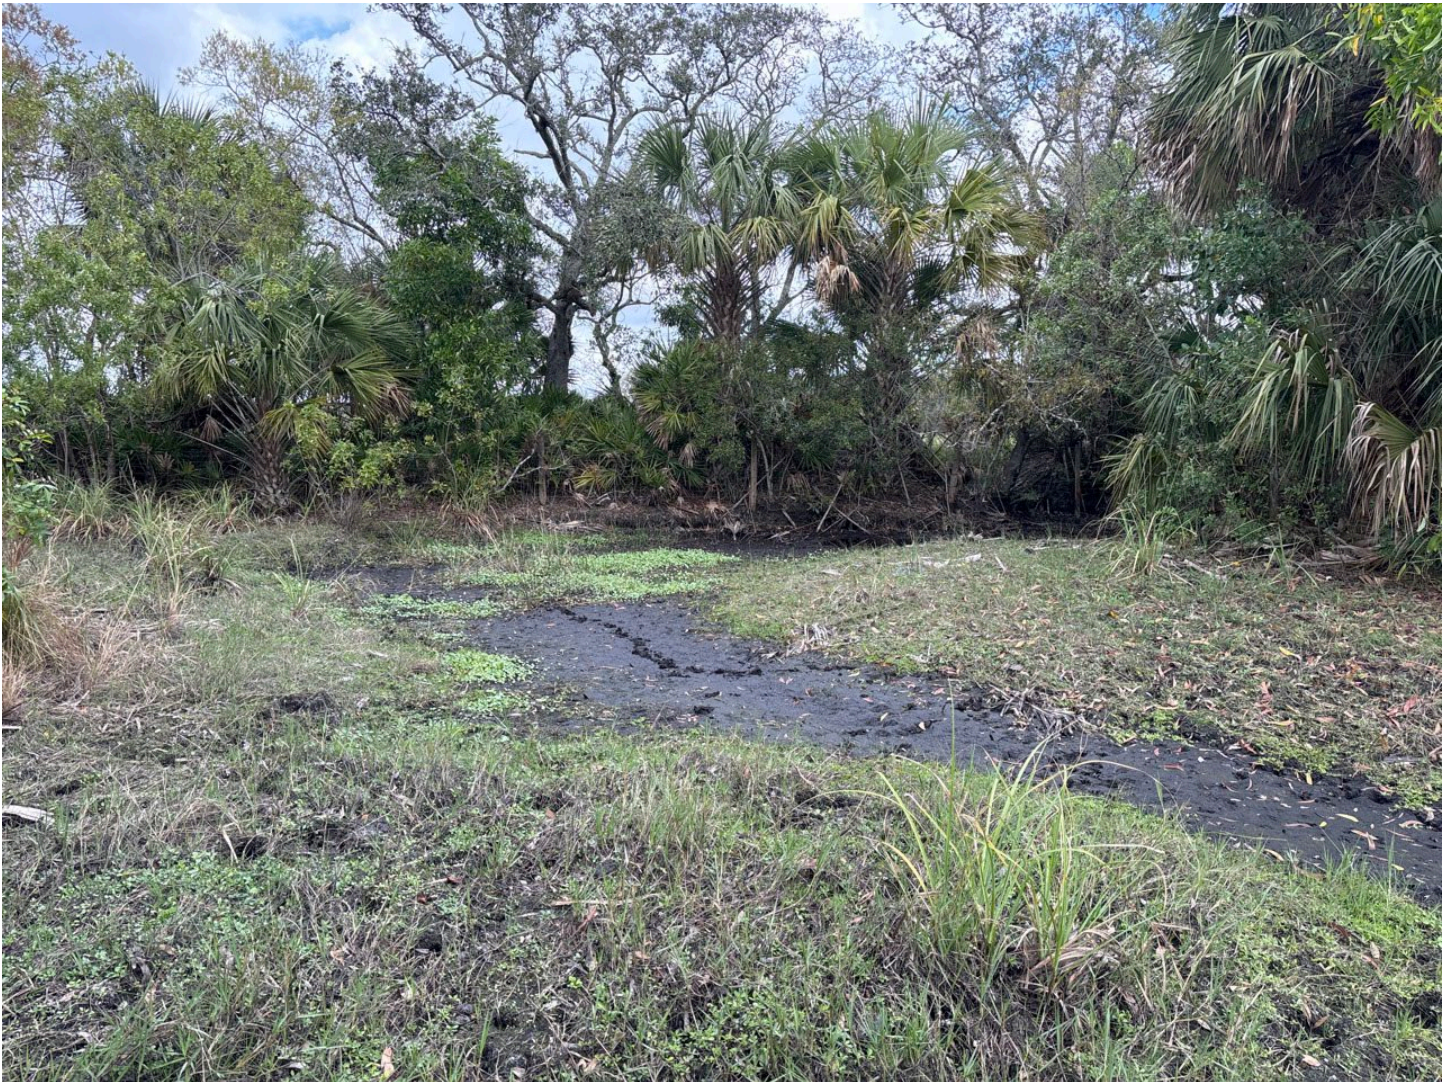
Photo Number: 6
Photo date: 2/03/2025
Direction: N

View of a wet area near one of the drainage ditches.

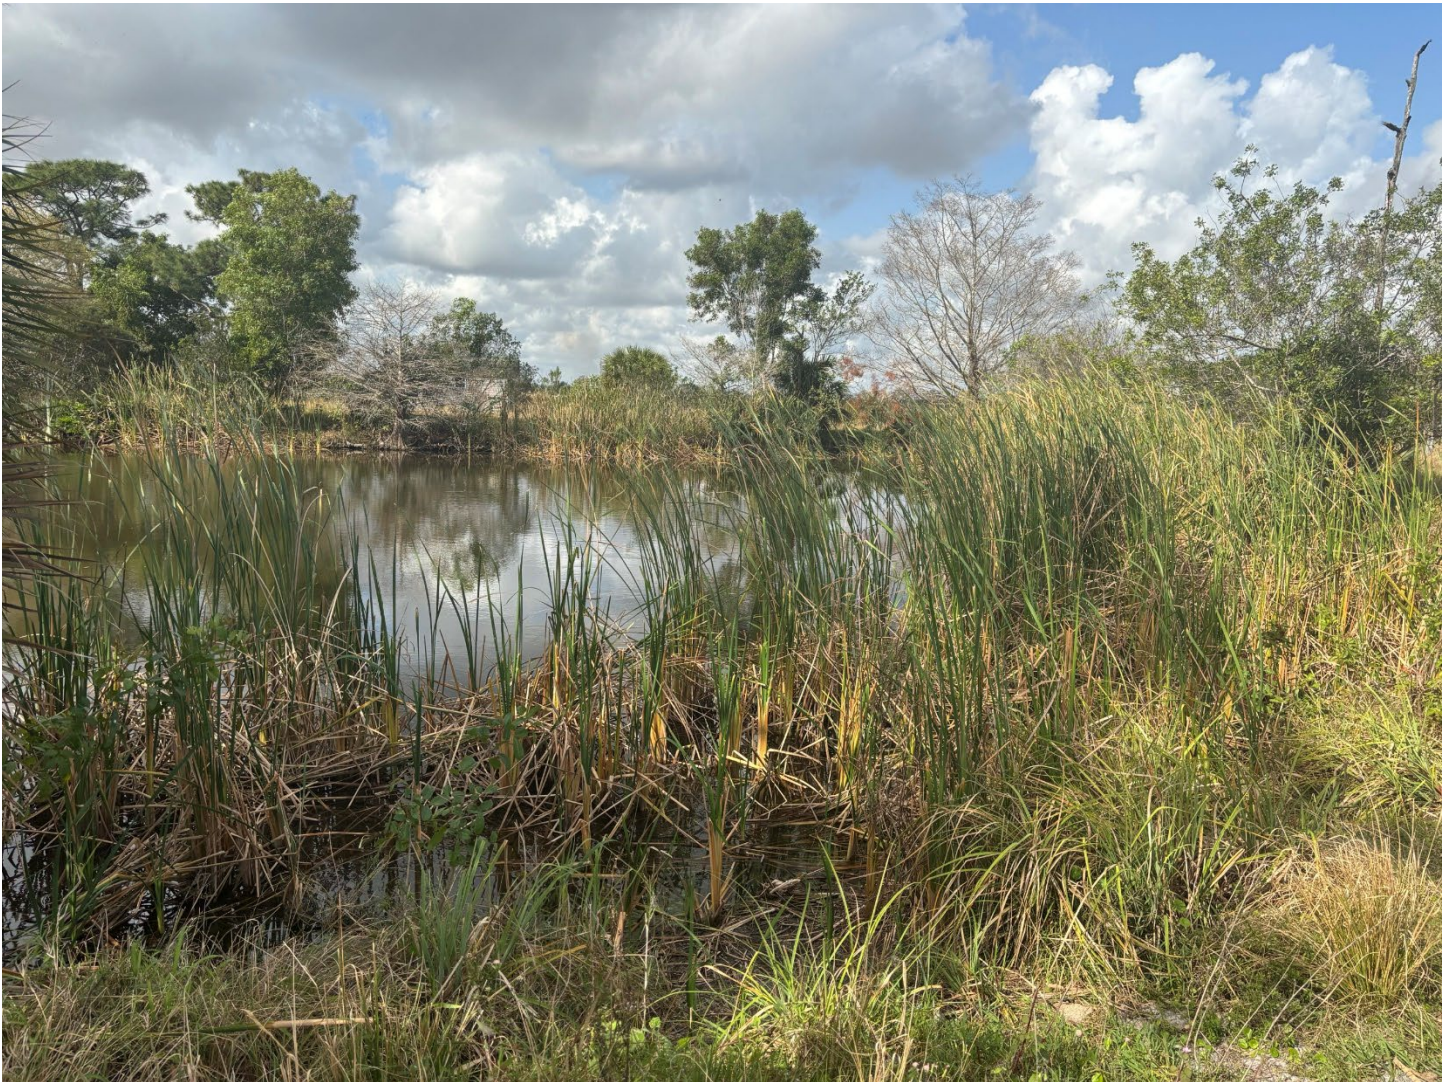
Photo Number: 7
Photo date: 2/03/2025
Direction: NW

These communities are associated with depressions and drainage areas that are not associated with streams or lakes. Wetlands 3 and 4 are historic wetlands that were dredged and are now used as drainage/irrigation ponds.

View of the centrally located pond by the maintenance area.
