# Jack Northrop Avenue Pedestrian Study

Jack Northrop Ave,  
Hawthorne, CA 90250

Prepared For:  
City of Hawthorne

**Kimley»Horn**

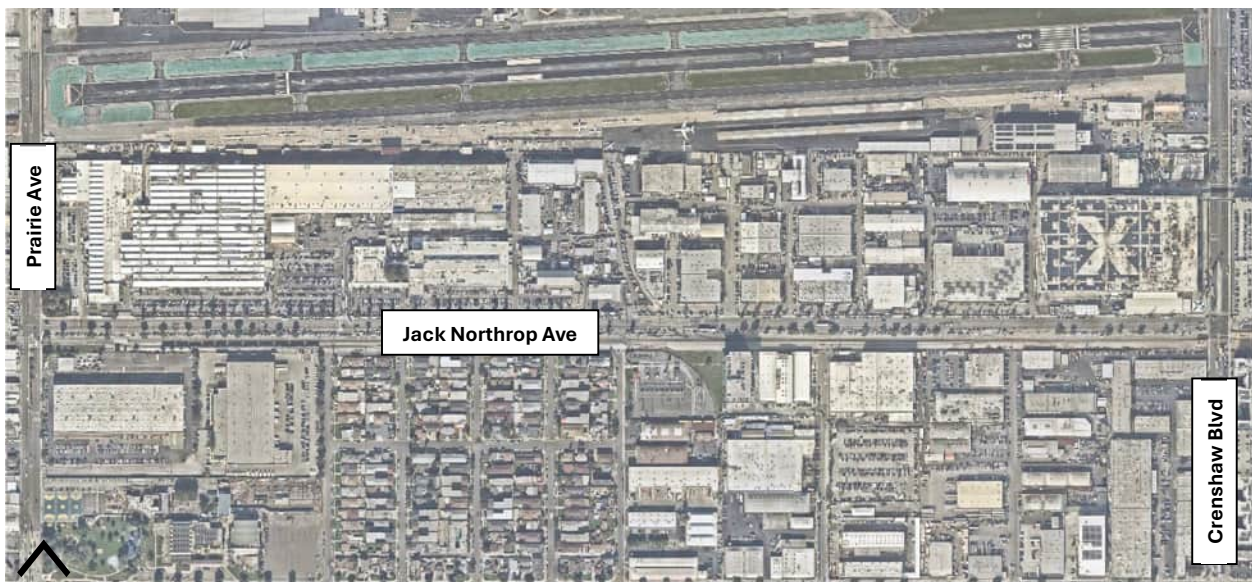
Figure 1: Project Study Area

This study first evaluates existing marked pedestrian crossings along Jack Northrop Avenue, all of which are currently controlled, to determine whether enhancements are recommended. The study then assesses pedestrian demand and roadway conditions to determine whether additional marked crosswalks are warranted at new locations. For potential new marked crosswalks, the study evaluates the need for pedestrian safety enhancements and the need for controlled crossings, consistent with guidance from the California Manual on Uniform Traffic Control Devices (CA MUTCD), Federal Highway Administration (FHWA), and applicable local agency standards. Conceptual-level improvements and planning-level cost estimates are provided. The Project Study area is shown in **Figure 1**.

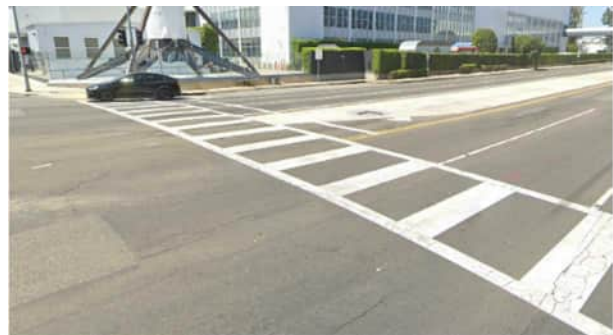
Figure 2. High-Visibility Crosswalk

High-visibility crosswalk markings use a series of longitudinal stripes, parallel to traffic, with or without transverse lines, to clearly define the pedestrian crossing and increase driver awareness. Data from the FHWA shows that high-visibility crosswalks reduce pedestrian injury crashes by up to 40%<sup>2</sup>. An example of a high visibility crosswalk can be seen in **Figure 2**.

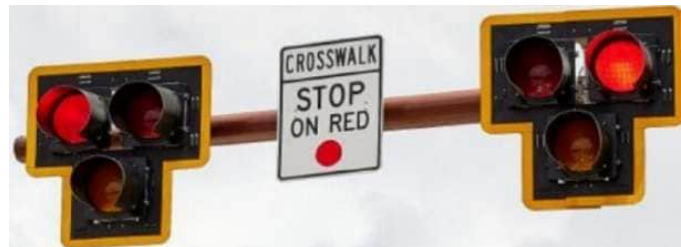
Figure 4: Pedestrian Hybrid Beacon

The Pedestrian Hybrid Beacon (PHB), also known as a High Intensity Activated Crosswalk Beacon (HAWK), is an overhead traffic control device designed to help pedestrians safely cross higher-speed roadways at midblock crossings and uncontrolled intersections. The beacon head consists of two red lenses above a single yellow lens. When activated by a pedestrian, the beacon features a sequence of flashing and solid lights that alert drivers to stop. An example of a PHB can be found below in **Figure 4**. Data shows that PHBs reduce pedestrian crashes by 55% and can result in a total crash reduction of 29%.<sup>4</sup>

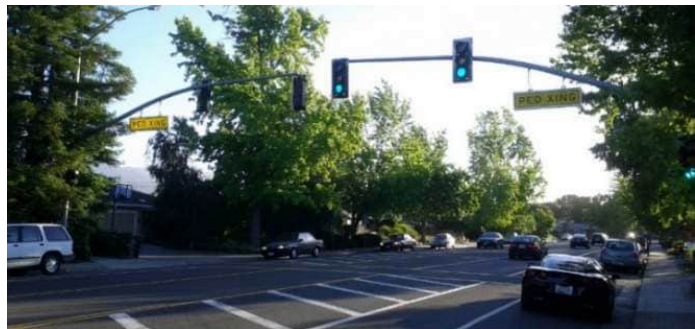
Figure 5: Mid-Block Pedestrian Signal

A Midblock Pedestrian Signal (MPS) is a traffic control device that functions similarly to a regular traffic signal. The signal stays green until a pedestrian or cyclist activates a push button, providing a red signal to drivers and a walk signal to pedestrians. Data from the FHWA shows that MPS's reduce pedestrian crashes by 45%.<sup>5</sup> An example of an MPS can be found in **Figure 5**.

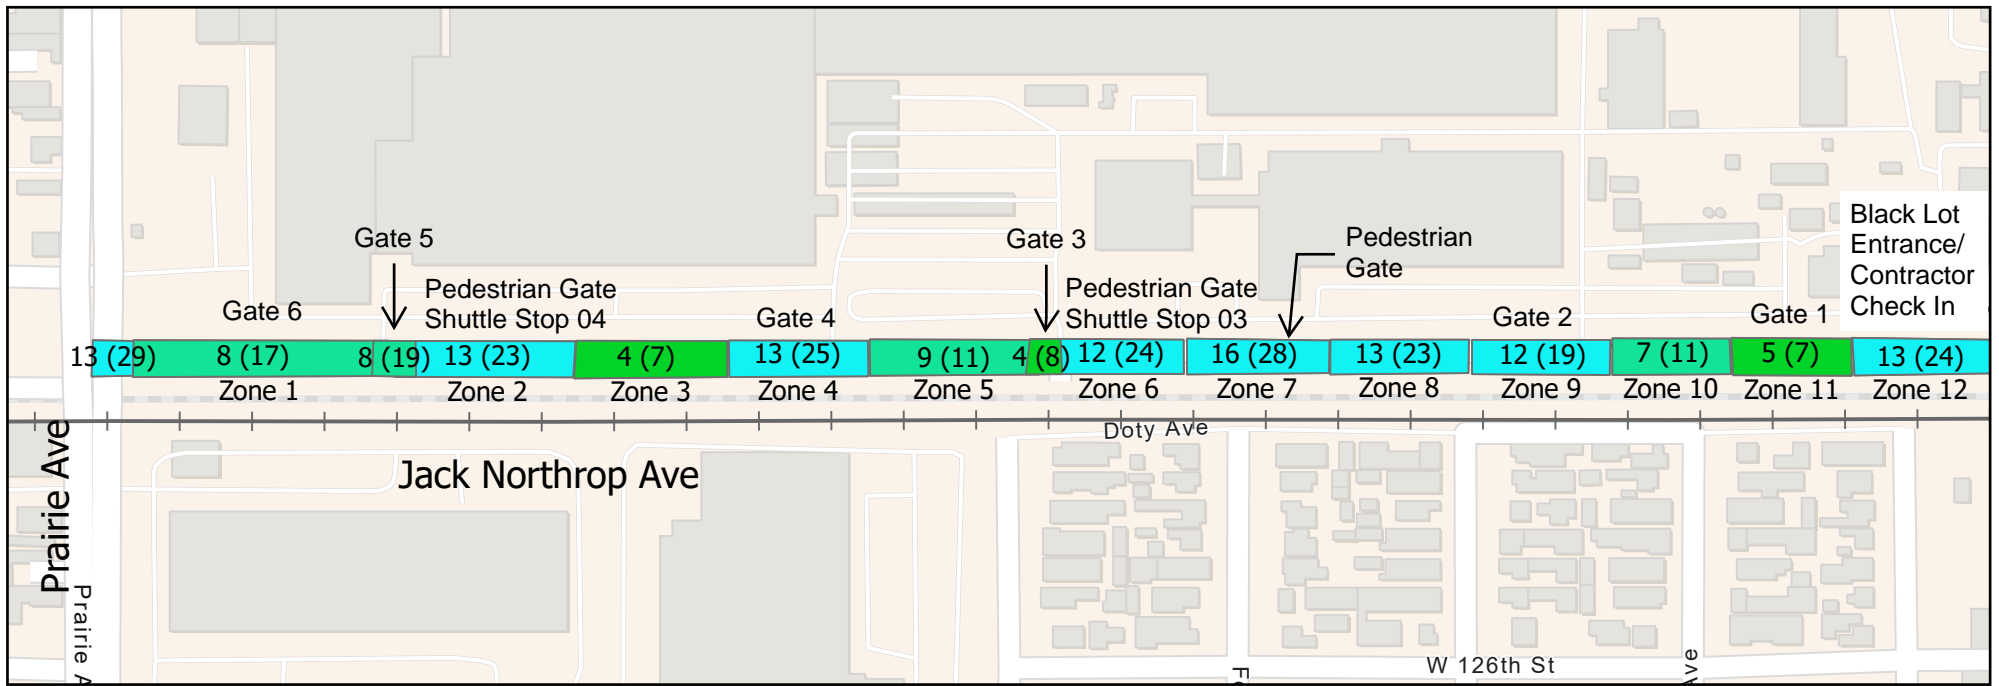
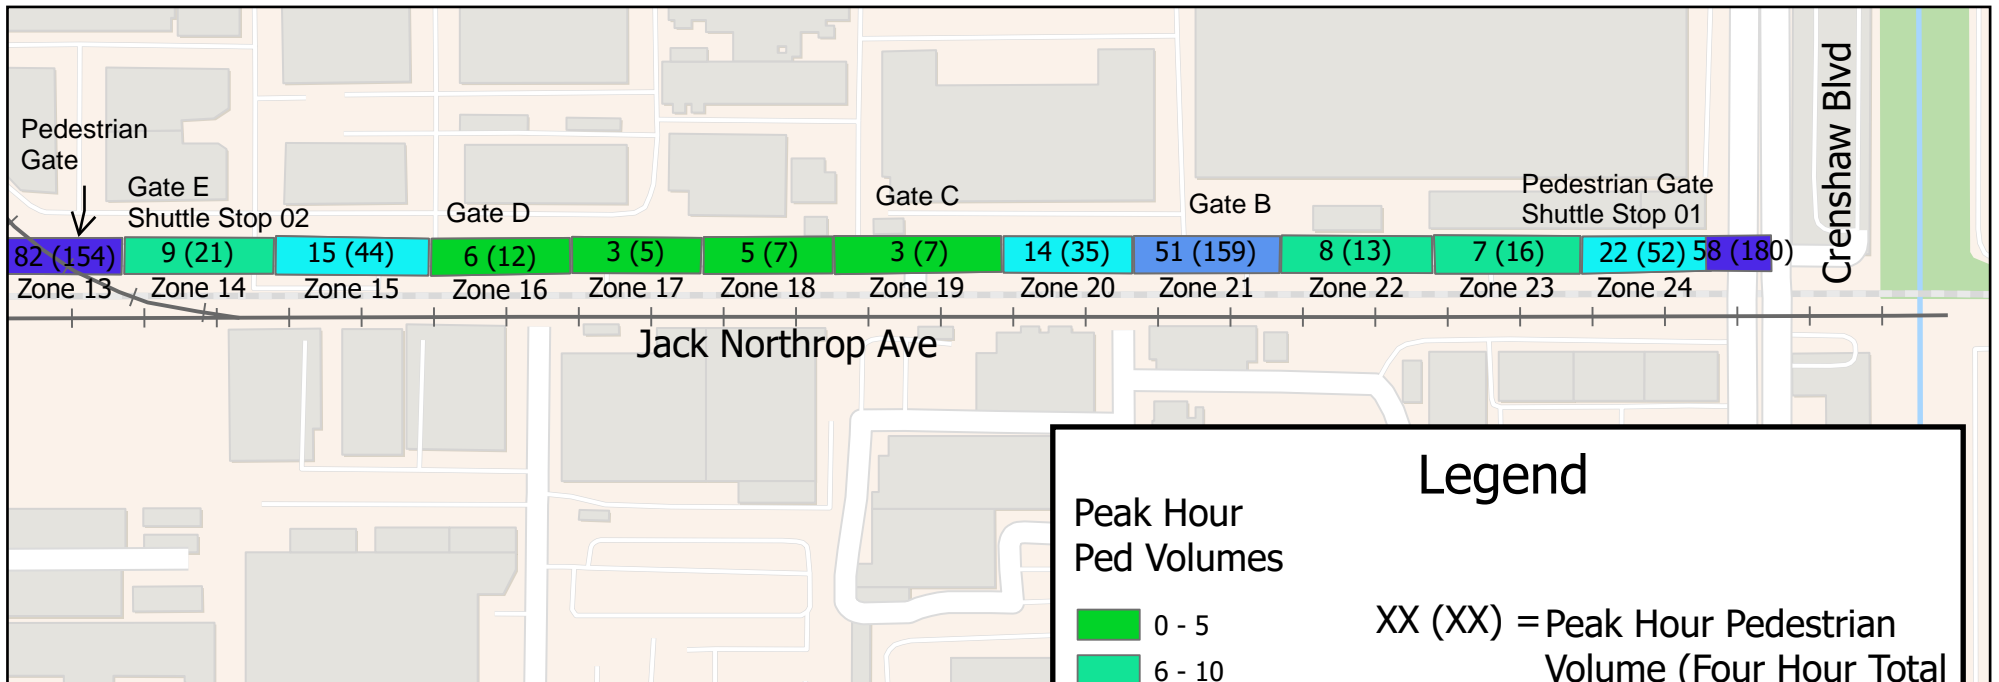
Figure 7: Jack Northrop Ave Pedestrian Volumes

For analysis purposes, the corridor was divided into 24 zones to better understand the distribution and concentration of crossing activity. A heat map illustrating pedestrian crossing patterns and relative crossing intensity is included as **Figure 7**.

Pedestrian crossings are concentrated near the gate in Zone 13 (adjacent to Shuttle Stop 02) and Zone 21 (near Gate B), providing a basis for evaluating crosswalk placement and appropriate pedestrian crossing treatments. Data collection sheets are provided in **Attachment A**.

XX (XX) = Peak Hour Pedestrian Volume (Four Hour Total Pedestrian Volume)

Pedestrian crossings are concentrated near the gate in Zone 13 (adjacent to Shuttle Stop 02) and Zone 21 (near Gate B), indicating locations of highest pedestrian activity along Jack Northrop Avenue.

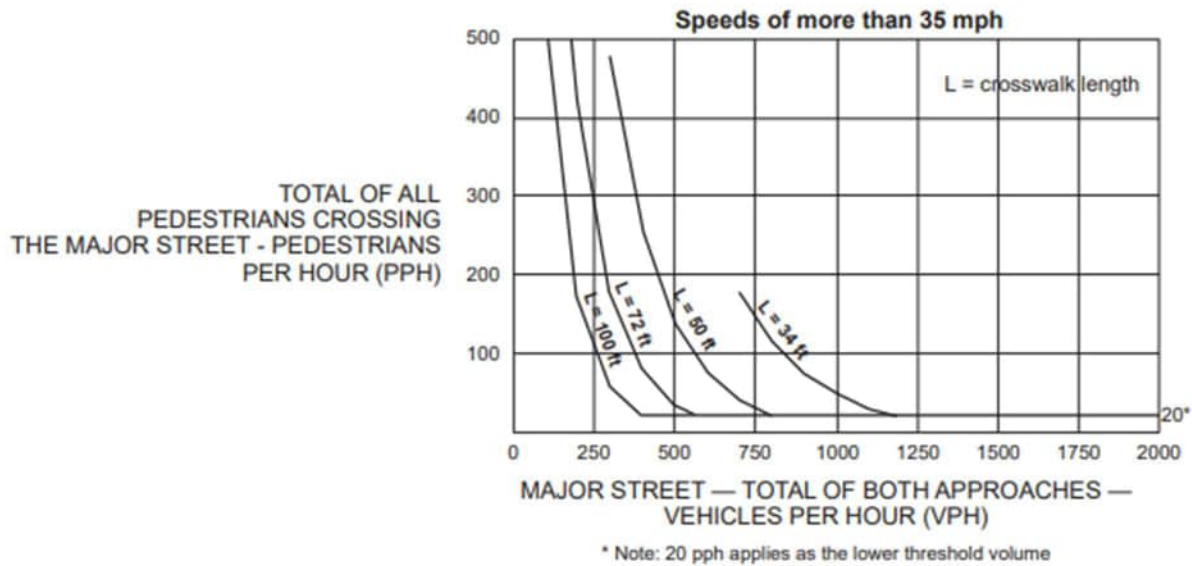
Figure 8: Guidelines for the Installation of Pedestrian Hybrid Beacons (CA MUTCD Figure 4J-2)

Figure 4J-2 of the CA MUTCD establishes Pedestrians Per Hour (PPH) and Vehicles Per Hour (VPH) thresholds to guide PHB installation decisions. When pedestrian and vehicle volumes meet or exceed these thresholds, a PHB should be considered to provide appropriate traffic control. **Figure 8** reproduces the CA MUTCD Figure 4J-2 volume thresholds for PHB installation. As noted in Section 4.3, **Table 1** from the FHWA also identifies PHBs as a countermeasure based on roadway characteristics.

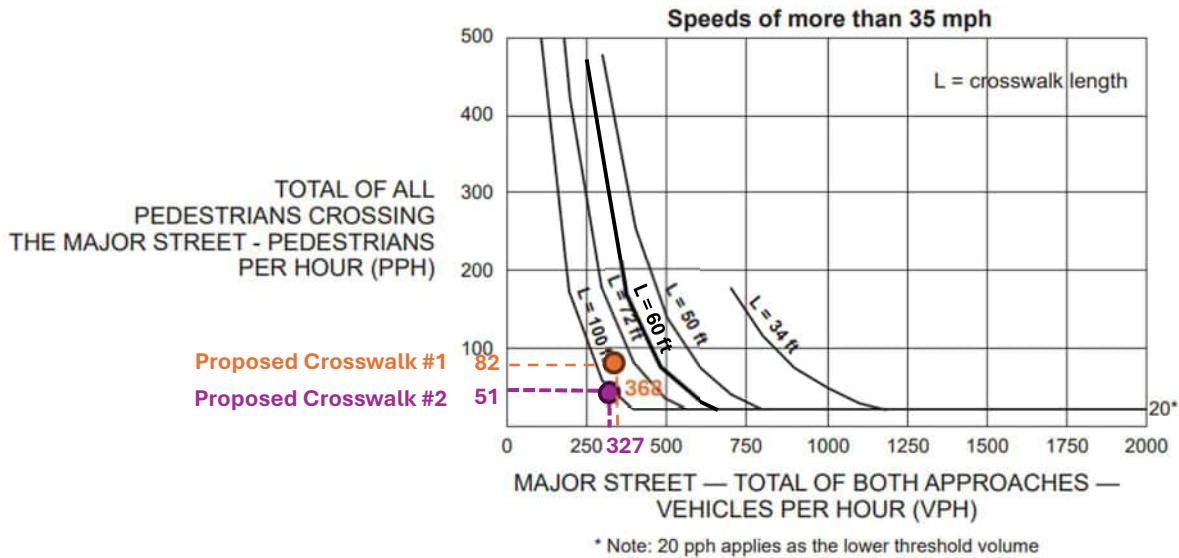
Figure 10: Proposed Crosswalks #1 and #2 (CA MUTCD Figure 4J-2)

For Proposed Crosswalk #1 (Zone 13), the peak pedestrian volume was 82 pedestrians per hour (9:00 AM), with a corresponding conflicting vehicle volume of 368 vehicles per hour. For Proposed Crosswalk #2 (Zone 21), the peak pedestrian volume was 51 pedestrians per hour (9:30 AM), with a corresponding conflicting vehicle volume of 327 vehicles per hour.

Based on a crossing length of approximately 60 feet, **Figure 10** shows that neither location meets the CA MUTCD Figure 4J-2 threshold for PHB installation, primarily due to low conflicting vehicle volumes.

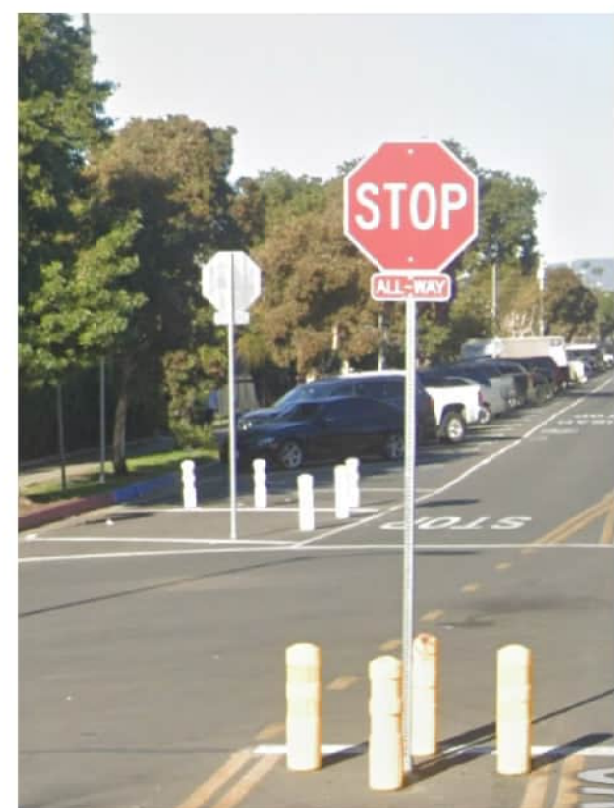
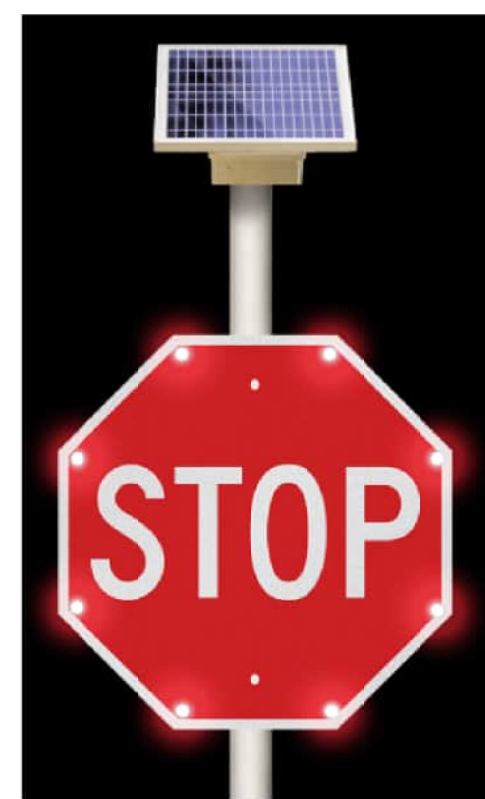
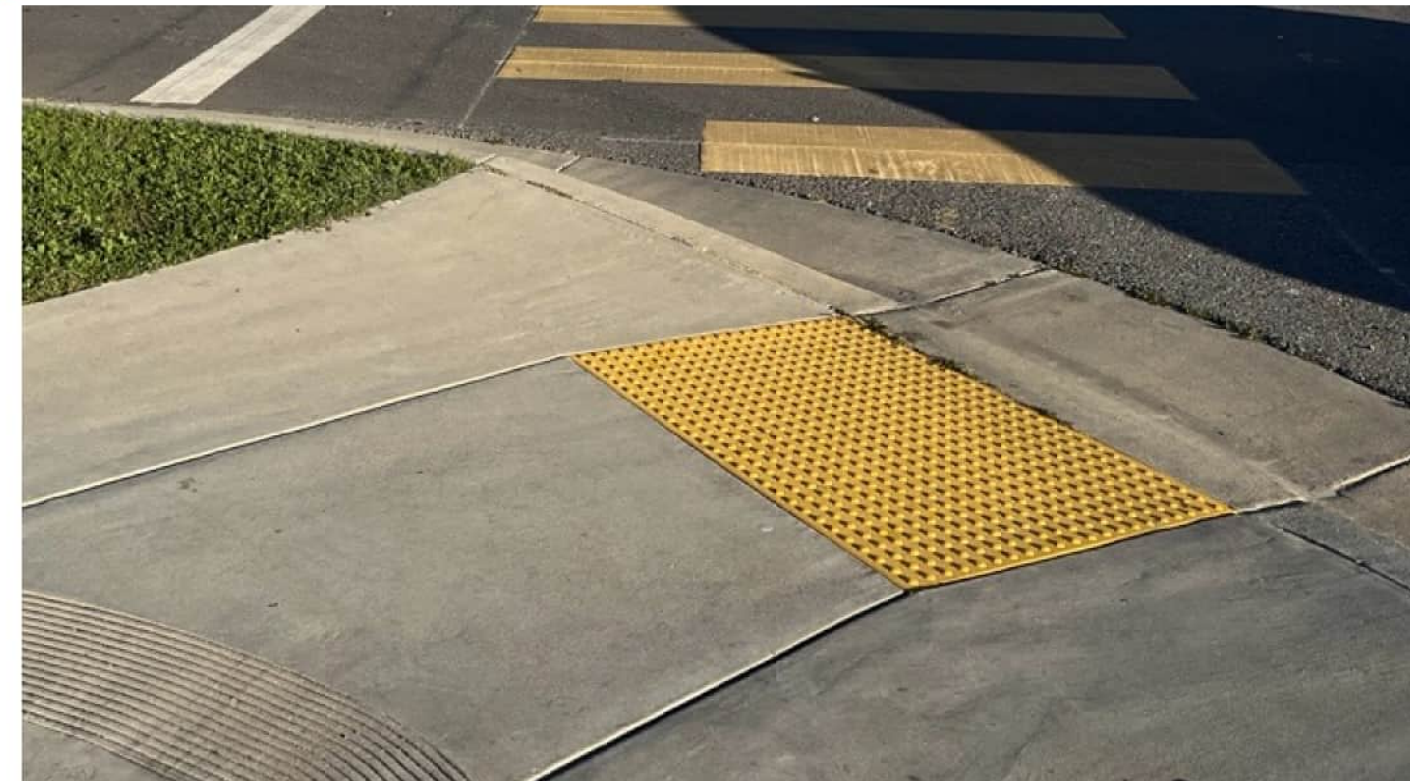
Figure 11: Existing Crosswalk #1 – Conceptual Design

- High-visibility pavement markings on the existing east leg crosswalk
- Addition of solar-powered LED stop signs in the center of the roadway (left side of travel lanes) on both east and west approaches to reinforce the stop control
- Replacement of existing stop signs with solar-powered LED stop signs

1 IN-STREET STOP SIGN INSTALLATION

2 STOP SIGN WITH LED BORDER

3 DETECTABLE WARNING SURFACE

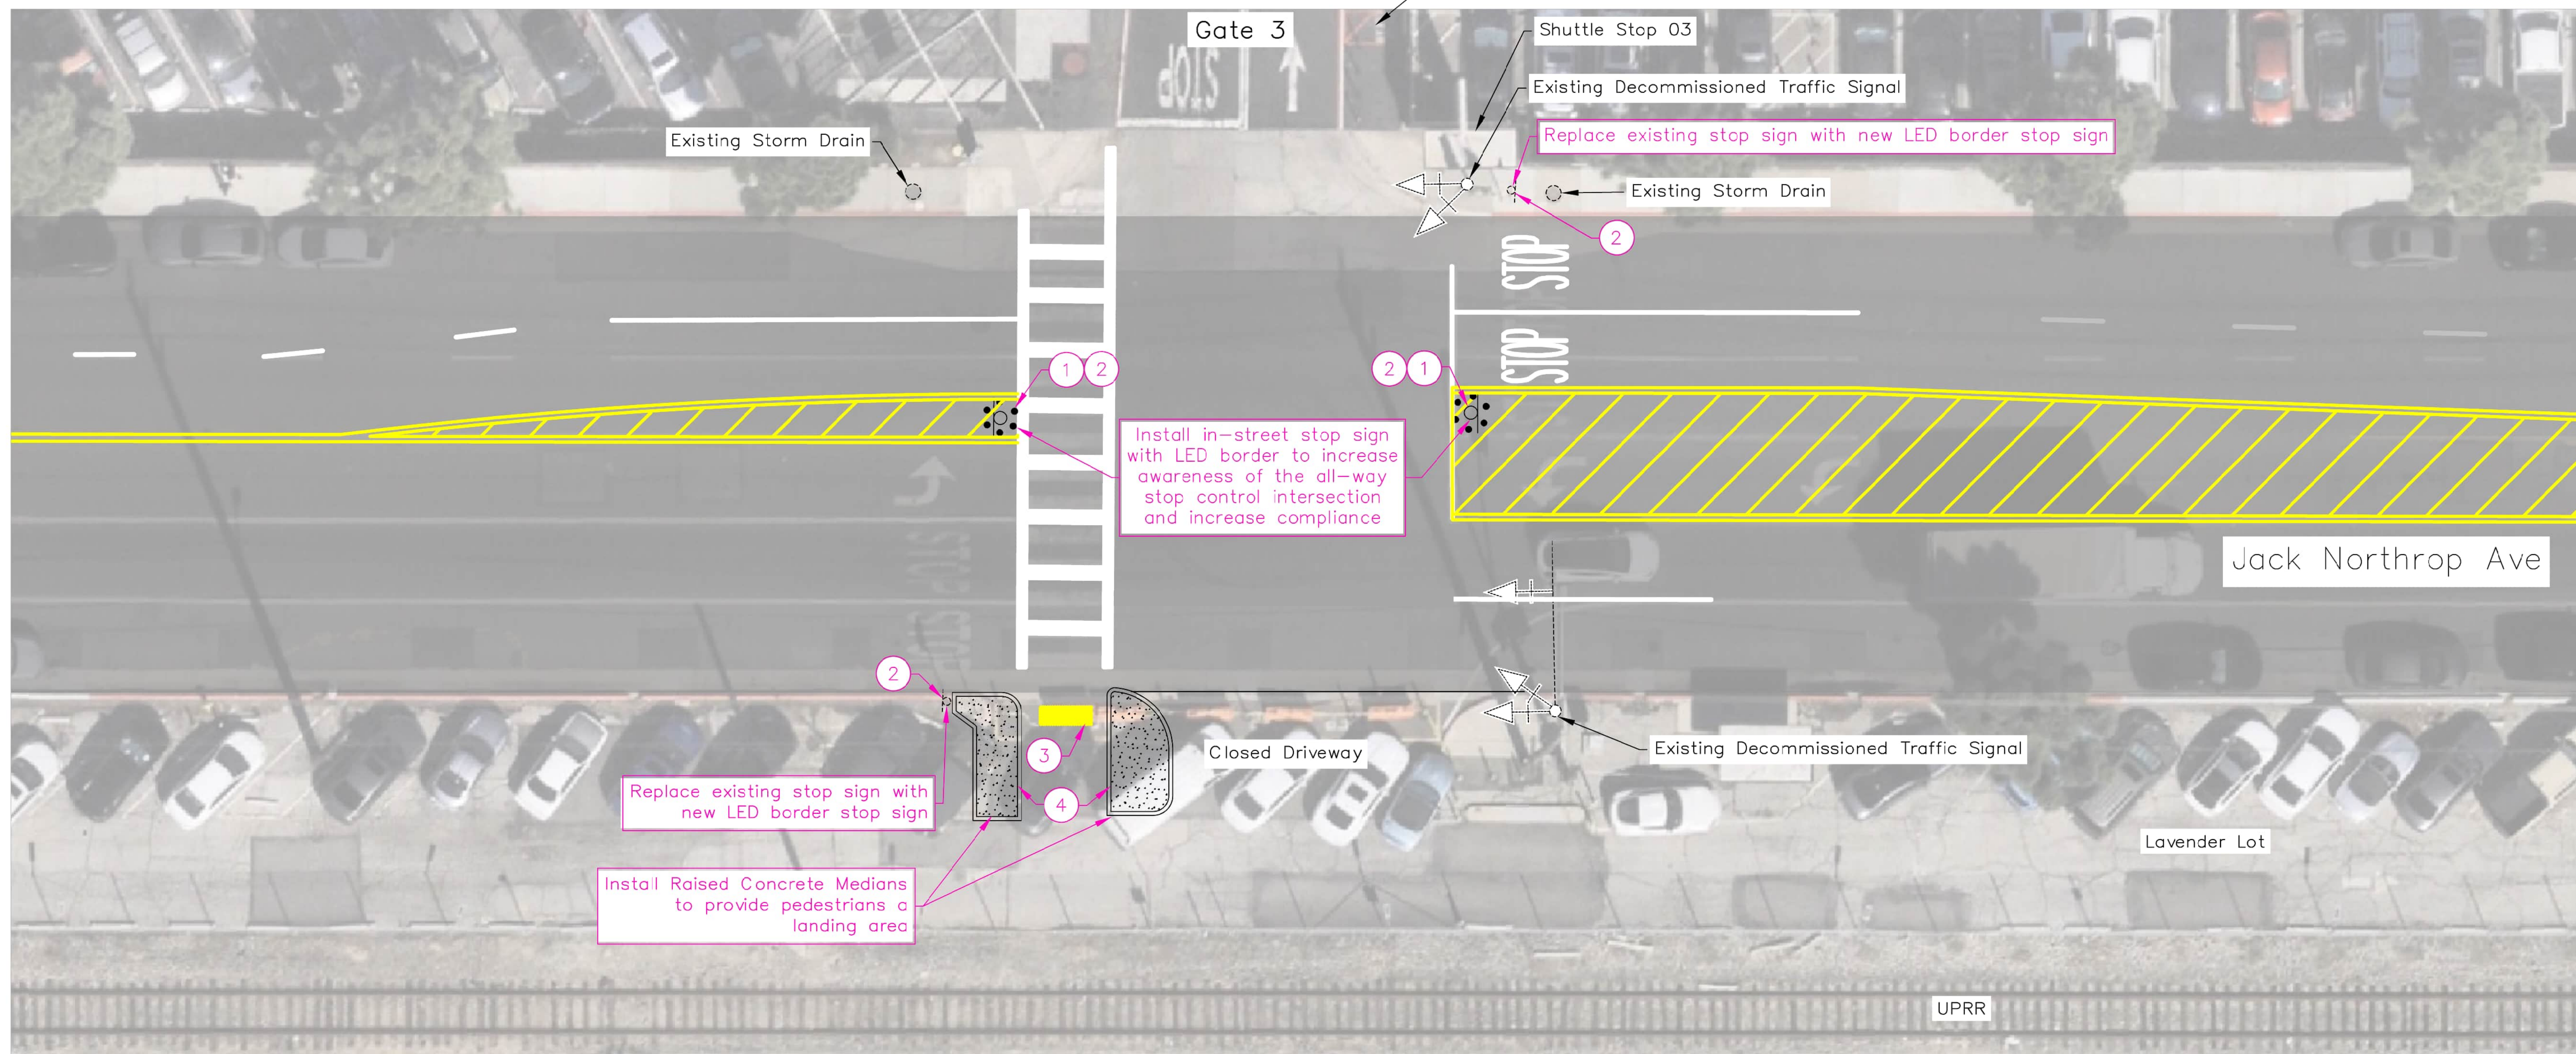
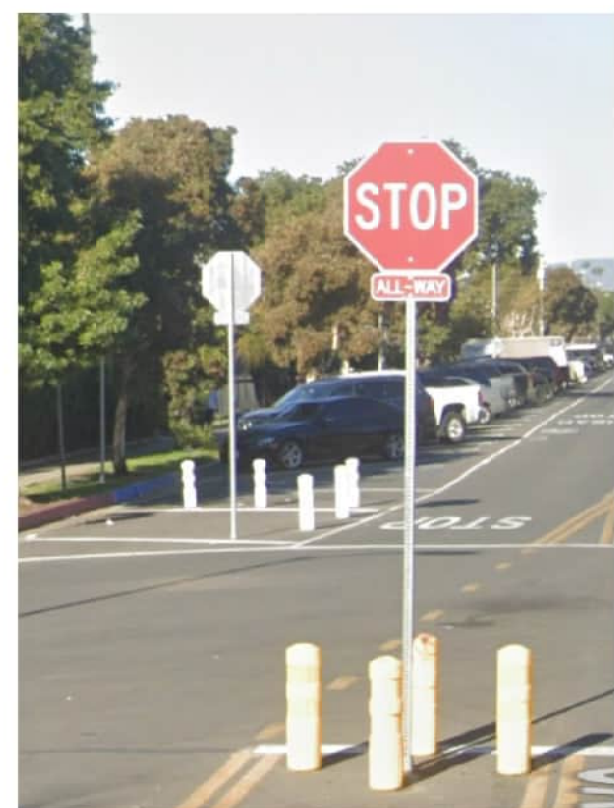
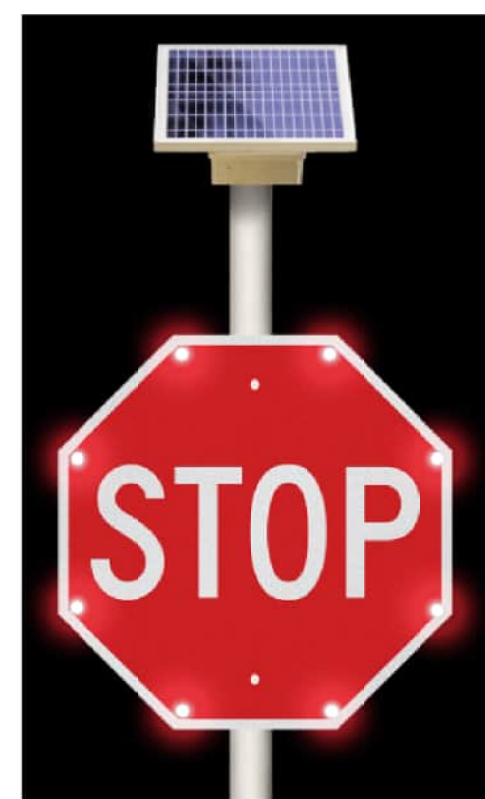
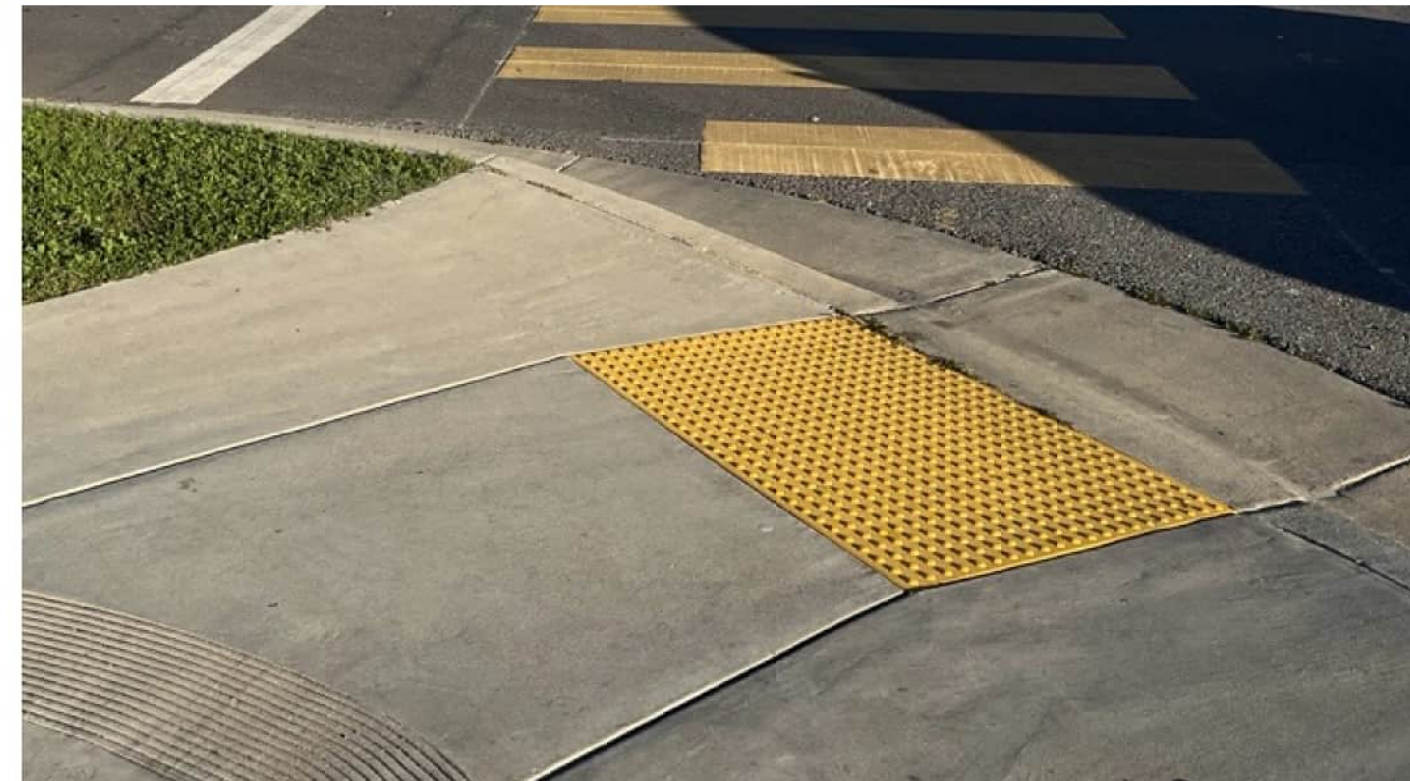
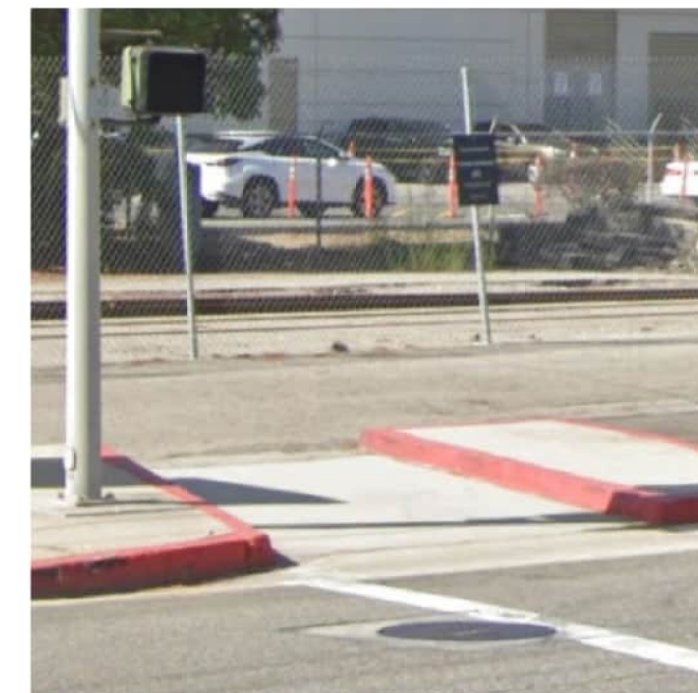
Figure 12: Existing Crosswalk #2 – Conceptual Design

- Addition of solar-powered LED stop signs in the center of the roadway (left side of travel lanes) on both east and west approaches to reinforce the stop control
- Replacement of existing stop signs with solar-powered LED stop signs
- Install raised medians to protect pedestrians on southwest corner and provide truncated domes to meet ADA requirements

1 IN-STREET STOP SIGN INSTALLATION

2 STOP SIGN WITH LED BORDER

3 DETECTABLE WARNING SURFACE

4 Concrete Medians

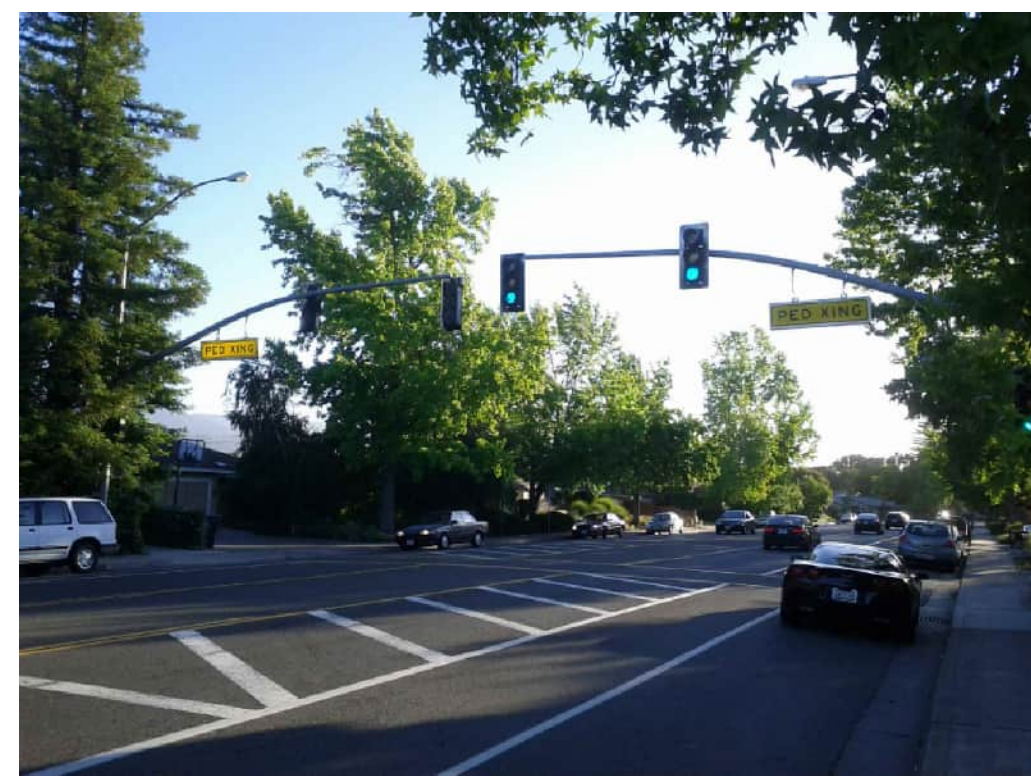
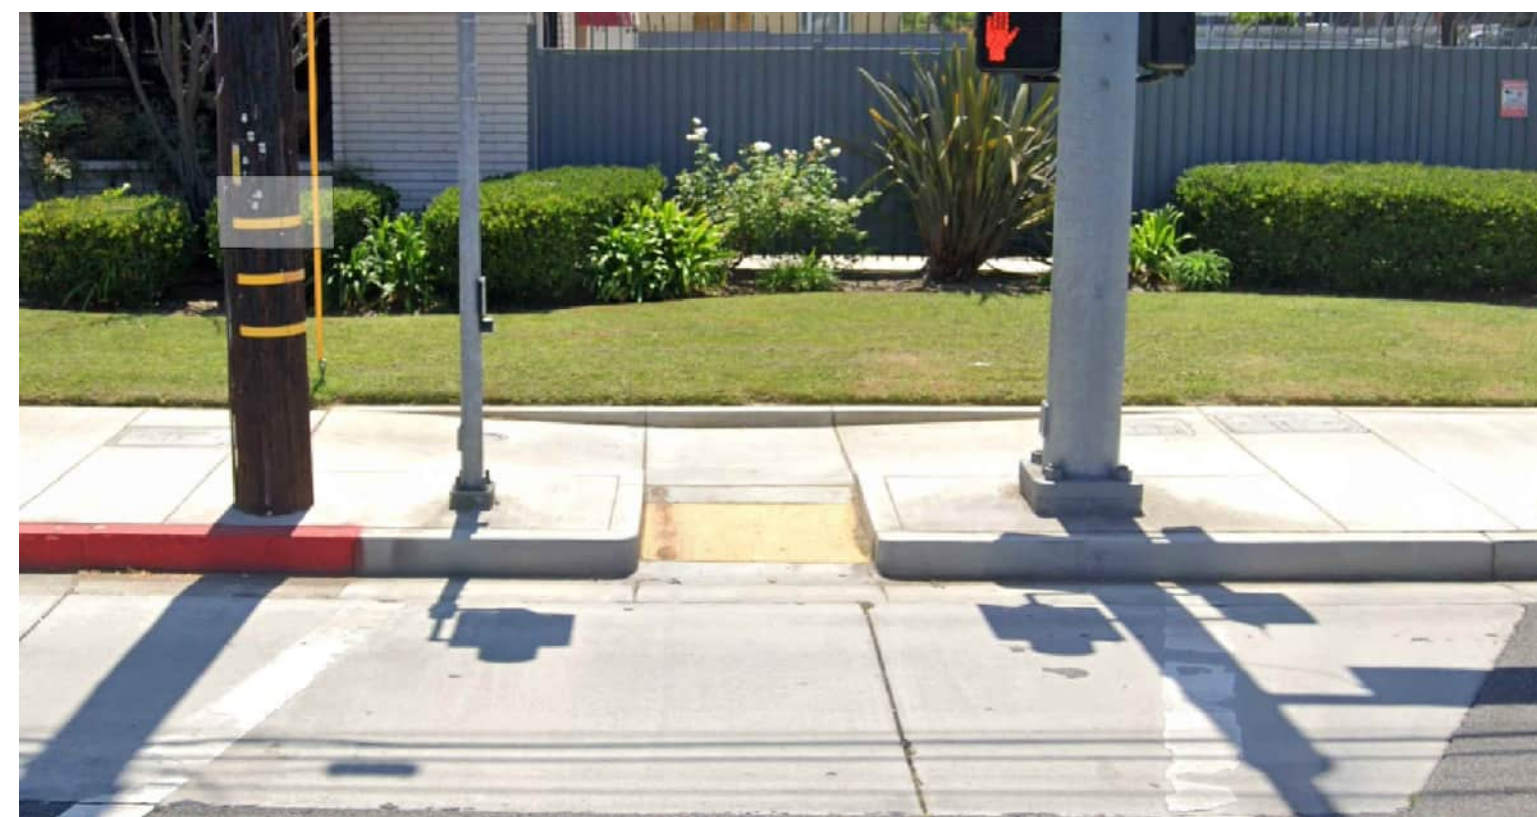
Figure 13: Proposed Crosswalk #1 – Conceptual Design

Proposed Crosswalk #1 is a midblock location near Shuttle Stop 02. Proposed improvements are shown in **Figure 13**.

1 Mid-Block Pedestrian Signal

2 Curb Ramp

Install Pedestrian Push button for pedestrians to activate the Mid-Block Pedestrian Signal. Pole shall include pedestrian signal head that displays WALK and DO NOT WALK indications

Given the roadway speed, multilane configuration, nighttime pedestrian activity, and visibility constraints, enhanced traffic control is warranted. An overhead midblock pedestrian signal with a conventional red-yellow-green indications is recommended, as it provides continuous signal control with standard indications that may improve driver recognition and compliance.

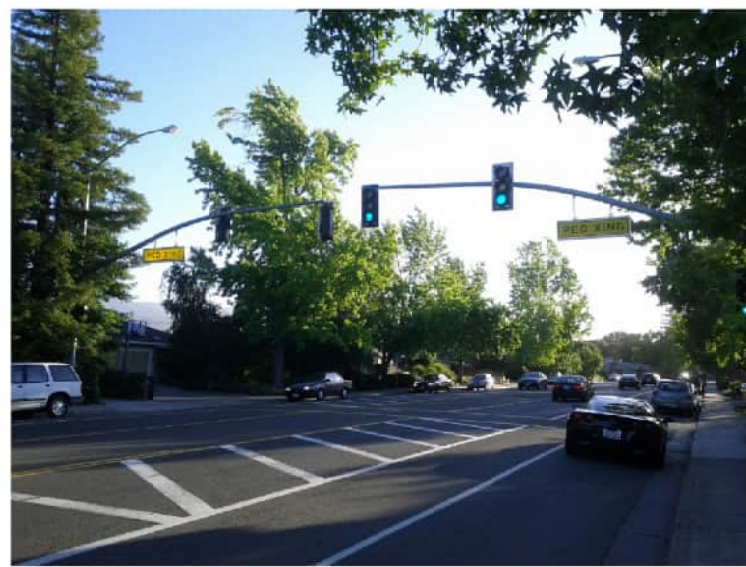
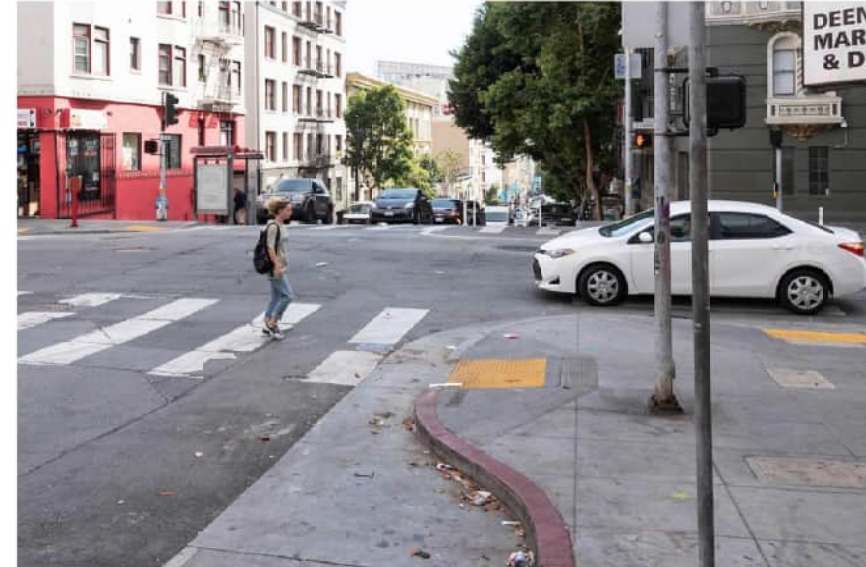
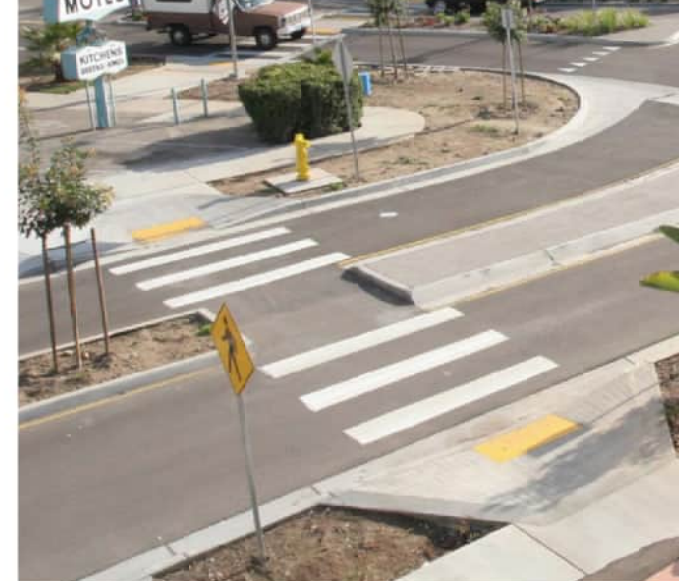
Figure 14: Proposed Crosswalk #2 – Conceptual Design

1 Mid-Block Pedestrian Signal

2 Curb Ramp

3 Raised Median with Pedestrian Refuge
