Certificate of Substantial Completion

PROJECT:
(Name and address)
Hidalgo Co. Pct. 4 - San Carlos CRC
Landscaping*Retaining Wall*Irrigation
Project, San Carlos, Texas

Hidalgo County Precinct 4 | 2016-145-04-13-MSS | Landscape/Structural and Irrigation Construction for the San Carlos Community Resource Center Project

PUNCH LIST (Conducted July 21, 2017 at 12 Noon)

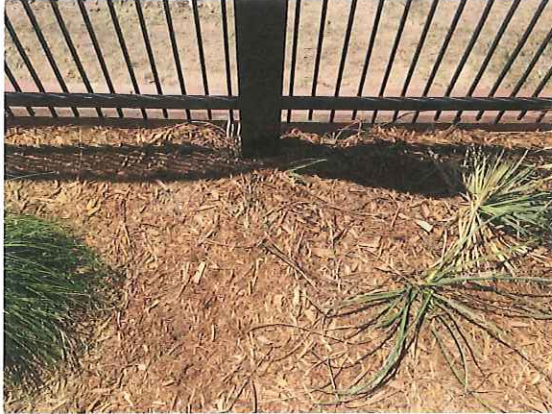
Plants were trampled during the installation of the perimeter wrought iron fencing by county crews. Landscaper will maintain, but not replace, during the next 30 days.

03. Arrangement of boulders to be changed to provide a more interesting/dynamic placement.
04. Some plants in the lower retaining wall have been damaged during the placement of the wrought iron fencing by county crews. The landscaper will maintain the plants during the 30-day substantial completion timeline but will not replace the damaged plants unless the county wants to pay for replacements. There is also some settling of the soil where the posts were installed. The county will need to keep tabs on these locations and fill / lightly compact accordingly.

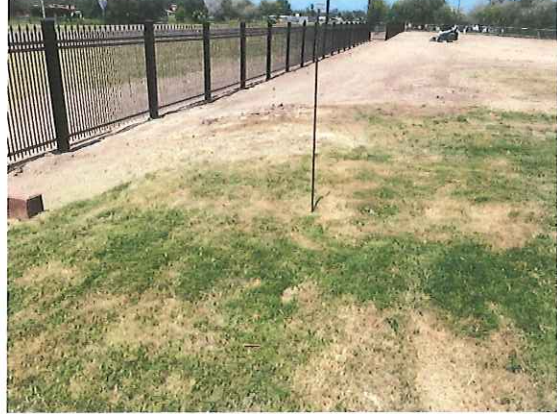
Sections of grass were scraped-off during the grading of of the property toward the perimeter fencing by county Crews. These sections will not be replaced.

08. Sections of grass and erosion netting have been scraped-off by county crews working on the grading/installation of the wrought iron fencing or the excavation of the plumbing lines on the west side of the community resource center. The landscaper will not be required to replace the grass or erosion netting in these locations unless the county wants to pay for replacements.

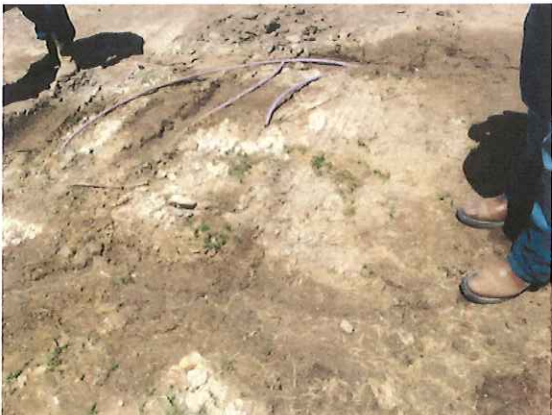
Irrigation drip-lines have been left exposed by county crews during the excavation of plumbing lines due to problems w/ sewage backing-up / unconnected lines of the CRC project.

09. A portion of the underground drip-line has been left exposed at the area graded by county crews near the perimeter fencing. The landscaper will not be required to bury the line at this location; pending further work by county crews.

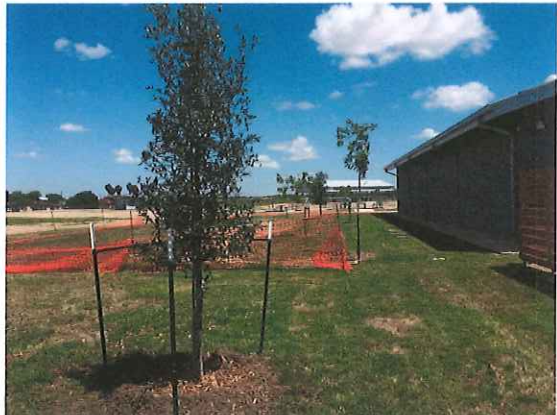
Dead tree at southwest corner of project has been replaced.

10. The dead tree at the south-west corner of the project boundary has been replaced and will be maintained during the 30-day substantial completion/punch-list period

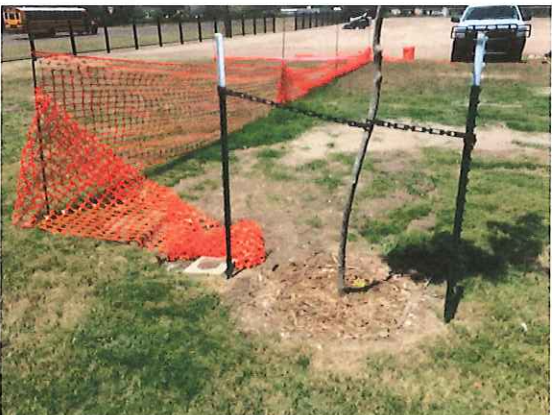
Grass removed | scraped-off during the excavation of the plumbing lines by county crews. Landscaper will not need to replace the grass.

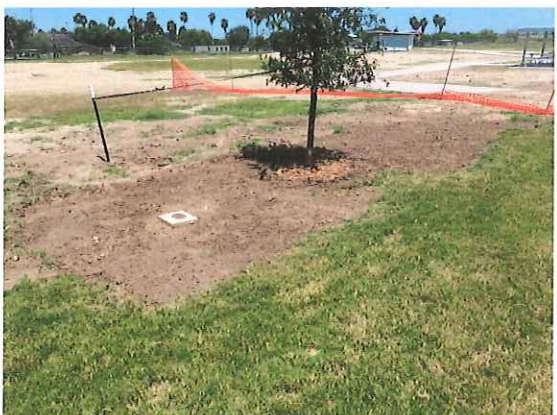
Grass removed | scraped-off during the excavation of the plumbing lines by county crews. Landscaper will not need to replace the grass.

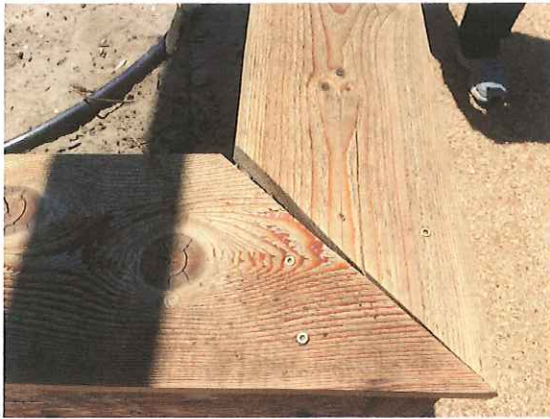
Landscafer to remove and replace boards at two locations.

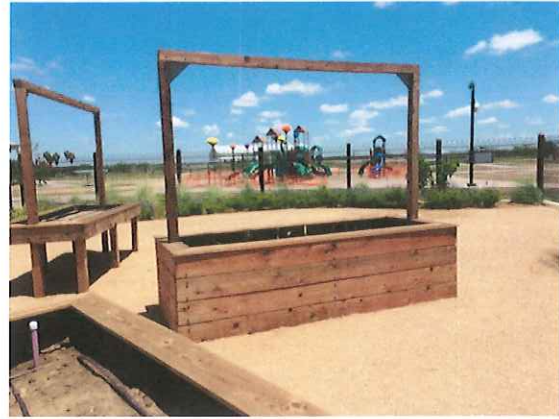
Contractor stated that the cable supports for vines were not installed per the owner's direction. Verification has been requested.

11. The steel cabling system for the planter boxes has not been installed. The general contractor stated that this was not done at the direction of Precinct 4. Verification in writing has been requested of the contractor. The cost for the steel cabling is to be credited to the project.

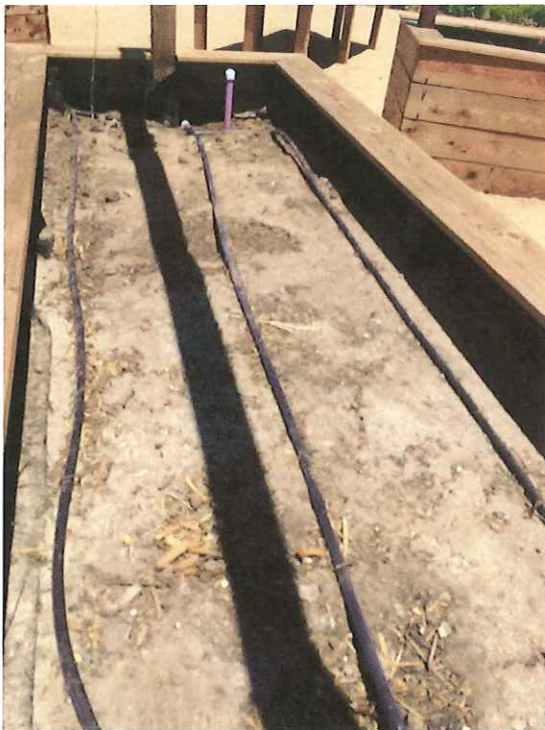
Verified the placement of soil/compost mix at planter boxes. Hose bib connection verified.

12. The hose bib at one planter box has been installed.
13. The landscaper has replaced dead plants in the courtyard with local native species approved by Precinct 4. The replaced specie types and locations are to be noted on the as-built drawings. Water will be placed in the pond, along with appropriate replacement plants for the dedication.

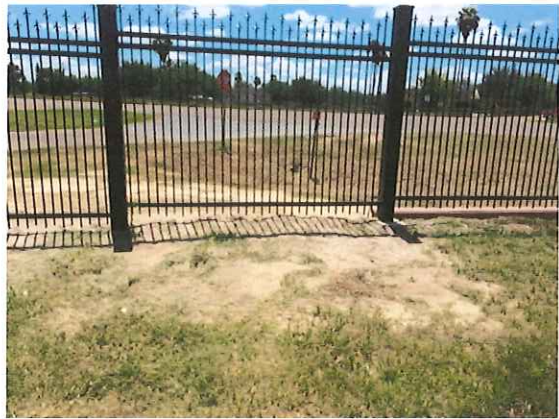
Grading near the intersection of Hwy 107 and Sunflower Road had been modified by county crews during the installation of the perimeter fencing, creating an area of water retention.

01. Verified correct species and placement of landscaping at parking median.
02. Verified correct species and placement of tree line along south side of parking area. The grading at the southeast corner has been changed during the installation of the wrought iron fencing by county crews. The contract grades show the area draining to the right-of-way, but the county crews have built-up the area to maintain a level fencing line and created a detention area that ponds water. The landscaper will not need to re-grade the area
