## Certificate of Substantial Completion

# HIDALGO COUNTY - ELECTIONS BUILDING

## Architectural Punch List

## M.E.P. Punch List

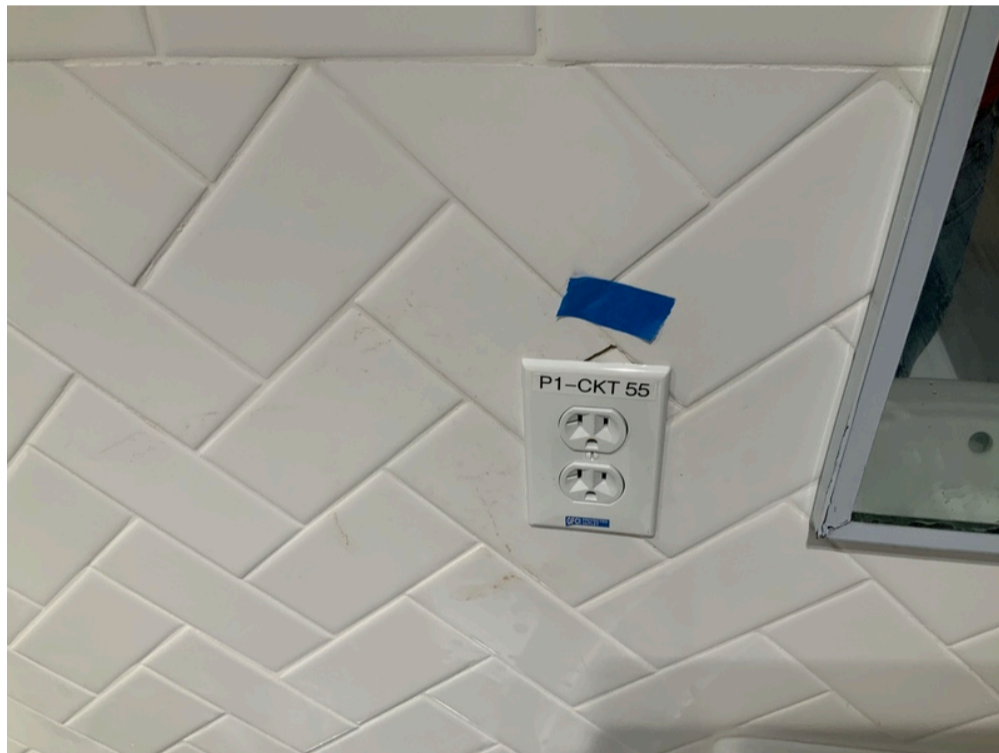
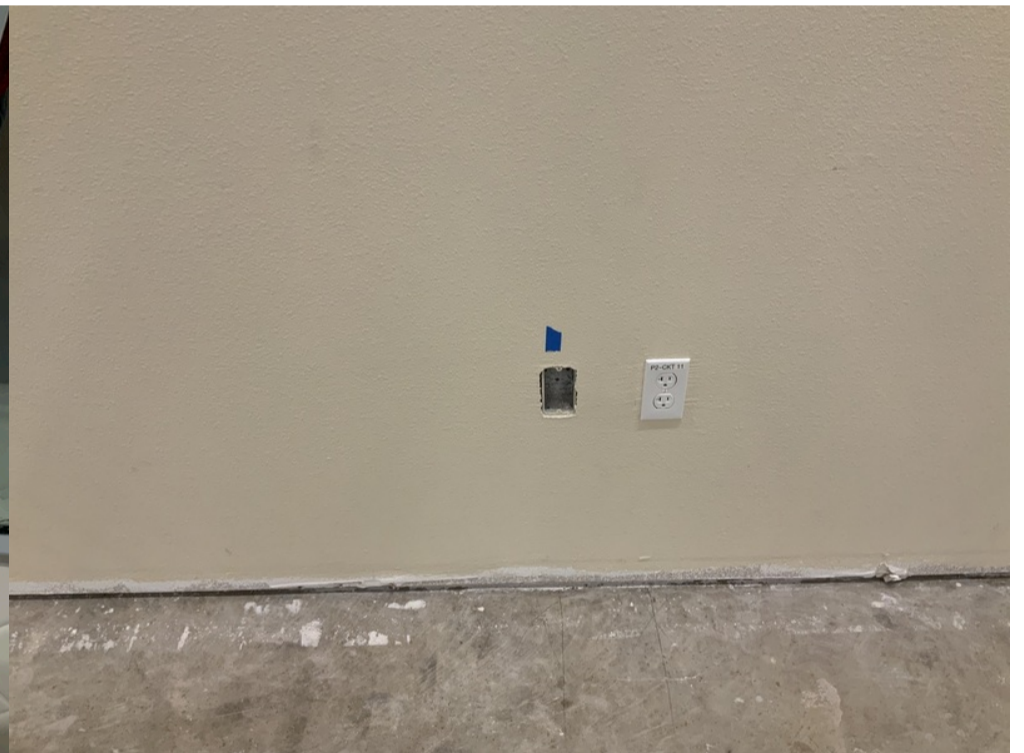
**Attached Images for ID 000008**

Open electrical box. Cover needs to be installed flush to tile and sealed properly.

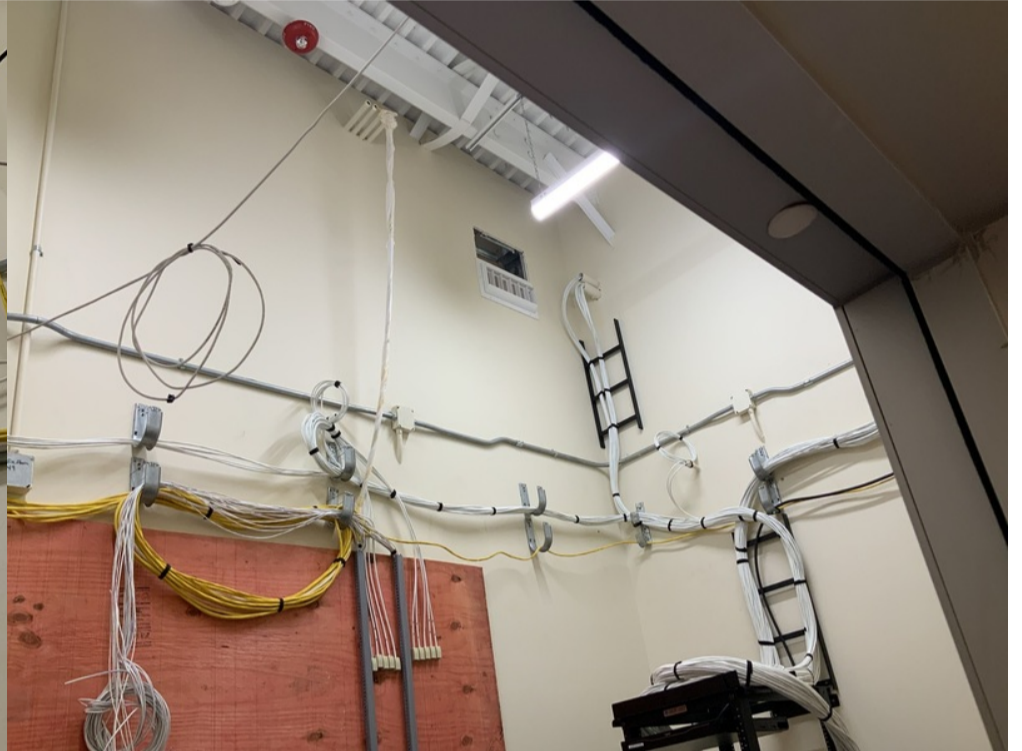
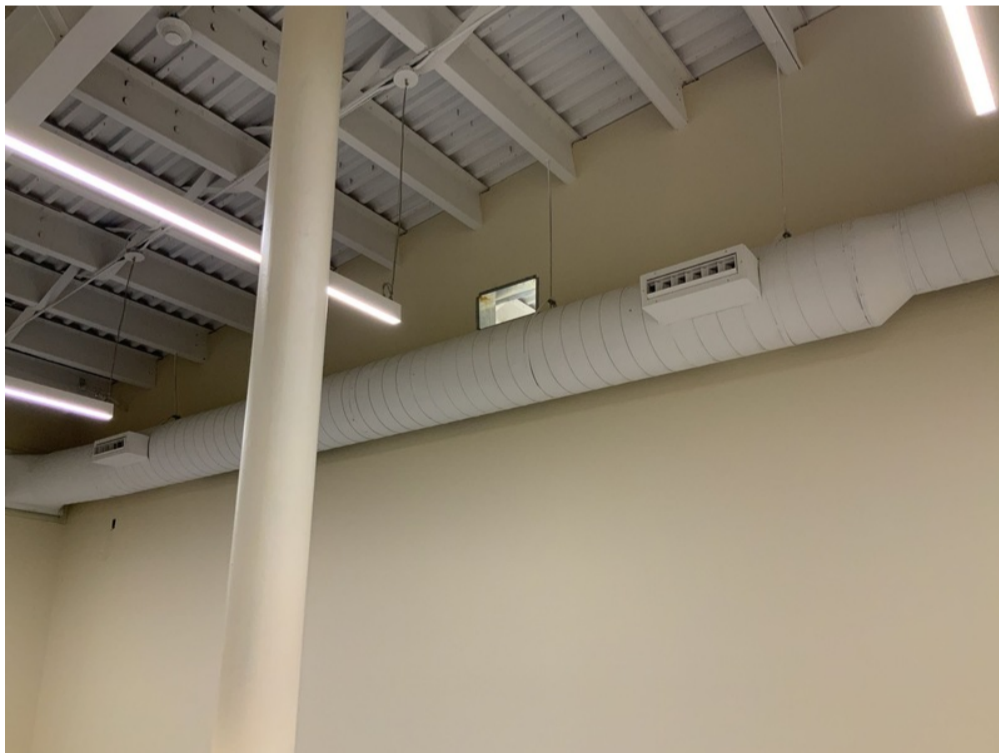
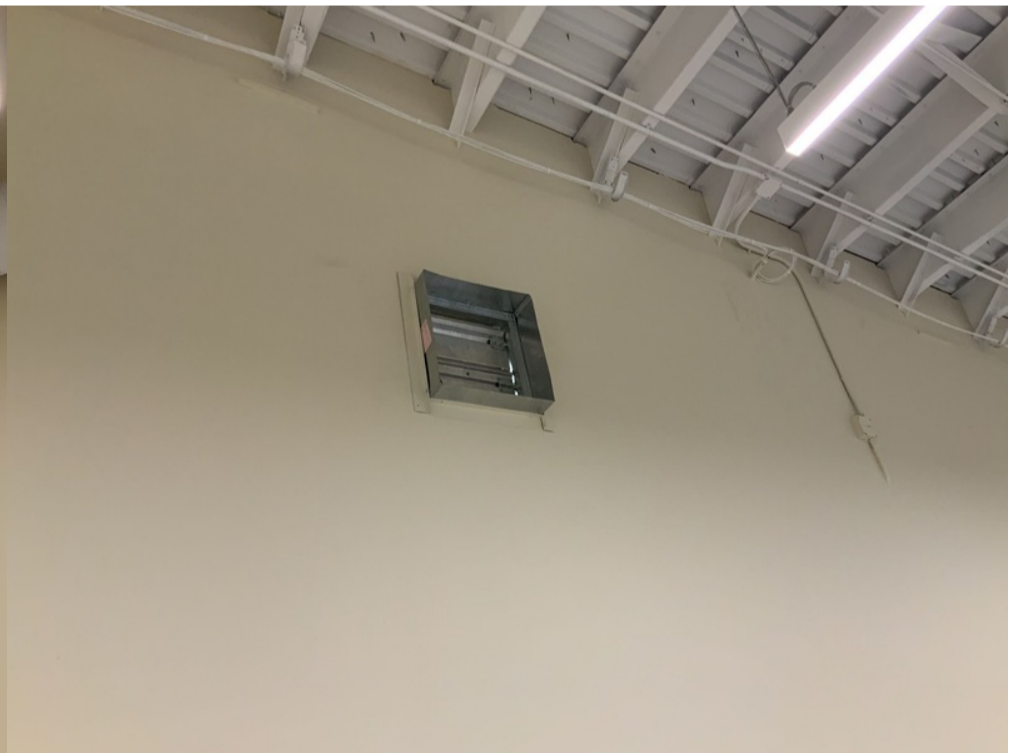
Attached Images for ID 000009

"Mechanical: Install missing supply/Return grill."  
"

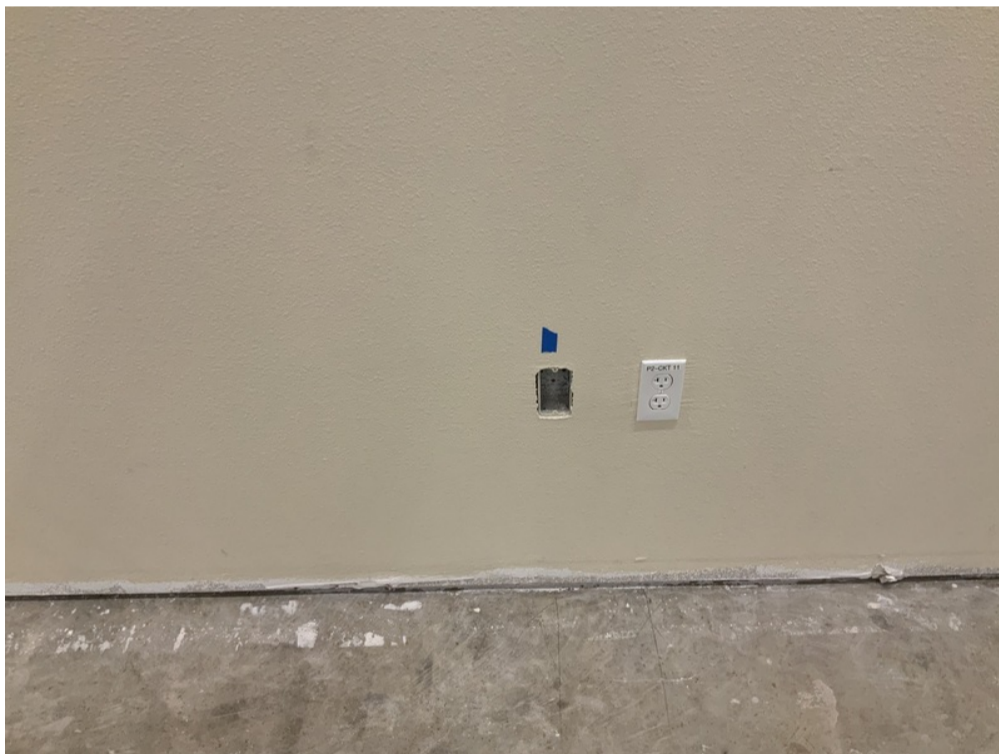
**Attached Images for ID 000010**

**Description**  
Receptacles - Install cover plate to be flush with wall.

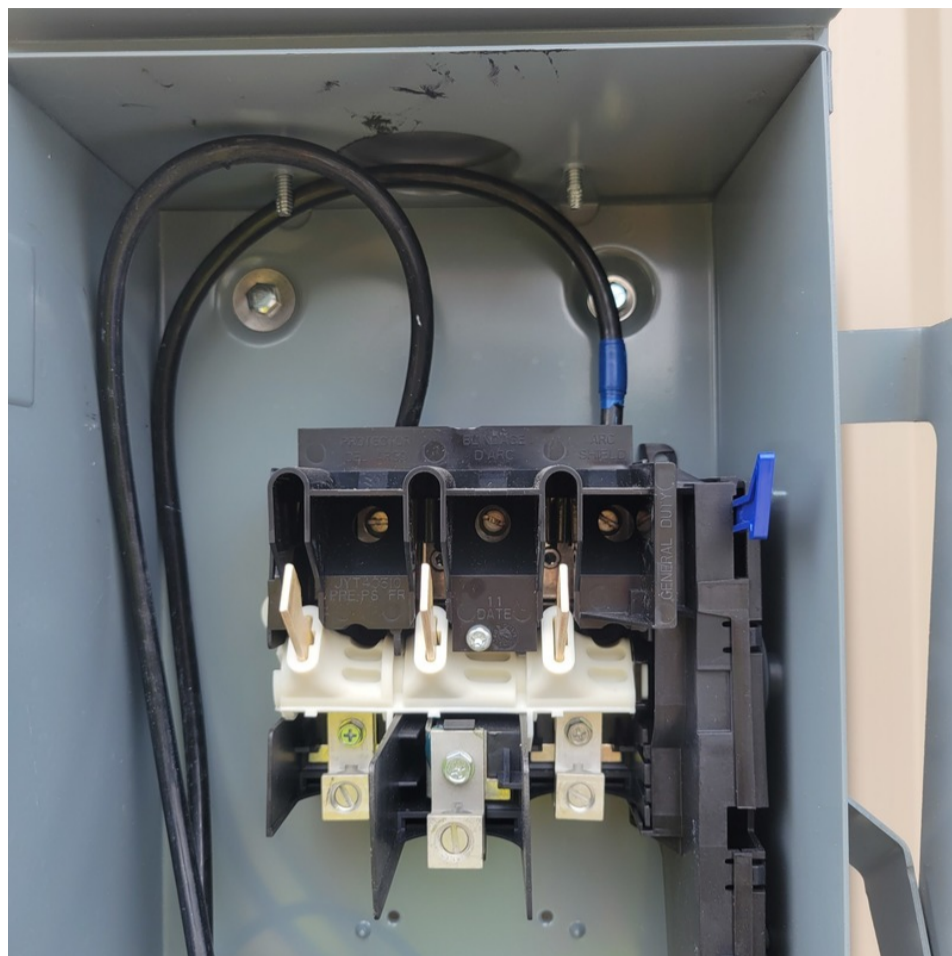
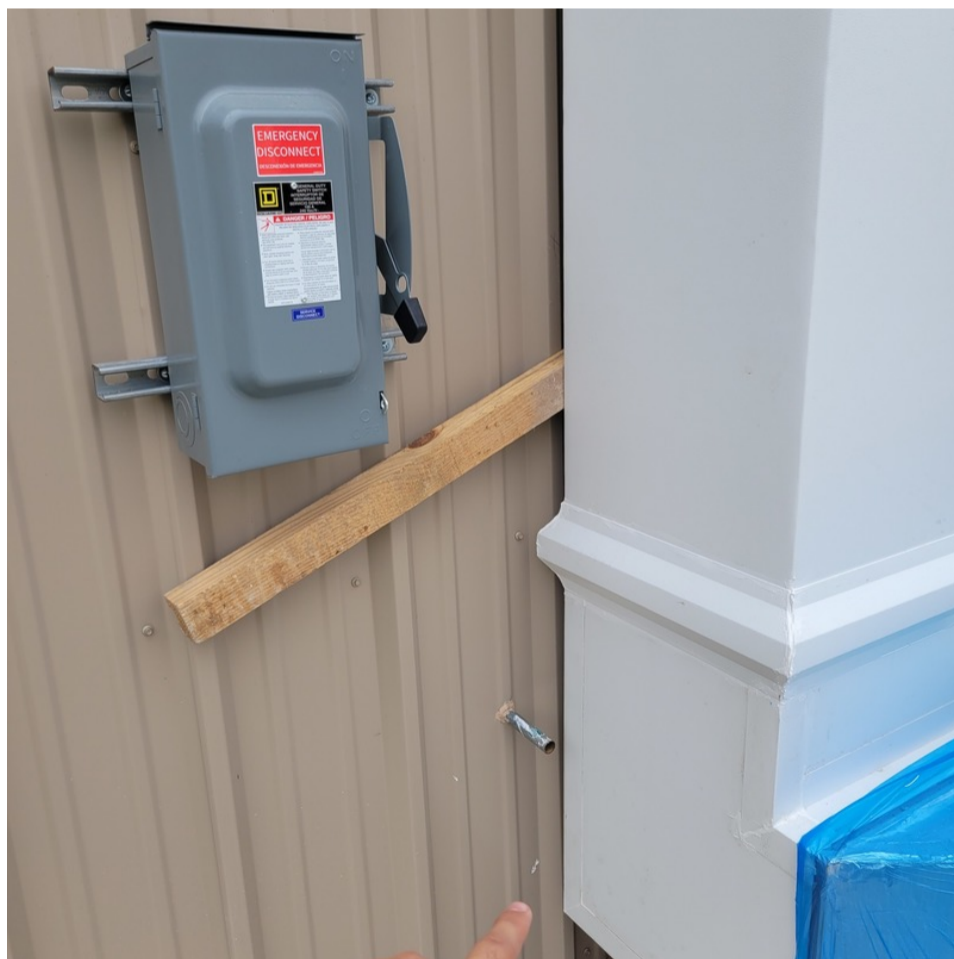
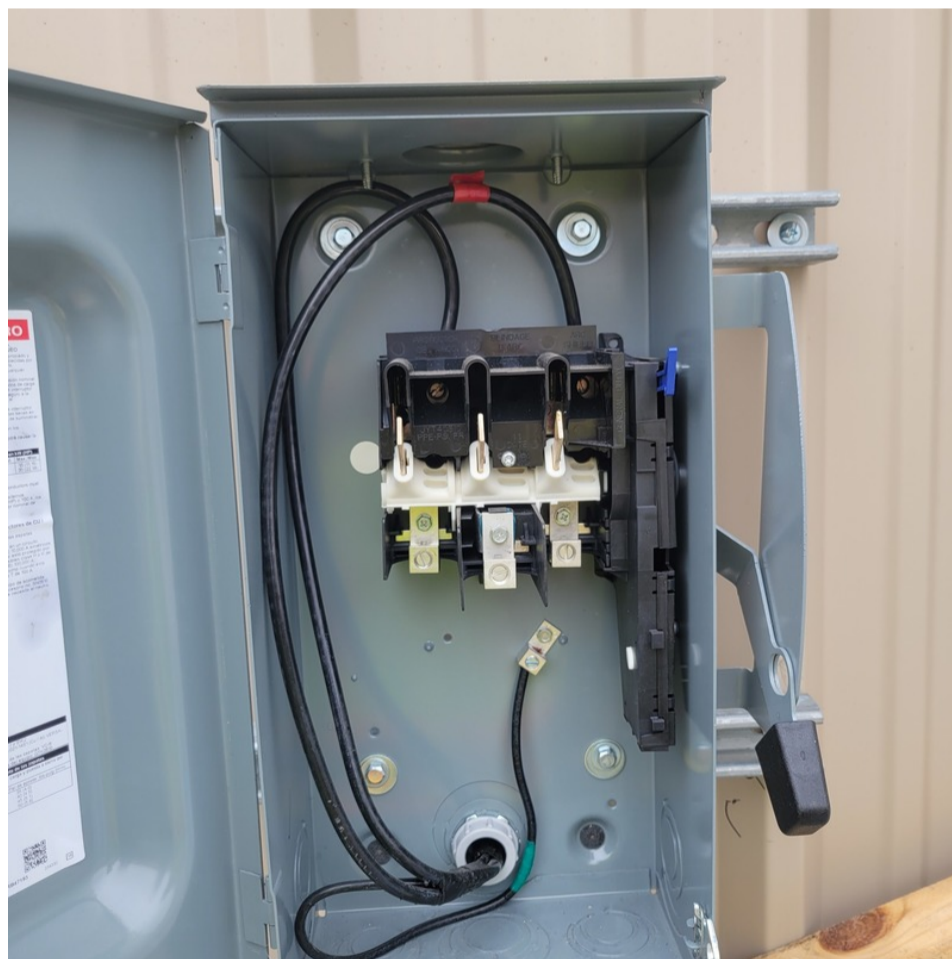
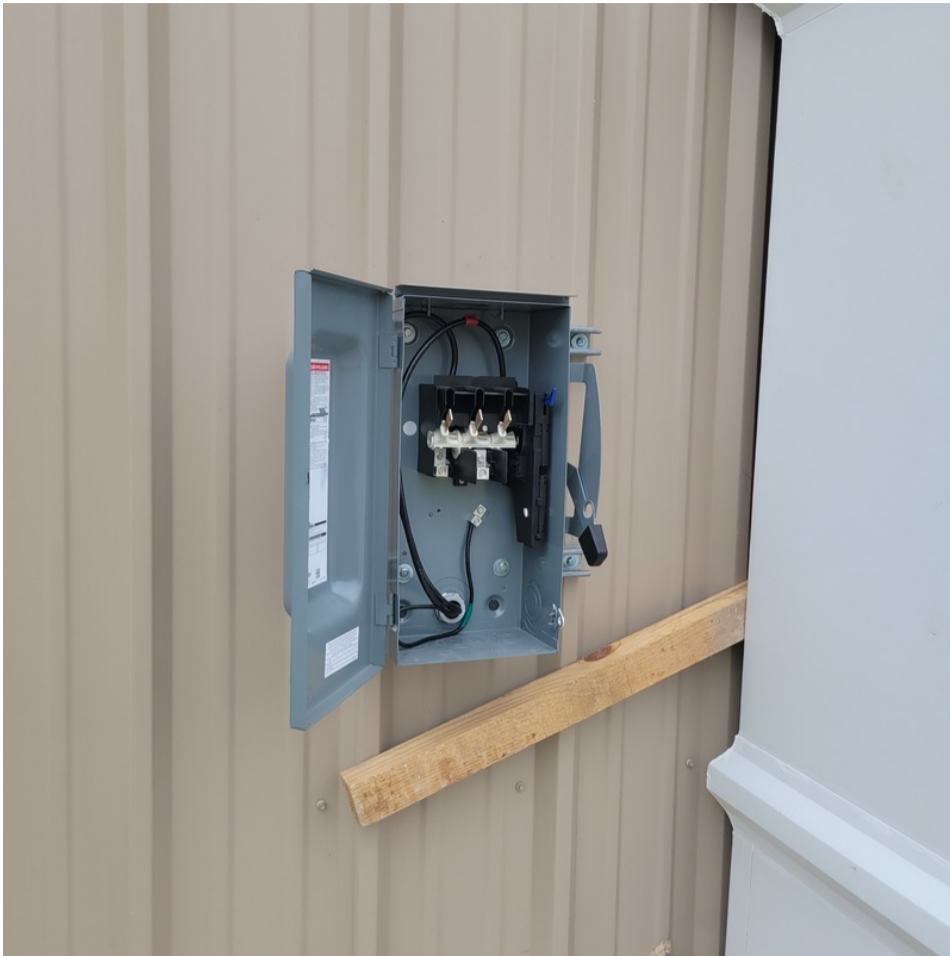
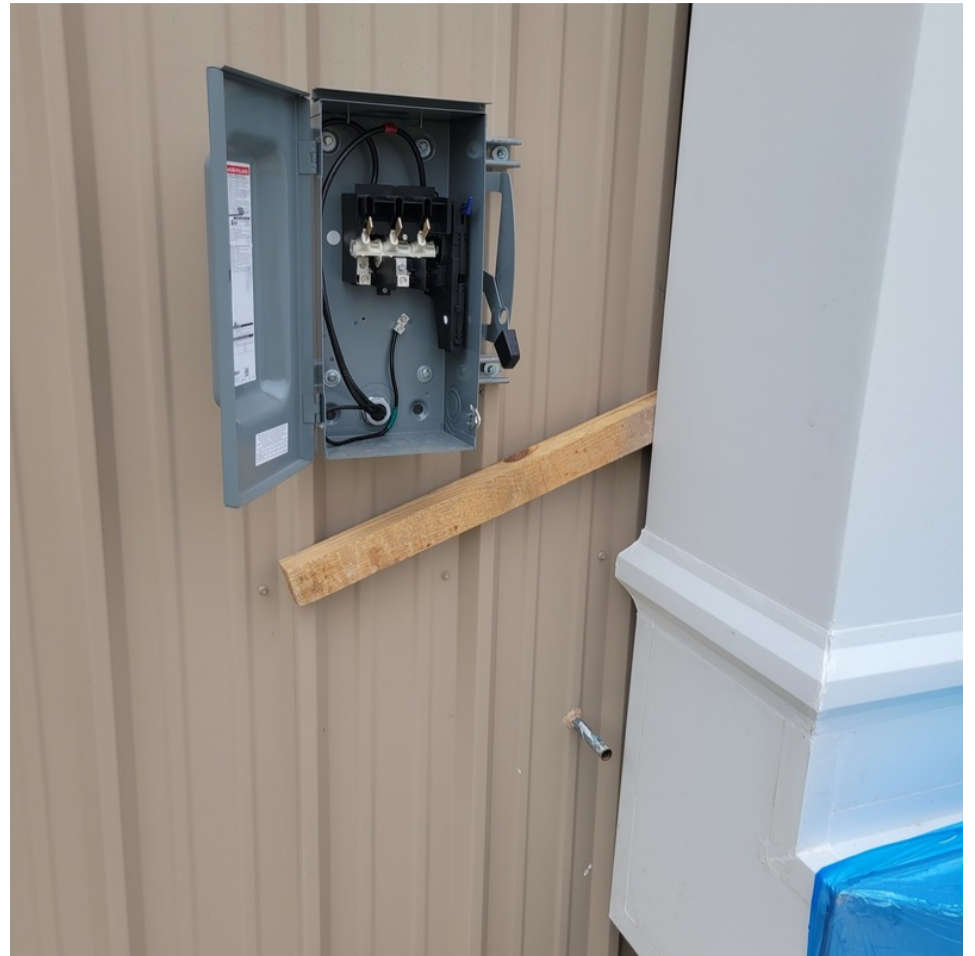
Attached Images for ID 0008

Disconnect fuses shall be provided per manufacturer's recommendation and as noted on submittal comment. Breaker size was not confirmed with final approved HVAC Equipment.

<b>Location</b>	<Top level>
<b>Location Detail</b>	Disconnects

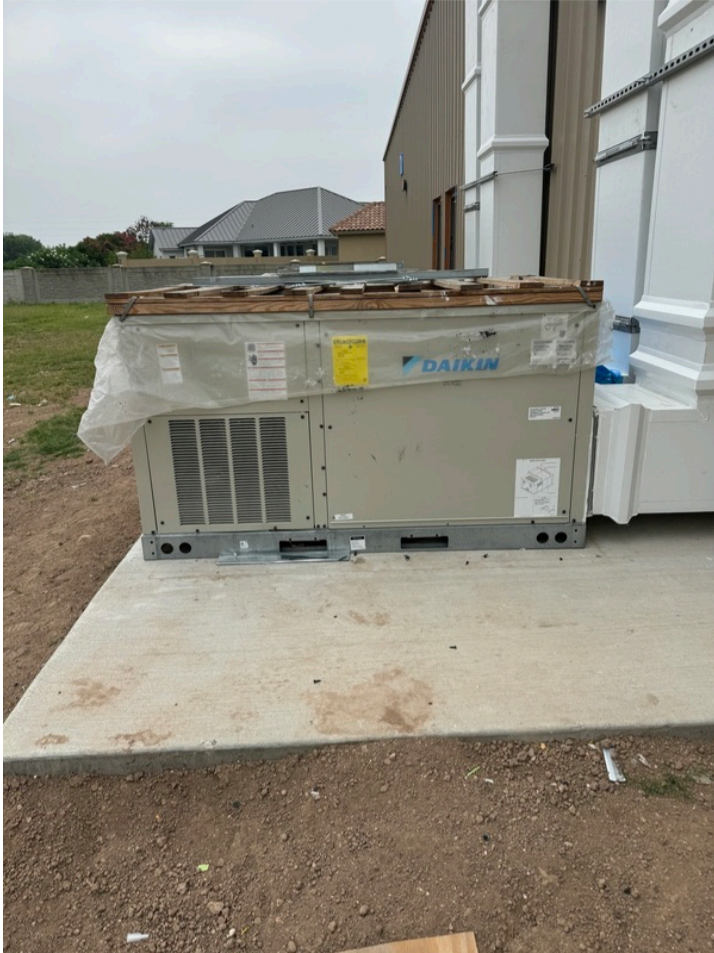
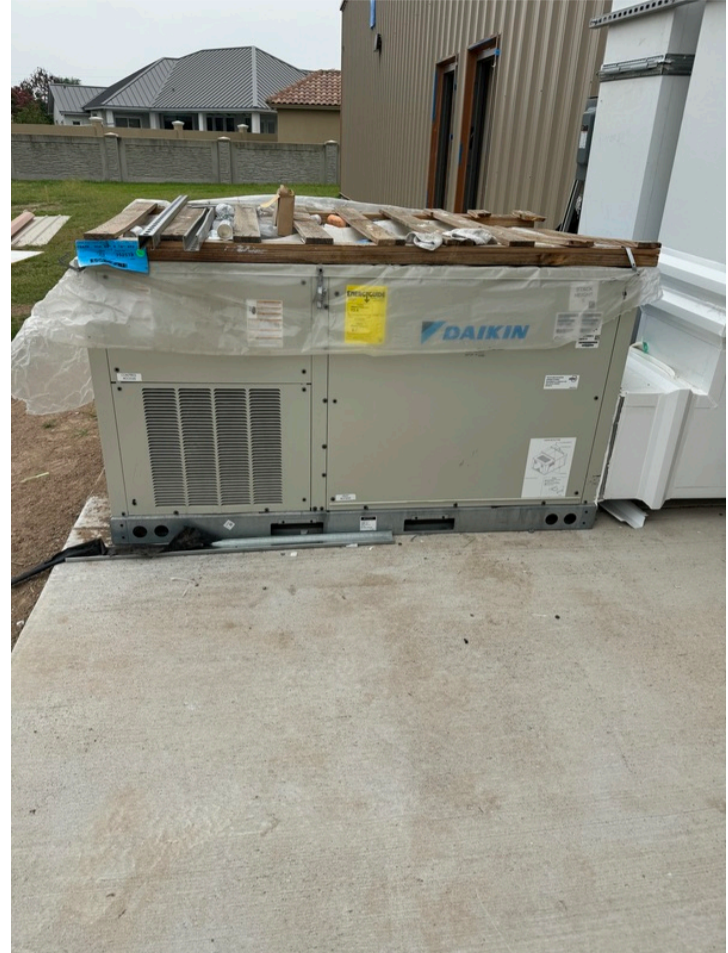
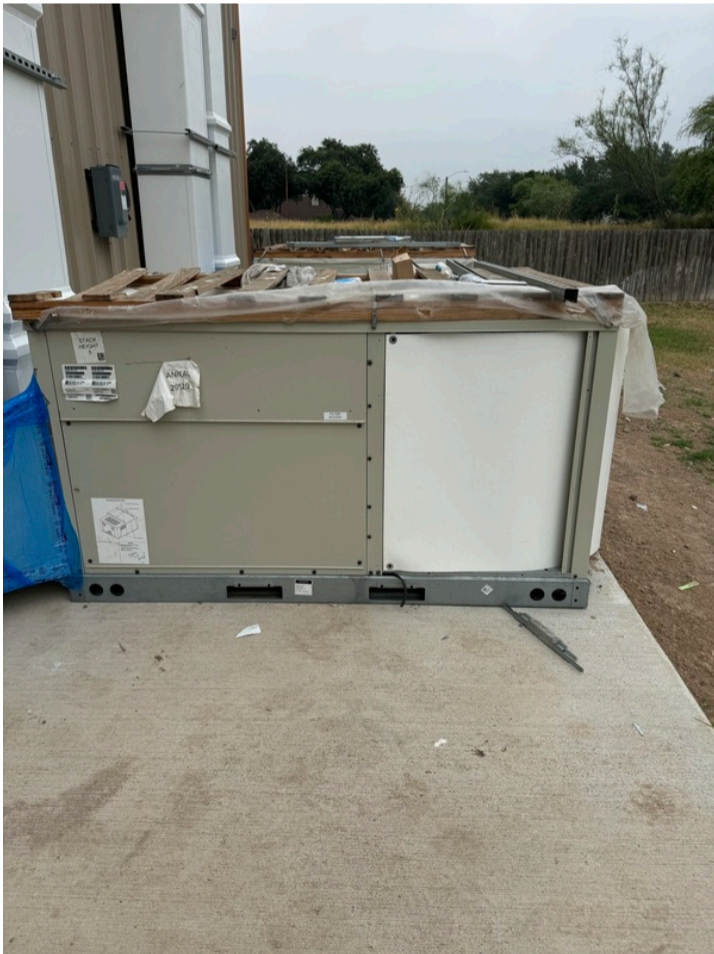
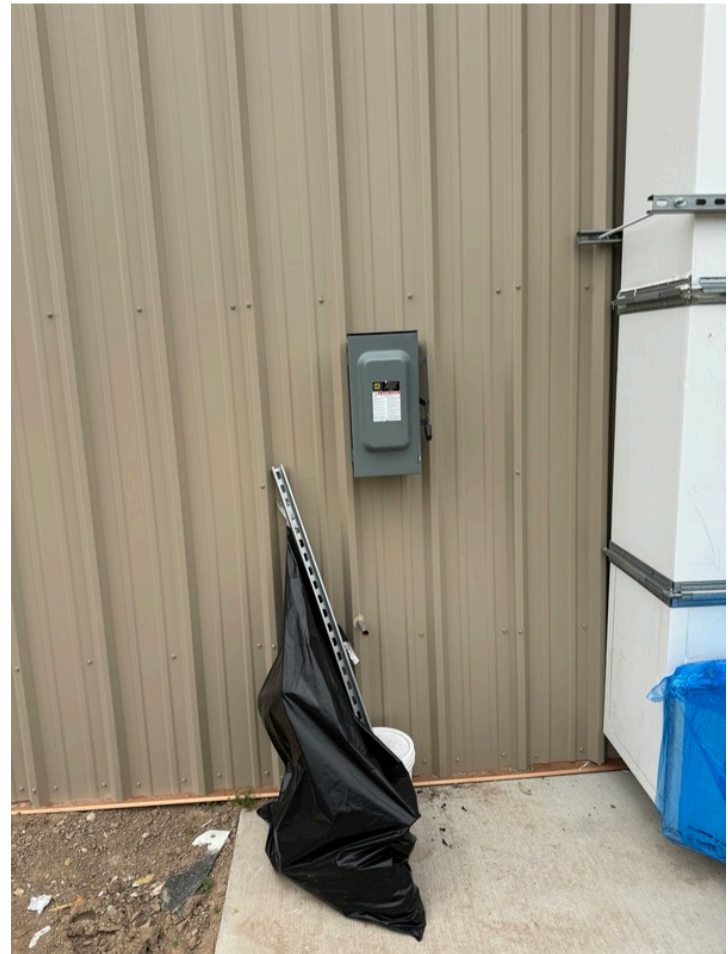
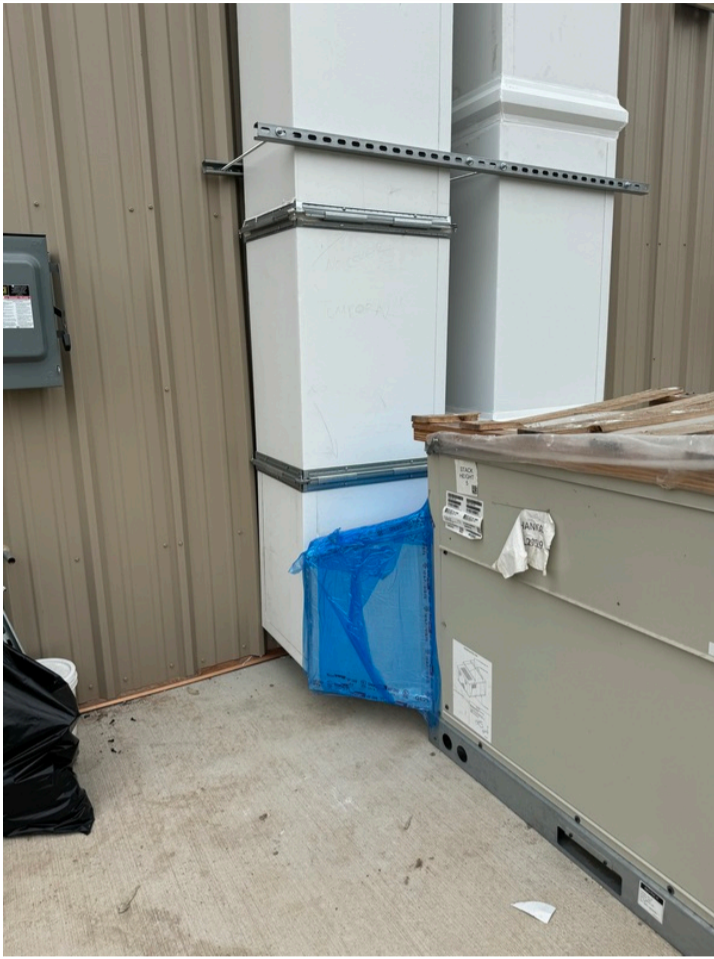
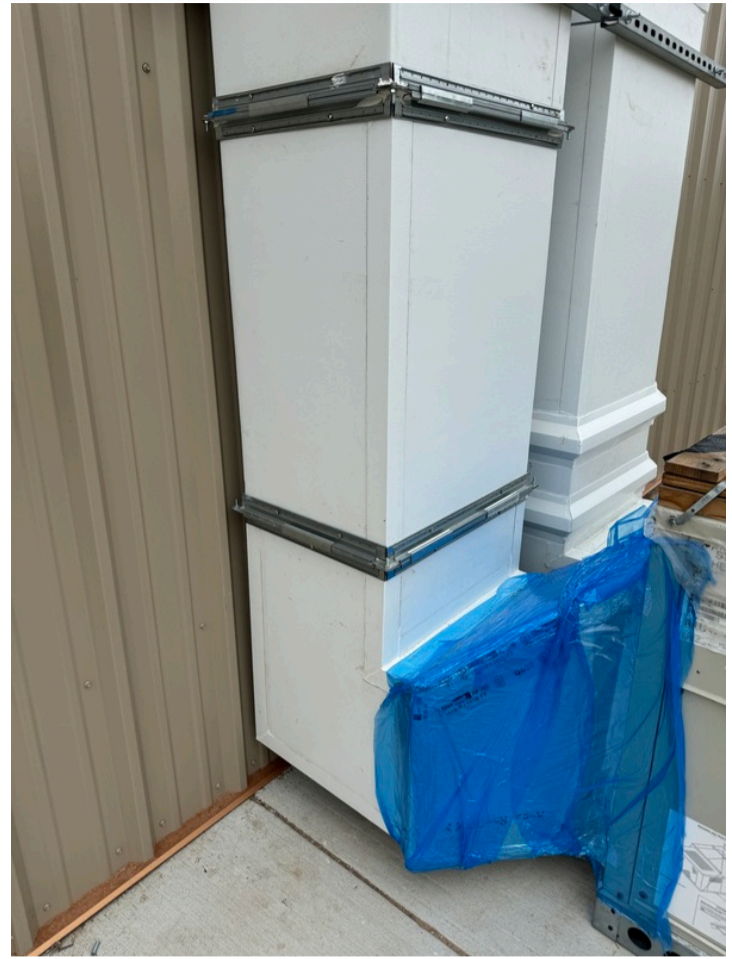
Attached Images for ID 0009

At the time of our visit. the Thermaduct installation was not complete.

<b>Location</b>	<Top level>
<b>Location Detail</b>	Outdoor Duct
