## Certificate of Substantial Completion

# HIDALGO COUNTY - ELECTIONS BUILDING

## Architectural Punch List

## M.E.P. Punch List

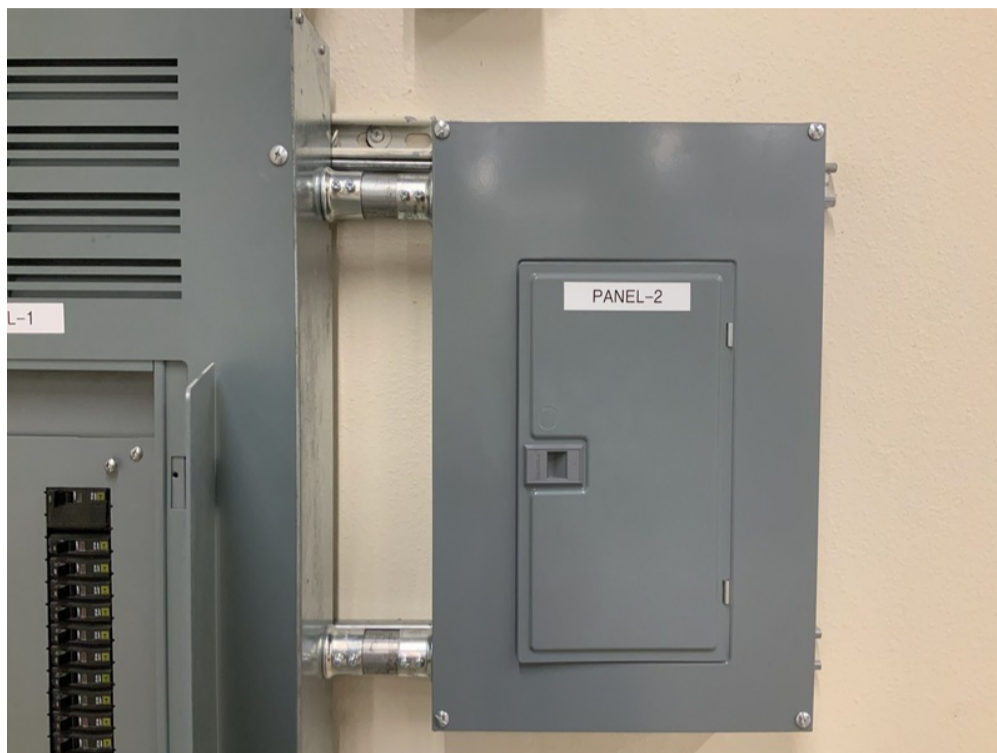
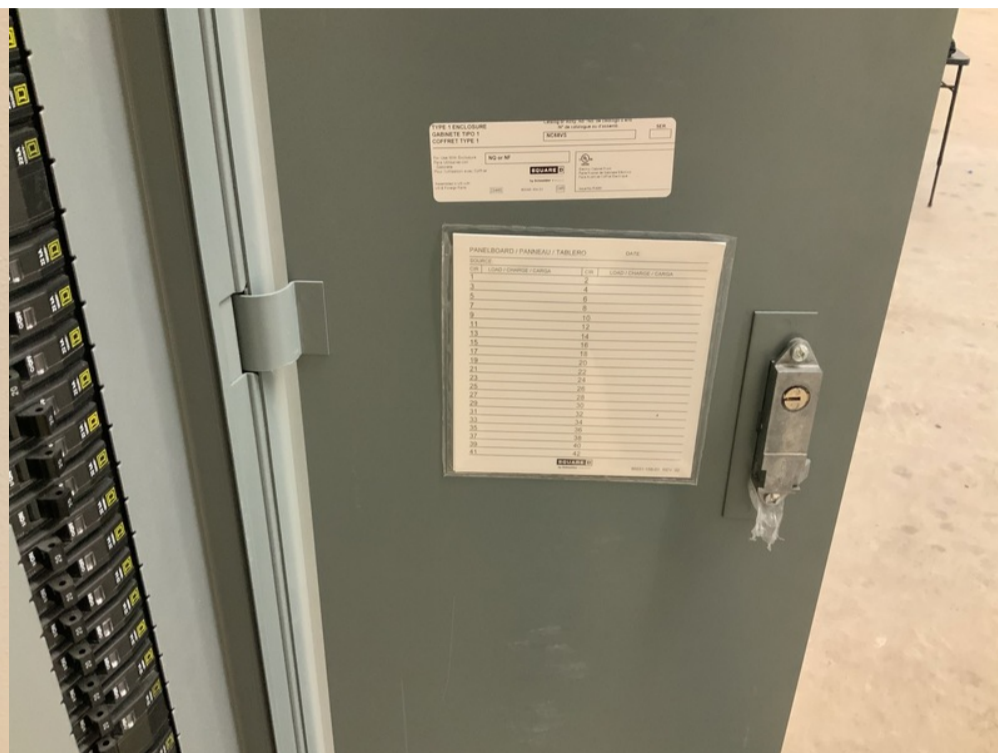
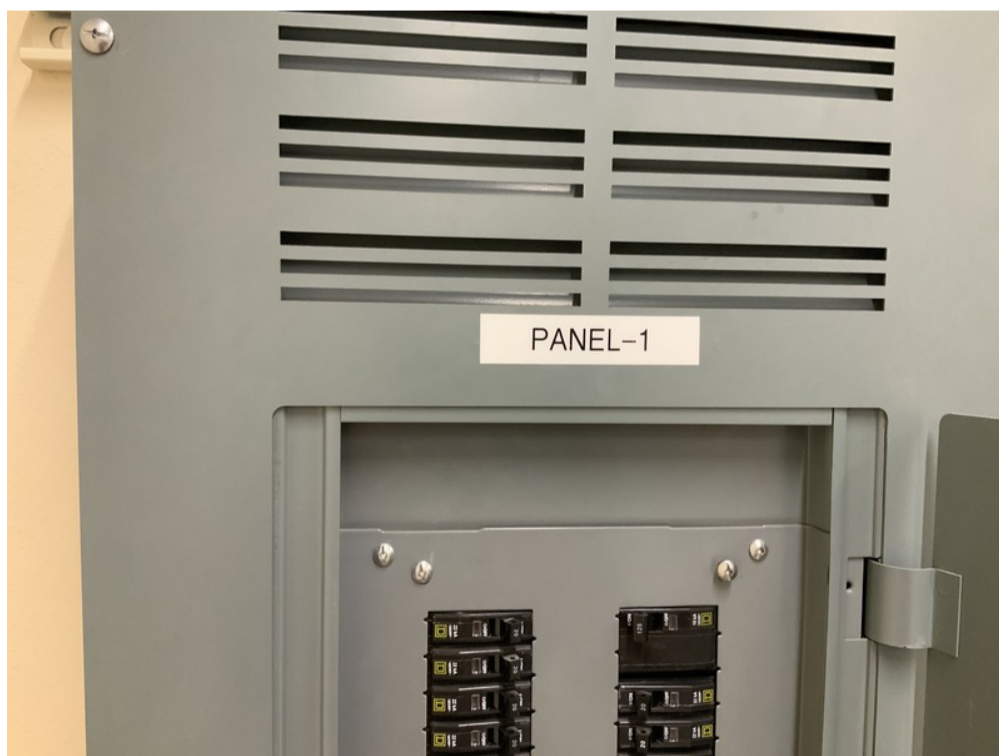
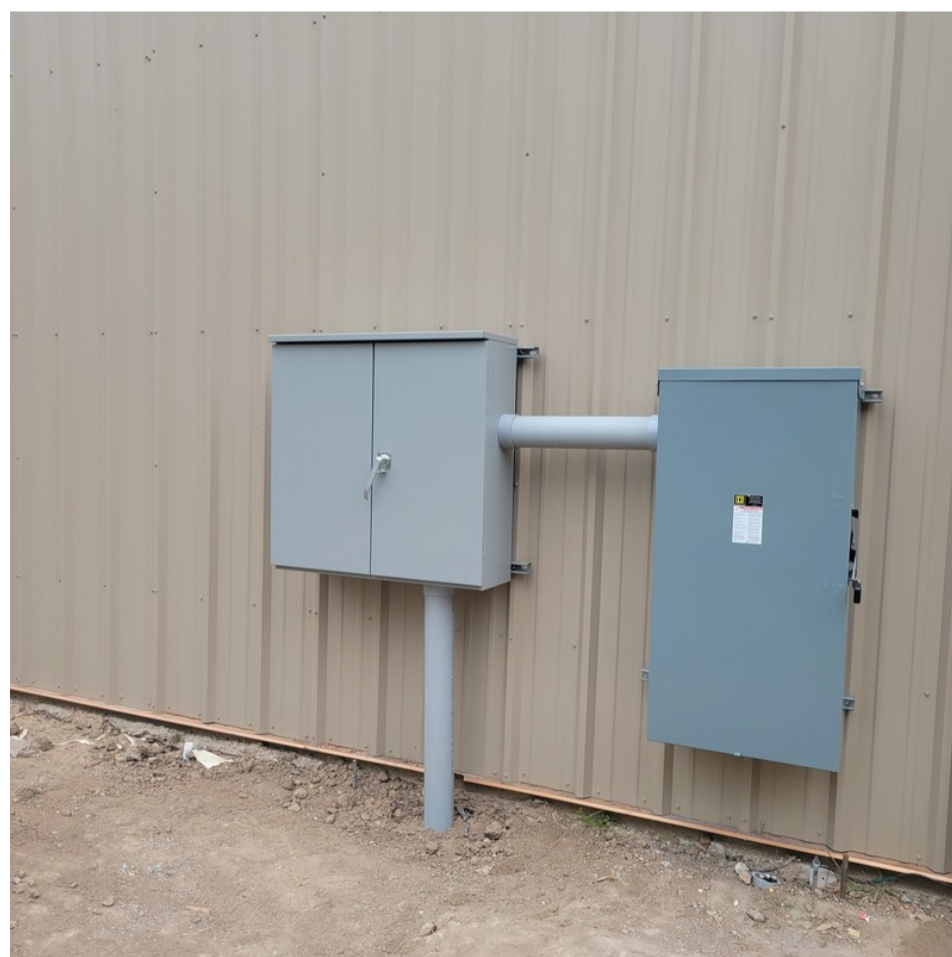
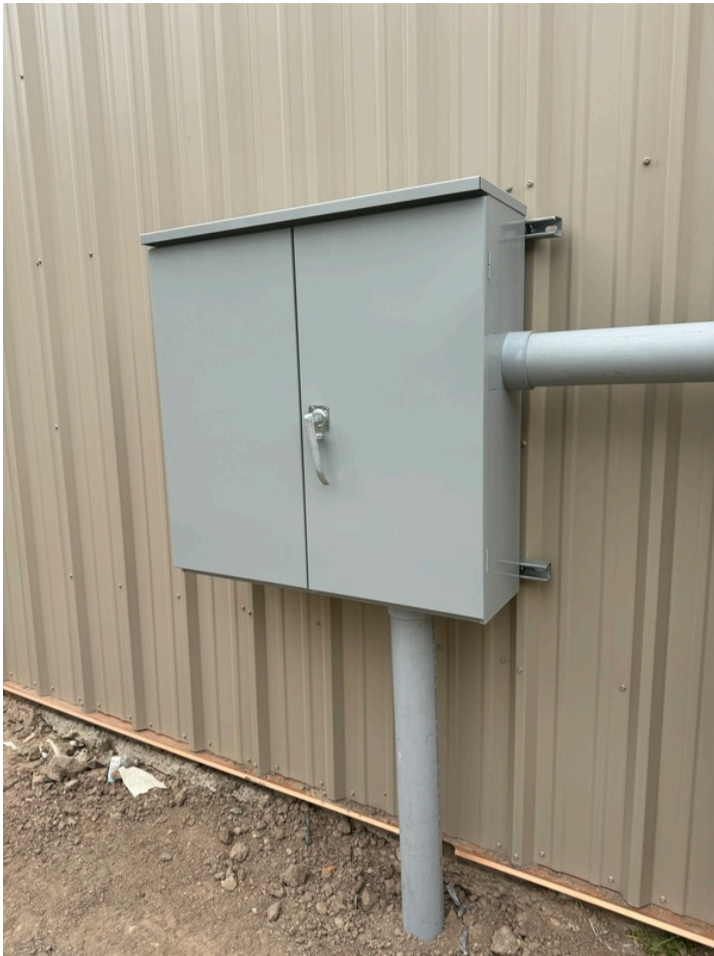
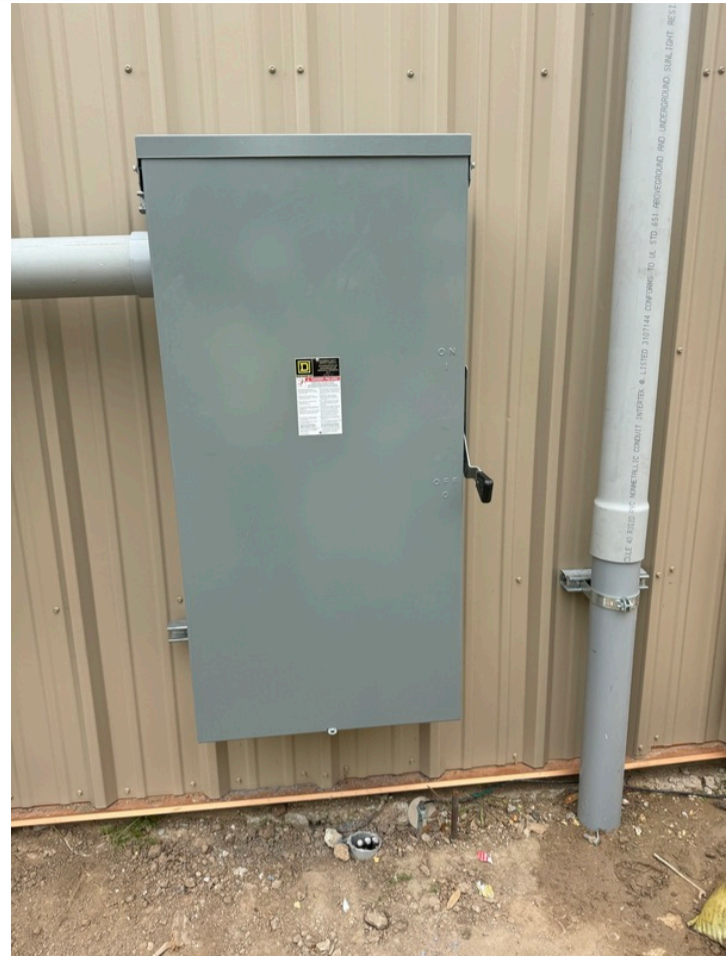
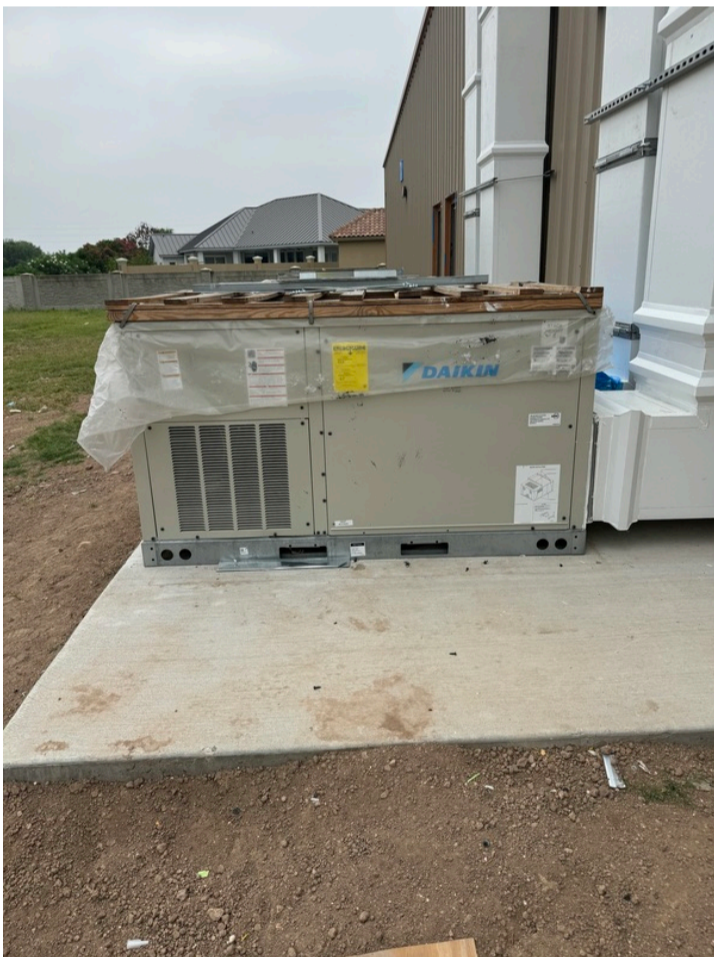
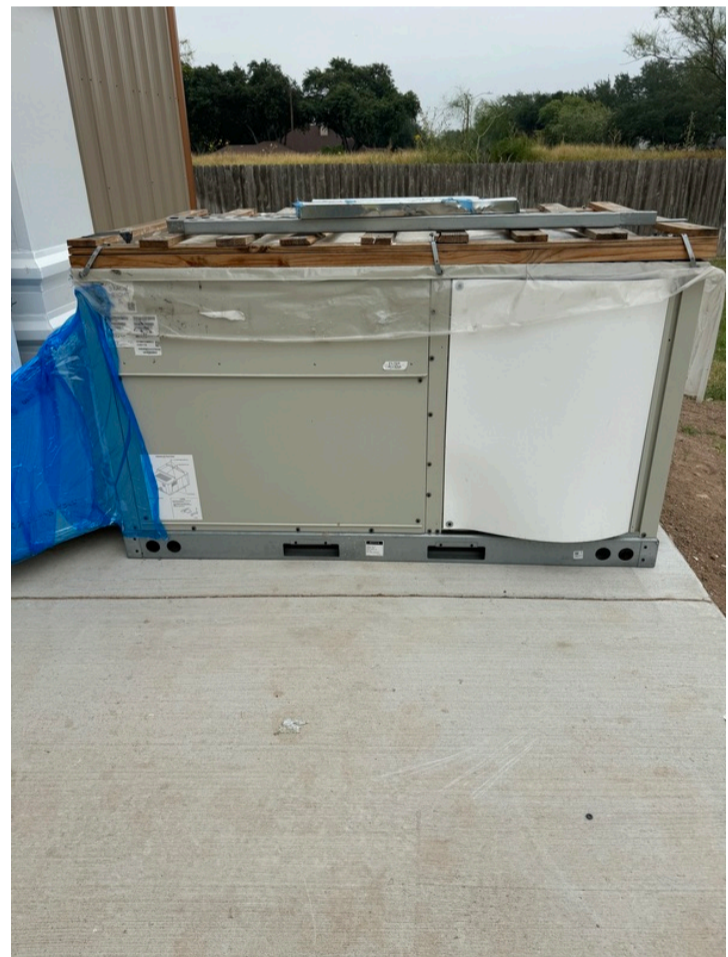
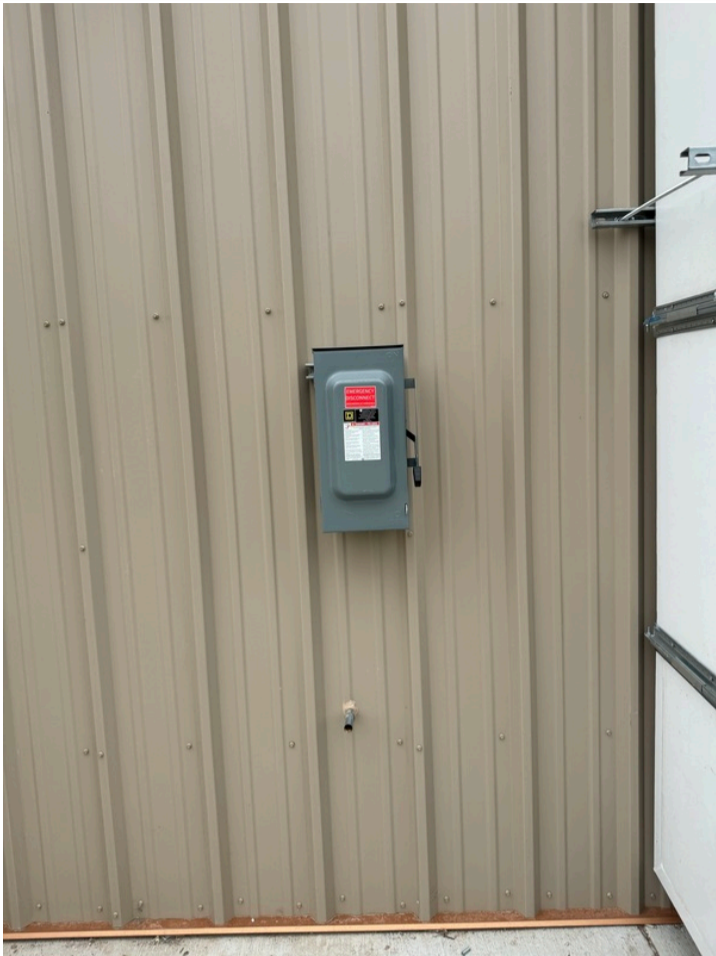
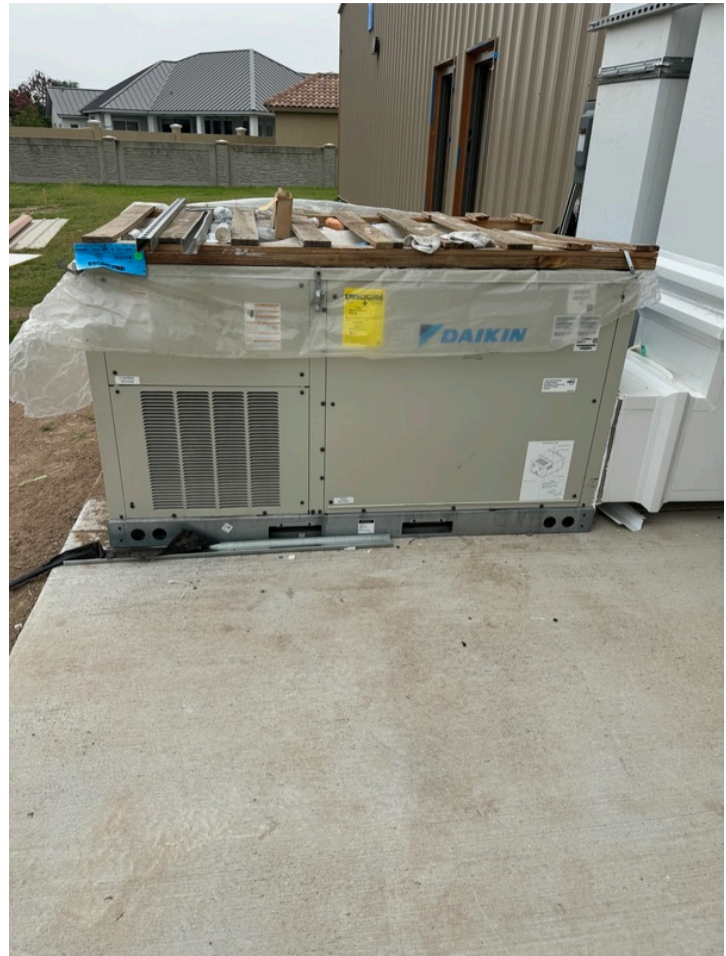
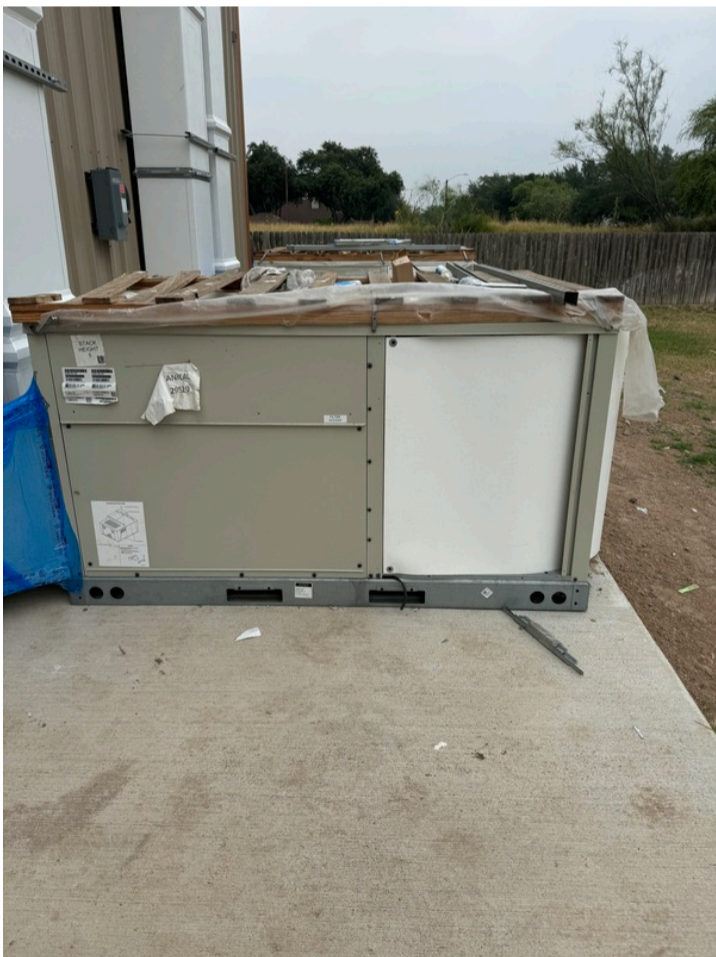
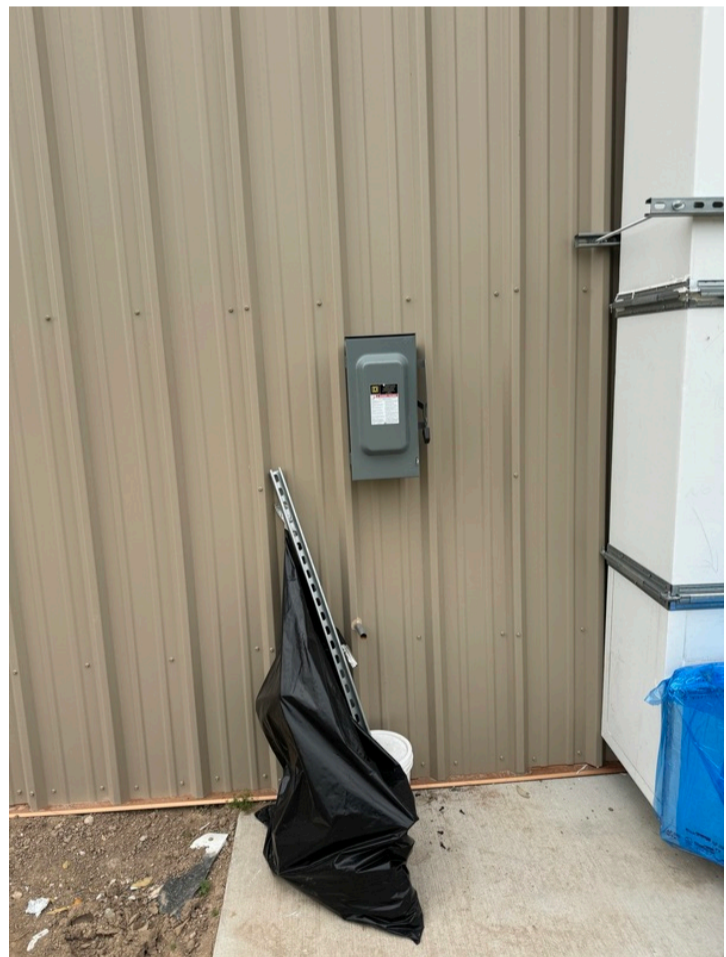
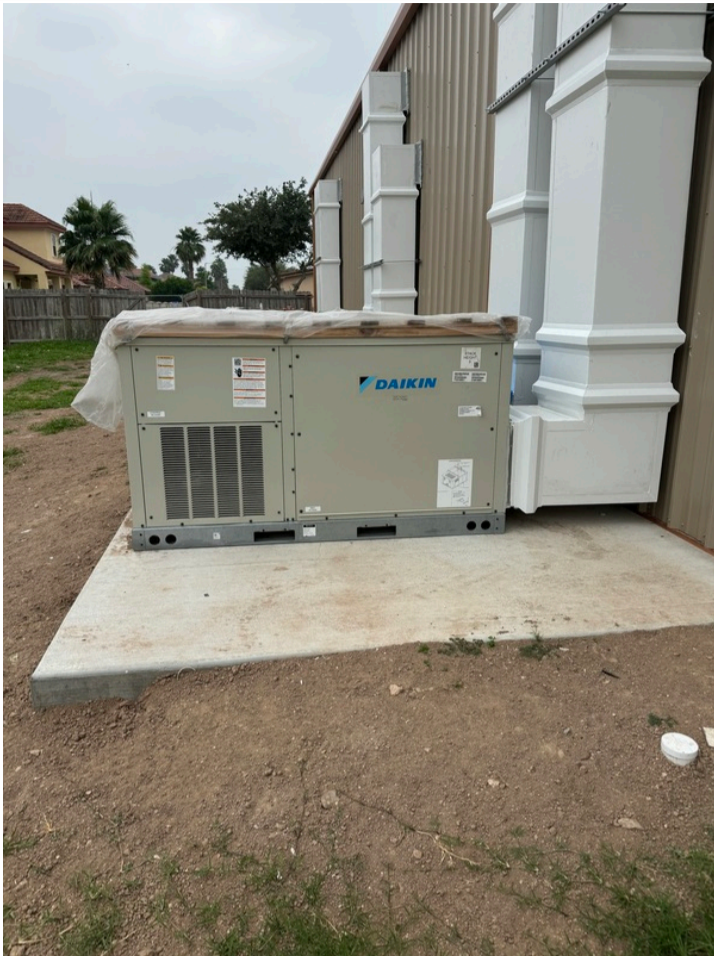
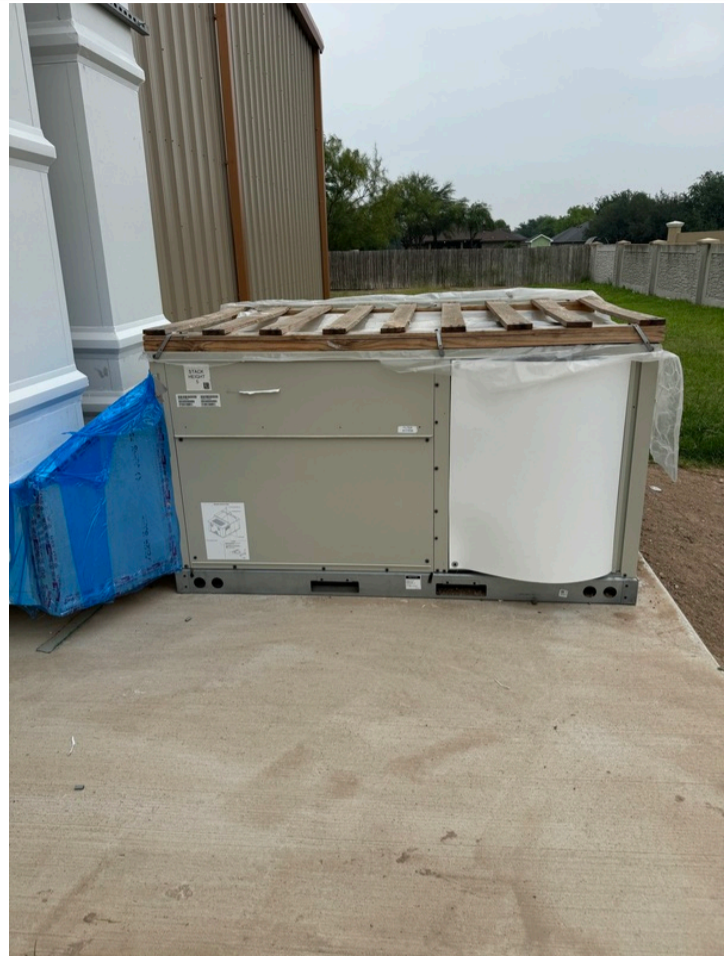
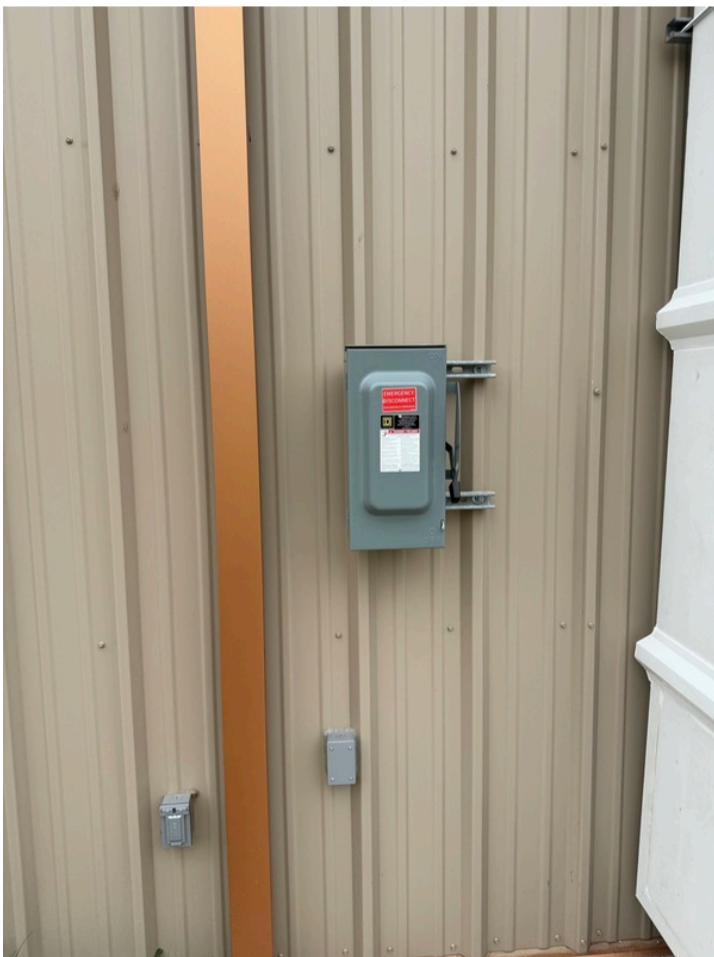
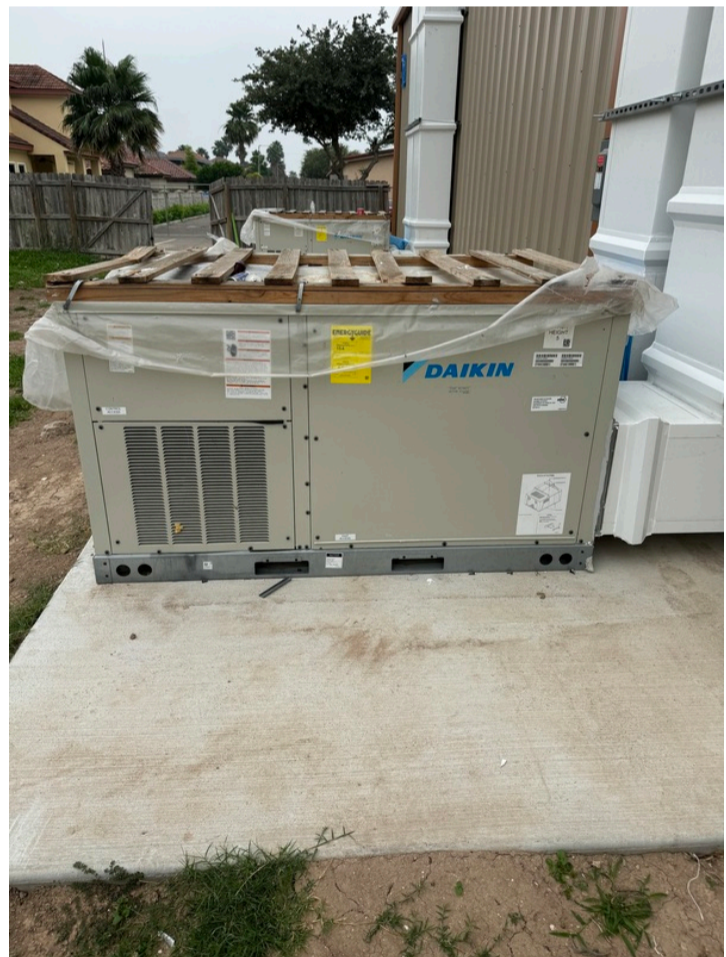
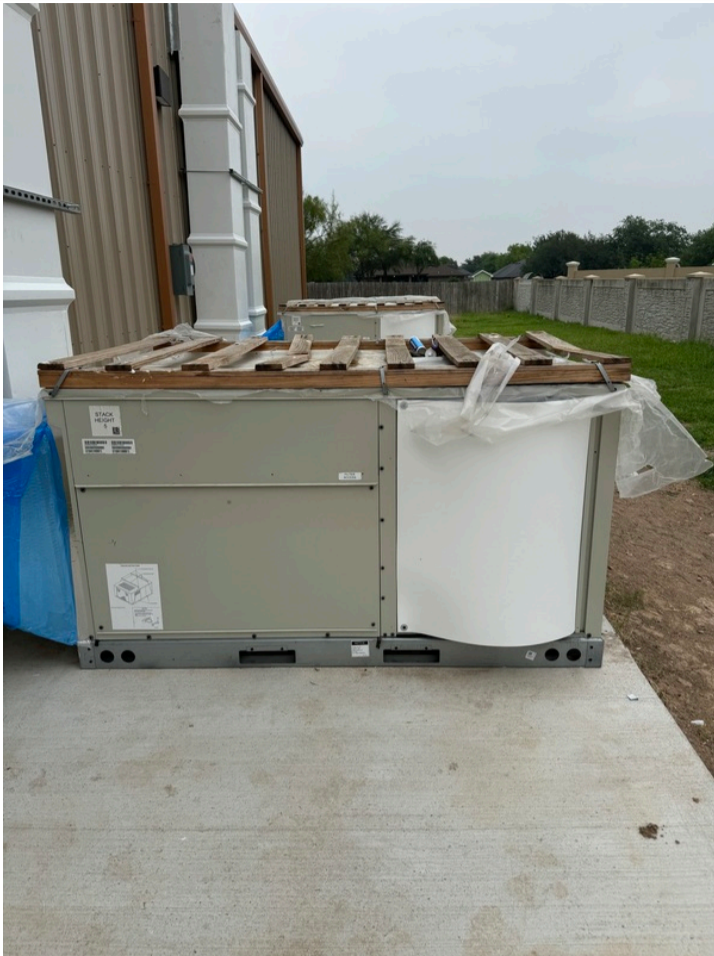
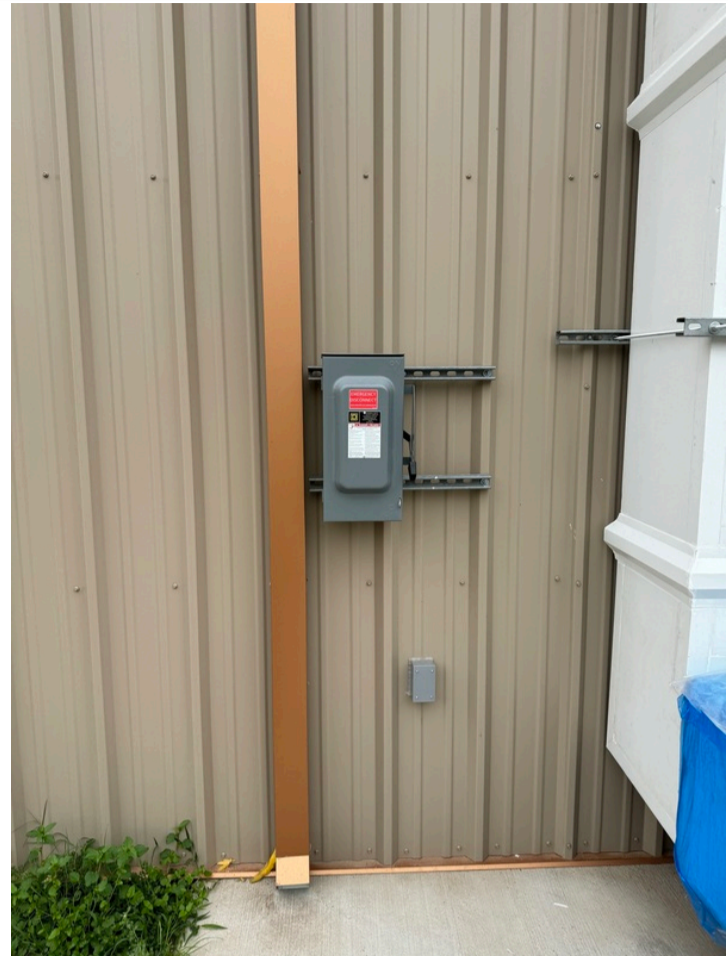
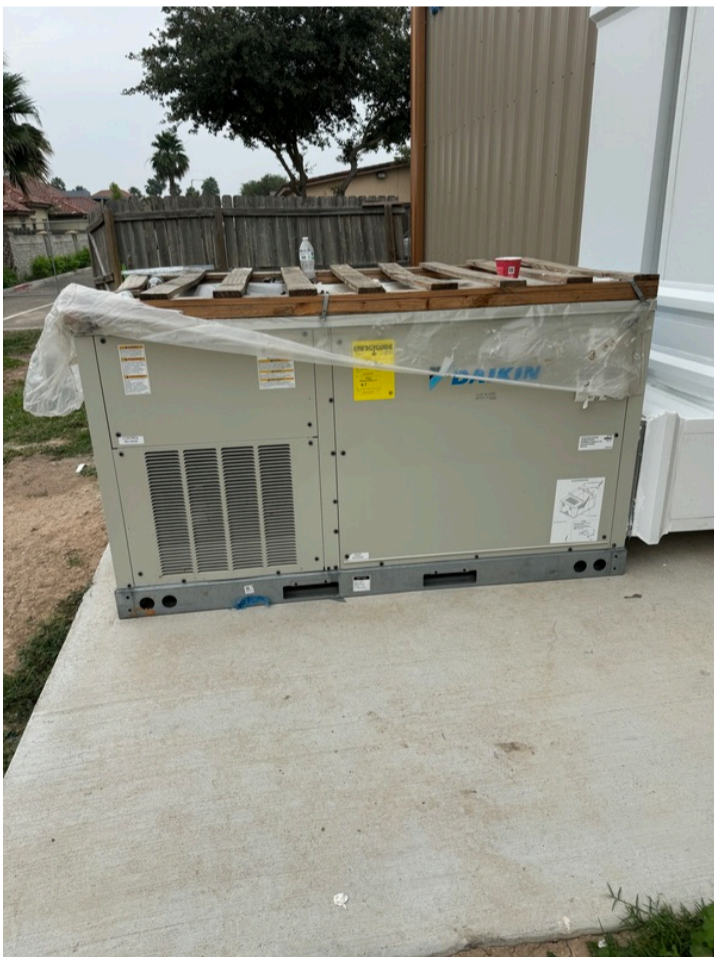
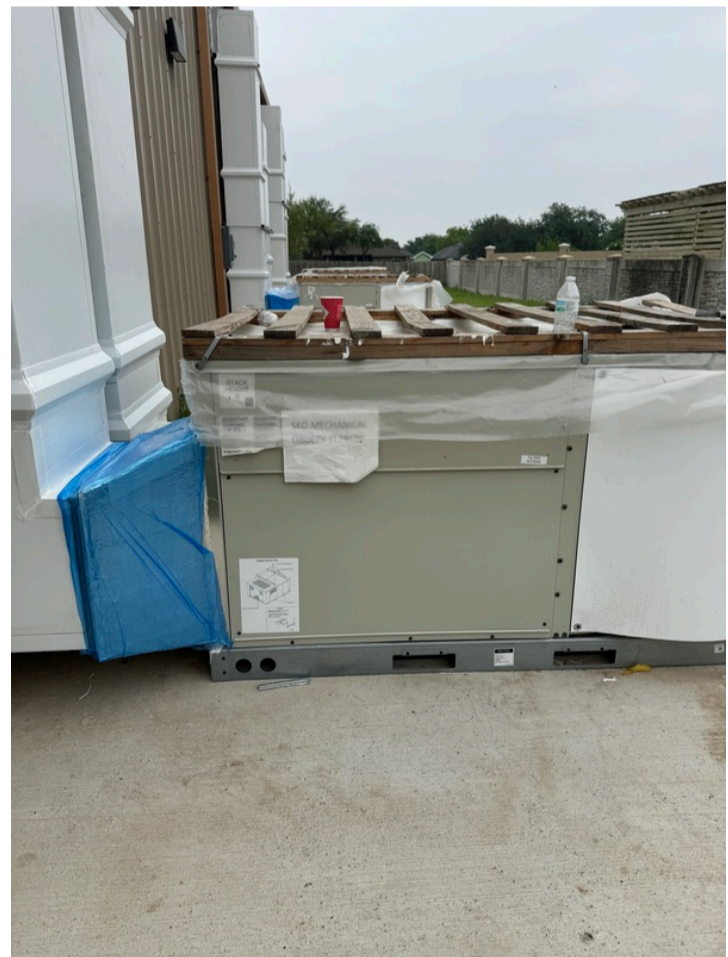
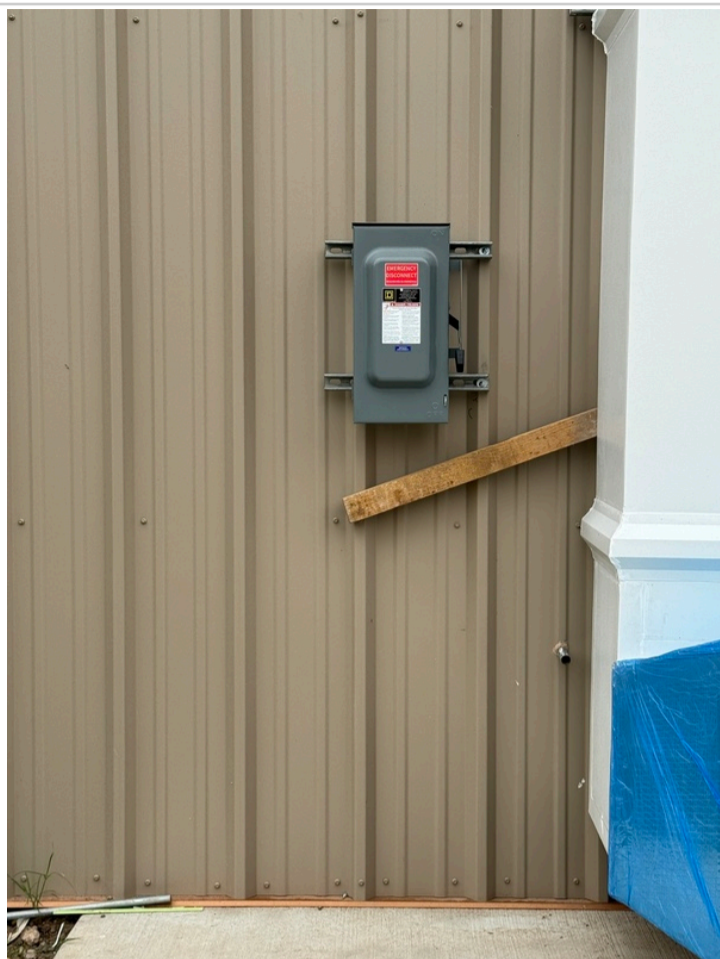
Attached Images for ID 0011

Mechanical and Electrical Equipment needs to be ID per specifications.

- \* 23 02 00 - 15 - 18 a & b
- \* 23 05 53 - 2 - 2.2 A
- \* 26 02 00 - 13(&14) - C -1 though 7

<b>Location</b>	<Top level>
<b>Location Detail</b>	All HVAC Equipment, Electrical Disconnects, Panelboards, Distribution Panel, Switchboards, etc

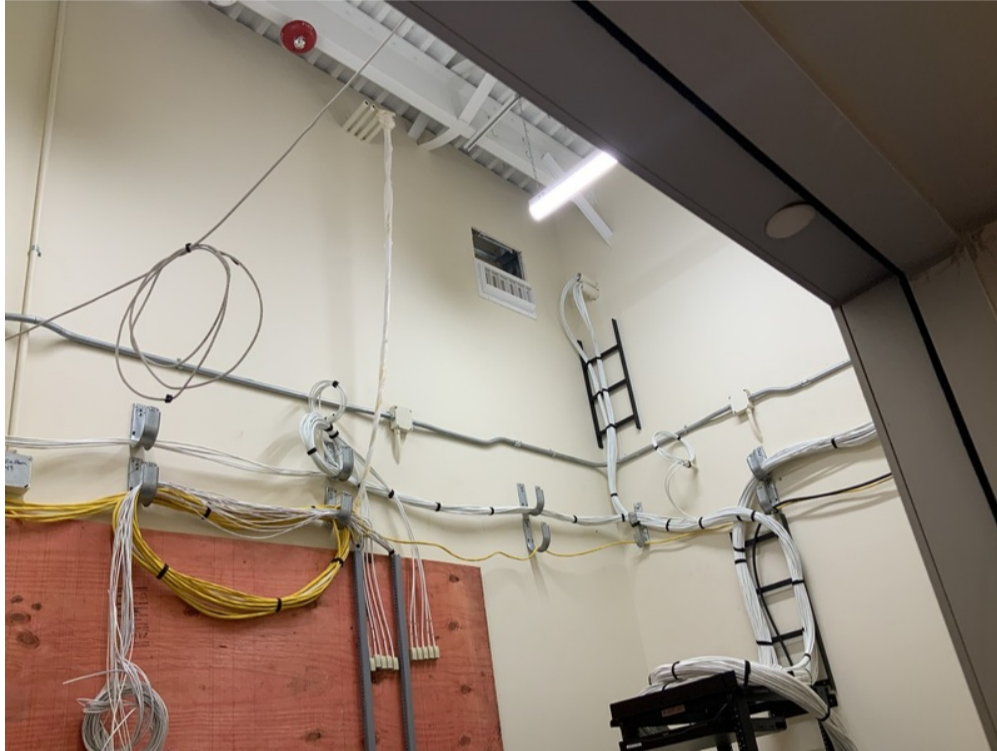
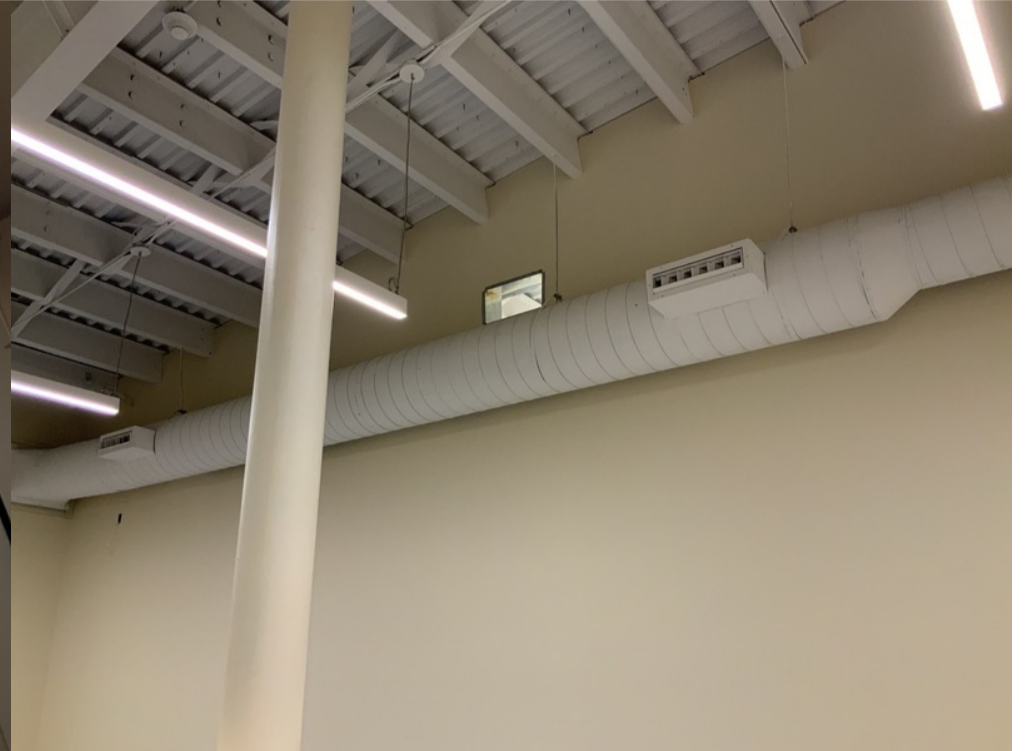
Attached Images for ID 0012

Install the return air transfer grille directly above the door. Coordinate elevation with the Architect.
