# **Aquatic EcoSolutions, Inc.**

## **Mankato Apartments Site**

## **Wetland Delineation Report**

Number: 25024BJ

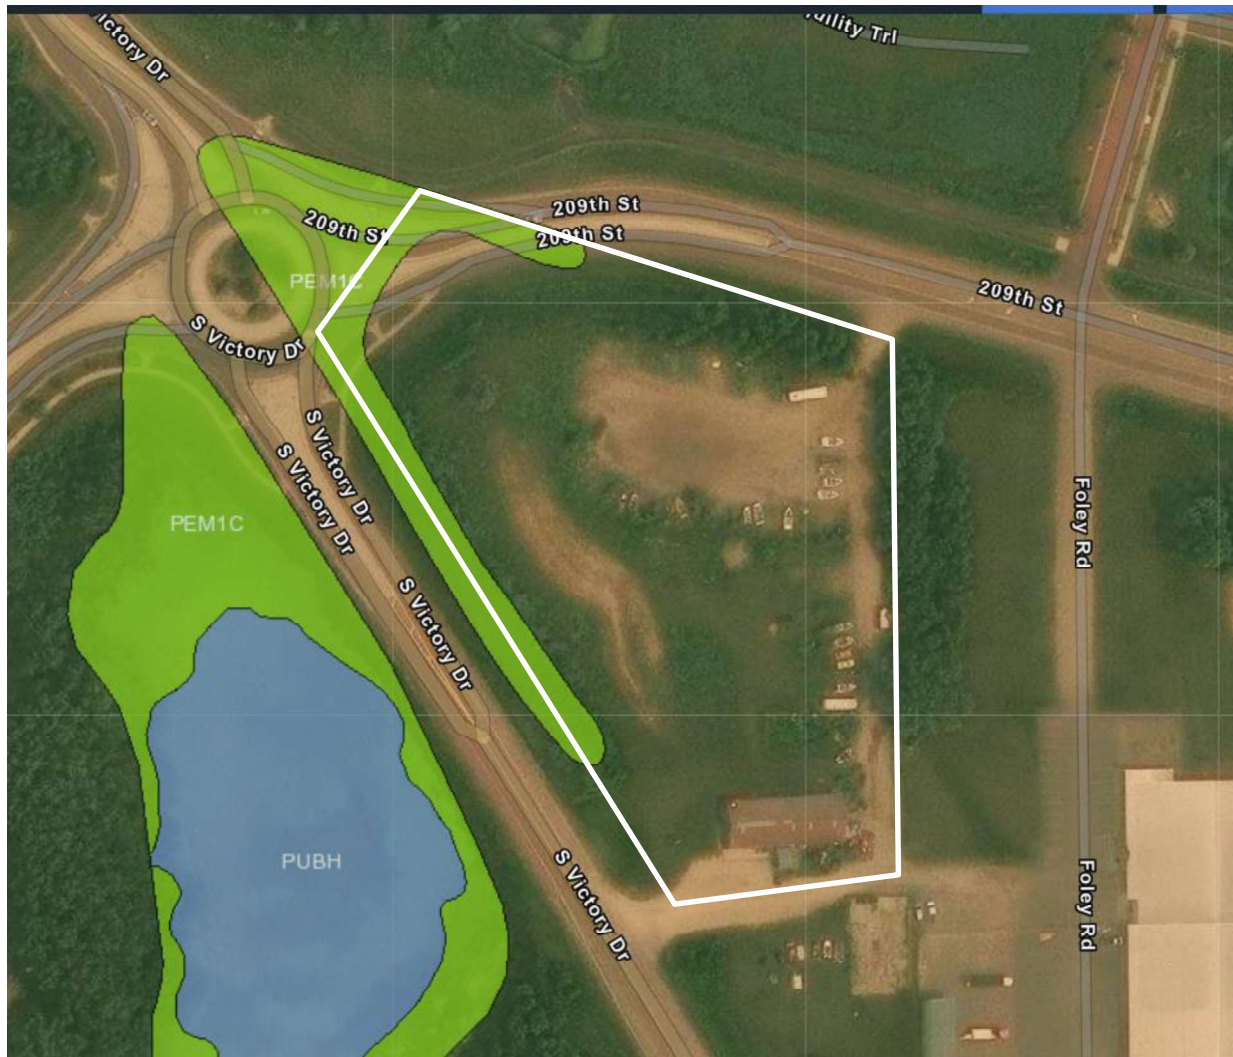
**National Wetland Delineation (NWI)**  
**US Geological Survey/US Fish & Wildlife Service**

The **National Wetlands Inventory (NWI)** identified a PEM1C polygon that coincided with the western portion of Basin 1 in a shape that matched the previous configuration of the roadway intersection at the northwest corner of the site. There was no polygon at the location of Basin 2.

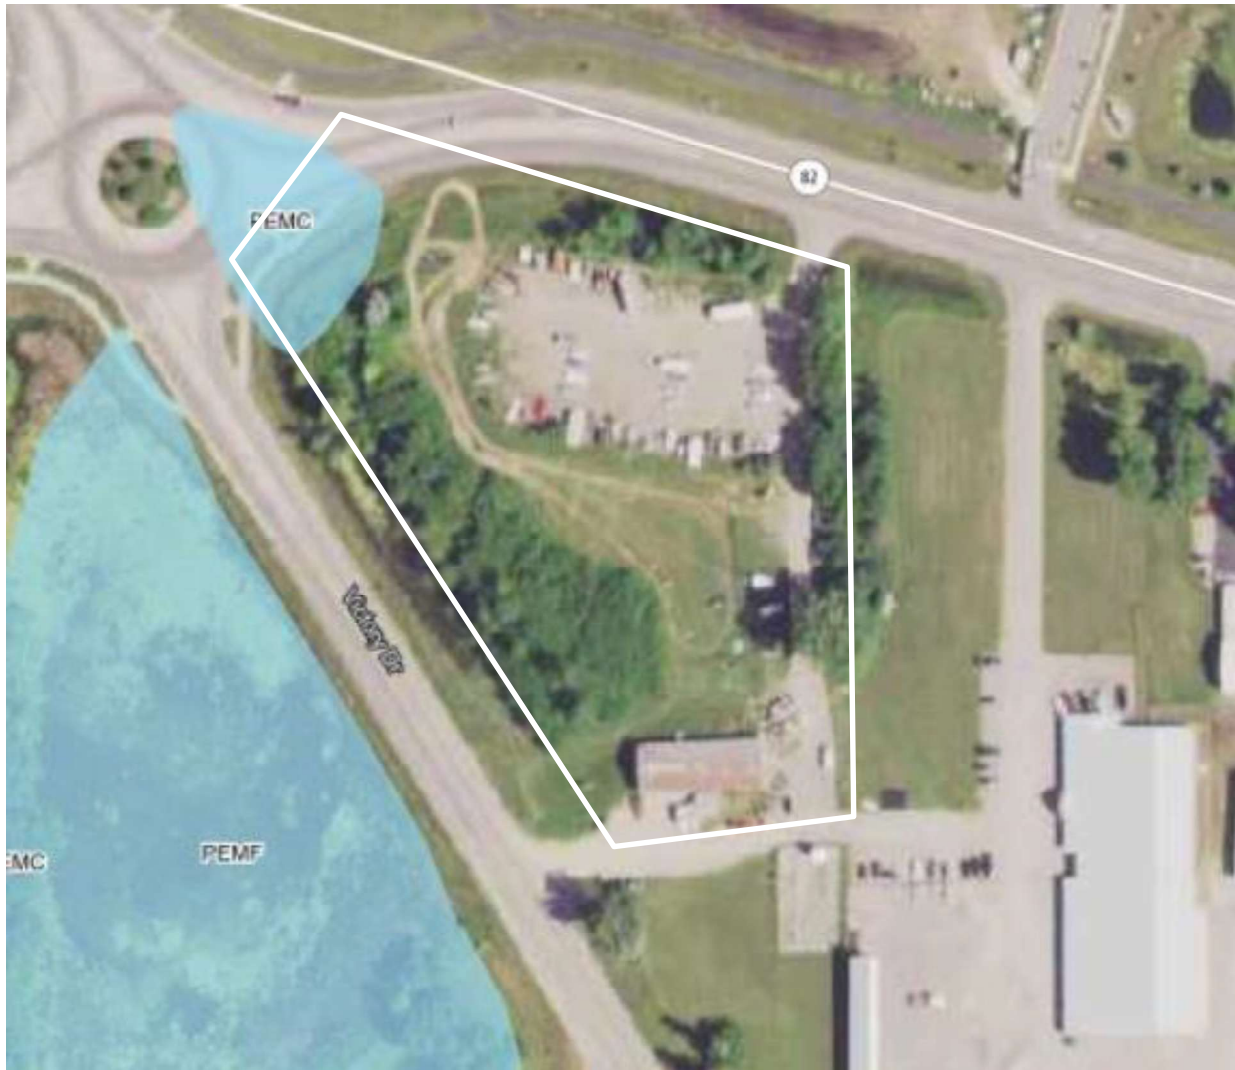
**Mn NWI Map  
Landview Interactive Map**

The **Minnesota NWI** (Landview Interactive Map) identified a PEMC polygon that coincided with the far northwestern corner of the site at the location of the new roundabout. No other polygons were mapped on the site.
