# Eagle Bluff

## Type & Boundary Application

Lime Township, Blue Earth County, Minnesota  
Jim Hilgers  
August 6, 2025

## Wetland Delineation Report

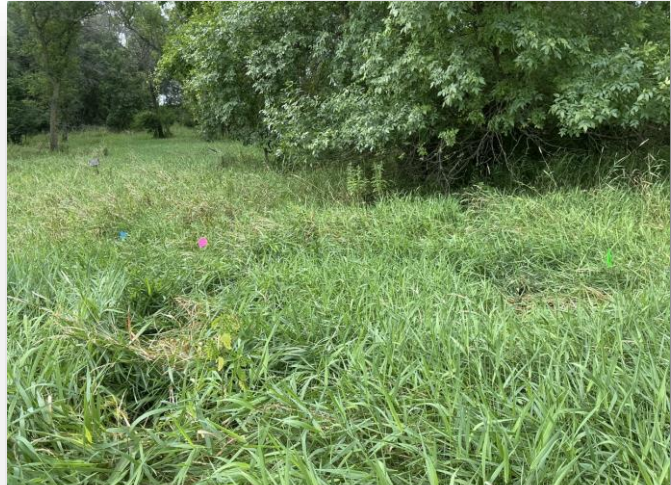
Soils in the W1-A wetland pit location met the hydric soil indicator A12-Thick Dark Surface. Soils in the W1-B upland pit location met the hydric soil indicator A12-Thick Dark Surface. Depletion below 34 inches of both pits is assumed to be present.

The W1-A wetland location met the hydrology indicators A3-Saturation, D5-FAC-Neutral Test, and D2-Geomorphic Position. The W1-B upland pit location met D5-FAC-neutral Test. W1-B did not meet hydrology.

***Photo 1: View of the W1-A & W1-B sample points looking into the wetland (West).***

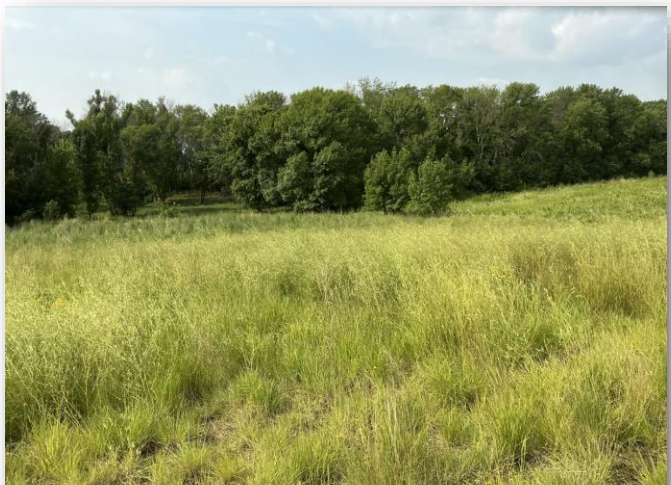
The field investigation found that the site has met all three wetland indicators, and this wetland complex should be considered a combination of a HGM Classification Lacustrine, palustrine emergent nonpersistent seasonally saturated (PEM2B). Two sample points were taken to determine the wetland boundary. The wetland boundary was largely drawn based on the changes in topography.

***Photo 2: View of the Fresh Wet Meadow, facing West***

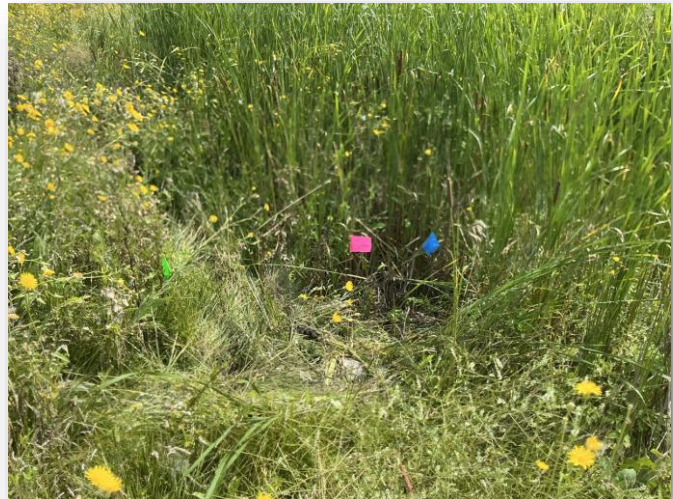
Soils in the W2-A wetland pit location met the hydric soil indicator A12-Thick Dark Surface. Soil in the W2-B upland pit location did not meet the hydric soil indicators.

The W2-A wetland location met A2-High water Table and A3-Saturation, the secondary hydrology indicator D5- FAC-Neutral Test. The W2-B upland pit location did not meet hydrology.

***Photo 3: View of the W2-A & W2-B sample points***

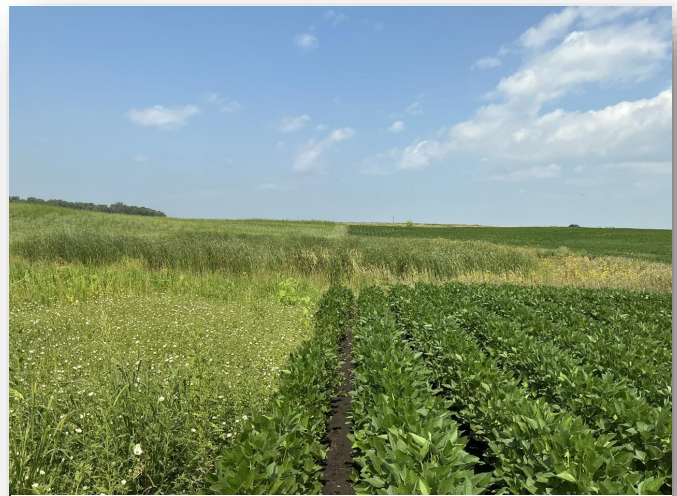
The field investigation found that the site has met all three wetland indicators, and this wetland complex should be considered a combination of a HGM Classification Depression, palustrine emergent nonpersistent seasonally saturated (PEM2B) and palustrine emergent persistent semi permanently flooded (PEM1F). Two sample points were taken to determine the wetland boundary. The wetland boundary was largely drawn based on the changes in topography and vegetation.

***Photo 3: View of the Wetland 2, facing North.***
