RE: Narrative: Sketch Plan, Minor Plat, and Variance: Diehl Acres

# CERTIFICATE OF SURVEY

Project Name:  
**VALLEY VIEW  
 ACRES  
 FLOOD ELEVATION  
 DETERMINATION  
 CO. DITCH 14**

Re: Flood Elevation – Lot 4, Block 1, VALLEY VIEW ACRES - Ramsey, MN  
Proposed Plat of DIEHL'S ACRES

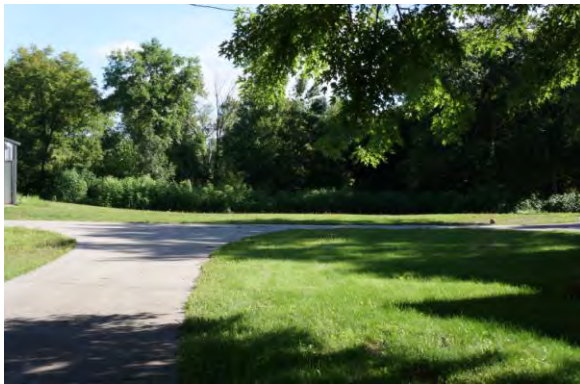
Looking North from CR 63 towards Ditch 14

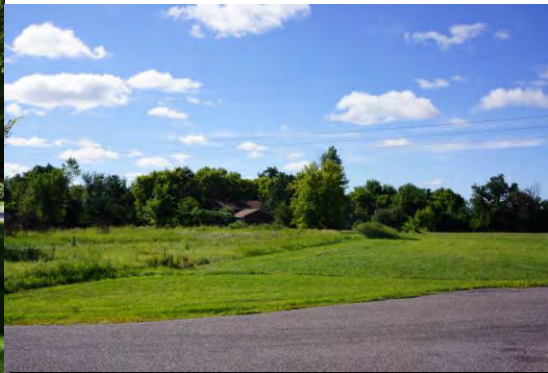
Property from 178<sup>th</sup> street:  
The property does not have access from this street. Property is separated by private property and a high voltage power line

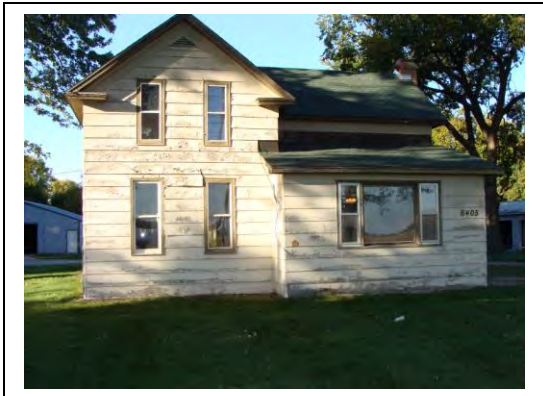
Existing home adjacent to CR 63 to be remodeled

- Roughly 1,500 Sq. Ft. single family 2-story home located 30 feet from the front lot line. This home has been and is continuing to be remodeled and retained by the Diehl’s for the time being.
- 2,000 Sq. Ft pole shed.
- 936 Sq. Ft. detached garage.
- Cell Tower:
  - Multi use 120 foot high cell tower.
  - Leased for 25 years.
- Small shed, orchard, garden and pasture.
- Concrete driveways.
- Two County ditch crossings, one of which is proposed to be removed and replaced with an improved crossing with a larger culvert.
- Removal of two small sheds that located in “front” of the proposed new home’ lot 1.

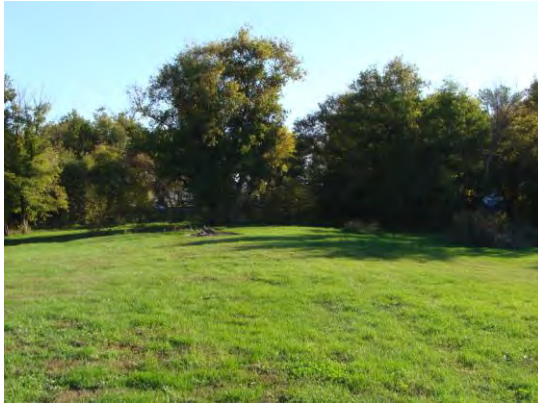
Proposed home site north of the Ditch

- Existing trees dominate the western edge of the property; use of this area for a new home will require the removal of trees.
- The Proposed location of the new home on the knoll north of the Ditch presents an excellent location for the new home because:

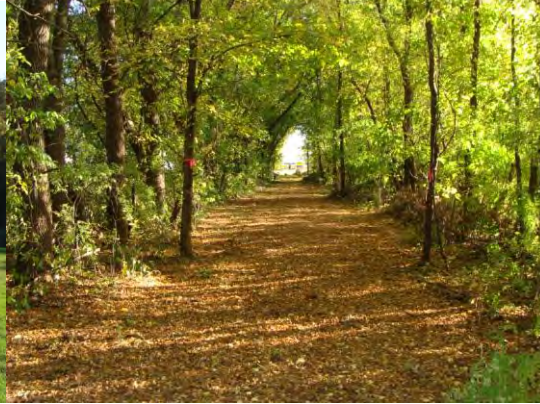
Location of new driveway to service new home site

- Approximately 2,700 Sq. Ft. new home and attached garage.
- New home will be serviced by a new bituminous 12-foot wide driveway with 18-foot wide drive at the Ditch crossing:
  - Designed to accommodate public safety equipment.
  - Preliminary specifications are included on the sketch plan.
