Regular Planning Commission

Discussion Item: Update on Variance Request for a Fence Installation at 7214 167th Terrace NW; Case of Brandon Sis

**CITY OF RAMSEY LAND USE APPLICATION
TECHNICAL REVIEW FILE**

DATE	JULY 25, 2017	PROJECT ADDRESS	7214 167 TH TERRACE
PROJECT. TITLE	7214 167 TH TERRACE VARIANCE REQUEST FOLLOW-UP REPORT		
ESCROW #			
DEPARTMENT:	Engineering		
TECHNICAL REVIEWER:	Name: Leonard Linton Phone: 763 433-9834 Email: llinton@ci.ramsey.mn.us

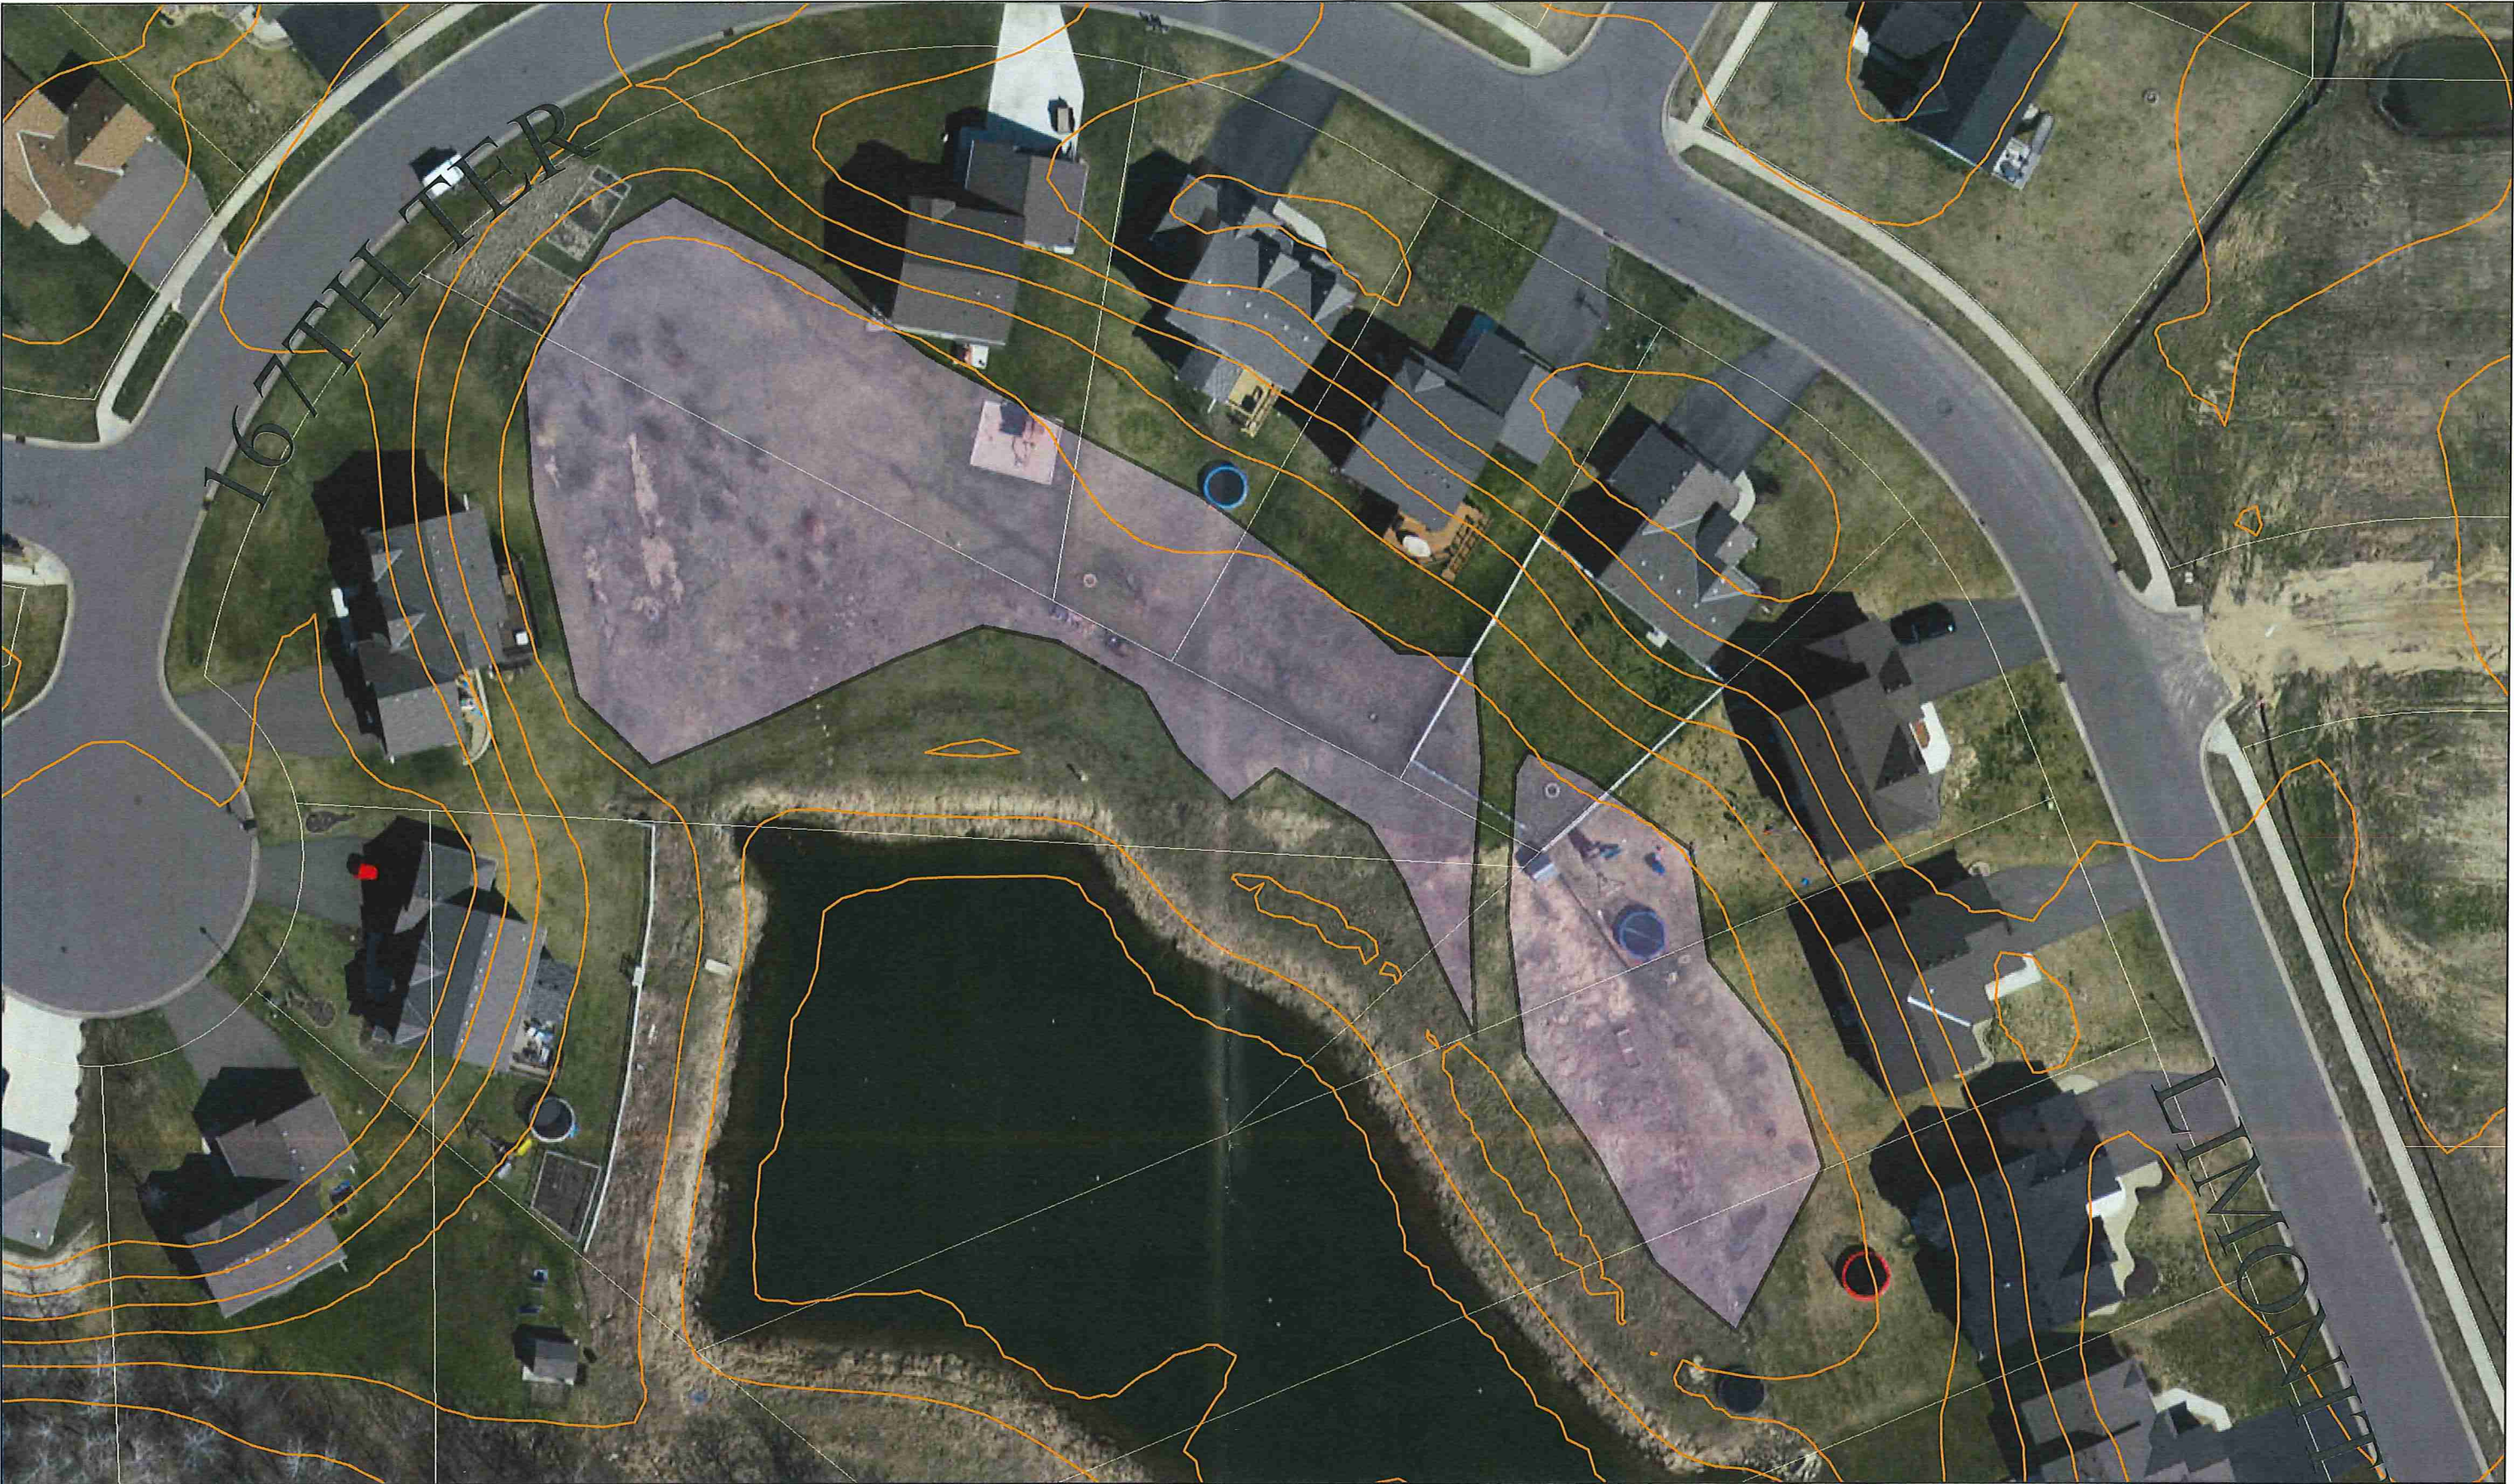
7214 167th Terrace Variance Request

Aerial with Wetlands Overlaid

Staff has used GIS to look at aerial photographs and contours of the site. The photographs are from 2003, 2006, 2008, 2011, 2014 and 2016. They show the progression of home construction in this area. The 2008 photo shows that no homes had been constructed on this lot or the ones sharing the common lot line. The 2011 photo show that two homes had been constructed on adjoining lots. The 2014 photo shows that there is a home on this lot and each of the adjoining lots.

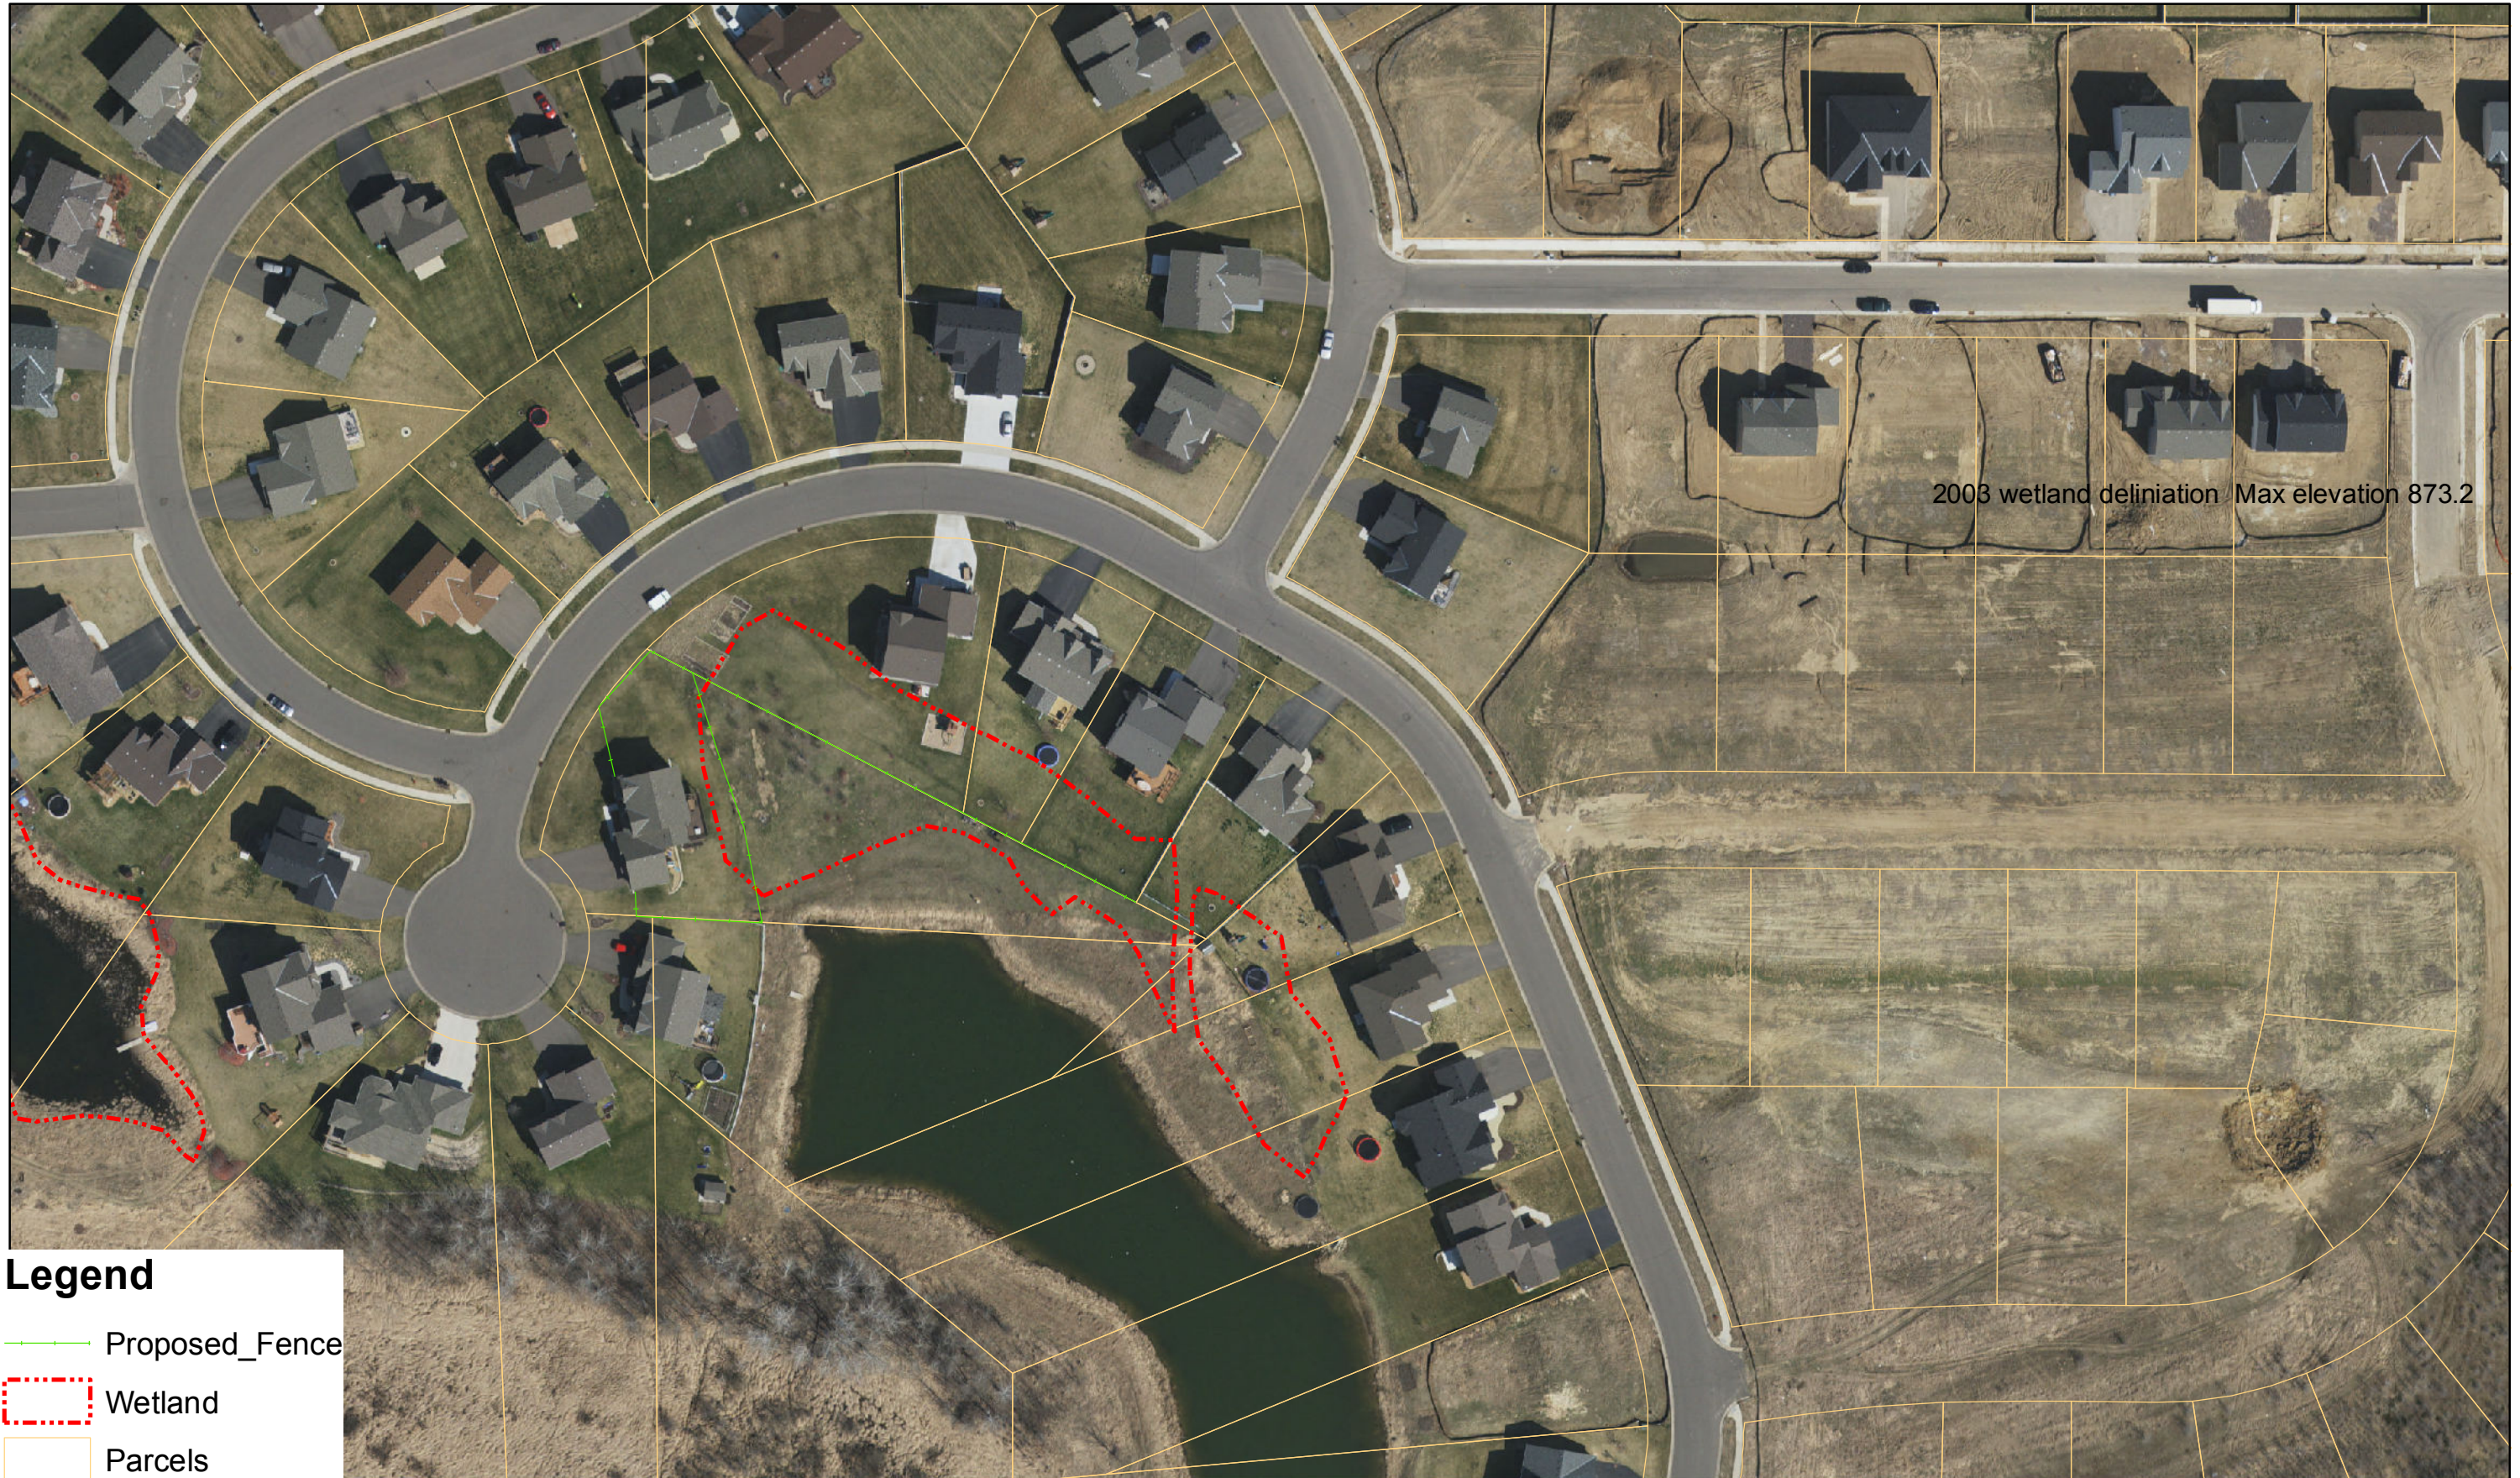
7214 167th Terrace Variance Request

Aerial with Wetlands and Fence Proposal

- Proposed_Fence
- Wetland
- Parcels

2011 Aerial Photo
