Prevention of Stripping Under Chip Seals

David L. Rettner, Principal Investigator
American Engineering Testing, Inc.

October 2017

Research Project
Final Report 2017-35

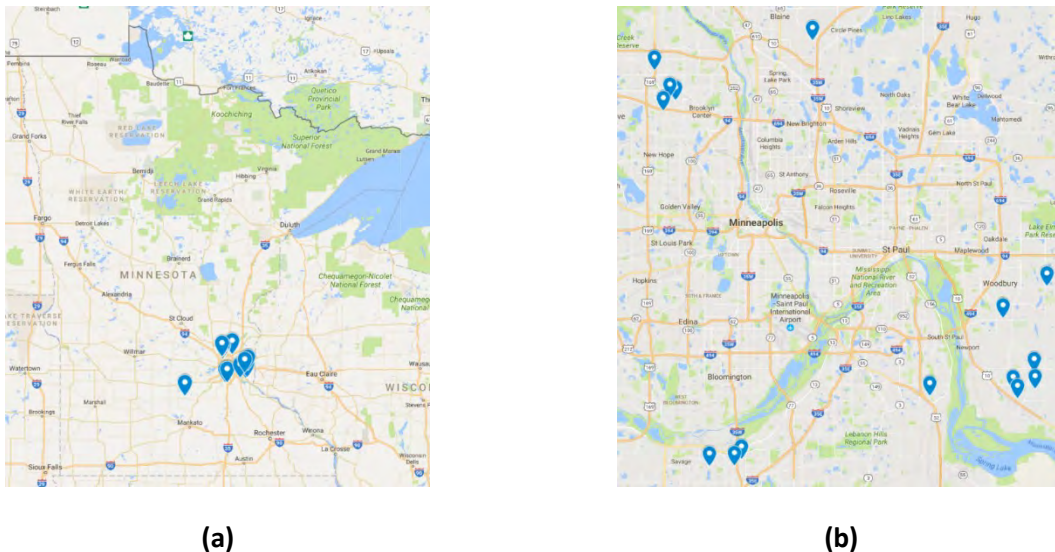
Figure 2. (a) State view and (b) Minneapolis-St. Paul metropolitan area view of locations of pavements surveyed for field and laboratory work

The primary 18 sections, located in seven municipalities and one county, consulted for the project work are indicated in the subsections below and shown in Figure 2. Appendix A to this report provides survey condition and core identification information for each location, and Appendix H provides all section information provided to the research team by city/county engineers during the project work.

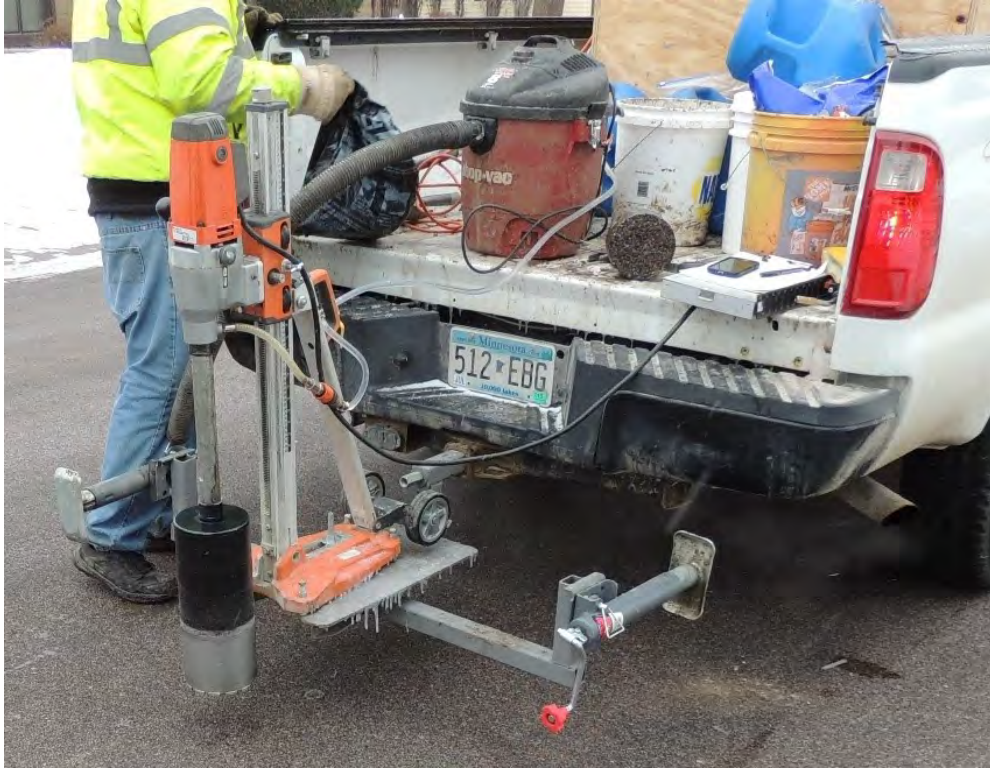
Figure 3. Truck-mounted rig used to obtain cores on-site

Coring operations for the project research involved the use of a coring rig mounted to the rear of a truck. The rig is shown in Figure 3. Six-inch diameter cores were obtained by drilling through the asphalt course to the top of the base layer. In addition to providing an intact specimen for testing, it allowed for the measurement of the in-situ pavement thickness.

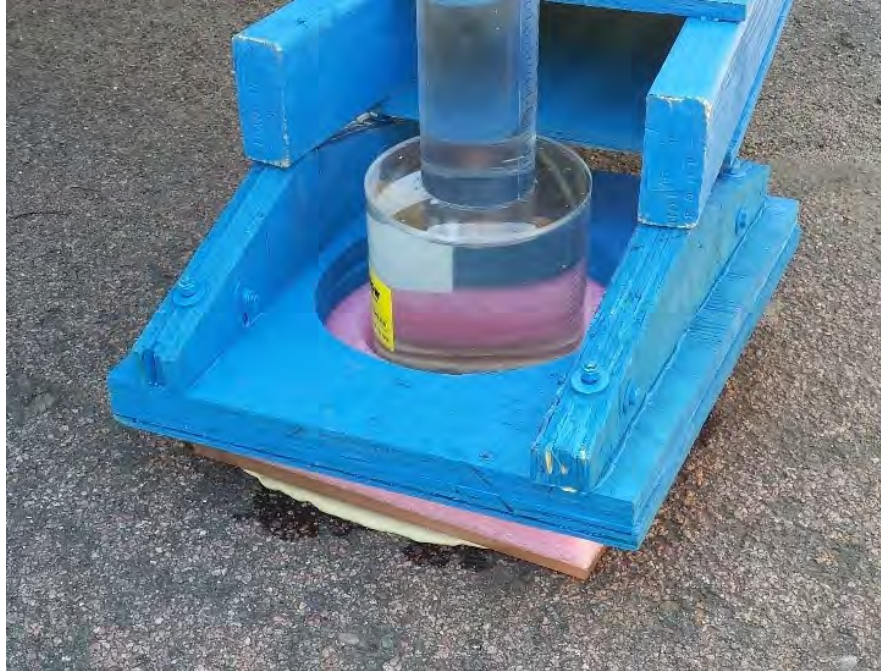
Figure 4. Configuration of the NCAT Permeameter in attempts at field permeability testing

Field permeability tests using the NCAT Permeameter were investigated for the Cottage Grove, Inver Grove Heights, and Blaine sections. An illustration of one test is shown in Figure 4. Depending on surface roughness, obtaining a good seal was difficult, which complicated both the test and the usefulness of results from the test. Future permeability tests for this project were ruled out, given that the field permeability test has too many variables to confidently measure the permeability of an in-situ pavement with uncertain design.

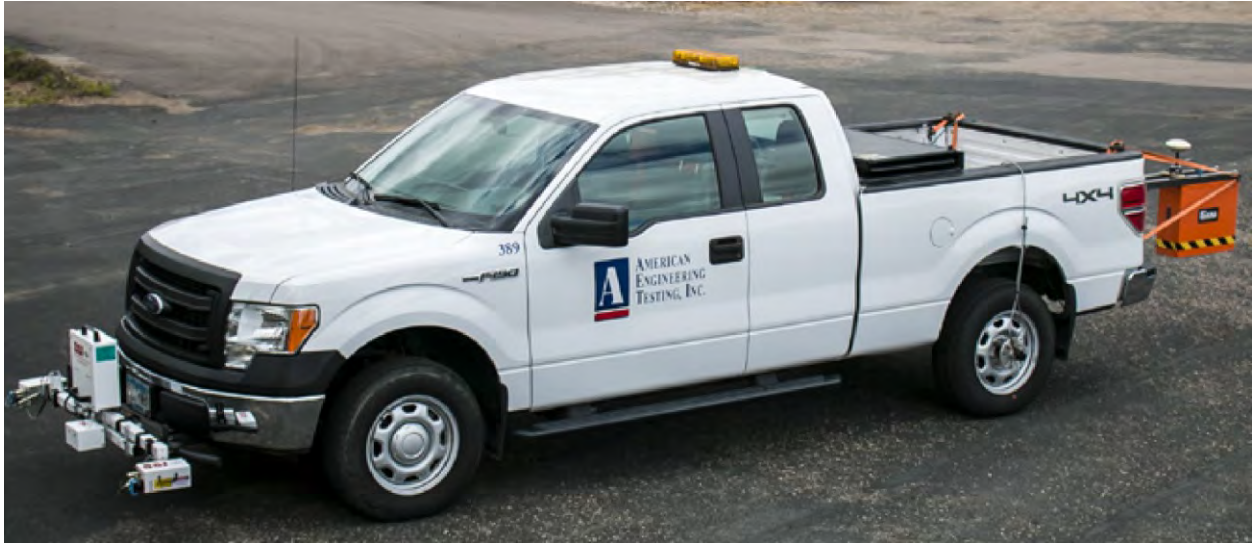
Figure 5. Vehicle-mounted GPR used for site evaluation

Field work in support of the project research included ground penetrating radar (GPR) testing of pavement sections. GPR data was continuously collected at residential roadway speeds (20-40 miles per hour) using equipment mounted with 400 MHz and 2 GHz antennas and a SIR-20 control and data acquisition processor. The GPR configuration used for the study met or exceeded the ASTM D4748 and ASTM D6087 standards. Multiple passes were conducted to ensure that sufficient data was collected at 13 locations across five municipalities. The truck-mounted antenna is shown in Figure 5. All GPR data was coupled with precise GPS location data in support of more sophisticated analysis, which is presented in Chapter 3.

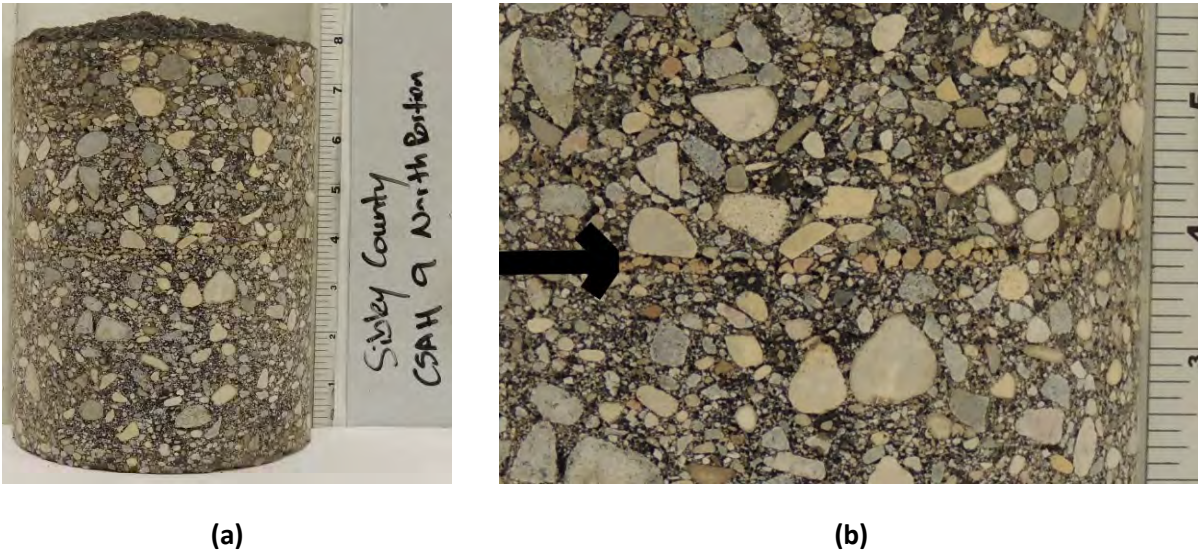
Figure 6. (a) Example of core extracted from pavement for study and (b) close-up of core shows evidence of past chip seal treatments

The research team conducted extensive laboratory testing to understand the behavior of chip sealed pavements. The laboratory testing relied upon the collection of a minimum of 12 cores from each of the locations; an example of a collected core is shown in Figure 6.

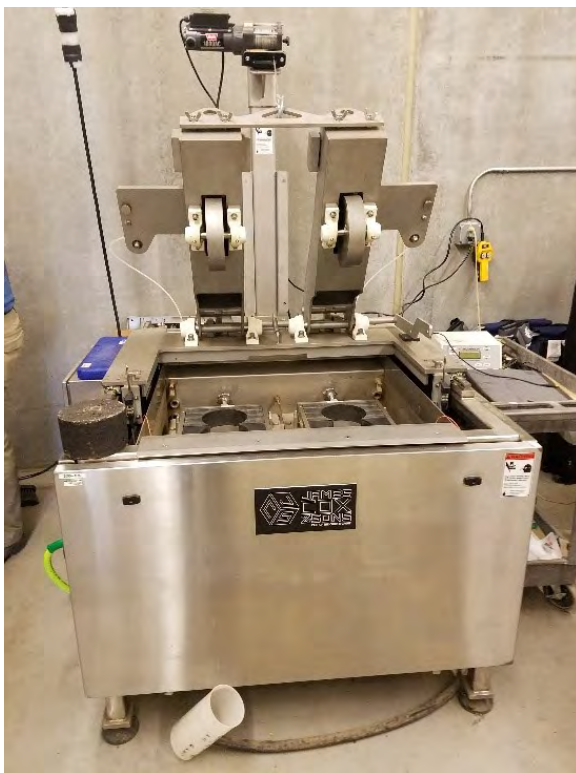
Disk-shaped compact tension (DCT) tests were conducted on specimens to evaluate the fracture energy of asphalt mixes and field specimens. DCT tests were conducted on a total of seven specimens, and all tests were conducted in accordance with ASTM D7313. The laboratory equipment used for the tests is shown in Figure 7b.

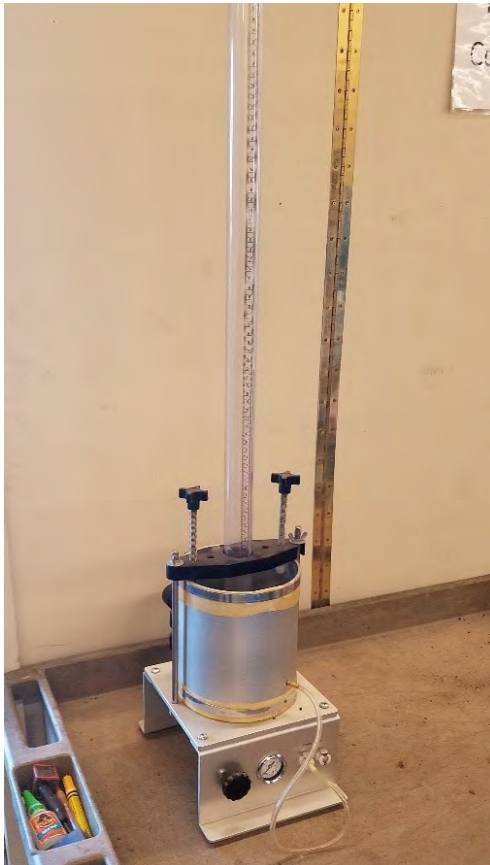
The tensile strength ratio (TSR) test measures tensile strength loss due to damage under accelerated water conditioning in the laboratory. The modified Lottman tensile strength ratio (TSR) test was conducted according to AASHTO T 283. TSR tests were applied to a total of 18 specimens. The laboratory equipment used for the tests is shown in Figure 8b.

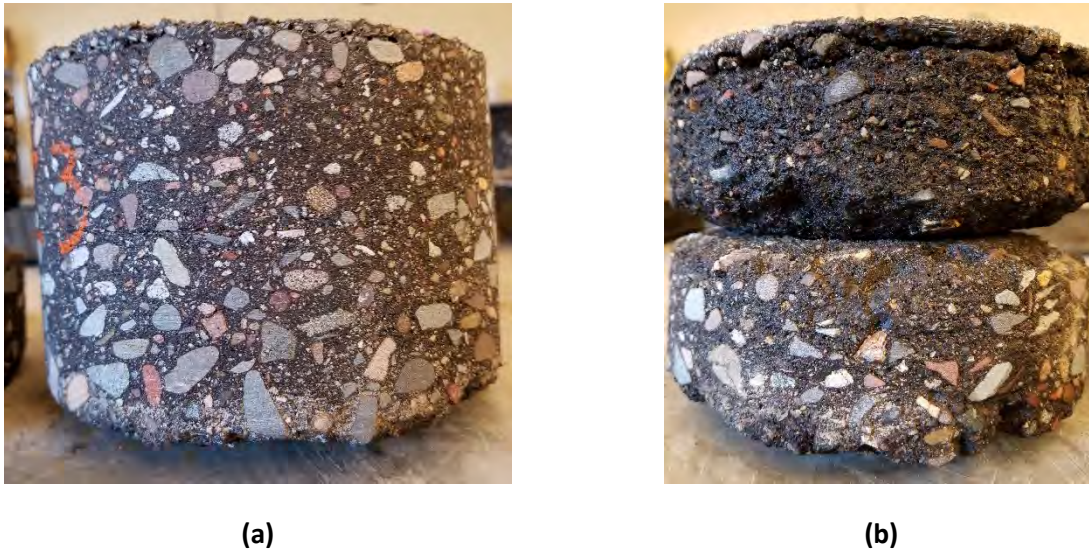
Figure 9. (a) Intact core and (b) core stripped under chip seal and between asphalt lifts, recovered from city of Shoreview, MN

The level of stripping varied from site to site. In the collection of core specimens, field observations were made on the extent of stripping in the vicinity of coring, in addition to general notes on the core itself. A comparison of core condition is shown in Figure 9 using cores collected for the study from a location in Shoreview, MN, that was not included in the final database. Figure 9b shows not only stripping behavior under the chip seal, but also stripping in asphalt lifts. An intact core from a nearby location is shown in Figure 9a to illustrate the extent of stripping through the core depth.

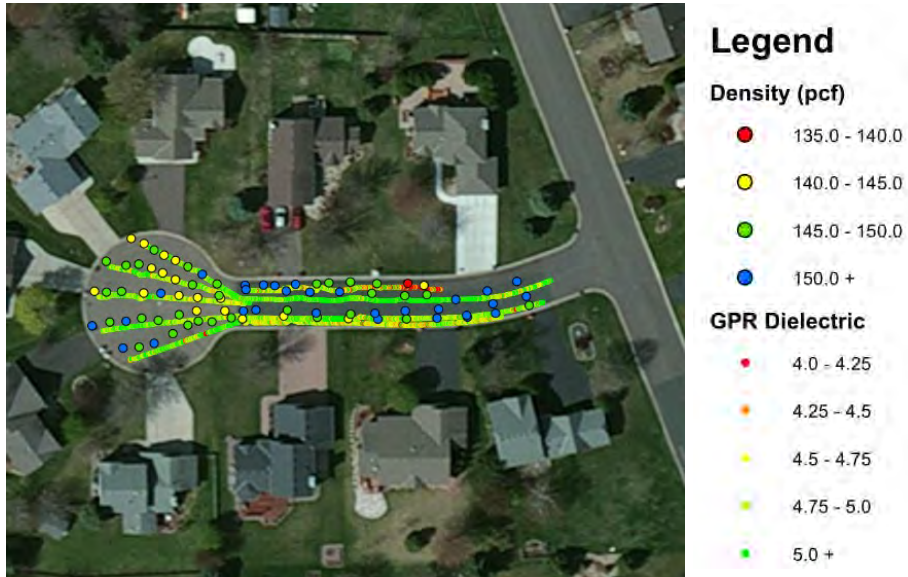
Figure 10. Map of dielectric and density data collected at Newbury Alcove site in Woodbury, MN

limitations of the GPR antenna used for the testing, which is a longer-wave antenna, correlating the dielectric with density data does not provide reliable maps of density in the asphalt.

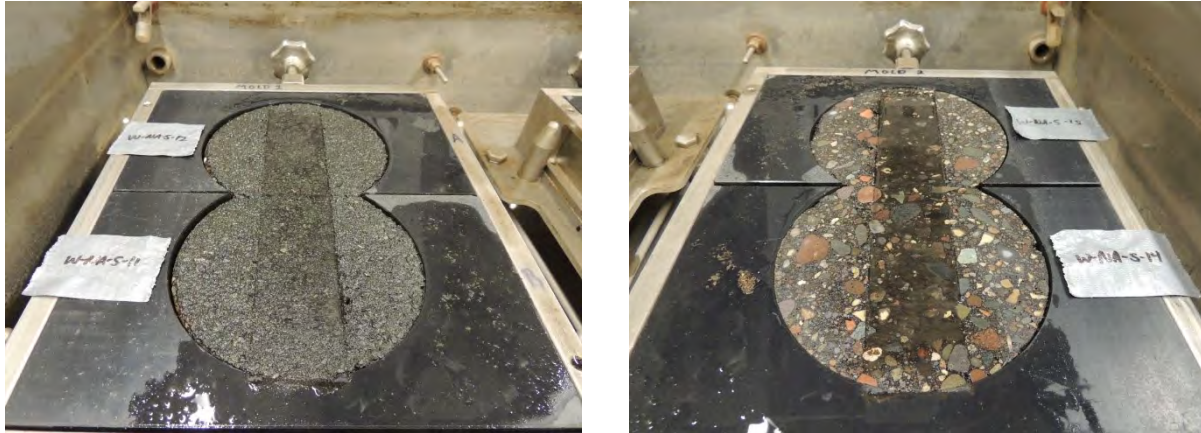
Figure 11. Specimens for stripping study undergoing Hamburg wheel testing

the Woodbury Newbury Alcove Straight Section sample, which showed signs of stripping after only 521 passes. An additional observation from the data is that mixes from older pavements performed better than those of newer pavements due to higher stiffness values for the aged binders.

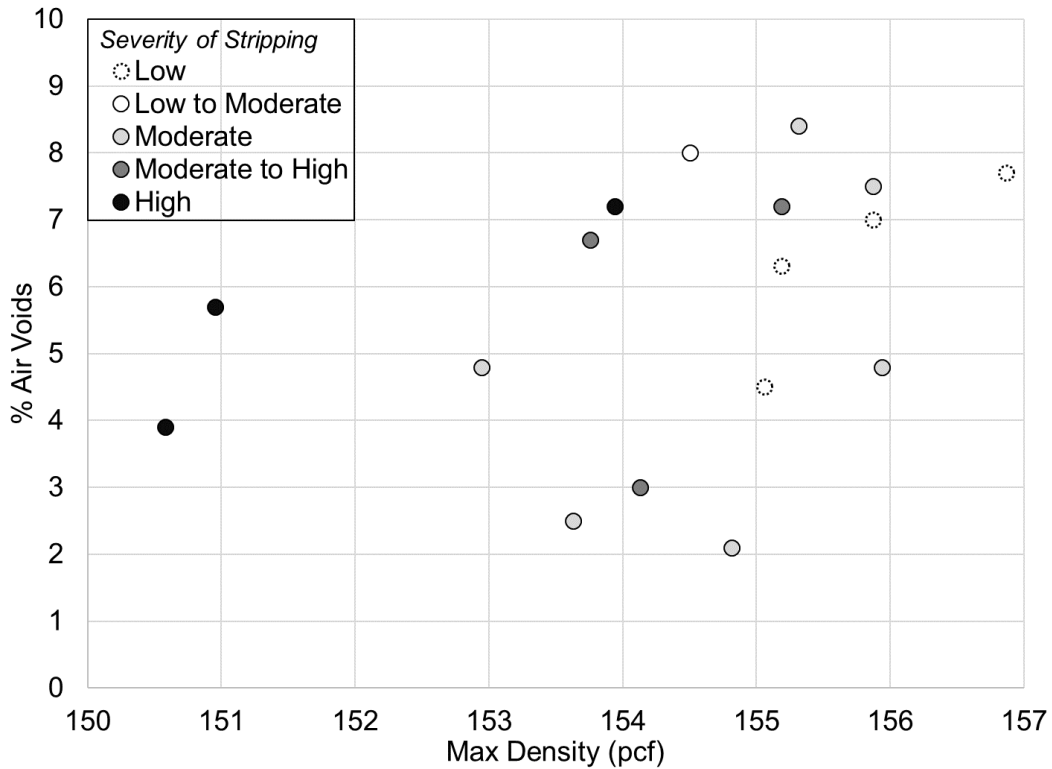
Figure 12. Severity of stripping in chip-sealed pavements in 18 locations with maximum theoretical density and percent air voids

from field testing, not all roads with chip seals exhibited stripping. Information provided by city engineers for field sites locations identified less than Moderate levels of stripping in 6 of the 18 primary field sites. Condition information relative to volumetric core data (percent air voids and maximum density) is described in Figure 12.

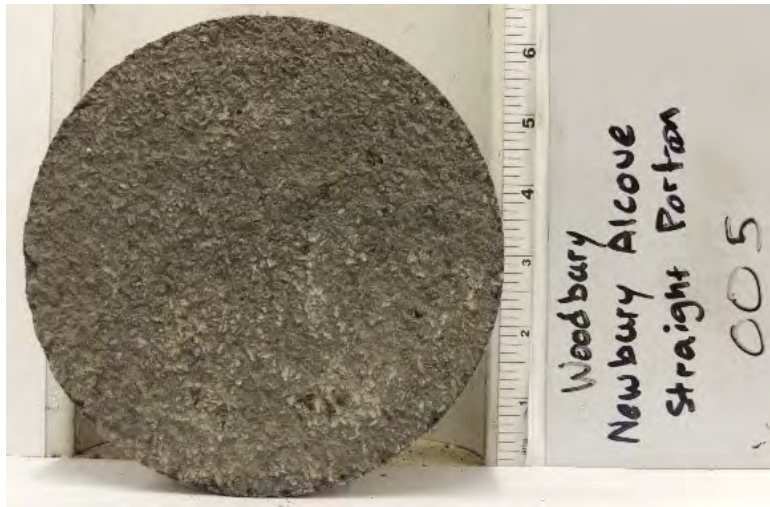
The project included one such road, Newbury Alcove in Woodbury, MN. The relative material lost due to stripping can be seen in comparing Figure 13b and Figure 13d. One confounding factor in this observation, however, is the fact that the Hamburg Wheel test found that the straight portion mix was the only mix susceptible to stripping due to moisture damage.

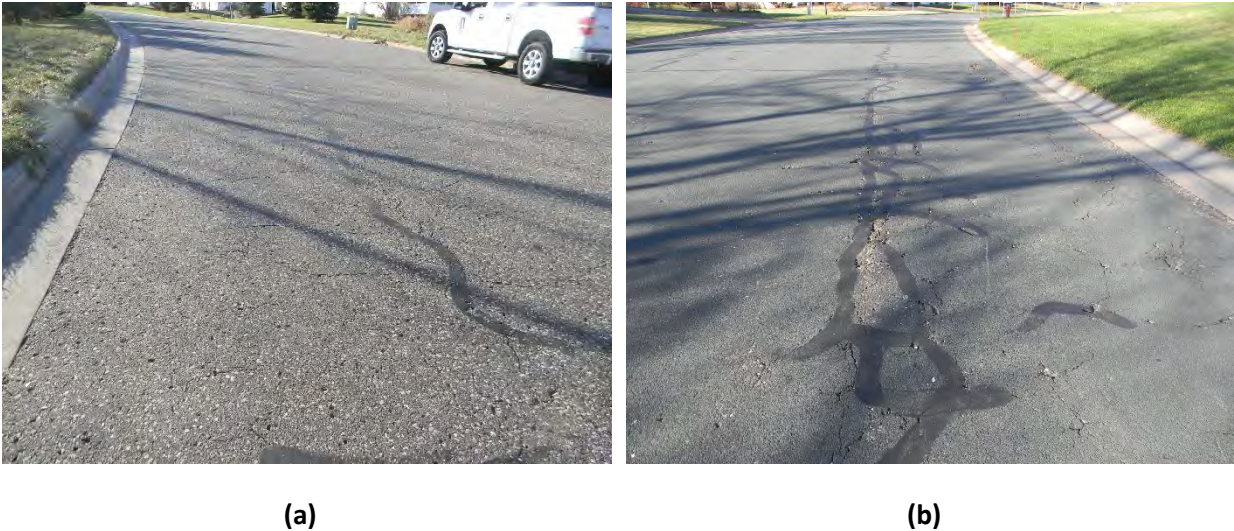
Figure 14. Possible contribution of chip seal to advanced cracking in (a) unsealed and (b) chip-sealed pavement on Blue Heron Road in Woodbury, MN

In addition, it has been observed that the presence of the chip seal can exacerbate distresses, as illustrated from a survey of Blue Heron Road in Woodbury, MN, in Figure 14. In other words, a road with sealed and unsealed sections may experience more block cracking in areas with the chip seal (Figure 14b) than in areas without the chip seal (Figure 14a).

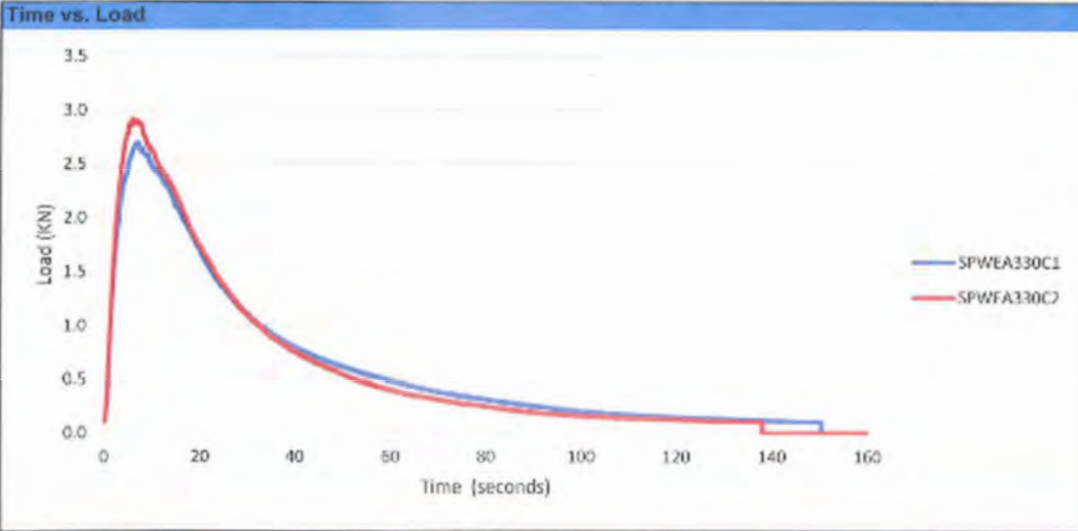
Sample Information	
Asphalt Mixture Type: SPWEA330C	Testing Temperature: -24.0 C

Specimen Information								Area	Length
ID	Air Voids %	Thickness mm	Ligament mm	Peak Load kN	Actual Slope mm/s	Fracture Energy J/m ²	Under the Curve Nmm	of Test s	
SPWEA330 C1		49.88	80.10	2.70	0.017	412.53	1648.21	150.40	
SPWEA330 C2		49.75	80.78	2.92	0.017	394.79	1586.60	138.16	
Average Fracture Energy:						403.66 J/m ²			
Standard Deviation:						12.54 J/m ²

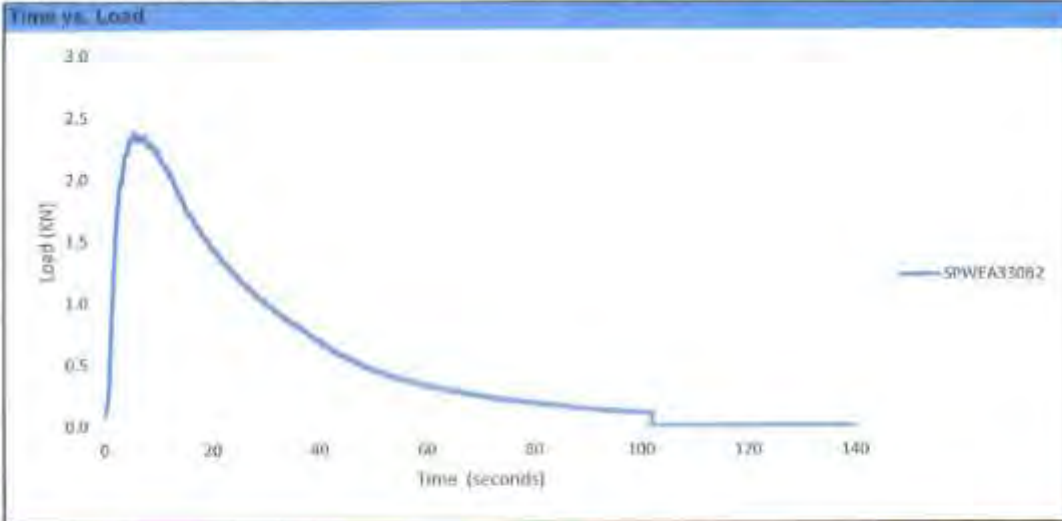
Sample Information		
Asphalt Mixture Type: SPWEA330B	Testing Temperature:	-18.0 C

Specimen Information									
ID	Air Voids %	Thickness mm	Ligament mm	Peak Load kN	Actual Slope mm/s	Fracture Energy J/m ²	Area Under the Curve Nmm	Length of Test s	
SPWEA330B2		49.91	79.28	2.39	0.017	322.30	1275.31	102.20	
Average Fracture Energy:						322.30 J/m ² ±			
Standard Deviation:						N/A J/m ²

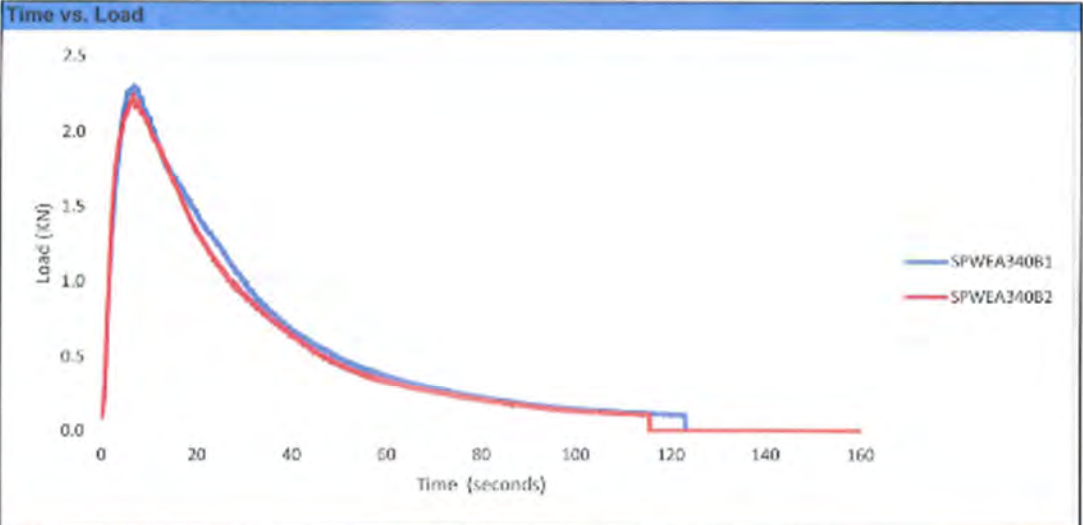
Sample Information		
Asphalt Mixture Type: SPWEA340B	Testing Temperature:	-18.0 C

Specimen Information									
ID	Air Voids %	Thickness mm	Ligament mm	Peak Load kN	Actual Slope mm/s	Fracture Energy J/m ²	Area Under the Curve Nmm	Length of Test s	
SPWEA340 B1		49.72	79.24	2.31	0.017	335.30	1321.02	123.28	
SPWEA340 B2		50.00	78.88	2.25	0.017	314.06	1238.65	115.78	
Average Fracture Energy:						324.68 J/m ²			
Standard Deviation:						15.02 J/m ²

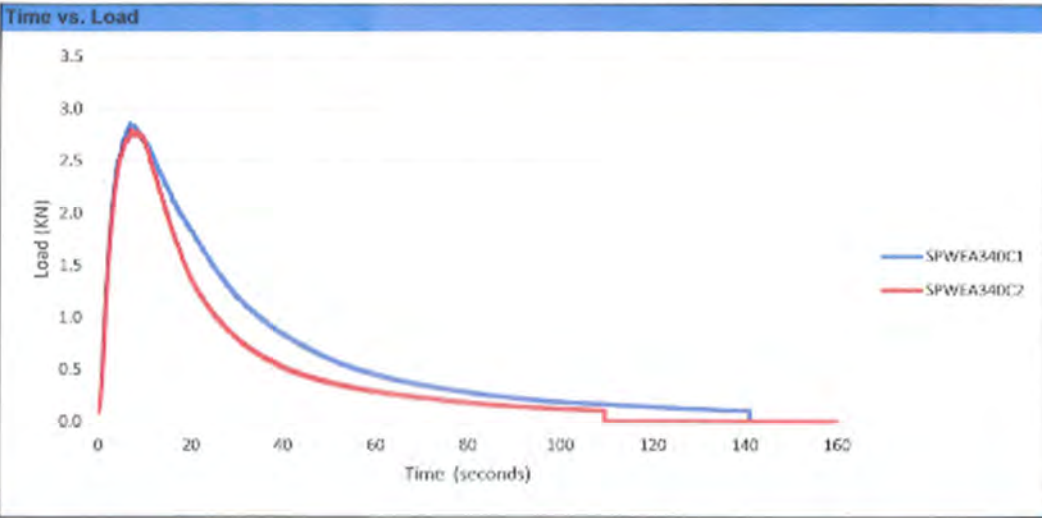
Sample Information		
Asphalt Mixture Type:	SPWEA340C	Testing Temperature: -24.0 C

Specimen Information								
ID	Air Voids %	Thickness mm	Ligament mm	Peak Load kN	Actual Slope mm/s	Fracture Energy J/m ²	Area Under the Curve Nmm	Length of Test s
SPWEA340 C1		49.88	80.22	2.86	0.017	420.32	1681.86	141.18
SPWEA340 C2		49.88	79.59	2.80	0.017	318.88	1265.93	109.68
Average Fracture Energy:						369.60 J/m ²		
Standard Deviation:						71.73 J/m ²

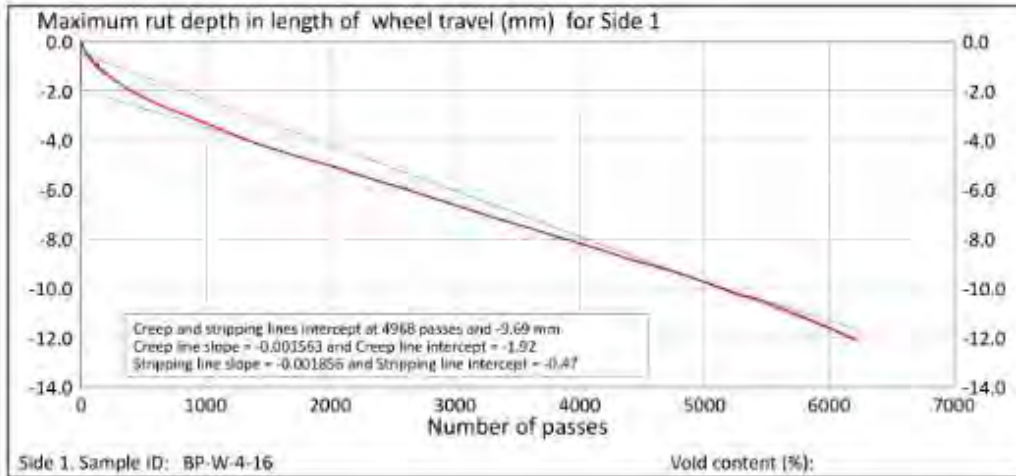
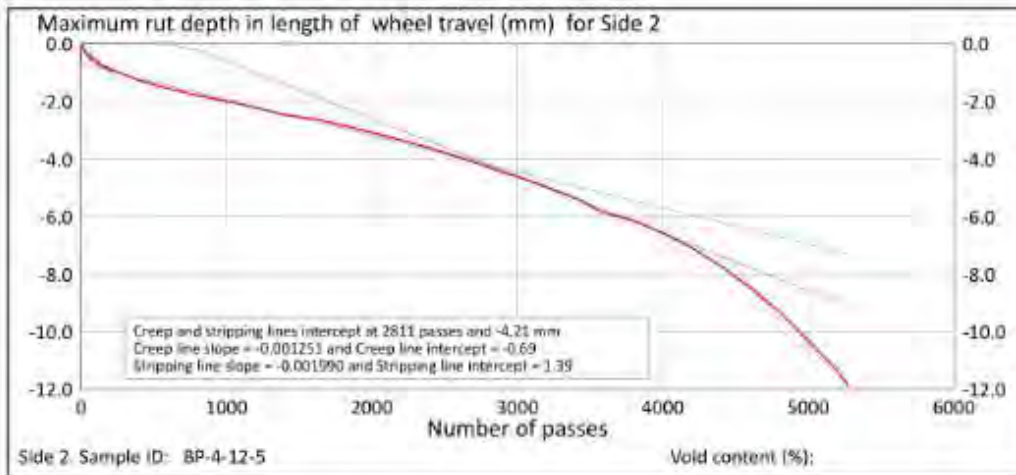
Rut depths (mm)		
Pass No.	Side 1	Side 2
5000	-9.74	-10.32
5272		-11.85
6220	-12.11

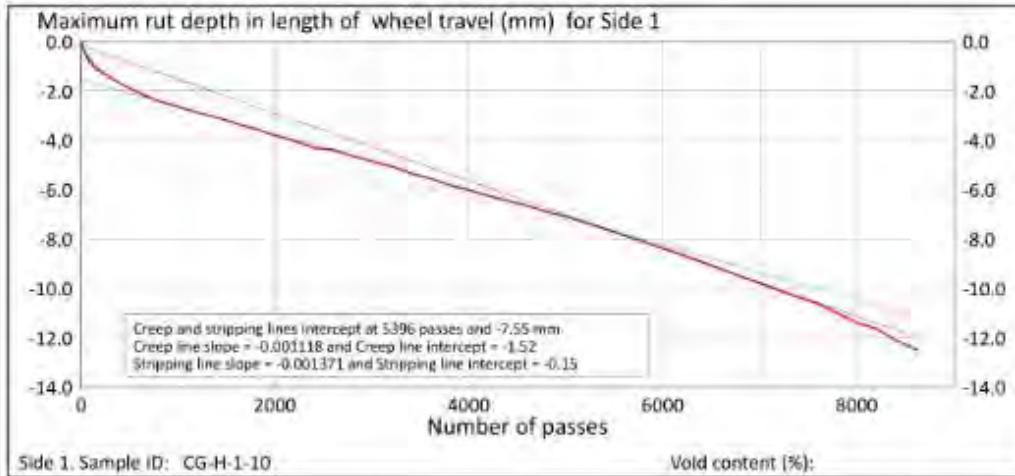
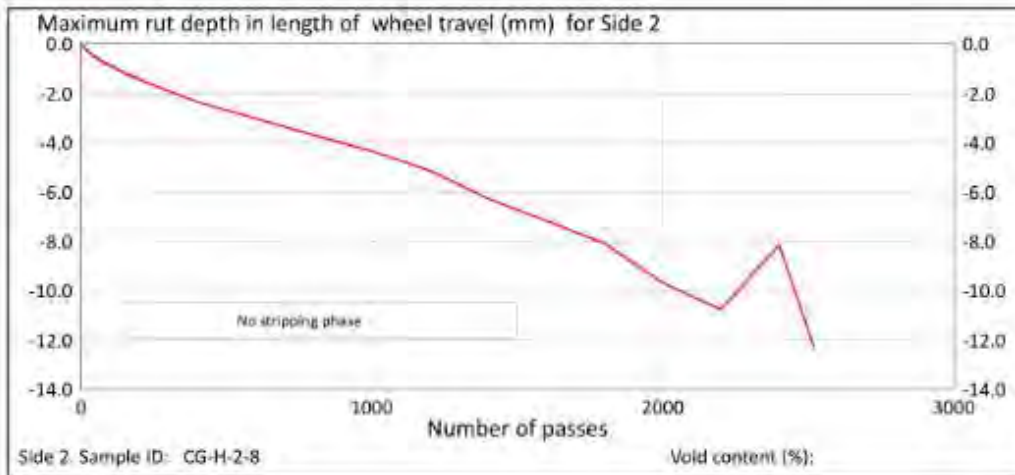
Rut depths (mm)		
Pass No.	Side 1	Side 2
5000	-7.09	
2518		-12.25
8626	-12.5

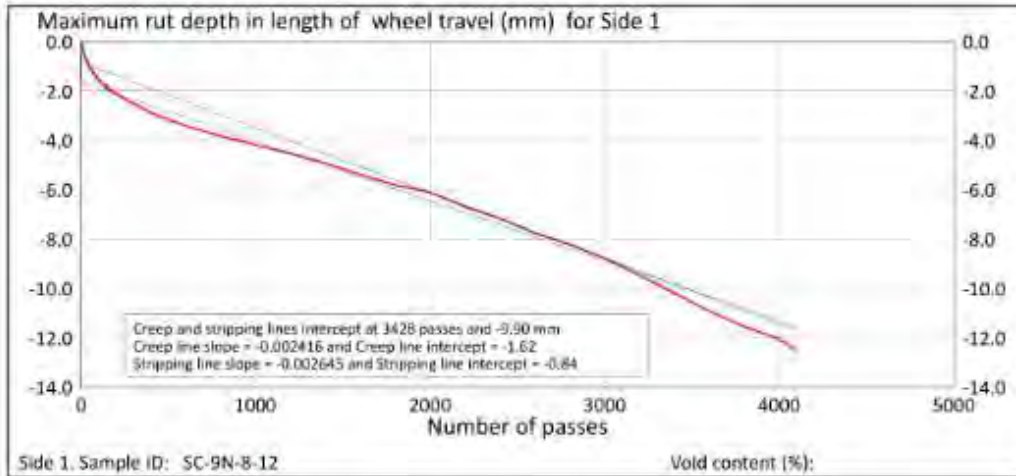
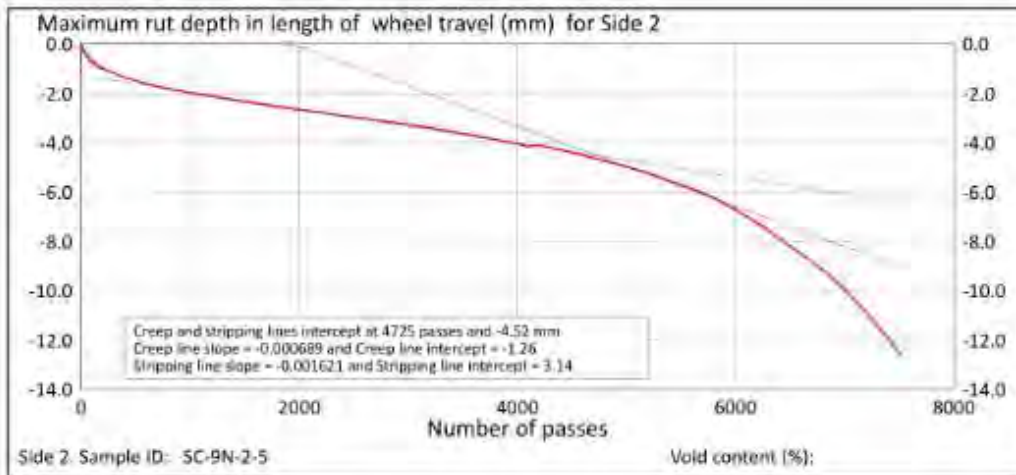
Rut depths (mm)		
Pass No.	Side 1	Side 2
5000		-4.98
4102	-12.53	
7506		-12.59

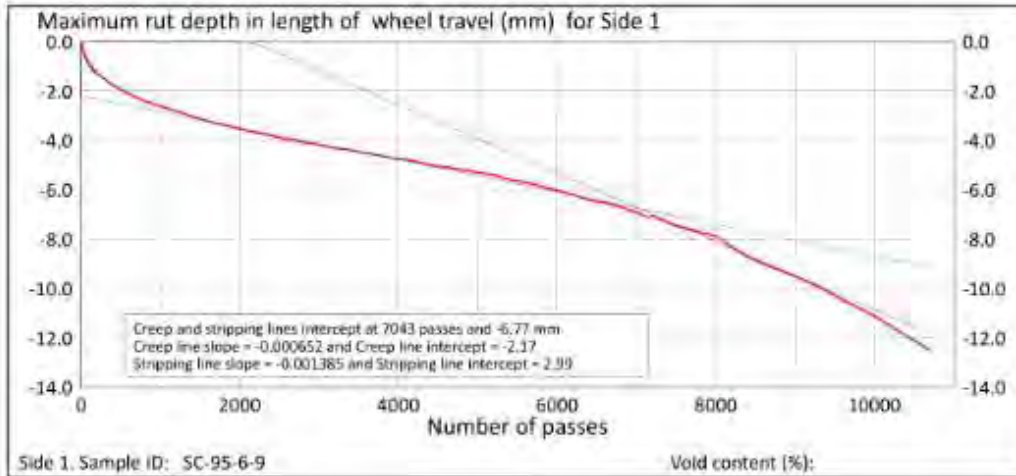
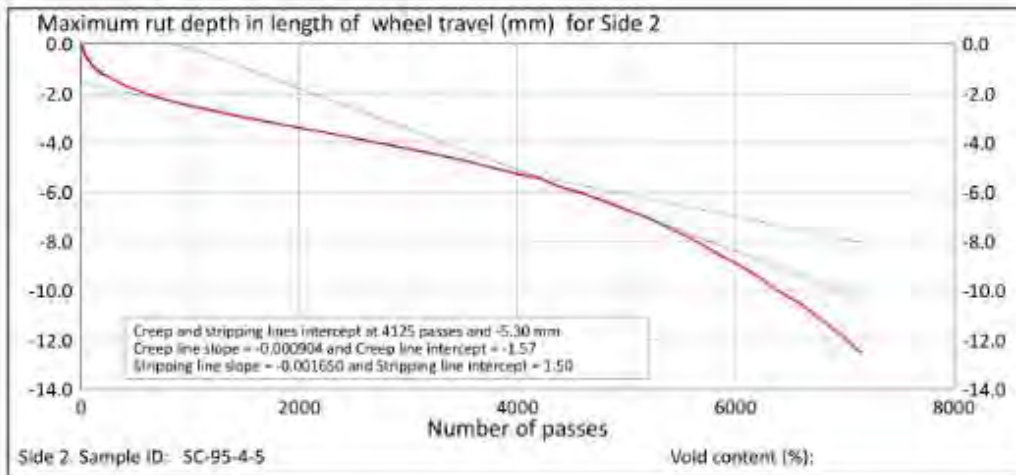
Rut depths (mm)		
Pass No.	Side 1	Side 2
5000	-5.3	-6.72
10000	-11.12	
7150		-12.53
10702	-12.51

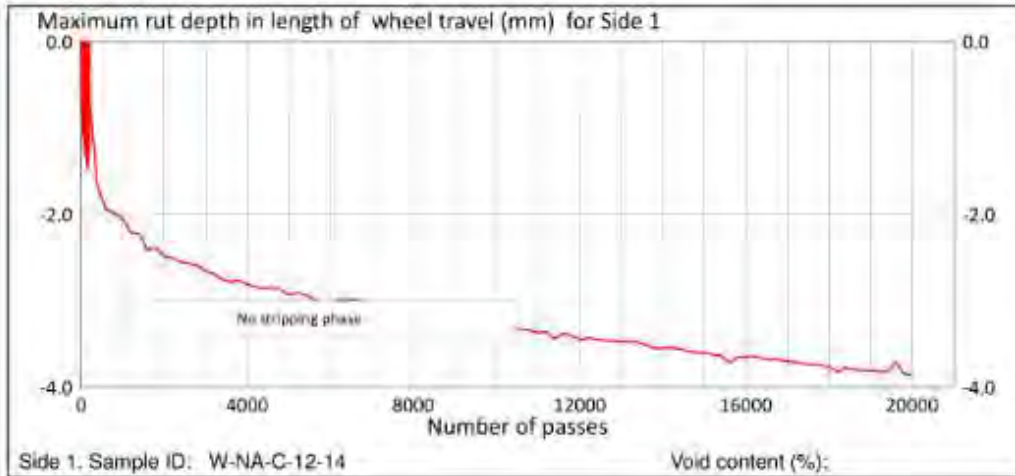
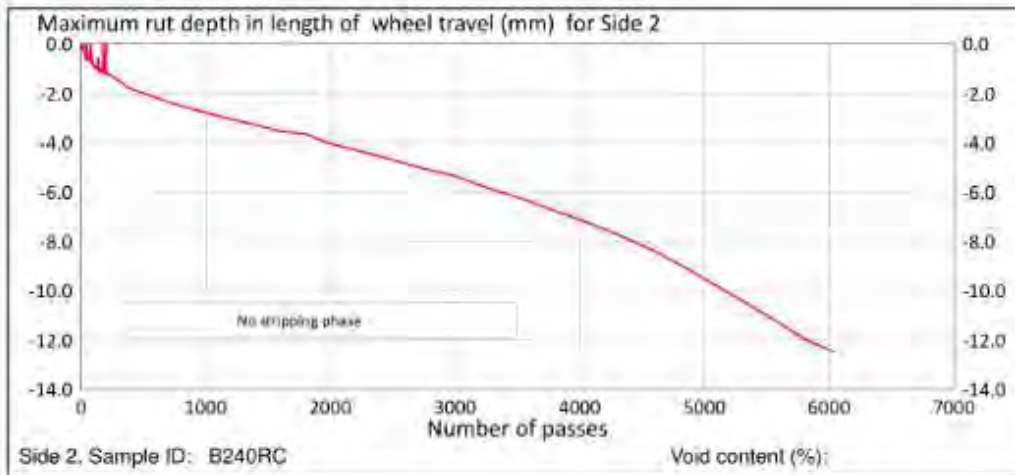
Rut depths (mm)		
Pass No.	Side 1	Side 2
5000	-2.93	-9.51
10000	-3.29	
15000	-3.6	
20000	-3.86	
6036		-12.5

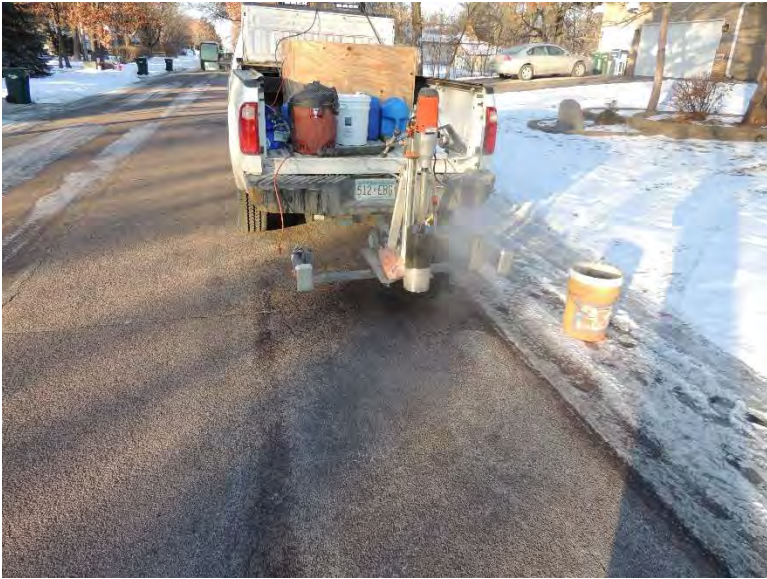
Figure I-1. Coring operations and sample core extracted from the east end of 93rd Avenue in Blaine, MN

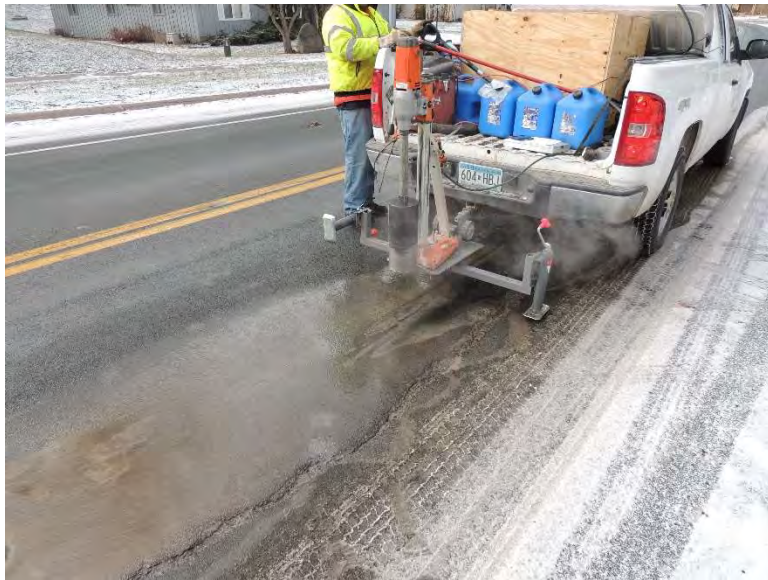
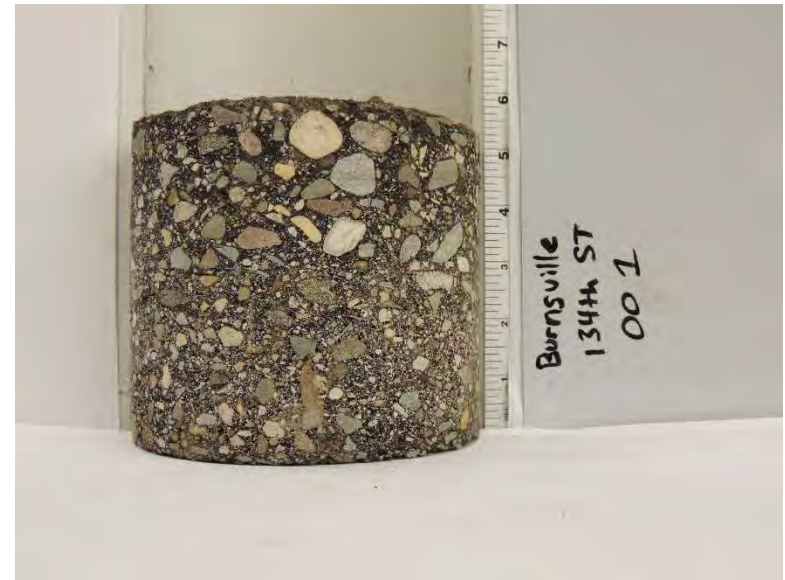
Figure I-6. Coring operations and sample core extracted from 134th Street in Burnsville, MN

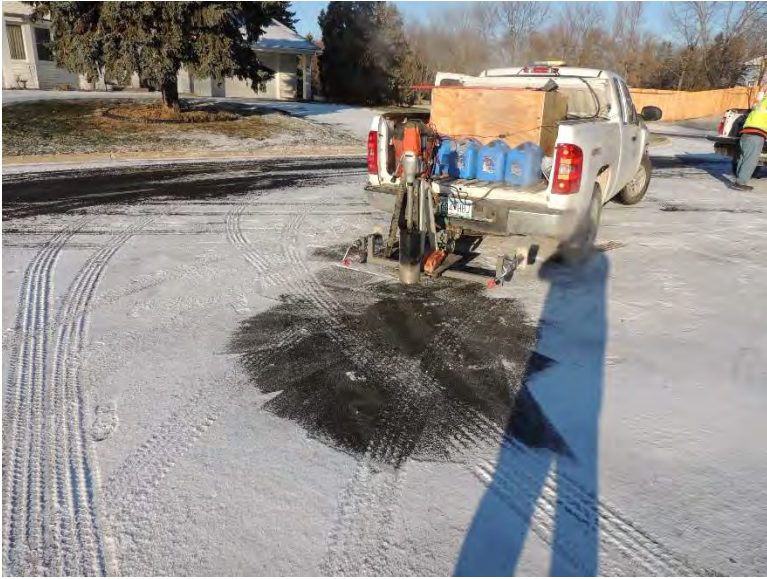
Figure I-7. Coring operations and sample core extracted from Heritage Circle in Burnsville, MN

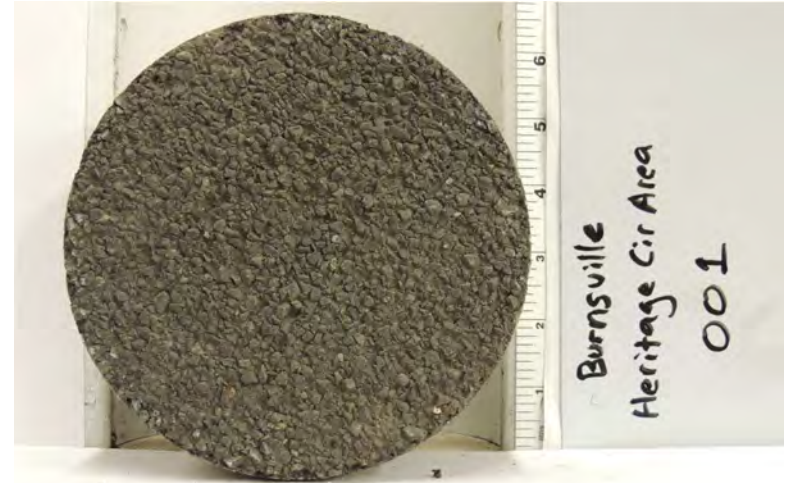
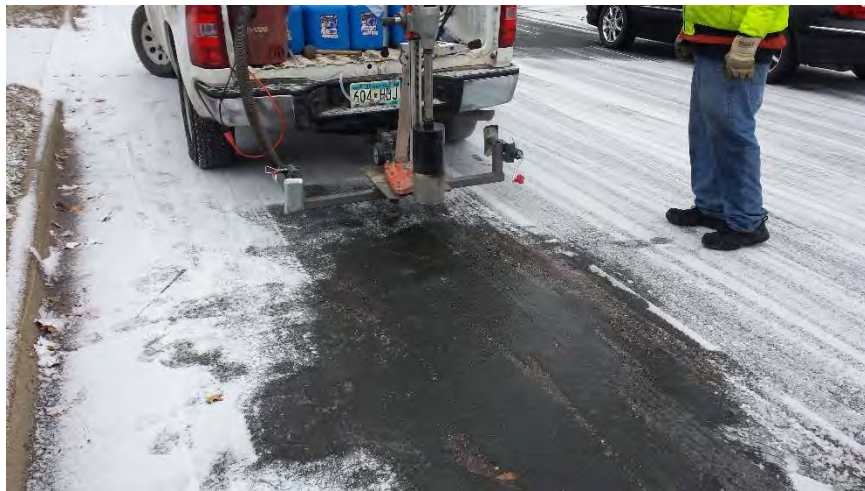
Figure I-8. Coring operations and sample core extracted from Knob Hill in Burnsville, MN

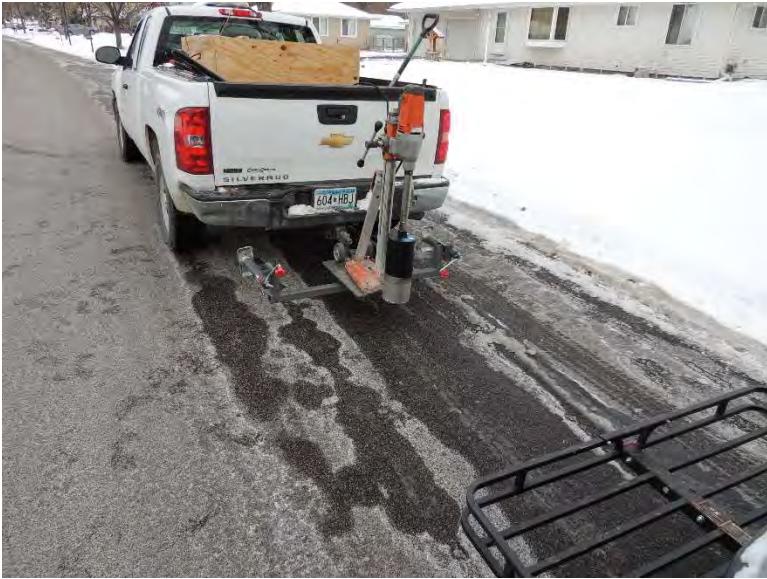
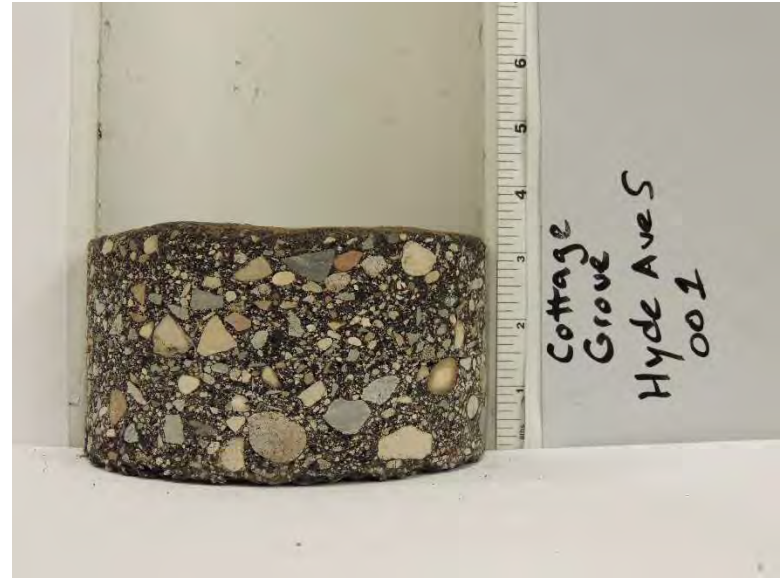
Figure I-9. Coring operations and sample core extracted from Hyde Ave in Cottage Grove, MN

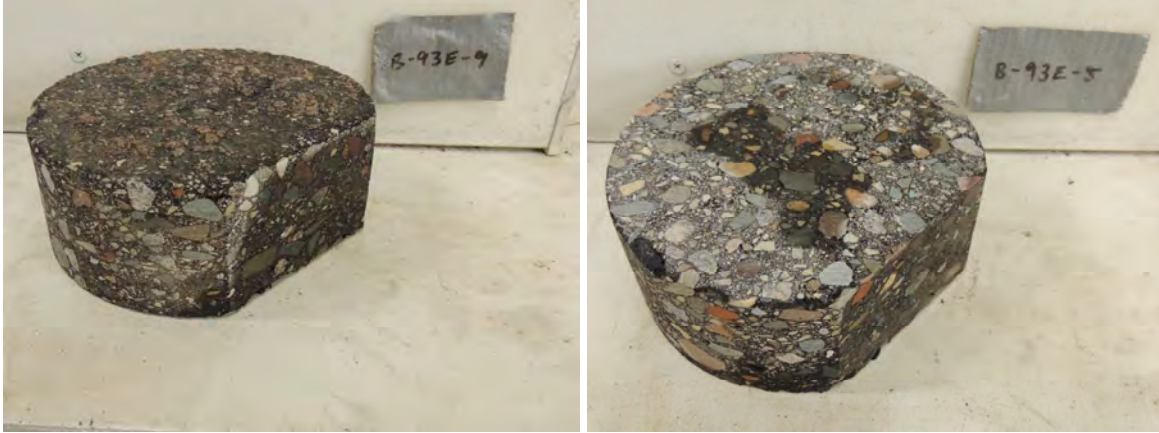
Figure J-1. Paired specimen from the east end of 93rd Avenue in Blaine, MN, before Hamburg test

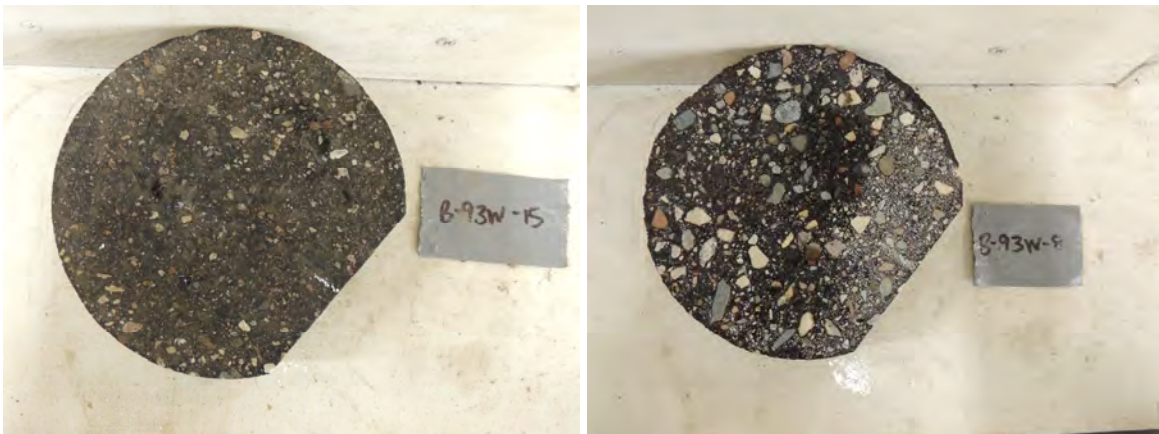
Figure J-2. Specimen from the west end of 93rd Avenue in Blaine, MN, before Hamburg test

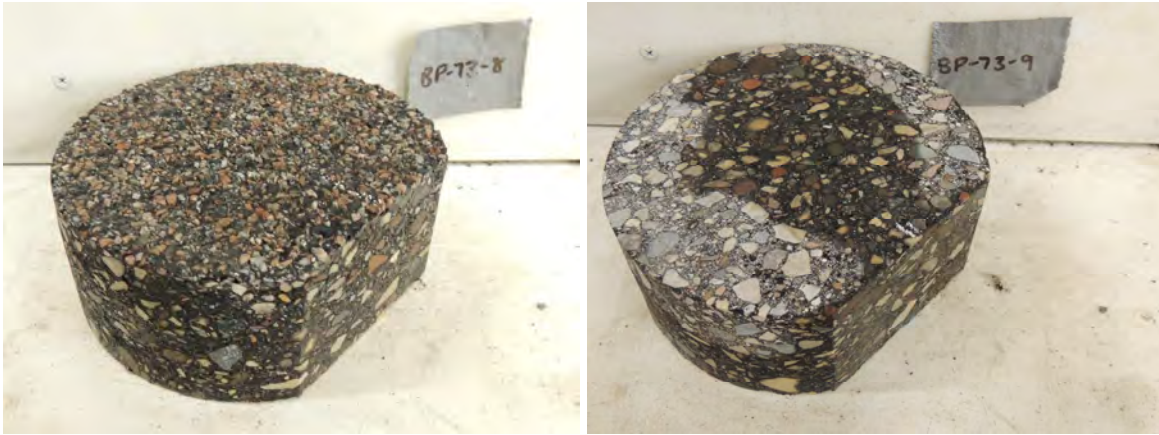
Figure J-3. Specimen from 73rd Avenue in Brooklyn Park, MN, after Hamburg test

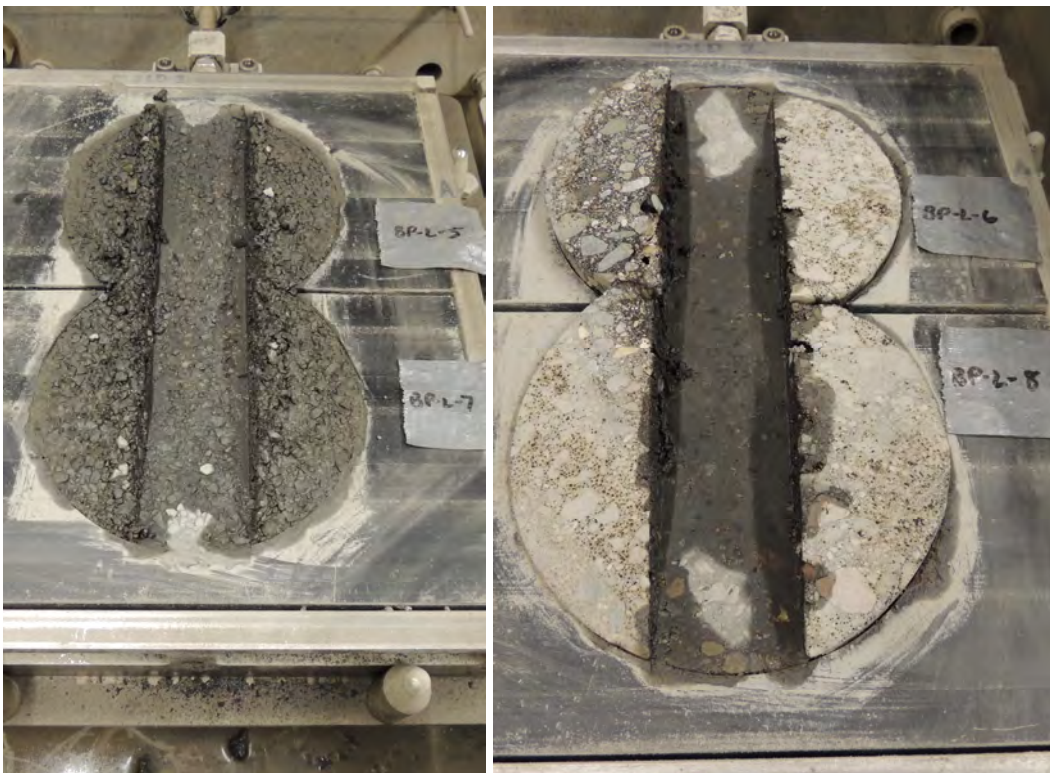
Figure J-4. Paired specimens from Louisiana Avenue in Brooklyn Park, MN, after Hamburg test
