Prevention of Stripping Under Chip Seals

David L. Rettner, Principal Investigator
American Engineering Testing, Inc.

October 2017

Research Project
Final Report 2017-35

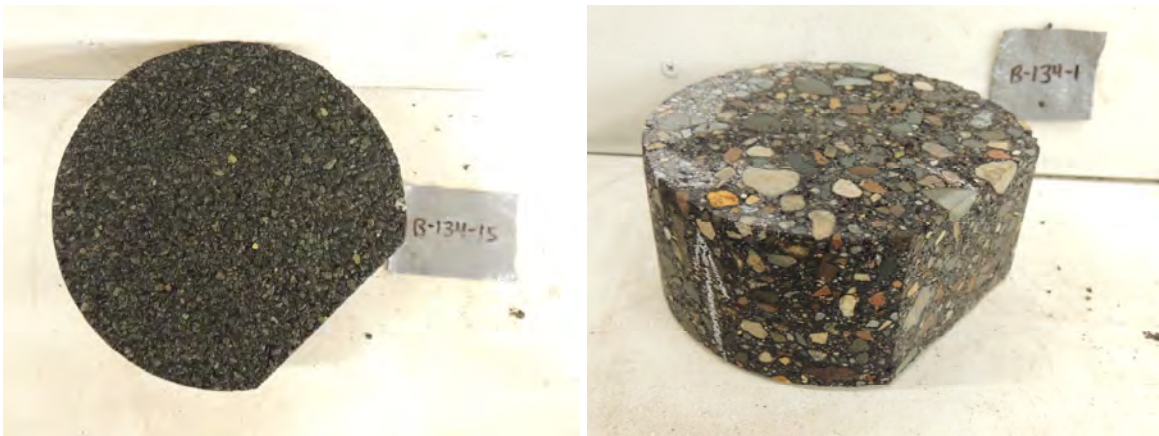
Figure J-5. Paired specimens from 134th Avenue in Burnsville, MN, before Hamburg test

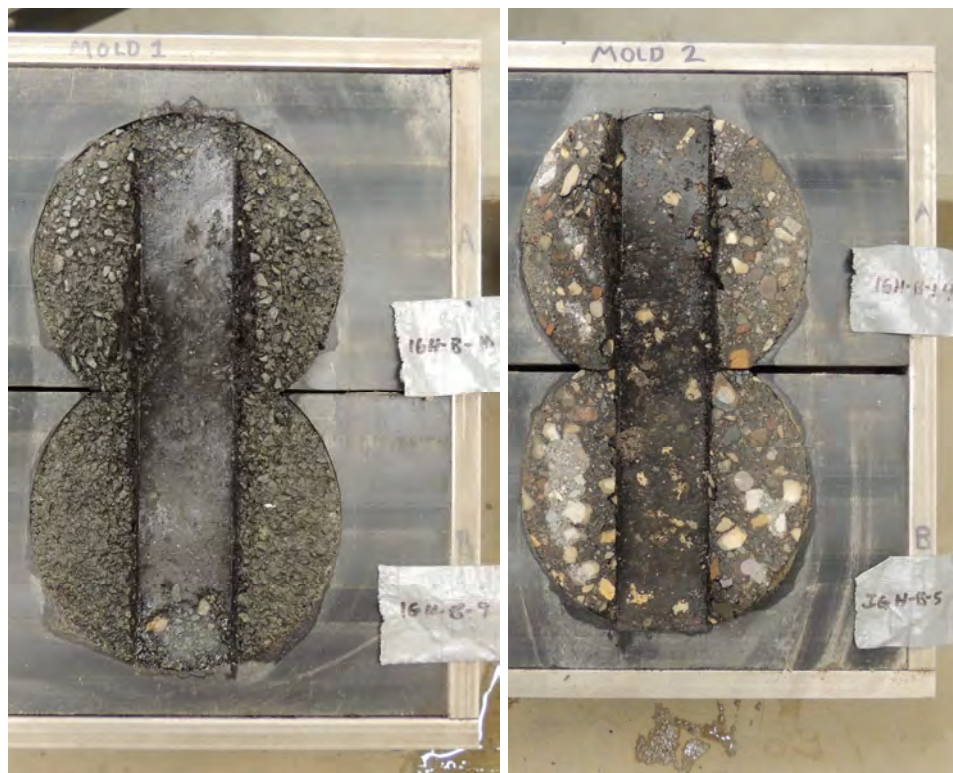
Figure J-6. Paired specimen from Brooks Blvd in Inver Grove Heights, MN, after Hamburg test

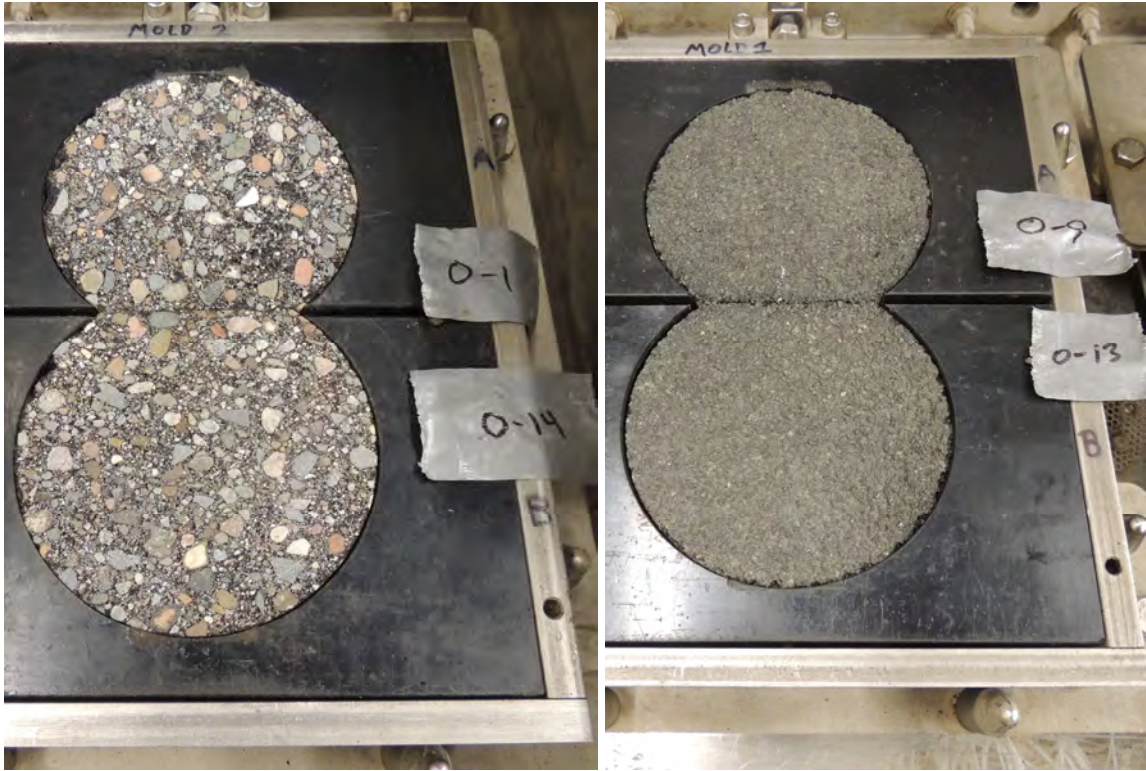
Figure J-7. Paired specimens from Osseo, MN, before Hamburg test

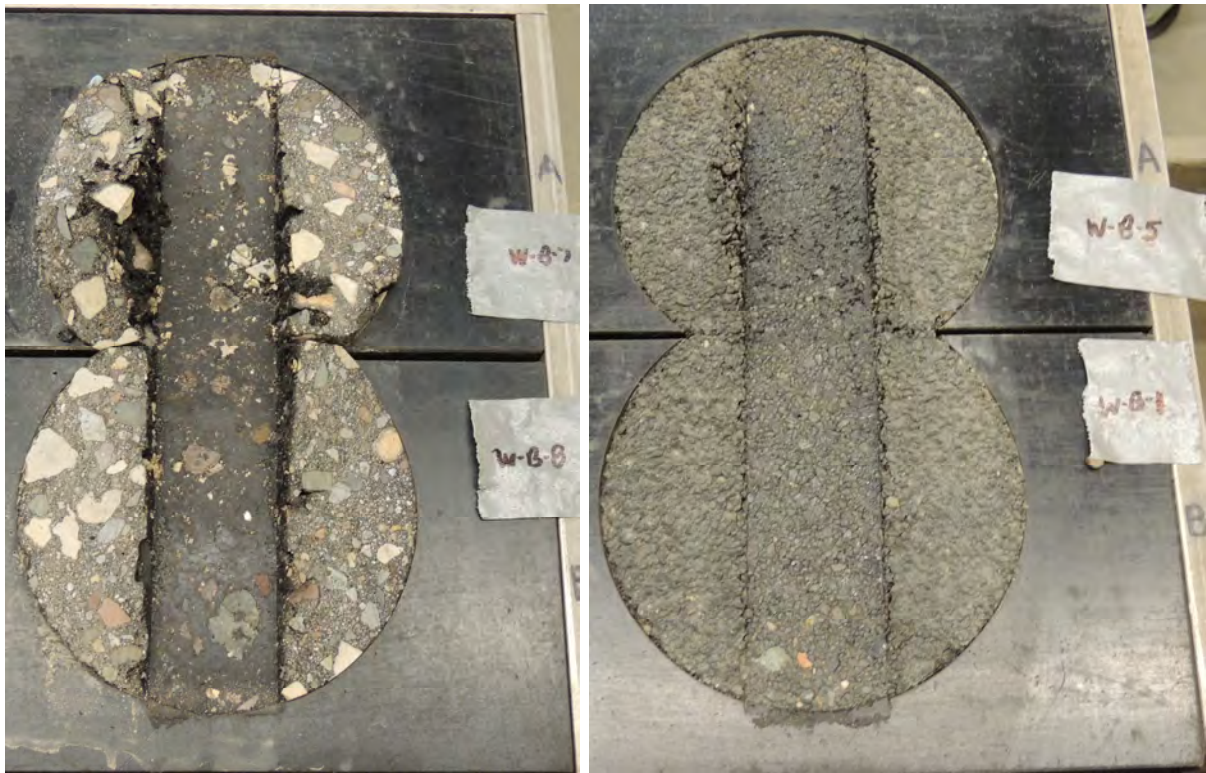
Figure J-8. Paired specimens from Bridgewater Road in Woodbury, MN, after Hamburg test

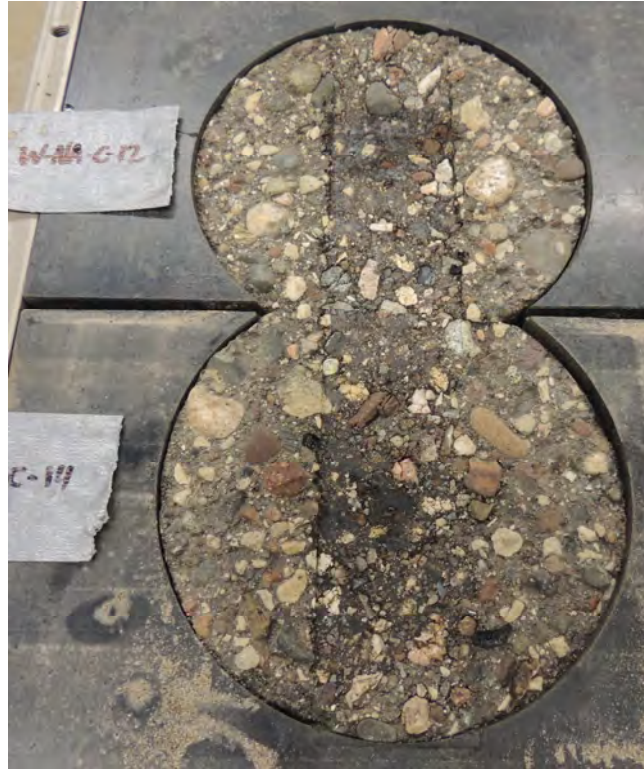
Figure J-9. Specimen without chip seal from Newbury Alcove Cul de Sac in Woodbury, MN, after Hamburg test

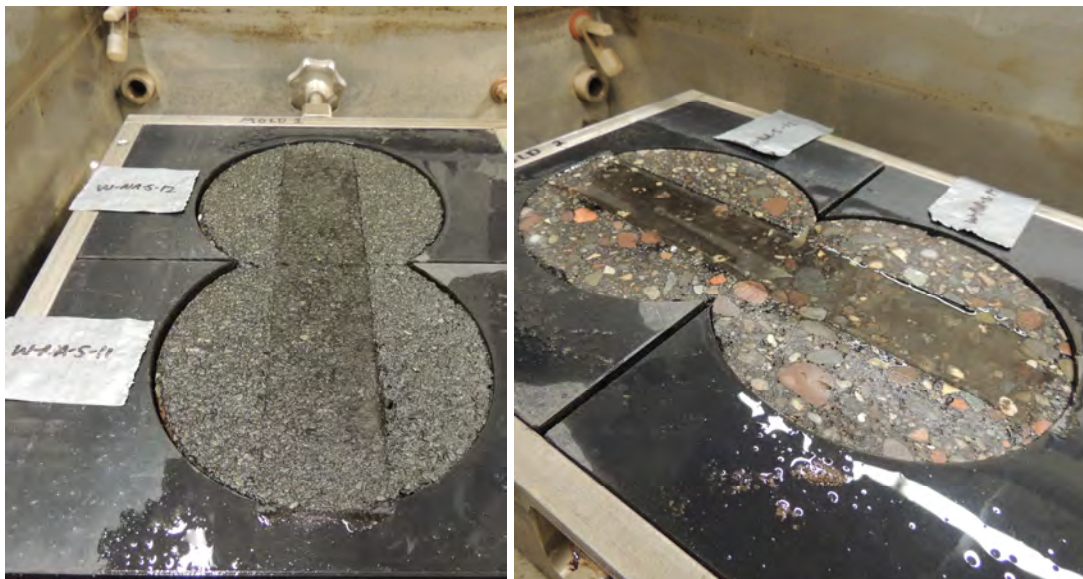
Figure J-10. Paired specimen from Newbury Alcove Straightaway in Woodbury, MN, after Hamburg test
