Trott Brook Crossing Environmental Assessment Worksheet

September 8, 2021

Environmental Assessment Worksheet (EAW)

Trott Brook Crossing

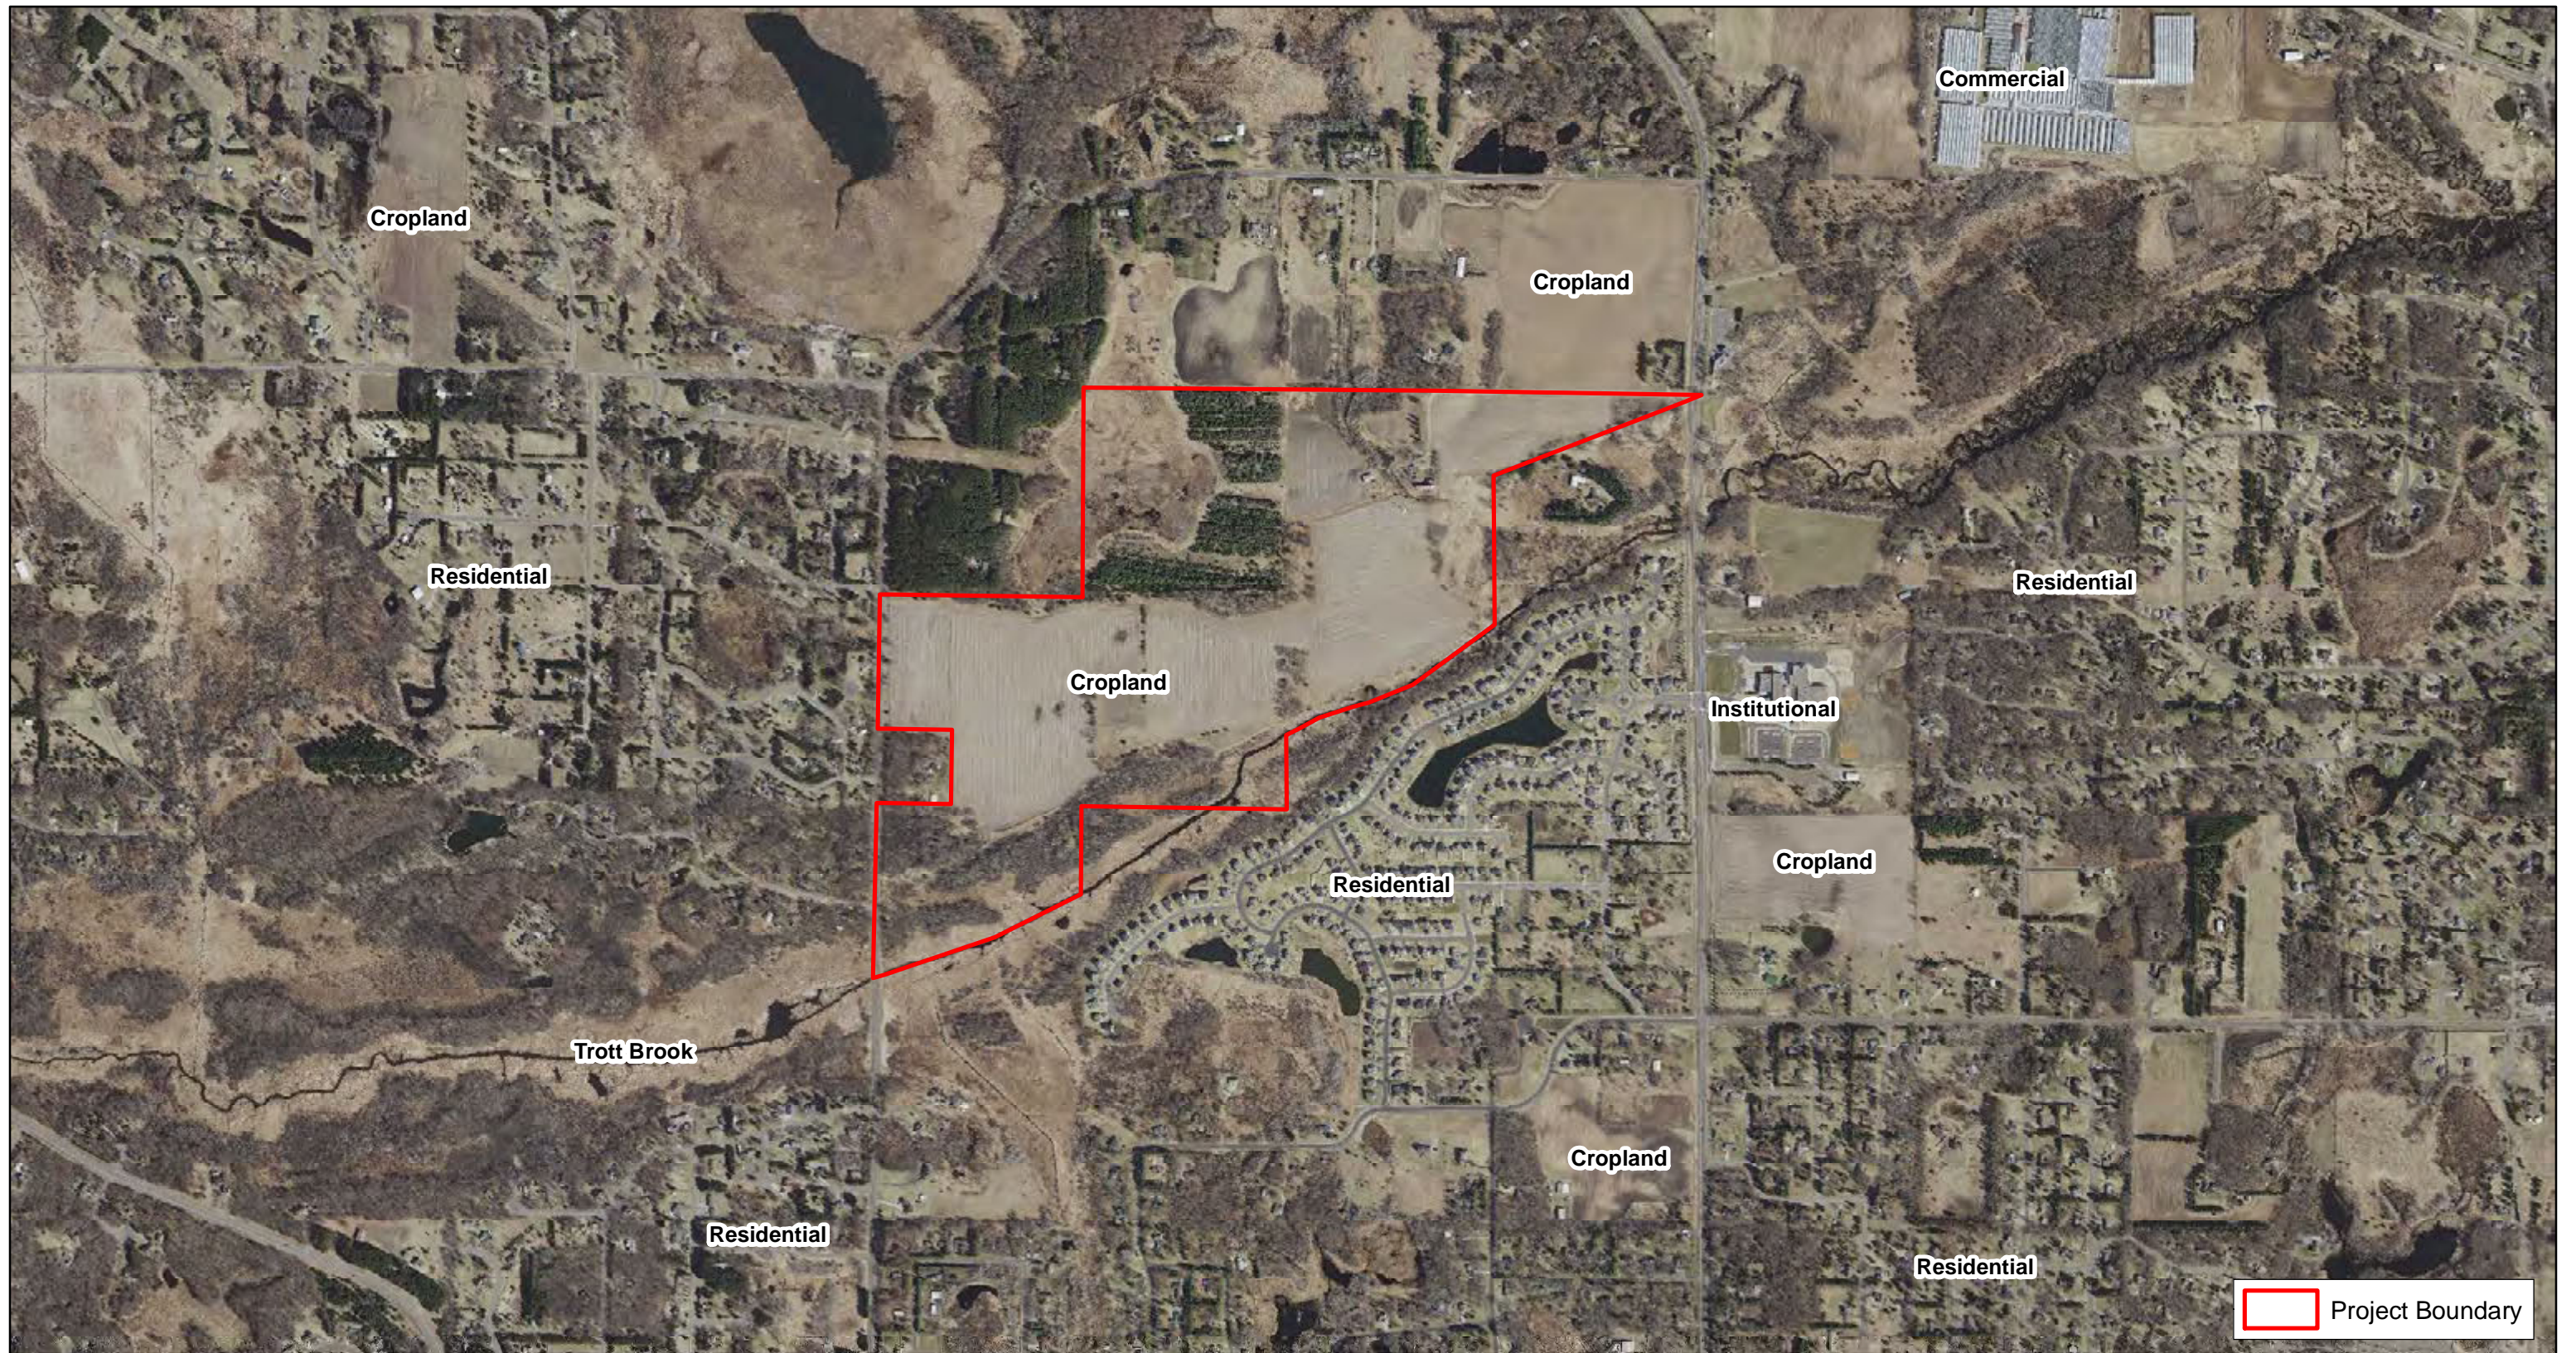
Figure 5 - Surrounding Land Use

Approximately 47% of the project area has been in agricultural use since at least the 1930s and the remaining portion consists of wetlands, woodland, grassland and a small amount of impervious and lawn at the farmstead and gravel access road. Surrounding land use is residential to the south and west, agricultural (future residential) to the north, and residential to the east (**Figure 5**).

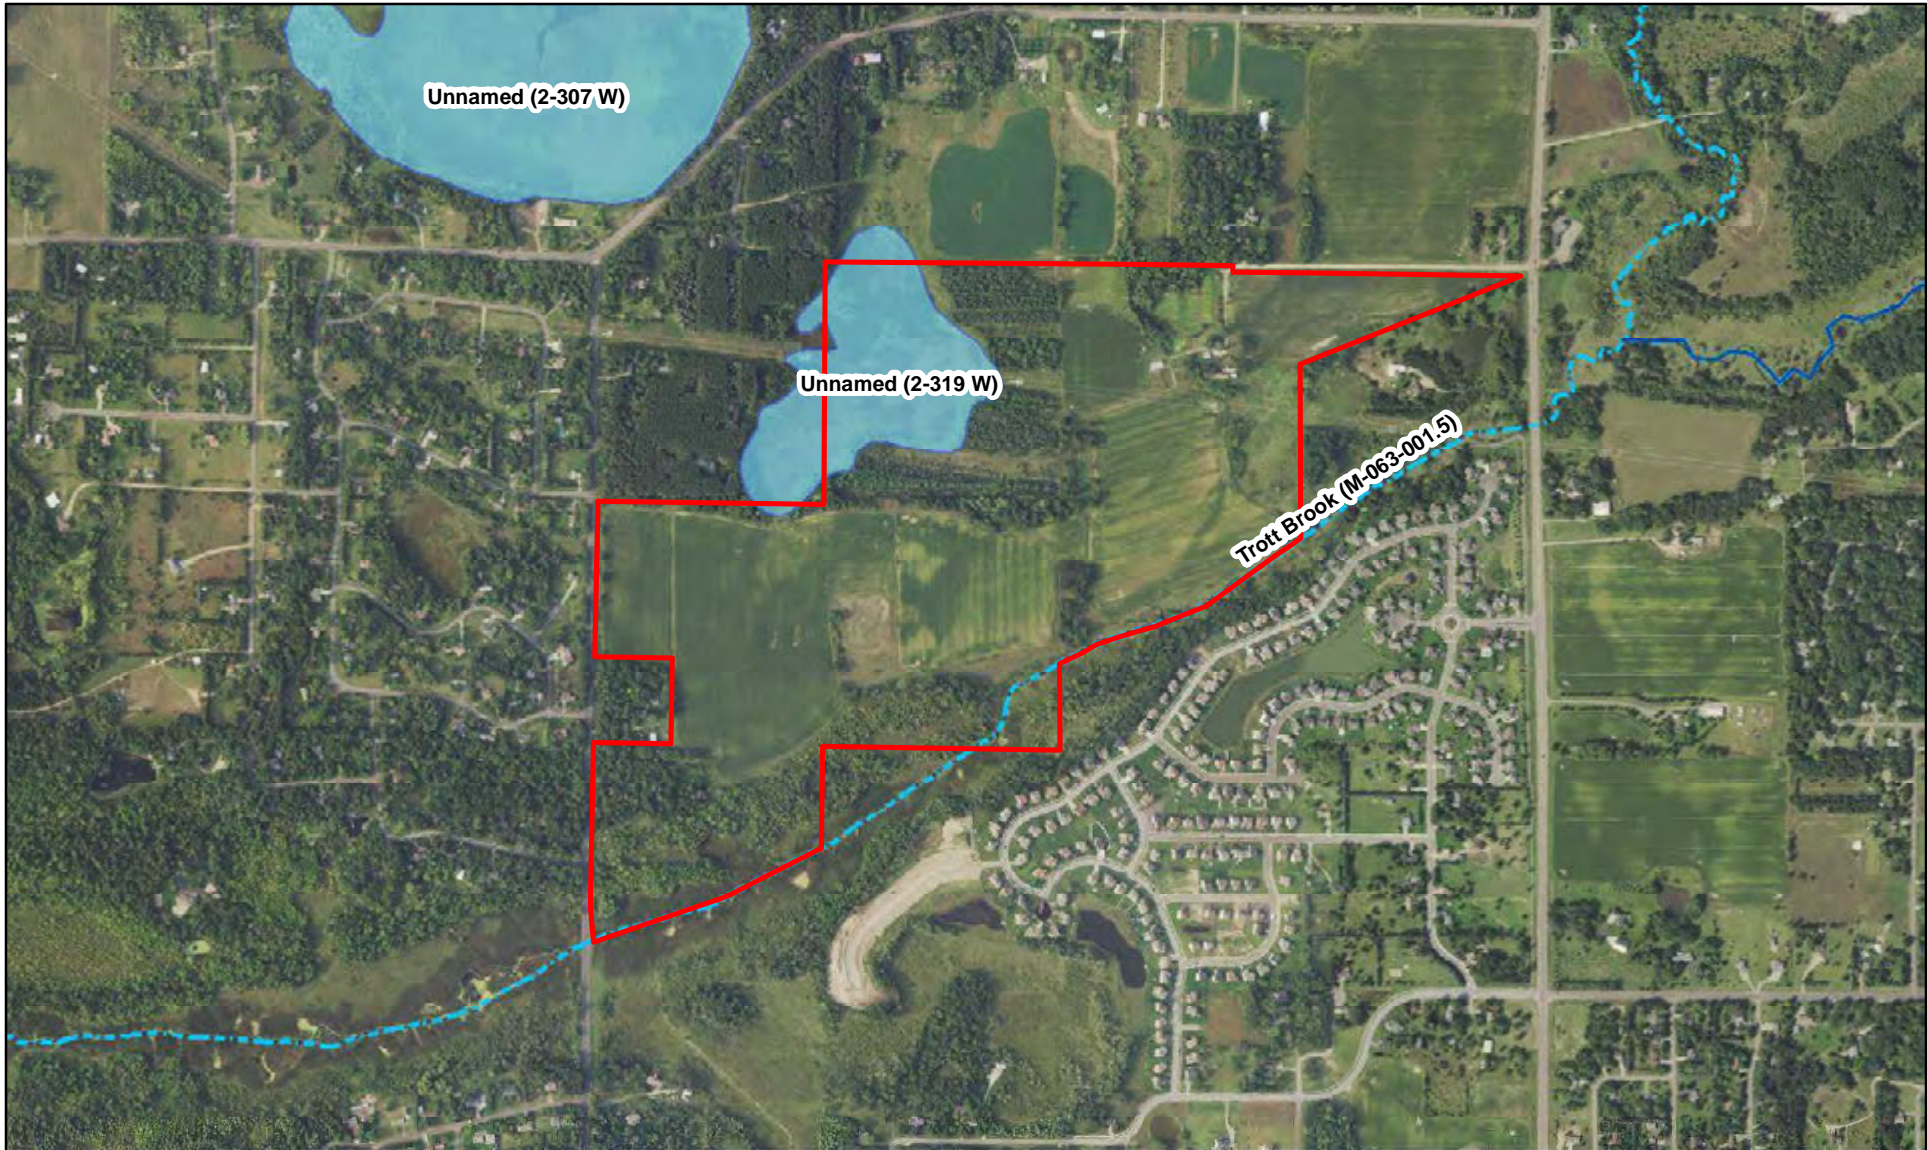
Figure 5 - DNR Public Waters Inventory

The Minnesota DNR Public Waters Inventory (Minnesota Department of Natural Resources 2015) showed DNR Public Wetland 2-319W (unnamed) within site boundaries, and Trott Brook (DNR Public Ditch/Altered Natural Watercourse M-063-001.5) along the much of the south site boundary (**Figure 5**).

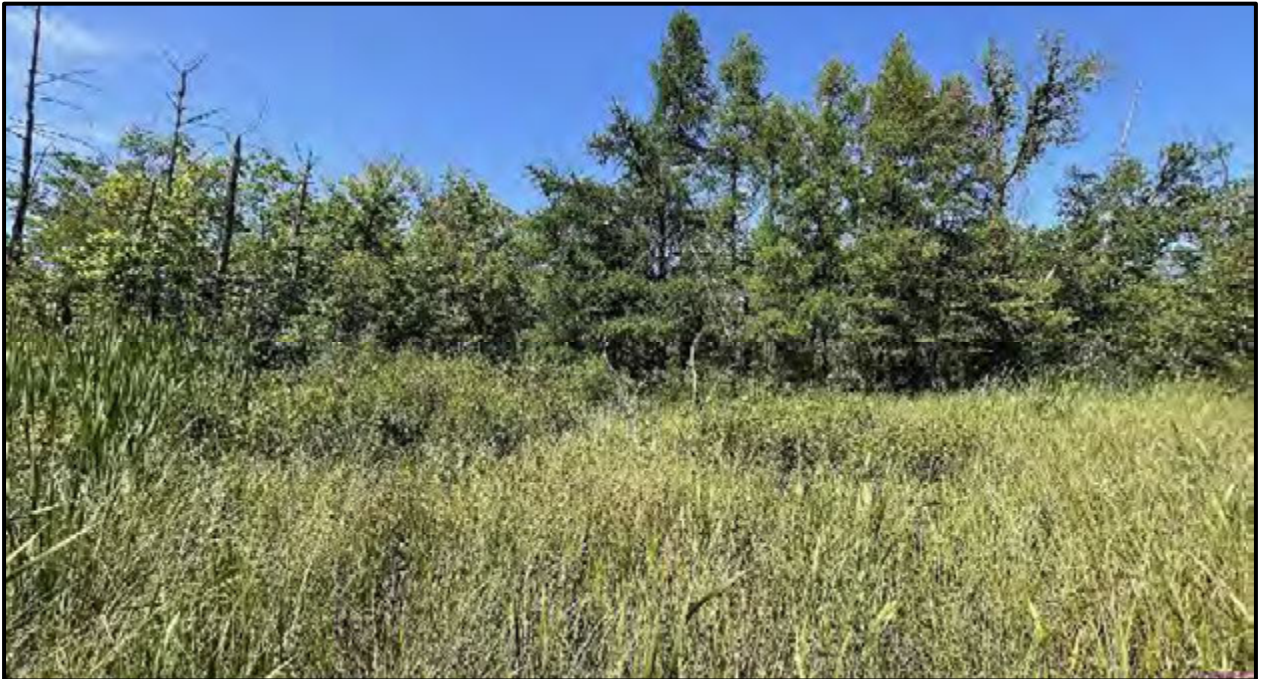
Photo of open graminoid-dominated discharge feature with tamarack in the background.

The southern wetland complex adjacent to Trott Brook is strongly influenced by groundwater discharge. This specific area corresponds to the Peat and muck map unit depicted in the Surficial Geology map. The wetland itself is intact and floristically diverse with both wet forest and wet meadow communities. This complex includes an open graminoid-dominated community with obvious groundwater discharge and dome-like topography. This area is bordered to the north by wet forest containing black ash (*Fraxinus nigra*), tamarack (*Larix laricina*), and a wall of non-native cattail. Species of note include bog birch (*Betula pumila*), fringed brome (*Bromus ciliatus*), spring cress (*Cardamine bulbosa*), water sedge (*Carex aquatilis*), porcupine sedge (*Carex hystericina*), interior sedge (*Carex interior*), prairie sedge (*Carex prairea*), sage-leaved willow (*Salix candida*) and bog aster (*Symphotrichum boreale*). The species list for this collective community is presented in **Appendix C**. Other noteworthy species include marsh stitchwort (*Stellaria palustris*) and the native broad-leaved cattail (*Typha latifolia*). The marsh stitchwort is identified as an introduced species from northern Europe. However, this is the second known occurrence of this species in the state that we are aware of. Both populations are present in discharge systems including a rich fen community in northern Minnesota and now this population. The broad-leaved cattail is sporadically distributed within the feature in contrast to the aforementioned wall of non-native cattail. It is either an issue of time or a combination of factors (soils, hydrology, and chemistry) that is currently inhibiting the non-native cattails from taking over this system.

Although it would be unusual and unexpected for this area, the mentioned assemblage of plants is suggestive of possible calcareous fen conditions. If using the calciphile species occurrence method in Leete and Smith (2005), this location (Minnesota River Valley Region) would have a point total of 65. The critical Vegetation Criterion threshold for calcareous fens is 50 points. However, key calciphile species, other than the prairie sedge, appear to be absent. Soils were evaluated on the second site visit in an attempt to collect

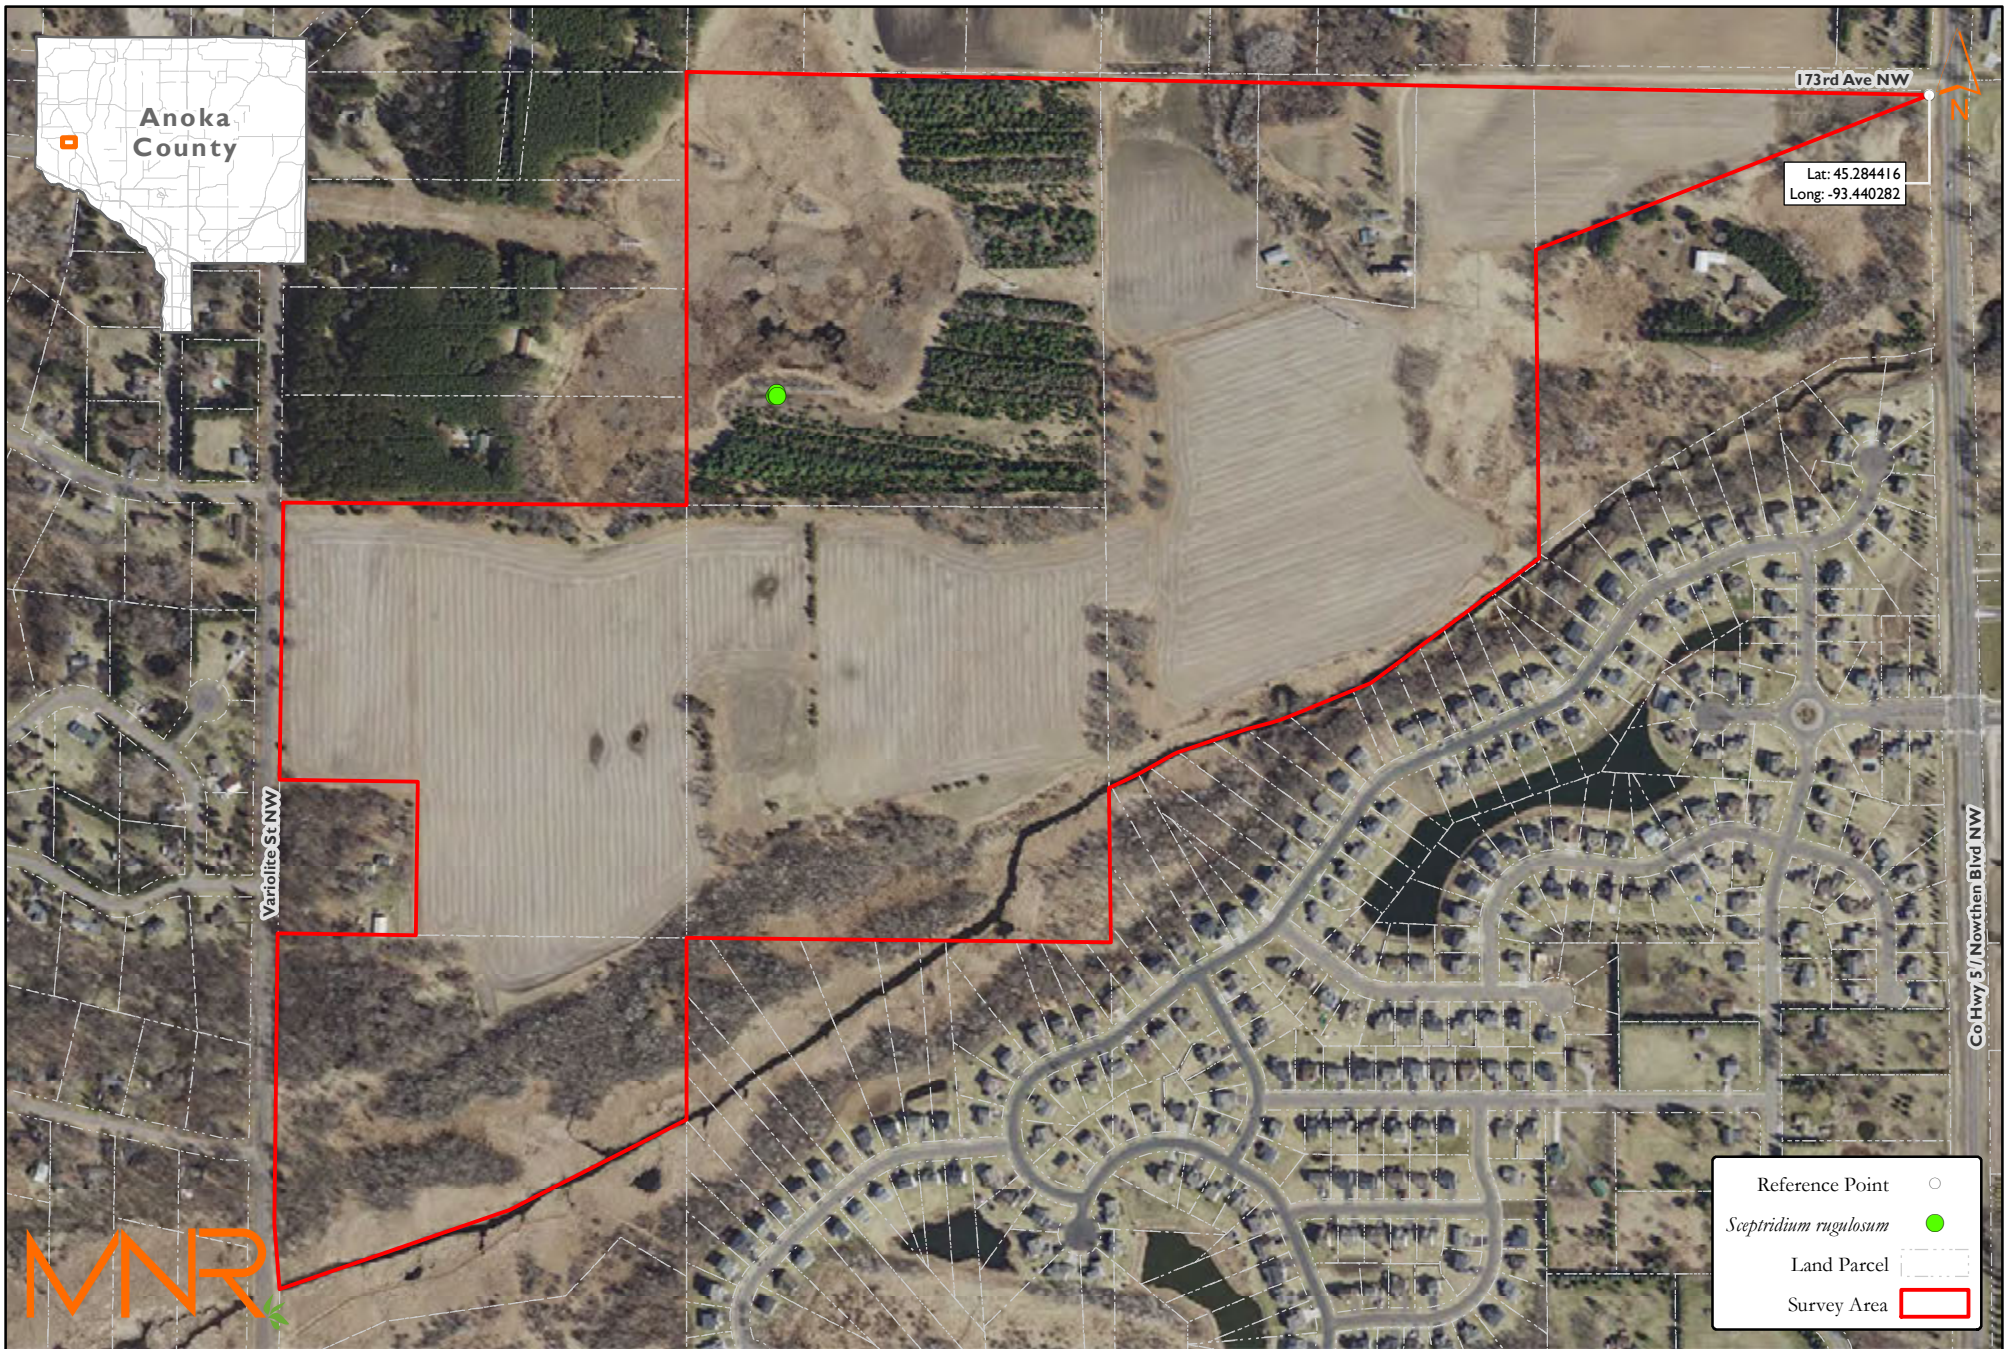
Figure 4

According to the 2012 Surficial Geology map of Anoka County, the site includes two map units, Richfield terrace (Qwr) and Peat and muck (Qp). The majority of the site is mapped as the Richfield terrace with Peat and muck associated directly with Trott Brook. The Peat and muck map unit is mapped for those areas with peat greater than four feet in depth and can include marl, a calcareous clay (**Table 2** and **Figure 4**).

Surficial Geology of Anoka County
Rare Plant Survey
 Trott Brook Project - The Excelsior Group
 Ramsey, Anoka County, Minnesota

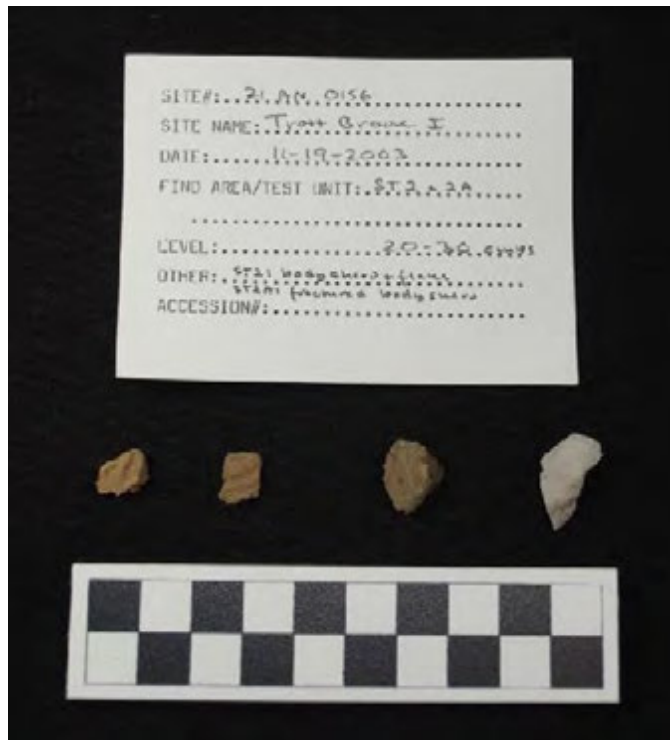
Figure 3: 21AN0156 Artifacts found in Shovel Tests 2 and 2A.

Site 21AN0156 (Trott Brook 1) consists of three grit-tempered cord-marked ceramic body sherds and a secondary flake of Prairie du Chien (PDC) chert located 20-30 centimeters below surface (cmbs) (Figures 3 and 4). While the presence of the grit-tempered and cord-marked ceramics indicates this was a Woodland Period habitation site, the low frequency of artifacts indicates the period of occupation was likely slight. Site 21AN0157 (Trott Brook II) was identified through surface survey and consists of an isolated broken tip of a PDC projectile point located on a cultivated crest overlooking Trott Brook (Figure 5). Site 21AN0158 (Trott Brook III) was also identified in a cultivated field during surface survey and consists of a grindstone fragment and secondary quartz flake (Figure 6). Shovel testing was completed at nine-meter intervals at and around all surface finds for 21AN0157 and 21AN0158, and all shovel tests were sterile for cultural materials.

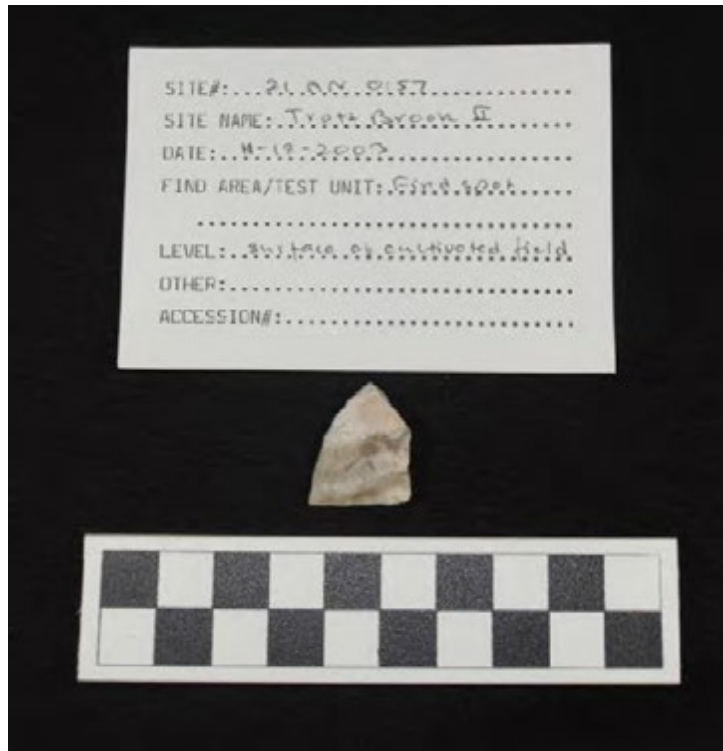
Figure 5: 21AN0157 Artifact, Found on Surface.

Fieldwork was completed June 14-16, 2021. This began with surface survey of all agricultural areas on a tight seven-meter interval. Surface visibility within all surface-surveyed areas varied between 70 and 90% (see Appendix A for example surface visibility photographs). Surface survey resulted in the identification of six surface find spots (labeled FS1 through FS6 on Figure 3). Five of the six artifacts were tertiary quartz flakes, with one quartz shatter. The locations of the find spots divided them into three archaeological sites: FS2 (single find spot of quartz shatter, Figure 4); FS6 (single find spot of a quartz tertiary flake, Figure 5); and FS1, 3, 4, and 5 (lithic scatter of quartz tertiary flakes, Figure 6).

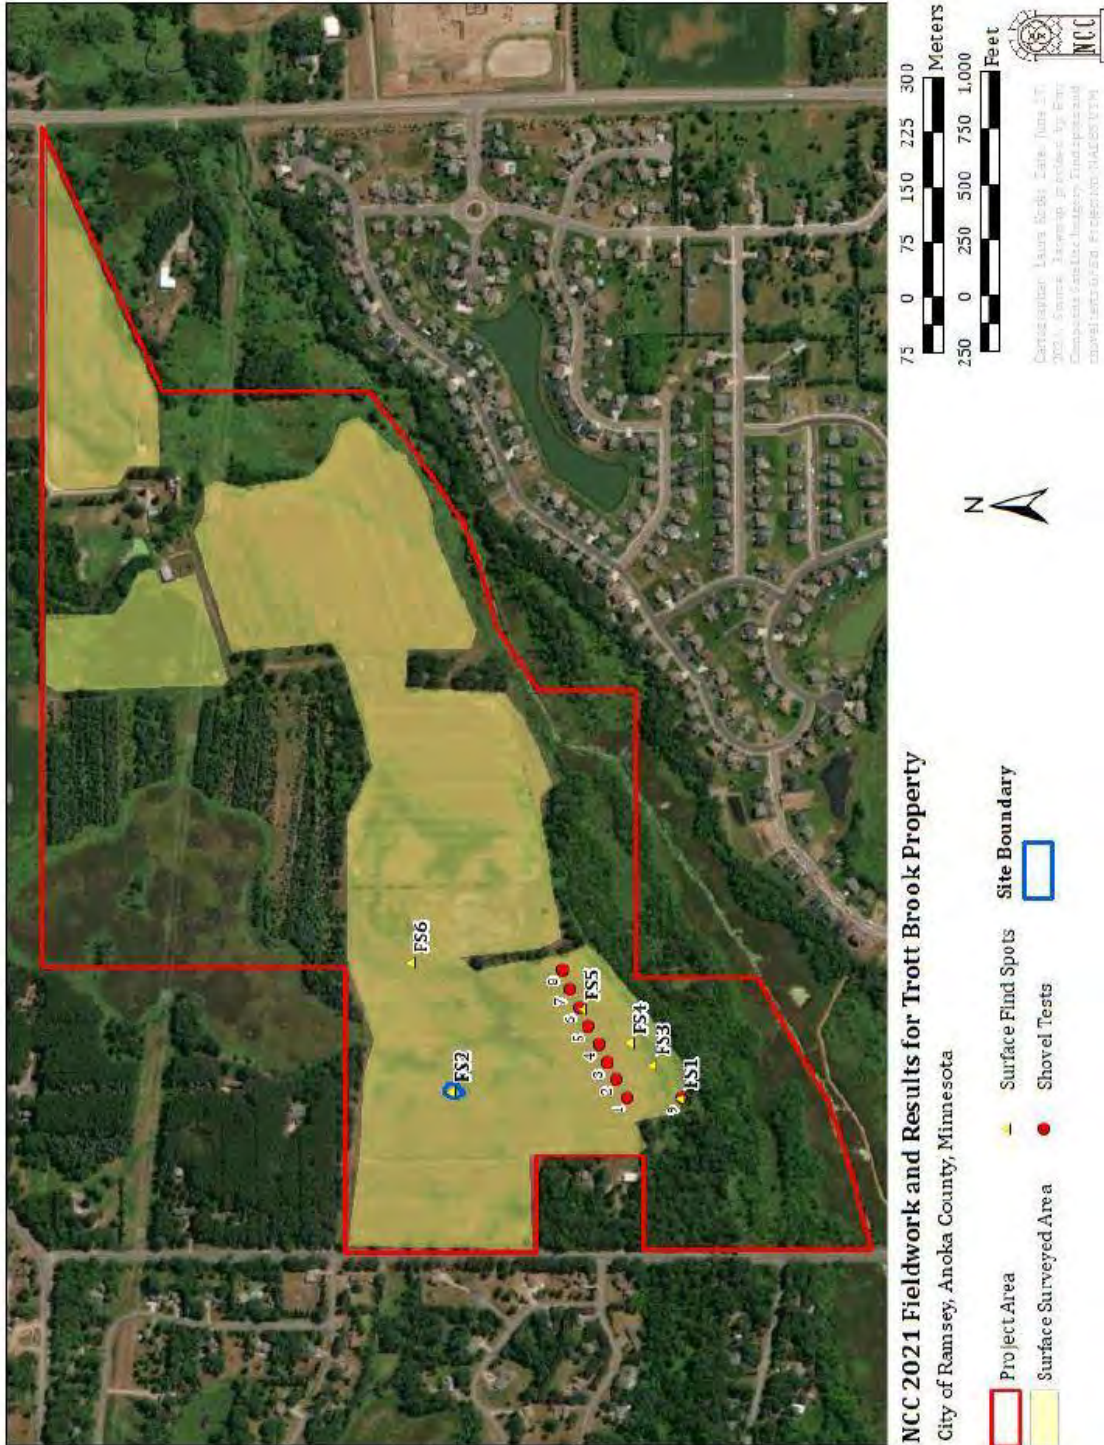
Map 2: Field map illustrating associated project area, fieldwork, and site location (at FS2).

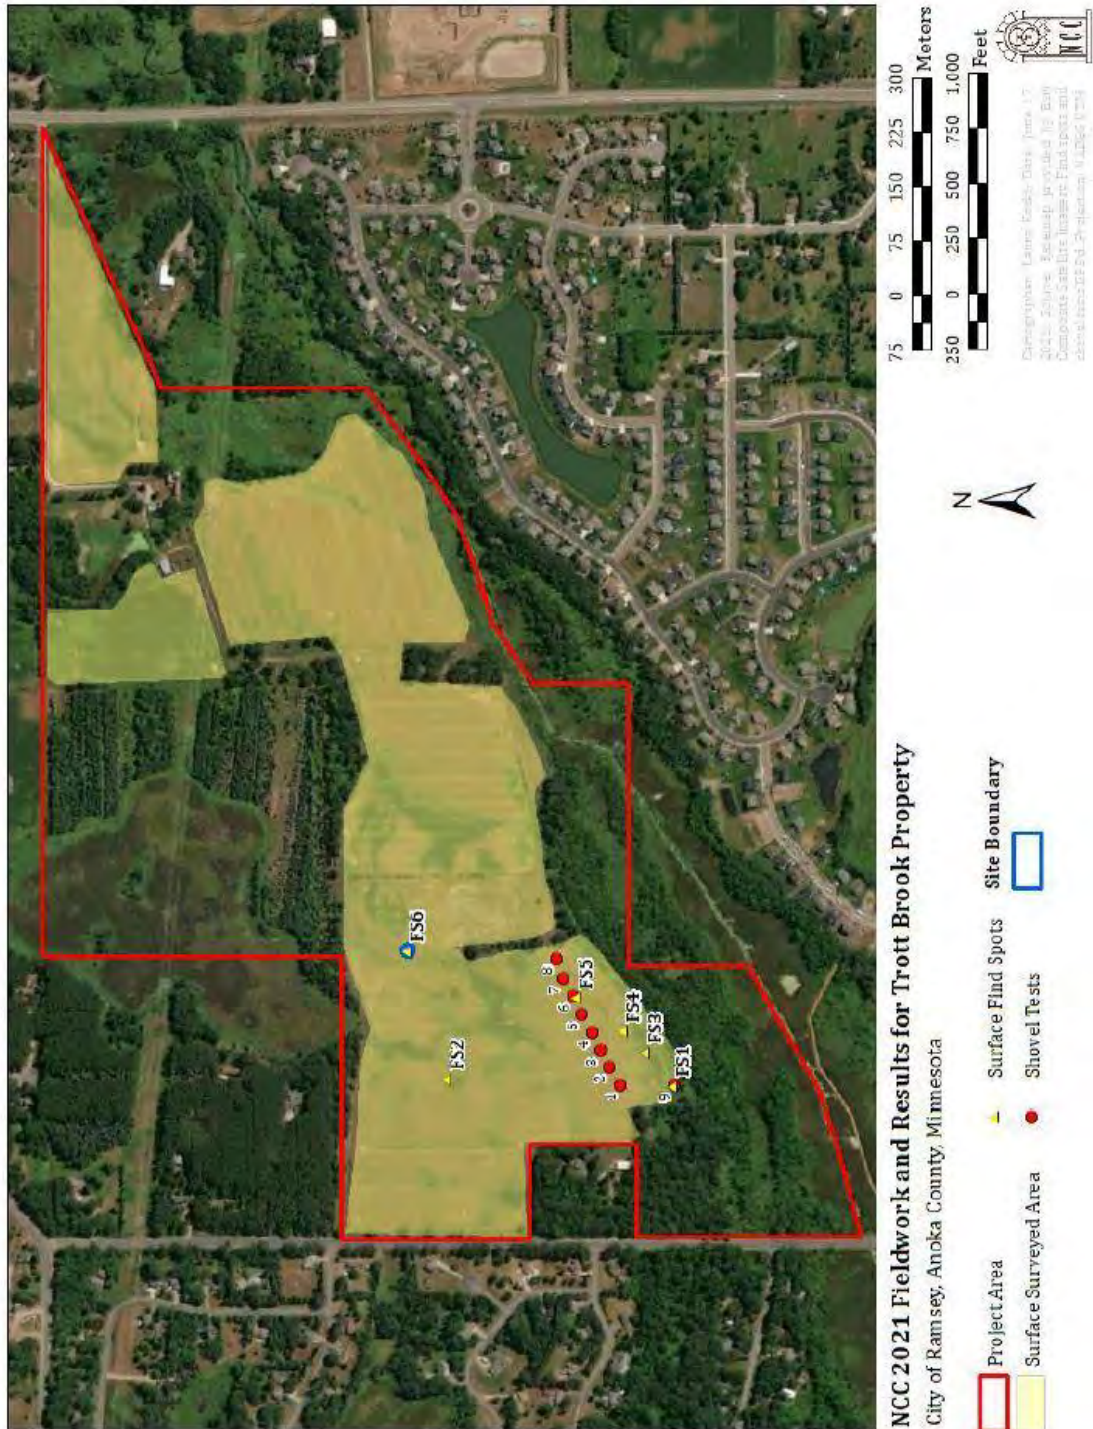
Map 2: Field map illustrating associated project area, fieldwork, and site location (at FS6).
