City of Ramsey
Agenda
Economic Development Authority (EDA)
Thursday, June 10, 2021
7:30 am
Council Chambers, 7550 Sunwood Drive NW

Historic Ramsey Town Hall: Ramsey, MN

Figure 1 – Ramsey Town Hall Primary Façade

Sustaining Our Legacy: The Future of Ramsey Town Hall

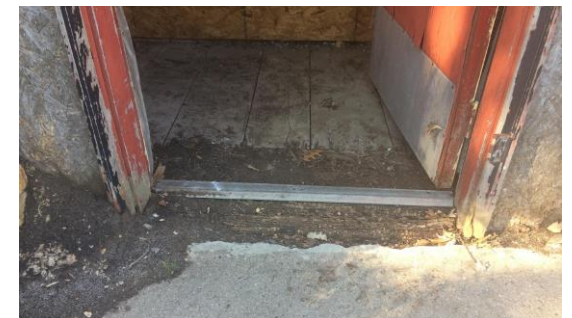
Figure 9 – Front Door Threshold

There is damage to the threshold of the front door and beyond the entrance exposing what looks to be part of the wood subfloor of the building.

The concrete stoop and steps that lead up to the building have several cracks and are uneven. It appears as if there has been some patching between the steps and the building. There are no hand railings. The building entrance is not currently ADA accessible and the steps are at the wrong rise and run for an entrance.

The current concrete steps should be removed and replaced with a system that is ADA compliant. All steps should have uniform riser heights and uniform tread depths. Risers should be 4 inches (100 mm) high minimum and 7 inches (180 mm) high maximum. Open risers are not allowed. Treads shall be 11 inches (280 mm) deep minimum. The radius of curvature at the leading edge of the tread shall be ½ inch (13 mm) maximum. Handrails shall be provided on both sides of stairs and ramps.

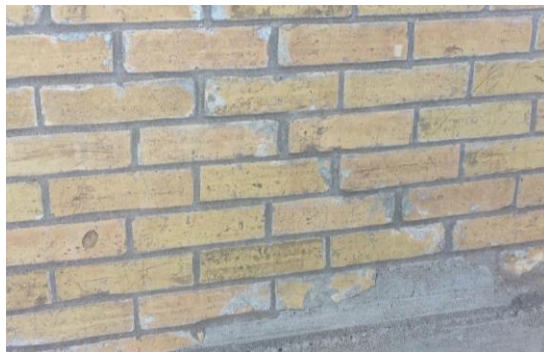
Figure 21 – Mortar Replacement to Fill Voids

There have been some attempts to repair some of the damaged brick in several places. Several of the repairs are closer to the concrete foundation on the Southern elevation. However, rather than replacing the brick that was broken off, concrete or mortar was used to fill in the broken pieces.

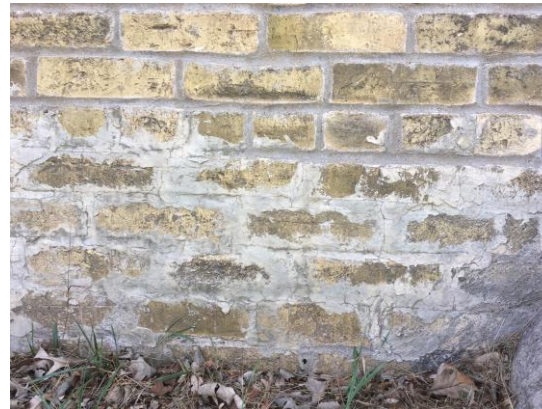
Figure 23 – Deteriorated Brick with Mortar

In one location, area of brick that was smeared with mortar on the rear elevation. The concrete curb that is located around the base of the North, South, and West elevations is most likely covering up deteriorated brick.

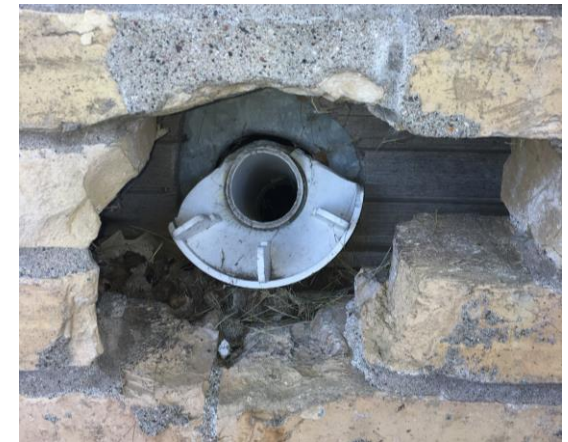
Figure 23 – Exterior Pipe Penetration

There is a pipe that runs from the basement to the exterior on the North elevation. The area around the pipe was not filled in, so there is currently a hole in the wall that exposes the wood structure.

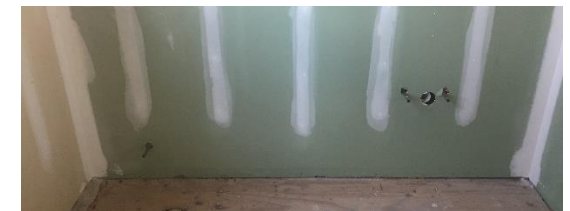
Figure 38 – Bathroom Plumbing

The exposed plumbing does not appear to be connected to a running water supply and is therefore not likely to cause water damage. If the plumbing is to be used, an expert should inspect them to ensure they are in working order and that none have burst or are leaking.

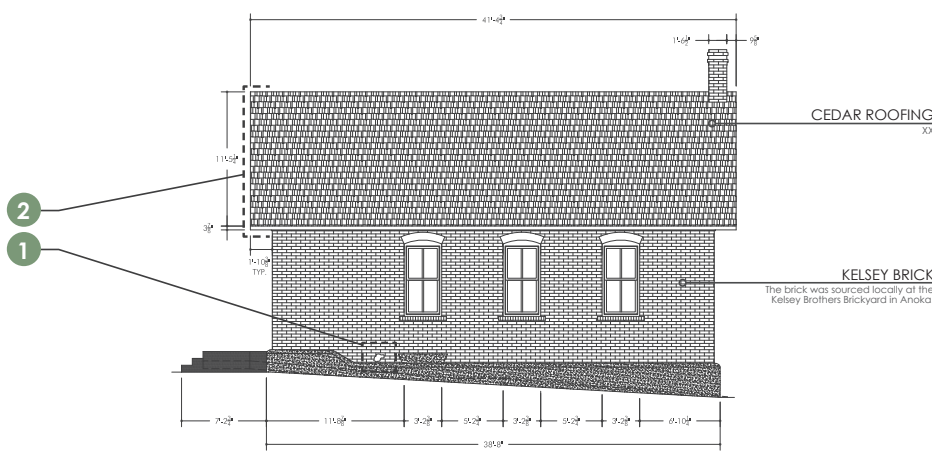
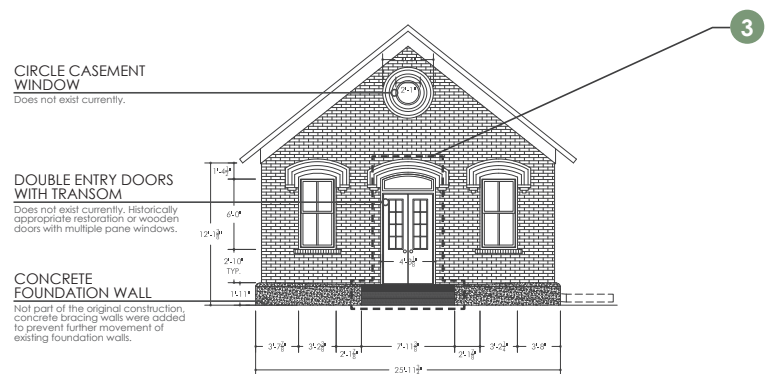
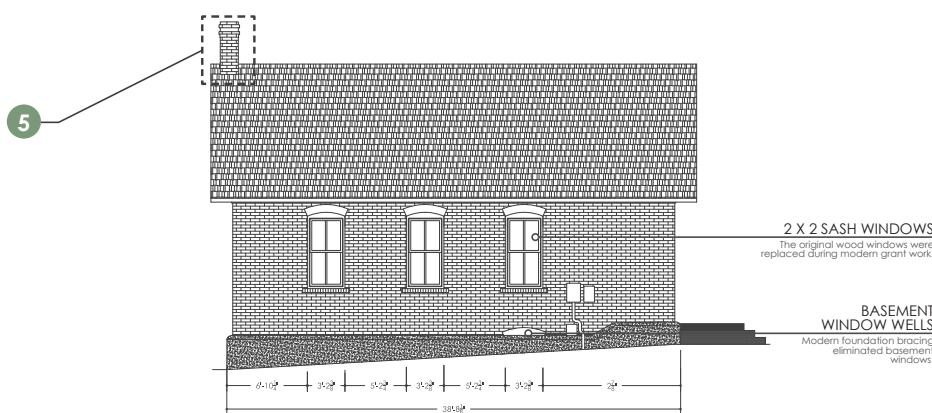
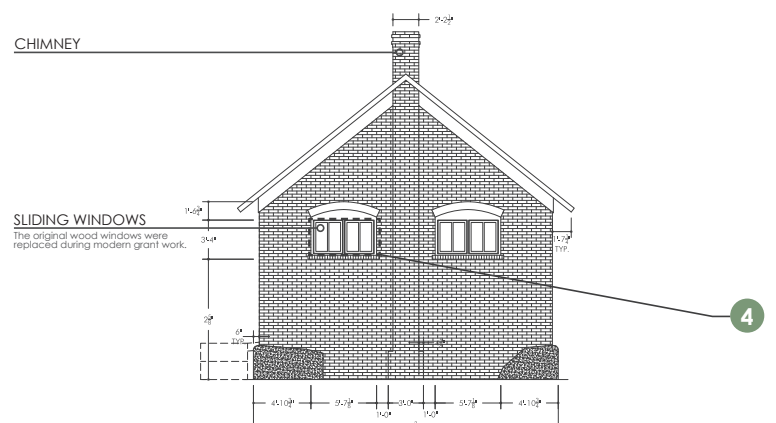
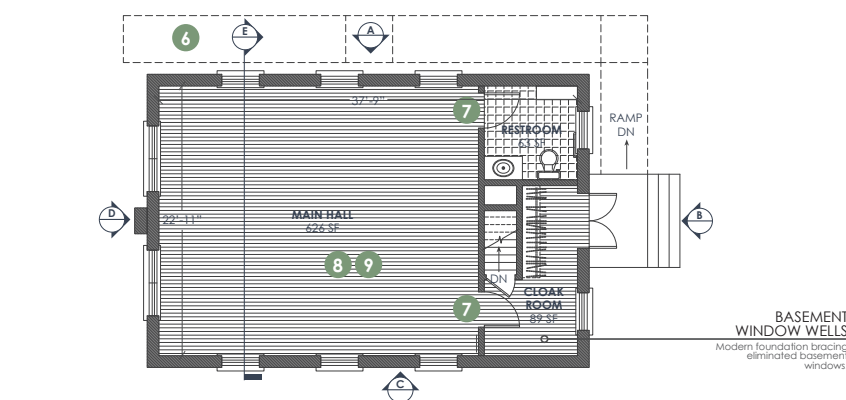
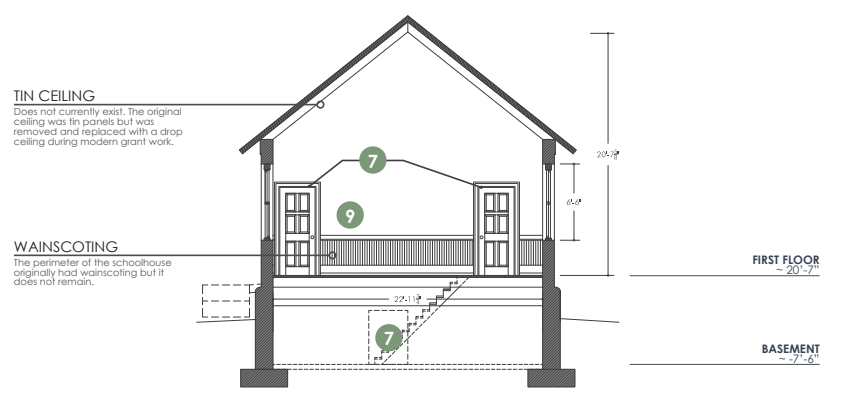
Architectural drawings—such as the ones shown below, which are based on previous renderings—are not only necessary in the construction process, but are also invaluable for **historical documentation of early construction methods** in Minnesota. The Old Ramsey Town Hall is a unique resource in Ramsey, as well as in the larger architectural landscape of Minnesota.

A NORTH ELEVATION

B EAST ELEVATION

C SOUTH ELEVATION

D WEST ELEVATION

FLOOR PLAN

E SECTION
