# MEMORANDUM

RE: COR Wetland Monitoring  
SEH No. RAMSY 158452 14.00

### COR Wetland Mitigation Monitoring Ramsey, Anoka County, Minnesota

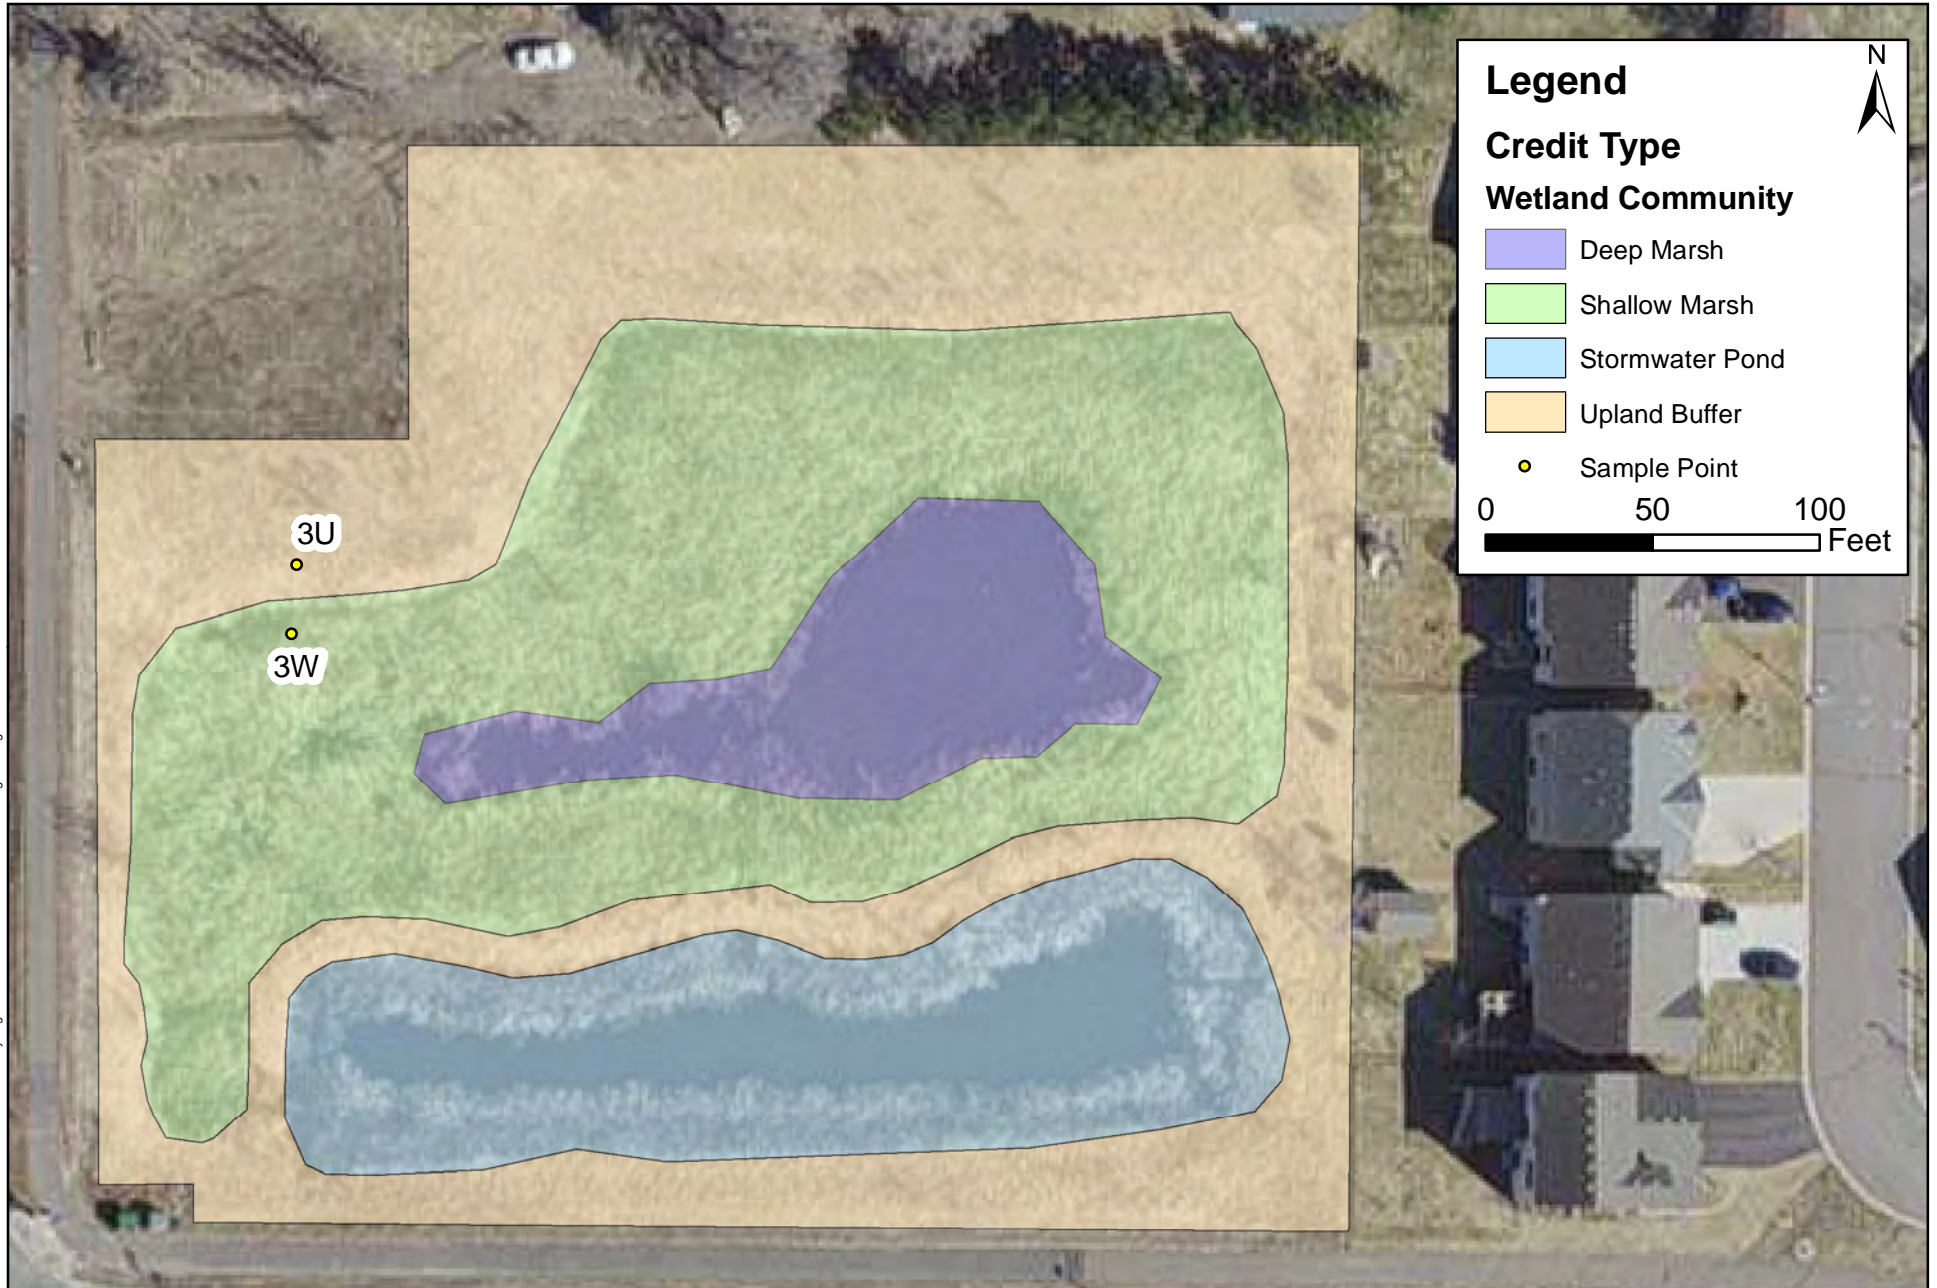
Figure 5 – Results – Northwest Wetland

Wetland boundaries were located and marked with pin flags with "WETLAND BOUNDARY" to allow for field review. The locations of the delineated wetland boundaries were collected with a sub-meter accuracy Global Positioning System (GPS) unit and mapped. The results of the delineation are shown on **Figures 3 and 4**. The sample points noted identify where data was collected.

The northwest mitigation site is comprised of a large wetland on the north side with a single stormwater treatment basin located on the south side of the site. Upland buffer is present around the perimeter of the wetland. A berm separates the storm water pond from the wetland and is considered part of the upland buffer component. The wetland is dominated by hybrid cattail (*Typha glauca*), which is present throughout the wetland. The exception being a larger area of deep marsh in the center of the basin which lacks vegetation. Along the perimeter there is minimal transition to upland, and the wetland is present essentially at the toe of the slope. While not dominant overall, small pockets of sedges are present, which are likely remnants from the 2011 restoration efforts. A few small black willow (*Salix nigra*) trees have also become established within the margins of the wetland. The stormwater pond components of the site are almost entirely composed of hybrid cattail and open water.

Upland buffer lies around the perimeter of the site. While reed canary grass is present at the base of the upland buffer the mixture of vegetation is more diverse than expected. Areas of spotted knapweed (*Centaurea stoebe*) and smooth brome (*Bromus inermis*) are present, but smaller density native species such as little bluestem (*Schizachyrium scoparium*), big bluestem (*Andropogon gerardii*), and sideoats grama (*Bouteloua curtipendula*) are also present. Overall, the upland buffer is diverse, but is not dominated by native species. Like the wetlands, native upland vegetation includes some remnants of the 2011 reseeding. The berm between the wetland and storm water treatment area is entirely reed canary grass, and much of it may be wetland, or at least wet enough to discourage upland species from being present. **Table 6** is a summary of the vegetation observed in the wetland and upland buffer portions of the Northwest mitigation site.

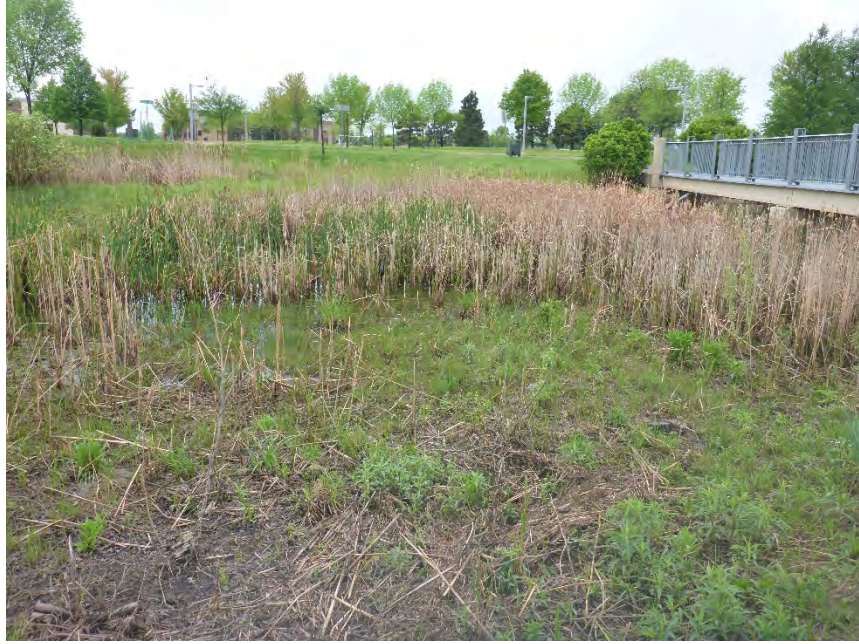
Charter Site – Wetland area, north side, east of bridge
