Project B2307595

Re: Pavement Evaluation
Bowers Drive Mill and Overlay Evaluation
US 10 to Cul-de-sac
Ramsey, Minnesota

BOWERS DRIVE PAVEMENT CORES

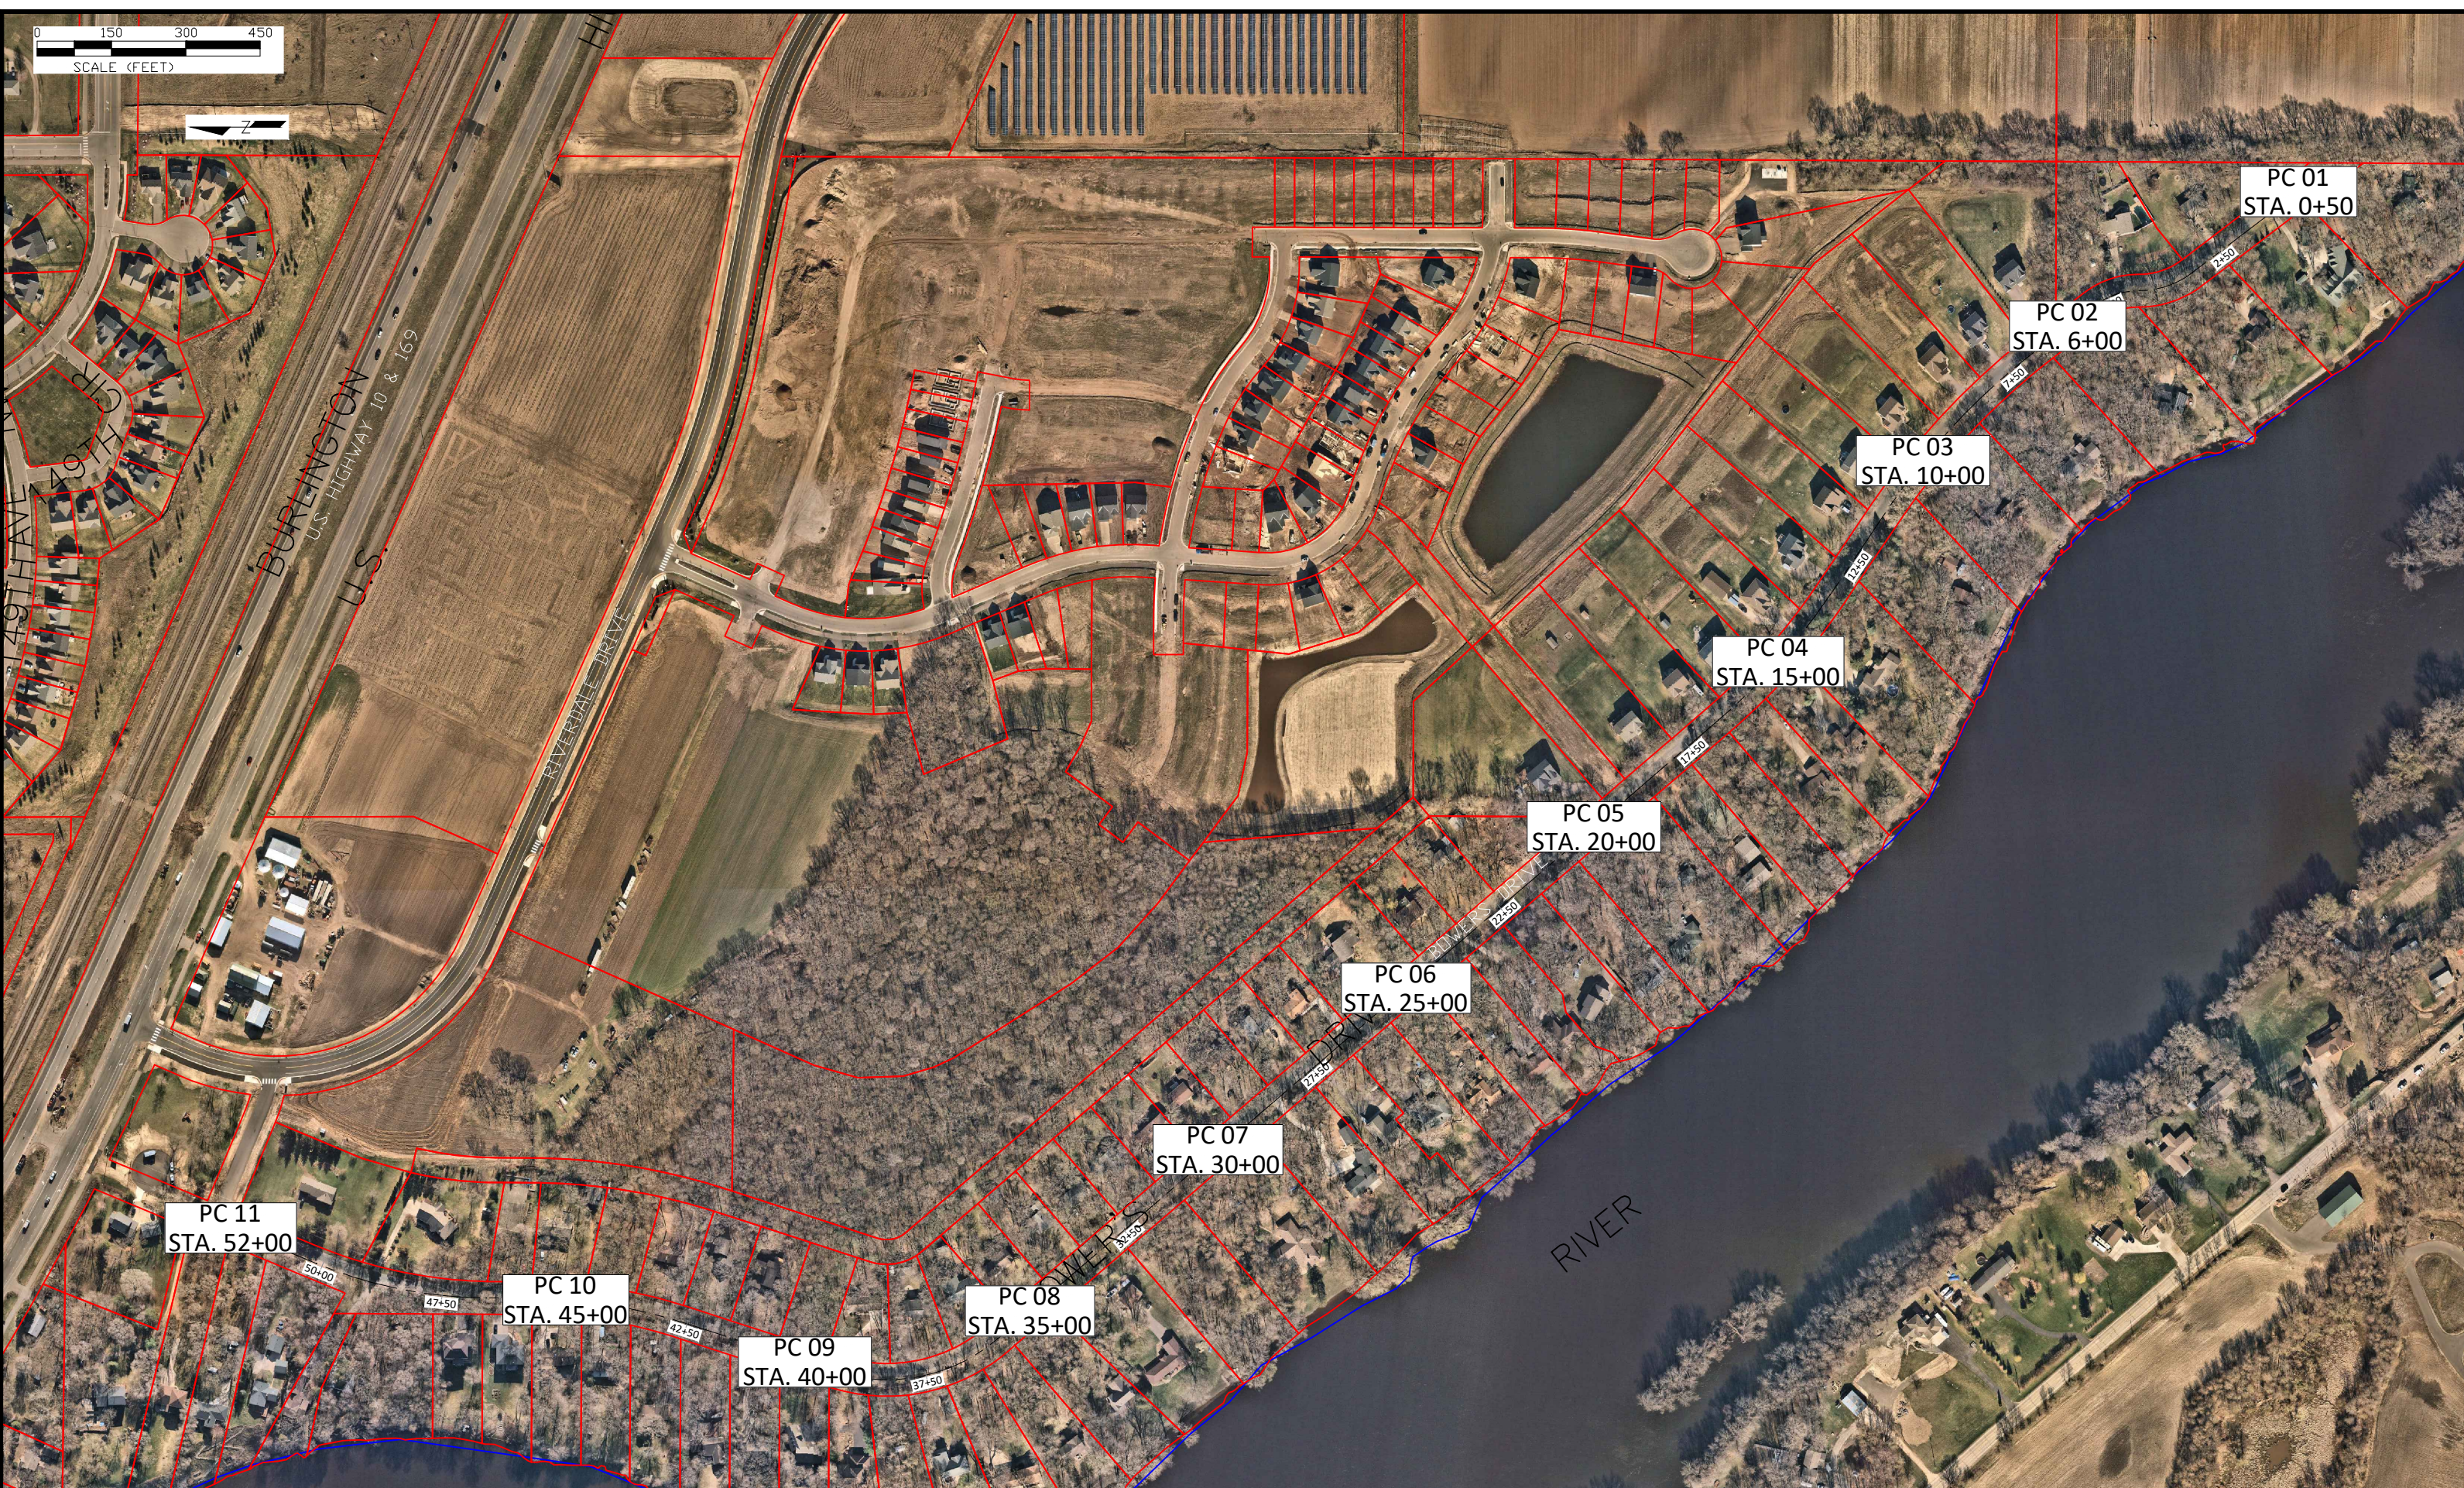
In August 2023, we conducted a subsurface investigation by extracting bituminous pavement cores at 11 locations selected by the City of Ramsey. In six of these locations, we extended manual soil borings (hand auger borings) to depths of about 2 feet below the surface. A sketch of these exploration locations is attached to this report.

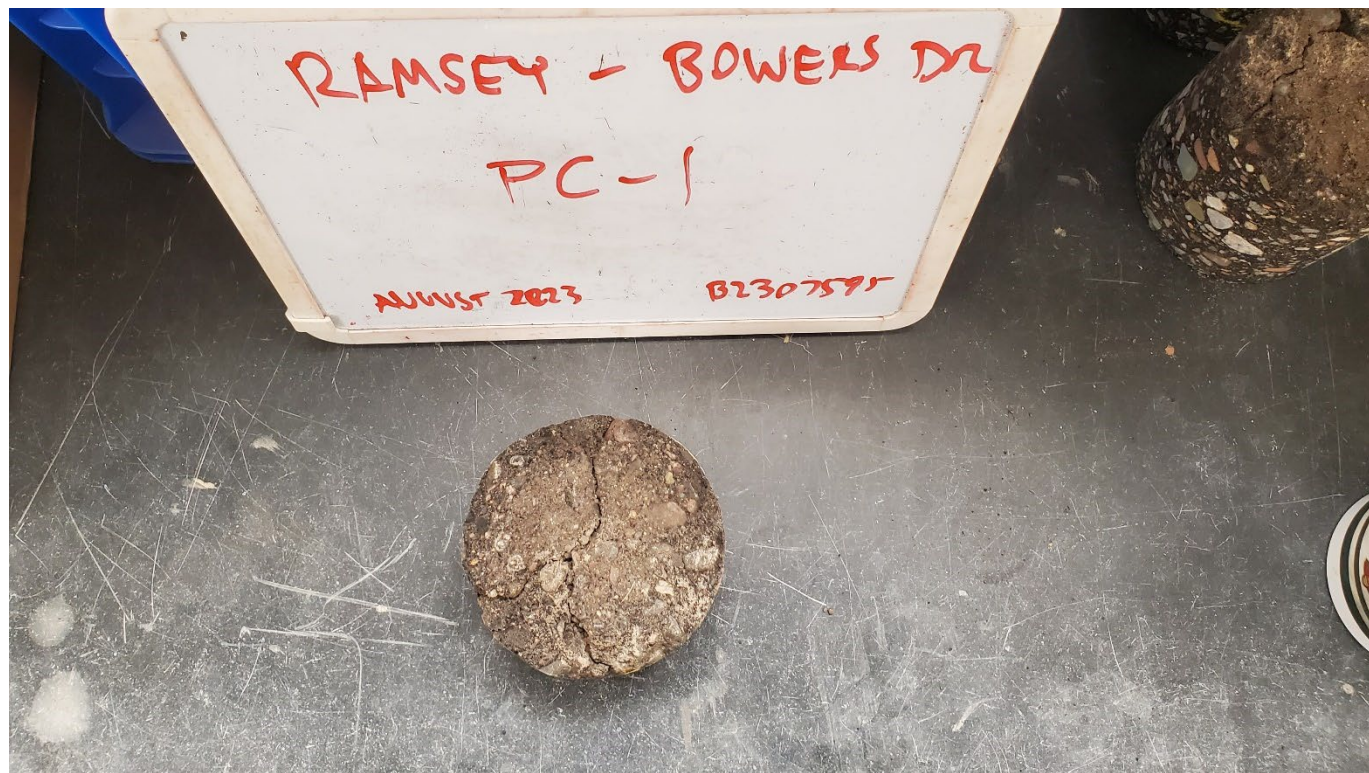
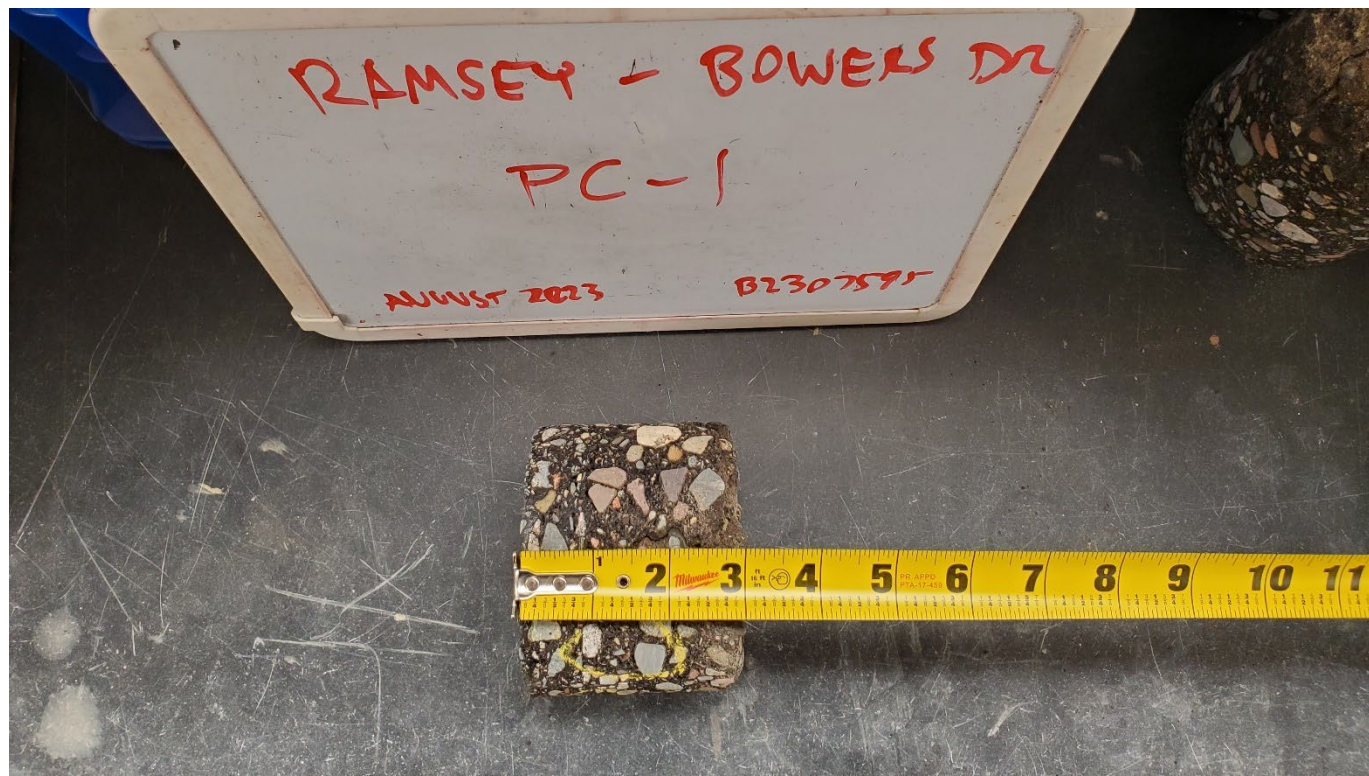
Core	Bit. Thickness (inches)	Core Condition	Apparent Aggregate Base Thickness (inches)	Apparent Aggregate Base Layer Description	Subbase/Subgrade Soil
PC-1	3	Crack through core, low-severity stripping	5	Sand and gravel	Silty sand (SM), fine-grained, trace gravel, dark brown, moist (to 26 inches)
PC-2	3 1/2	Cracks through core	**	**	**
PC-3	3 3/4	Crack through core	3	Sand and gravel (fine)	Poorly graded sand (SP), fine-grained, brown, moist (to 26 inches)

Core #:	PC-1			Project: B2307595 BRAUN INTERTEC
Pavement thickness:	3 inches	Agg base thickness:	5 inches	
Facility:	City of Ramsey - Bowers Drive			
Date:	August 2023

Notes: Bottom view

Notes: Side view

If mill and overlay will proceed, we recommend a mill depth of 1 1/2 inches, with a 1 1/2-inch-thick replacement mix meeting SPWEA240B. Thicker mill depths will risk breaking through the thin or damaged areas or will leave too little pavement to support construction equipment.

We recommend full depth milling or sawcutting and complete removal of pavements exhibiting these conditions, recompaction of the exposed soils and replacement with the same thickness of bituminous materials used for the overlay. We recommend having an experienced engineer walk the milled surface to delineate areas where further repair may be warranted based on conditions exposed by the milling process.

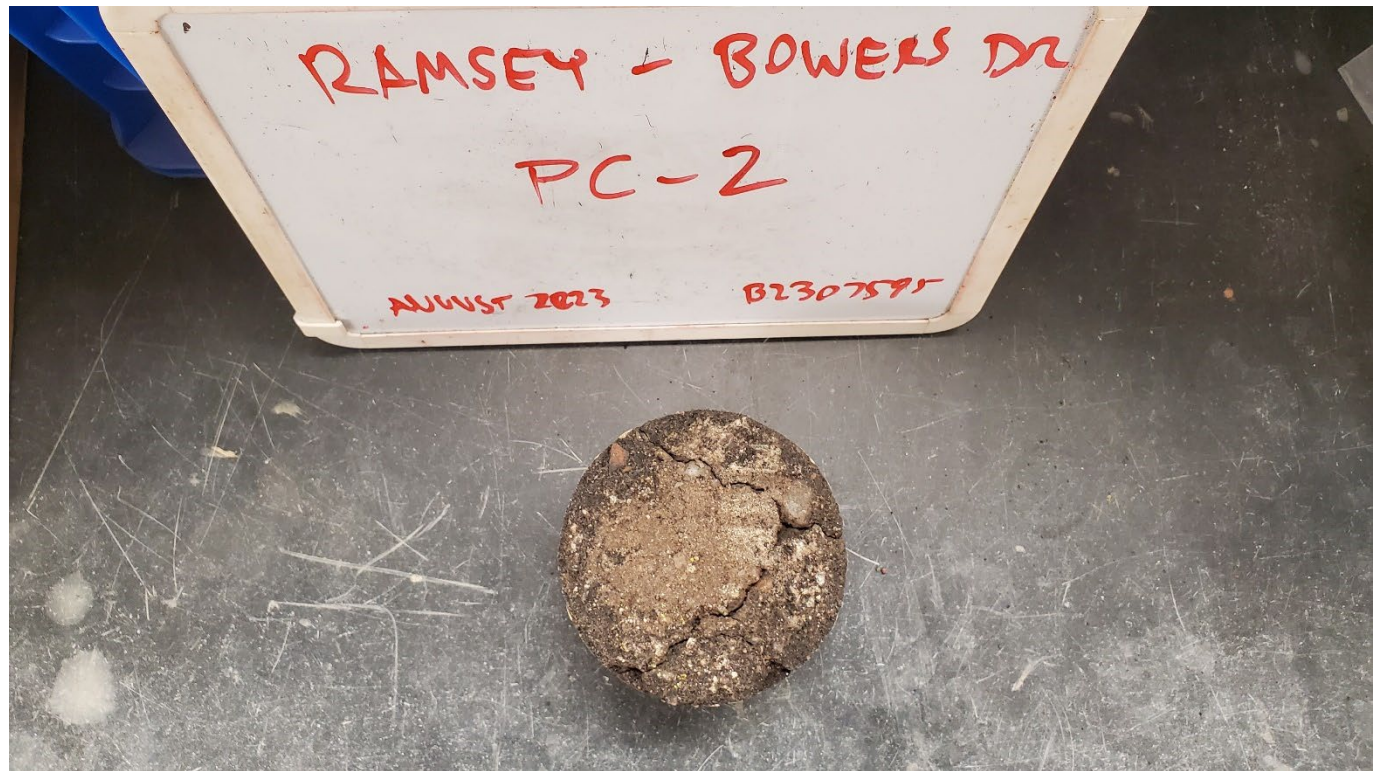
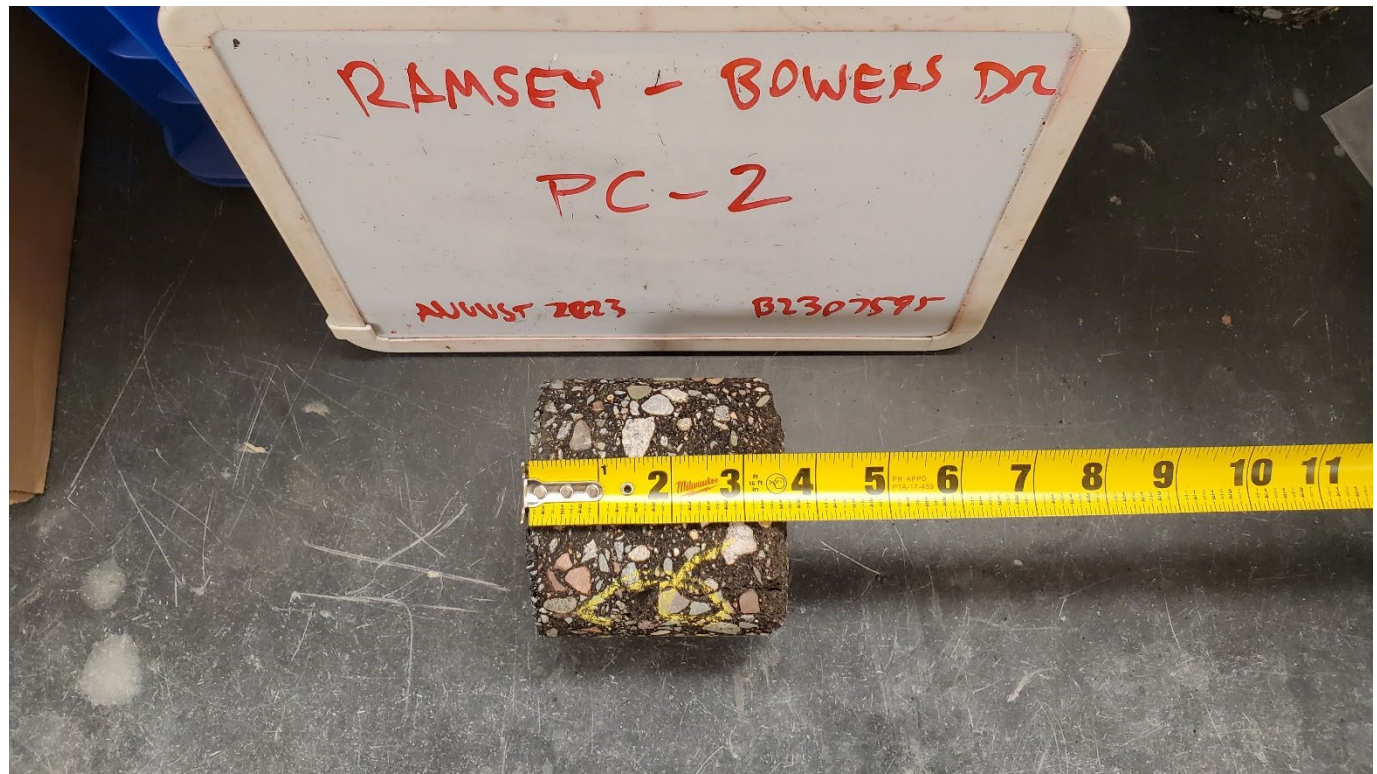
Core #:	PC-2			Project: B2307595 BRAUN INTERTEC
Pavement thickness:	3 1/2 inches	Agg base thickness:	--	
Facility:	City of Ramsey - Bowers Drive			
Date:	August 2023

Notes: Bottom view. No hand auger completed

Notes: Side view. No hand auger completed

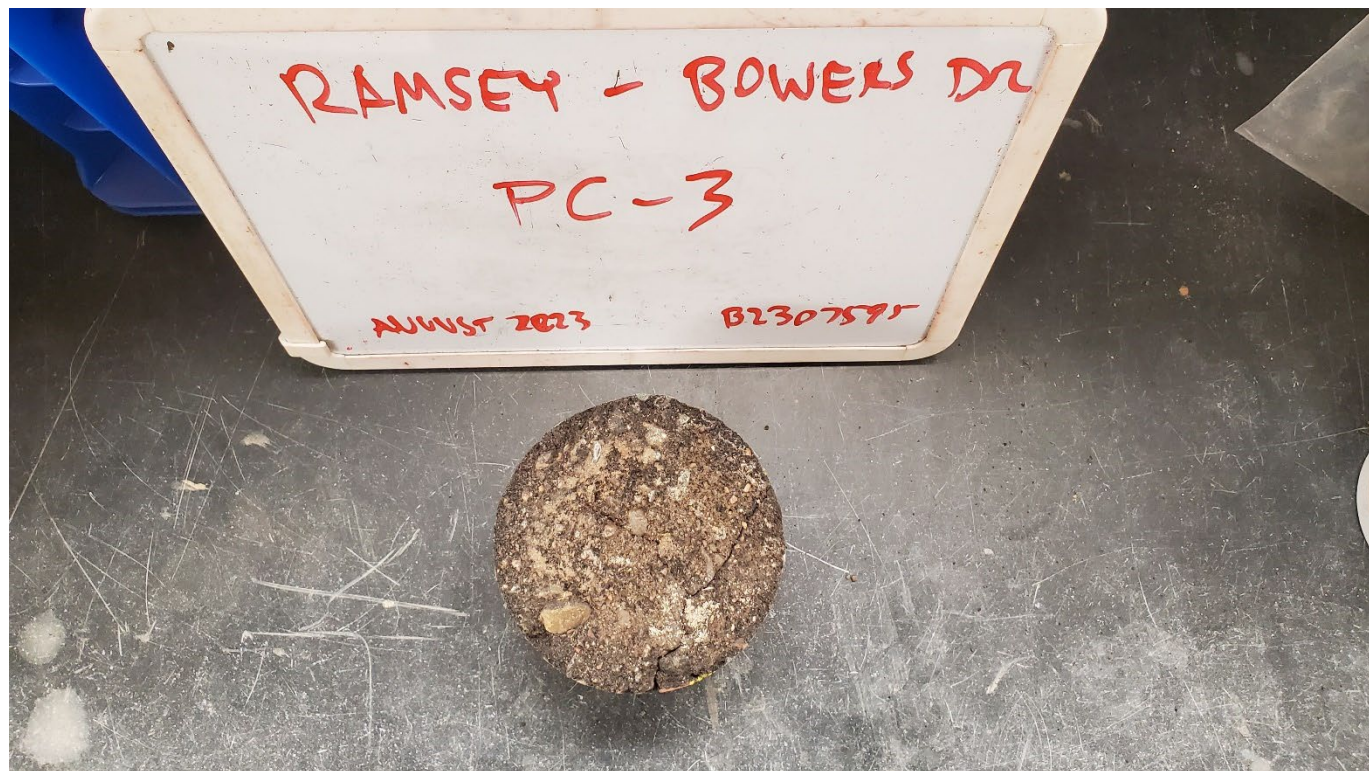
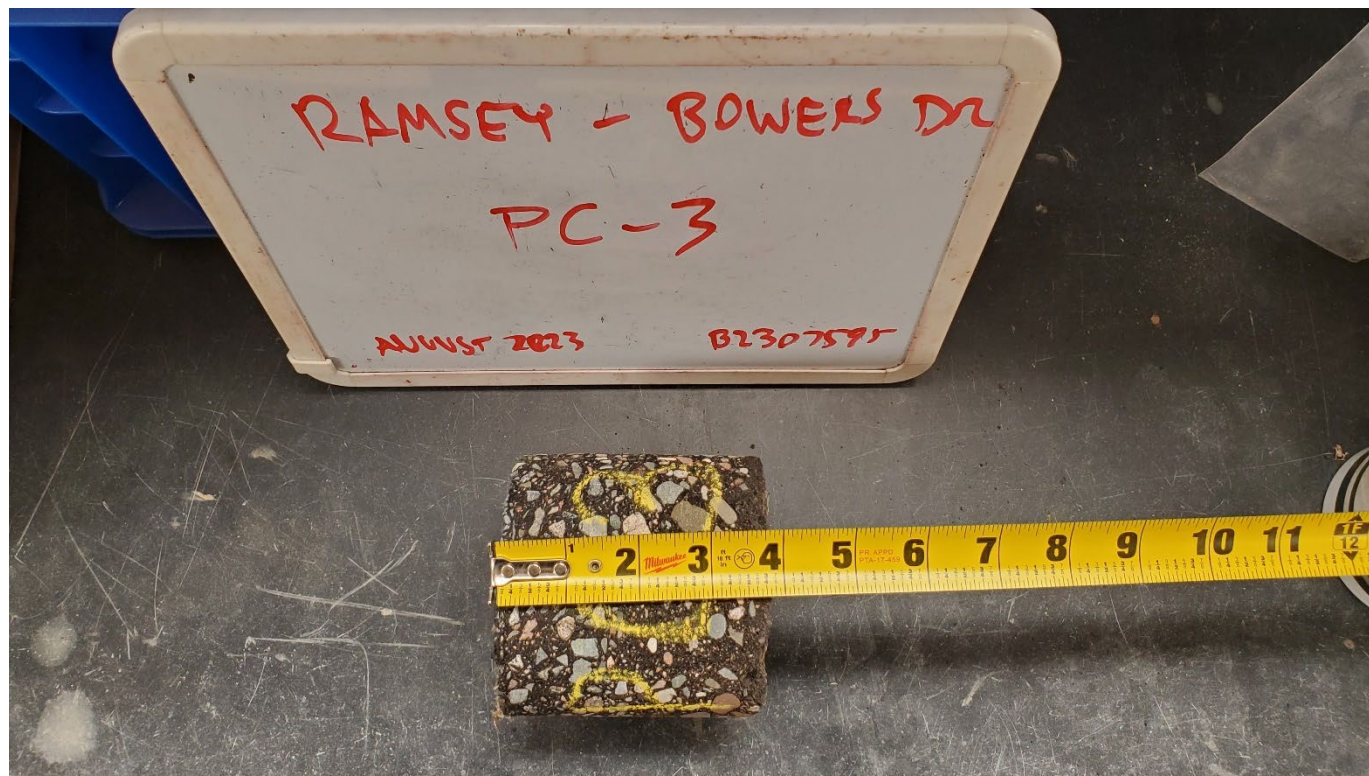
Core #:	PC-3			Project: B2307595 BRAUN INTERTEC
Pavement thickness:	3 3/4 inches	Agg base thickness:	3 inches	
Facility:	City of Ramsey - Bowers Drive			
Date:	August 2023

Notes: Bottom view

Notes: Side view

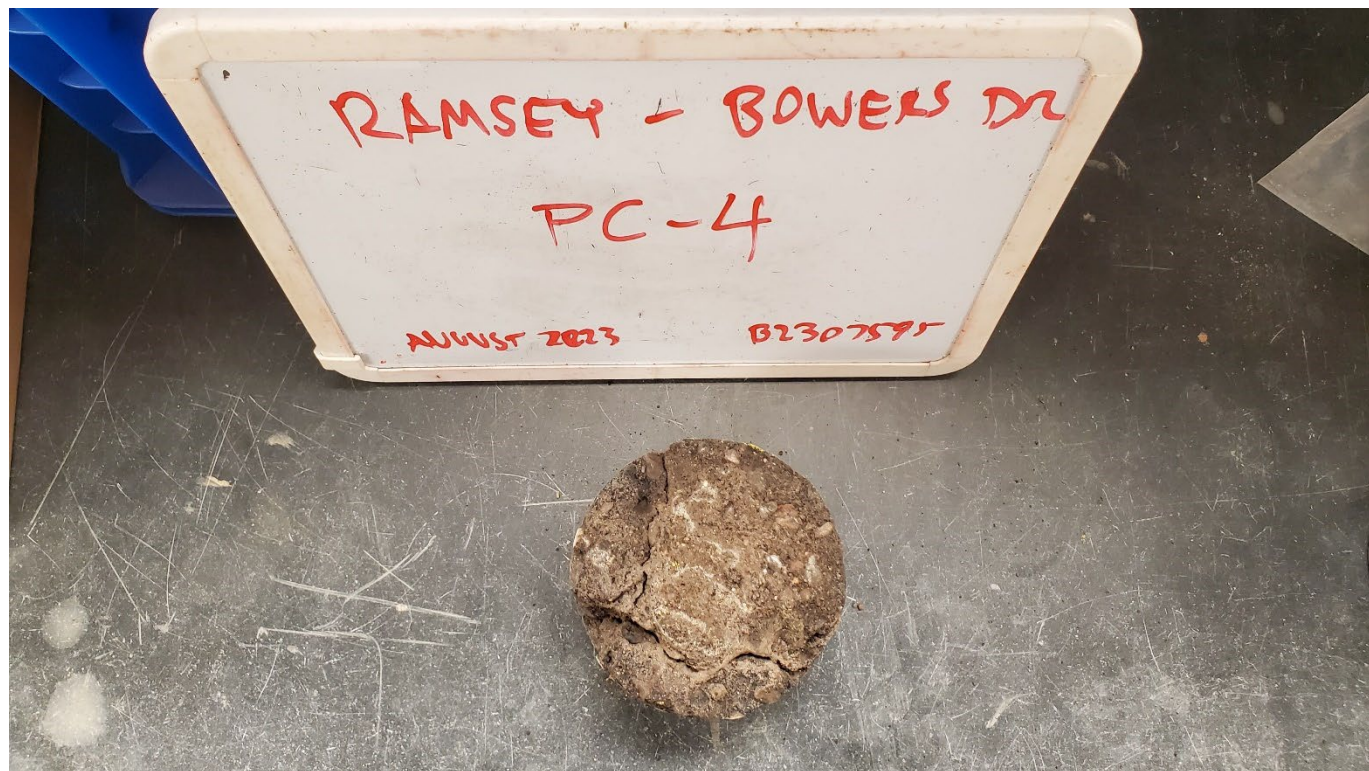
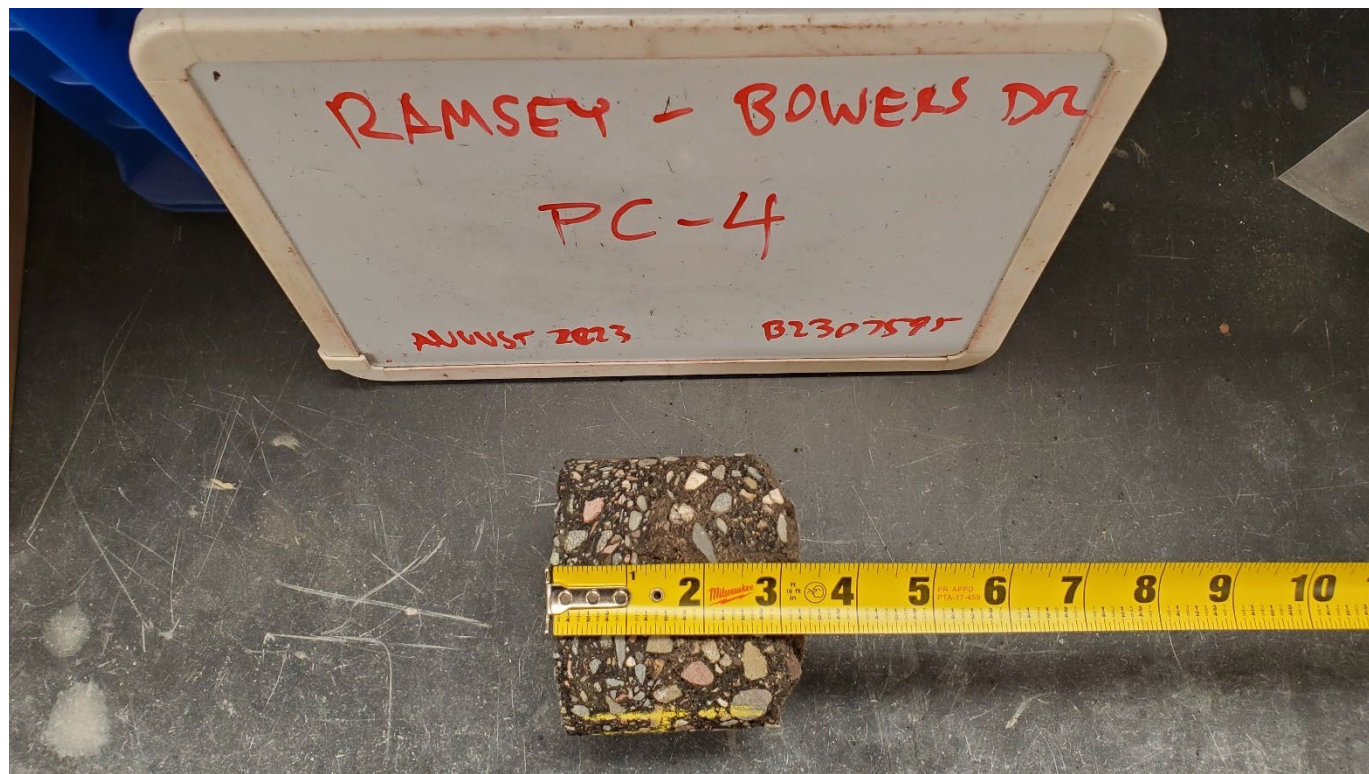
Core	Bit. Thickness (inches)	Core Condition	Apparent Aggregate Base Thickness (inches)	Apparent Aggregate Base Layer Description	Subbase/Subgrade Soil
PC-4	3 1/4	Cracks through core, low-severity stripping	**	**	**
PC-5	5	Crack through core, low-severity stripping	12	Sand and gravel	Poorly graded sand with silt (SP-SM), fine-grained, brown, moist (to 28 inches)
PC-6	2 1/4	Cracks through core	**	**	**
PC-7	2 3/4	Cracks through core; high severity stripping, debonding	4	Sand and gravel	Silty sand (SM), fine-grained, dark brown, moist (to 17 inches) Sandy lean clay (CL), brown, moist (17 to 27 inches)
PC-8	3 3/4	Cracks through core	**	**	**
PC-9	2 3/4	Cracks through core; high severity stripping, debonding	4	Sand and gravel	Silty sand (SM), fine-grained, dark brown, moist (to 17 inches) Sandy lean clay (CL), brown, moist (17 to 27 inches)
PC-10	3	Cracks through core; high severity stripping, debonding	**	**	**

Core #:	PC-4			Project: B2307595 BRAUN INTERTEC
Pavement thickness:	3 1/4 inches	Agg base thickness:	--	
Facility:	City of Ramsey - Bowers Drive			
Date:	August 2023

Notes: Bottom view. No hand auger completed

Core #:	PC-4			Project: B2307595 BRAUN INTERTEC
Pavement thickness	3 1/4 inches	Agg base thickness:	--	
Facility:	City of Ramsey - Bowers Drive			
Date:	August 2023

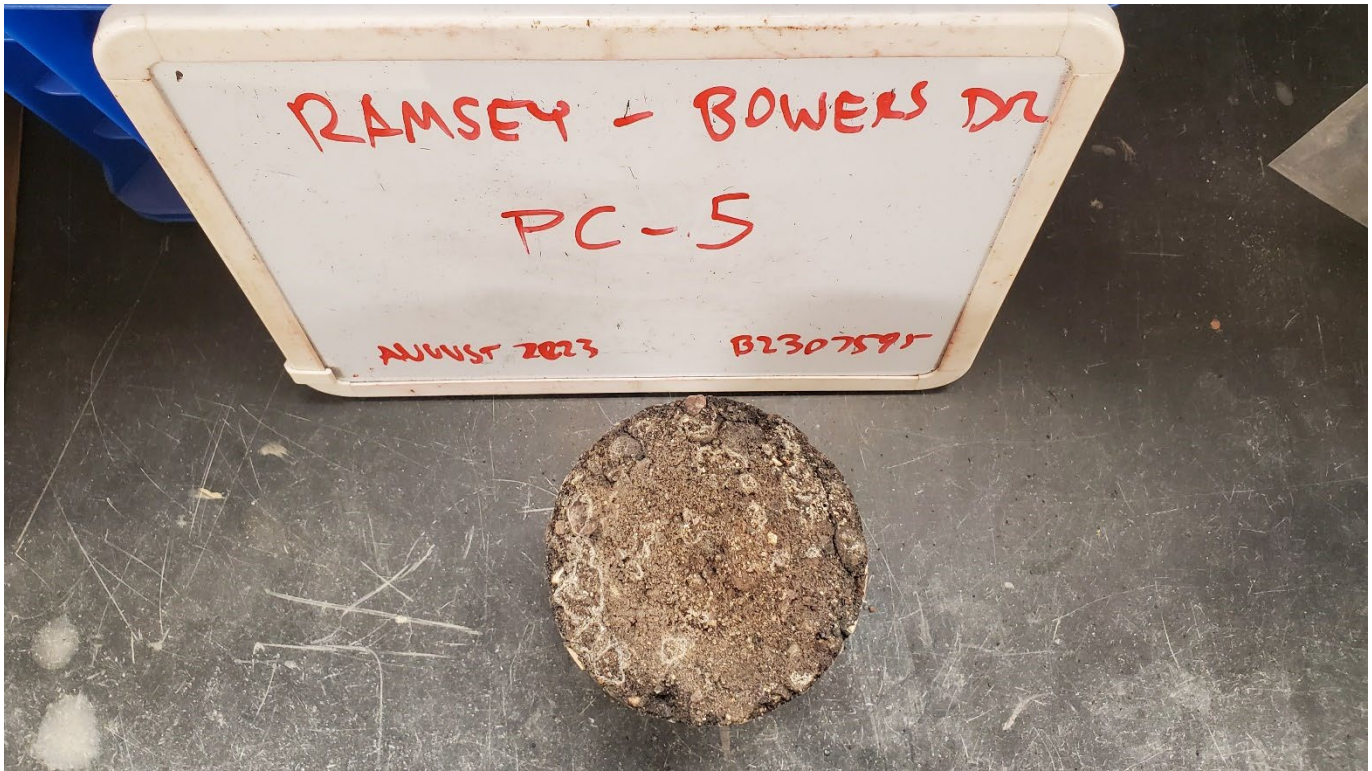
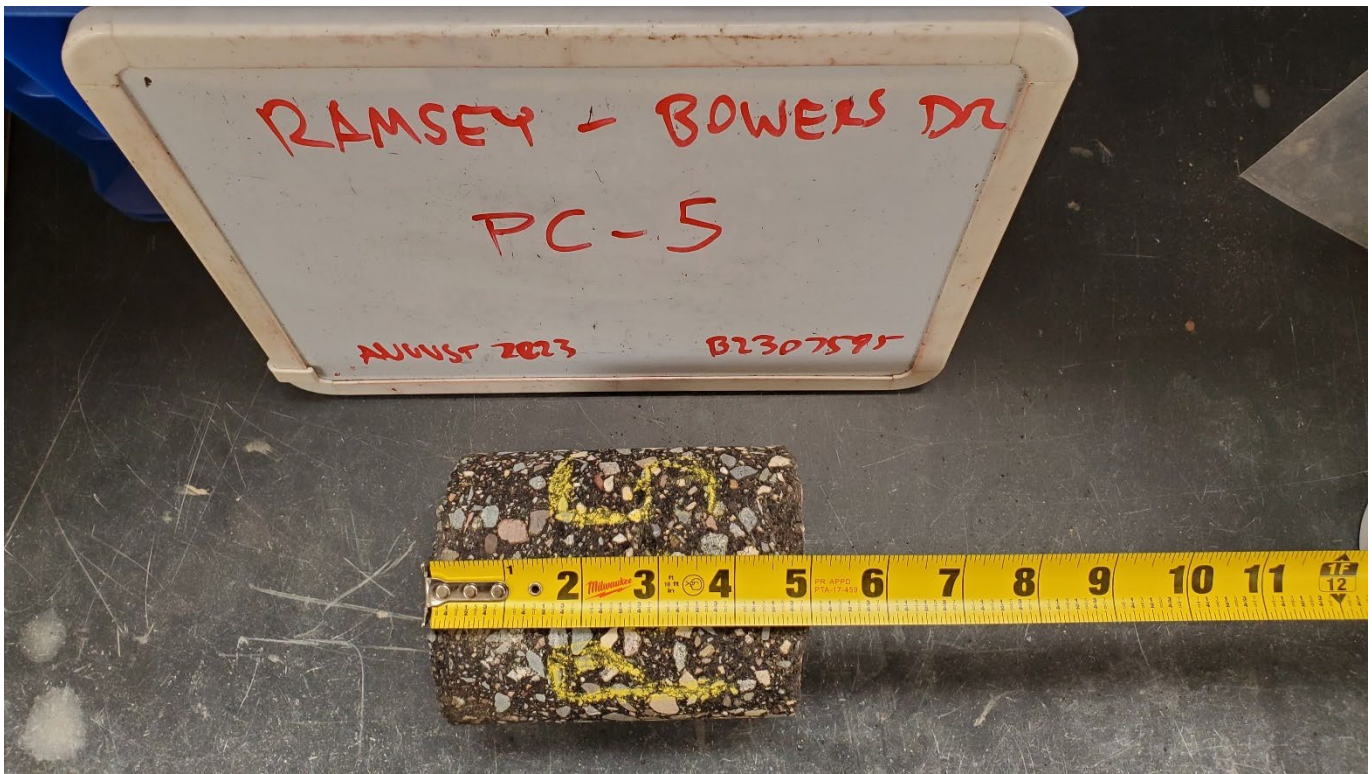
Core #:	PC-5			Project: B2307595 BRAUN INTERTEC
Pavement thickness:	5 inches	Agg base thickness:	12 inches	
Facility:	City of Ramsey - Bowers Drive			
Date:	August 2023

Notes: Bottom view

Notes: Side view

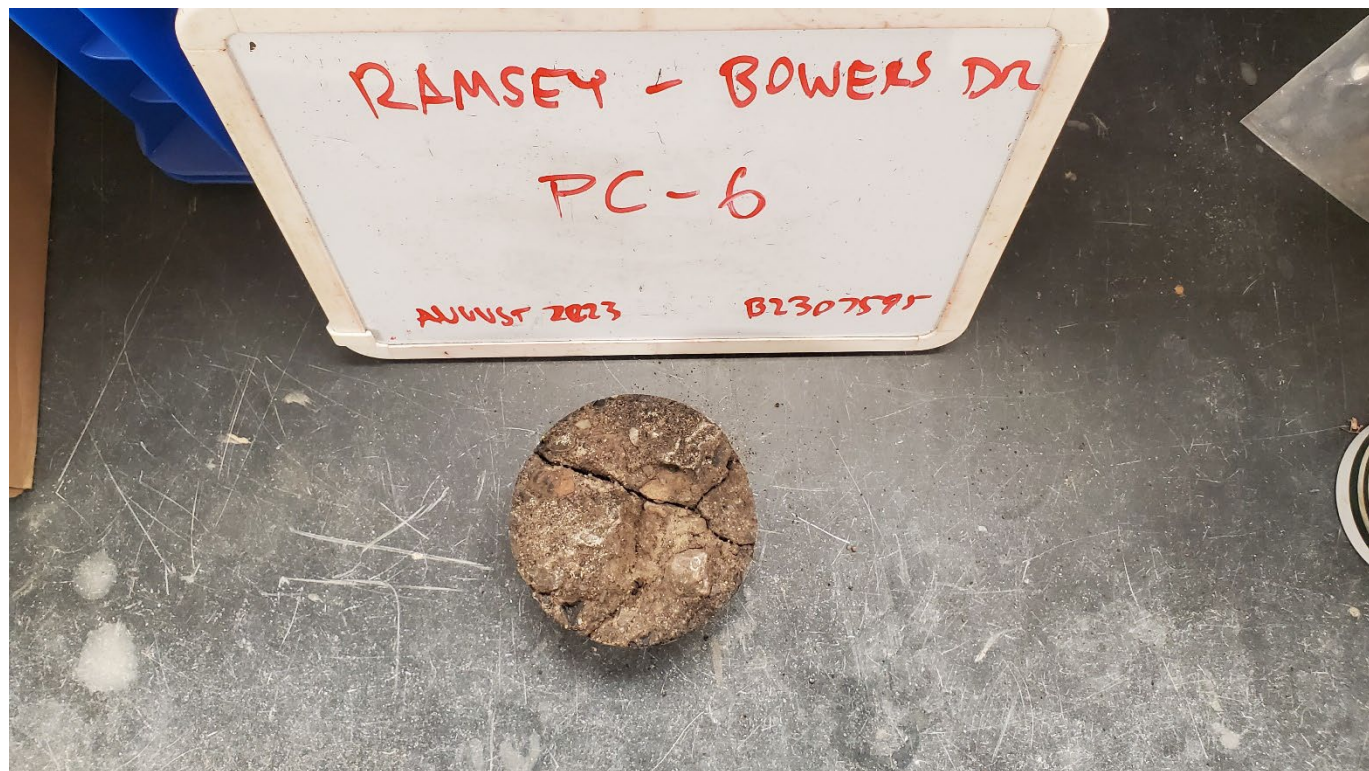
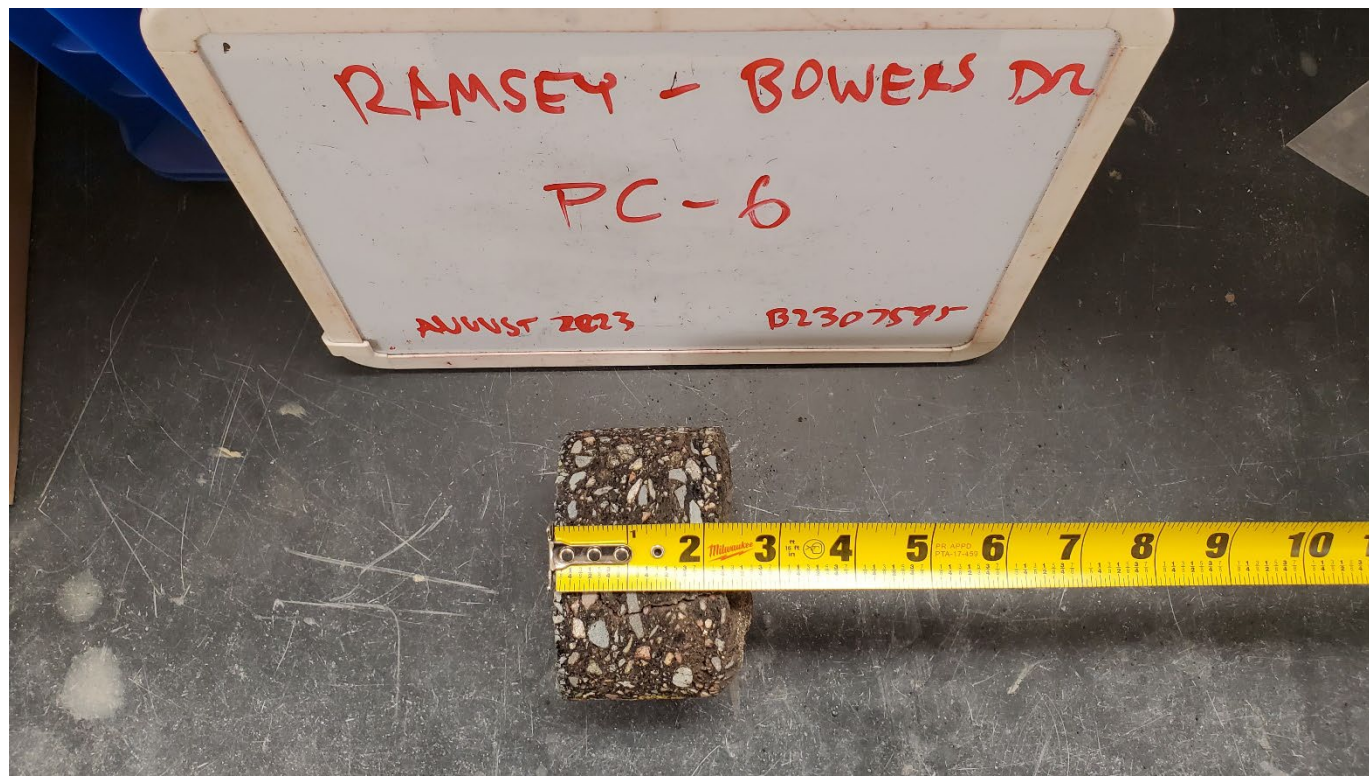
Core #:	PC-6			Project: B2307595 BRAUN INTERTEC
Pavement thickness:	2 1/4 inches	Agg base thickness:	--	
Facility:	City of Ramsey - Bowers Drive			
Date:	August 2023

Notes: Bottom view. No hand auger completed

Notes: Side view. No hand auger completed

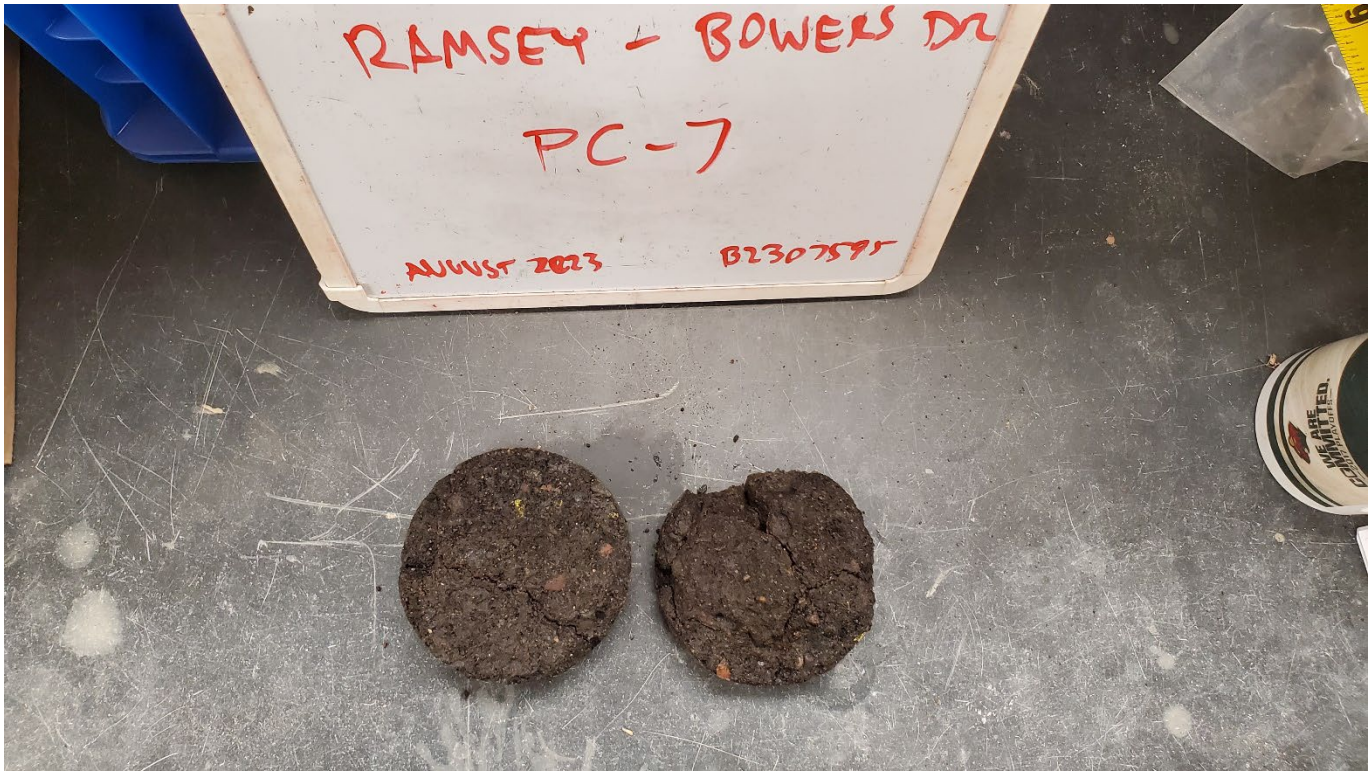
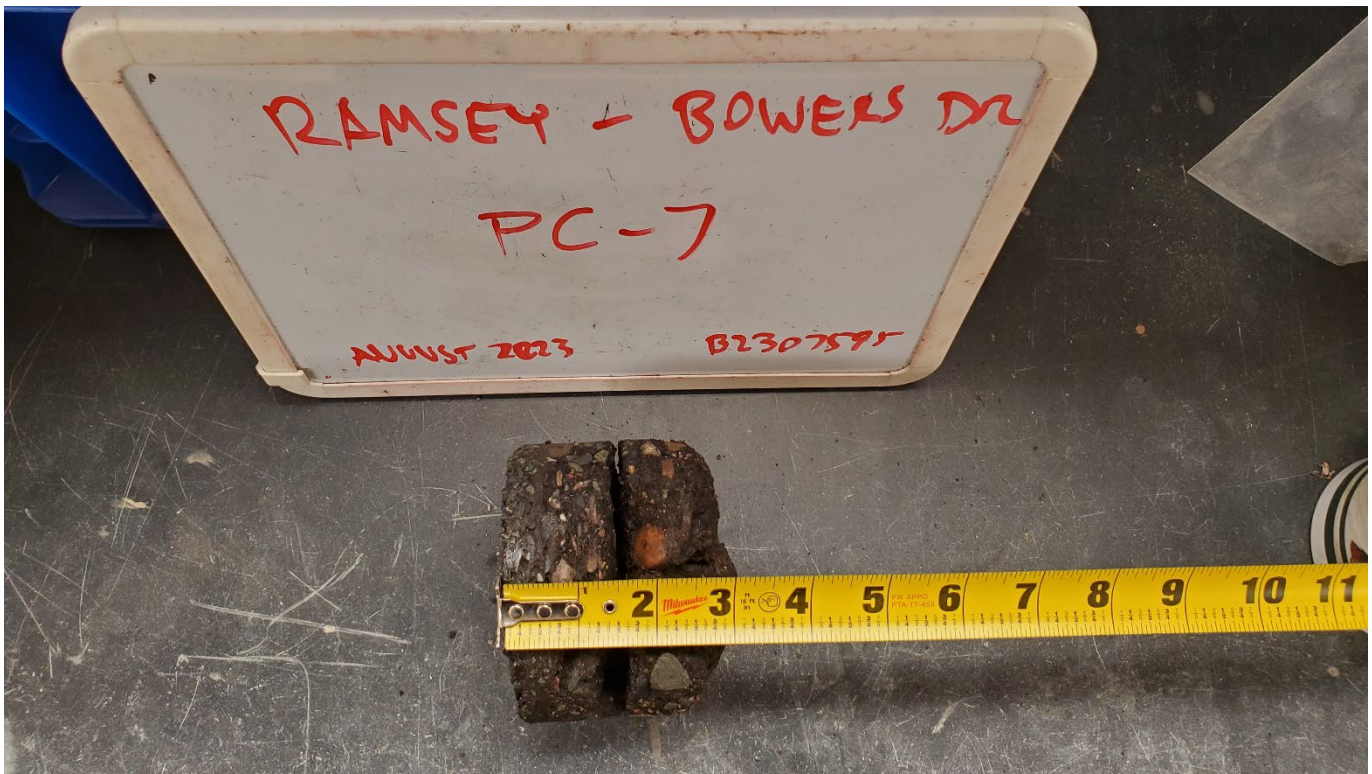
The subgrade soils underlying apparent aggregate base consisted of mainly of granular soils with varying silt content. The exception is PC-7, where we penetrated a layer of sandy lean clay between 17 inches deep and the termination of the hand auger boring.

Core #:	PC-7			Project: B2307595 BRAUN INTERTEC
Pavement thickness:	2 3/4 inches	Agg base thickness:	4 inches	
Facility:	City of Ramsey - Bowers Drive			
Date:	August 2023

Notes: Bottom view

Notes: Side view

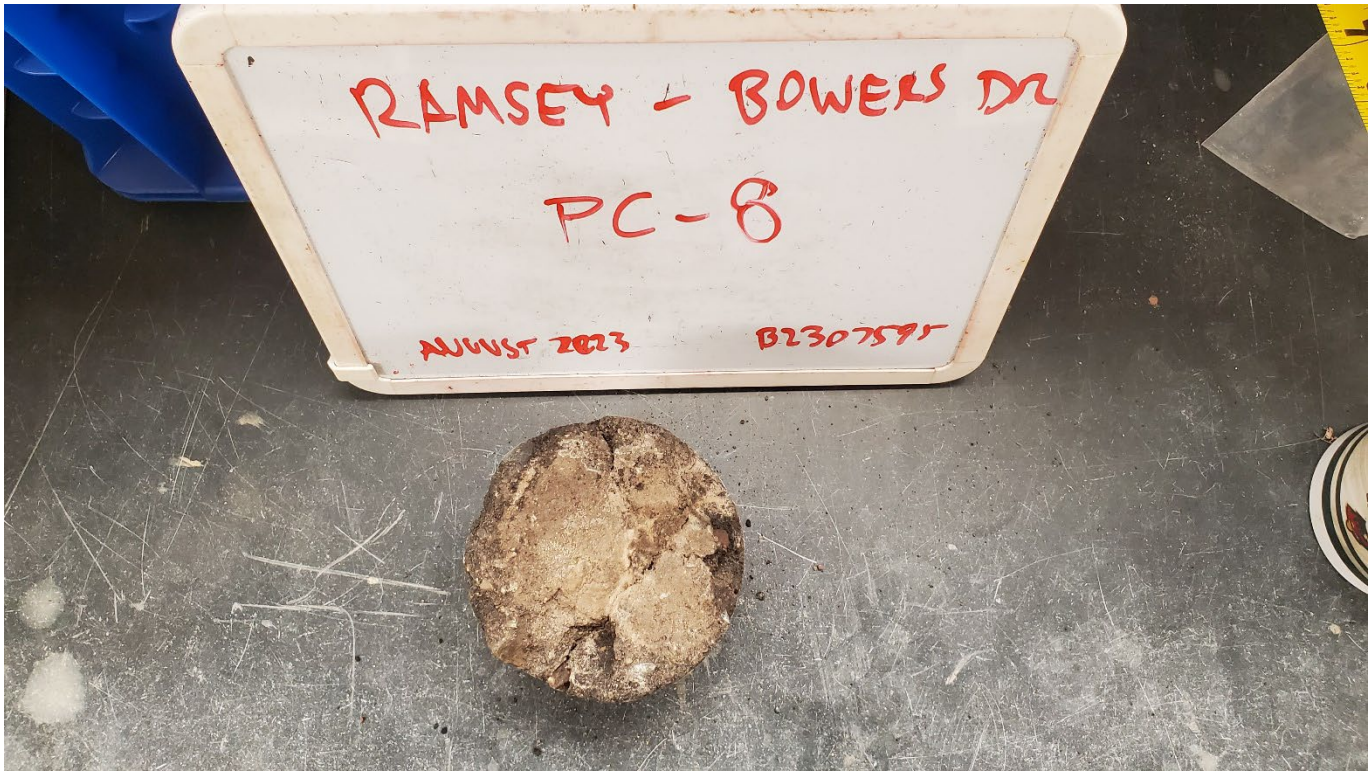
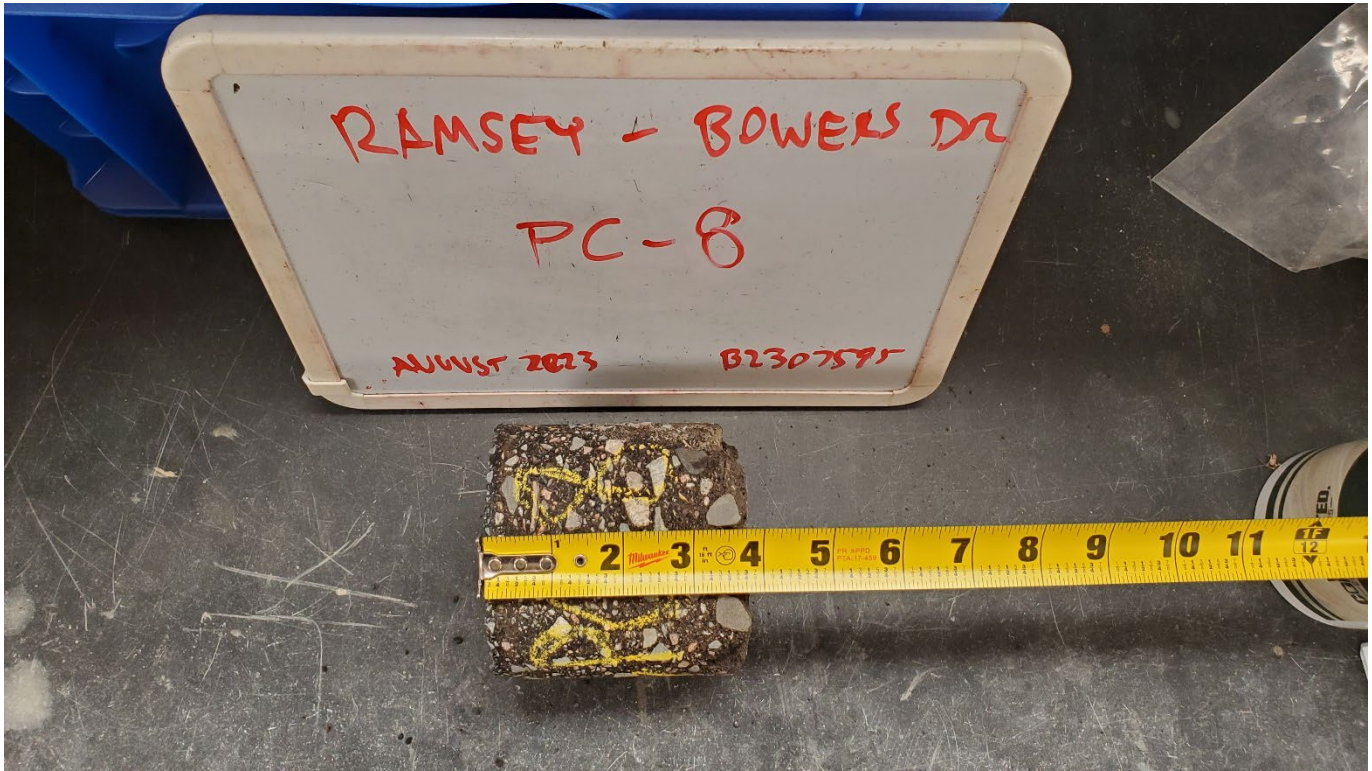
Core #:	PC-8			Project: B2307595 BRAUN INTERTEC
Pavement thickness:	3 3/4 inches	Agg base thickness:	--	
Facility:	City of Ramsey - Bowers Drive			
Date:	August 2023

Notes: Bottom view. No hand auger completed

Notes: Side view. No hand auger completed
