Project B2307595

Re: Pavement Evaluation
Bowers Drive Mill and Overlay Evaluation
US 10 to Cul-de-sac
Ramsey, Minnesota

BOWERS DRIVE PAVEMENT CORES

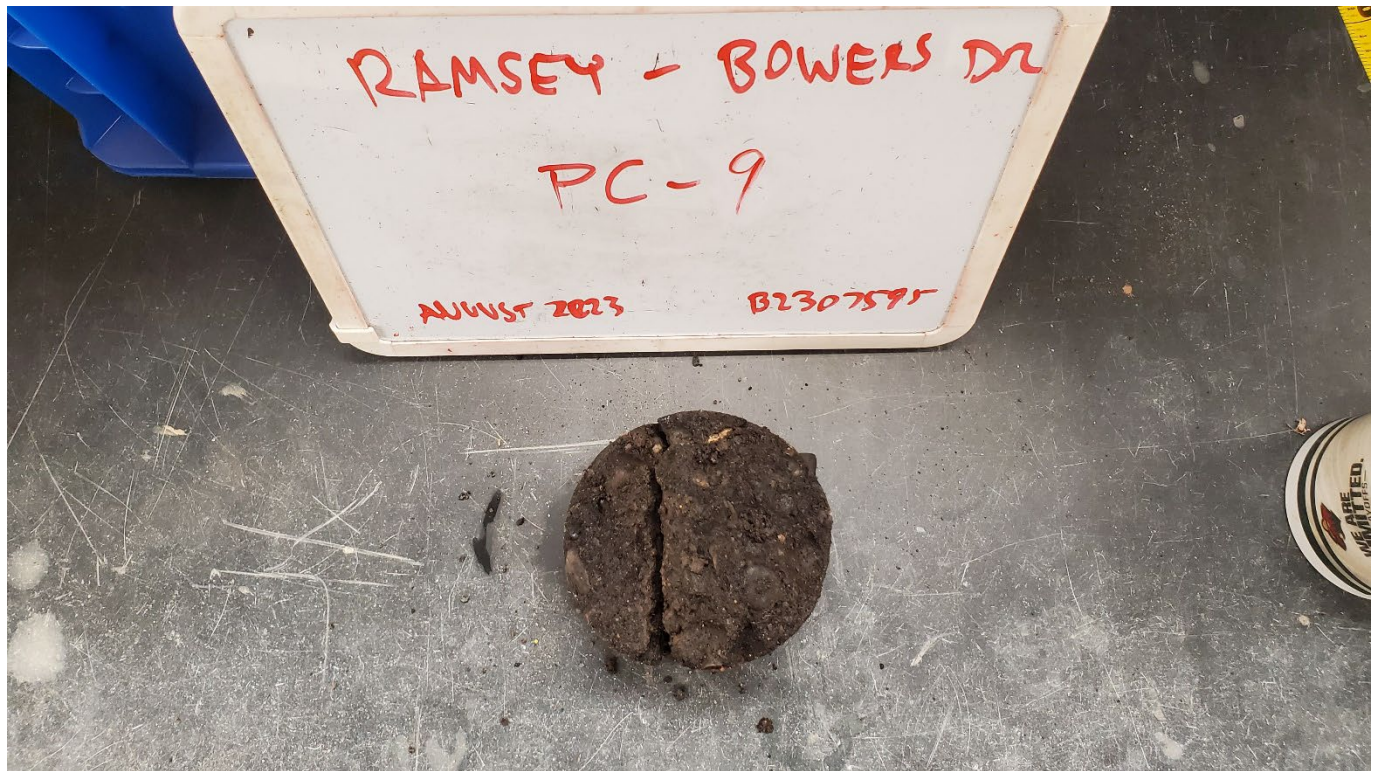
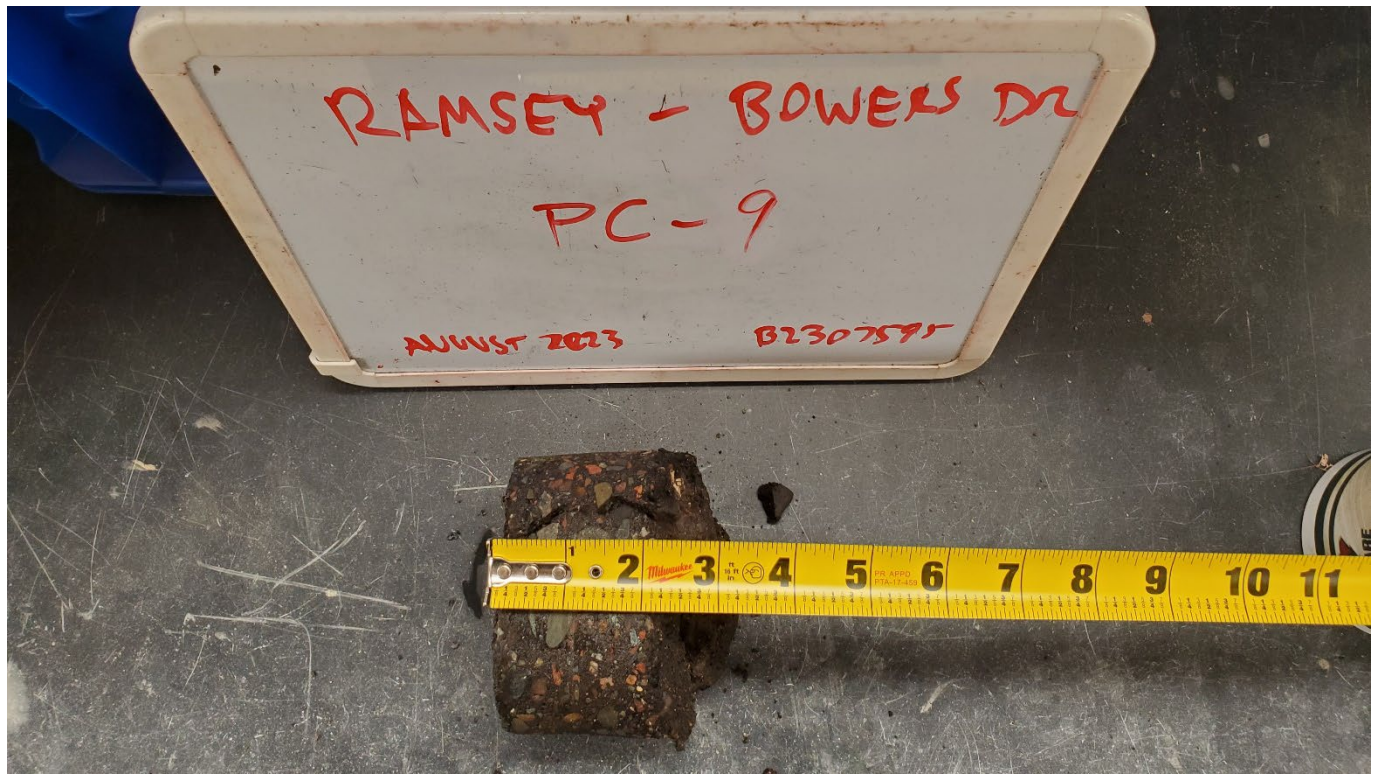
Core #:	PC-9			Project: B2307595 BRAUN INTERTEC
Pavement thickness:	2 3/4 inches	Agg base thickness:	4 inches	
Facility:	City of Ramsey - Bowers Drive			
Date:	August 2023

Notes: Bottom view

Notes: Side view

If mill and overlay will proceed, we recommend a mill depth of 1 1/2 inches, with a 1 1/2-inch-thick replacement mix meeting SPWEA240B. Thicker mill depths will risk breaking through the thin or damaged areas or will leave too little pavement to support construction equipment.

We recommend full depth milling or sawcutting and complete removal of pavements exhibiting these conditions, recompaction of the exposed soils and replacement with the same thickness of bituminous materials used for the overlay. We recommend having an experienced engineer walk the milled surface to delineate areas where further repair may be warranted based on conditions exposed by the milling process.

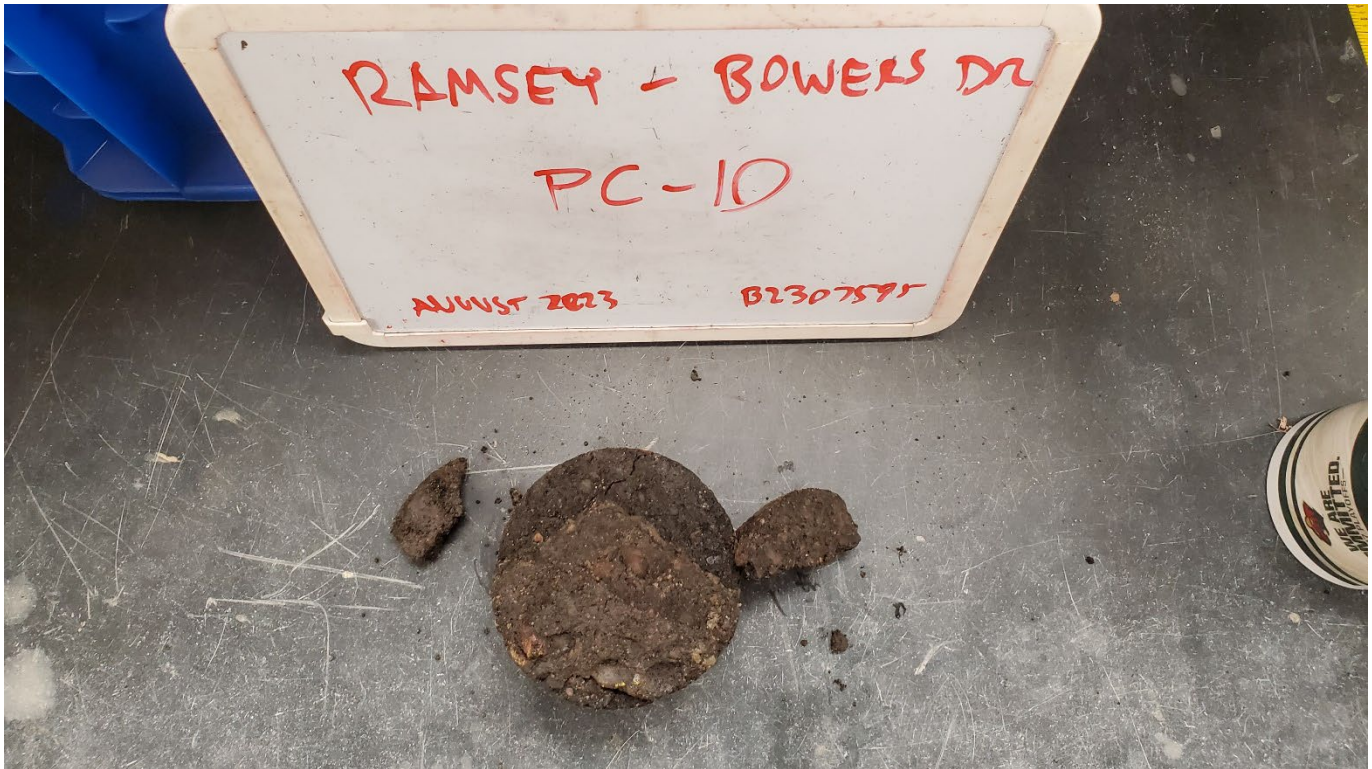
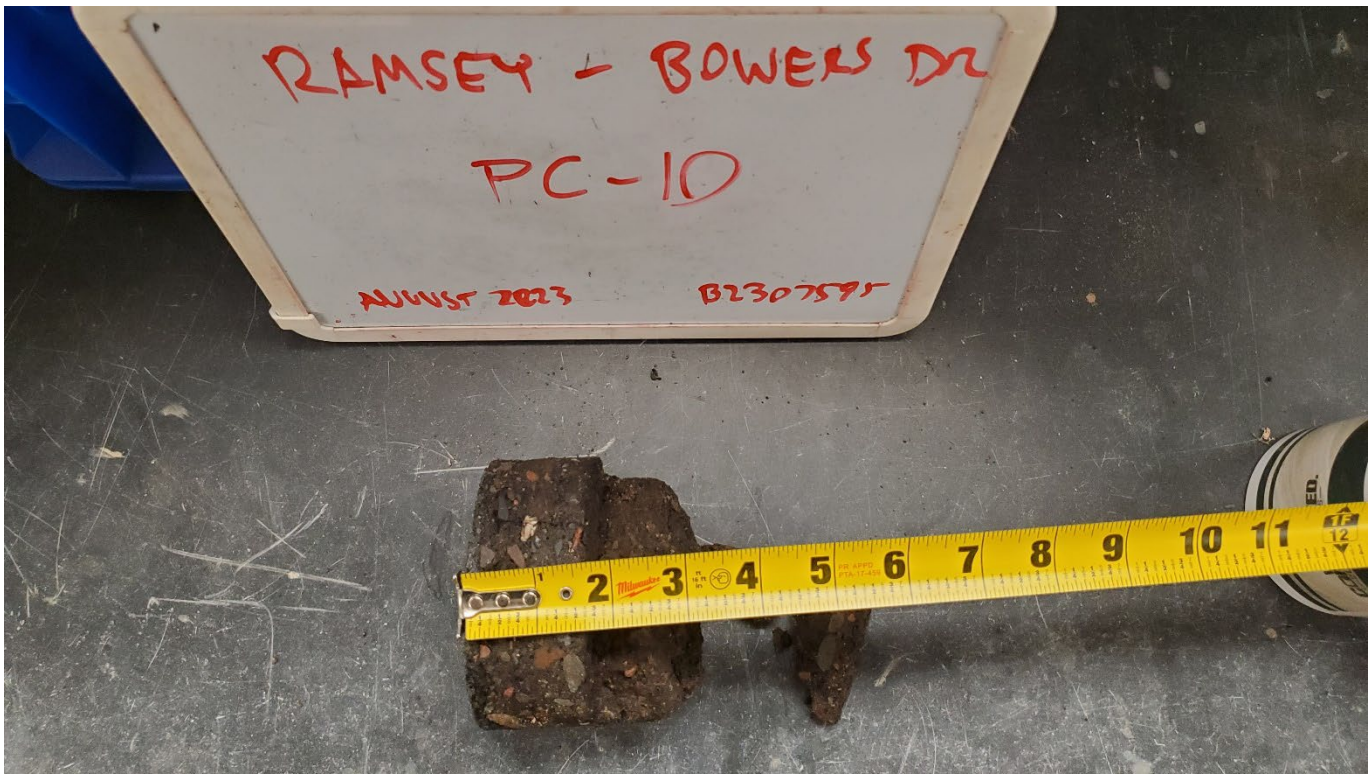
Core	Bit. Thickness (inches)	Core Condition	Apparent Aggregate Base Thickness (inches)	Apparent Aggregate Base Layer Description	Subbase/Subgrade Soil
PC-4	3 1/4	Cracks through core, low-severity stripping	**	**	**
PC-5	5	Crack through core, low-severity stripping	12	Sand and gravel	Poorly graded sand with silt (SP-SM), fine-grained, brown, moist (to 28 inches)
PC-6	2 1/4	Cracks through core	**	**	**
PC-7	2 3/4	Cracks through core; high severity stripping, debonding	4	Sand and gravel	Silty sand (SM), fine-grained, dark brown, moist (to 17 inches) Sandy lean clay (CL), brown, moist (17 to 27 inches)
PC-8	3 3/4	Cracks through core	**	**	**
PC-9	2 3/4	Cracks through core; high severity stripping, debonding	4	Sand and gravel	Silty sand (SM), fine-grained, dark brown, moist (to 17 inches) Sandy lean clay (CL), brown, moist (17 to 27 inches)
PC-10	3	Cracks through core; high severity stripping, debonding	**	**	**

Core #:	PC-10			Project: B2307595 BRAUN INTERTEC
Pavement thickness:	3 inches	Agg base thickness:	--	
Facility:	City of Ramsey - Bowers Drive			
Date:	August 2023

Notes: Bottom view. No hand auger completed

Notes: Side view. No hand auger completed

If the potential service life or cost of the mill and overlay as described above is not acceptable, an option is to full depth mill the damaged pavements and replace them with at least 3 inches of SPWEA240C in two lifts. This will provide the opportunity to recompact aggregate materials, test roll and treat soft subgrades and perform fine grading, all of which will contribute to a more uniform pavement section that will have a service life of 15 to 20 years.

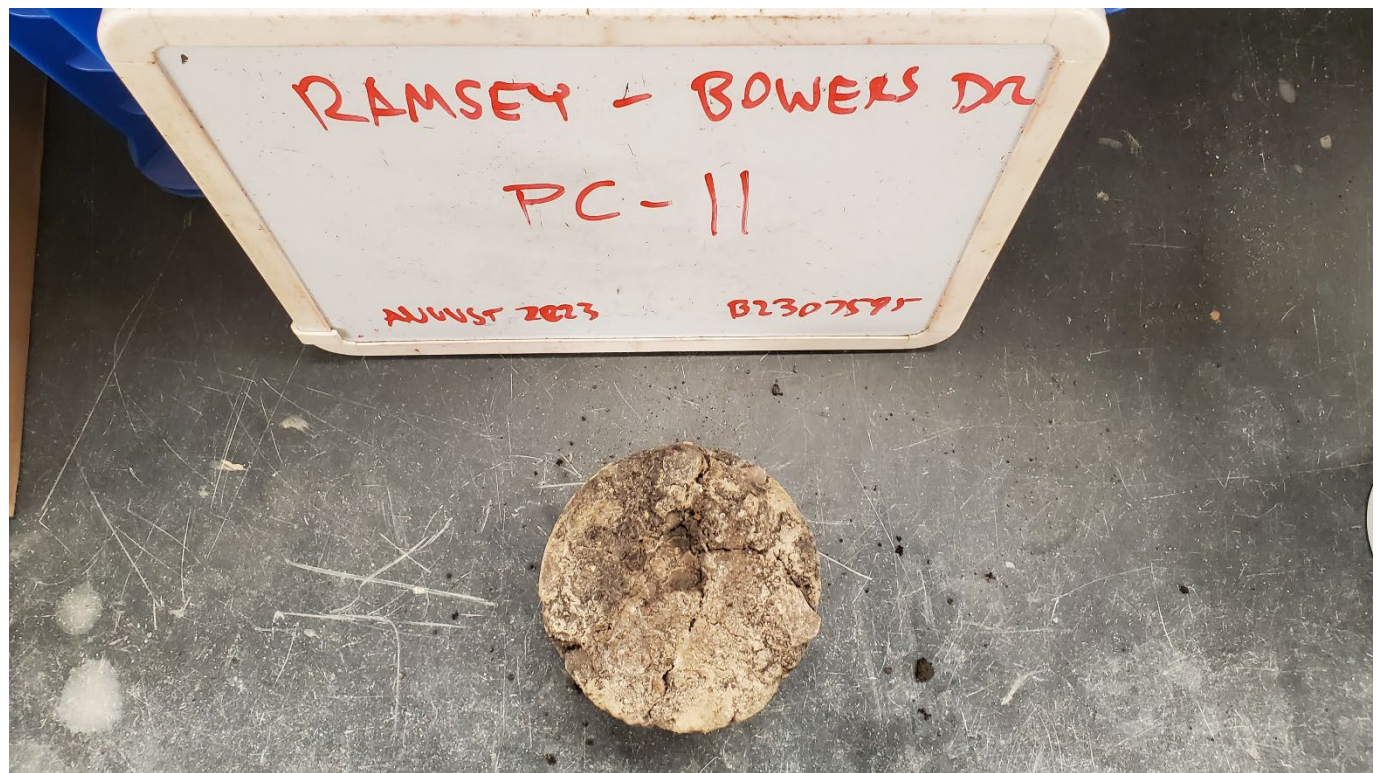
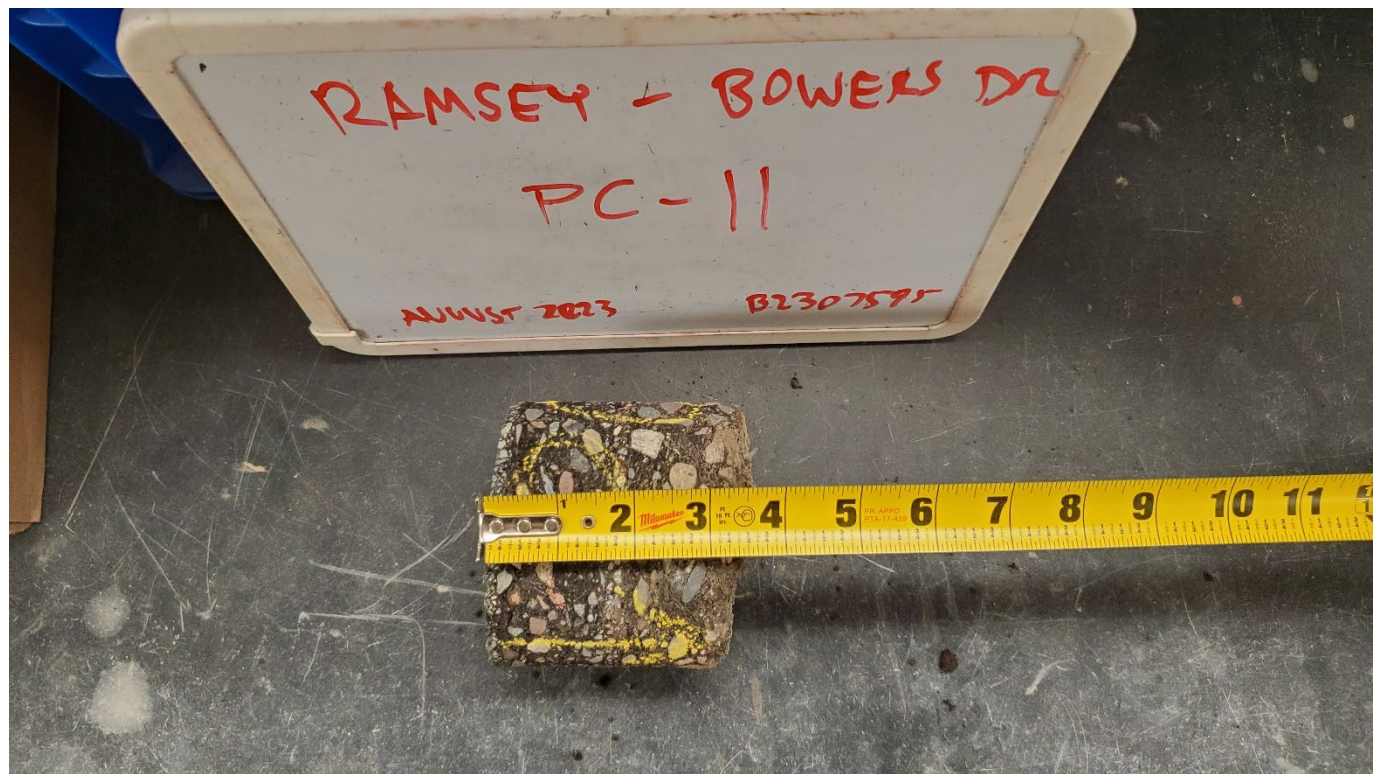
PC-11	3 1/2	Cracks through core	24	Sand and gravel	Poorly graded sand (SP), fine-grained, brown, moist (to 36 inches)

Core #:	PC-11			Project: B2307595 BRAUN INTERTEC
Pavement thickness:	3 1/2 inches	Agg base thickness:	24 inches	
Facility:	City of Ramsey - Bowers Drive			
Date:	August 2023

Notes: Bottom view

Notes: Side view
