**City of Ramsey**  
**Agenda**  
**City Council Work Session**  
**Tuesday, April 9, 2024**

The Waterfront - Community Building Operations Forecast and Planning Status

# RAMSEY TOWN HALL, Ramsey, Minnesota

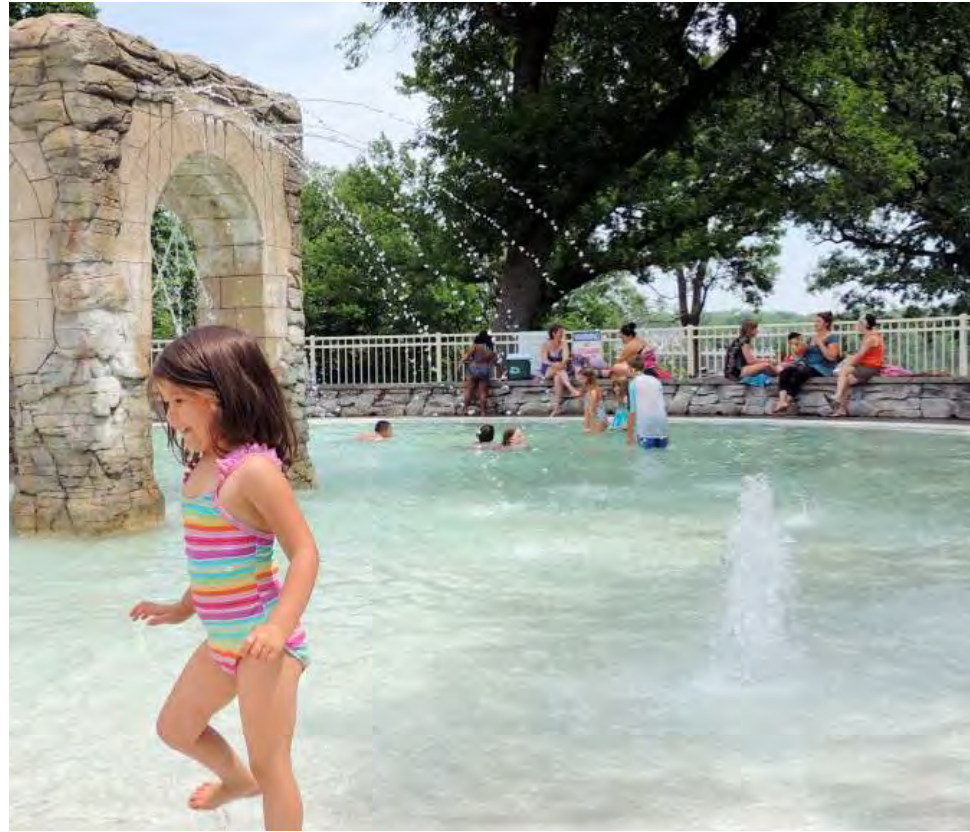
## WADING POOL:

Wading pools are shallow pools that are usually less than two feet deep. They're best for young children to splash around and cool off without having to worry about swimming. Wading pools are governed by the MN pool code.

- **Defining Features:** 2' standing water depth, can also incorporate fountains, jets, structural play elements
- **Seasonal Interest:** Open when the temperature is 65 degrees and higher.
- **Depth**  
Min: 2"      Max: 24"
- **Fencing:** Yes - code now requires a 48" high perimeter fence.
- **Rules:** Requires the direct supervision by an adult caregiver.
- **Revenue:** Possible - Staff could monitor access at fence gate.
- **Capacity:** Varies depending on size. 15 square feet per bather.
- **Approximate Days of Use:** 100

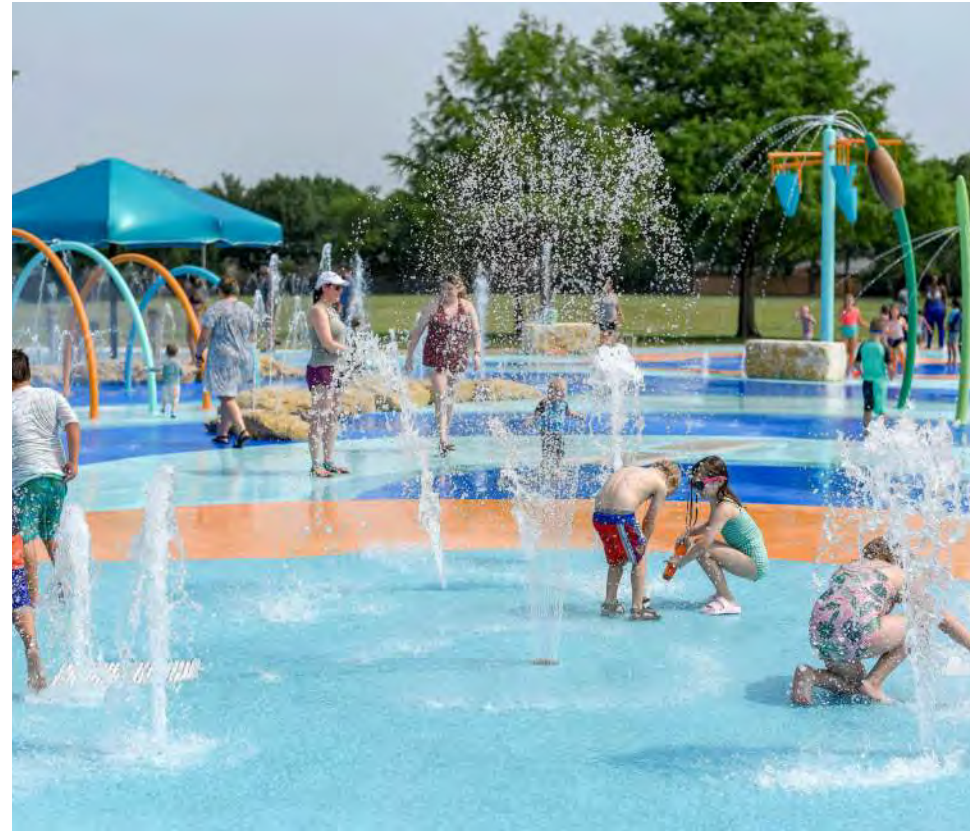
## SPLASH PAD:

Traditional splash pads are fountain/water features intended for recreational use and designed to contain no more than 1 inch of water depth. Splash pads vary greatly in design, scale and features, but in general they allow users interact with bubblers, water nozzles and sprinklers and fountains.

- **Defining Features:** 1" max standing water depth with interactive fountains, jets, structural play elements
- **Seasonal Interest:** Open when the temperature is 65 degrees and higher.
- **Depth**  
Min: 0" / Zero Entry      Max: 2"
- **Fencing:** Fencing is not required
- **Rules:** Not required, but recommended for caregivers to accompany and supervise children
- **Revenue:** If the design includes a fenced area - revenue generation is possible.
- **Capacity:** Varies depending on size. 15 square feet per bather.
- **Approximate Days of Use:** 100

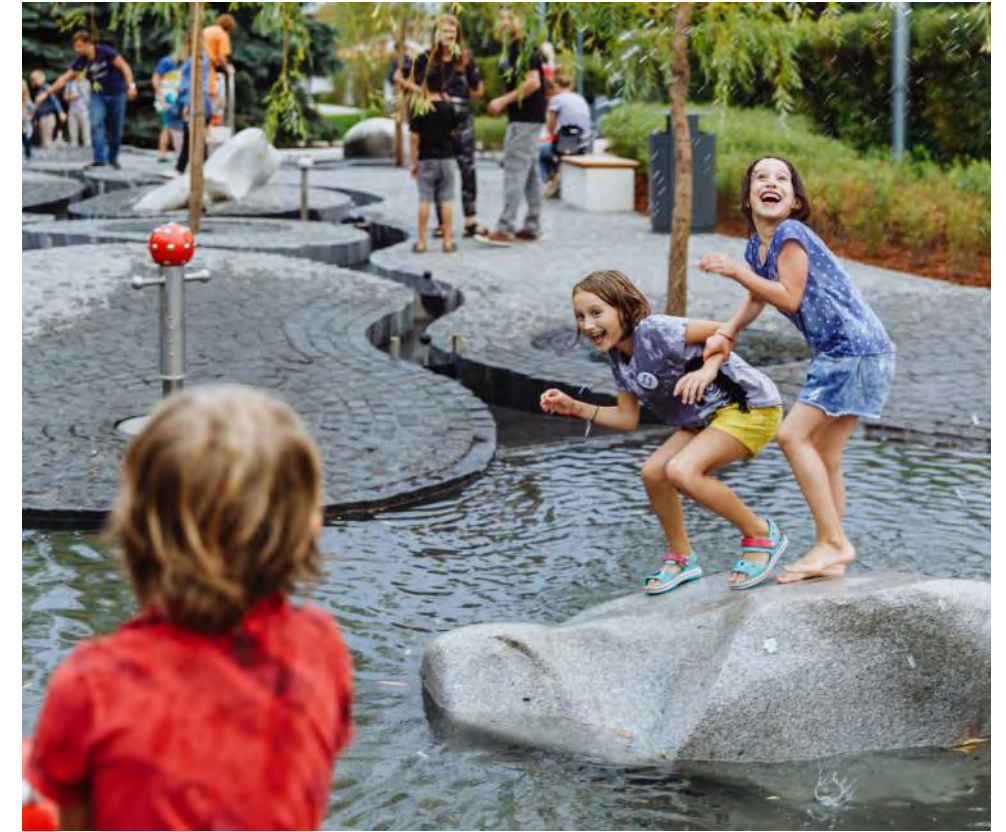
## ARCHITECTURAL WATER PLAY:

Custom experience for users. Artistic/sculptural features provide outdoor interest for users throughout all seasons. Contextually unique design affords users a sensory destination even when water features are not available.

- **Defining Features:** Integrated sculptural/interpretive water features
- **Seasonal Interest:** Open when the temperature is 65 degrees and higher. Lights and artistic/sculptural features provide 4 season interest.
- **Depth**  
Min: 0" / Zero Entry      Max: 24"
- **Fencing:** Not required, but recommended for caregivers to accompany and supervise children
- **Rules:** If the design includes a fenced area - revenue generation is possible.
- **Revenue:** Somewhat (private/reserved private events)
- **Capacity:** Varies depending on size. 15 square feet per bather.
- **Approximate Days of Use:** 365

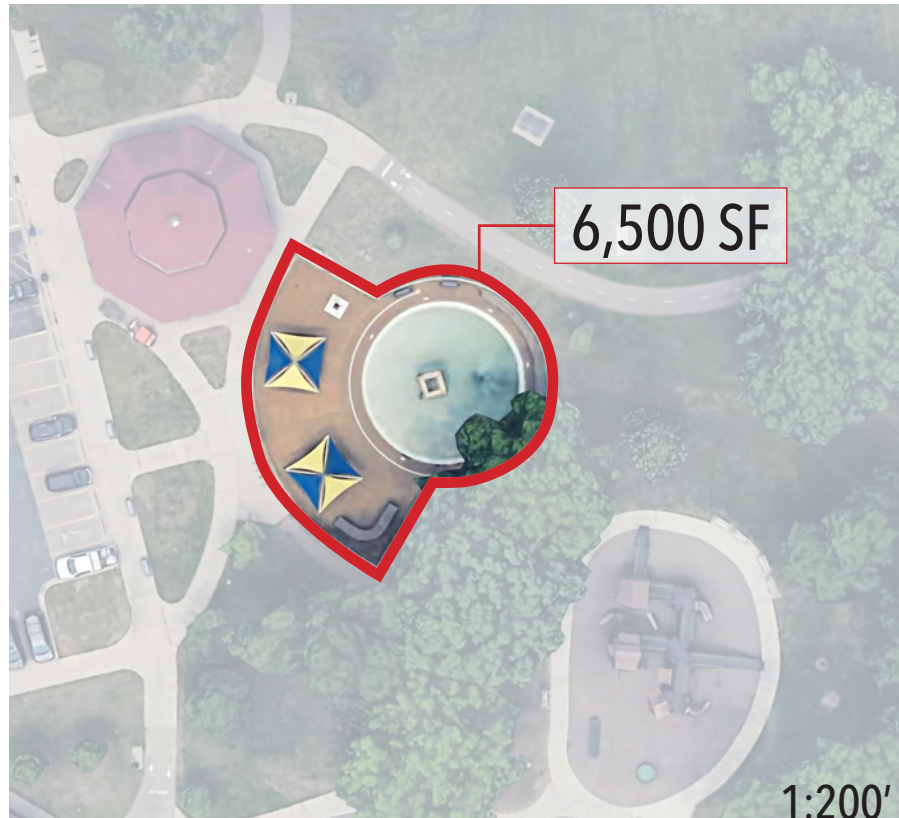
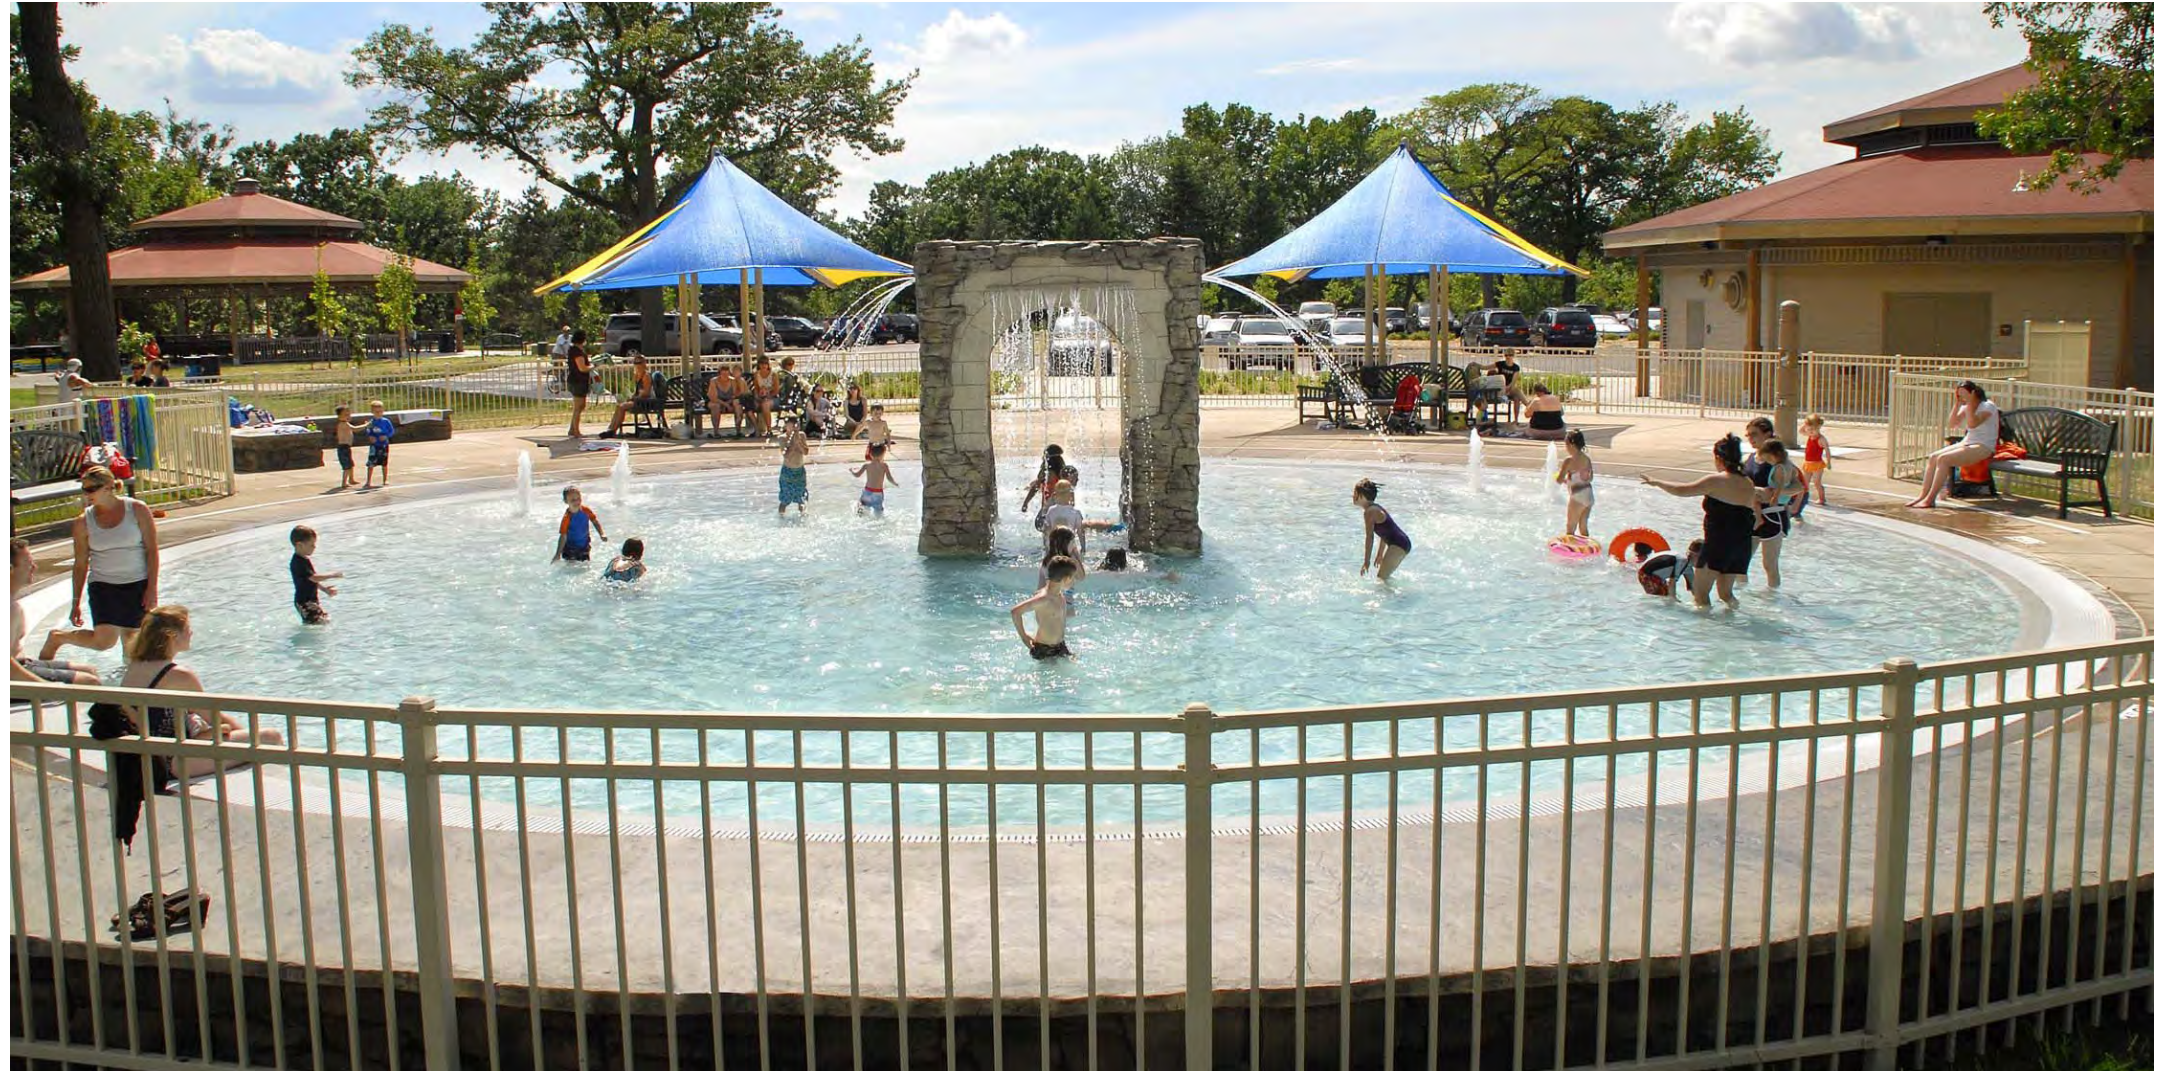
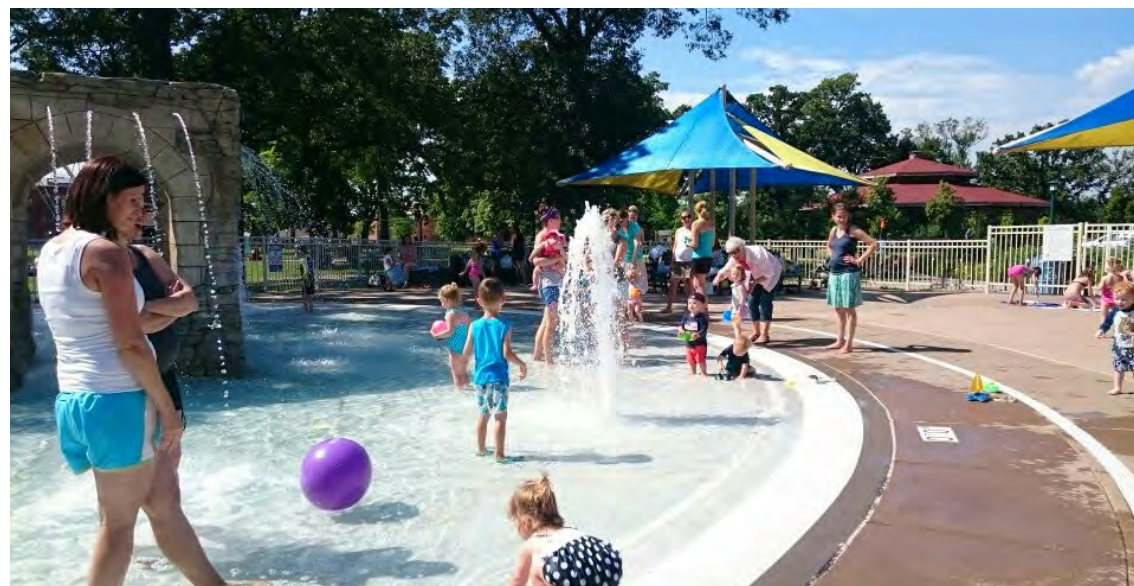
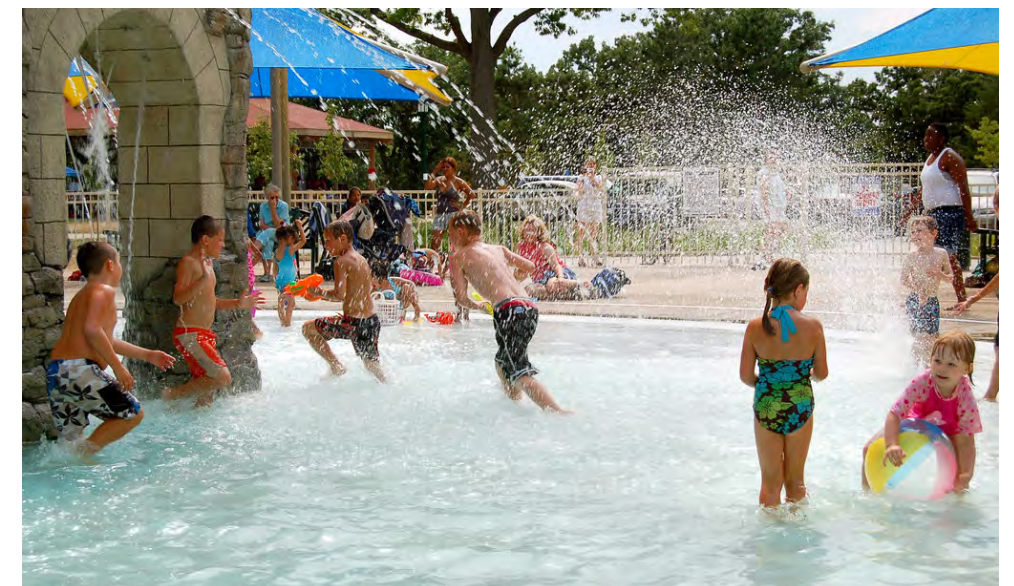
## WABUN PARK WADING POOL MINNEAPOLIS, MN

- Equipment/Features: Wading Pool With Spraying Rock Structure
- Chlorinated: Fountain water is chlorinated and recycled through a filtration system and the water is reused just like in a swimming pool
- Surrounding Area: Concrete with Furnishings & Umbrellas
- Water Depth: Zero-Depth Entry To 24" Depth @ Deepest
- Fencing: Yes - 42" perimeter fencing per MN wading pool code.
- Targeted Age Group: Tot - 12 Years
- Seasons of Use: Summer Only

WATER PLAY USER CAPACITY 140

- Wading Pool With Spraying Rock Structure, Sprayers
- Recycled Water Via Filtration System
- 2 Umbrellas @ Patio
- Zero-Depth Entry To 24" Depth @ Deepest
- 42" Fencing
- Tot - 12 Years Targeted Age Group

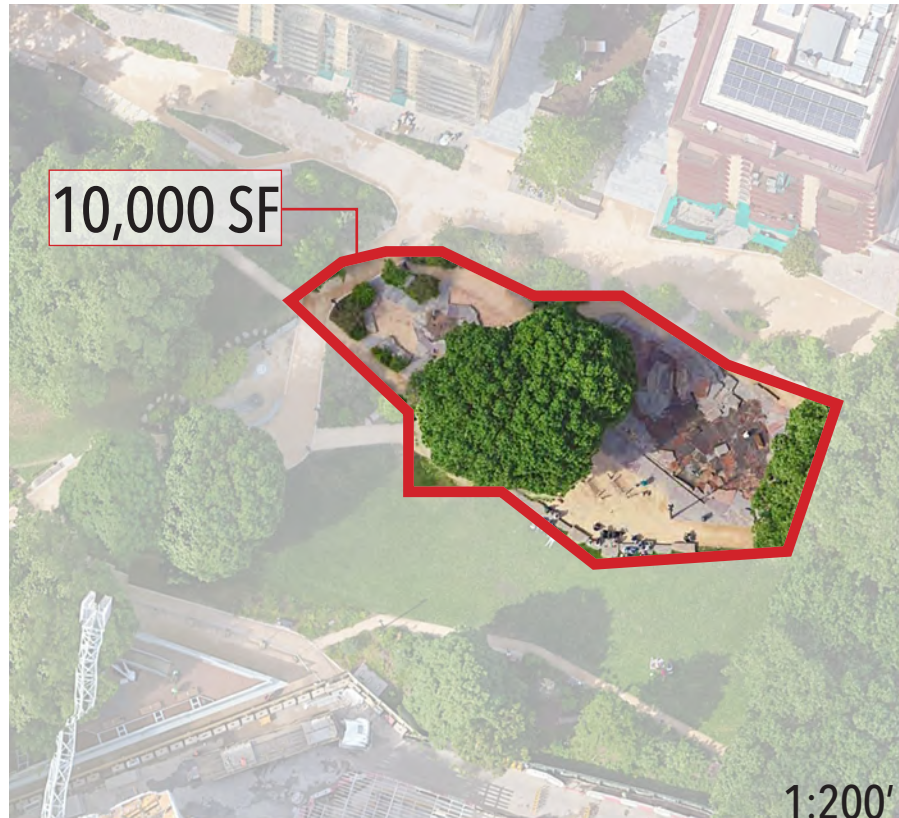
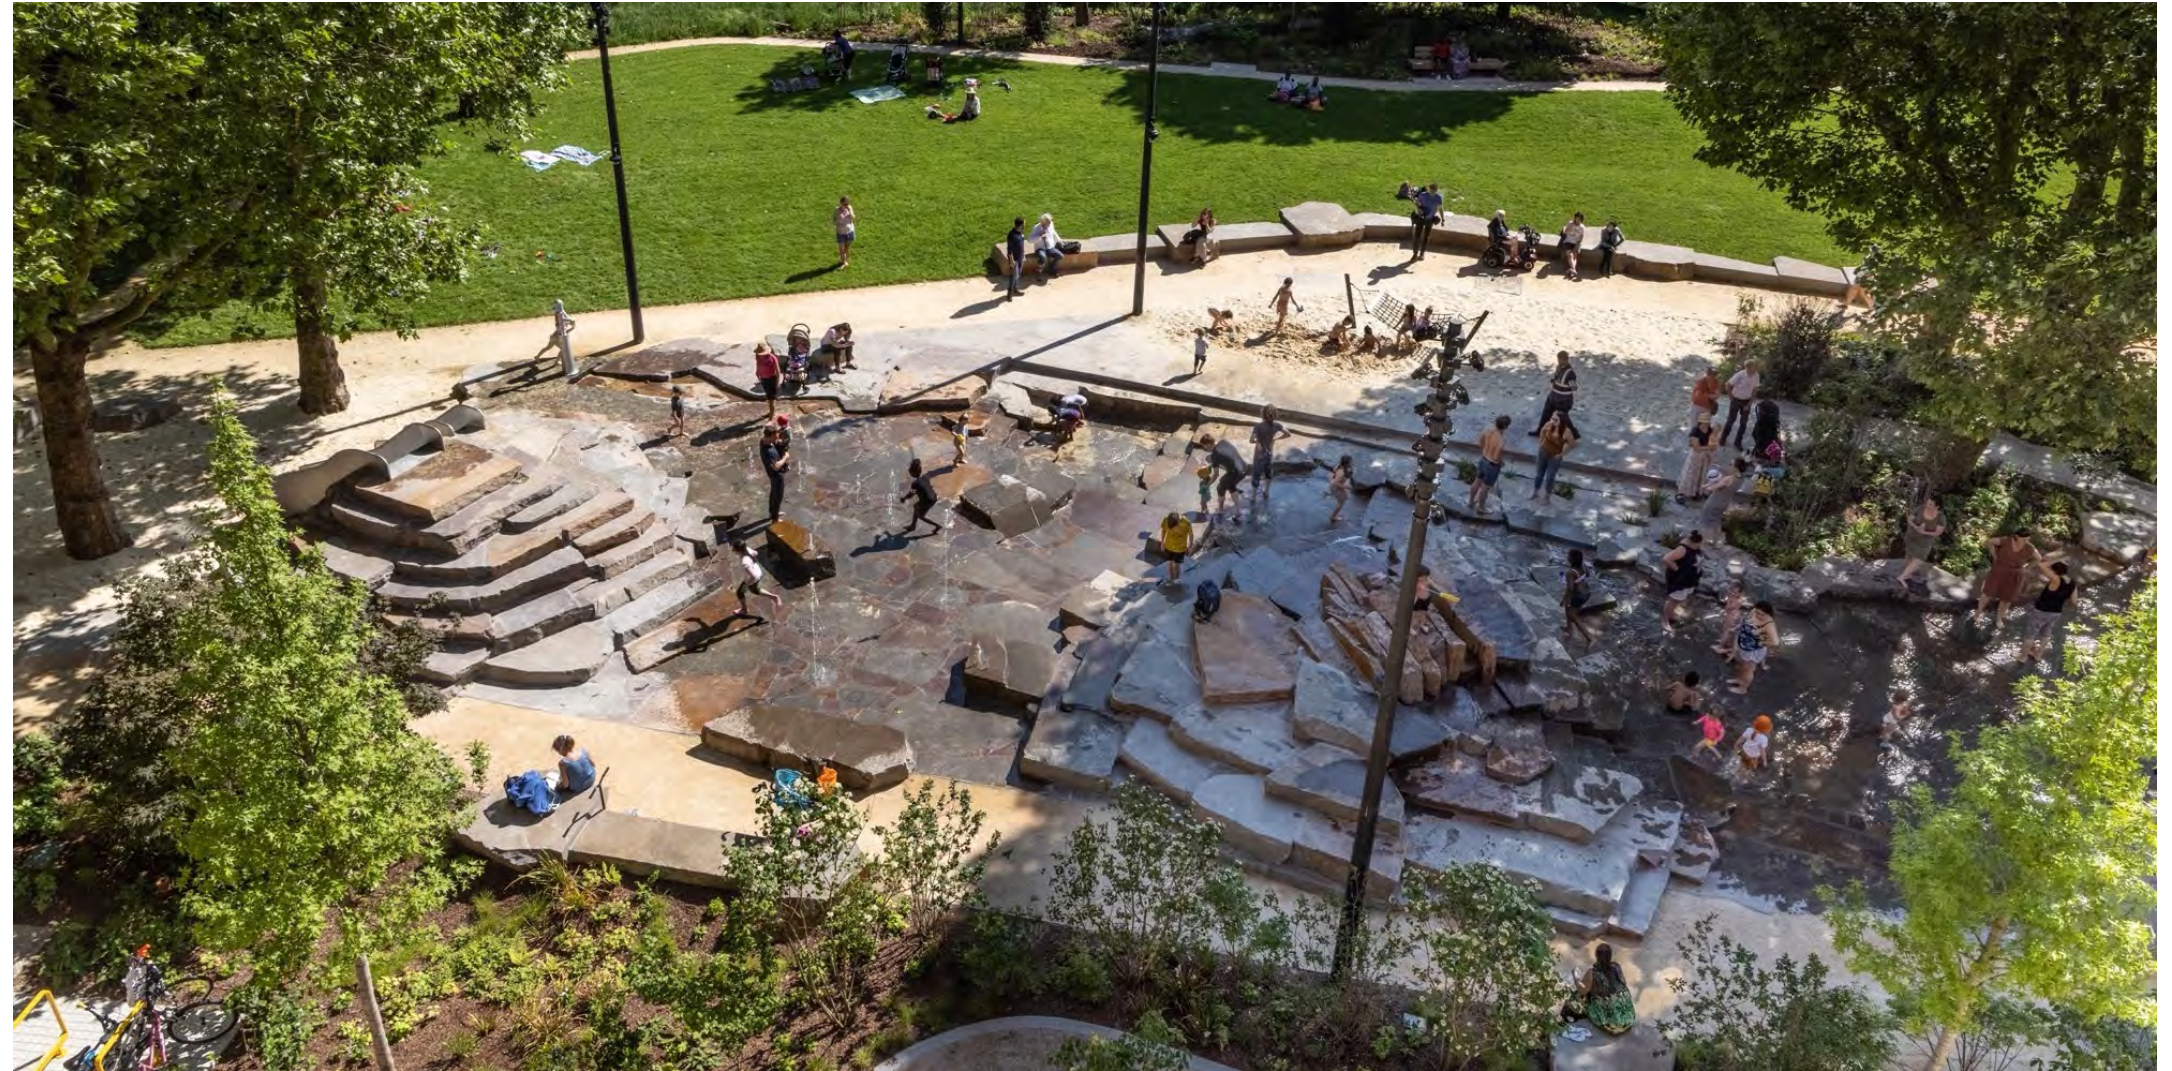
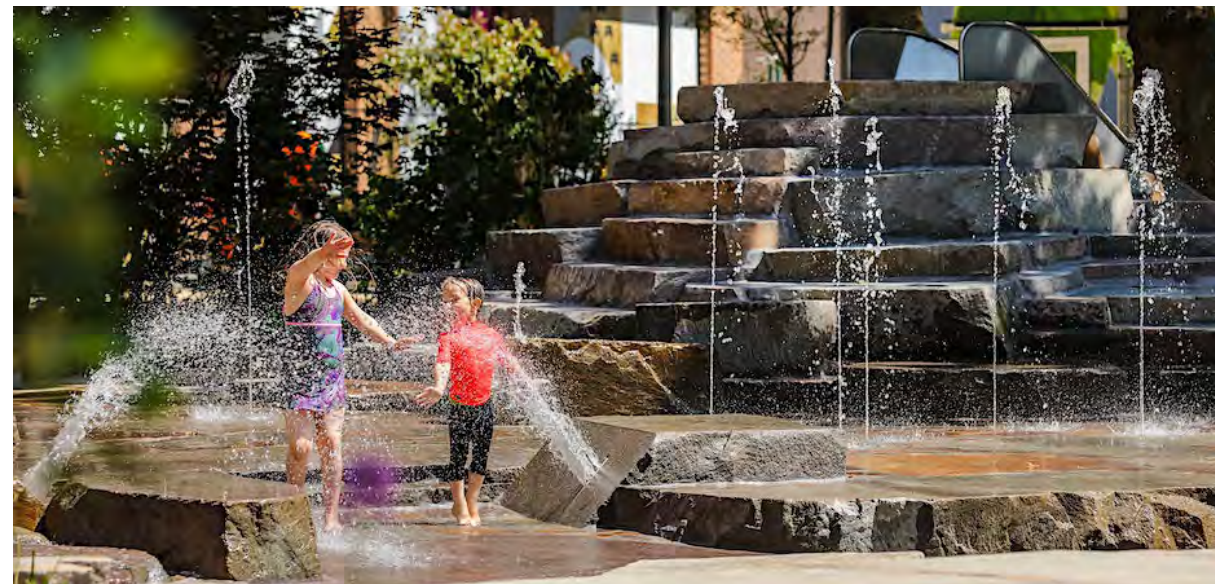
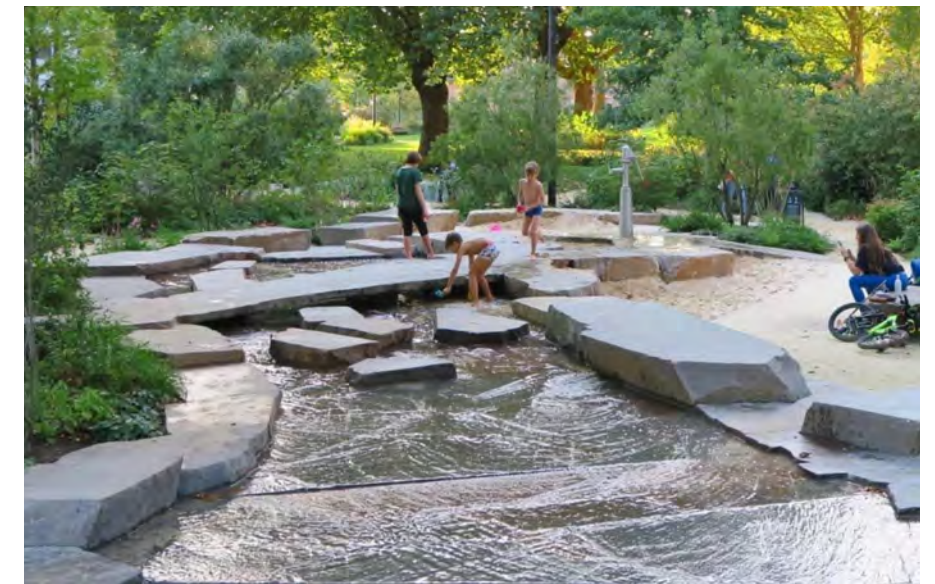
## ELEPHANT PARK LONDON, UK

- Equipment/Features: "Village" Pumps, Jets, Water Cascades, Rock Channels, Babbling Stream, Sand Pits
- Surrounding Area: Sand Play, Lawn, Stone Paving, Landscaping
- Water Depth: Zero-Depth Entry To 3"
- Lighting: Perimeter Post Lights
- Targeted Age Group: Tot - 18 Years
- Seasons of Use: Open year-round (water in warmer temps)

WATER PLAY USER CAPACITY 400

- "Village" Pumps, Jets, Water Cascades, Rock Channels, Babbling Stream, Sand Pits
- Chlorinated: Unknown
- Lush Planted Edges
- Zero-Depth Entry To 1"
- Perimeter Post Lights
- Fencing: Unknown
- Tot - 12 Years Targeted Age Group

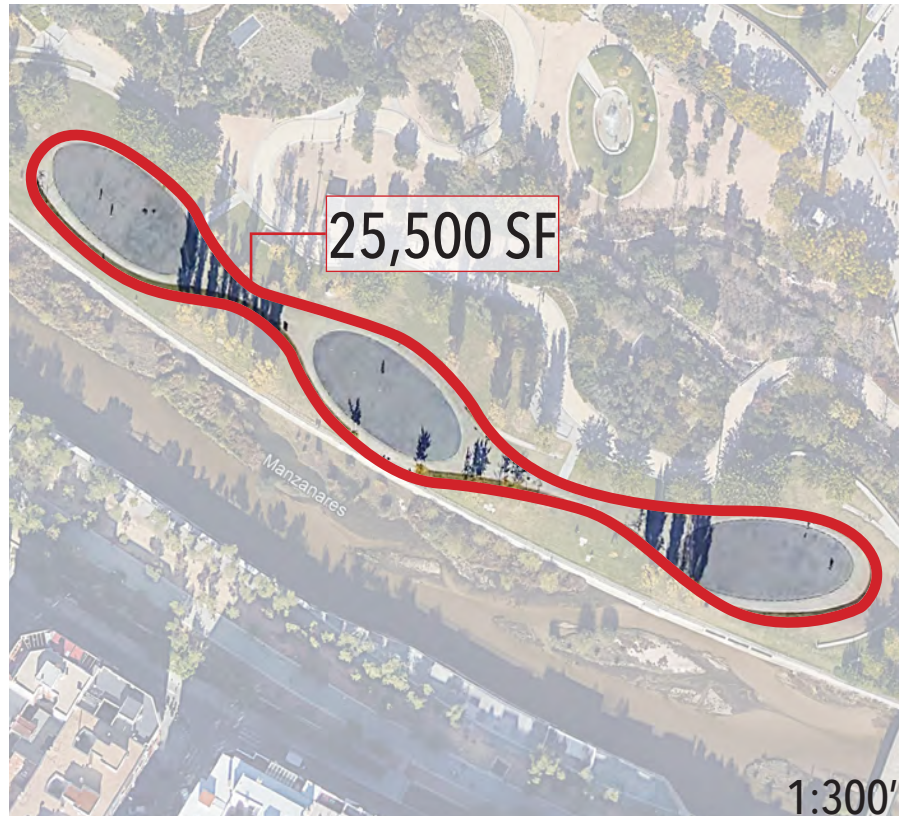
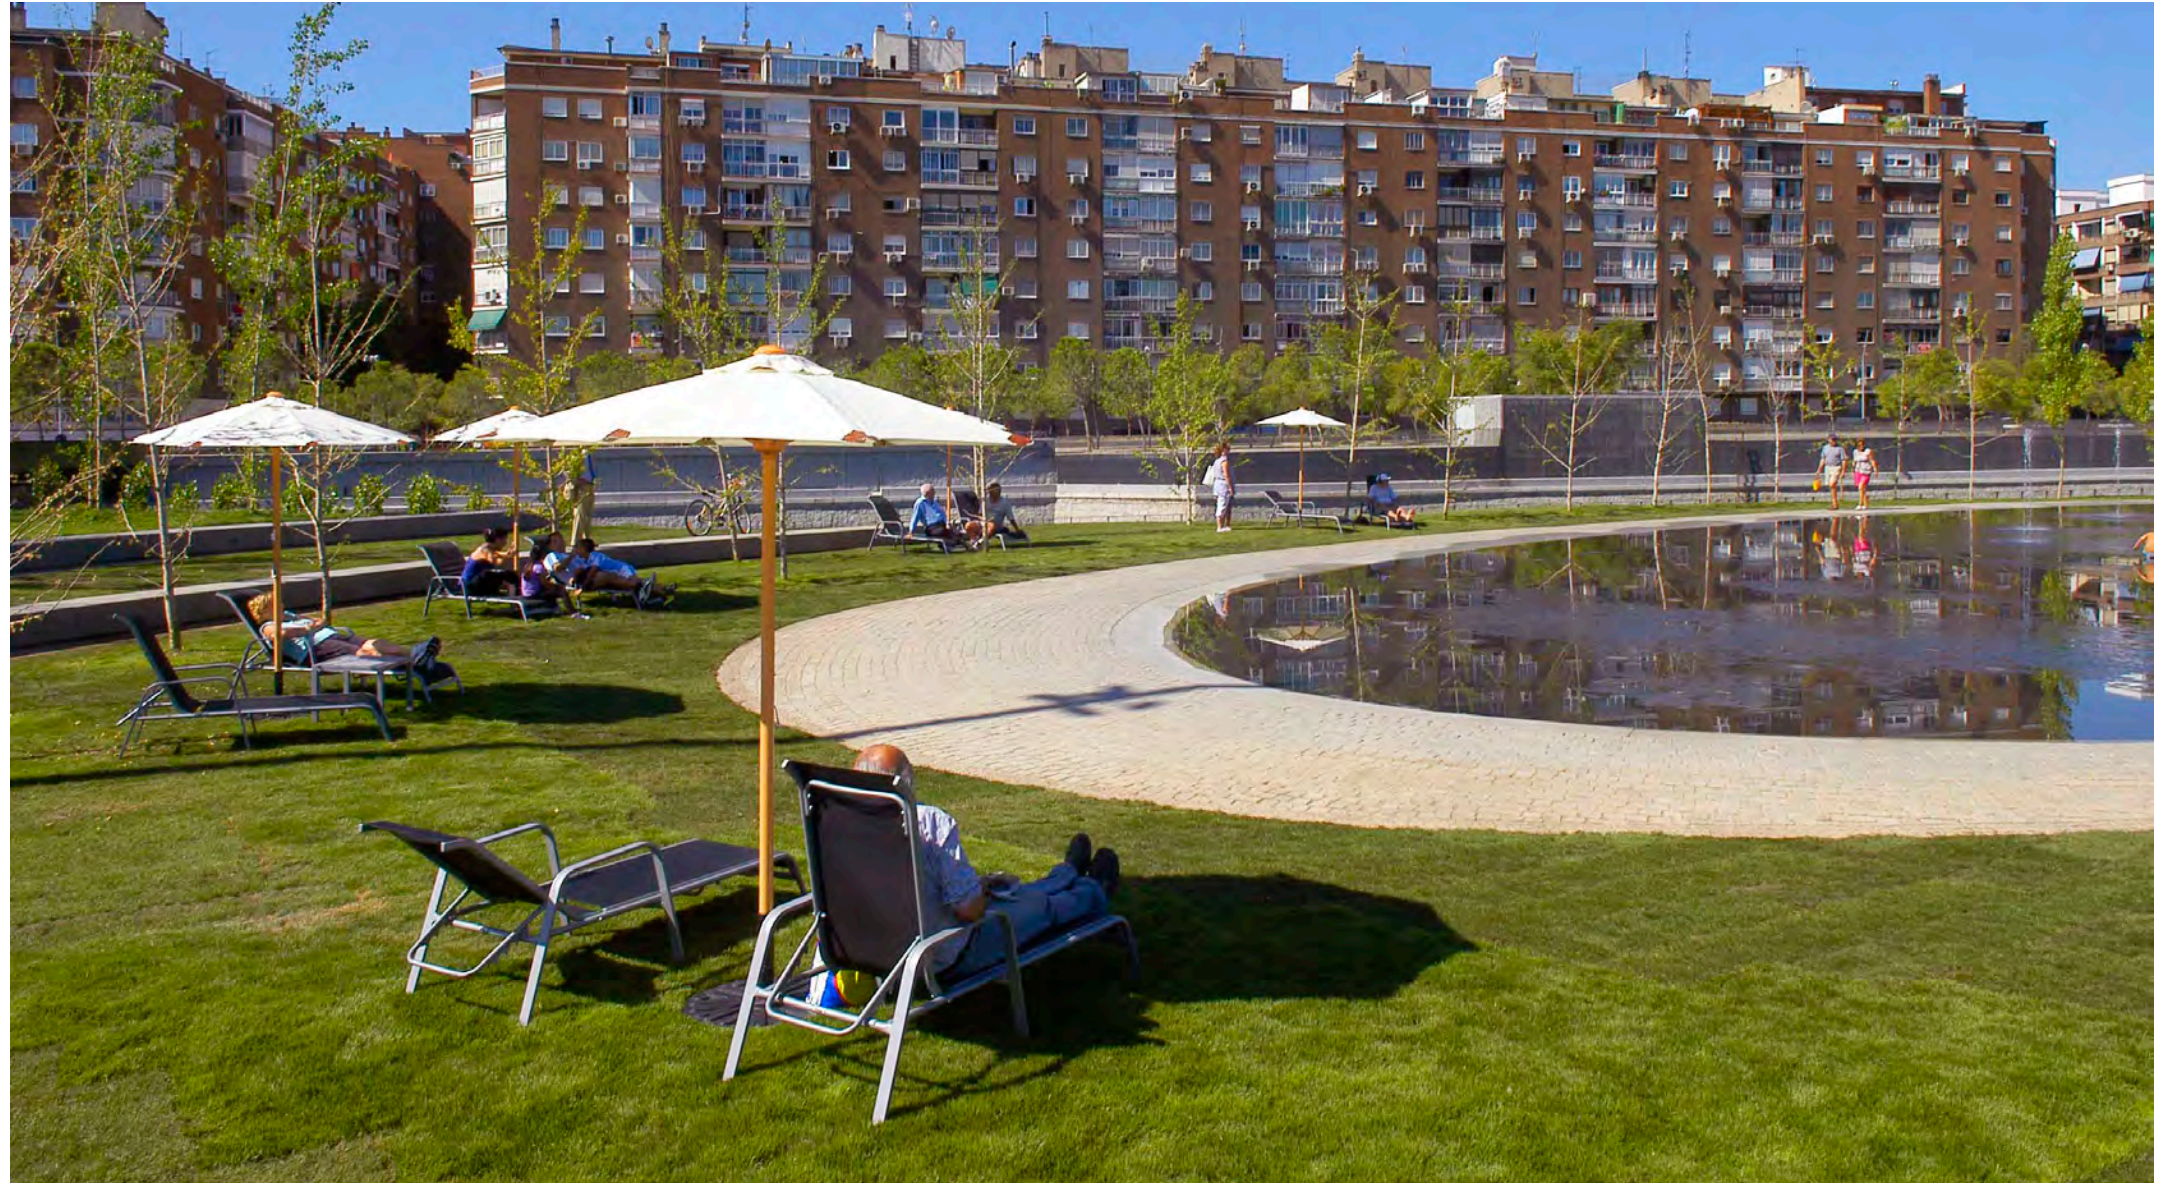
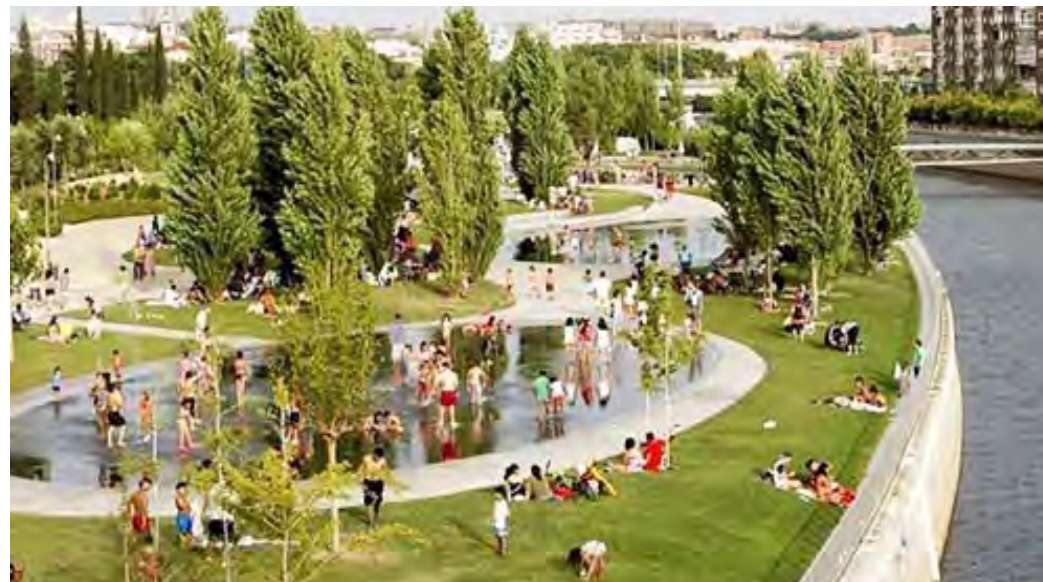
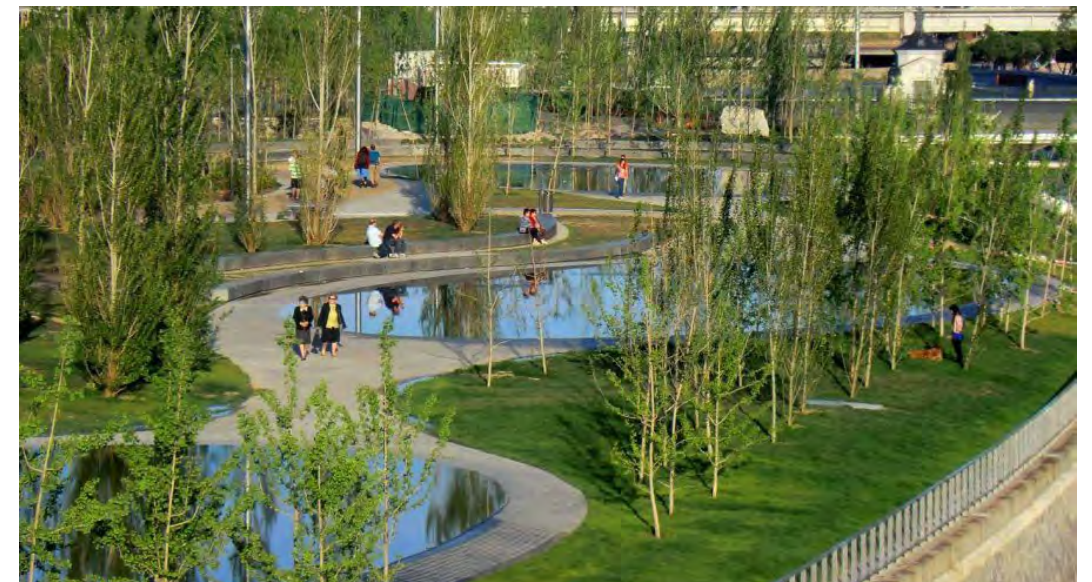
## MADRID RIO PARK MADRID, SPAIN

- Equipment/Features: Splash Pads with Water Jets
- Surrounding Area: Unit Pavers, Lawn, Landscaping
- Water Depth: Zero-Depth Entry To 1"
- Lighting: Park Lamp Posts
- Targeted Age Group: All Ages
- Seasons of Use: Open year-round (water in warmer temps)

WATER PLAY USER CAPACITY 900

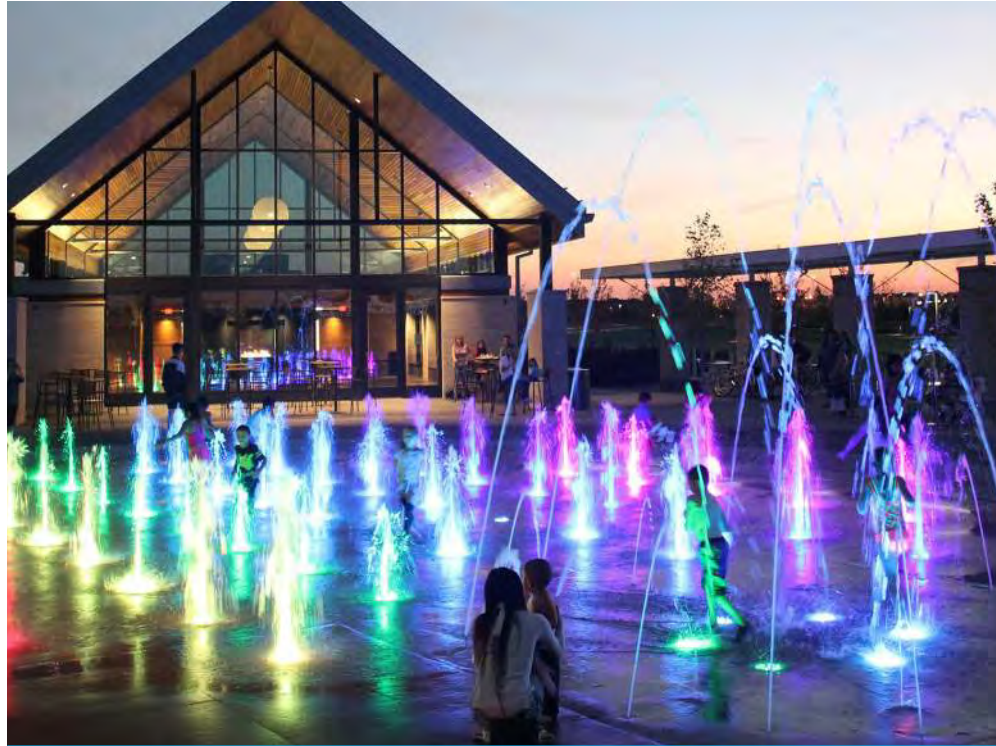
## CENTRAL PARK - MAPLE GROVE, MN

4,000 SF OF WATER PLAY

- Jet & Arching Spray Pad
- Recycled Water Via Filtration System
- Hardscape Perimeter Patio w/ Seatwalls
- 0" Depth Water - Spray Only
- Integrated LED Fountain Lighting
- No Fencing
- All Age Groups

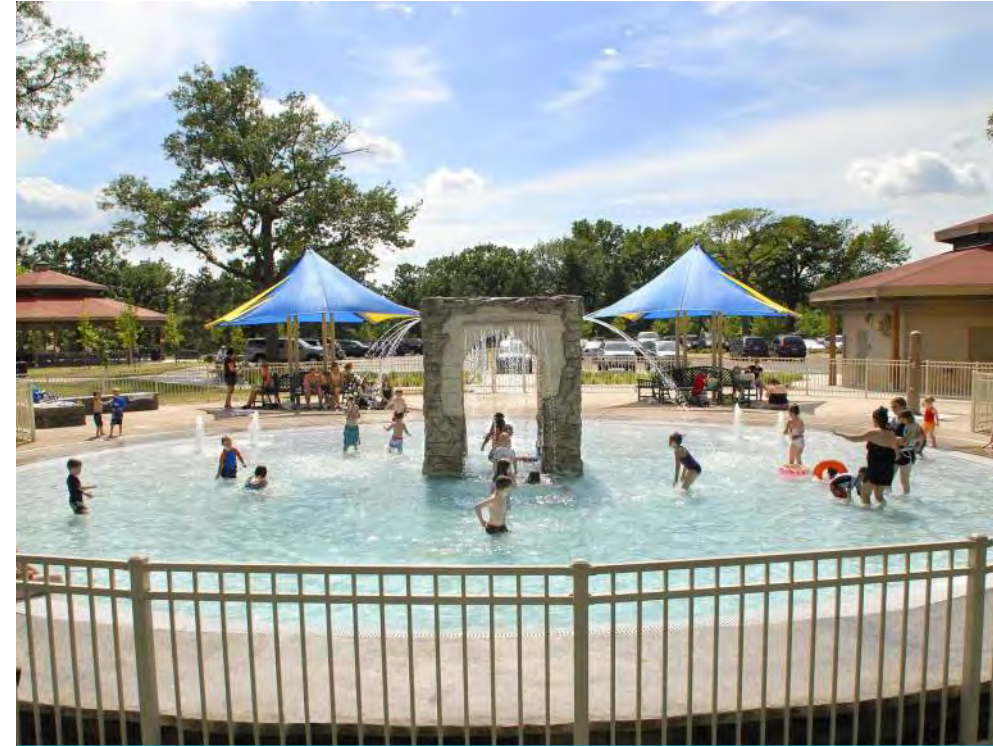
## WABUN WADING POOL - MINNEAPOLIS, MN

6,500 SF OF WATER PLAY

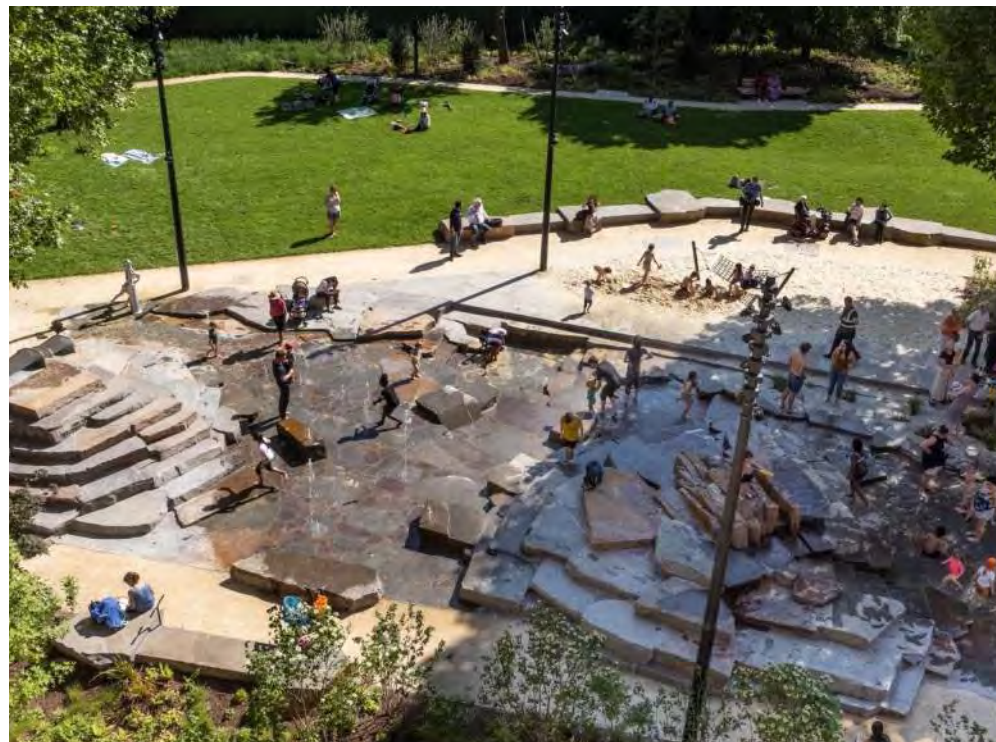
## ELEPHANT PARK - LONDON, UK

10,000 SF OF WATER PLAY

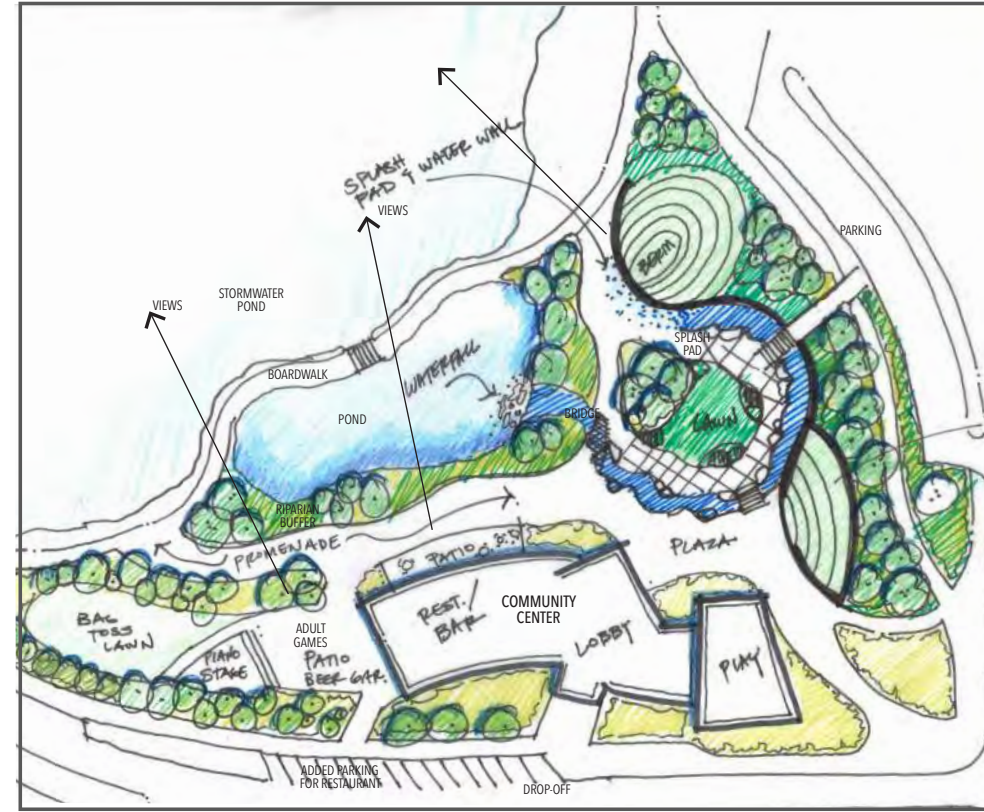
## CONCEPT 1 SPACE PROGRAM

FLEXIBLE LAWN	5,000 SF
PICNIC MOUND	9,135 SF
WATER PLAY	6,530 SF
PLAZA	4,592 SF
DINING TERRACE	1,700 SF
BEER GARDEN	4,000 SF
STAGE	1,620 SF

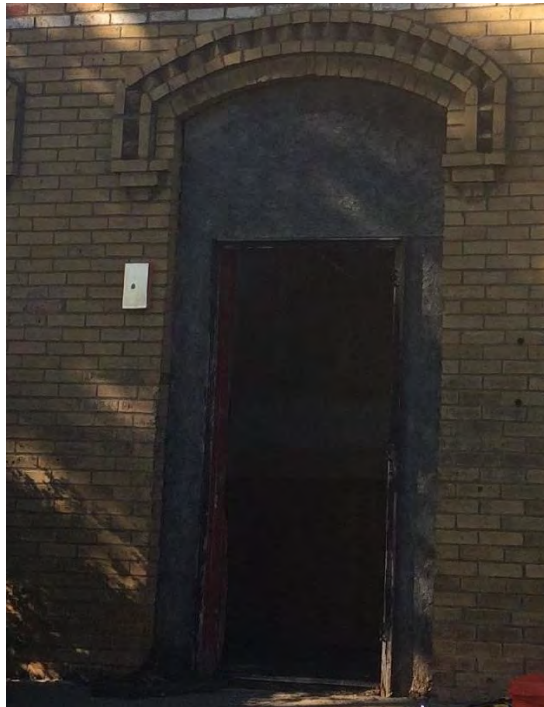
Figure 5 – Front Entrance with Particleboard

The entrance of the building is fitted with particleboard, which has allowed the use of a standard size door in place of what was likely a door and curved transom window.

By the looks of the paint that is left on the brick near top and sides of the particleboard insert, the original wood door and framing was red. The door that is currently present, while functioning, is in poor condition.

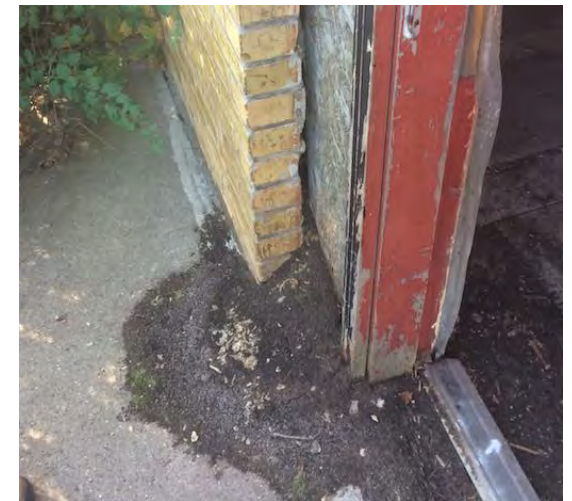
Figure 8 – Organic Matter near Front Door

There is damage to the threshold of the front door and beyond the entrance exposing what looks to be part of the wood subfloor of the building.

Primarily, the pile of organic matter at the entrance of the door should be removed. It poses a health hazard.

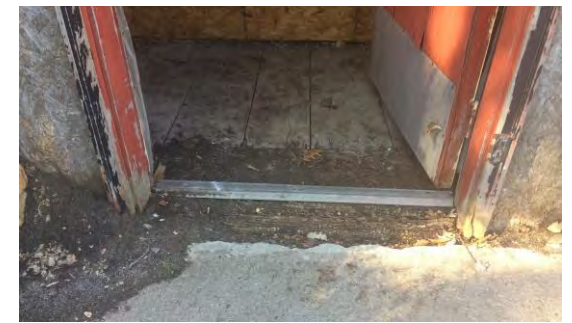
Figure 9 – Front Door Threshold

The concrete stoop and steps that lead up to the building have several cracks and are uneven. It appears as if there has been some patching between the steps and the building. There are no hand railings. The building entrance is not currently ADA accessible and the steps are at the wrong rise and run for an entrance.

The current concrete steps should be removed and replaced with a system that is ADA compliant. All steps should have uniform riser heights and uniform tread depths. Risers should be 4 inches (100 mm) high minimum and 7 inches (180 mm) high maximum. Open risers are not allowed. Treads shall be 11 inches (280 mm) deep minimum. The radius of curvature at the leading edge of the tread shall be ½ inch (13 mm) maximum. Handrails shall be provided on both sides of stairs and ramps.

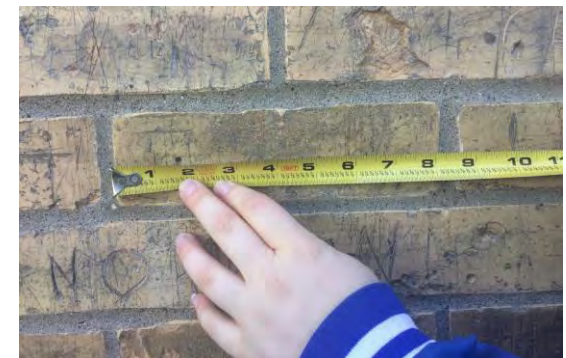
Figure 11 – Carvings and Etchings in Brick

There is some deterioration of the brick caused by humans. Many of the bricks have carvings and etchings.

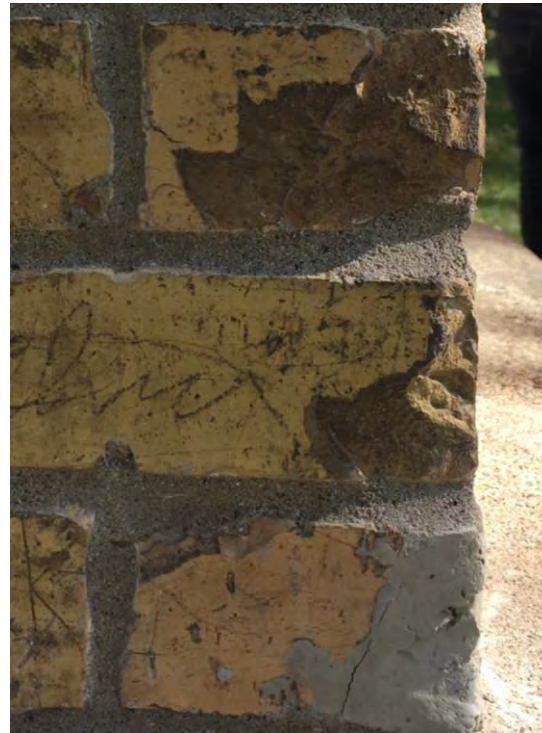
Figure 13 – Broken Brick at Corner

There are multiple areas where there is broken brick. This is most evident on the window sills on the North and South elevations, around the front entrance, and on the chimney on the West elevation. This damage could have been caused by humans, objects hitting the brick, or water damage.

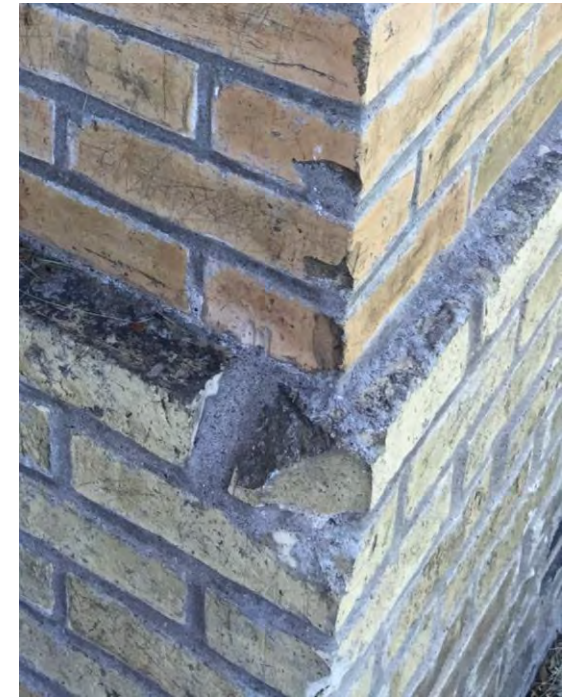
Figure 14 – Environmental Degradation

There is also deterioration of the brick that was caused by the environment. There are bricks on all four facades that are experiencing spalling, especially near the entrance of the building. Spalling is caused by water being absorbed into the brick and cracking the front face of the brick when the water freezes, therefore, it is evidence that water is not able to drain properly behind the veneer. The freezing and thawing of water can also crack large parts of the brick off in the locations noted previously.

Carvings in the brick are not currently a problem. Some would argue that leaving them provides a specific aesthetic that is worth keeping. However, spalling and holes should be repaired. The large penetration in the brick around the pipe should be repaired, and sealant should be applied.

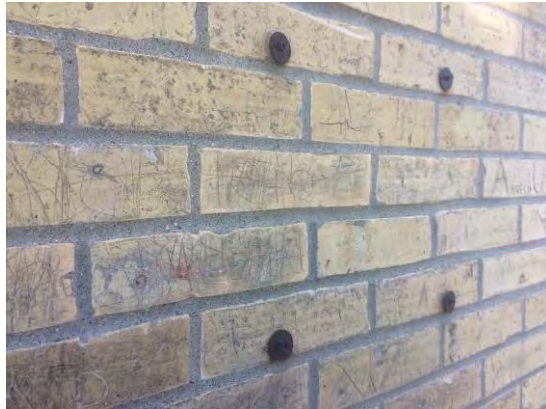
Figure 16 – Metal Brackets in Brick

There are also some metal brackets in the façade; these were where electric lines and some services were connected.
