**City of Ramsey**  
**Agenda**  
**City Council Work Session**  
**Tuesday, April 9, 2024**

The Waterfront - Community Building Operations Forecast and Planning Status

# RAMSEY TOWN HALL, Ramsey, Minnesota

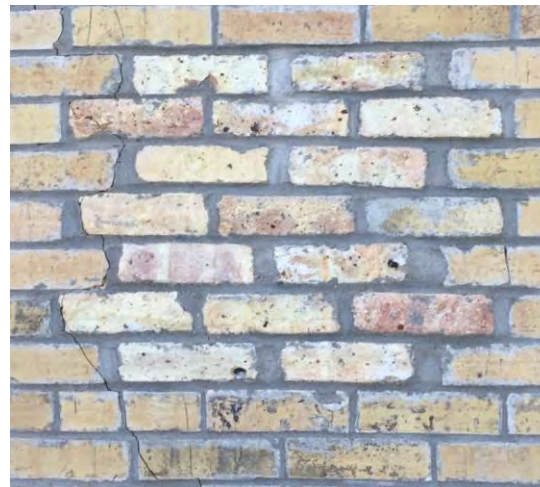
Figure 18 – Attempted Repointing

There are several sections of the primary façade where it looks like some repointing has taken place, specifically under the window on the right-hand side, where the mortar is a different color, and to the top of the circular window at the top of the structure. Figures 18, 19 and 20 show other areas where repointing was done, including the chimney. The mortar joints where the repointing was done are much more prominent due to the following characteristics: over-grinding during repointing process damaged the brick around the repointed areas, a different color of mortar was used, possibly a different strength of mortar was used, and the size of the mortar joints are larger. The mortar is supposed to be weaker than the brick so that it cracks before the brick can.

Any repointing done going forward must be done in a manner so as not to not grind into the bricks while removing the mortar. The mortar and brick used for any replacements must be of quality strength and grades as the original.<sup>3</sup>

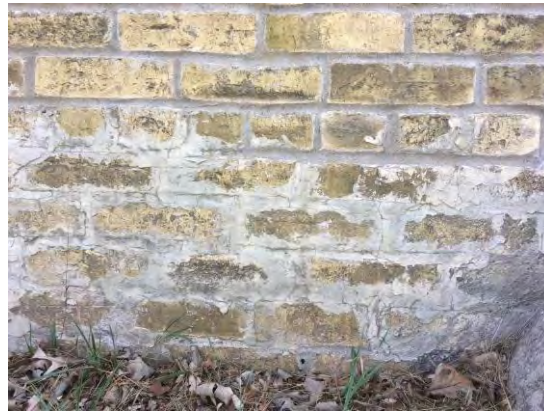
Figure 23 – Deteriorated Brick with Mortar

In one location, area of brick that was smeared with mortar on the rear elevation. The concrete curb that is located around the base of the North, South, and West elevations is most likely covering up deteriorated brick.

The mortar that is covering the brick should be removed if possible. This process must be done by hand without damaging the brick. Replace the bricks as needed.

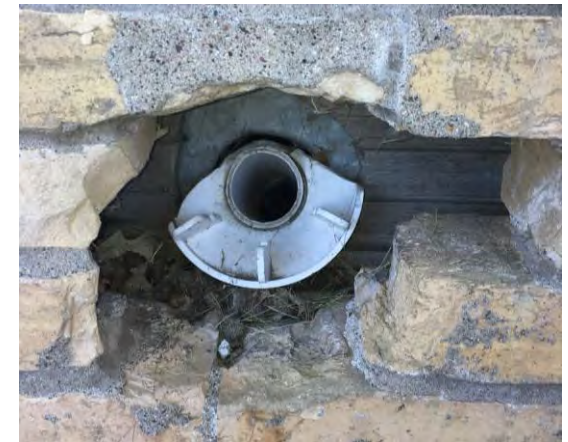
Figure 23 – Exterior Pipe Penetration

There is a pipe that runs from the basement to the exterior on the North elevation. The area around the pipe was not filled in, so there is currently a hole in the wall that exposes the wood structure.

Carvings in the brick are not currently a problem. Some would argue that leaving them provides a specific aesthetic that is worth keeping. However, spalling and holes should be repaired. The large penetration in the brick around the pipe should be repaired, and sealant should be applied.

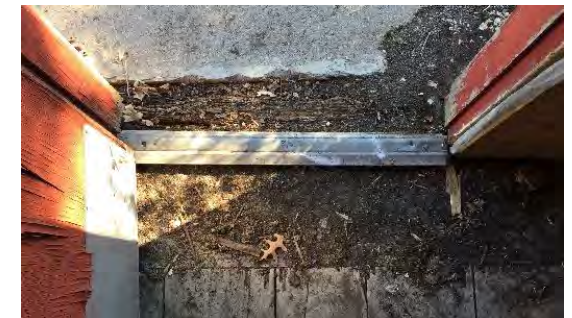
Figure 34 – Entry Hall Flooring at Threshold

Approximately half of the original wood floor is intact in the entry hall. A section of the original flooring has been removed immediately upon entry. The subfloor that remains has significant damage from exposure to the weather.

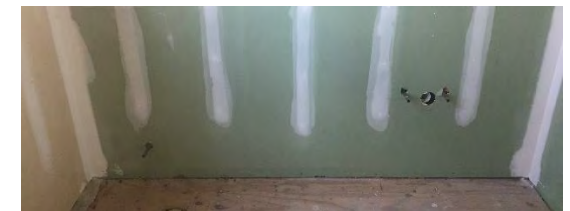
Figure 38 – Bathroom Plumbing

The exposed plumbing does not appear to be connected to a running water supply and is therefore not likely to cause water damage. If the plumbing is to be used, an expert should inspect them to ensure they are in working order and that none have burst or are leaking.

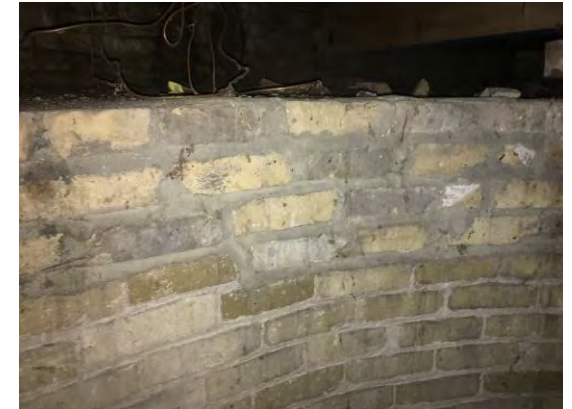
Figure 40 – Clay Masonry Wall

The clay masonry portion of the wall is in good condition. The units should be examined with better lighting conditions; however, no major issues were initially discovered that require remediation.

The concrete masonry wall should be examined. Cracks in below-grade structures can cause complications with soil pressures and ground water flow. Sealing and stabilizing the cracks may be the best option.

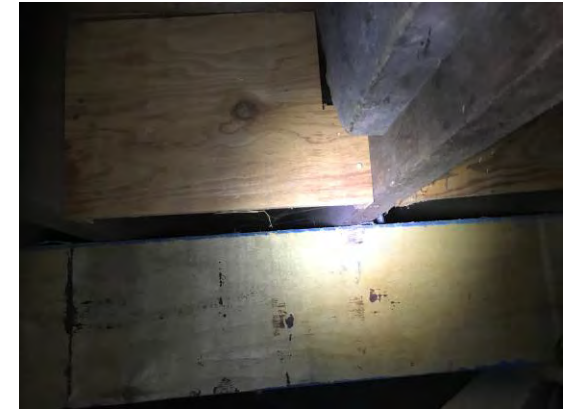
Figure 46 – Intermediate Beam

Shoring will be needed to provide temporary support during reinforcement or installation. An engineer should be consulted to create a safe plan.

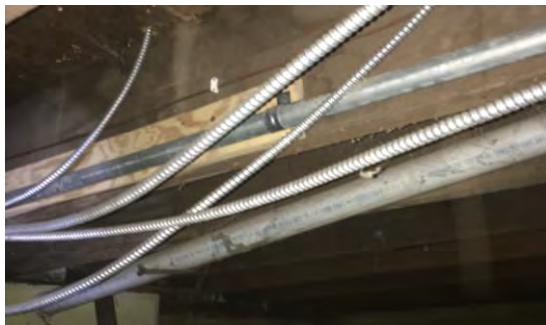
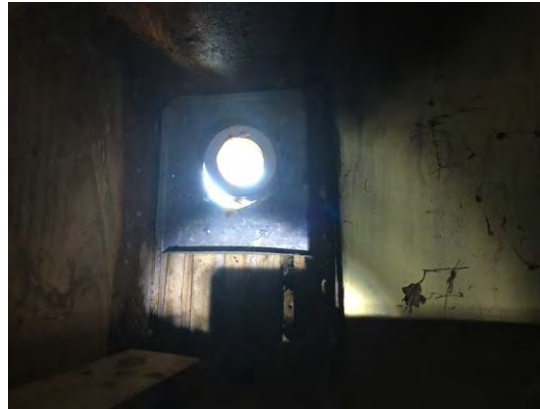
Figure 48 – Utilities Hole in Exterior Wall

All of the wires and conduits must be organized and secured. It poses a safety risk to have them in their current configuration.

The hole is not original to the structure. It should either be used to provide modern amenities or taken out. The discontinuity can be easily patched with cementitious material.

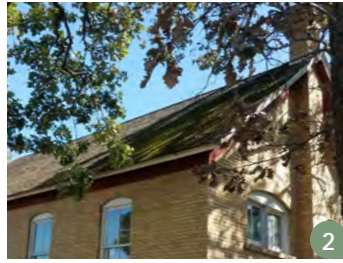
##### 2 Replace Roof & Repair Eaves

Replacing the roof will **prevent any future water infiltration**. The roof should be replaced with wood shingles or shakes. More research could determine the historical profile typical of the time of construction. More insulation could be added to **improve energy efficiency** at the same time.

ESTIMATED COST: \$20,000  
<https://www.homeadvisor.com/cost/roofing/replace-roof.html>

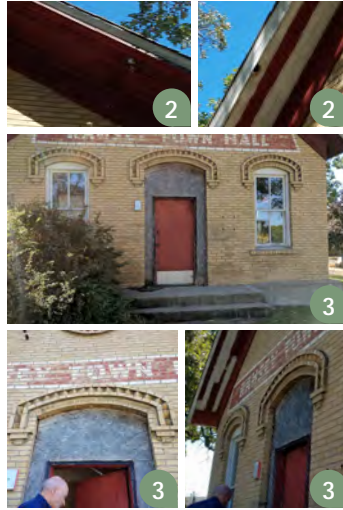
##### 3 Replace Entry Door & Stairs

The existing entry door is water-damaged, and the door surround does not properly join the brick veneer, leaving room for vermin infestation and water infiltration. The door should be replaced with **double swinging doors with a glass transom above**, which is the appropriate historical replacement.

ESTIMATED COST: \$3,700 (doors & transom), \$2,400 (stairs)  
<https://www.thrifty.com/building-landscapes/decks-for-backyards-outdoors-2132014>

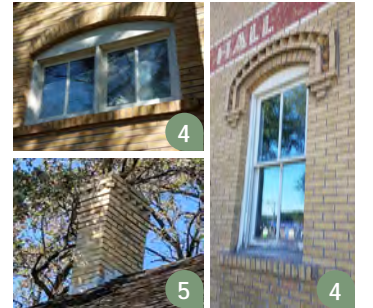
##### 4 Repair & Restore Windows

The windows were replaced during an earlier grant project but could benefit from **new paint and caulk** where brick meets wood. A rear window needs to be replaced.

ESTIMATED COST: \$450 (recaulking), \$900 (window)  
<https://www.homeadvisor.com/cost/interior-decoration/interior-painting.html>  
<https://www.homeadvisor.com/cost/interior-decoration/interior-window-replacement.html>

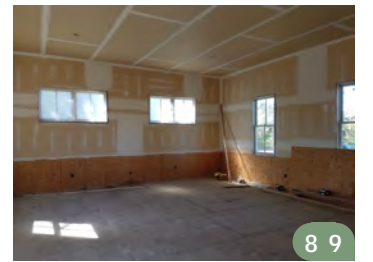
##### 7 Install doors, plumbing, HVAC

Previous grants were used to purchase **doors and a furnace**. Neither was installed completely. New **plumbing fixtures** need to be purchased and installed.

ESTIMATED COST: \$300 (doors), \$600 (plumbing), \$1,700 (HVAC)  
<https://www.homeadvisor.com/cost/interior-decoration/install-toilet.html>
