The COR Analysis Update

City of Ramsey

February 24, 2023

Bolton & Menk, Inc.
7533 Sunwood Drive NW #206
Ramsey, MN 55303
P: 763-433-2851
F: 763-427-0833

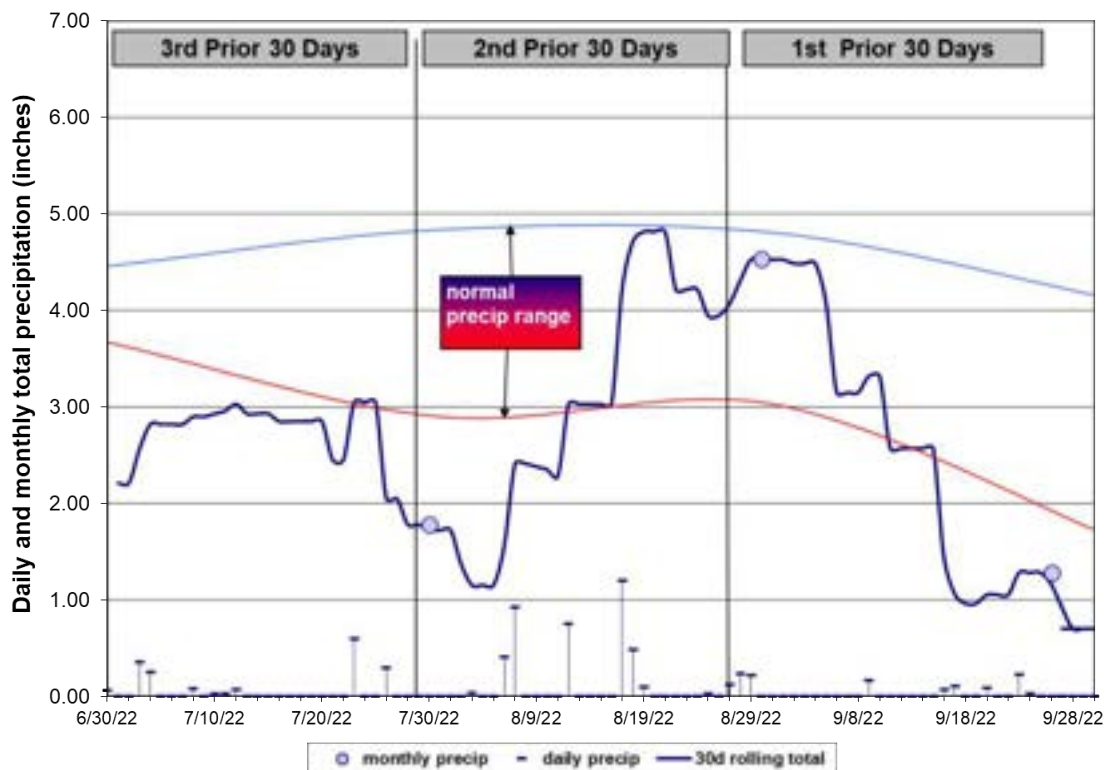
ANTECEDENT PRECIPITATION CONDITIONS

Antecedent precipitation was evaluated using a combination of the NRCS Method and the Rolling Totals Method. The analysis found that precipitation was normal at the time of the delineation.

This climatic data was gathered using the Climatology Working Group Website, <http://climate.umn.edu/> and the National Weather Service Forecast Office, <http://w2.weather.gov/climate/>. The information for the investigation was retrieved from the WETS Station at Andover 1 N, MN; Station ID – 210190.

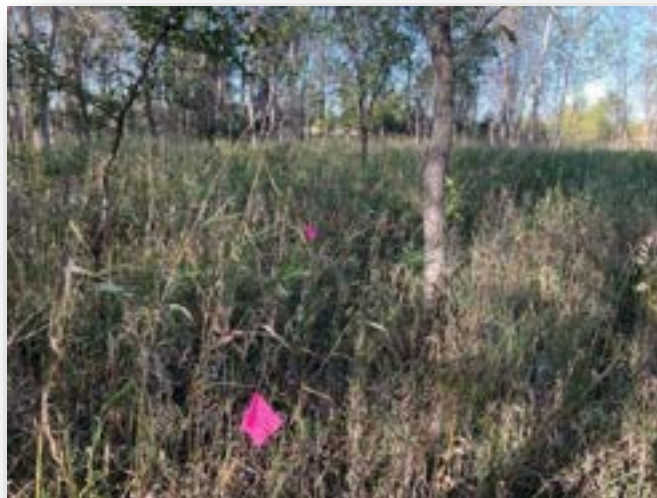
W1

The field investigation found the site has met all three wetland indicators and this portion of the wetland should be considered a palustrine emergent semipermanently flooded/palustrine forested

broad-leaved deciduous temporarily flooded (PEMF/PFO1A) wetland. One transect and several sample points were taken to determine the wetland boundary. Soils, hydrology and topography aided in determining the wetland boundary.

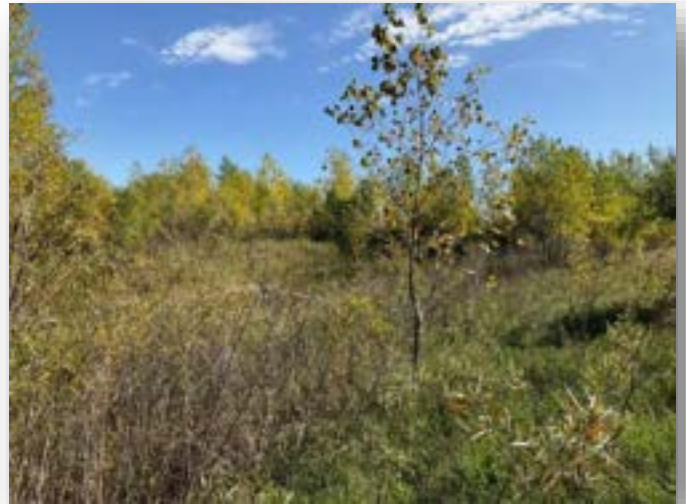
W4

At the wetland pit location W4A the plant community is dominated by common Canada bluejoint, giant goldenrod, riverbank grape, sandbar willow, quaking aspen, and black willow. The upland pit location W4B is dominated by white sweet clover, Canada bluejoint, quaking aspen, and sandbar willow. Both plant communities are considered hydrophytic.

Soils in the wetland pit location W4A met hydric soil indicator F3 – Depleted Matrix. Soils in the upland pit location W4B did not meet any hydric soil indicators.

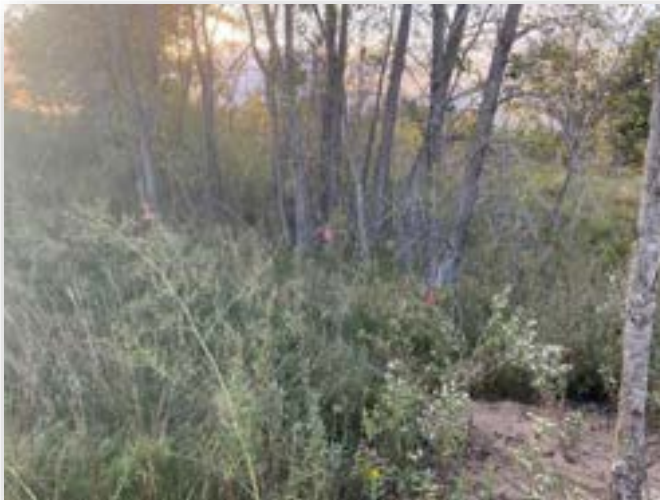
W4 Transect

Soils in the wetland pit W4A were not saturated. The wetland pit location met secondary hydrology indicators D2 and D5. Soils in the upland pit location W4B were not saturated and only met secondary hydrology indicator D5.

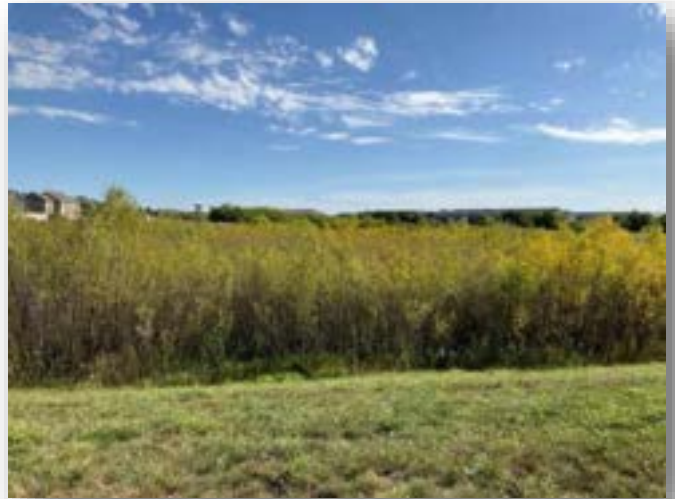
W5

Wetland 5 is dominated by sandbar willow and cattails. The upland areas adjacent to W3 are dominated by Kentucky bluegrass.

The determining factor for this delineation was the lack of hydrophytic vegetation in the surrounding upland areas. The boundaries were determined by following the topographic break and vegetative break.

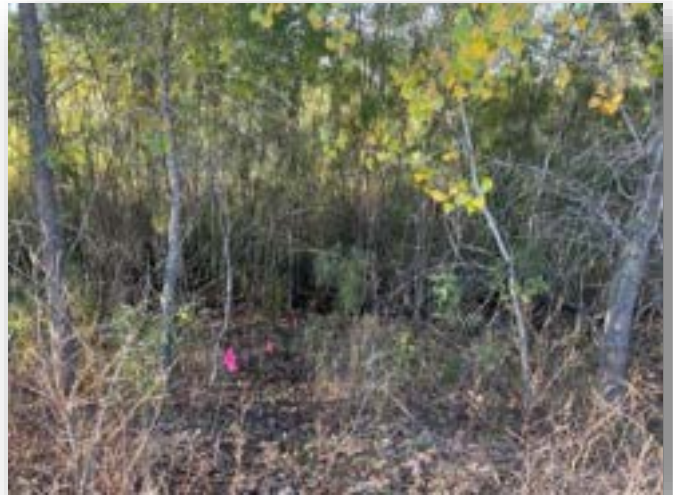
W7

Soils in the wetland pit W7A were not saturated. The wetland pit location met secondary hydrology indicators D2 and D5. Soils in the upland pit location W7B were not saturated and did not meet any hydrology indicators.

The determining factor for this delineation was the lack of hydric soil and wetland hydrology indicators at the upland pit location. The boundaries were determined by following the topographic break and vegetative break.

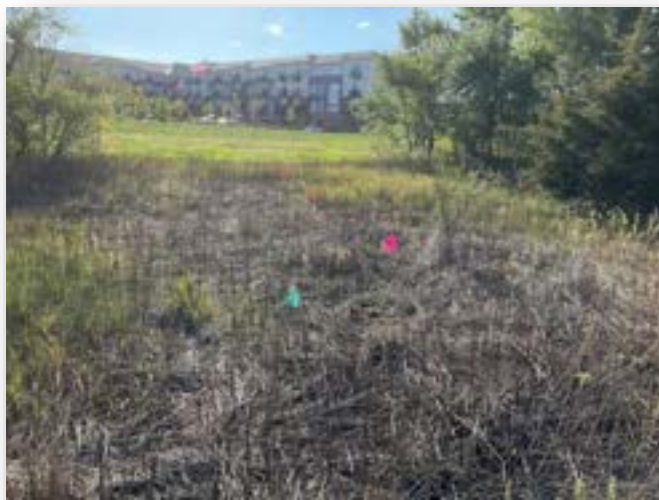
W8

The field investigation found the site has met all three wetland indicators and this portion of the wetlands should be considered a

palustrine emergent temporarily flooded (PEMA) wetland. One transect and several sample points

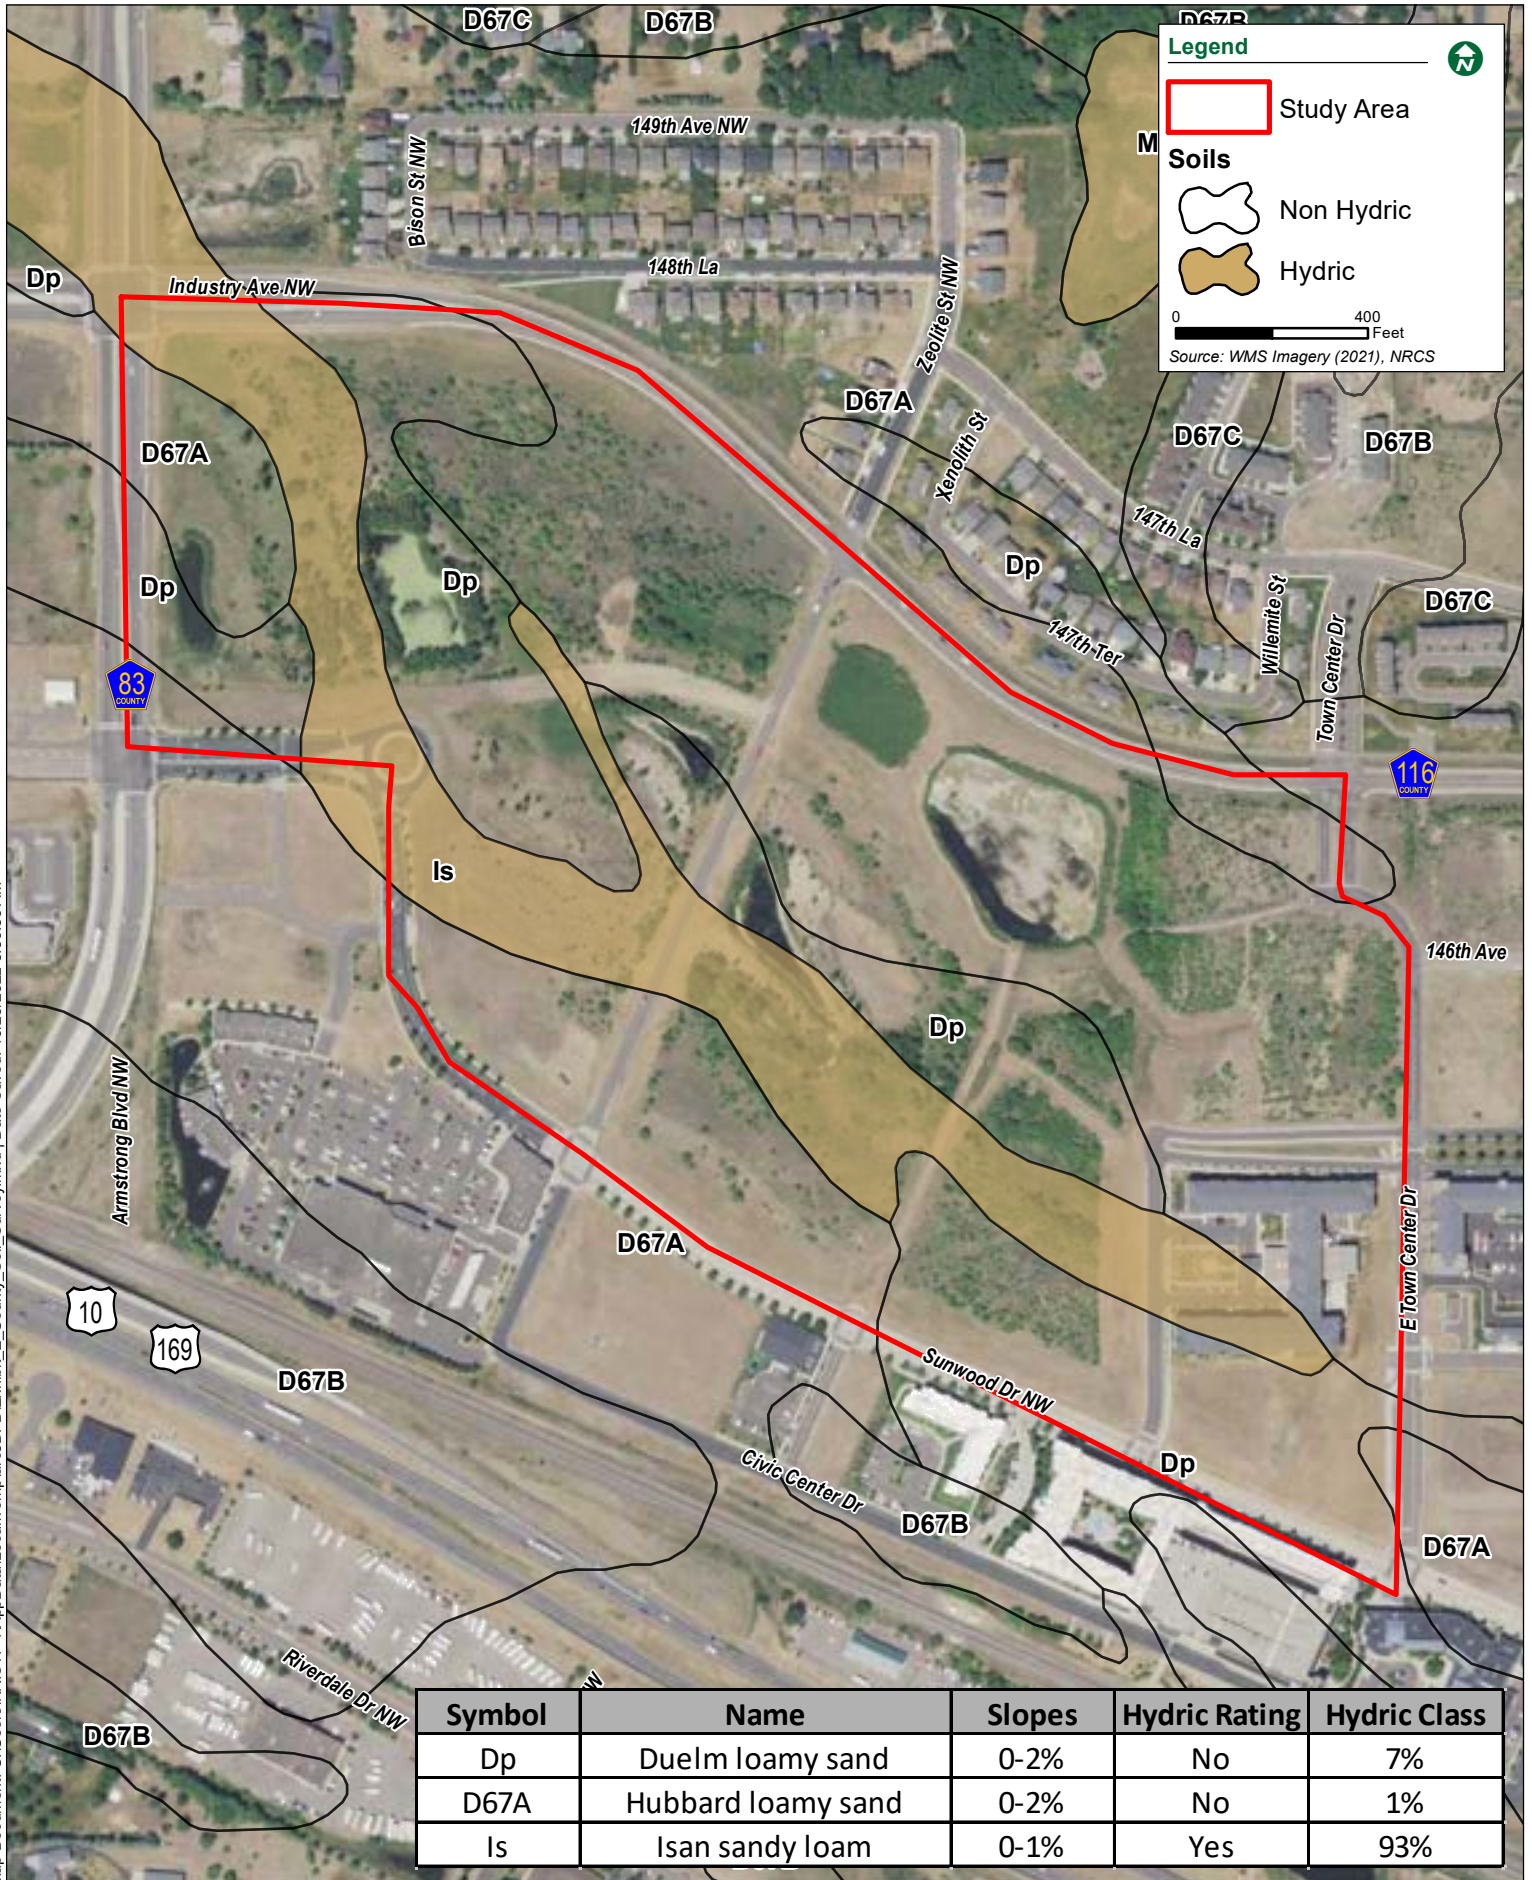
Symbol	Name	Slopes	Hydric Rating	Hydric Class
Dp	Duelm loamy sand	0-2%	No	7%
D67A	Hubbard loamy sand	0-2%	No	1%
Is	Isan sandy loam	0-1%	Yes	93%

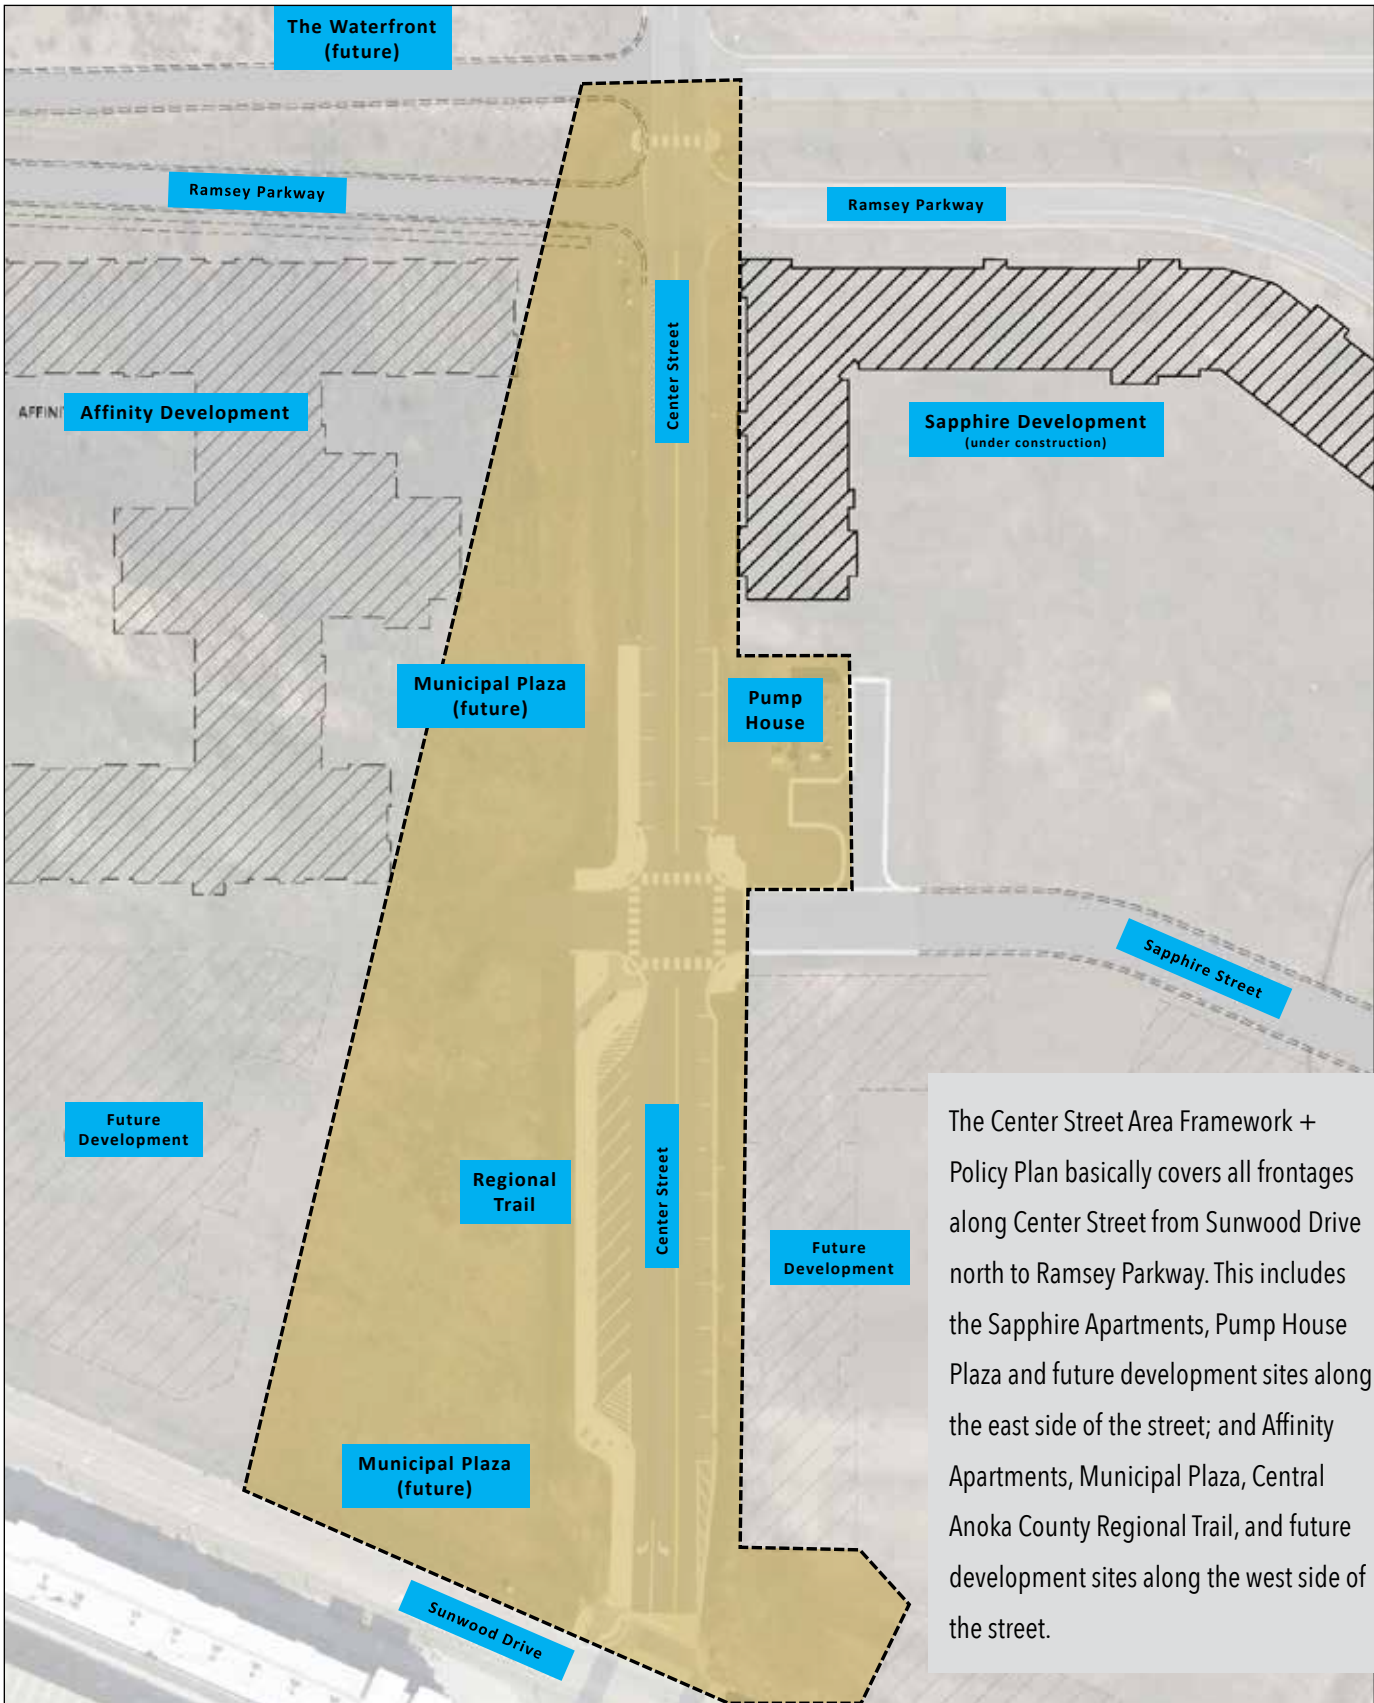
Components Diagram

The Center Street Area Framework + Policy Plan basically covers all frontages along Center Street from Sunwood Drive north to Ramsey Parkway. This includes the Sapphire Apartments, Pump House Plaza and future development sites along the east side of the street; and Affinity Apartments, Municipal Plaza, Central Anoka County Regional Trail, and future development sites along the west side of the street.

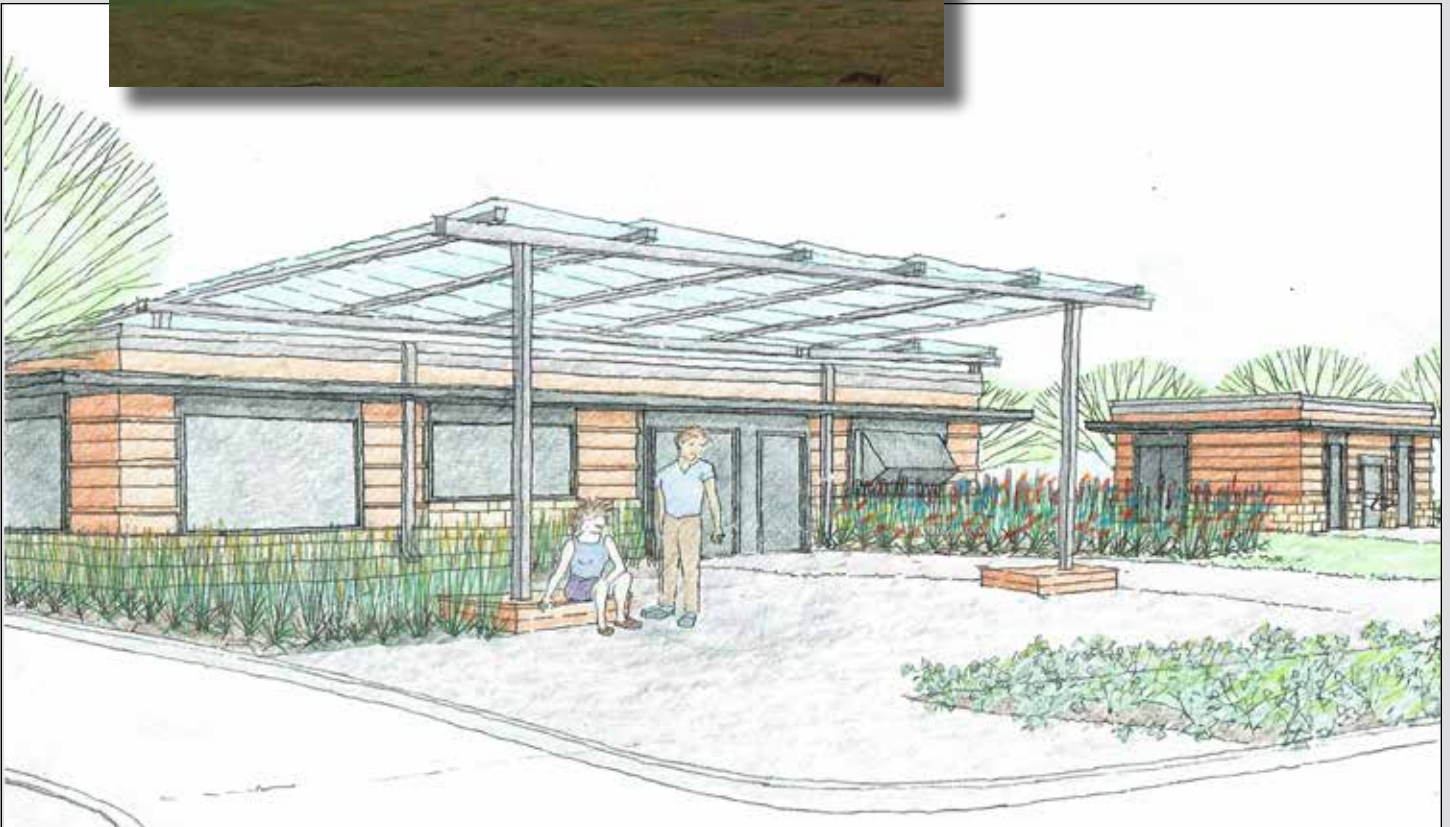
Pump House Building

The existing Municipal Pump House #3 is located on the east side of Center Street at the intersection with 145th Street; adjacent to, and just south of the new Sapphire Apartment development, across Center Street from future Municipal Plaza.

Since the time of its construction, Municipal Pump House #3 has been a simple concrete masonry building. As new development occurs around it, Pump House #3's appearance can contribute to the character of surrounding buildings and the proposed plaza by applying new exterior finishes to the existing building. Stone, wood, and metal finishes and colors compliment other civic buildings in Ramsey Downtown District.

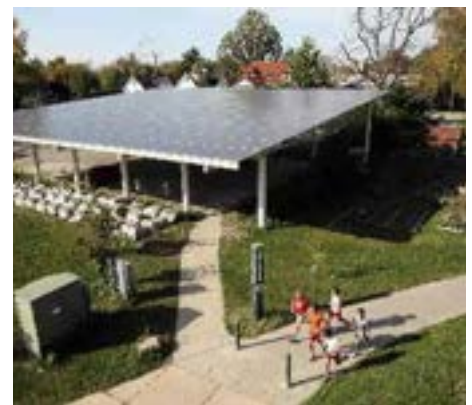
The feasibility of adding photo-voltaic array over Pump House #3 and the adjacent plaza.

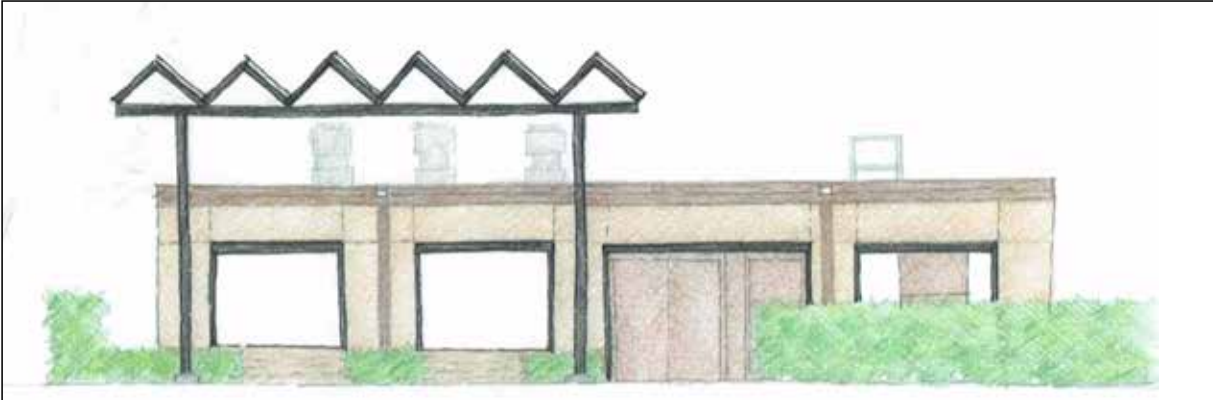
- Concept A: Split-faced concrete masonry & cement board siding

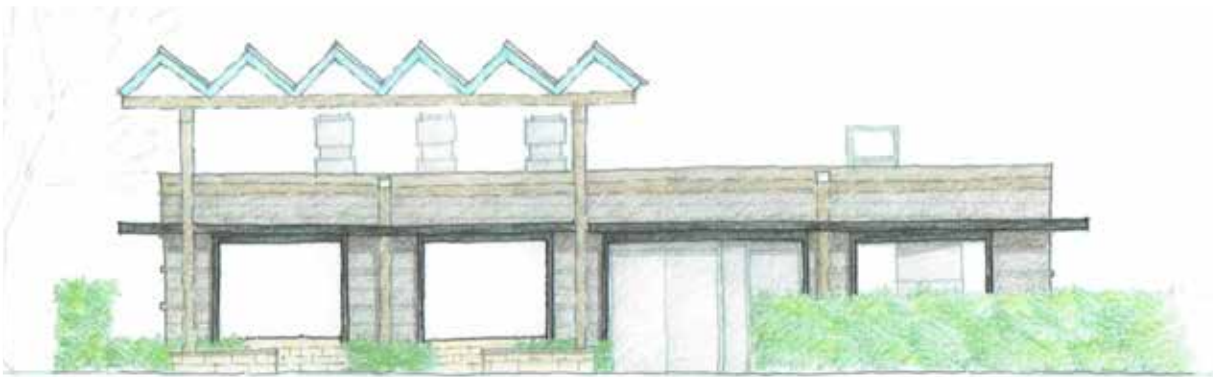
- Concept B: Limestone & wood siding

Based on design refinements, cost considerations, the limestone and wood siding alternative has been selected for design development.

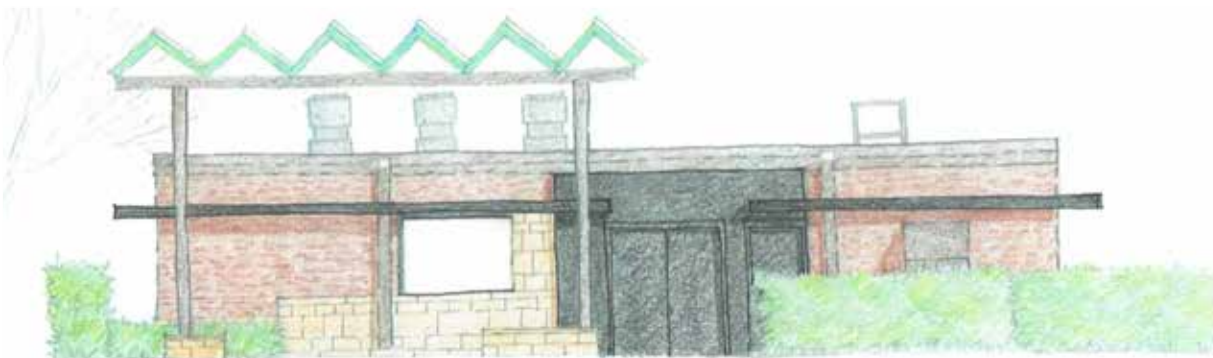
- Concept C: Limestone & brick

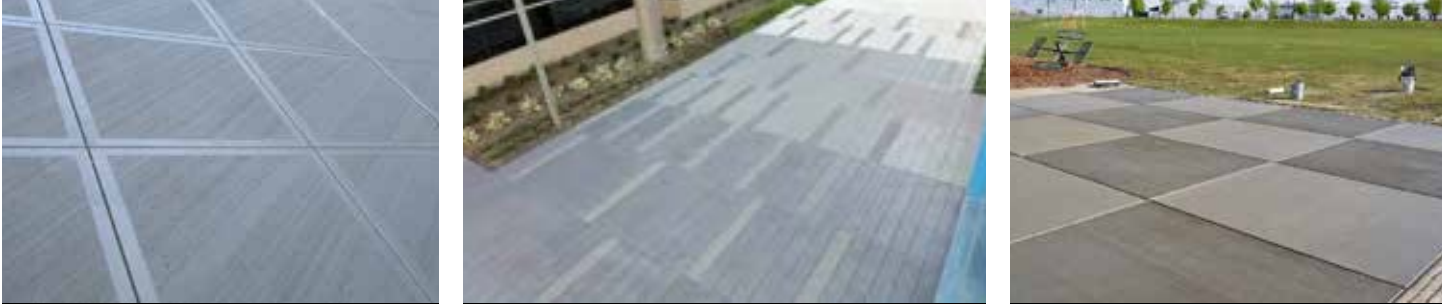
Pavement

Concrete plaza with broom finish and tooled joints to create interesting pattern is preferred; color additives, acid tints or etching, and exposed aggregate are other acceptable options.

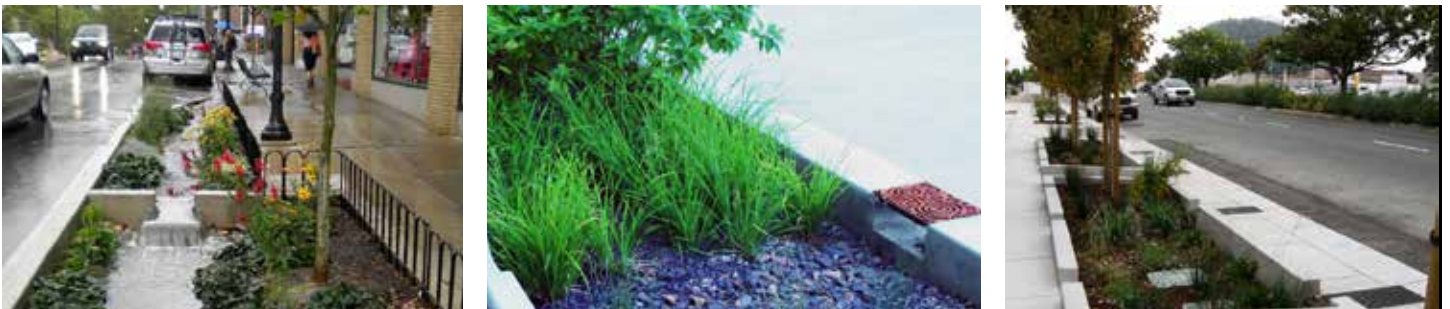
Stormwater Basins

Curb-cuts on both street side and plaza side of each basin direct surface water flow, but still create a physical/visual separation for pedestrian circulation, snowplowing and other maintenance operations.

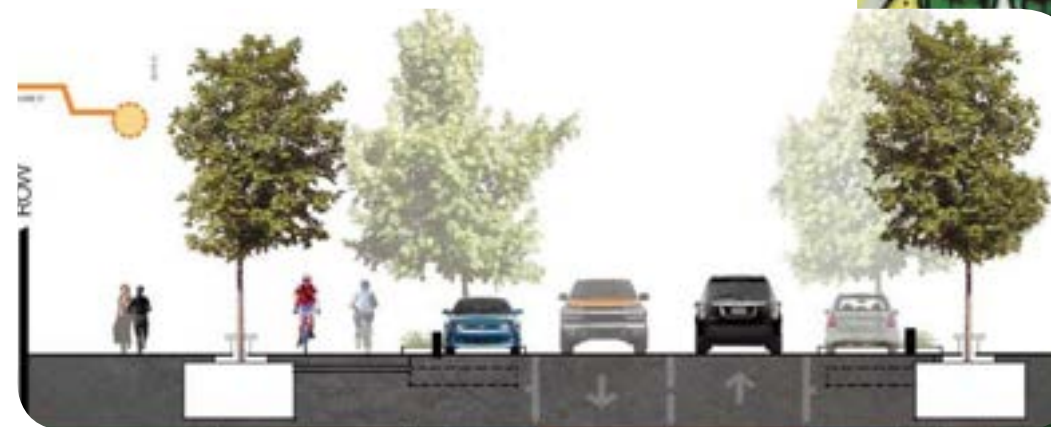
Typical street cross section.

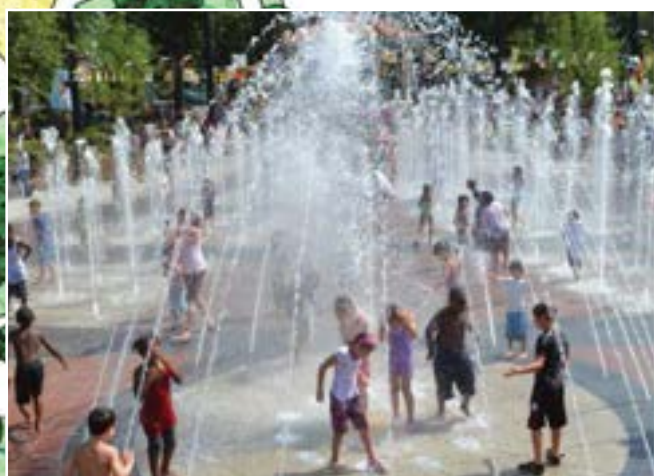
THE WATERFRONT: WATER PLAY AREA

The Water Play Area will feature two primary amenities: a concrete-lined wading pond and a multizoned splash pad designed to attract children of all ages and abilities to The COR.

As a major new public amenity, The Waterfront will fulfill a list of community-desired objectives related to water-oriented recreational uses within a native/natural landscape that characterizes the entire park. Along with the proposed wading pond and splash pad, additional facilities such as concessions/restaurant building, pavilion, pergola/cabana and other amenities, will further enhance the Water Play Area as a significant community destination.

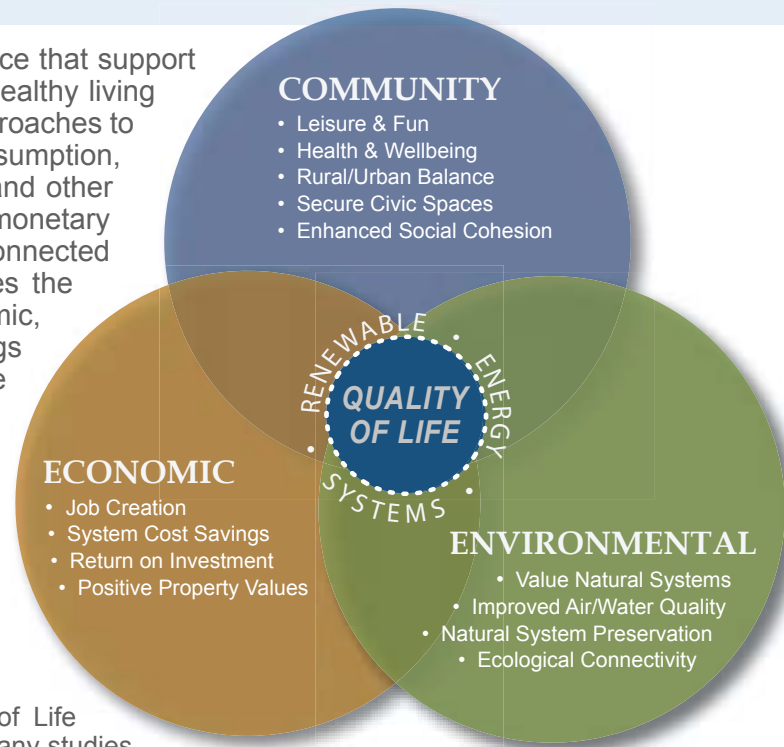
Investing in a system of public parks, trails and open space that support high quality recreational amenities, and promotes other healthy living objectives remains a high priority for the City. Creative approaches to design of public places can positively impact energy consumption, air quality, carbon reduction, property prices, recreation and other elements of community health and vitality that have monetary or other social value. In short, it is this network of connected spaces that attracts private development interest, defines the qualities and character of The COR as a vibrant, dynamic, must-experience local and regional destination that brings measurable triple-bottom-line benefits maximizing the City's return on their investment. Multiple benefits and measurable value as highlighted in this diagram and the brief descriptions below.
