***Interim* Playground Replacement Policy**

City of Ramsey, Minnesota

Adopted: x/x/2021

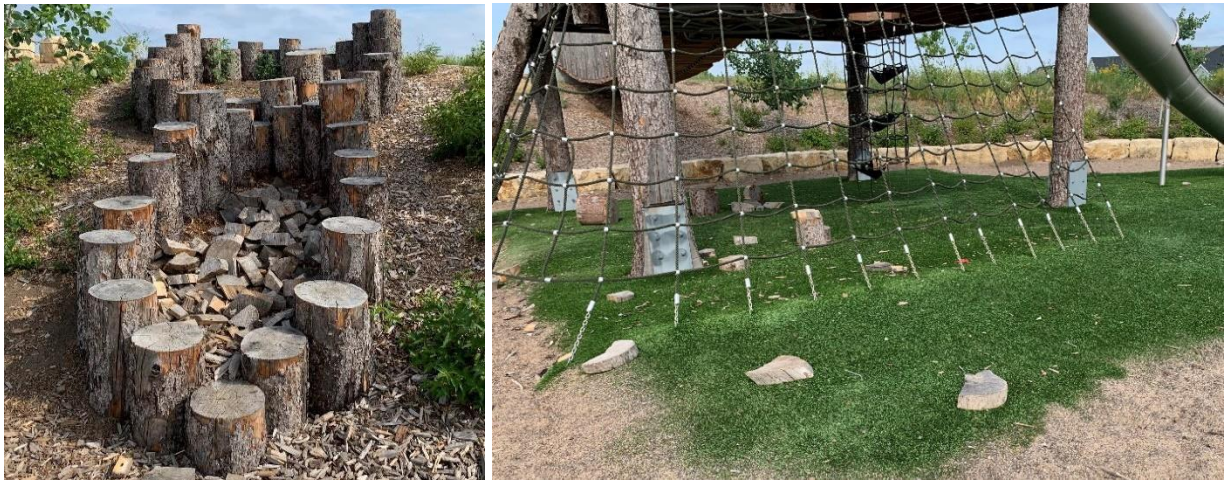
Figures 1-2: Nature-based play features at Pearson Park: (left to right) figure-eight stair stepping logs; sand and artificial turf surfacing, scattered ‘tree cookies’

In instances where the public may not support the elimination of a playground per se, but full or partial replacement is not feasible, other actions can be taken to preserve space for children to engage in outdoor recreation without entirely new play structure components. Alternative play spaces however are best considered with appropriate public input. Residents may embrace for example, ‘nature based’ play areas made with trees, branches, boulders etc. which *may* be less expensive to install and maintain than traditional playground equipment. Pearson Park has elements like these, which are proven to be popular.

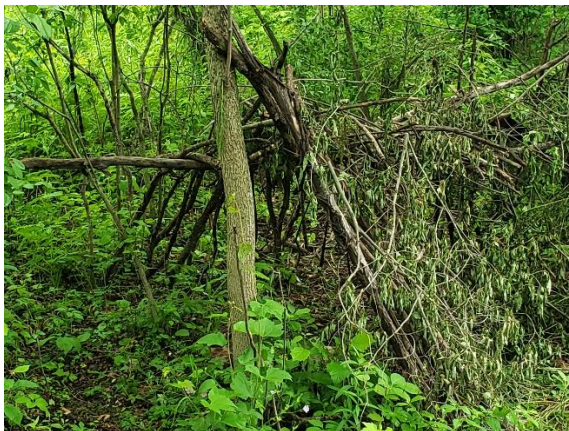
Ford Brook Park

Tree forts are almost a rite of passage for children, like this one in the wooded area of Ford Brook Park, or one below at Pearson Park manufactured from imported branches.

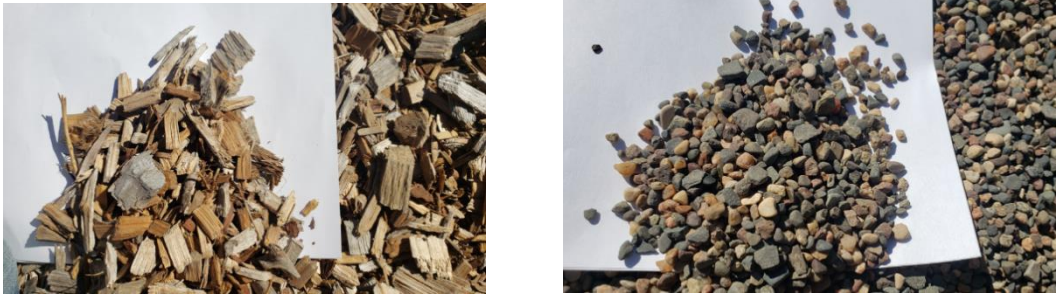
The city of Ramsey primarily uses two different types of surfaces for its playgrounds—engineered wood fiber (known colloquially as wood chips) and pea gravel (reused seal coating rock). Both surfaces are considered safe as long as kept at a depth of at least twelve inches, though pea gravel may have concerns due to its shape, making it an attractive nuisance for young children to put in their mouth. Additionally, the surfaces—as well as rubber mulch—are desirable due to generally low upfront installation costs (with pea gravel being the cheapest), but require regular maintenance (raking and levelling to maintain a proper depth for cushioning falls but still remaining accessible) and need to be replaced roughly every five years. Funding for the reoccurring surface replacement could be from the Lawful Gambling Fund, instead of the General Fund as has been the case.

Figures 3-4: (left to right) engineered wood fiber (EWF); pea gravel

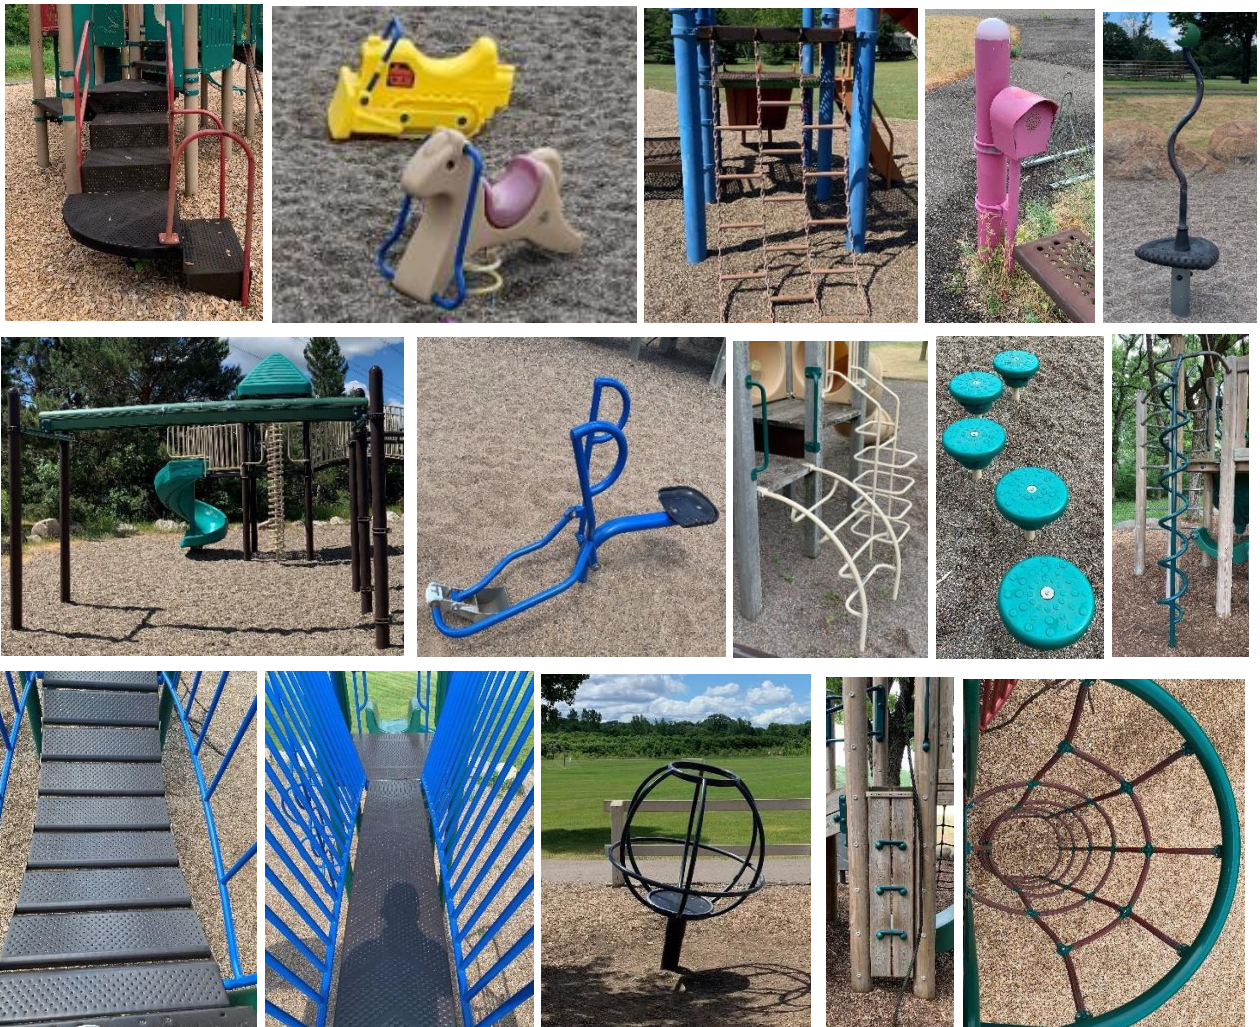
Figures 5-19: Playground Equipment: (left to right, top to bottom) transfer surface; spring rider; chain ladder; talk tube; spinner; track-ride; sandbox excavator toy; metal ladders; stepping pods; corkscrew climber; clatter bridge; belt bridge; globe spinner; climbing wall with rope; enclosed rope climber.

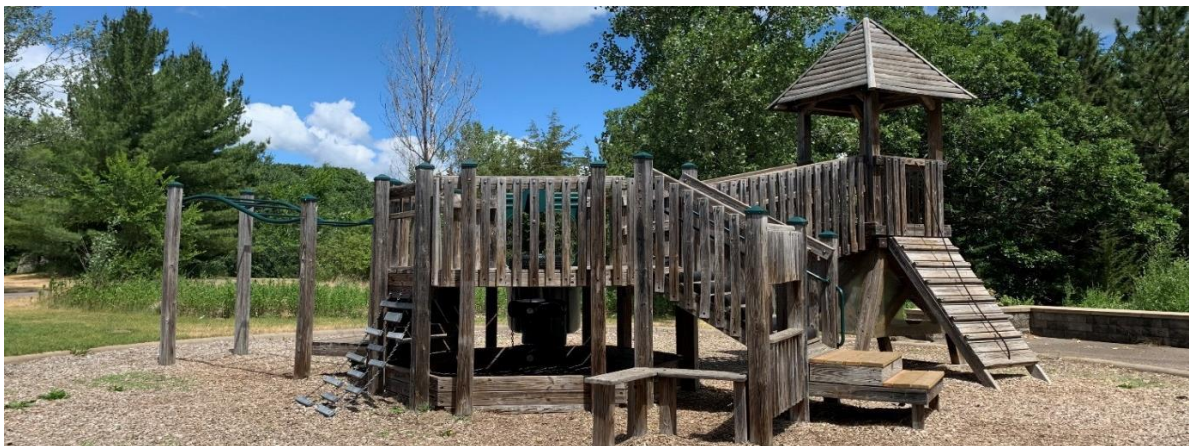
Figure 20: Alpine Park Playground

There are five means of entry—the aforementioned transfer surface and ladder, a wooden staircase, a chain link ladder (with four parallel chains) with metal footings, a chain link ladder on the interior of the structure which three rubber tires serving as steps, and a wooden climbing wall (sloped roughly 60 degrees with the ground) with six wooden steps and a rope for balance. The bottom of the climbing wall is worn, likely due to use as an additional step. The protective covering on the rope is worn and the metal inside of the rope is exposed in places. The rope has also been stretched considerably.

The entire surface of the structure is wooden with the exception of a bridge, which has a rubber mat for a surface. The bridge is sloped slightly (less than 15 degrees) from one end to the other, however there are four peaks on the rubber surface with thin wooden planks on top. The rubber surface is somewhat worn and there are cross slopes in some places that are unrelated to the design. The chains for both ladders are in fairly good condition. The wood throughout the structure ranges from okay to poor condition visually. The wood on the supports for the tallest portion of the structure (i.e. the area with the wooden climbing wall) is in the poorest condition with several of the planks making up horizontal and diagonal supports being splintered. The playground also has talk tubes (metal megaphone toys through which children may communicate with one another through opposite ends), which are both in good working condition.

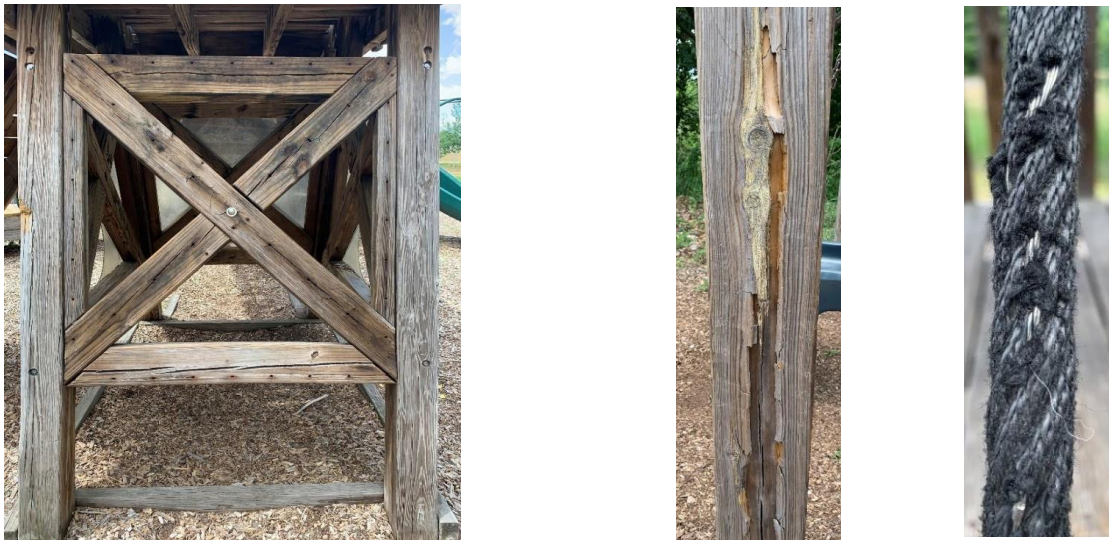
Figures 21-23: (from left to right) Splintered wood on horizontal and diagonal supports; Splintered wood on support for swing set; Worn rope covering on climbing wall

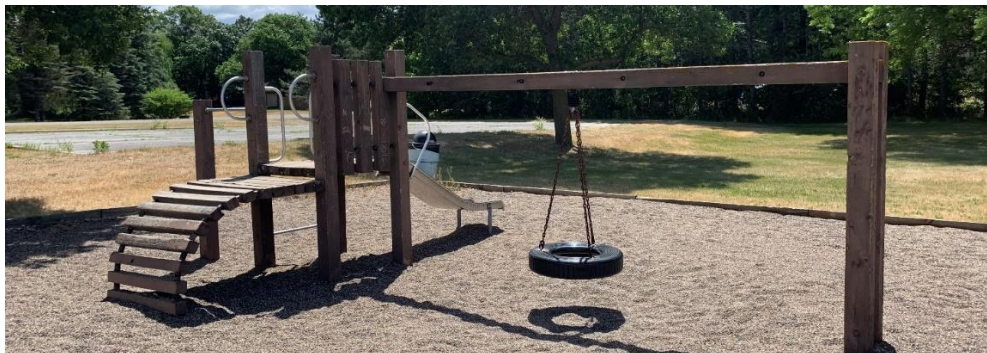
Figure 24: Autumn Heights Park Playground

The playground consists of a single wooden play structure with a tire swing and a metal pull-up bar. The tire itself is in good condition, but the chain it is attached to is rusted and shows wear. The top surface of the play structure consists of five parallel wooden planks, all of which are loose (with the exception of the second-to-rightmost plank). There are two means of entry, neither of which are ADA-compliant. One is a ladder with two metal bars serving as steps. The other is a curved surface with narrow gaps for footholds, comprised of eight wooden planks, all of which are fully attached. The flat surface between this surface and the top surface (which is three inches above this surface) is comprised of six wooden planks (none of which are fully secured) perpendicular to those on the top surface and parallel to those on the curved surface. There is a single straight stainless steel slide, which is in fair condition, (however it is South facing, which is not desirable). *The terms of this Interim Playground Replacement Policy point to the playground components' removal, without replacement.*

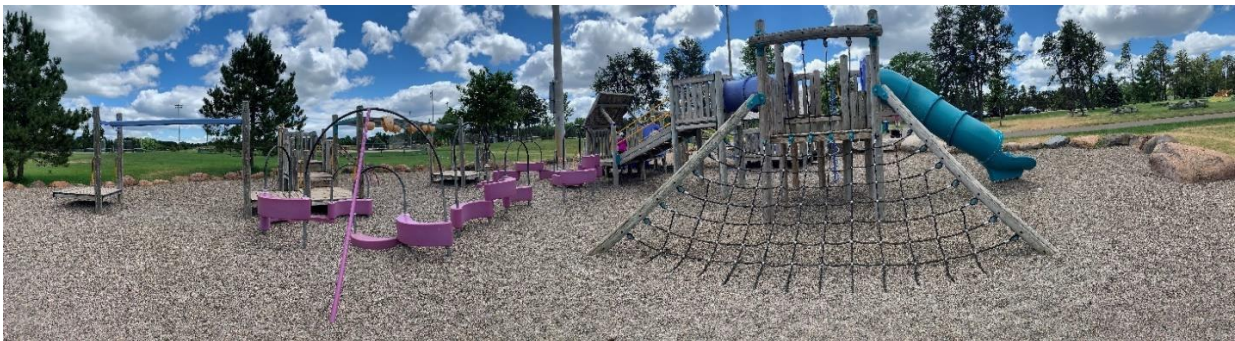
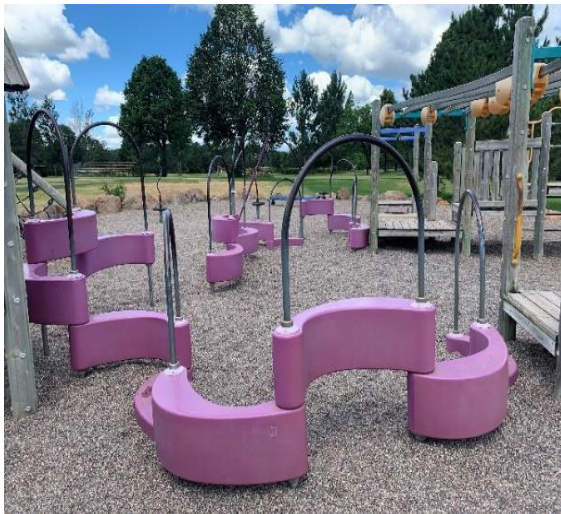
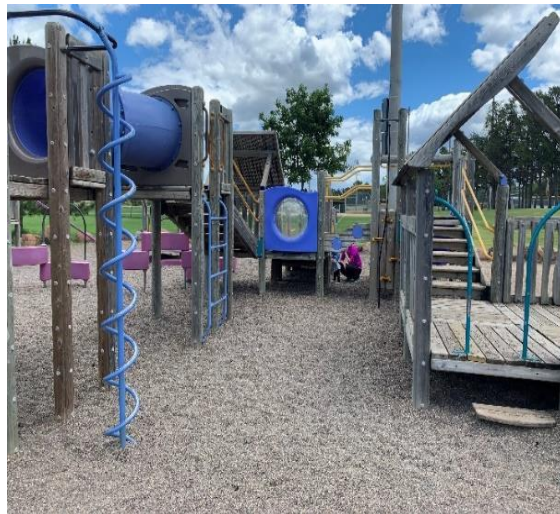
The structure is largely wooden, but there are multiple plastic and metal components as well, such as two plastic slides—one enclosed and one open with three parallel tracks—and a plastic tunnel. The wood is in fair condition, but is exhibiting some wear and tear. There are two track-rides, one straight with a single track and one curved with five parallel tracks. The grip for the first track-ride is metal, with chipped paint, and the grips for the latter are plastic and are in good condition, albeit with slightly faded paint.

Linking the two track-rides is a series of four wooden transfer platforms. The topmost platform is accessible via a metal chain-link ladder as well as two parallel metal bars for climbing. Linking the track-rides and transfer platform between them with the rest of the playground structure is a series of seventeen arched plastic platforms. Additional means of entry include a rope climbing wall, metal ladder, a wooden climbing wall with a rope, a step with handrails for accessing a transfer platform, a corkscrew climber, and a wooden ramp.

Figure 25: Central Park Playground wide shot; Figures 26-27: (left to right) seventeen curved platforms; several means of entry, including a metal ladder, a wooden climbing wall with a rope,

a corkscrew climber, and a step with handrails

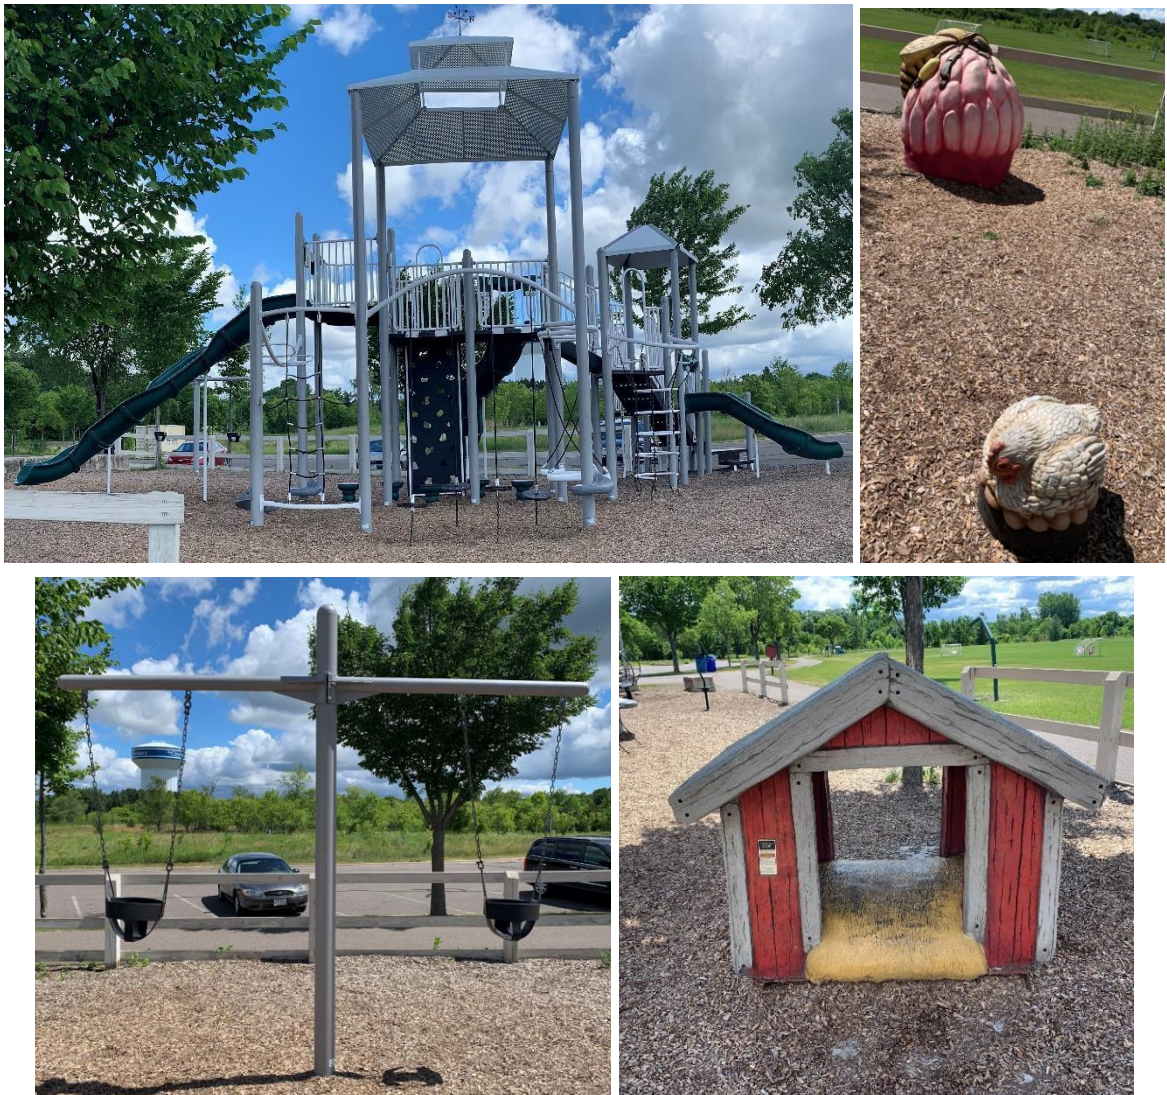
The farm-themed playground features a main playground structure, a swing set with two bucket swings, a play barn, two spinners (one globe spinner), two chicken sculptures and one bee sculpture for climbing. The main play structure contains an obstacle course with a rope ladder, four angled platforms secured into the ground by a chain, a curved metal bar with four ropes crossing one another for balancing, a set of inclined monkey bars comprised of three rings forming six handholds, and five stepping pods. Additionally, the playground has three zigzagging slides and five means of entry—one transfer surface, two platforms forming a quasi-staircase, a ladder consisting of three platforms, an enclosed chain-link ladder with five metal semicircular footholds, and a climbing wall with slots cut out for footholds. All components of the playground are in excellent condition.

Figures 28-31: (clockwise from the top left) main play structure; chicken sculpture, bee and flower sculpture, swing set with bucket swings, and play barn

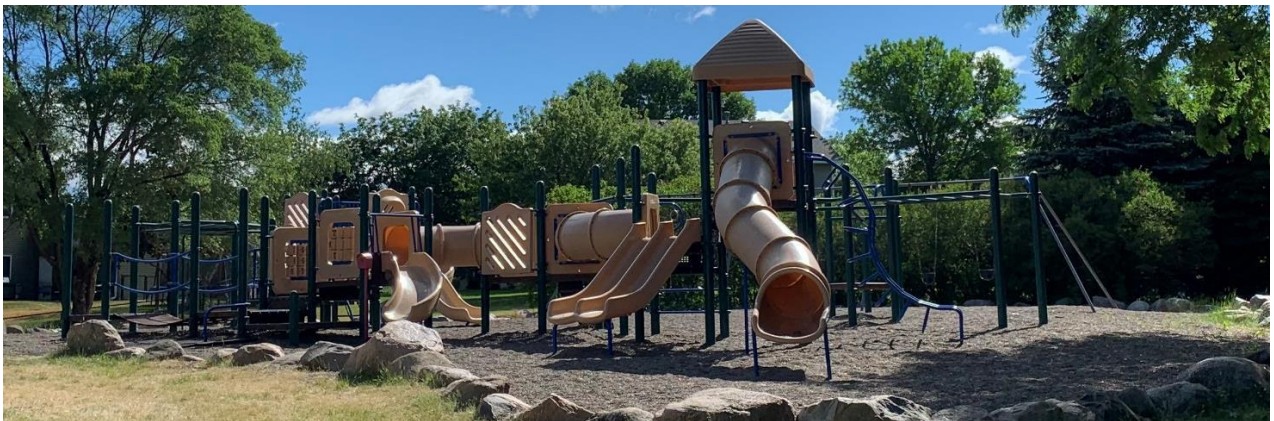
Figure 32: Emerald Pond Park Playground (looking northeast)

Emerald’s playground consists of three components—a seesaw spring rider, a swing set, and a large composite play structure. The seesaw’s surface is well-worn from use, with paint chipped and metal beginning to rust in some places, but it is still functional. The swing set is mostly in good condition, albeit with some of the chains exhibiting rust. The swing set consists of three bays, two with two belt swings each, and the third with two bucket swings.

Additionally, it features five slides—one short straight slide with two parallel tracks, one straight slide with a single hump in the middle, one short curved slide rotating 90 degrees, one curved slide rotating 360 degrees, and one enclosed zig-zagging slide. The enclosed slide has drainage issues, with water occasionally pooling at the bottom, but this does not pose a safety issue. All of the slides are in good condition otherwise. The other plastic components—two tunnels, two interactive sensory components with 3 x 3 rotatable blocks with letters on them, most of the guardrails, and a roof—are in good condition.

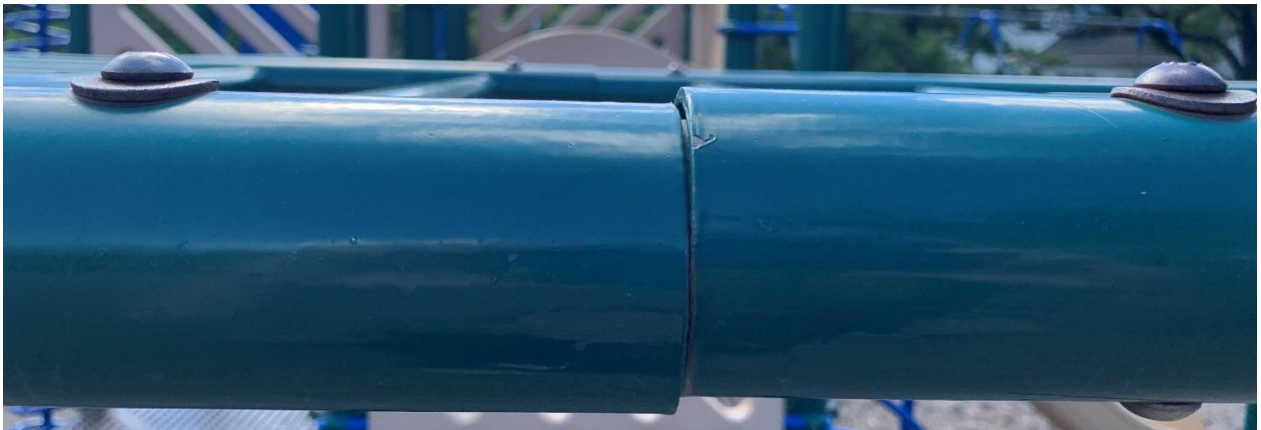
Adjacent to the clatter bridge is a set of flat monkey bars with a curved path. Two of the metal shafts in adjacent sections of the monkey bar structure are not completely flush, which is not a safety issue in and of itself, but should be repaired outside of a full playground replacement. On the opposite side of the playground structure, there are two sets of monkey bars as well as a track-ride, linked together by a triangular transfer platform. One of the sets has flat bars while the other has six rings suspended by short chains, the latter linking the former as well as the track-ride with the rest of the play structure.

Figure 34: Section of monkey bars with minor misalignment

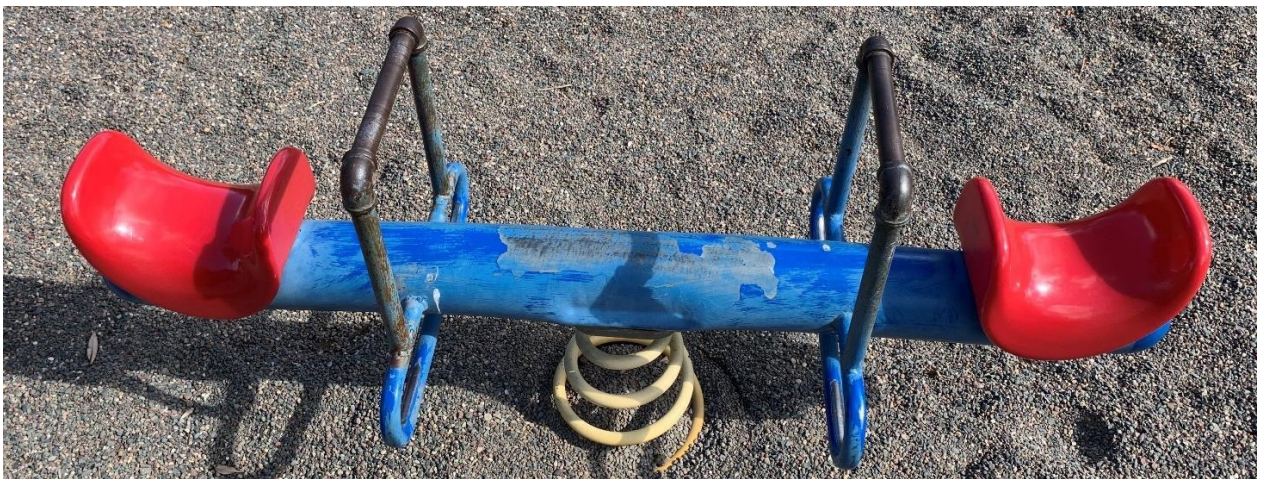
Figure 35: Seesaw spring-rider

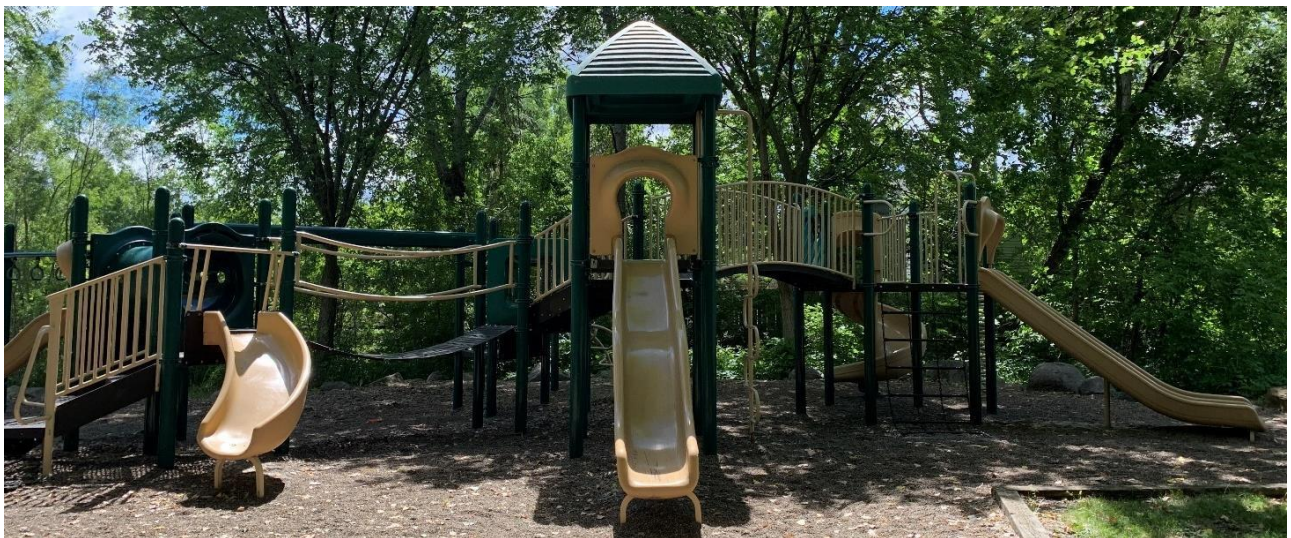
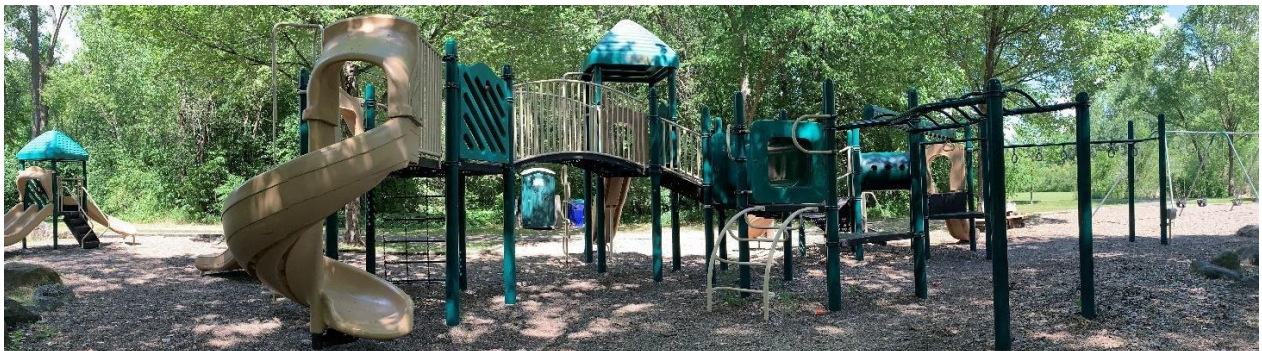
Figures 36-37: Flintwood Terrace Park Playground (looking east and west, respectively)

The playground consists of three components—a swing set, a small play set, and a large play set. The swing set has three bays—two with two belt swings each, and one with two bucket swings. The small play set has two slides—one straight with two parallel tracks and one curved 90 degrees—as well as a staircase and two opposing handrails for entering the structure.

There are five different ways one can enter the main structure—a staircase, a metal ladder with five alternating semicircular rungs forming ten footholds, a curved metal ladder with four semi-rectangular rungs, a chain-link ladder with six rungs, and a corkscrew climber. The main play set has five slides—a straight slide, a straight slide with a hump, a straight slide with two parallel tracks, a curved slide rotating 90 degrees and a curved slide rotating 360 degrees. Linking the different elements of the structure are two bridges—a clatter bridge and a belt bridge—and a plastic tunnel. Additionally, there is a track-ride and two sets of monkey bars. One set of monkey bars has seven upwardly curving bars, while the other has seven rings suspended by chains. Overall, the playground is in great condition.

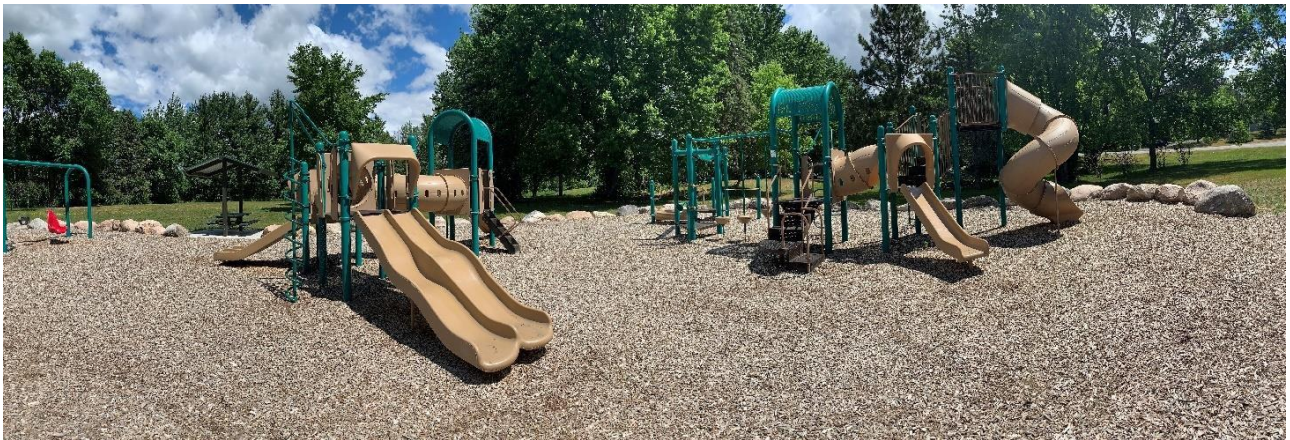
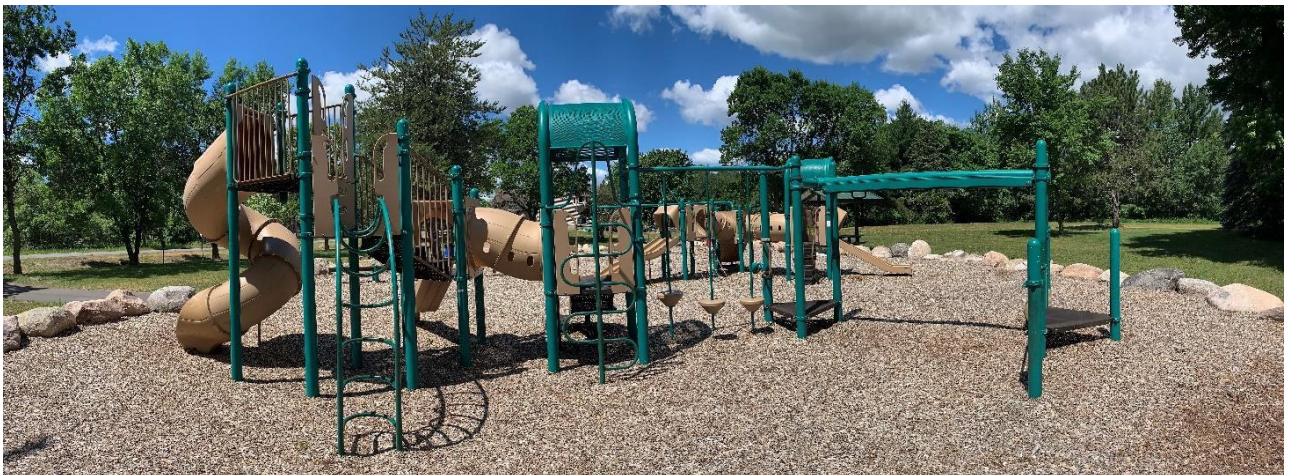
Figures 38-39: Ford Brook Park Playground, facing southeast and southwest, respectively

The other playset has three main means of entry—a staircase and two metal ladders—and two slides—one straight, the other enclosed and rotating 360 degrees. It also features an obstacle course consisting of three platforms connected to metal poles, a track-ride, a pull-up bar, and a log roll.

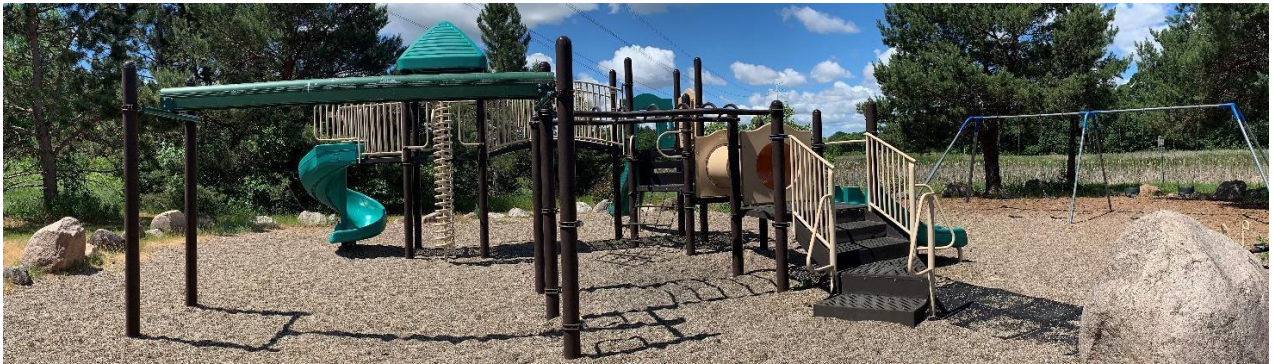
Figure 40: Fox Park Playground

The main playground has three means of entry—one transfer surface, one chain link ladder with metal steps, and one corkscrew climber—and three slides—one straight slide with two parallel tracks, one straight slide with a hump, and one curved slide that turns 180 degrees. Different components of the structure are connected by one plastic tunnel and one upwardly curving belt bridge. Lastly there is a set of monkey bars with seven bars that curl upwards, as well as a track-ride. All playground components are in good condition.

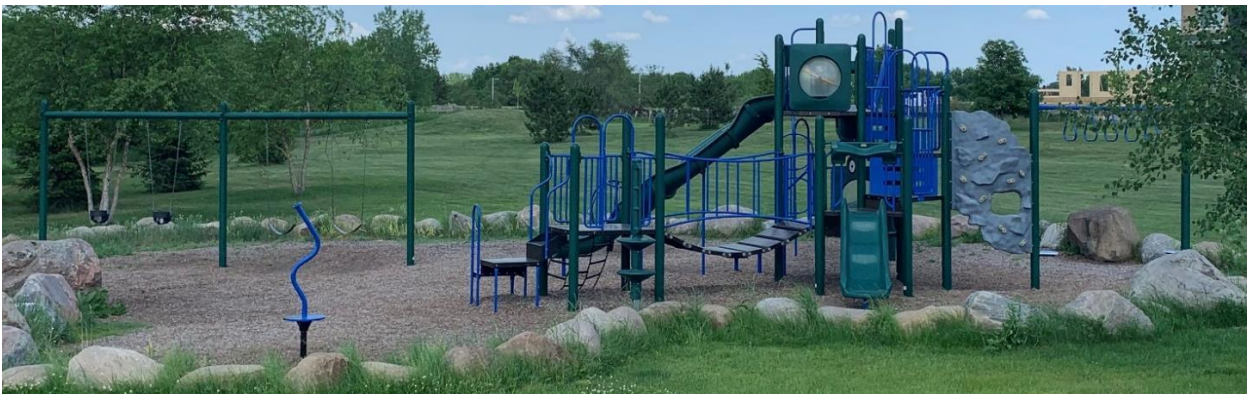
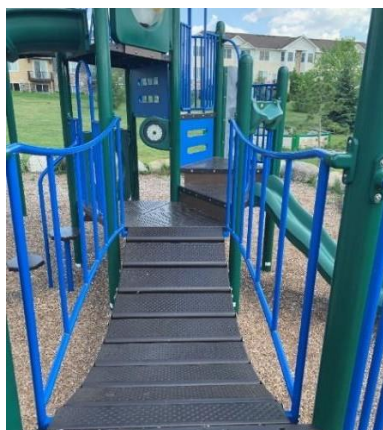
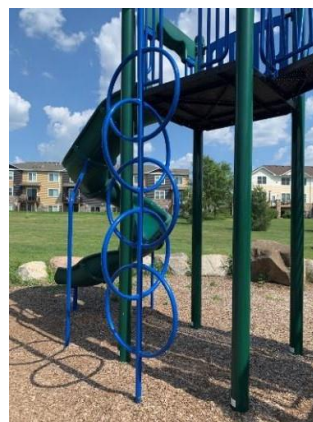
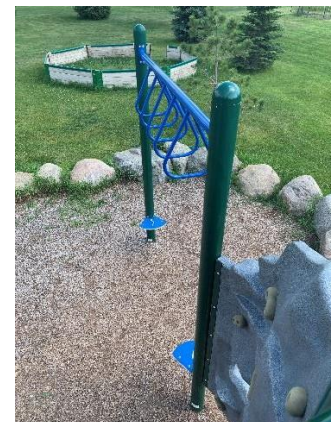
The monkey bars consist of five triangular bars. The climbing wall is plastic with nine holds on the front side and seven holds on the back side and a hole near the bottom of the wall (on the right side when viewed from the front) that can serve as a hand hold or foot hold. The top portion of the structure is accessible via two separate ladders made from walls with two slots cut out for foot holds. The bottommost of these ladders may have accessibility concerns—although one can use the guardrails as handholds, there is not a lot of room to maneuver through the opening.

Figure 41: North Commons Park Playground wide shot; **Figures 42-44:** (left to right) bridge connecting to upper portion of the playground structure, ladder in the background, climber with five orthogonal rings; monkey bars and climbing wall

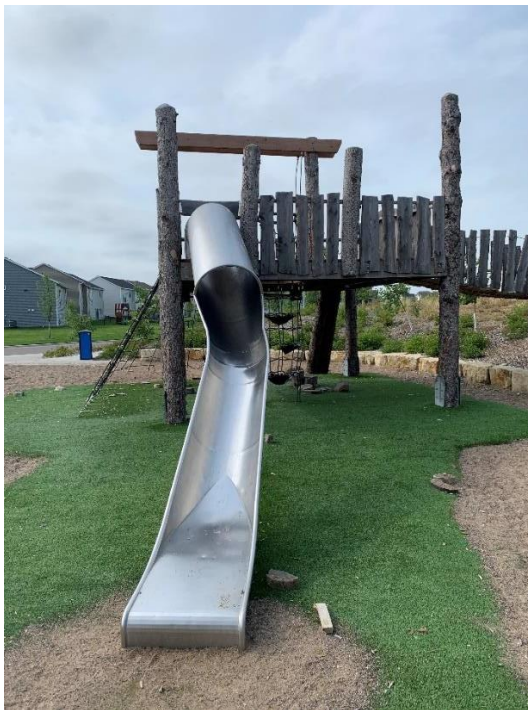
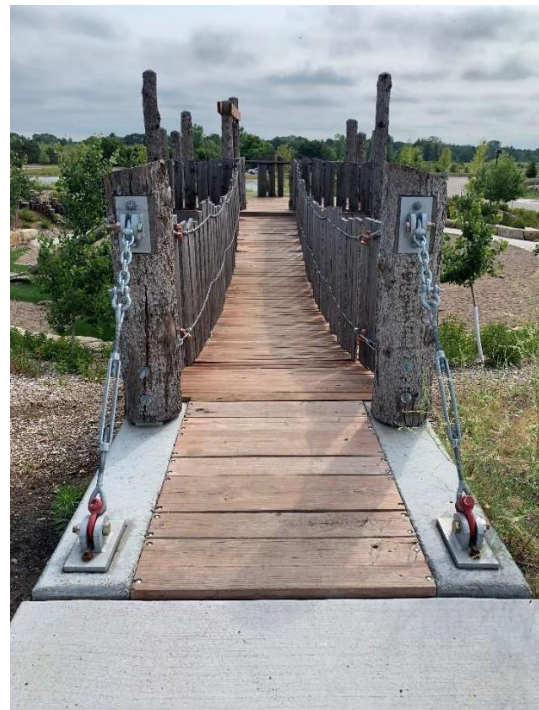
The playground includes a \$35,000 long stainless steel slide (enclosed near the top, but open near the bottom) that bends slightly near the middle. The main point of entry is a wooden bridge accessible via a concrete sidewalk. The other three means of entry are a thin wooden climbing wall (background of *Figure 15*) and two rope climbing structures. The larger one lines the southeast corner of the playground structure, while the smaller rope structure is located in the center. An octagonal opening in the wooden deck of the playground structure allows one to enter via the smaller rope structure. The smaller rope structure is enclosed and also has large curved footholds for ease of use. All playground components are in near-new condition.

Figures 45-46: (left) Pearson Park Playground (not pictured: bridge); (right) Bridge

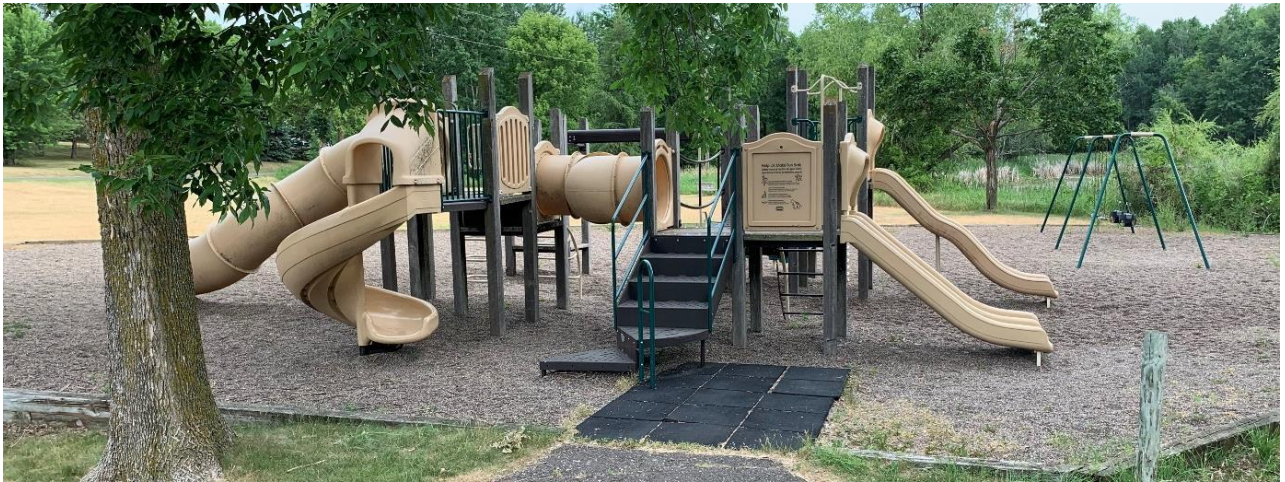
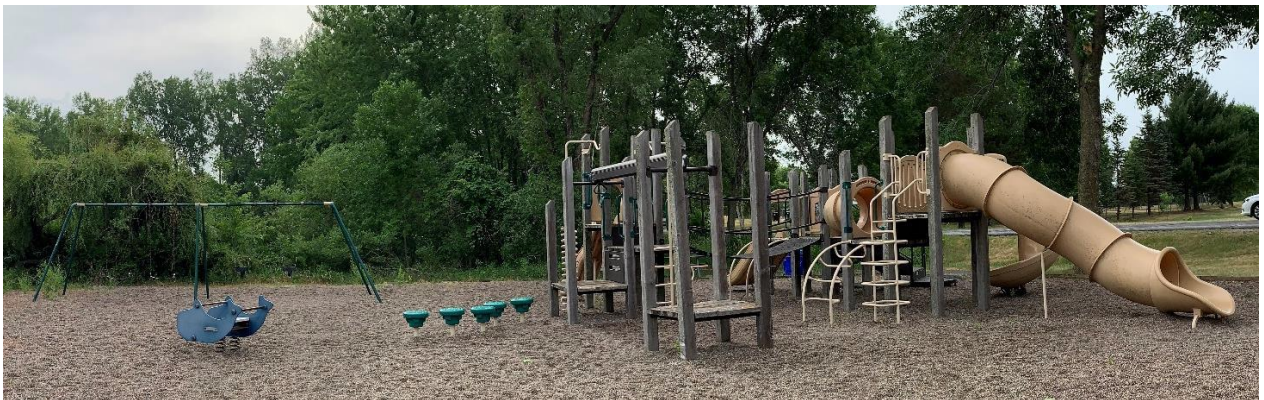
Figure 47-48: Peltzer Park Playground (facing North and Southeast, respectively)

The spring rider is in fair condition, though its paint is faded and some of the metal is in the initial stages of rust formation. The swing set consists of two bays with two swings each; one bay contains belt swings and the other contains bucket swings. The swings are all in good condition.

Overall, the playground is in fair condition. The paint on the plastic components has faded and the wood on the decks and supports is slightly worn but the playground is structurally in working condition.

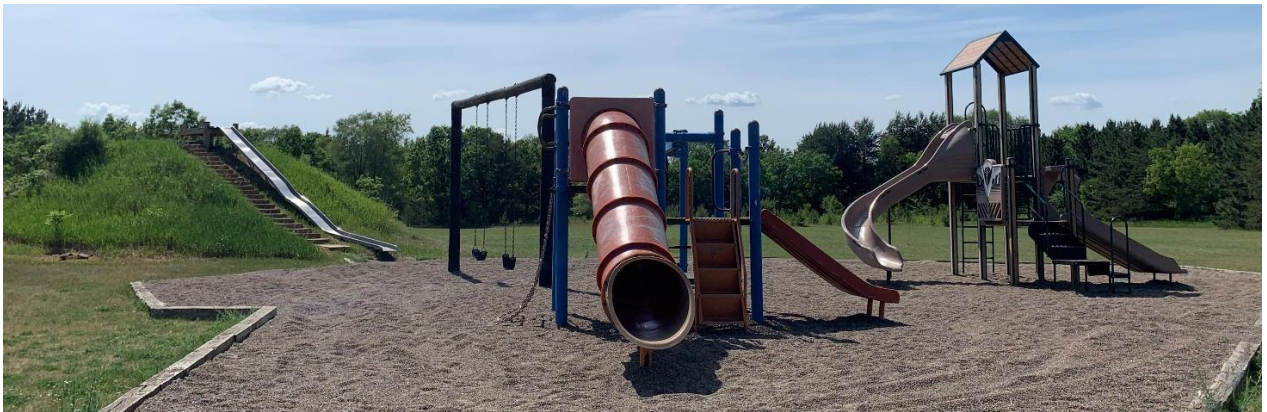
Figure 49: Rabbit Park Playground

The other play structure has two slides (one enclosed), three means of entry—one transfer surface, one chain-link ladder, and one-metal ladder—and a track-ride. The transfer surface steps are narrow and steep, and appear to not be ADA compliant. The chains for both swings are also worn and/or surface rusted. The playground is not accessible via an ADA trail.

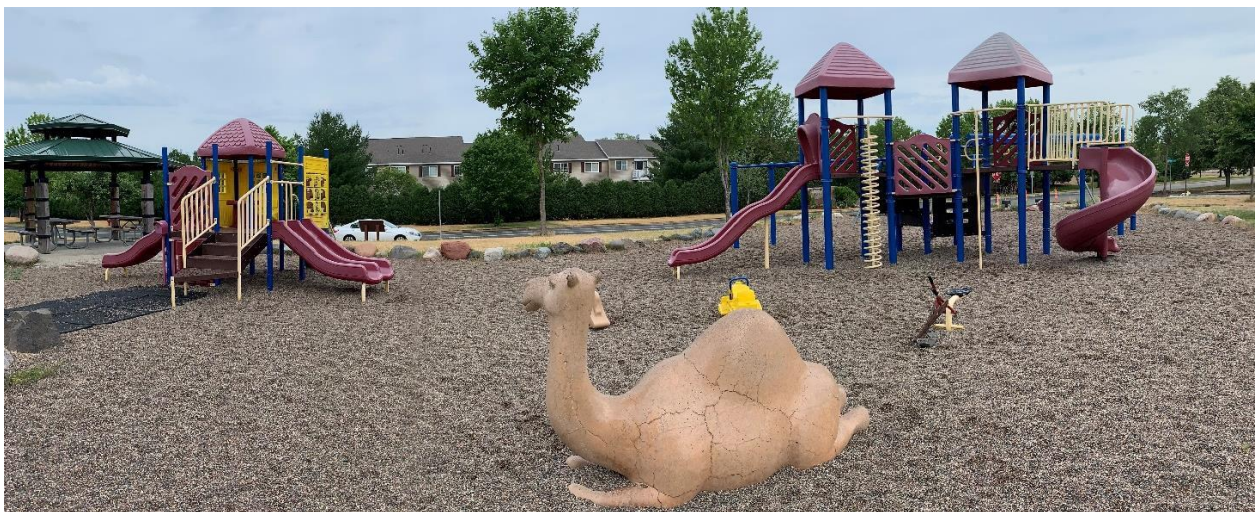
Figure 50: Riverdale Park Playground

The playground consists of three main components—two distinct play structures and one swing set—as well as four other components—a concrete camel sculpture, an excavator toy, and two spring-riders (one in the shape of a horse, the other in the shape of a bulldozer). The four components are in fair condition (however the concrete sculpture does have small cracks). The swing set has two bays with two swings each (two bucket swings and two belt swings in separate bays). The two talk tubes linking the two main play structures are deteriorating.

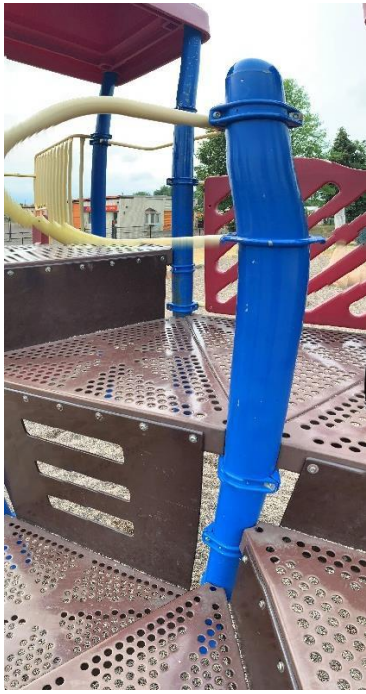
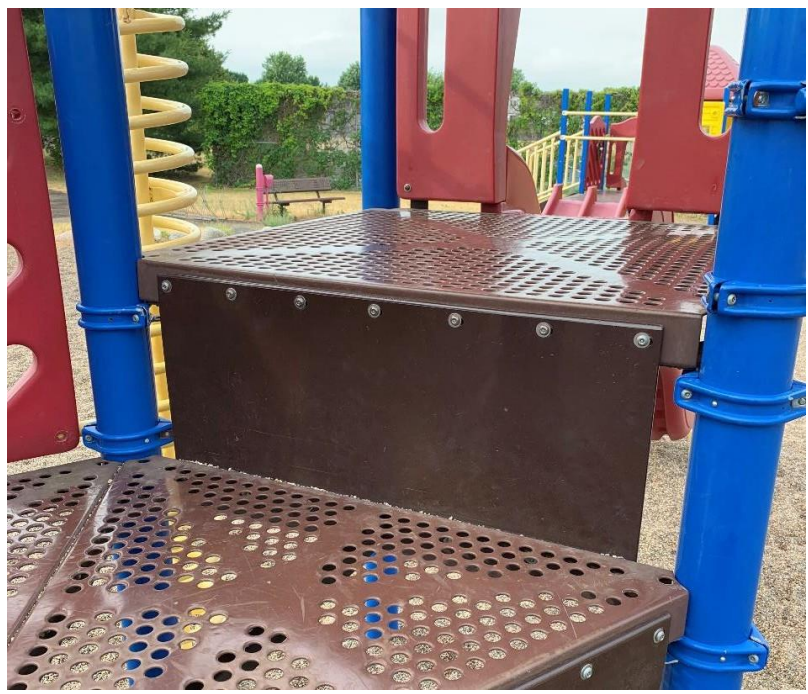
The larger play structure has a corkscrew climber and two slides—one straight with a single hump and one curved 360 degrees. Additionally, there is a set of monkey bars with eleven straight bars and a track-ride. Both are in good condition, though there is a small area on the grip for the track-ride with chipped paint. The transfer surfaces are in good condition but there are some accessibility concerns. The play set is not accessible via a flat surface and the transfer platforms are spaced vertically from one another by 18 to 24 inches. The six transfer surfaces are triangular and arranged together in a hexagonal shape with the last three being level with one another, forming a trapezoid. This top platform is alternatively accessible via a ladder formed by three slots cut into a wall, which is supplemented by two handholds. Even with the handholds, there are still accessibility concerns.

Figures 51-52: Transfer Surfaces on the Larger Playground at Riverdale Park (note that the picture on the left is part of a vertical panorama and is compressed vertically and angularly distorted)

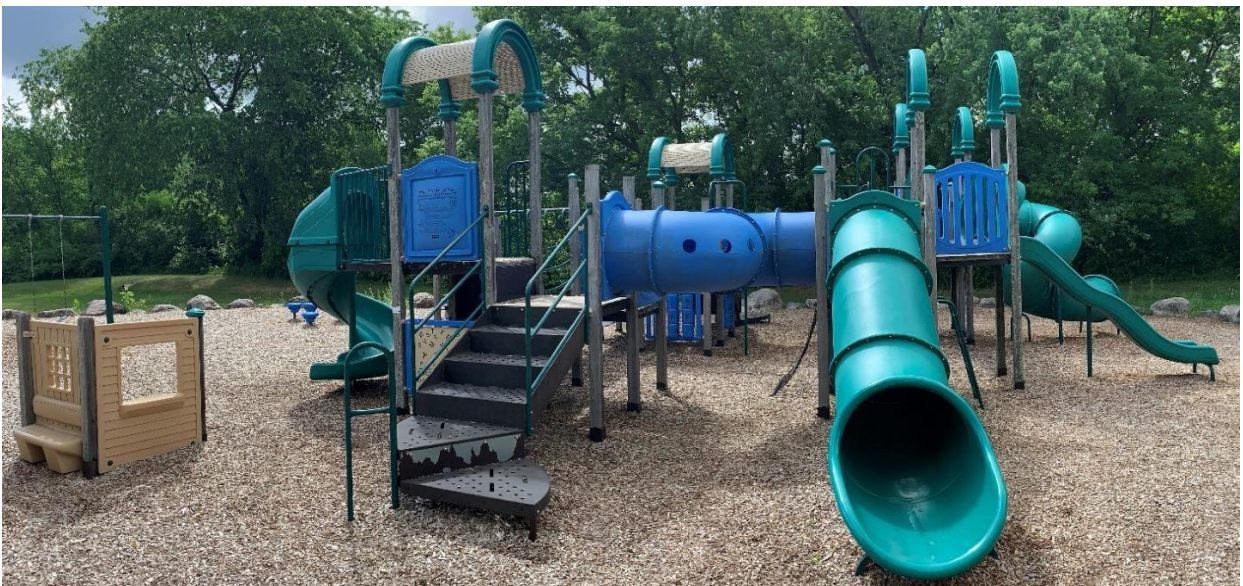
Figure 53: Rivers' Bend Playground

The two play houses are mirror-images of one another, each consisting of two plastic walls held together by three wooden posts. The walls facing each other both have a small window with a 3 x 3 pattern as well as a bench below the window. The other two corners of each of the houses are open. The houses are both in good condition. The swing set has two bays, one with two bucket swings and one with two belt swings. The entire structure is in good condition. The paint on the dolphin spring-rider is chipped and the concrete base is worn, but it is otherwise in good condition.

The main play structure is a mix of plastic (slides, tunnels, roofs, and sensory components), metal (transfer platforms, some guardrails and supports), and wood (most platforms and supports). Visually the playground is in great condition, besides some faded paint and mud on the side of some of the plastic components. The main play structure has six entrances—two transfer surfaces, one chain-link ladder, one metal ladder with four alternating semicircular rings forming eight footholds, one metal ladder with four flat rungs, and one corkscrew climber. The main play structure also consists of five slides—one straight enclosed slide, one curved enclosed slide rotating 360-degrees, one straight slide with two parallel tracks, one straight slide with a hump, and another curved slide rotating 360-degrees. Additionally, there is a set of monkey bars with seven round rings. Tying the structure together are a clatter bridge, a belt bridge, and two tunnels each with two 90-degree turns.

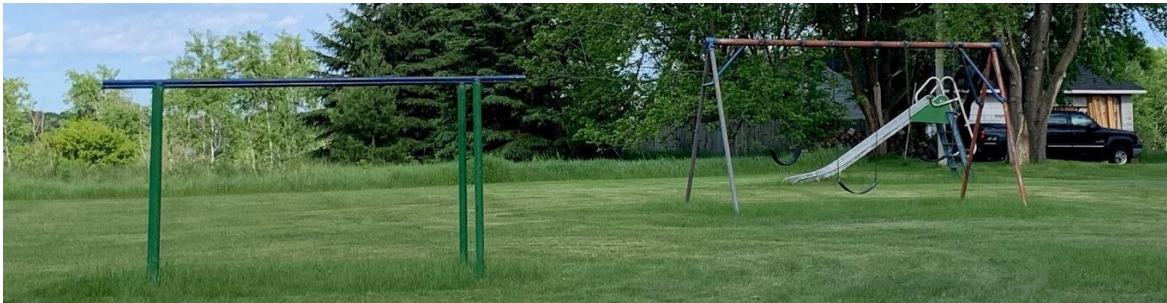
Figure 54: Shawn Acres Park Playground

Shawn Acres is a neighborhood park located in a low-density area in northern Ramsey along Chameleon Street, 1/5 mile north of 173rd Avenue, and west of Thorn Lake. Its playground was placed there before 1980, and it is believed that it was used components at that time. The playground consists of three separate small elements: a rusted metal-pole swing set with three swings, a stand-alone metal slide, and a parallel set of metal bars akin to monkey bars without rungs. The paint on each of three components is peeling. Two of the three swings are inaccessible to younger children and those with mobility limitations without the help of an adult. The slide is also inaccessible to those with mobility impairments. The playground is not ADA compliant, nor does it have resilient surfacing, and has limited or low ‘play value’. *The terms of this Interim Playground Replacement Policy point to the playground components removal, without replacement.*

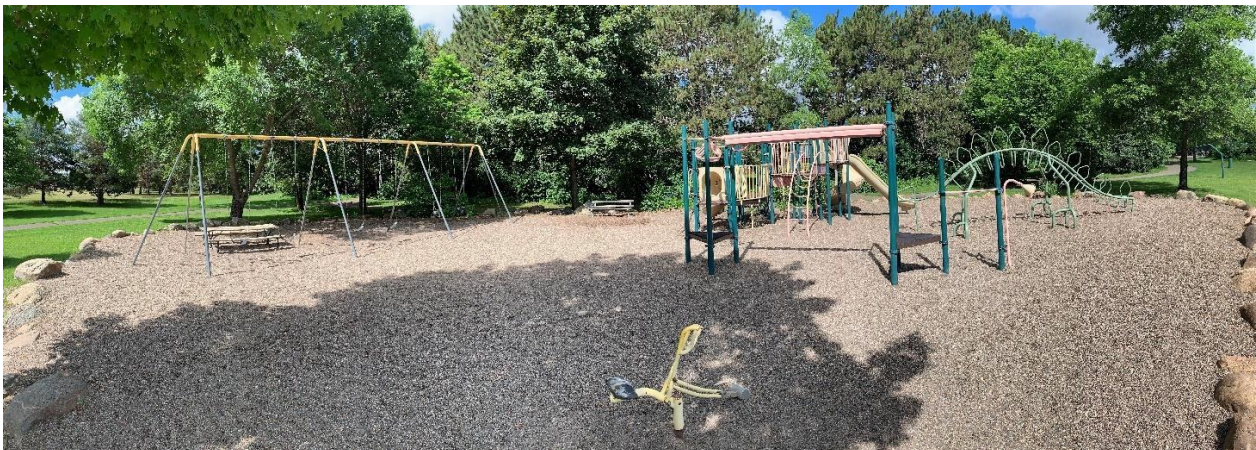
Figure 55: Solstice Park Playground

There are two curved slides, the shorter one turning 90 degrees and the longer one turning 360 degrees. There is a third straight slide. All of the slides are in good condition, however there are scratch marks in several places.

There are three main points of entry for the main composite playground structure—one transfer surface / staircase, one metal ladder curving upwards then horizontally, and one chain link ladder. Additionally, a corkscrew climber can be used for entry. Transfer platforms serving the monkey bars can also serve as a means of entry. There is a tunnel linking different parts of the structure that is in fair condition.

The sandbox excavator like many, due to their popularity, is in poor condition with paint chipped and metal rusted in several places. The swing set has three sections, divided by supports with two legs each, with two swings per section. One of the sections has two tot, bucket swings. All of the swings are in good condition. The monkey bars, comprised of nine triangular metal rings, are in good condition, as is the track-ride, though there is chipped paint in one place. There are two miscellaneous interactive sensory components, a tic-tic-toe board and a steering wheel, both of which are in good condition. Finally, there is a pull-up bar and talk tubes, both of which are in fair condition.
