***Interim* Playground Replacement Policy**

City of Ramsey, Minnesota

Adopted: x/x/2021

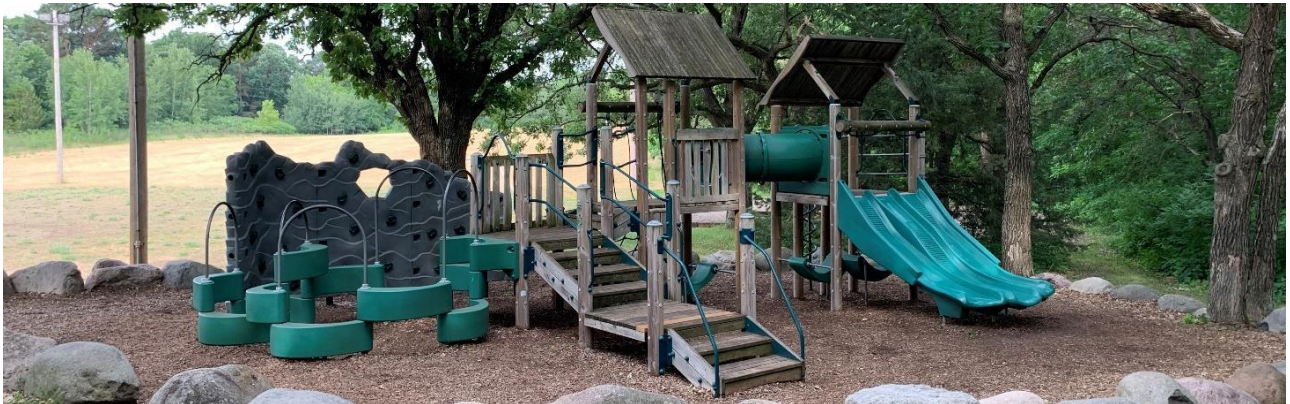
Figure 56: Titterud Park Main Play Area

The swing set is made of wooden posts and a metal crossbar, and has two belt swings. The main structure is largely wooden, but with metal guardrails and a single plastic slide with three parallel tracks and a plastic tunnel. The main means of entry is a transfer platform and staircase. Another entrance is via a gray plastic rock climbing wall attached to a series of twelve green arched climbing platforms arranged in circular patterns. Adjacent to this is a rope climbing ladder with four parallel ropes at the top for handholds. On the opposite end of the playground structure is another means of entry—a ladder consisting of seven rungs and another ladder connected at a 135-degree angle with four rungs. The fifth and sixth means of entry are a narrow ladder with a rope for balancing, and a corkscrew climber. One of the boards on the transfer surface was recently replaced, with the structure in overall in good condition.

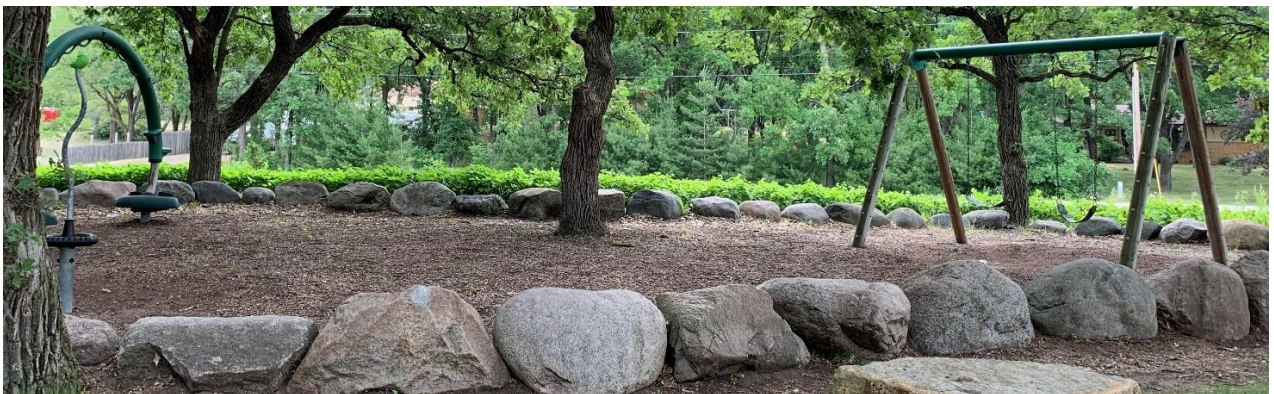
Figure 57: Titterud Park Secondary Play Area

There are three areas for playing—one with the main play set, one with a swing set and two pieces of equipment for bouncing, and an empty sandbox (with pea gravel for surfacing). The bouncing equipment is in good condition. One consists of a spiral pole with a singular platform from bouncing and the other is in the shape of a ring, allowing for two children to take turns jumping and launching the other upward.

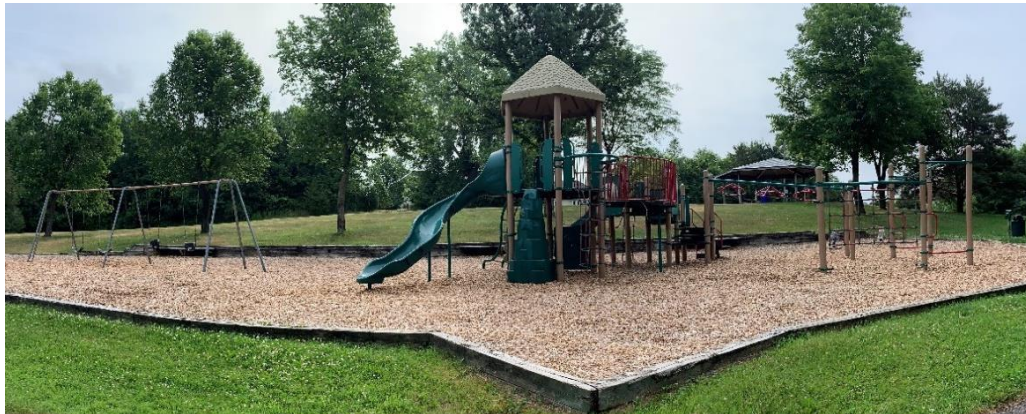
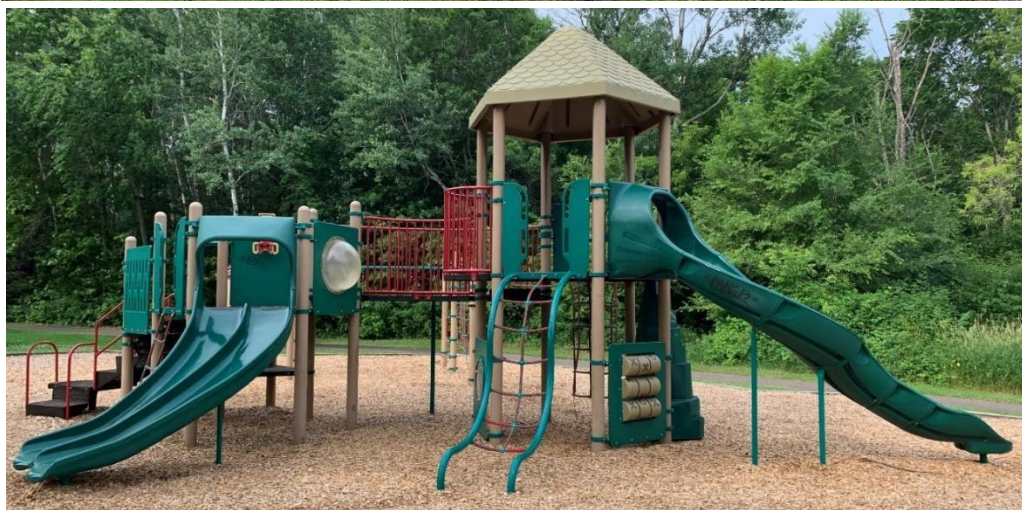
Figures 58-59: Woodland Green Park Playground (looking east and west, respectively)

The playground features four components—the main structure with an attached jungle gym, a swing set, and two spring riders (both of which are in good condition). The swing set, consisting of two bays with two belt swings and two bucket swings in the respective bays, is in fair condition, though the crossbar is beginning to rust.

The main play structure has two curved slides, one with parallel tracks and curving roughly 45 degrees and another slide (longer than the first) zigzagging, but curving roughly 45 degrees as well. There are six means of entry, the main one being a transfer surface and staircase. There are three metal rope-like ladders—one enclosed with a metal ring on top, one with two parallel metal bars on the sides, and one with a single climbing track. A fifth means of entry is a green plastic climbing structure adjacent to the longer slide. A sixth possible method of entry is the jungle gym attached to the main structure. It also consists of a rope climbing wall, a set of monkey bars made up of five rings each attached to the end of a chain, a pull-up bar, and a set of monkey bars with three tilted, rotating, circular handholds. The second set of monkey bars is slanted. The jungle gym and main playground structure are both in good condition.
