**City of Ramsey**  
**Agenda**  
**City Council Work Session**  
**Tuesday, March 25, 2025**

Old Town Hall Discussion - Next Steps

# Historic Ramsey Town Hall: Ramsey, MN

# Sustaining Our Legacy: The Future of Ramsey Town Hall

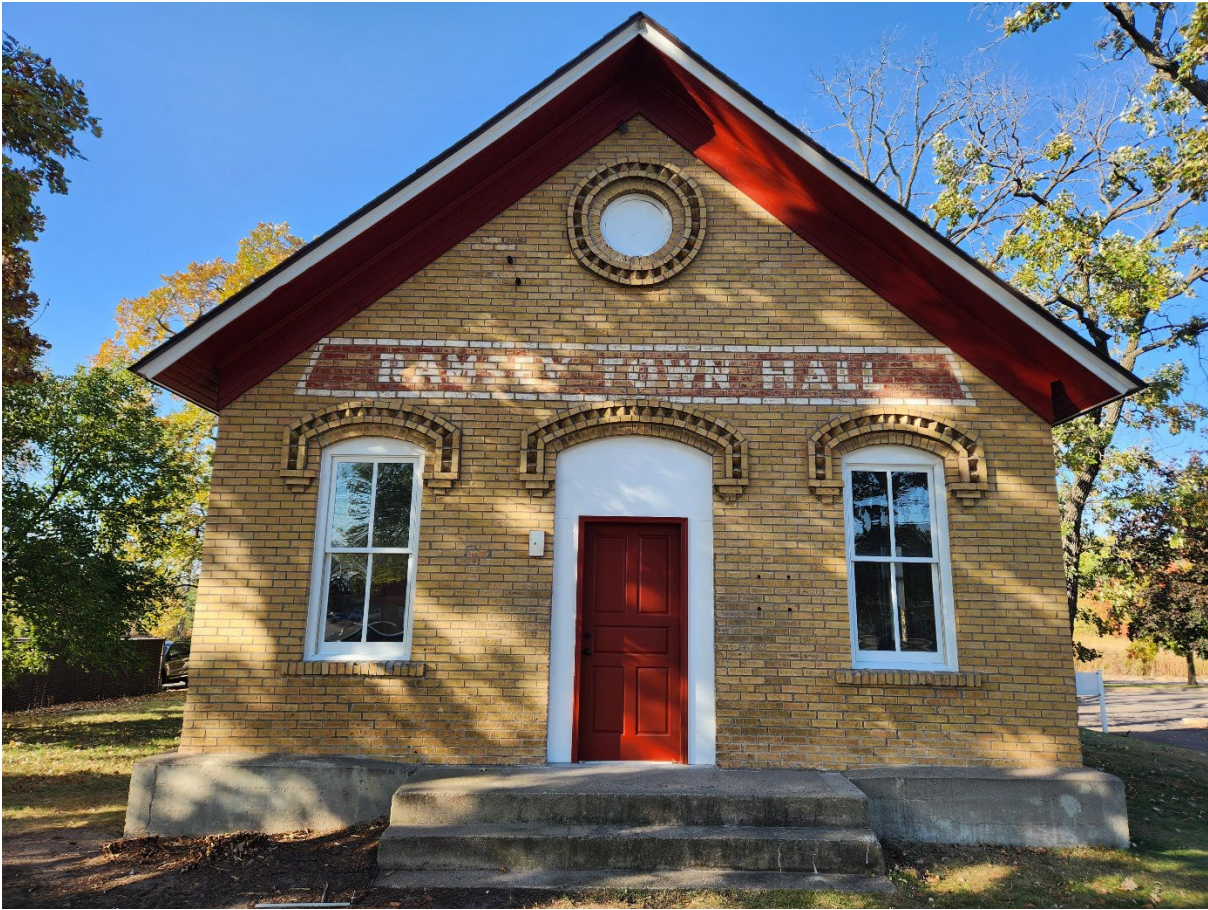
Front Door / Windows / Soffits / West Exposure (repaired)

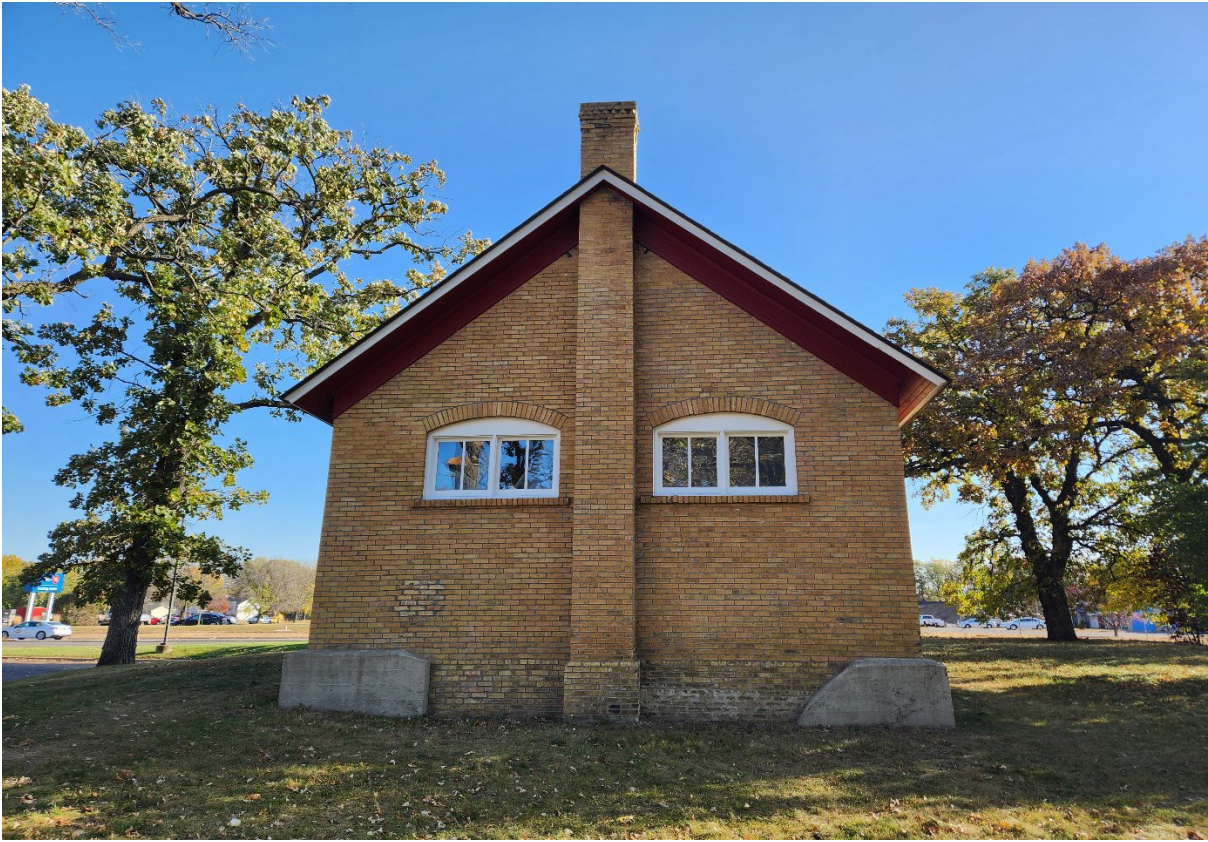
Window Fixed / Windows Painted / Soffits (repaired)

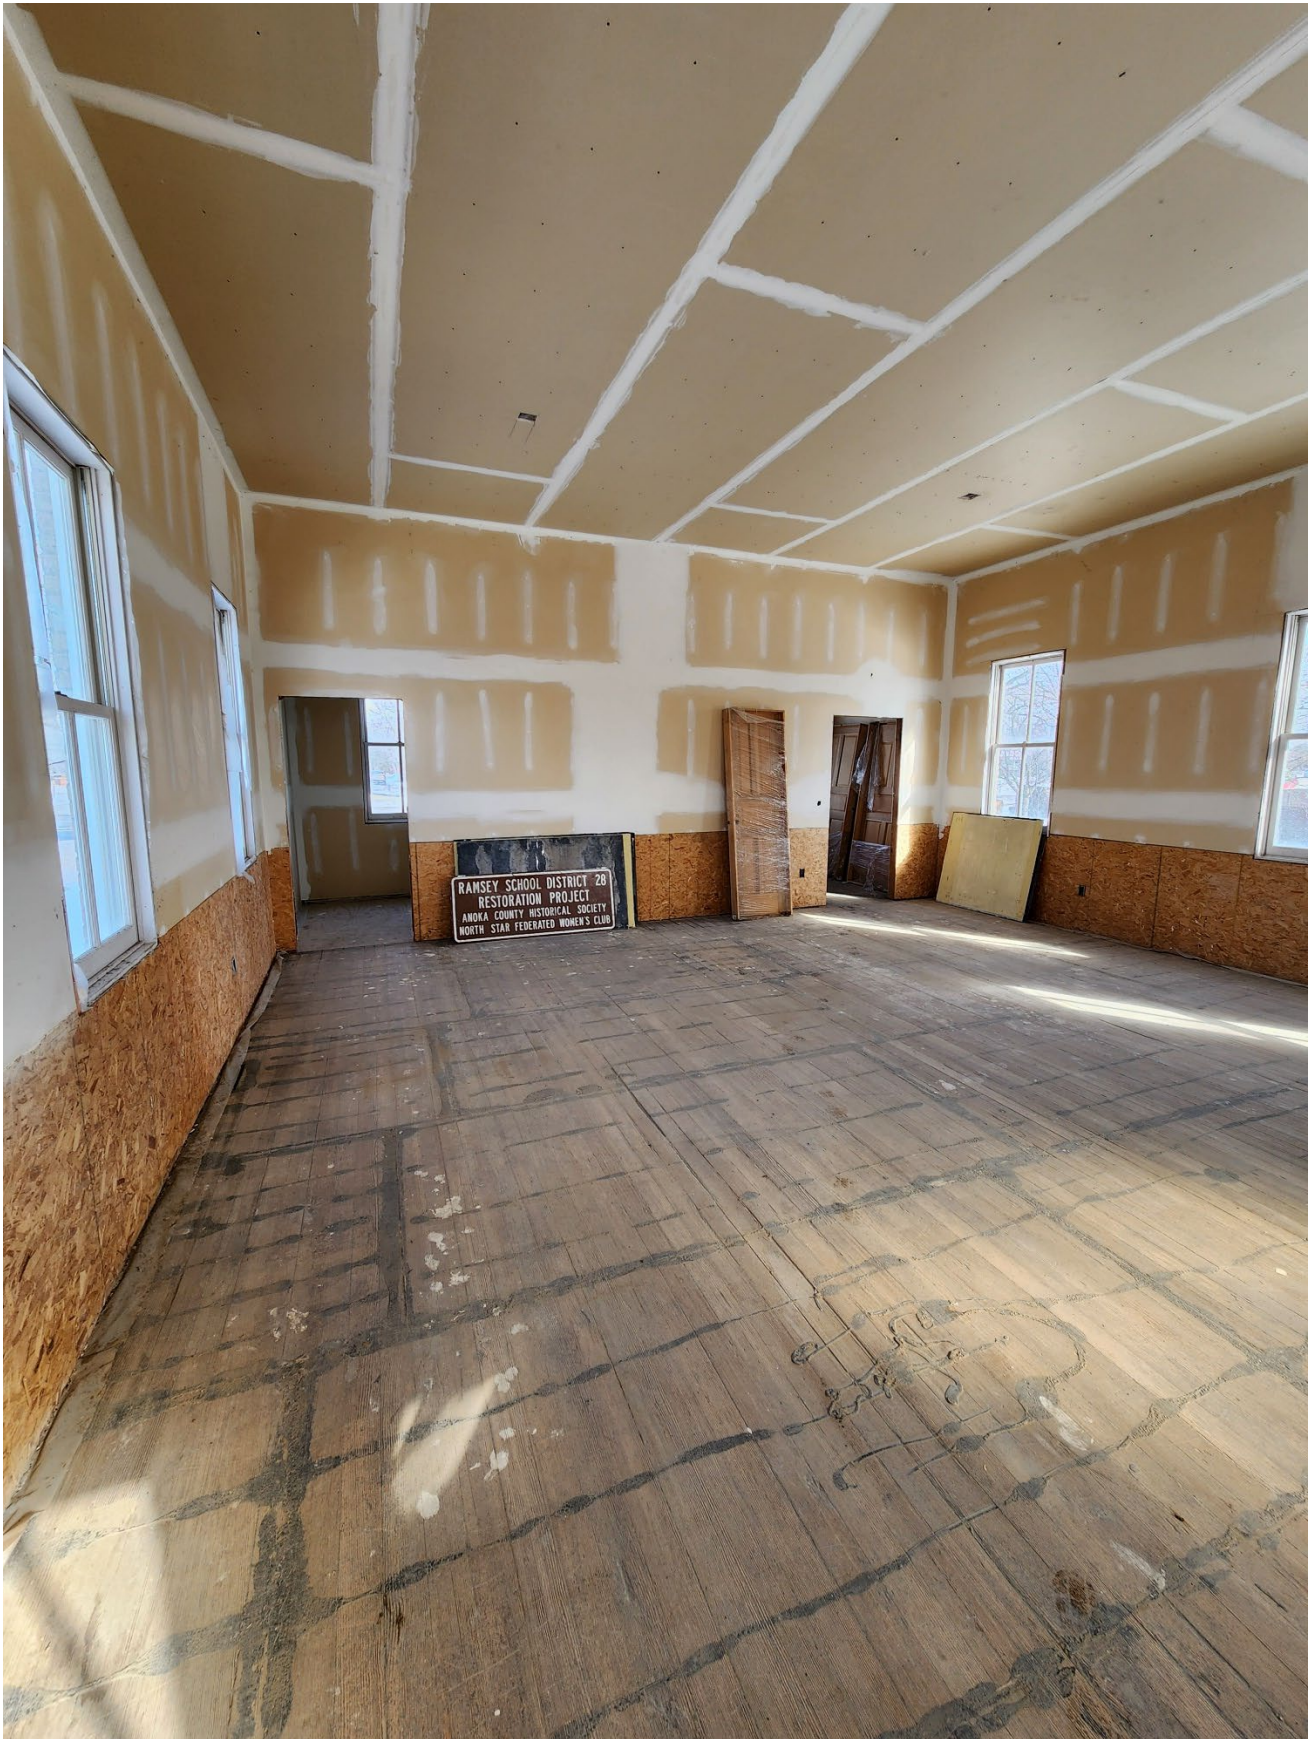
Inside Facing E (Cleaned)

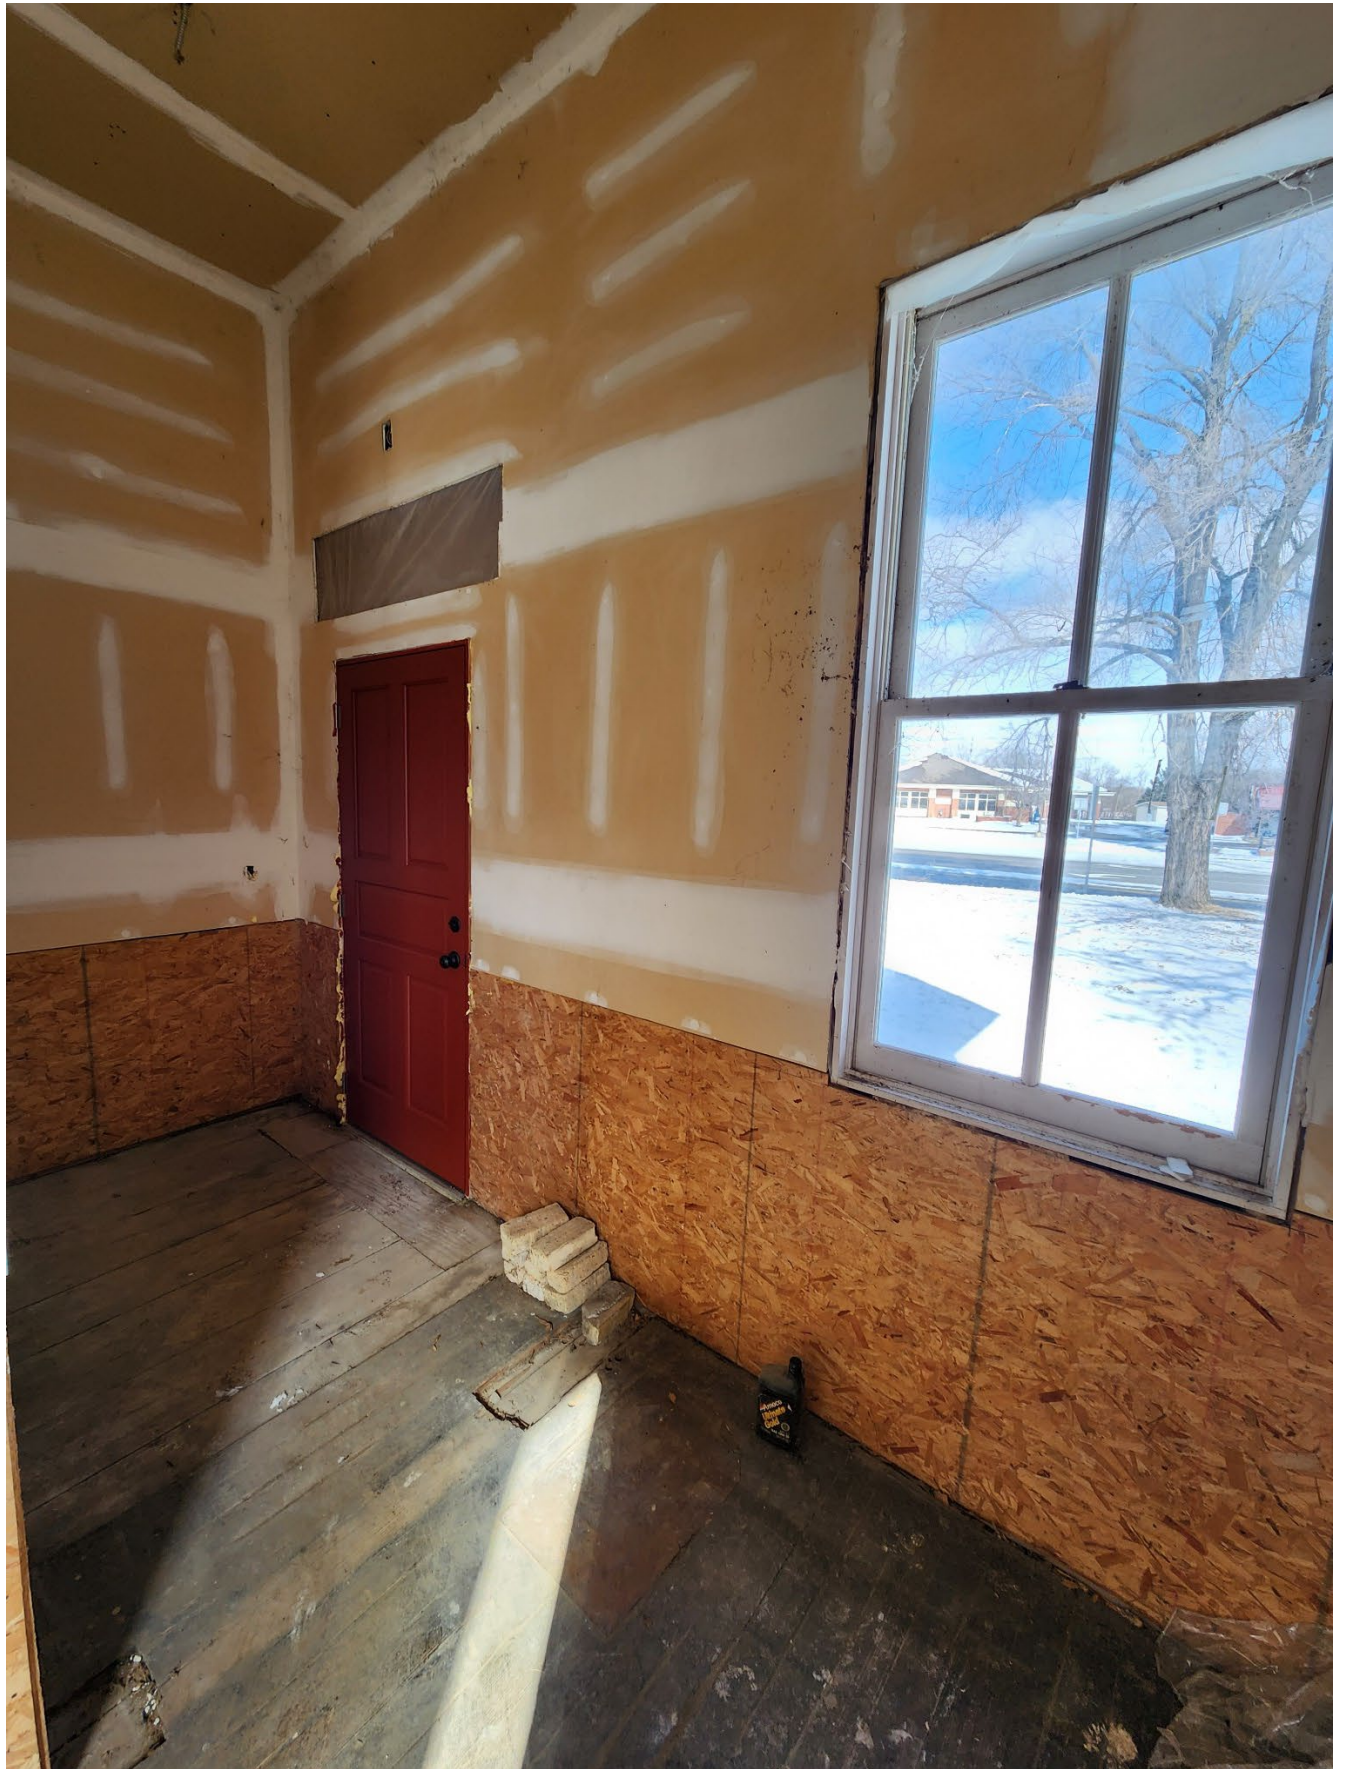
Coatroom (Cleaned)

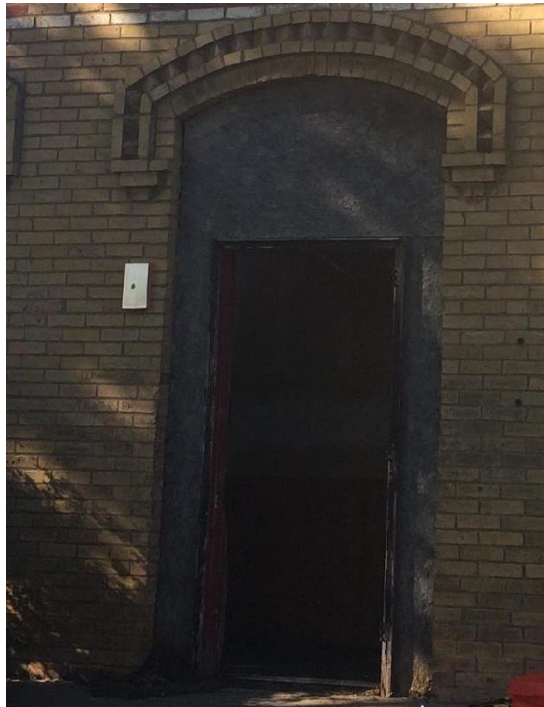
Figure 5 – Front Entrance with Particleboard

The entrance of the building is fitted with particleboard, which has allowed the use of a standard size door in place of what was likely a door and curved transom window.

By the looks of the paint that is left on the brick near top and sides of the particleboard insert, the original wood door and framing was red. The door that is currently present, while functioning, is in poor condition.

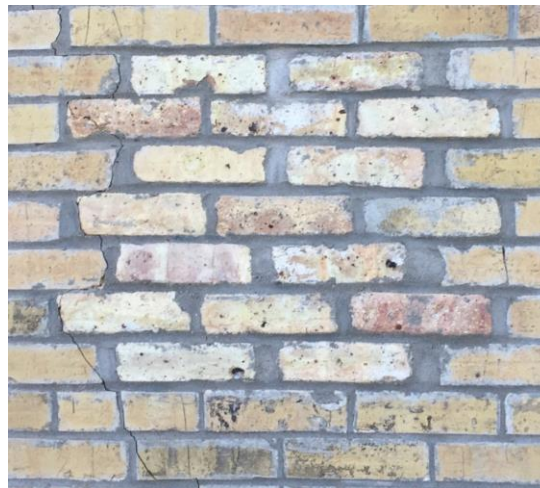
Figure 18 – Attempted Repointing

There are several sections of the primary façade where it looks like some repointing has taken place, specifically under the window on the right-hand side, where the mortar is a different color, and to the top of the circular window at the top of the structure. Figures 18, 19 and 20 show other areas where repointing was done, including the chimney. The mortar joints where the repointing was done are much more prominent due to the following characteristics: over-grinding during repointing process damaged the brick around the repointed areas, a different color of mortar was used, possibly a different strength of mortar was used, and the size of the mortar joints are larger. The mortar is supposed to be weaker than the brick so that it cracks before the brick can.

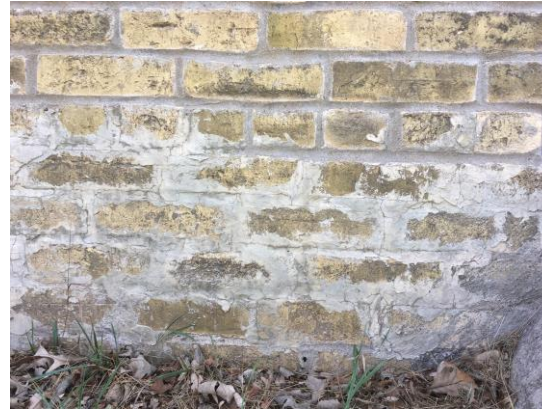
Figure 23 – Deteriorated Brick with Mortar

In one location, area of brick that was smeared with mortar on the rear elevation. The concrete curb that is located around the base of the North, South, and West elevations is most likely covering up deteriorated brick.

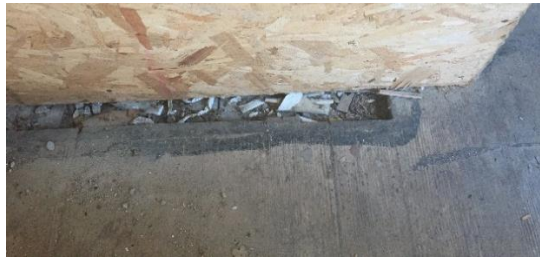
Figure 35 – Main Room, Holes in Floor

Overall, the original flooring in both rooms is very dirty, there are some holes along the wood grain caused by wear and previous renovations, and there is remnant of adhesive from the vinyl flooring.

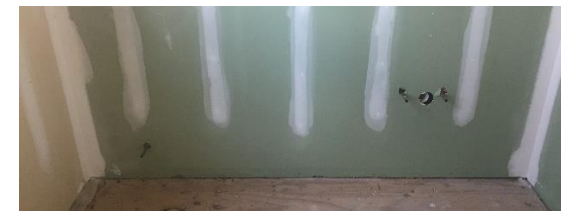
Figure 38 – Bathroom Plumbing

The exposed plumbing does not appear to be connected to a running water supply and is therefore not likely to cause water damage. If the plumbing is to be used, an expert should inspect them to ensure they are in working order and that none have burst or are leaking.

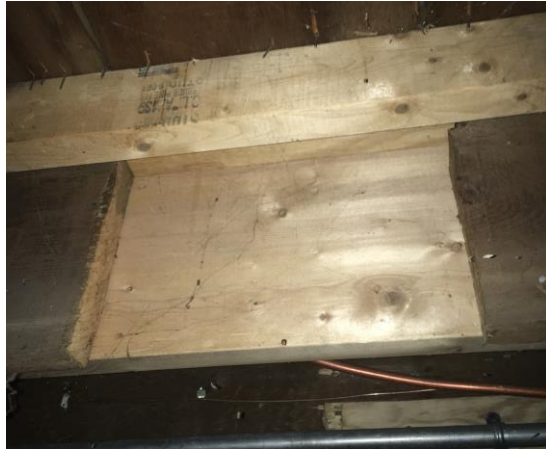
Figure 44 – Replacement Floor Joist

A few of the floor joists appear to not rest on the intermediate beam. Their natural lower elevation is about one centimeter above the beam. The joists may need to be realigned to provide the intended load path.

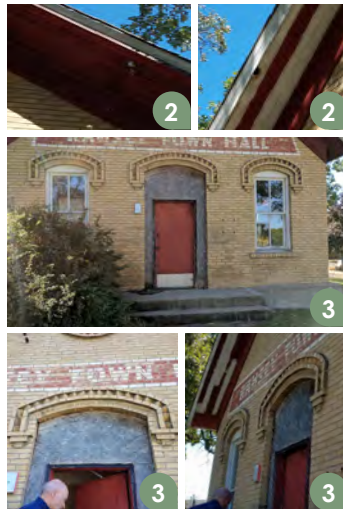
##### 3 Replace Entry Door & Stairs

The existing entry door is water-damaged, and the door surround does not properly join the brick veneer, leaving room for vermin infestation and water infiltration. The door should be replaced with **double swinging doors with a glass transom above**, which is the appropriate historical replacement.

ESTIMATED COST: \$3,700 (doors & transom), \$2,400 (stairs)  
<https://www.homeadvisor.com/cost/doors-to-replace-door.html>  
<https://www.thumbtack.com/building-landscaping/repair-for-historic-outdoors-2132014>

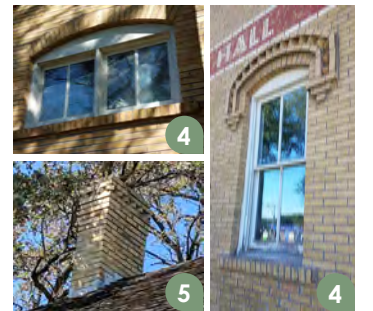
##### 4 Repair & Restore Windows

The windows were replaced during an earlier grant project but could benefit from **new paint and caulk** where brick meets wood. A rear window needs to be replaced.

ESTIMATED COST: \$450 (recaulking), \$900 (window)  
<https://www.homeadvisor.com/cost/door-and-window-repair/repair-window.html>

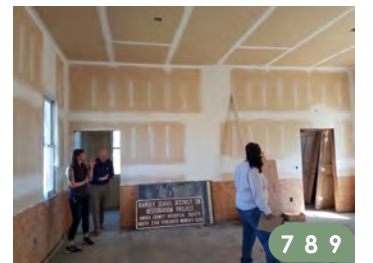
**Increasing access** to the building for future tenants is a top priority. The ramp addition will be removable.

ESTIMATED COST: \$4,400 (ramp), \$450 (45' sidewalk)  
<https://www.homeadvisor.com/cost/interior-accessibility/build-a-disability-ramp/>

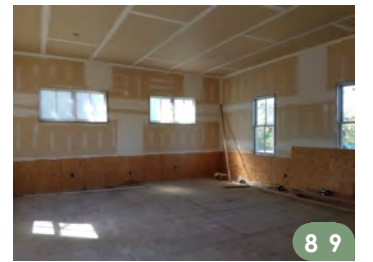
##### 7 Install doors, plumbing, HVAC

Previous grants were used to purchase **doors and a furnace**. Neither was installed completely. New **plumbing fixtures** need to be purchased and installed.

ESTIMATED COST: \$300 (doors), \$600 (plumbing), \$1,700 (HVAC)  
<https://www.homeadvisor.com/cost/interior/replace-door.html>
