MONITORING REPORT
FILTRONICA Inc.-City of San Luis, Az

Filtronica Job# 10152018-001
Pump Removal-Cable Test-Power Quality Study
Wellsite #7-Well # 11

Subject: Pump Removal and PQ Measurement at Wellsite #7, Well # 11

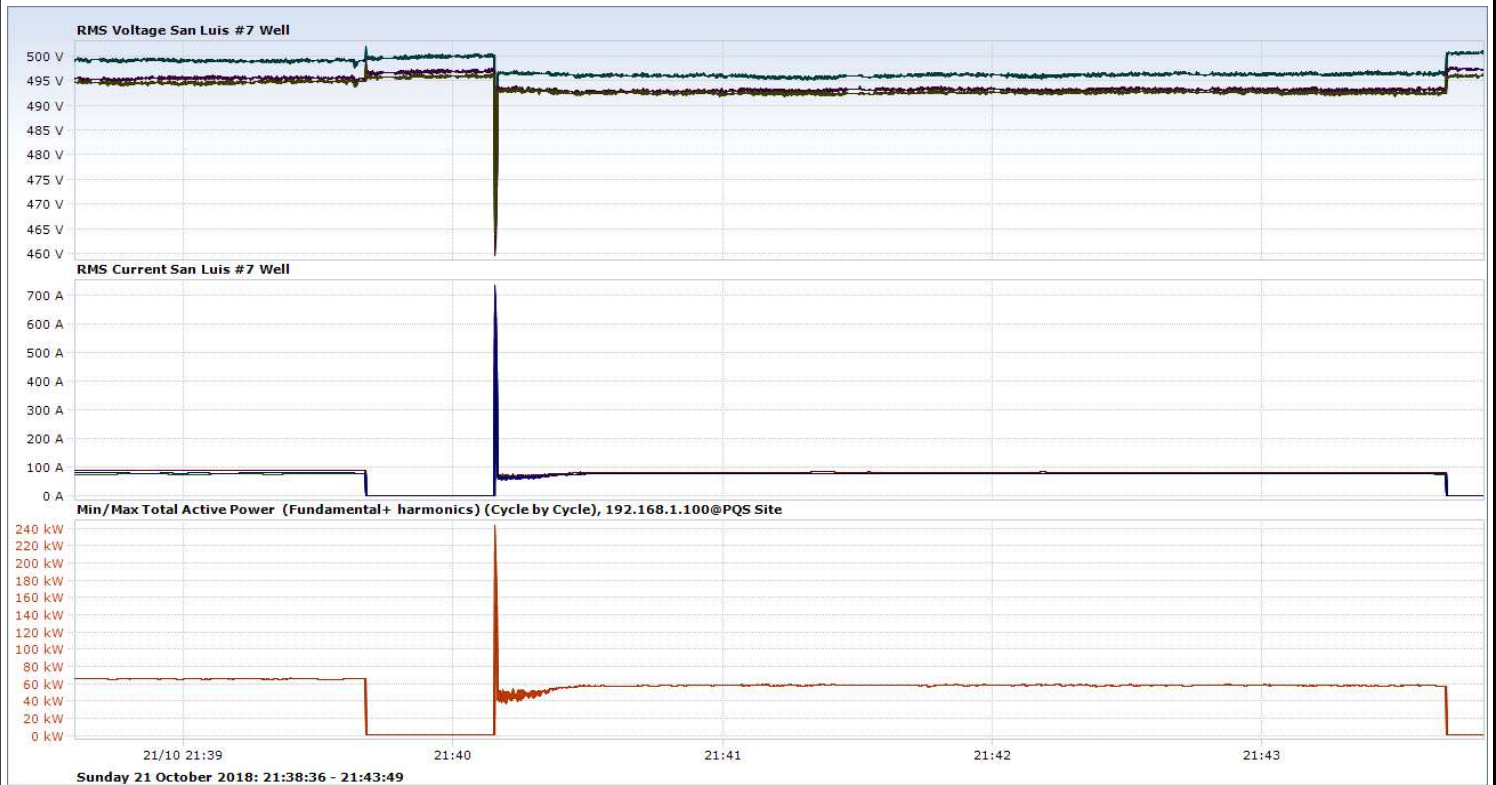
Figure 2.1.1 Motor Start-up

Table 2.1.1 shows the minimum, average and maximum values recorded during the measurement period. If one looks at the voltages alone, one can see where there are many an instance where the voltage is either too low (at 378 Volts) or too high (at 508 Volts). Any VFD is programmed to shut off when voltages of about 450 Volts on the low end or 505 Volts at the high end are reached. The large voltage differential is primarily due to a somewhat weak infrastructure. The infrastructure, i.e. utility can not supply the required reactive power during a motor start-up and that causes the voltage to drop. See graph below in Figure 2.1.1.

The power quality measurement indicates a weak infrastructure. In most cases, such as this it is the responsibility of the owner (City of San Luis) to install equipment, designed to mitigate such conditions. It is Filtronica's opinion that a fast switching capacitor bank be installed. The capacitor bank should be able to compensate at least 600 kVAr of reactive energy and should be able to do that in less than 10 milli seconds to achieve best performance. Filtronica Inc is glad to assist the City of San Luis with the selection of such equipment.

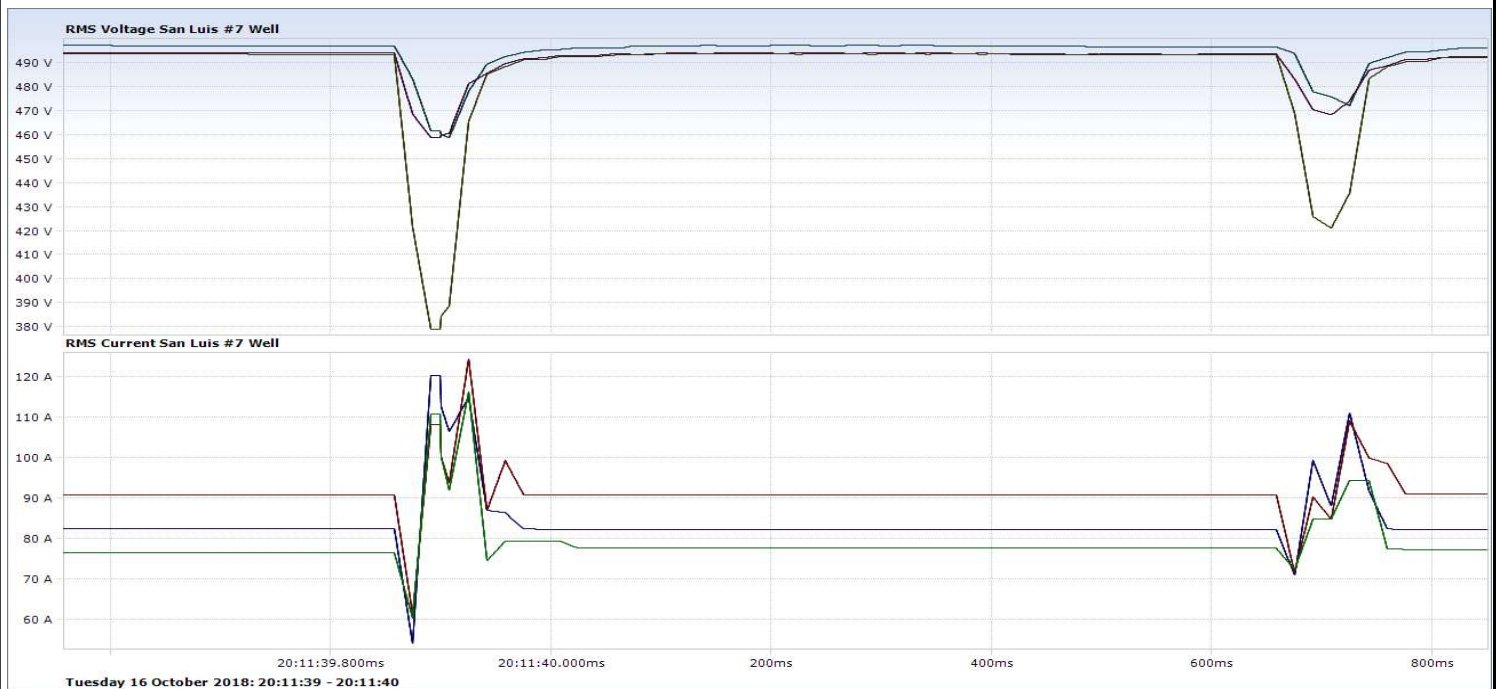
Figure 2.1.2 External Voltage Drop

Also measured was an externally caused voltage drop. This drop is as low as 378 Volts and was caused by an external source. See Figure 2.1.2.

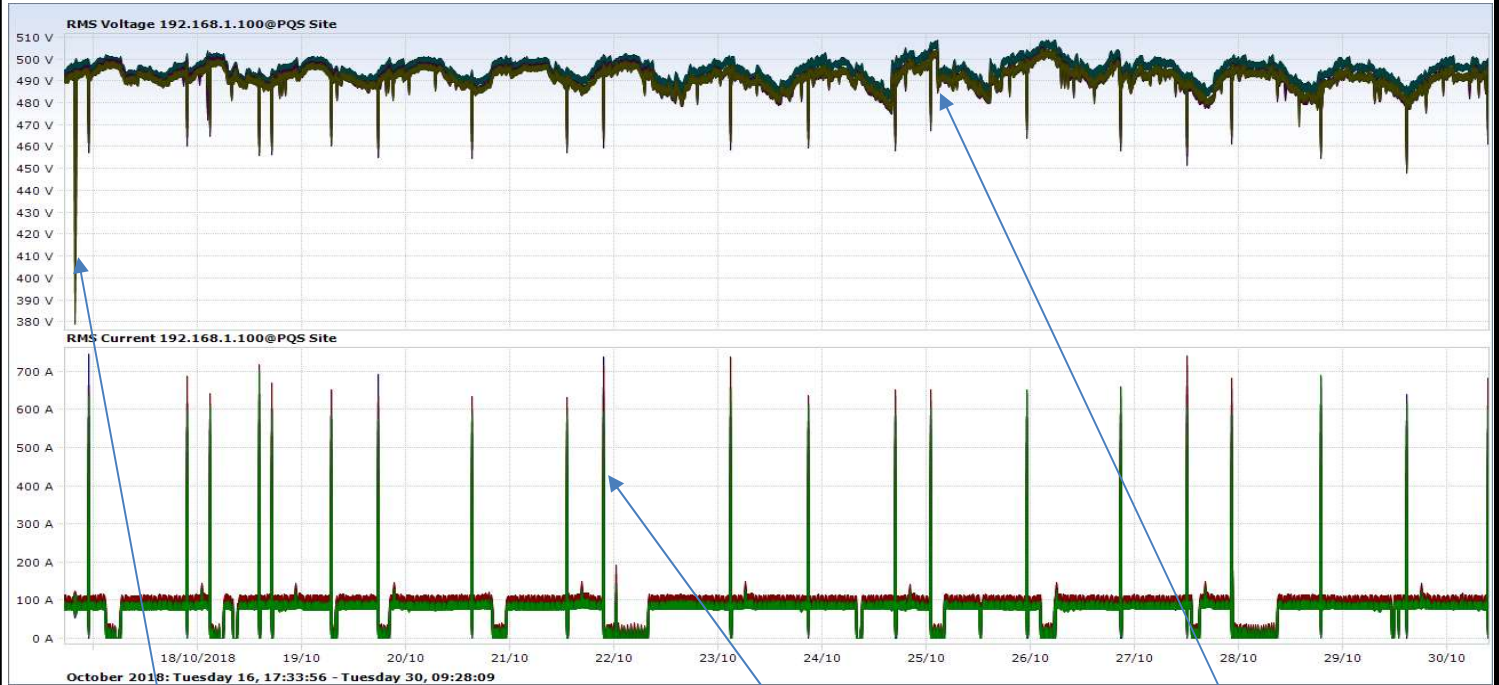
Figure 2.1.3 Total Measurement

Figure 2.1.3 shows the total measurement

Externally caused voltage drop

One of many motor starts and shut down

Utility capacitor switching
to adjust line voltage

Figure 2.3 is indicative of all of the motor starts during the measurement period

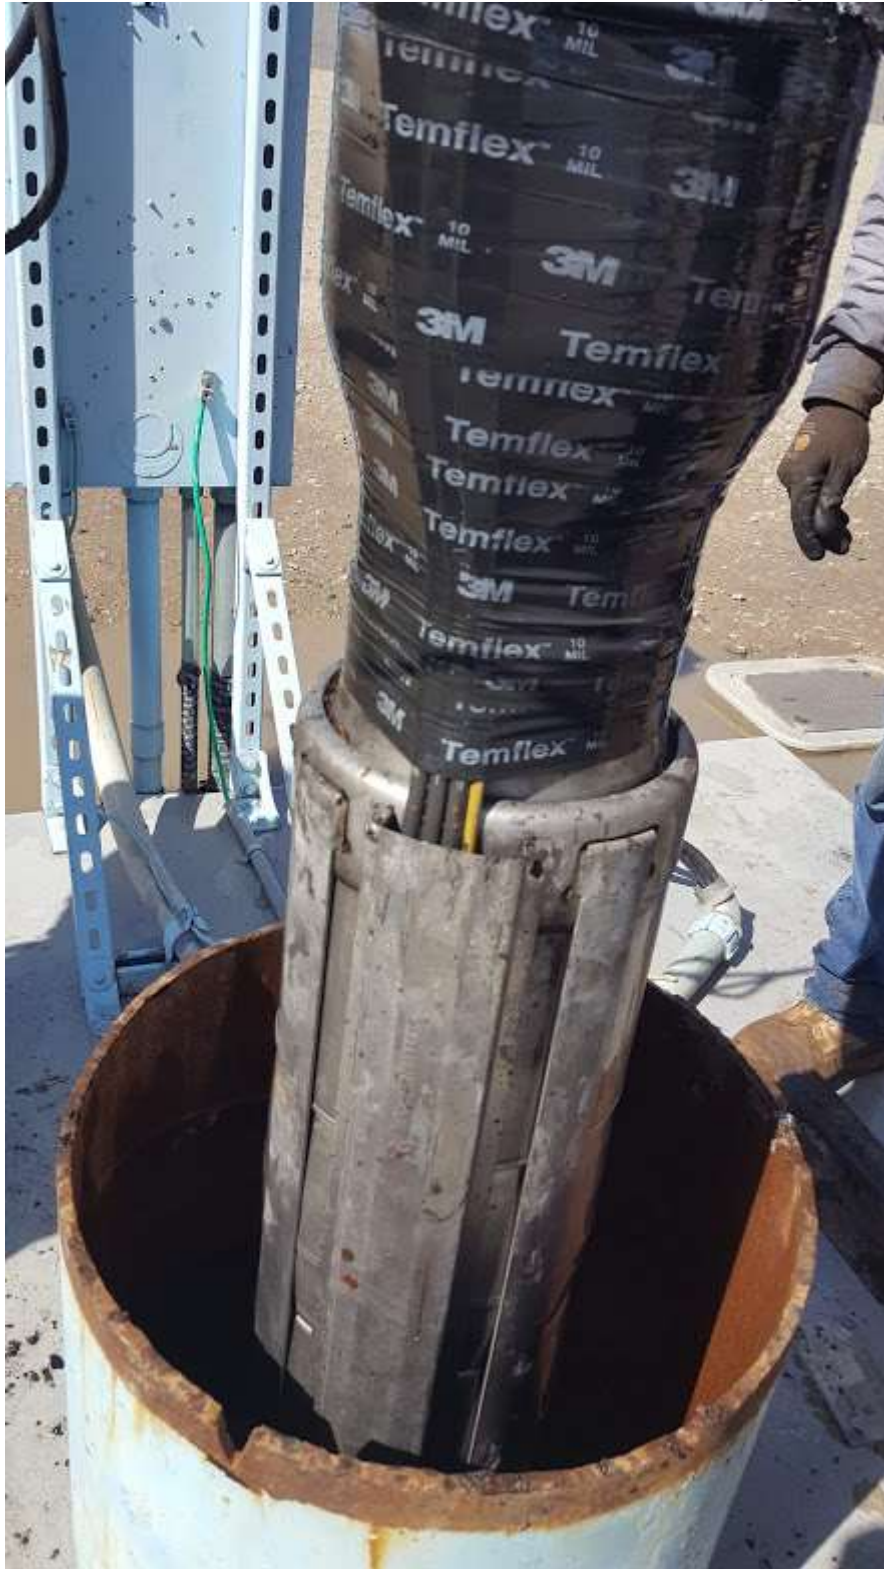
Figure 2.2.4-Pump and Motor removed, Motor hanging concentric in in well head shaft, no connection to ground

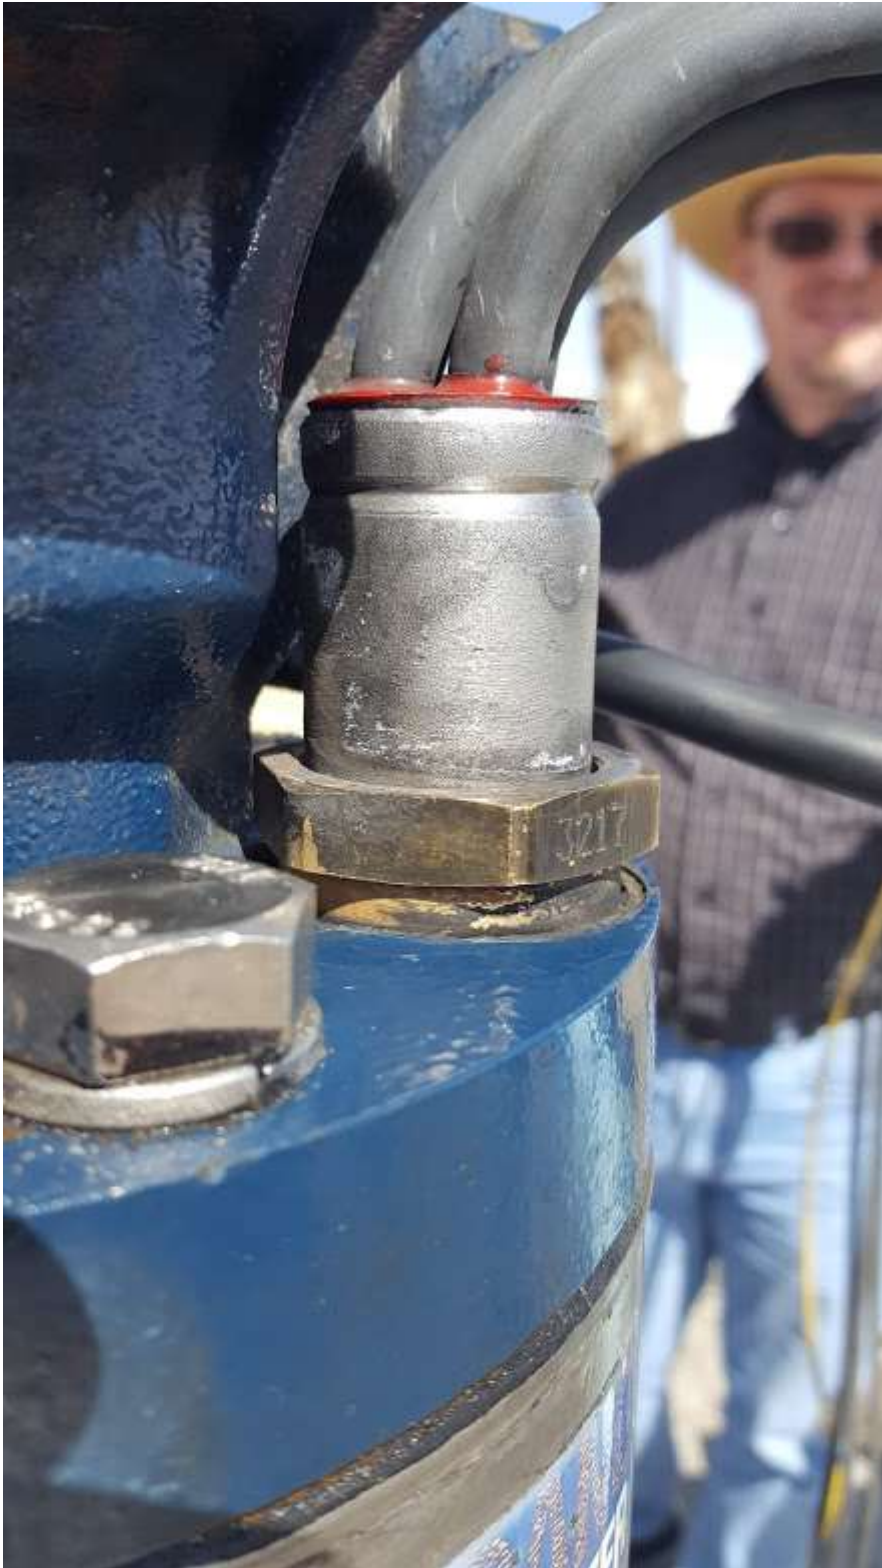
Figure 2.2.4-Electrical connector from Cable to Motor

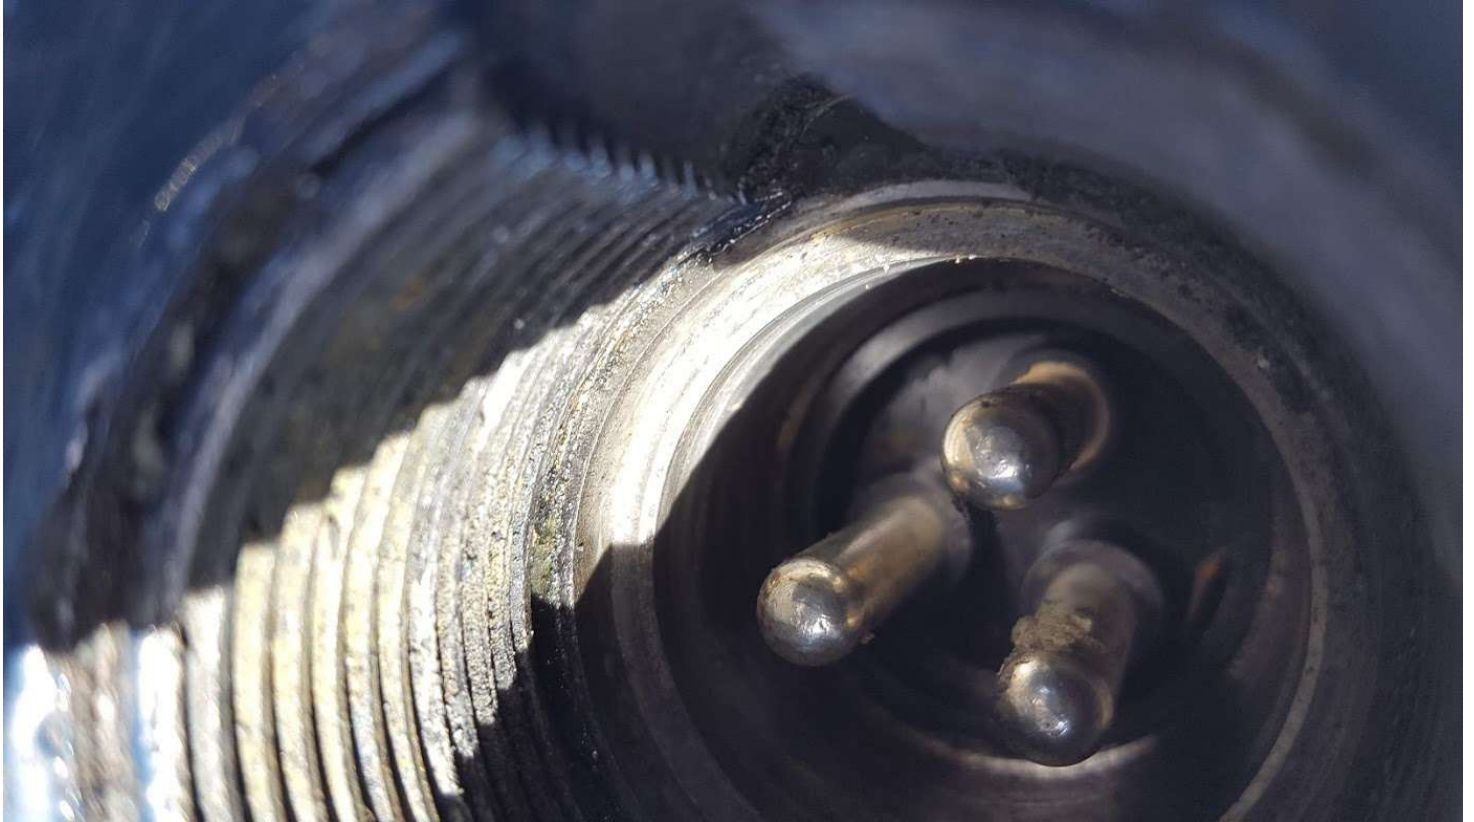
Figure 2.2.5- View of the internal components of the connector. Note: Once the cable was removed, the resistance remained low as throughout the previous measurements, pointing to internal components of the motor.

The measurements indicate that the low resistance is in the motor, not the cable. The motor has been presented to the manufacturer's representative for inspection. Filtronica Inc. has not been advised of any findings by the manufacturer.

Filtronica Inc was just now advised that a new motor will be installed on November 30, 2018, using the existing cable.
