**PRELIMINARY INITIAL SITE ASSESSMENT**

**Juan Sanchez Boulevard, US 95 to SR 195**

**Federal Project No.: SLS-0(203)T**

**EEC PROJECT NO. 11022.04  
REPORT DATE: April 18, 2019**

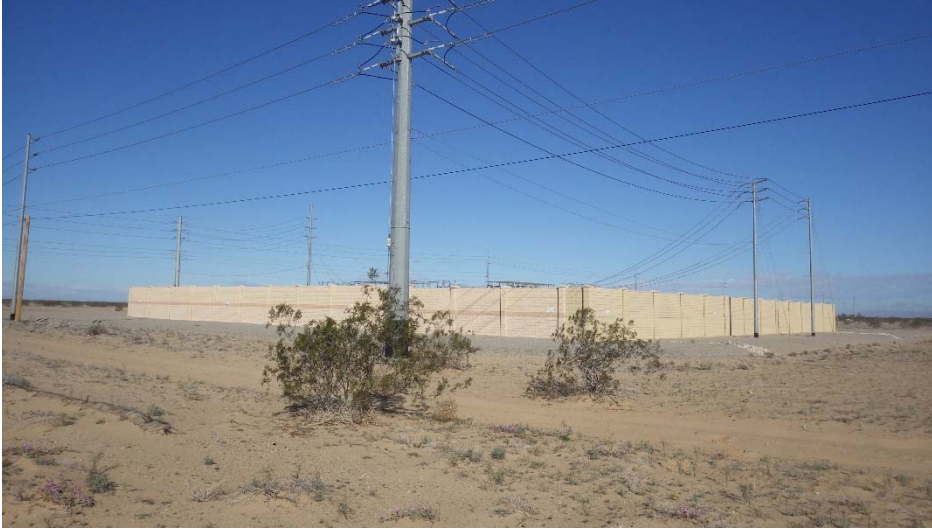
**Photo No. 4**

**Description:** East end of project area showing a substation, north side of the right-of-way and adjoining properties near Avenue F.

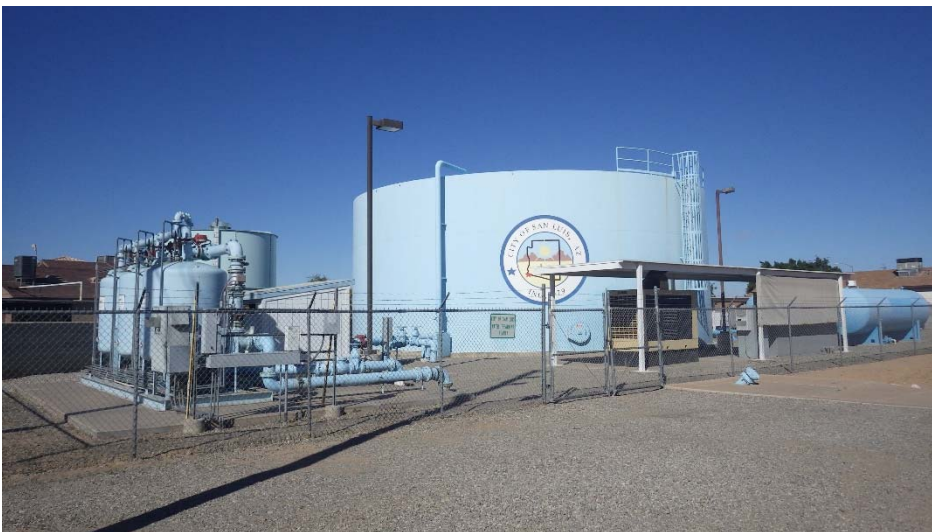
**Photo No. 8**

**Description:** Central portion of the project area showing City of San Luis Water Treatment Plant 4 at the northwest corner of the intersection of Juan Sanchez Boulevard and 8<sup>th</sup> Avenue.

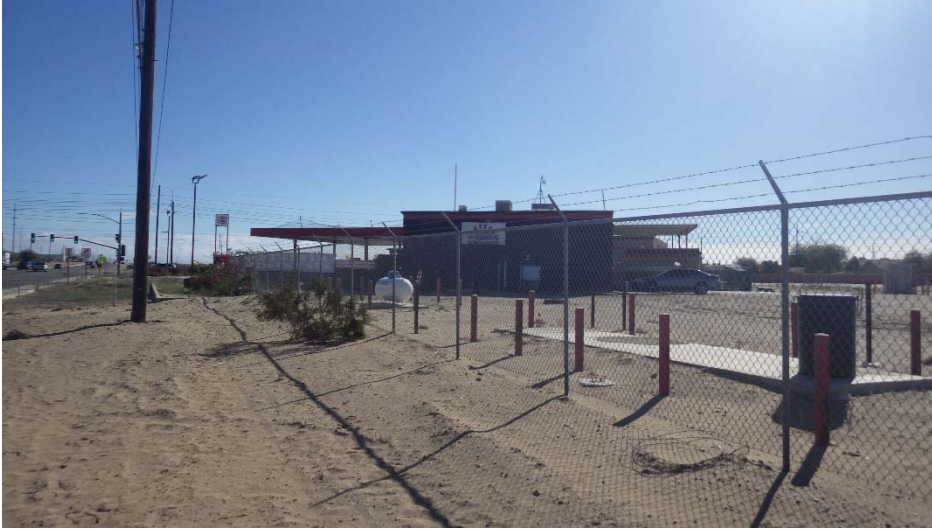
**Photo No. 10**

**Description:** Central portion of the project area showing gas station at the southwest corner of the intersection of Juan Sanchez Boulevard and 8<sup>th</sup> Avenue.

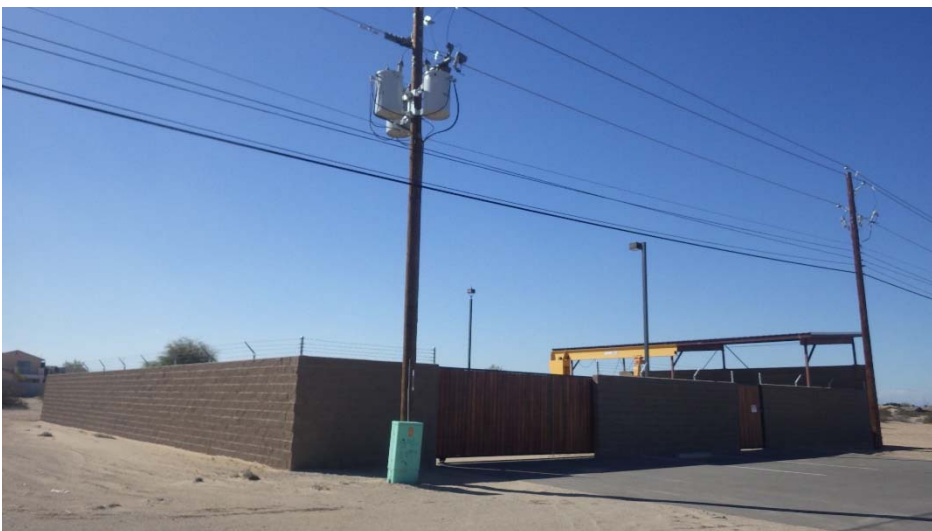
**Photo No. 12**

- EEC observed multiple pole-mounted and pad-mounted transformers throughout the project area. The transformers did not have labels indicating they have been tested for polychlorinated Biphenyls (PCBs) and EEC could not confirm if they had been tested. Therefore the transformers are assumed to be classified as contaminated (with 50 parts per million (ppm) to 500 ppm) PCBs, per Section 40 Code of Federal Regulations, Part 761. No indication of leakage was identified during the site visit (Attachment 4, Photos 12 and 16). EEC recommends coordination with San Luis power utilities in the event the transformers will be relocated.

- EEC observed multiple pole-mounted and pad-mounted transformers. The transformers did not have labels indicating they have been tested for PCBs and EEC could not confirm if they had been tested. Therefore the transformers are assumed to be classified as contaminated (with 50 parts per million (ppm) to 500 ppm) PCBs, per Section 40 Code of Federal Regulations, Part 761. No indication of leakage was identified during the site visit (Attachment 4, Photos 19, 23 and 24). EEC recommends coordination with San Luis power utilities in the event the transformers will be relocated.

**Description:** Central portion of the project area showing pole-mounted transformers and block wall.

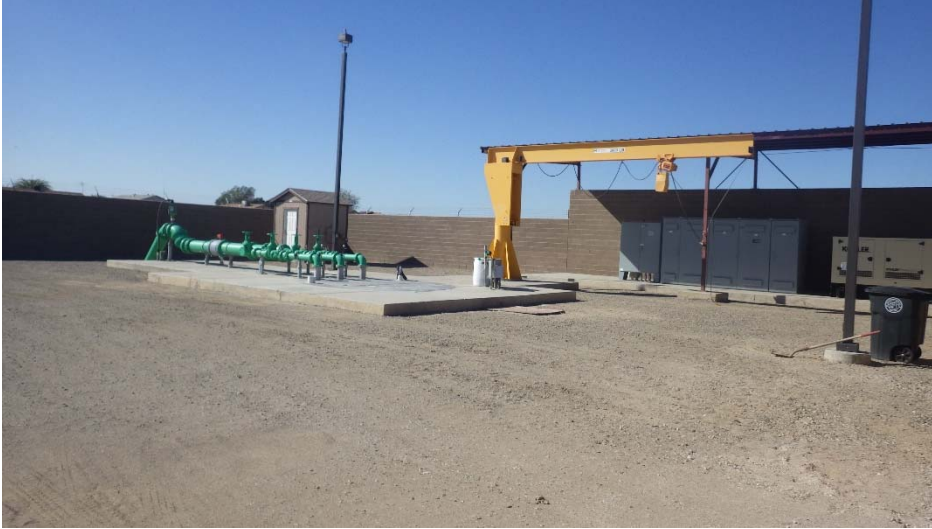
**Photo No. 13**

**Description:** Central portion of the project area showing well facility beyond block wall at the southwest corner of the intersection of Juan Sanchez Boulevard and 6<sup>th</sup> Drive.

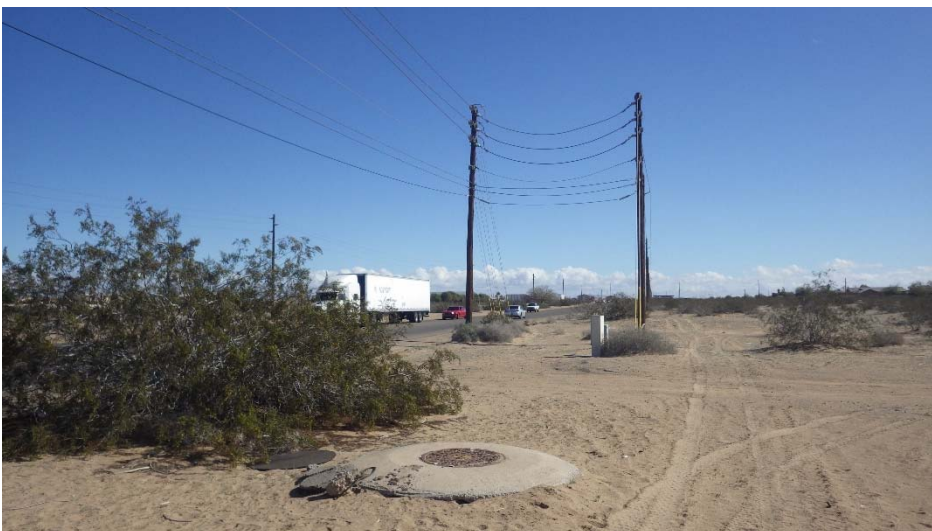
**Photo No. 15**

- EEC observed evidence of various utilities throughout the Project Area. EEC recommends proper coordination with utility companies prior to performing any subsurface disturbance.

**Description:** Central portion of the project area showing in-ground utilities (sewer manhole).

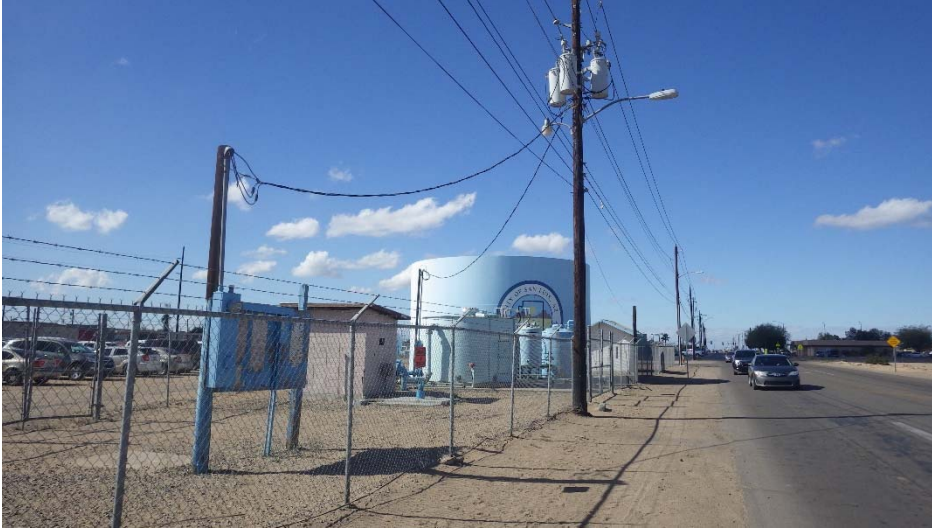
**Photo No. 16**

**Description:** Central portion of the project area showing City of San Luis Water Treatment Plant 2 just west of the southwest corner of the intersection of Juan Sanchez Boulevard and 4<sup>th</sup> Street.

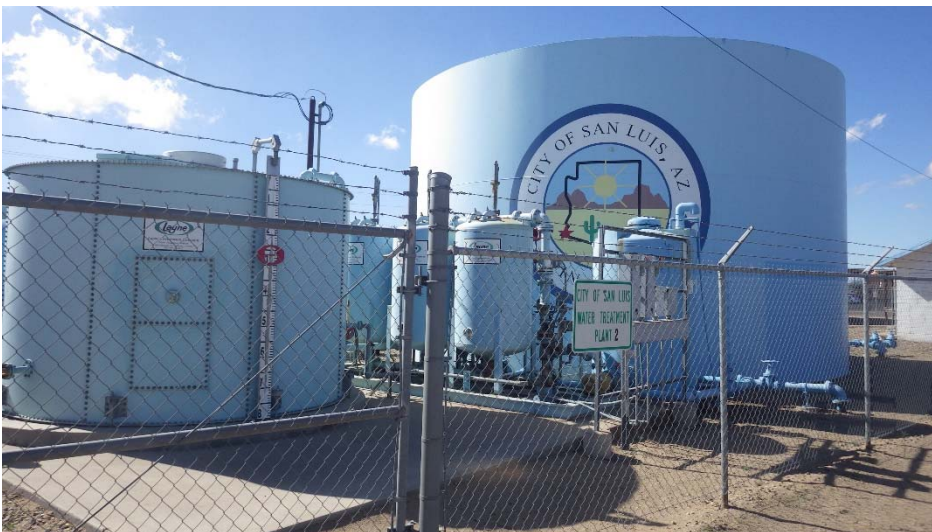
**Photo No. 17**

**Description:** Central portion of the project area showing City of San Luis Water Treatment Plant 2 just west of the southwest corner of the intersection of Juan Sanchez Boulevard and 4<sup>th</sup> Street.

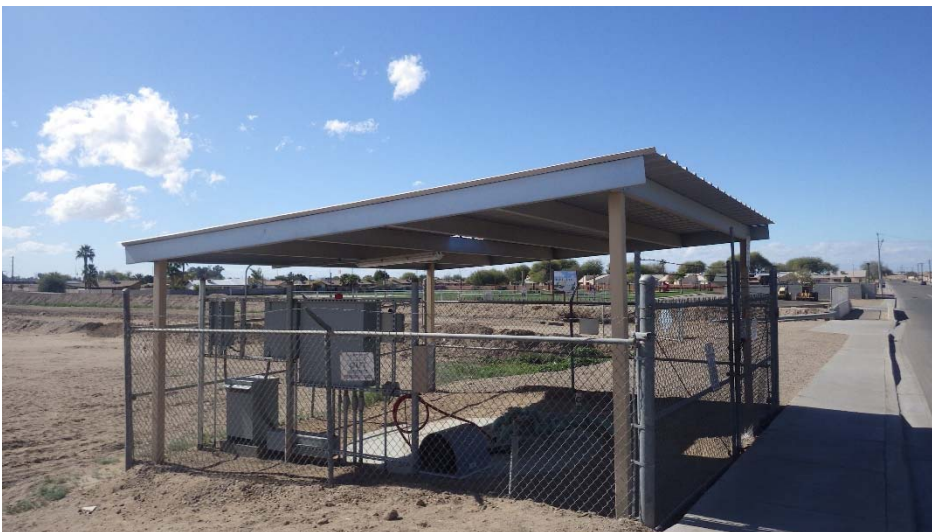
**Photo No. 20**

Six (6) groundwater wells were identified on the same or adjacent 10 acres as the Project Area. The well uses are commercial, domestic, municipal, monitoring, none and utility. Multiple wells were noted within the project area during Site Reconnaissance. EEC recommends caution in areas where wells are located during construction activities.

**Description:** Western portion of the subject property showing well just south of intersection of Juan Sanchez Boulevard and Escondido Street Alignment.

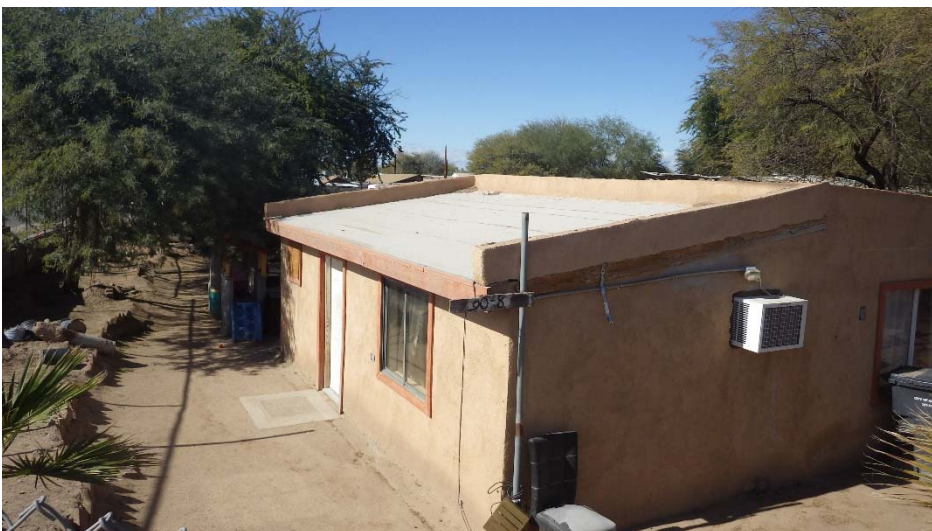
**Photo No. 21**

- EEC observed one private residential structure and shed located within the western portion of the project area. Yuma County APN 775-29-018 is located at 908 Escondido St. (Attachment 4, Photo 21). The Project Area Map in Attachment 2, Item 1D shows the western portion of the project area at the intersection of Juan Sanchez Boulevard and Escondido Street. The home and shed located at 908 Escondido St. most likely contain household chemicals, maintenance tools, fluids in containers less than 55 gallons and other related items. EEC recommends any materials within the property boundary be removed and properly disposed. Also any tanks, including ASTs and septic systems should be properly abandoned in accordance with any Yuma County and Arizona Department of Environmental Quality (ADEQ) standards.

- EEC observed the exterior portion of the residence contains painted surfaces that would be suspect for containing lead-based paint. EEC recommends a lead-based paint survey to be conducted to properly identify lead paint (if required) prior to any demolition or renovation activities. This is not an REC to the subject property.

- EEC observed one private residential structure located within the western portion of the project area. Yuma County APN 775-29-018 is located at 908 Escondido St. (Attachment 4, Photo 21). EEC was unable to access this portion of the project area. The home and shed located at 908 Escondido St. most likely contain household chemicals, maintenance tools, fluids in containers less than 55 gallons and other related items. EEC recommends any materials within the property boundary be removed and properly disposed. Also any tanks, including ASTs and septic systems should be properly abandoned in accordance with any Yuma County and Arizona Department of Environmental Quality (ADEQ) standards.

- EEC observed the exterior portion of the home contains painted surfaces that would be suspect for containing lead-based paint. EEC recommends a lead-based paint survey to be conducted to properly identify lead paint (if required) prior to any demolition or renovation activities. This is not an REC to the subject property.

**Description:** Western portion of the project area showing private residence at 908 Escondido Street (Yuma County APN 775-29-018).

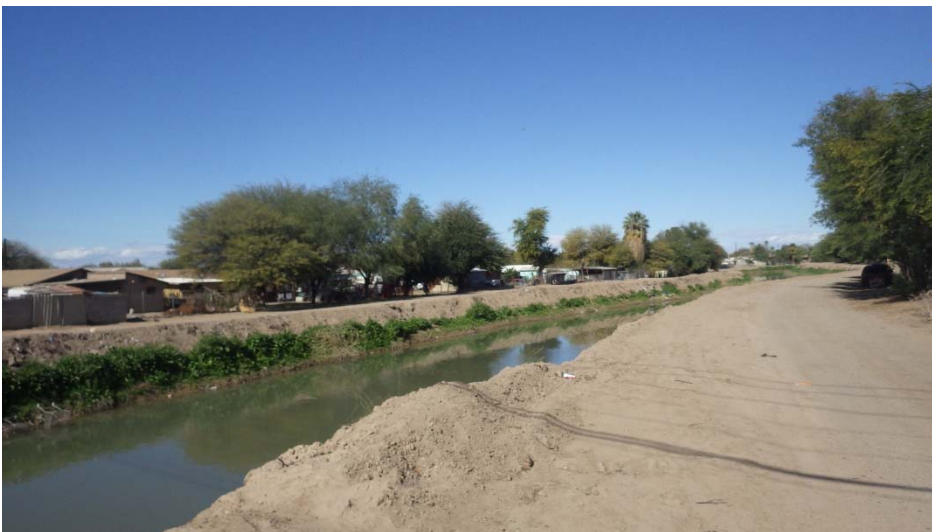
**Photo No. 23**

**Description:** Adjacent property to the west of the project area showing the Main Drain canal.
