Re: City of Schertz Animal Center
HVAC Installation
Bid Number: # 4016

**CITY OF SCHERTZ
ANIMAL ADOPTION CENTER**

HVAC Findings & Recommendations

RETRO-COMMISSIONING REPORT

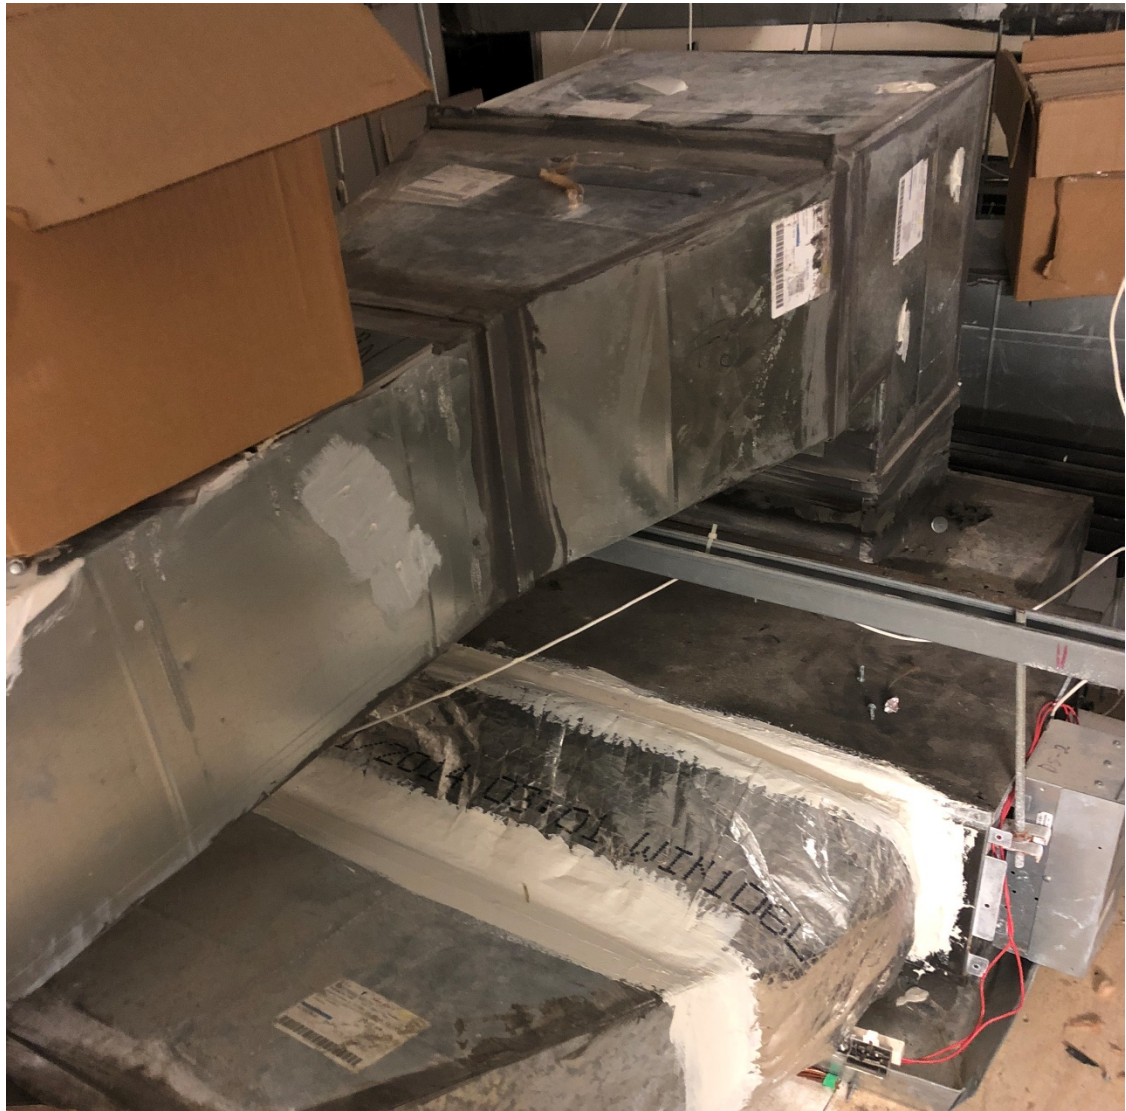
Figure 1: High Loss Elbow into Fan Inlet

1. Unit Inlet Conditions: Highly undesirable inlet conditions were observed at all of the ducted VRF units that may contribute to increased system effect and result in reduced airflow capability for the supply fans. The installation of ductwork is consistent with the original design documents. Refer to Figure 1 below.

2. OA Duct Design: Additionally, high static pressure loss conditions were observed with the ducted OA which may contribute to the reduced OA experienced by TAB. Per the original design documents, many of the OA branch ducts were sized with higher than desirable static pressure losses, especially for the equipment and systems used in the project. Standard engineering practice is to size low pressure ductwork not to exceed a pressure loss of 0.08 inches of water column (")/100 ft of duct (and often a lower value for return and outdoor air ducts). It is especially important for OA ducts to have low pressure drops when the OA system is absent of a dedicated fan and relies on induction, such as this system. OA ducts serving DS-03 and DS-04 have a pressure drop of 0.17"/100 ft (twice the standard loss). OA ducts serving DS-08 and DS-09 also have higher than desirable pressure drops at 0.13"/100 ft.

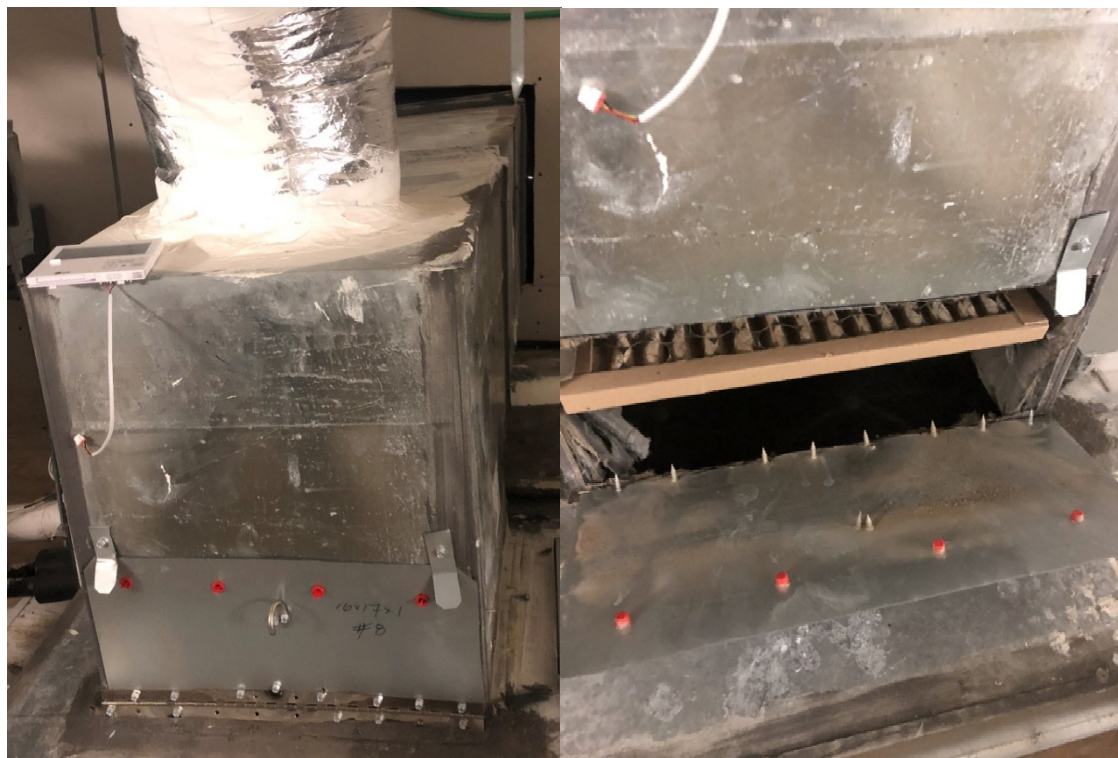
Figure 2: Field-Built Filter Access

5. **Insufficient Filter Access:** Original design/construction did not allow for sufficient filter access. Field-built filter access doors were provided after occupancy. See Figure 2 below. Filter frames and access doors appear to be improperly constructed (access doors not sealed, filter trays not square) which will allow significant air bypass and has resulted in fouling of the coils. Additionally, the location and size of the filters results in an inordinately high pressure drop which may be contributing to reduced airflow capacity of the fan coil units. For example, based on the duct sizes indicated in the original construction documents, the filter location for DS-09 results in a filter velocity of over 1200 fpm at design condition. Standard recommended filter velocity is 500 fpm maximum.

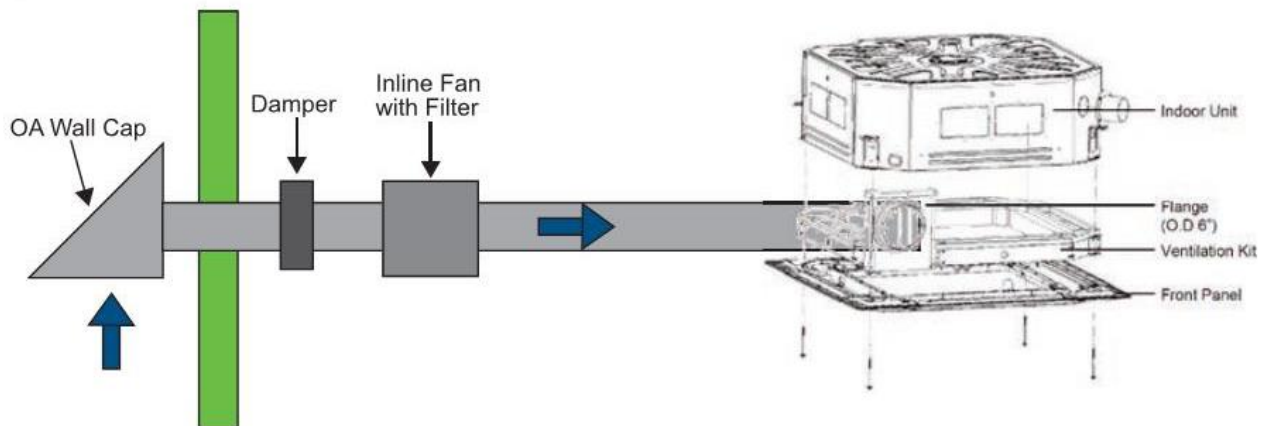
Figure 241: Unconditioned Outdoor Air Ducted to Indoor Units.

- Fan(s) will be required to push outdoor air to the indoor unit to overcome the additional static pressure.
- Filter required to be added to the outdoor air duct.
- Ducted and four-way cassette models are the only indoor units that accept the connection of an outdoor air duct to the unit case.
- In most cases, in lieu of using the factory mounted return-air thermistor on indoor units, a remote wall temperature sensor or zone controller will be needed to provide an accurate reading of the conditioned area temperature.
- Unconditioned outdoor air may affect indoor unit performance, which may necessitate oversizing the indoor unit.
