Phase I Environmental Site Assessment for the Ramirez 10.538 acres, Comal County, Texas

Prepared for
Great Springs Project
and
The City of Schertz

RAINCROW

November 28, 2022

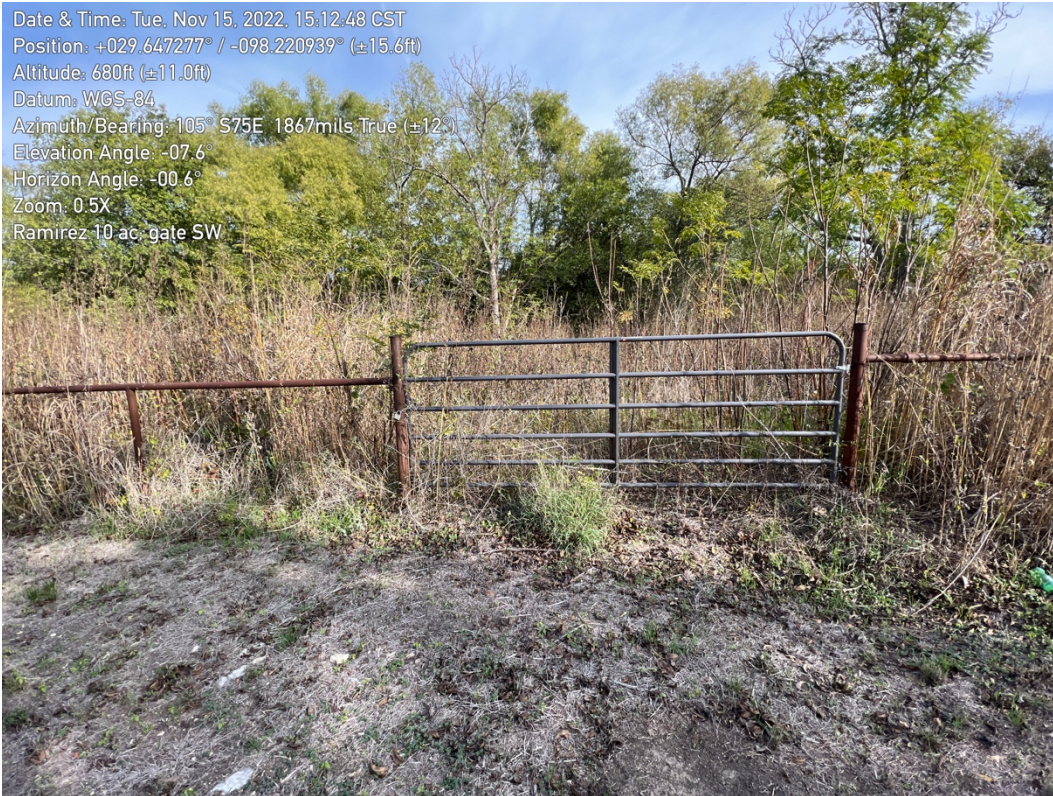
Photo 1. Gate off Wenzel Lane cemetery road, with access to southwest corner of subject property. No evidence of recent use of gate.

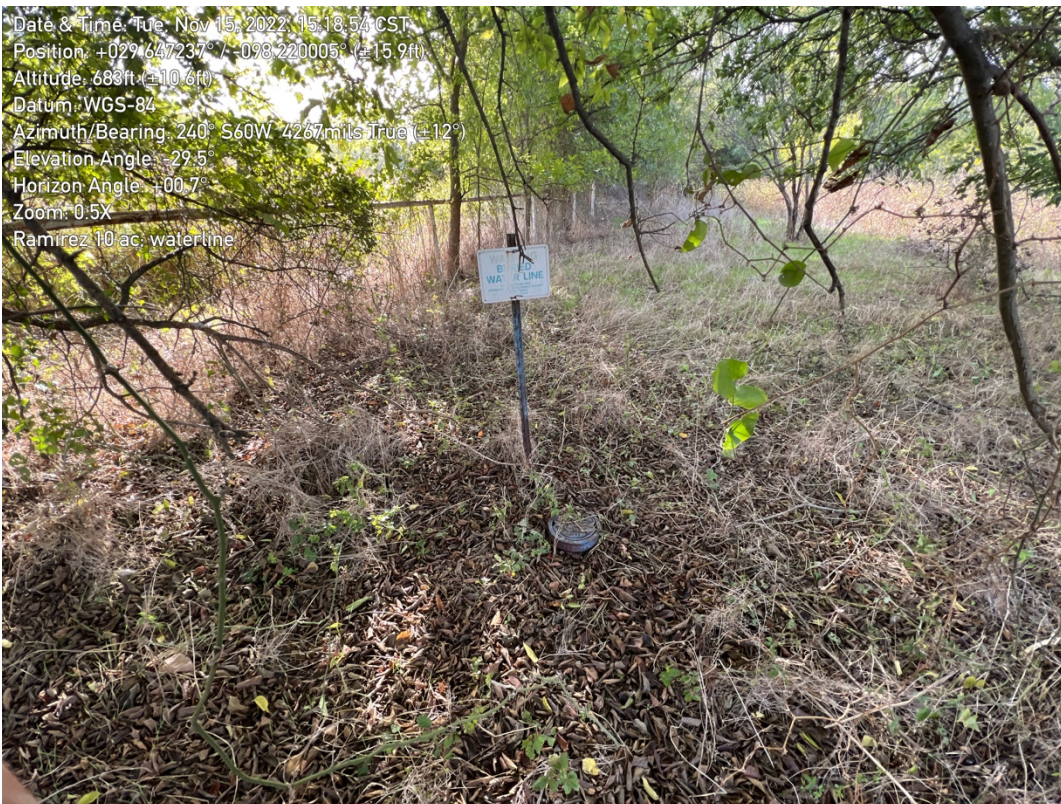
Photo 4. Waterline sign in south end of subject property, just north of south fenceline.

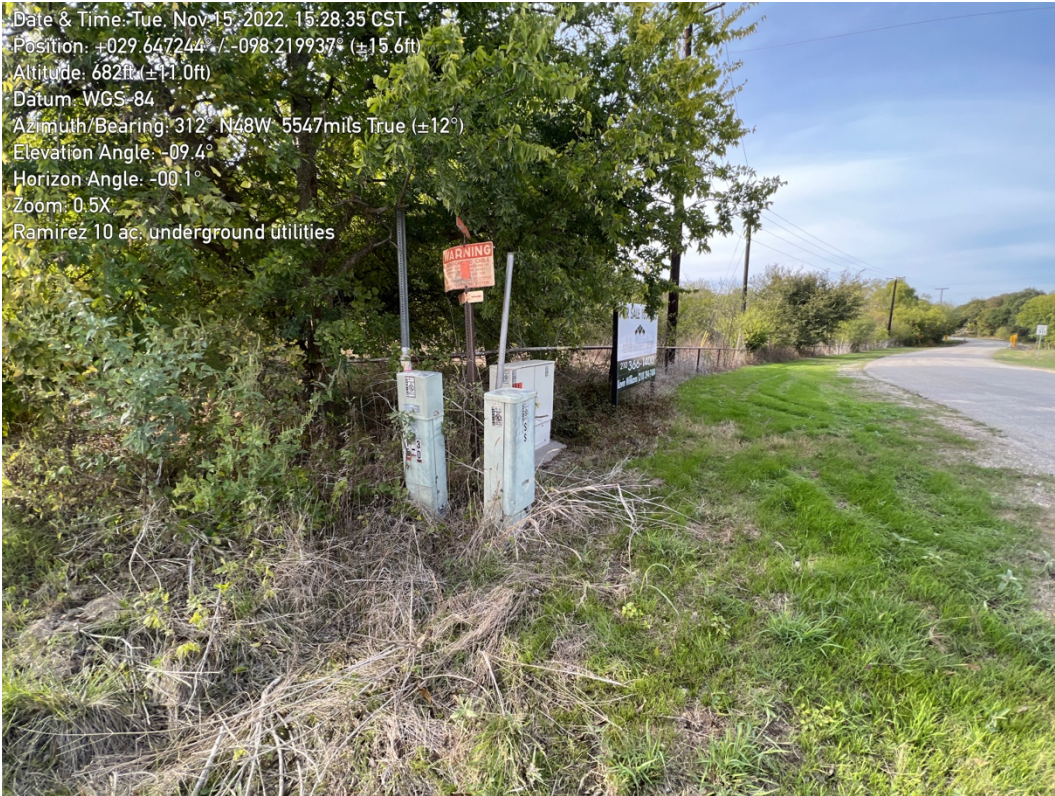
Photo 5. Underground utilities at southeast corner of subject property (Bunker Street on right).

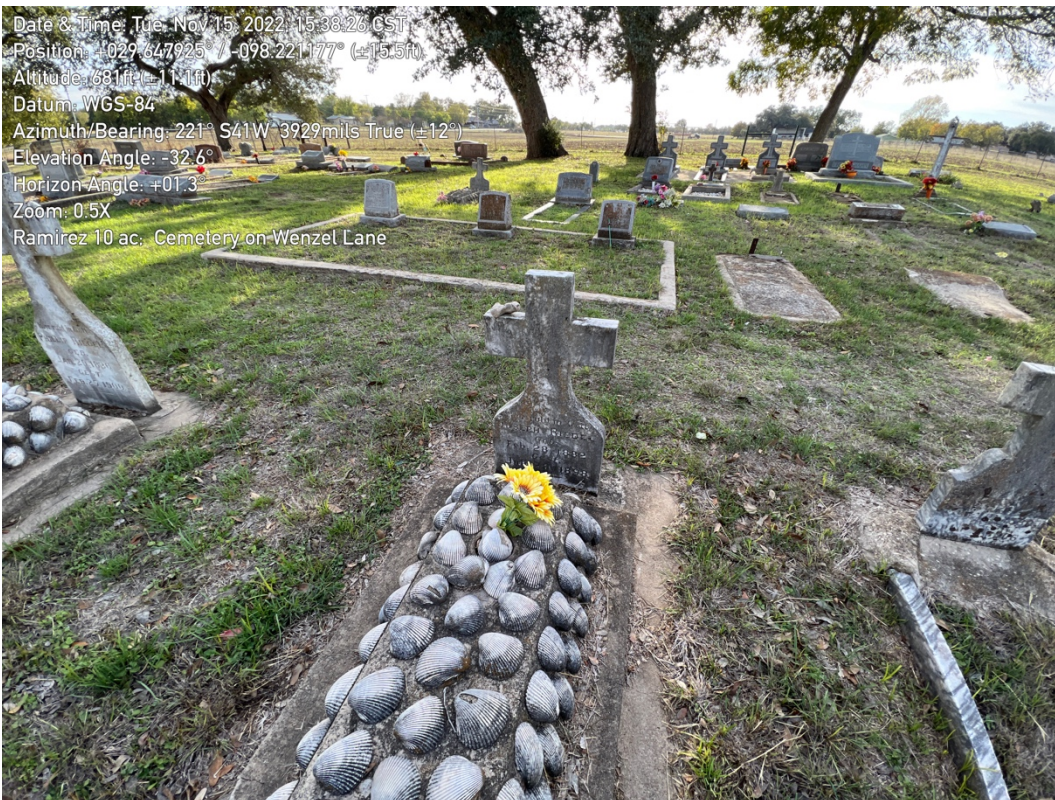
Saint Joseph's Cemetery, also known as Wenzel Cemetery, is adjacent to the subject property on the western side. It is likely that some of the remains buried in the cemetery were embalmed with formaldehyde and possibly arsenic. This is considered a *de minimus* condition.

Photo 10. Cemetery with grave from 1898.

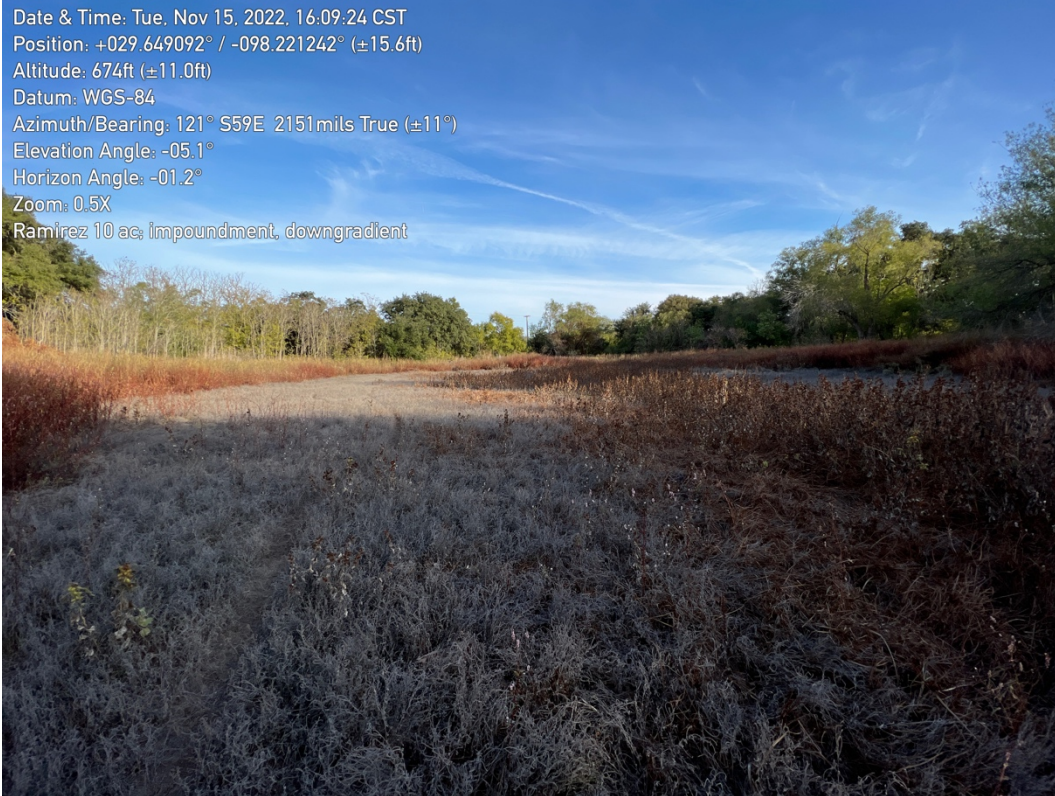
Vegetation communities on the subject property are a mix of grassland, shrubland, riparian woodland, and herbaceous wetland that is typical for the region. The herbaceous wetland in the center of the subject property is approximately 1.5 to 2.0 acres. The wetland appears to have been at least partially created by alterations to the hydrology of Dry Comal Creek caused by the construction of Bunker Street, and this conclusion is supported by the 1973 and 1983 aerial photos (Appendix D).

Photo 13. Wetland area along Dry Comal Creek, as seen from north end of subject property, view downgradient.

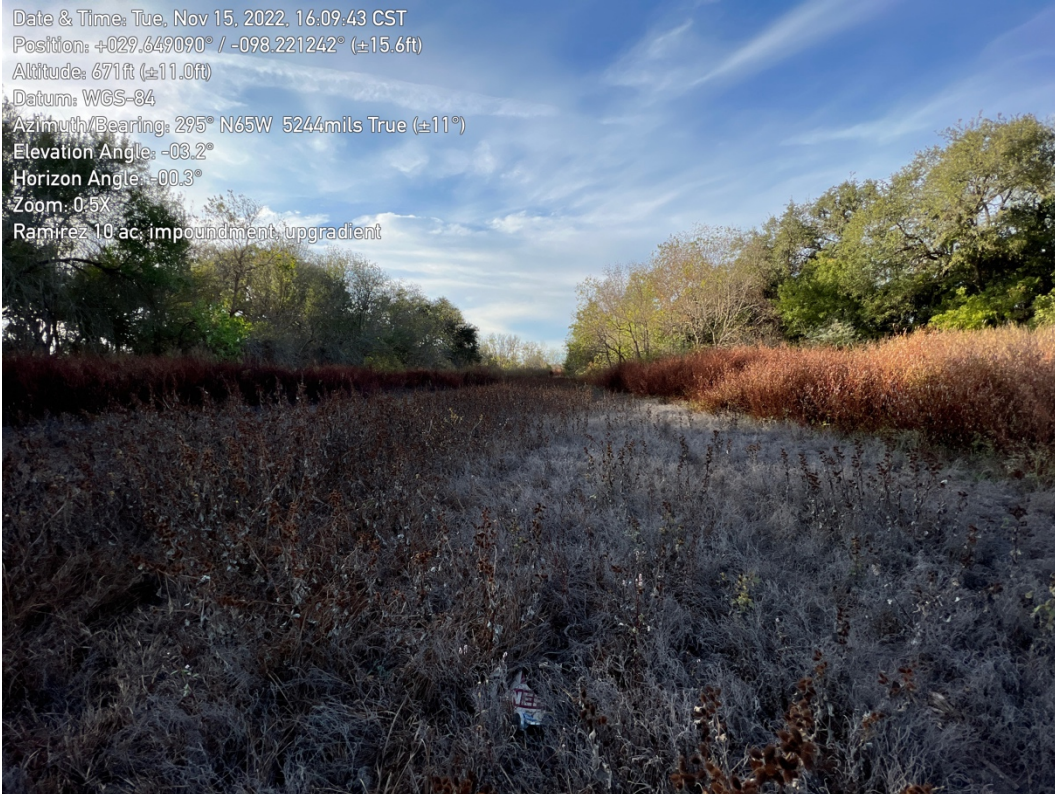
Photo 14. Wetland area along Dry Comal Creek, as seen from north end of subject property, view upgradient.

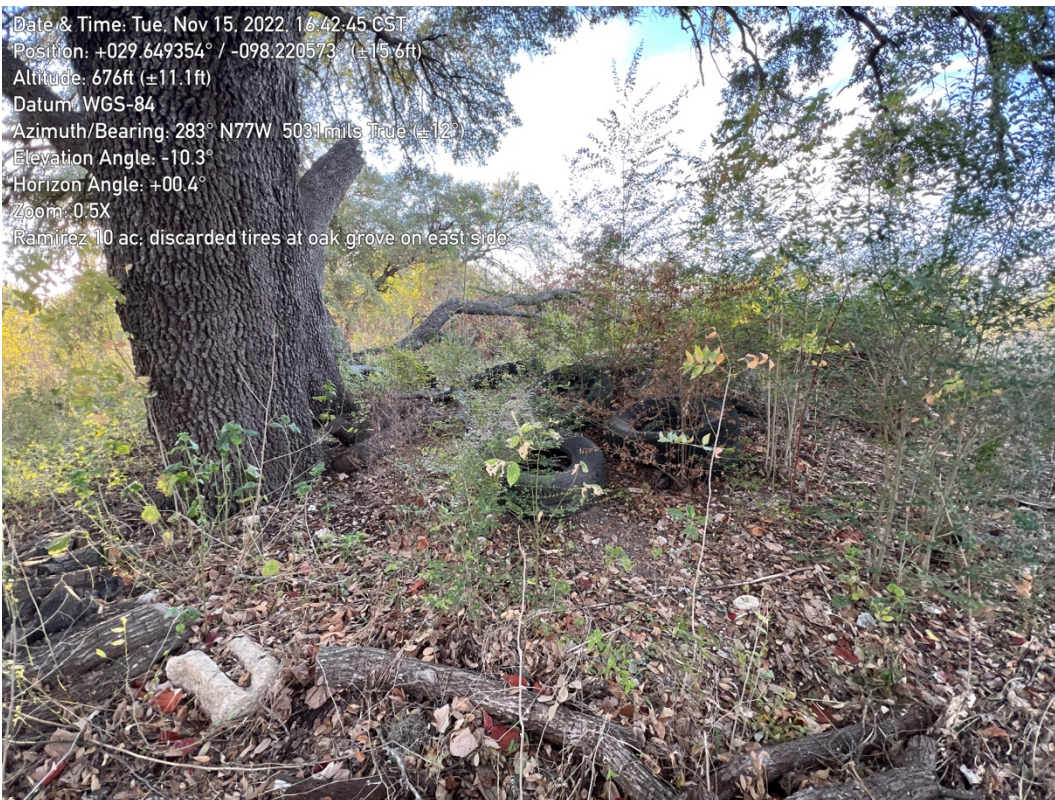
No “recognized environmental conditions” were noted or inferred on the subject property. The only *de minimus* condition on the subject property was the presence of several discarded tires in the oak grove on the eastern side of the subject property.

Photo 18. Discarded tires in oak grove on east side of subject property.

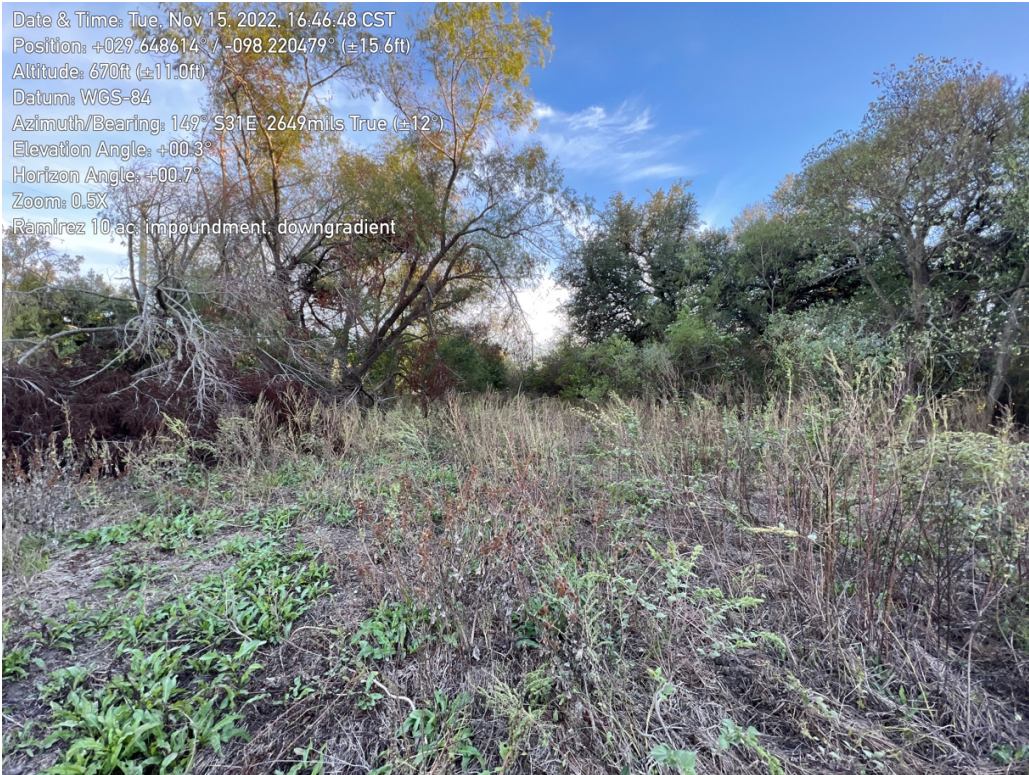
Photo 19. Wetland area on Dry Comal Creek, as seen from center of subject property, view downgradient.

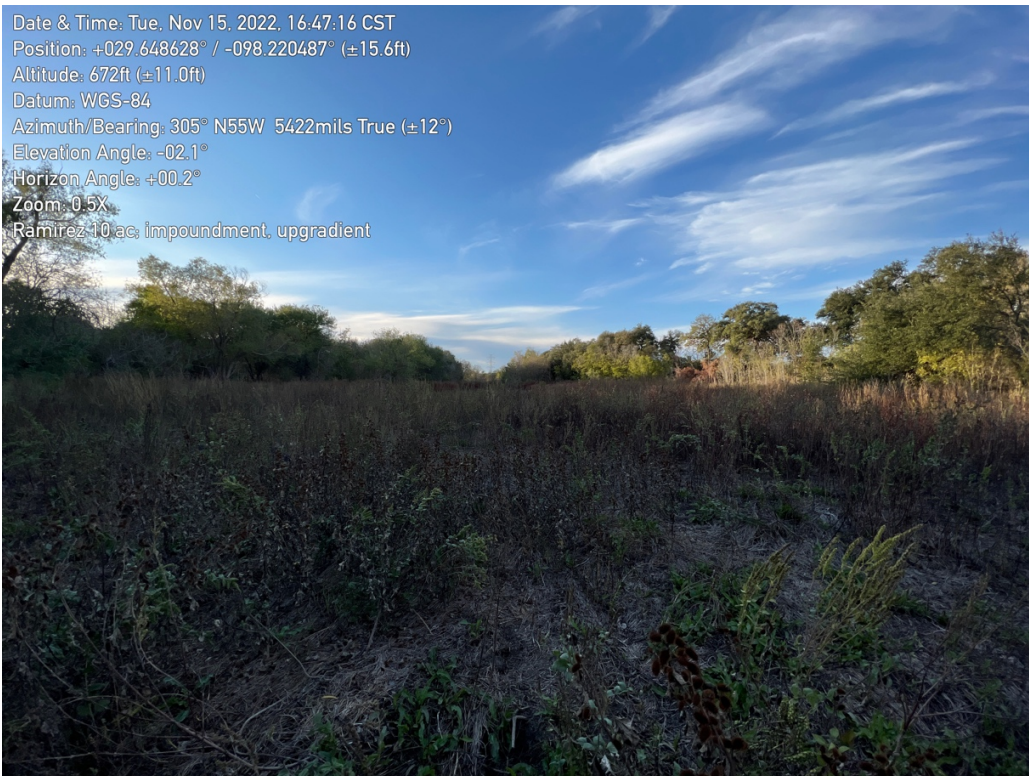
Photo 20. Wetland area on Dry Comal Creek, as seen from center of subject property, view upgradient.
