Change Request

Number: 25
Date: 5/22/2018
Project: Wilco WCCHD Office Renovations
Job #: 6148E

Description: Exterior Renovations

Exterior Wall Assessment for
355 Texas Ave.
Round Rock, Texas

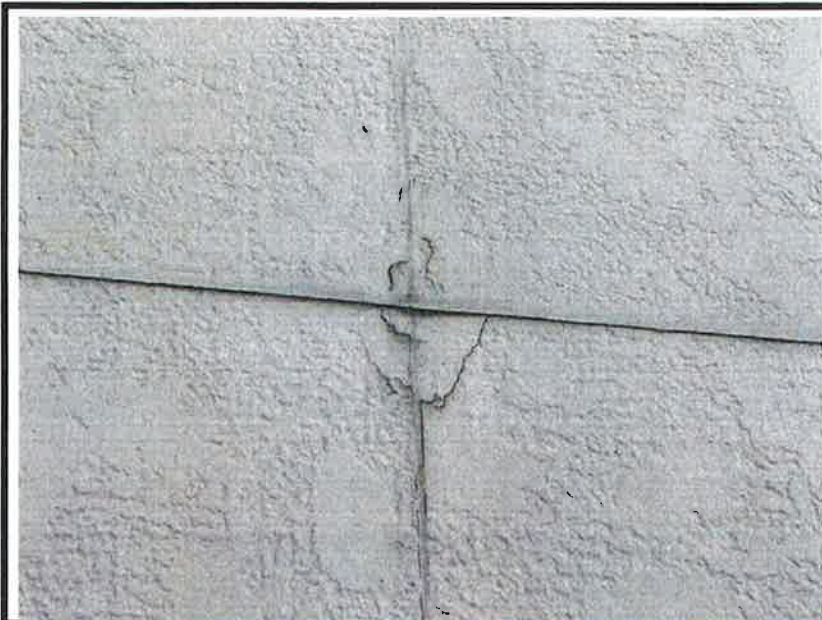
- c. Various sheathing boards were observed damaged with corners missing
 - d. Sheathing is face nailed into wall framing behind. Nail heads were originally covered with plaster. Fasteners were observed backing out and proud of exterior sheathing at numerous locations. Plaster covering nail head has deteriorated at numerous locations exposing nail head.

Photo No. 1
Example of damaged siding.

Restoration of the existing siding will result in continued maintenance for the Owner but is a viable solution to limit water intrusion through the exterior wall assembly. Due to the existing construction it is anticipated that the current issues observed will continue to proliferate through the system as the building continues to move and age. Option 2 consists of replacement of damaged siding panels (panels where cracking or fracturing has isolated a portion of the panel from the main body / attachment points). Removal of all loose material / plaster. Proper surface preparation. Application of new sealant at joints / panel terminations. Application of breathable, reinforced wall coating (an example of acceptable product is attached to this report).

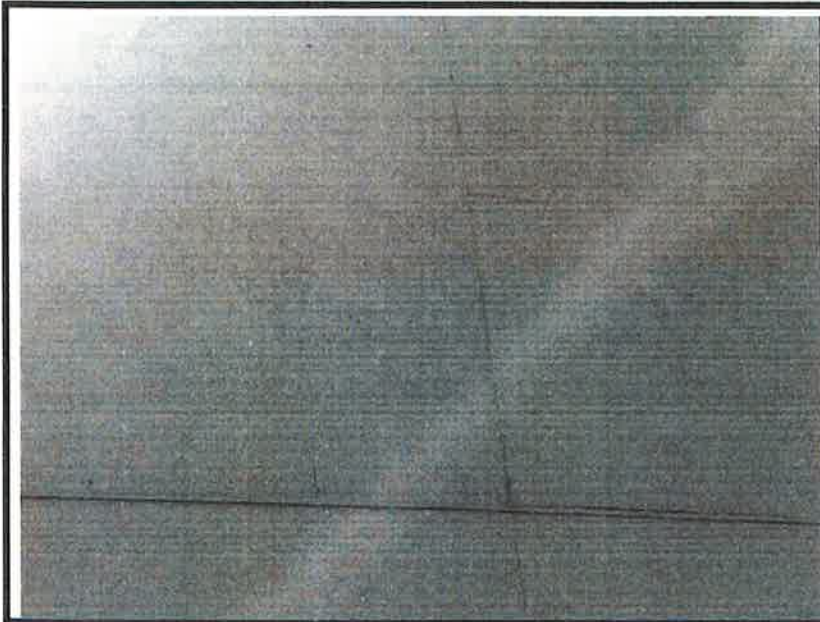
- a. Sheathing is butted to adjacent boards with trim flashing at the head and bottom of each panel.
 - b. Sheathing was observed with numerous cracks and open joints.

Existing building construction type does not lend itself to the installation of cementitious siding with butt joints. Building movement has resulted in open siding joints and various levels of damaged panels.

Photo No. 3
Example of open siding joint between panels
Example of cracked panels

Coating will bridge minor cracking and accommodate minimal movement in the substrate, but it is expected board joints will continue to be an issue. Owner may consider additional protection at board to board joints in the form of an extruded silicone bridge (an example of acceptable product is attached to this report). The attached product will accommodate movement at joints and remain watertight long-term.
