CHANGE ORDER NUMBER: 4

**San Gabriel Ranch Road Bridge
Williamson County Project No. 1807-252**

Change Order No. 4

To: Derrick Ward
From: William Lyons
RE: Williamson County – SGRR Bridge
SUBJECT: Wet Base Remediation

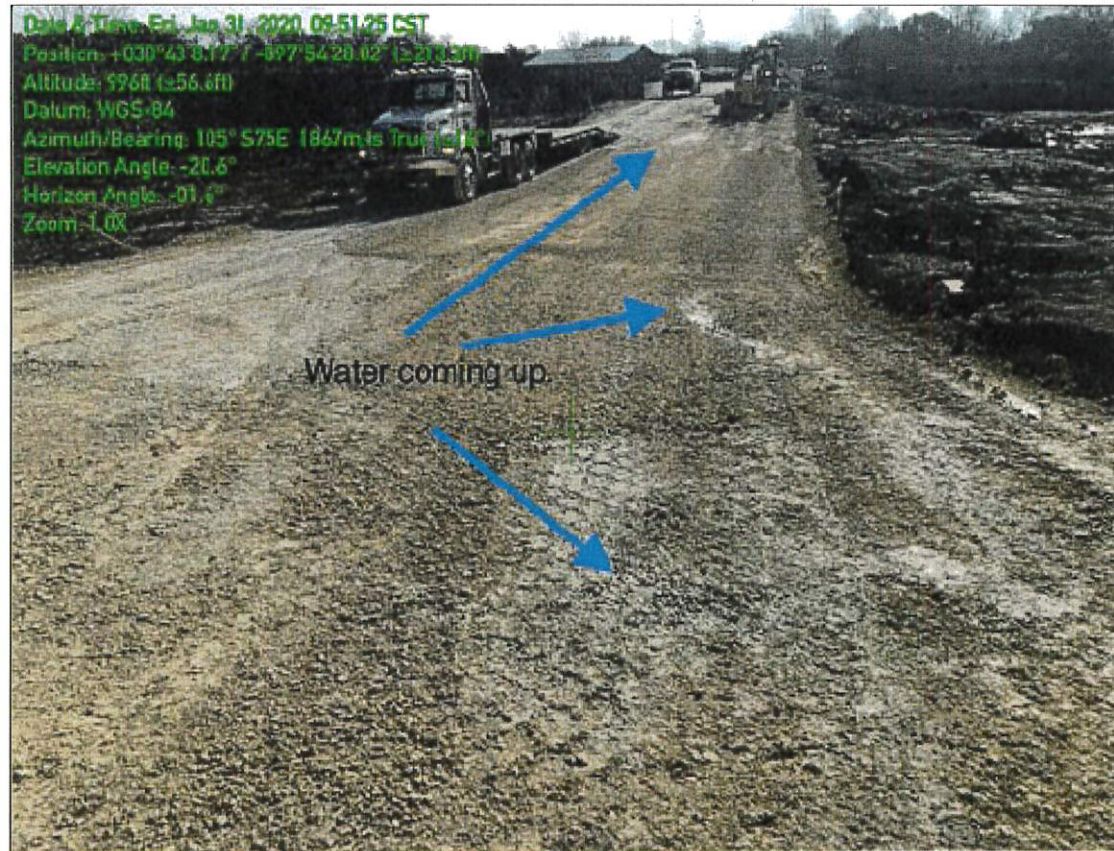
181700 - San Gabriel Ranch Rd Bridge at Lackey Crk Image 47 of 55

Areas marked are where water has been lately coming up from the ground.

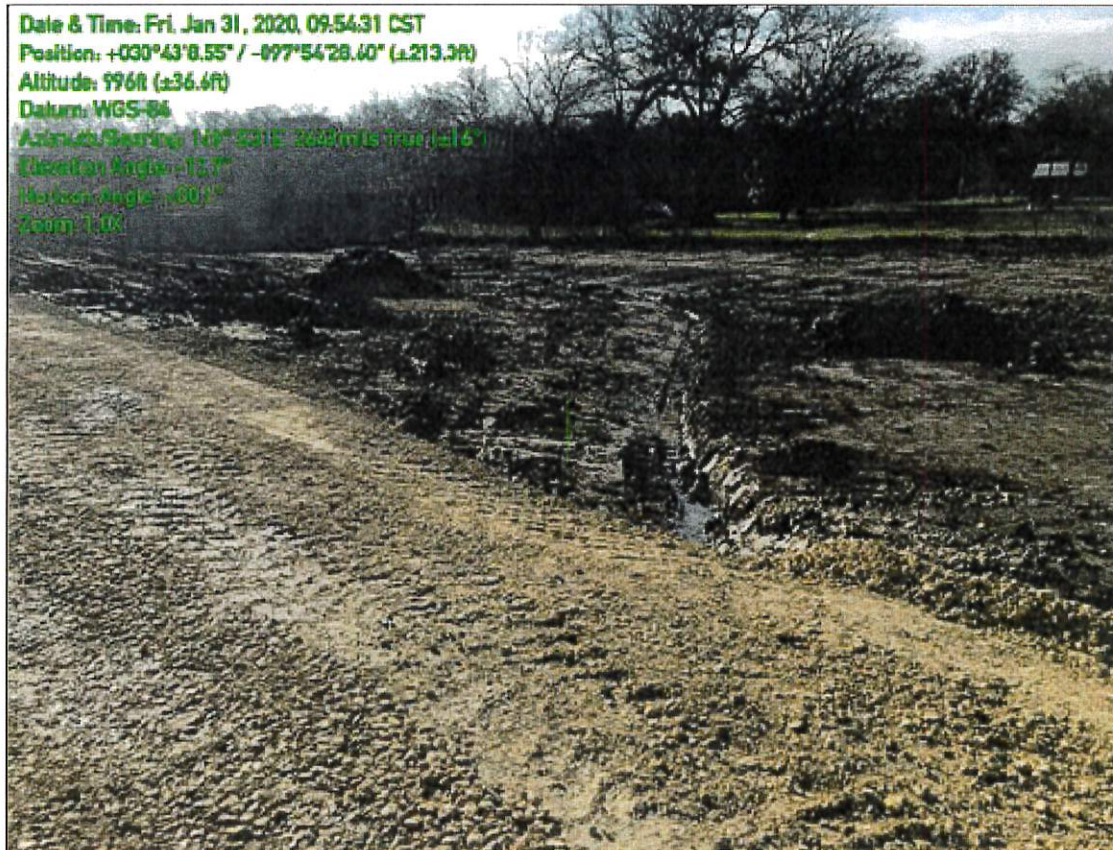
181700 - San Gabriel Ranch Rd Bridge at Lackey Crk Image 49 of 55

A trench on the side of road has been made for water to flow out.

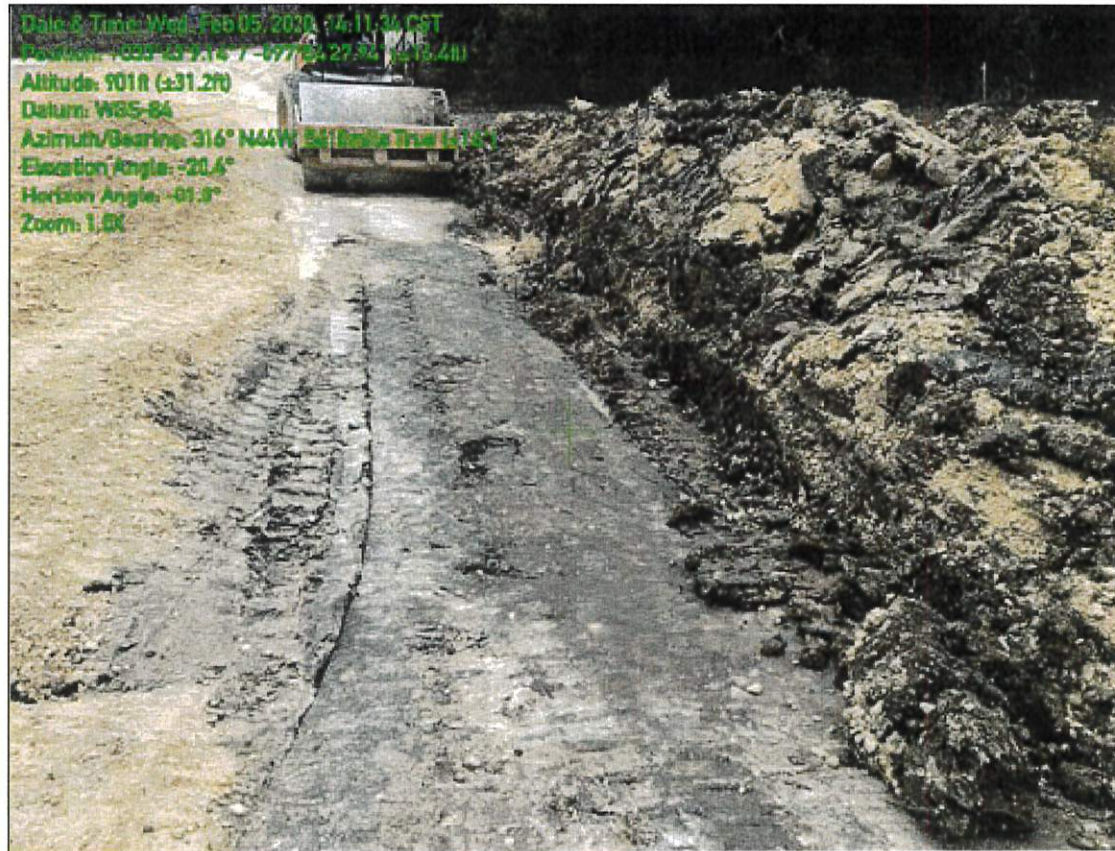
181700 - San Gabriel Ranch Rd Bridge at Lackey Crk Image 51 of 55

Excavated material down cause it was pumping and water coming out.

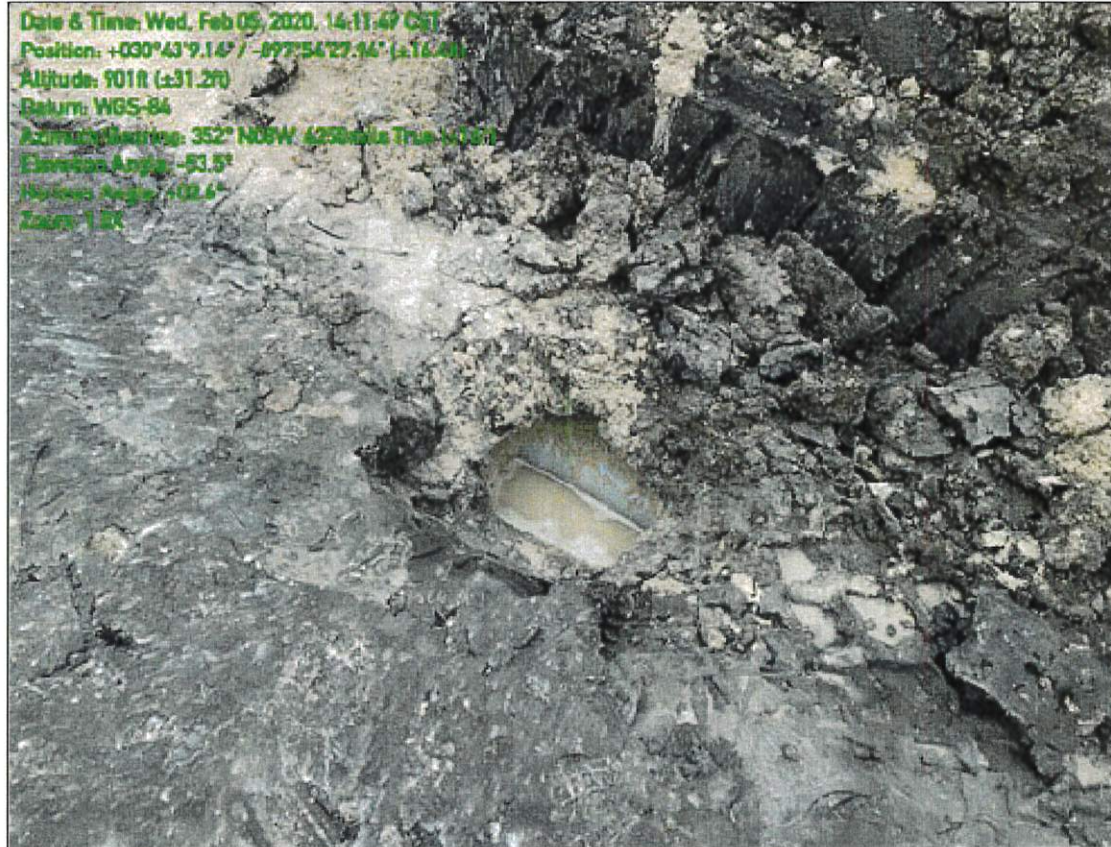
181700 - San Gabriel Ranch Rd Bridge at Lackey Crk Image 52 of 55

Electrical conduit pipe was filled with water due to water leak north end of bridge. Let super know about the situation and was instructed to fill it back in in lifts. Pipe is in the edge of our 3 foot off set.

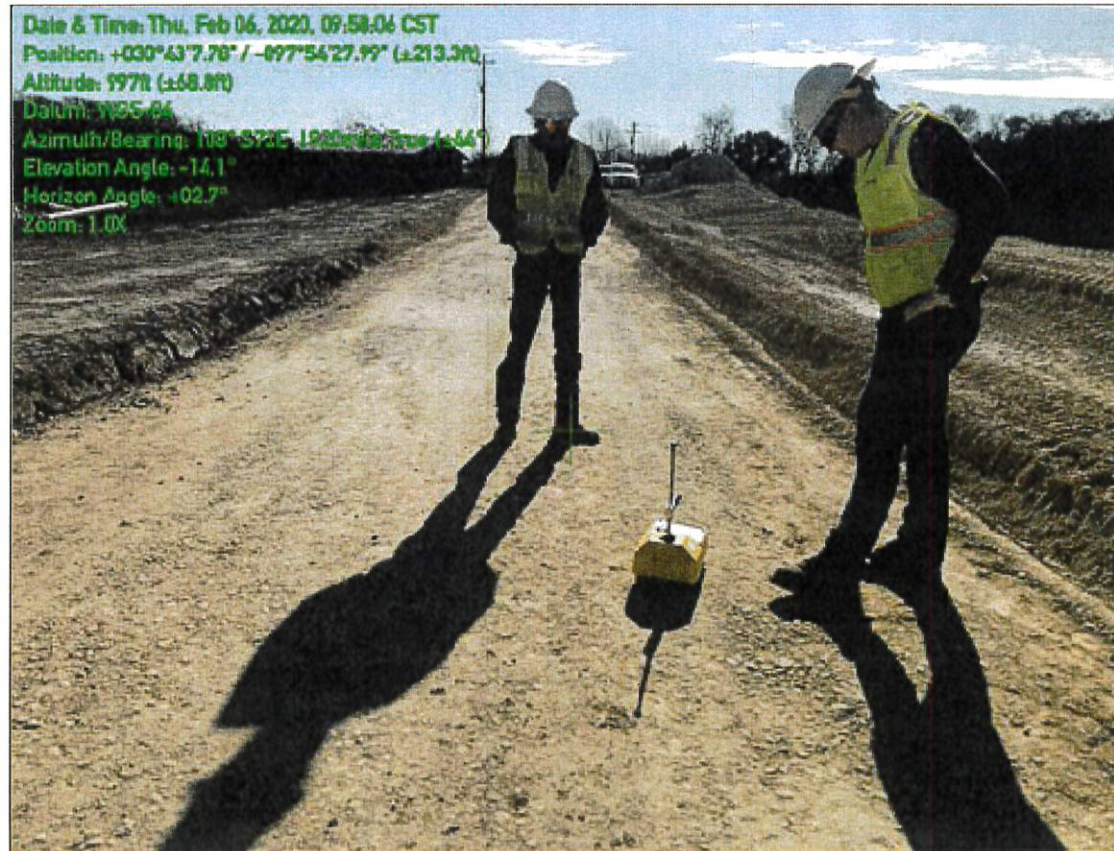
181700 - San Gabriel Ranch Rd Bridge at Lackey Crk Image 55 of 55

Base densities on first lift with Inspector and Kleinfelder. Densities passed.
