**Number:** 25  
**Date:** 5/22/2018  
**Project:** Wilco WCCHD Office Renovations  
**Job #:** 6148E

**Description:** Exterior Renovations

Exterior Wall Assessment for  
**355 Texas Ave.**  
Round Rock, Texas

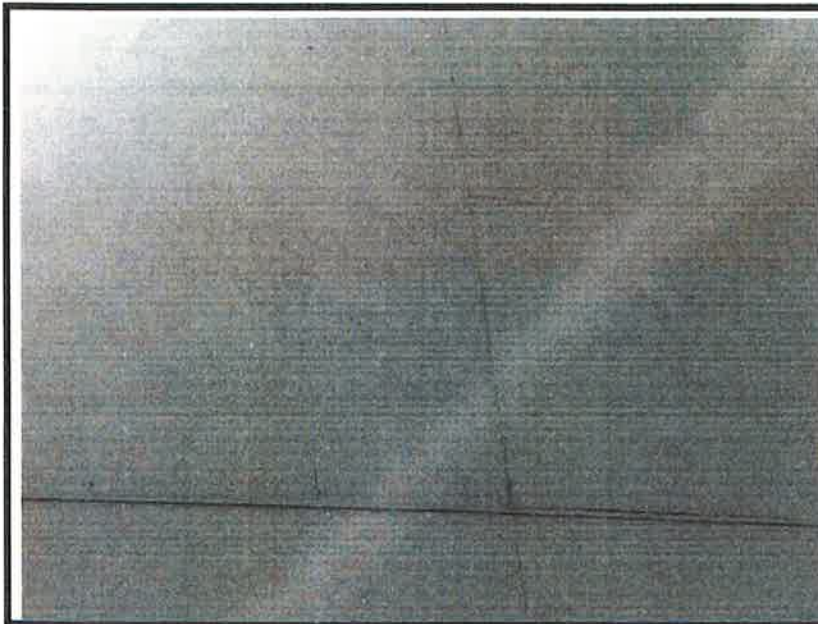
**Photo No. 3**

- a. Sheathing is butted to adjacent boards with trim flashing at the head and bottom of each panel.
  - b. Sheathing was observed with numerous cracks and open joints.

Existing building construction type does not lend itself to the installation of cementitious siding with butt joints. Building movement has resulted in open siding joints and various levels of damaged panels.

Example of open siding joint between panels

Example of cracked panels

Coating will bridge minor cracking and accommodate minimal movement in the substrate, but it is expected board joints will continue to be an issue. Owner may consider additional protection at board to board joints in the form of an extruded silicone bridge (an example of acceptable product is attached to this report). The attached product will accommodate movement at joints and remain watertight long-term.
