WILLIAMSON COUNTY, TEXAS

CHANGE ORDER NUMBER: 4

**San Gabriel Ranch Road Bridge
Williamson County Project No. 1807-252**

Change Order No. 4

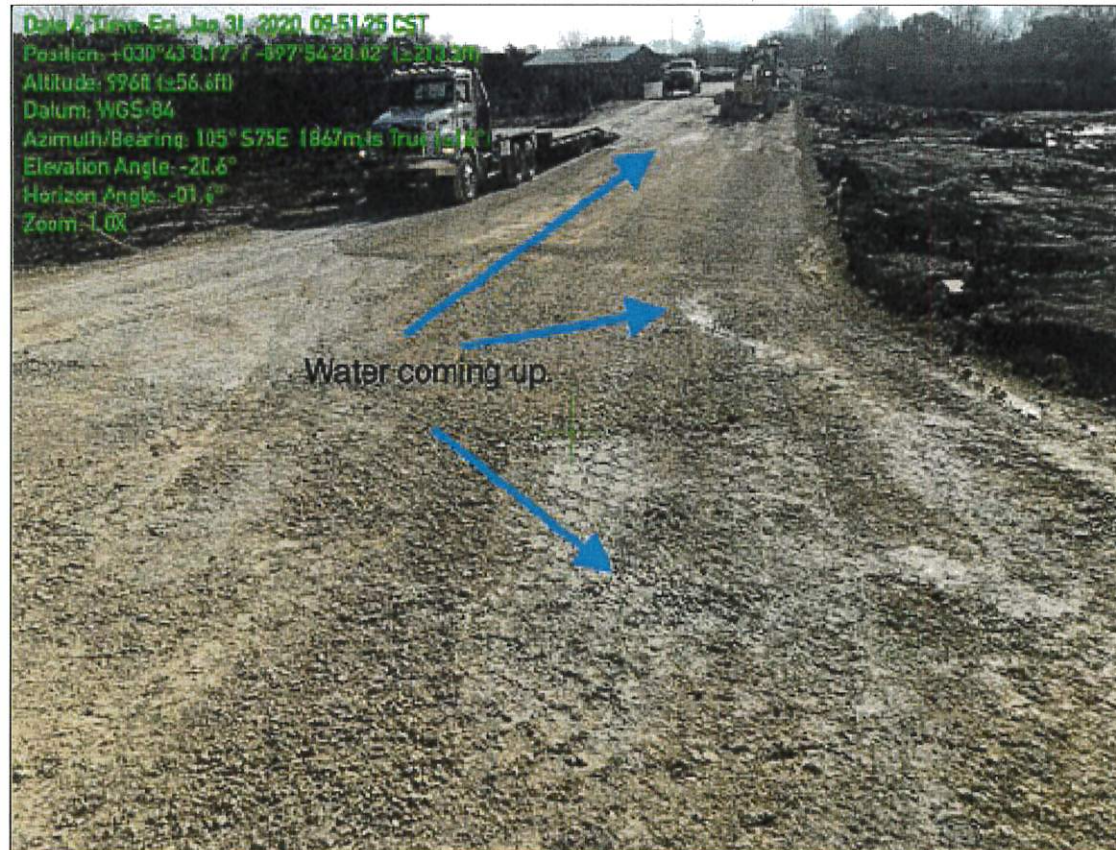
181700 - San Gabriel Ranch Rd Bridge at Lackey Crk Image 47 of 55

Areas marked are where water has been lately coming up from the ground.

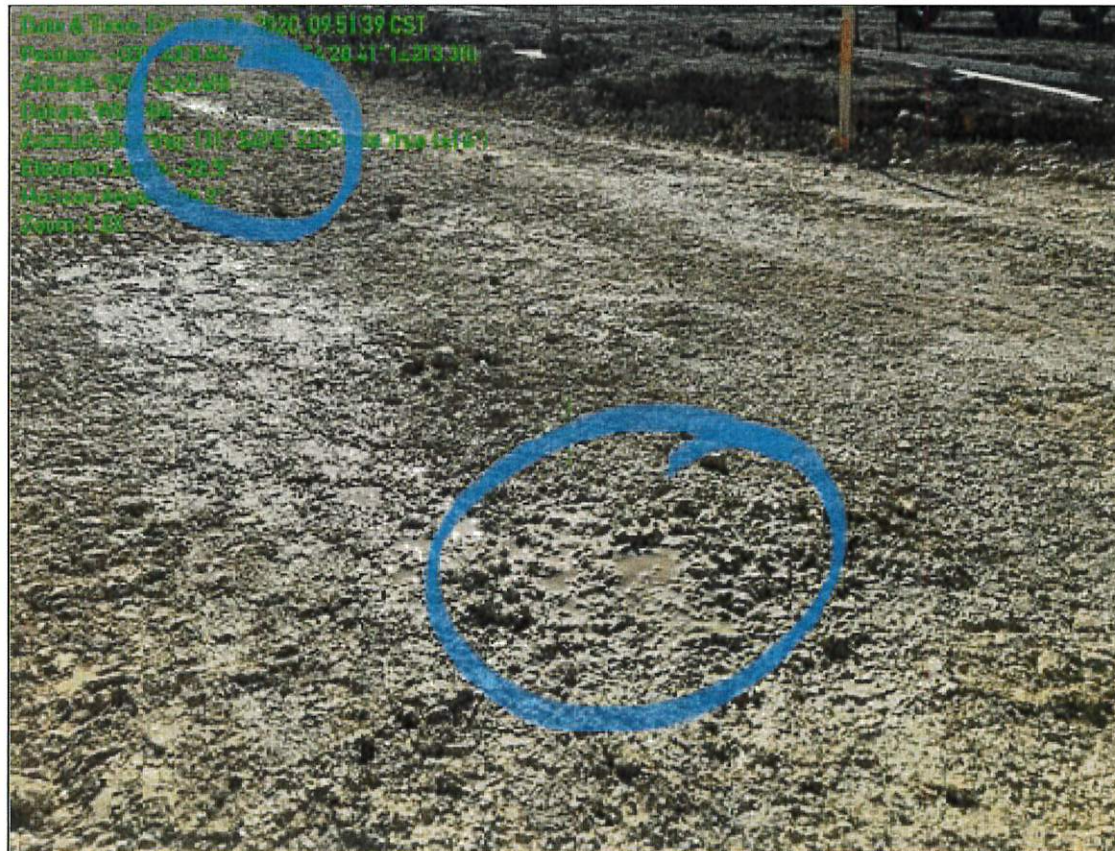
181700 - San Gabriel Ranch Rd Bridge at Lackey Crk Image 48 of 55

As you can see water starting to come up.

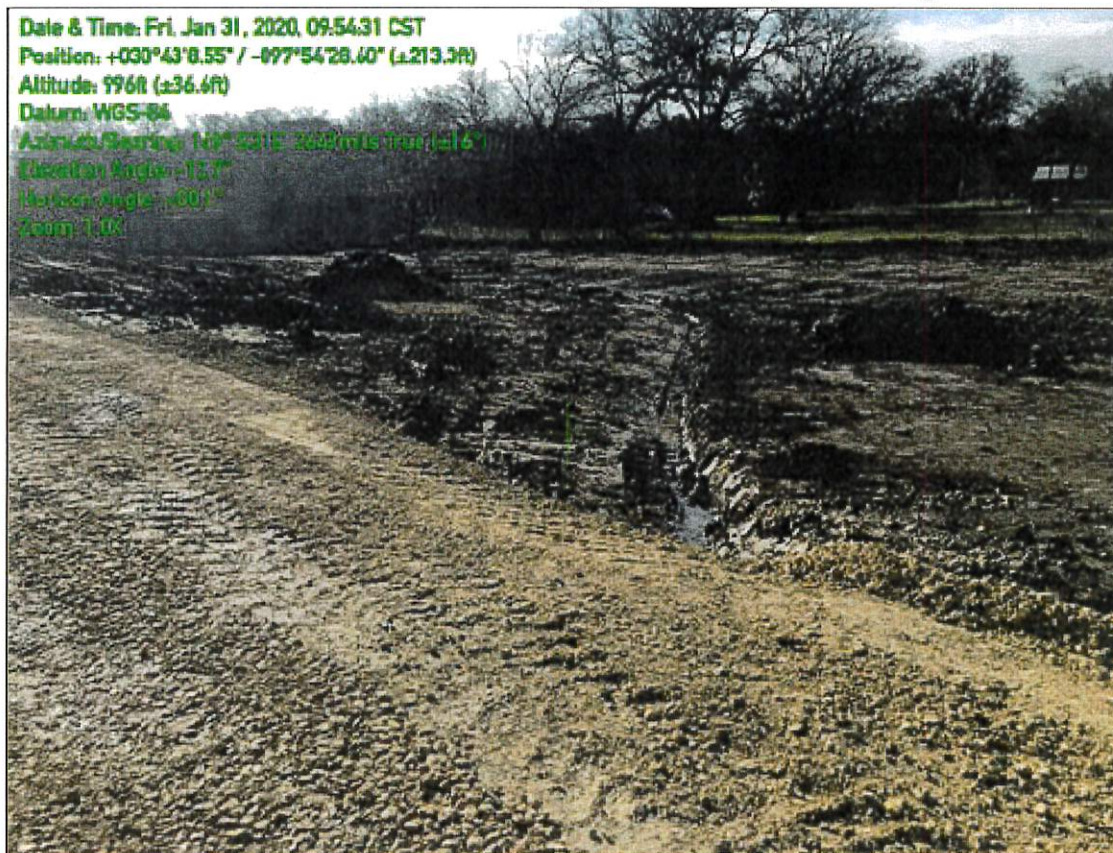
181700 - San Gabriel Ranch Rd Bridge at Lackey Crk Image 49 of 55

A trench on the side of road has been made for water to flow out.

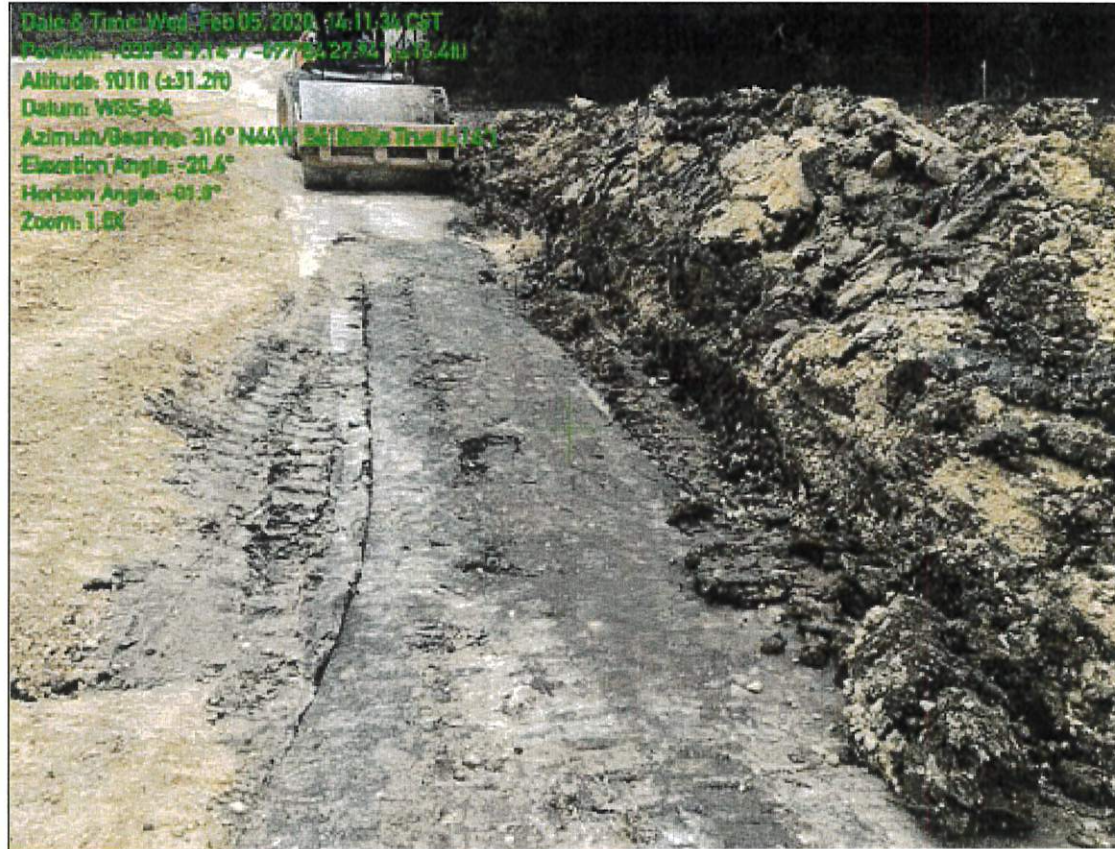
181700 - San Gabriel Ranch Rd Bridge at Lackey Crk Image 51 of 55

Excavated material down cause it was pumping and water coming out.

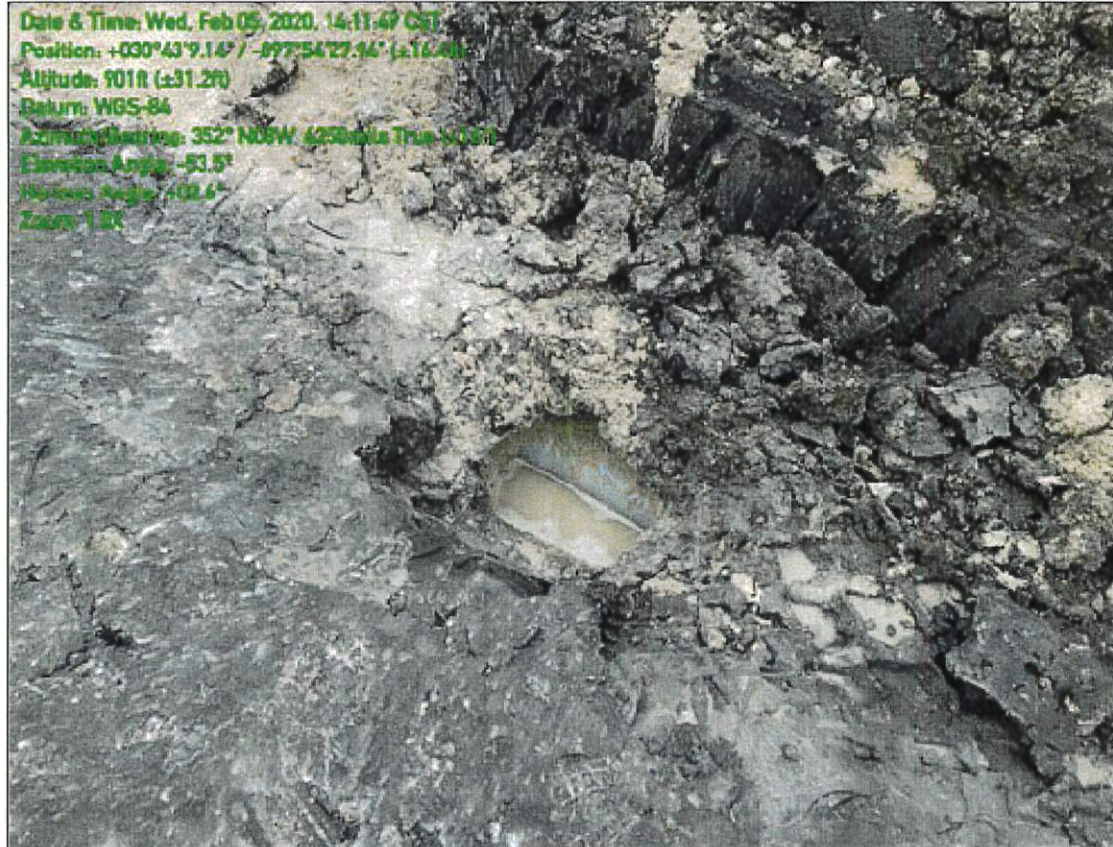
181700 - San Gabriel Ranch Rd Bridge at Lackey Crk Image 52 of 55

Electrical conduit pipe was filled with water due to water leak north end of bridge. Let super know about the situation and was instructed to fill it back in in lifts. Pipe is in the edge of our 3 foot off set.

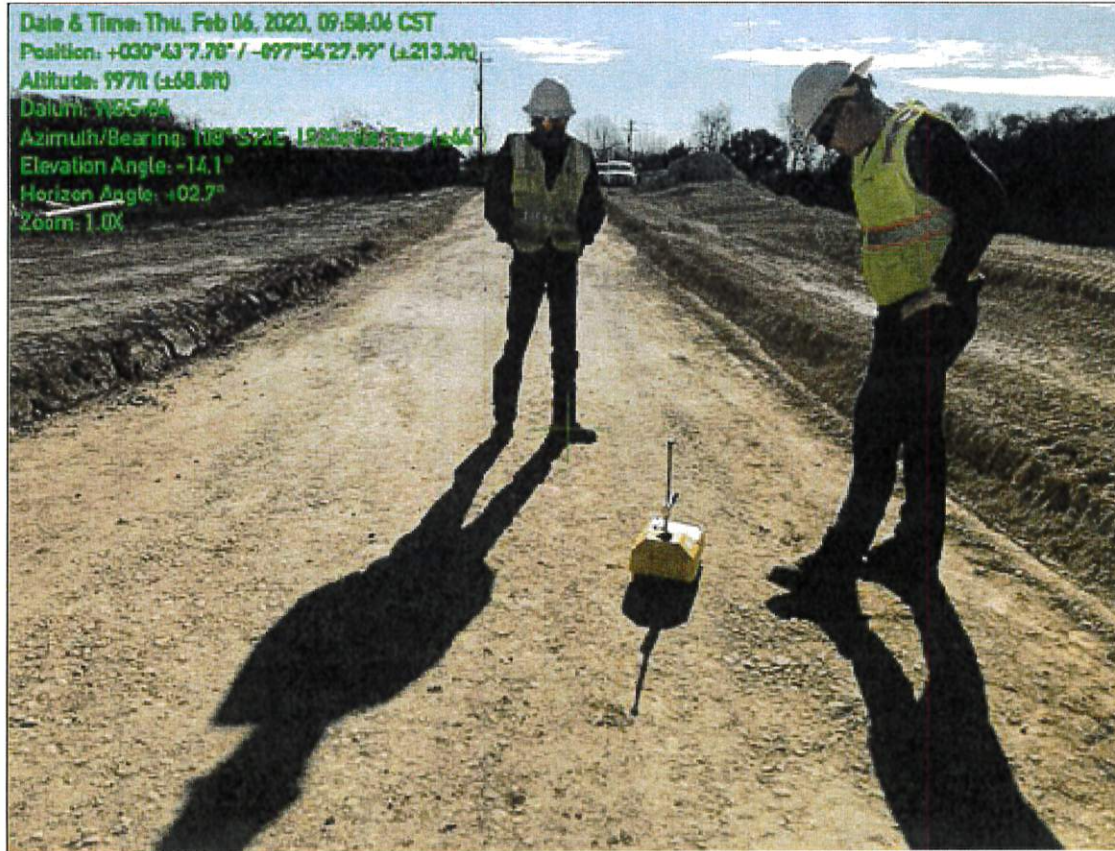
181700 - San Gabriel Ranch Rd Bridge at Lackey Crk Image 55 of 55

Base densities on first lift with Inspector and Kleinfelder. Densities passed.
