U.S. Army Corps of Engineers (USACE) Fort Worth District

Nationwide Permit (NWP) Pre-Construction Notification (PCN) Form

Williamson County Corridor H - Sam Bass Road

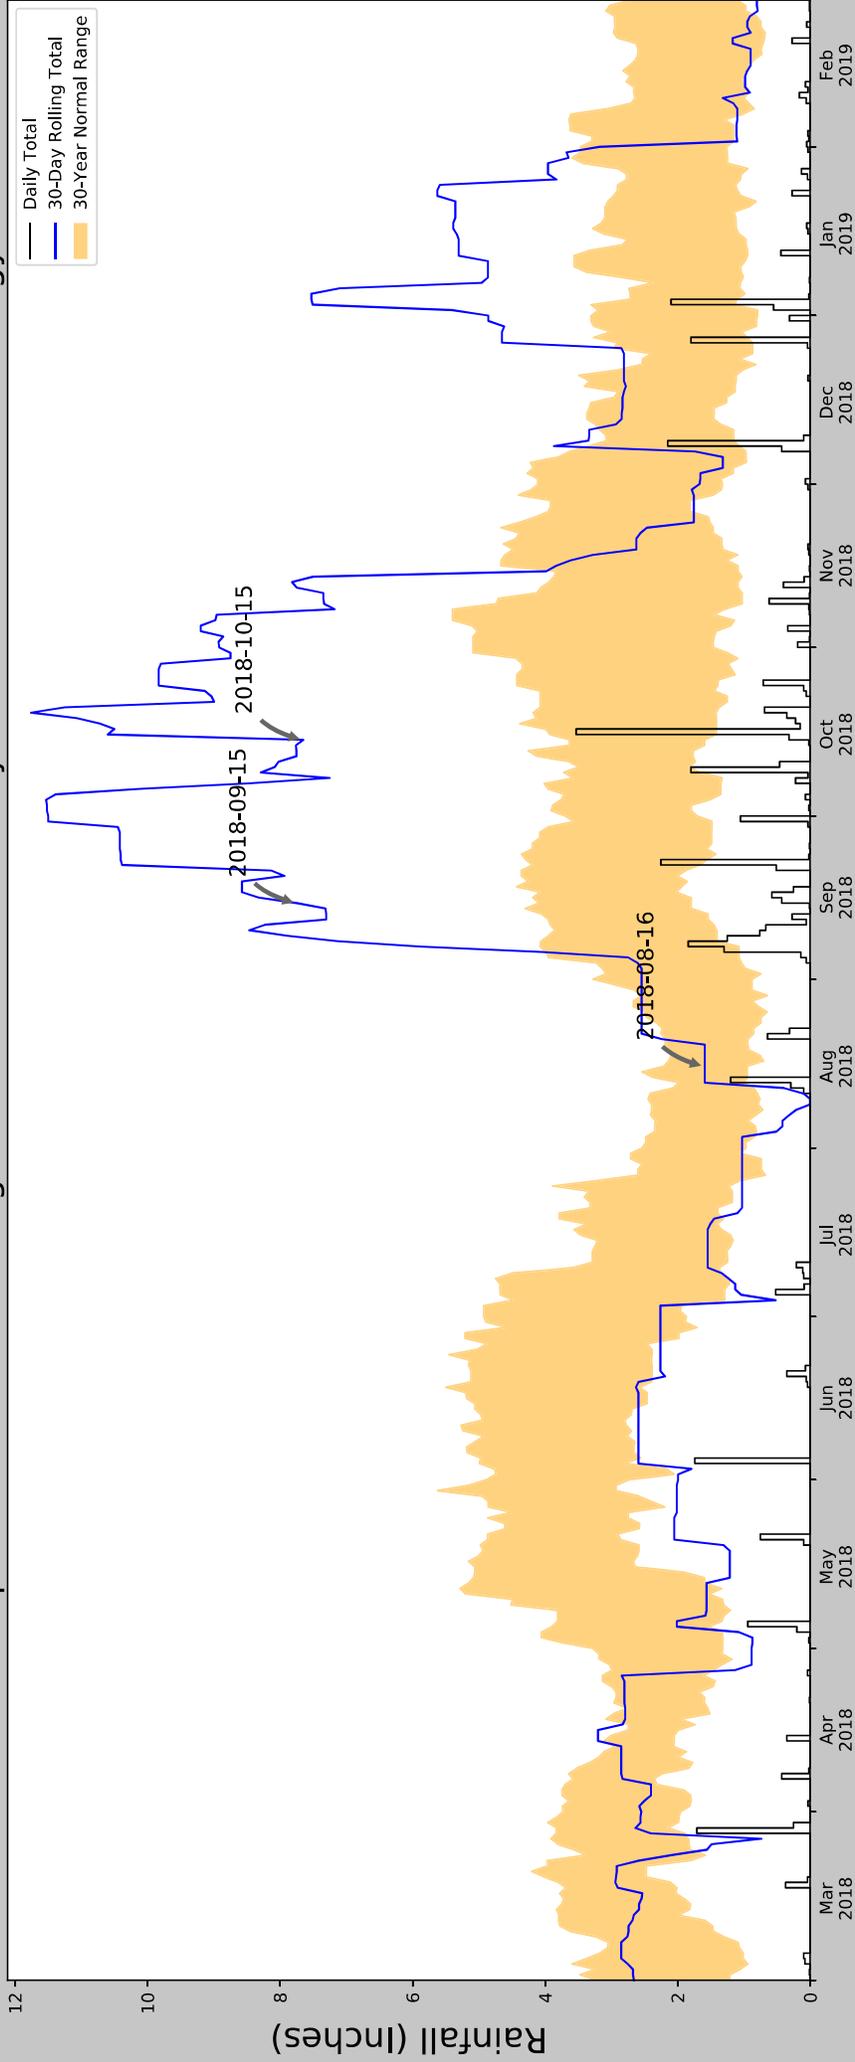
Antecedent Precipitation vs Normal Range based on NOAA's Daily Global Historical Climatology Network

— Daily Total
— 30-Day Rolling Total
 30-Year Normal Range

Coordinates	30.538454, -97.751154
Observation Date	2018-10-15
Elevation (ft)	819.24
Drought Index (PDSI)	Severe wetness
WebWIMP H ₂ O Balance	Dry Season

The USACE-based Antecedent Precipitation Tool (APT), Version 1.0 was utilized to determine the normality of rainfall at the time of the field investigations. APT 1.0 results indicate wetter than normal climatic conditions were present for the October 2018 field visit and drier than normal climatic conditions were present for the March 2019 field visit. No wetland data was recorded during the other field visits. Data are provided in **Attachment C**.

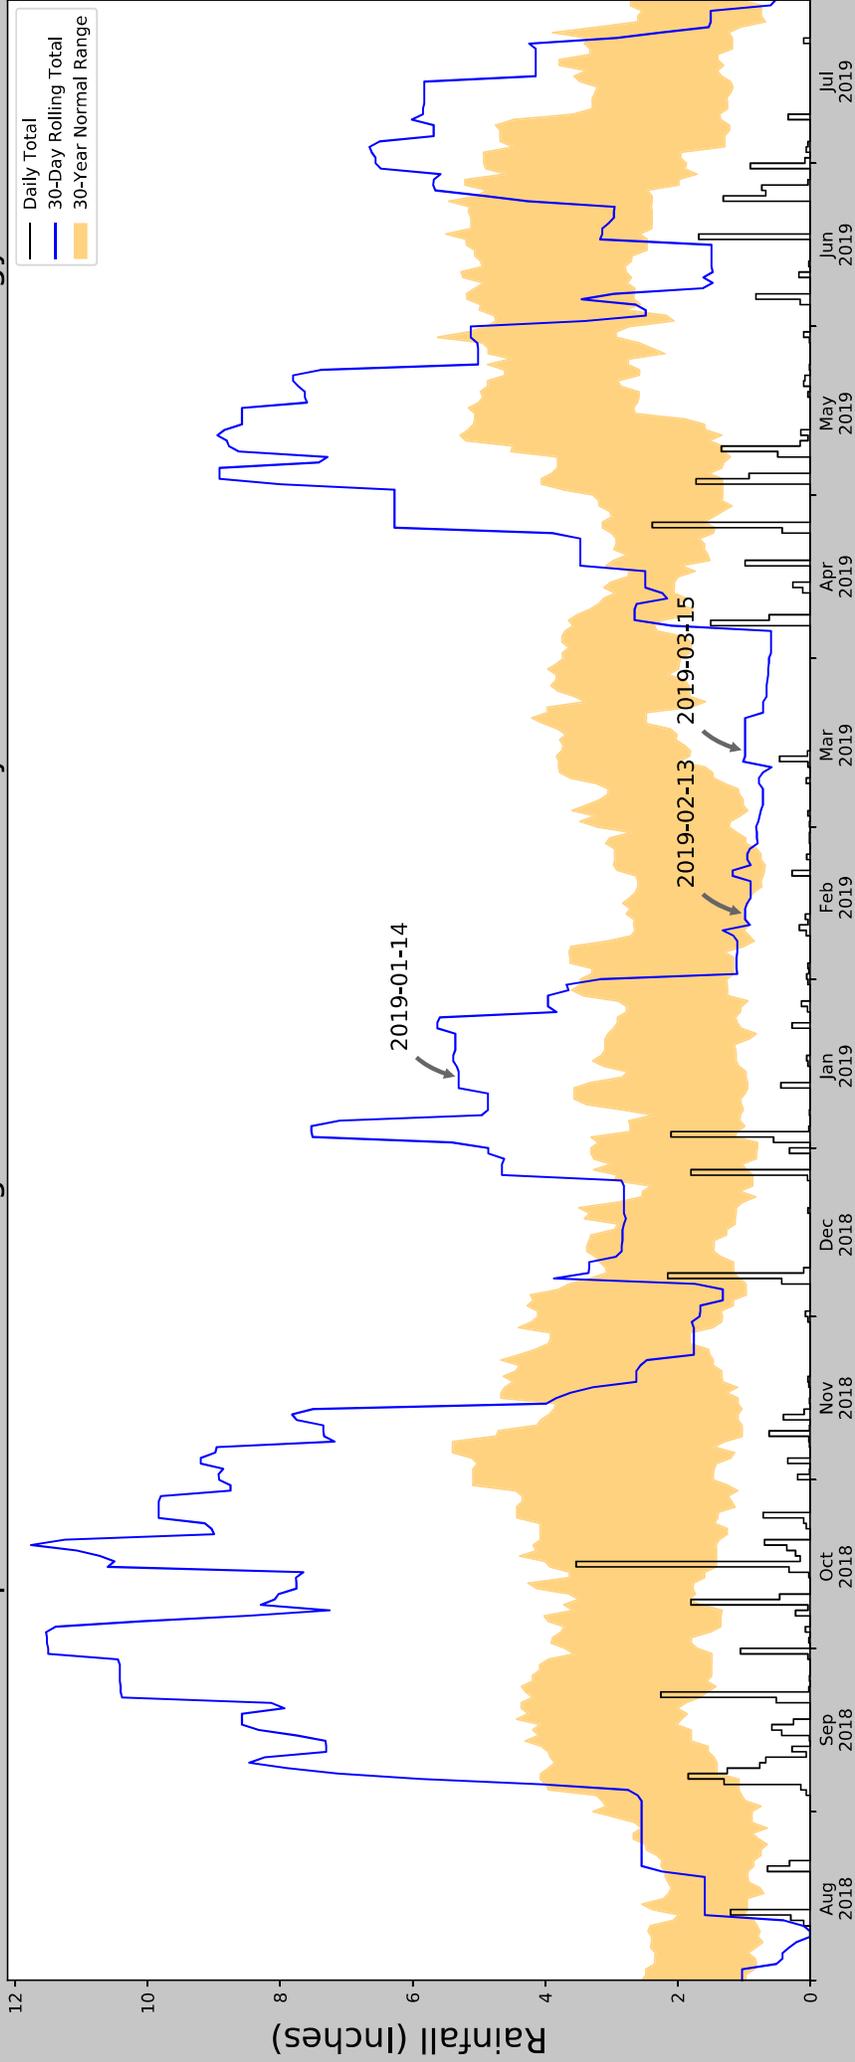
Antecedent Precipitation vs Normal Range based on NOAA's Daily Global Historical Climatology Network

— Daily Total
 — 30-Day Rolling Total
 30-Year Normal Range

Coordinates	30.538454, -97.751153
Observation Date	2019-03-15
Elevation (ft)	819.24
Drought Index (PDSI)	Severe wetness
WebWIMP H ₂ O Balance	Wet Season

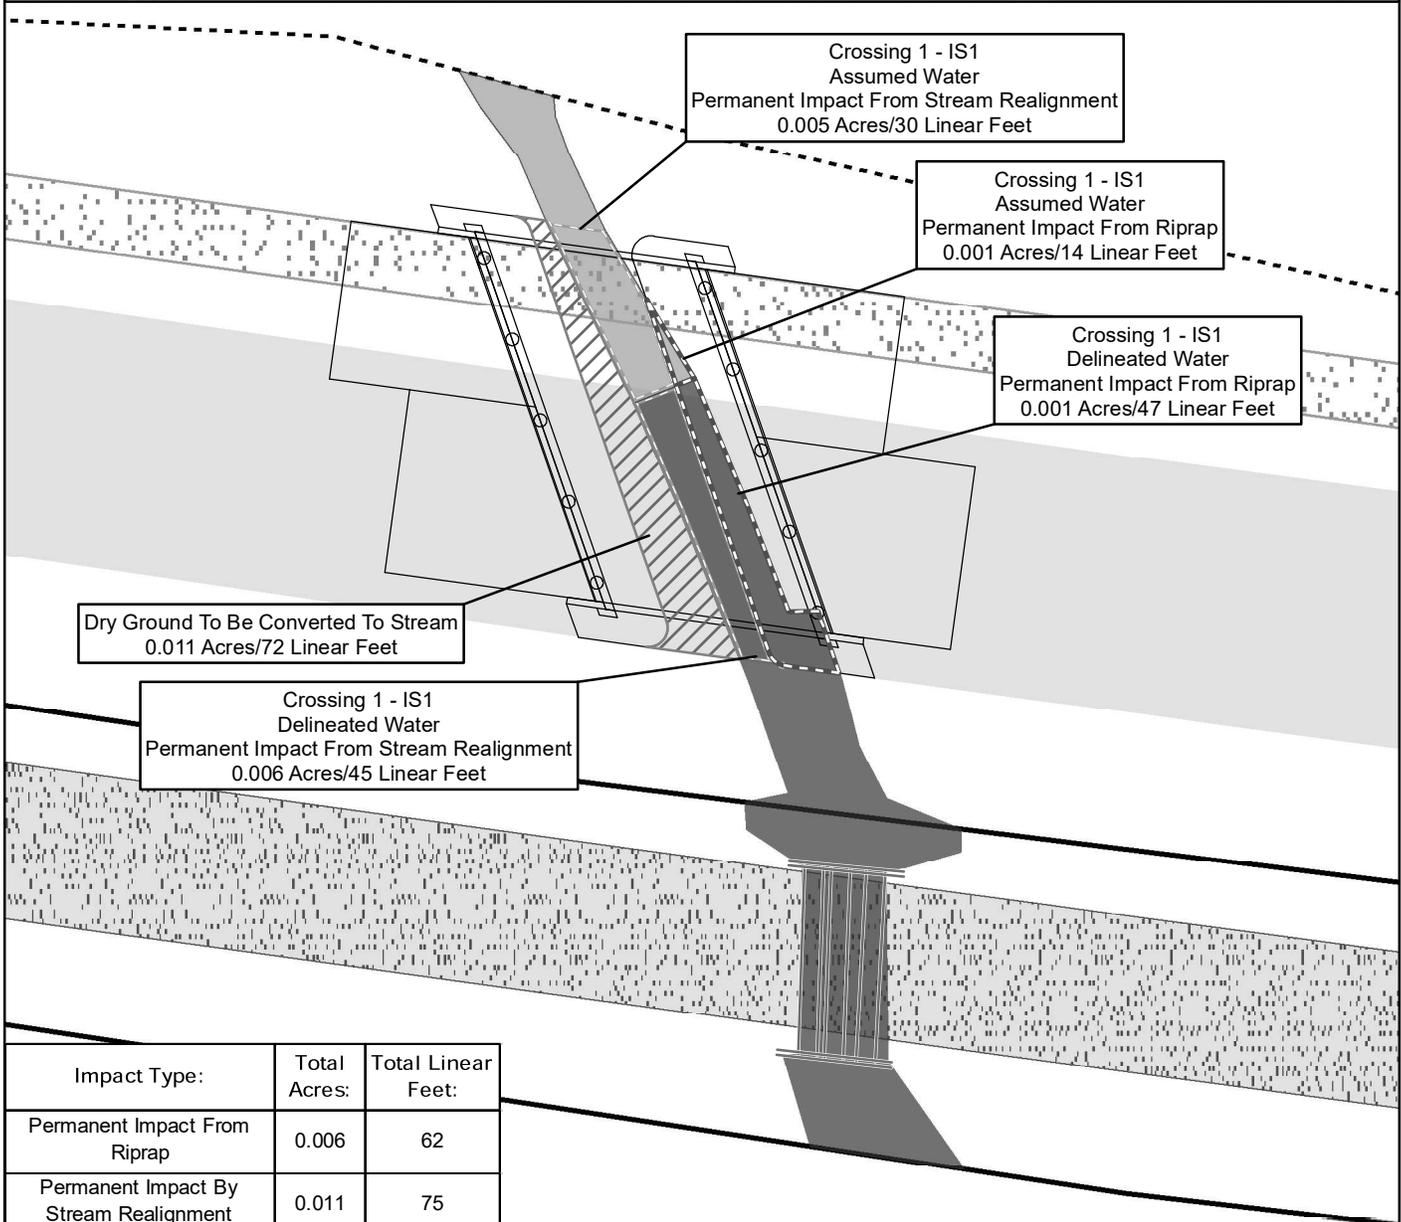
Impact Type:	Total Acres:	Total Linear Feet:
Permanent Impact From Riprap	0.006	62
Permanent Impact By Stream Realignment	0.011	75
Dry Ground To Be Converted To Stream	0.011	72

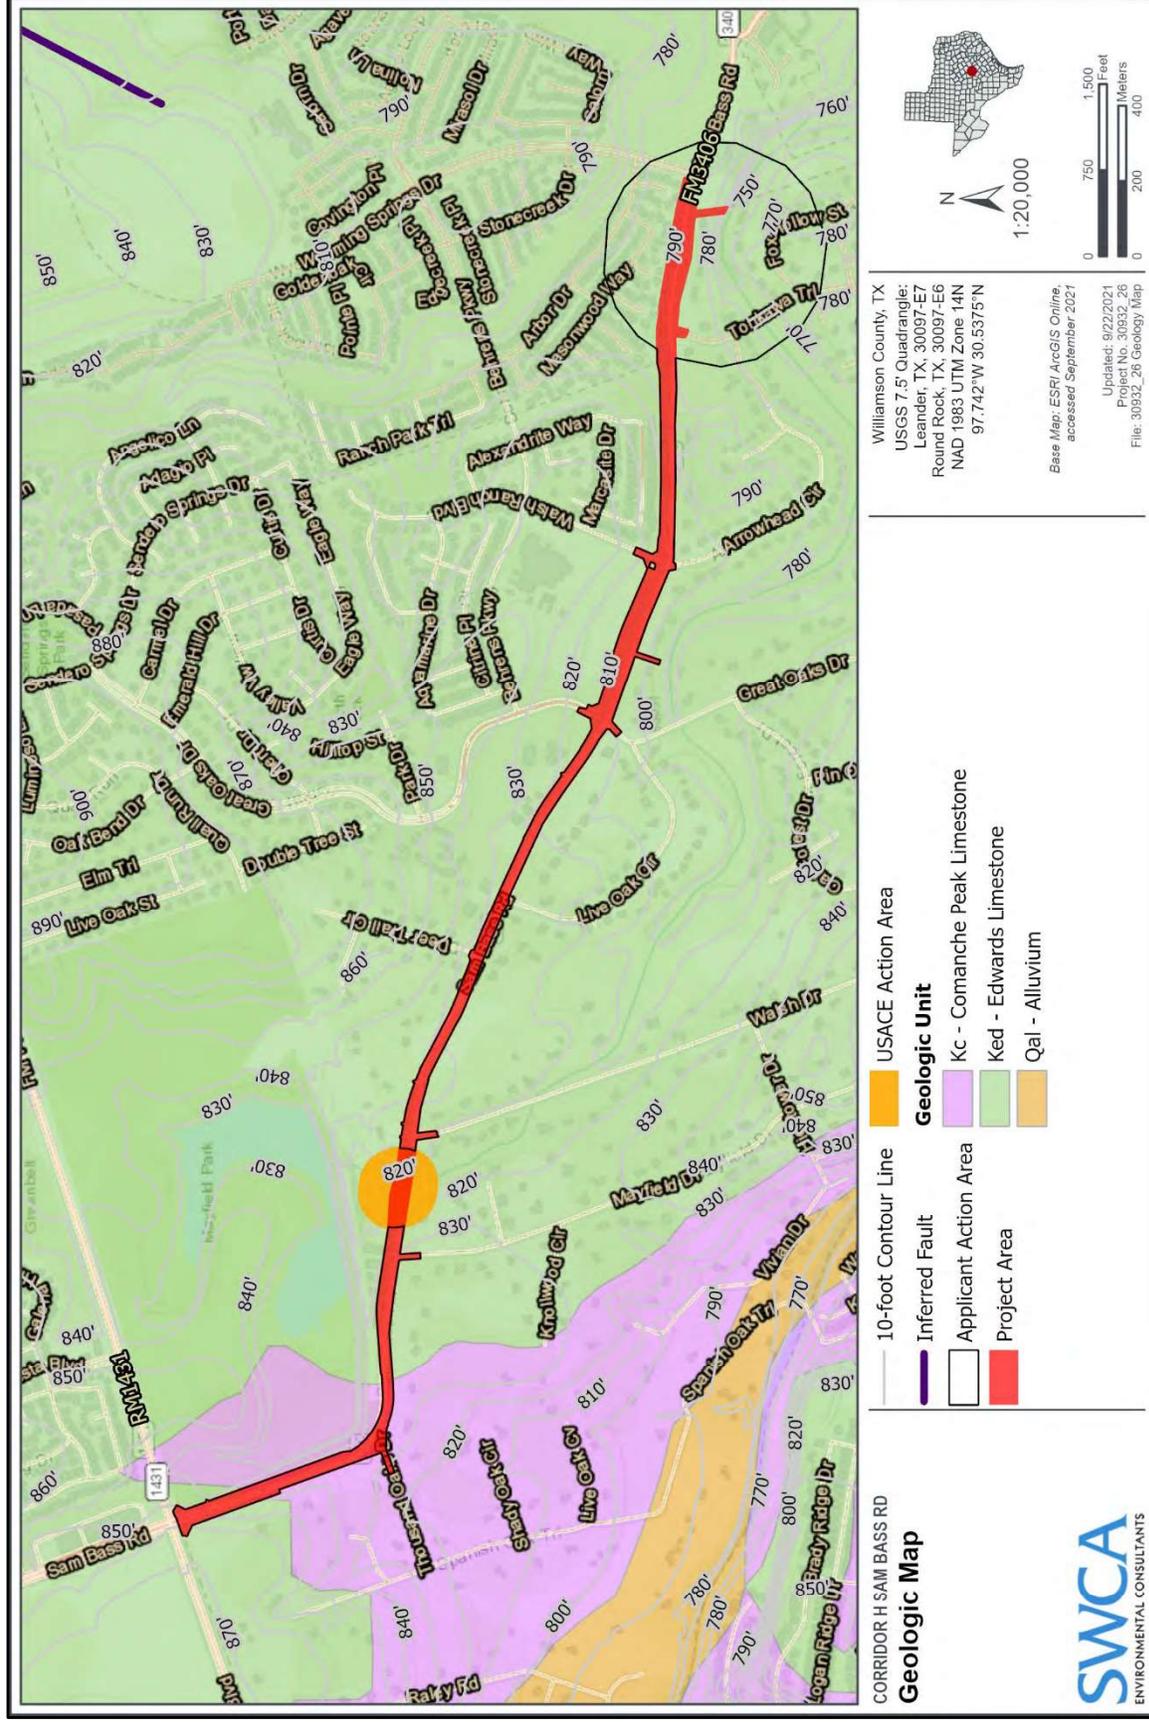
Figure 3. Geology of the Action Areas (Collins 1997, 2005).

Recharge into the Edwards Aquifer primarily occurs in areas where the Edwards Formation and overlying Georgetown Formation are exposed at the surface (Jones 2003). The Northern Segment of the Edwards Aquifer is a hydrologically distinct groundwater system with fault-influenced, rapid-flow paths and local recharge primarily resulting from rainfall on the exposed outcrop of the aquifer itself (Jones 2003). Most recharge is from direct infiltration via precipitation and streamflow loss (Jones 2003). Recharge occurs predominantly along secondary porosity features such as faults, fractures, and karst features (caves, solution cavities, sinkholes, etc.). Karst features are commonly formed along joints, fractures, and bedding plane surfaces in the Edwards and Georgetown Formations (Clark et al. 2016). The amount of recharge occurring on any given site can vary tremendously, but a groundwater availability model for the Northern Segment estimates that, on average, 20% of annual rainfall on the recharge zone becomes groundwater (Jones 2003).

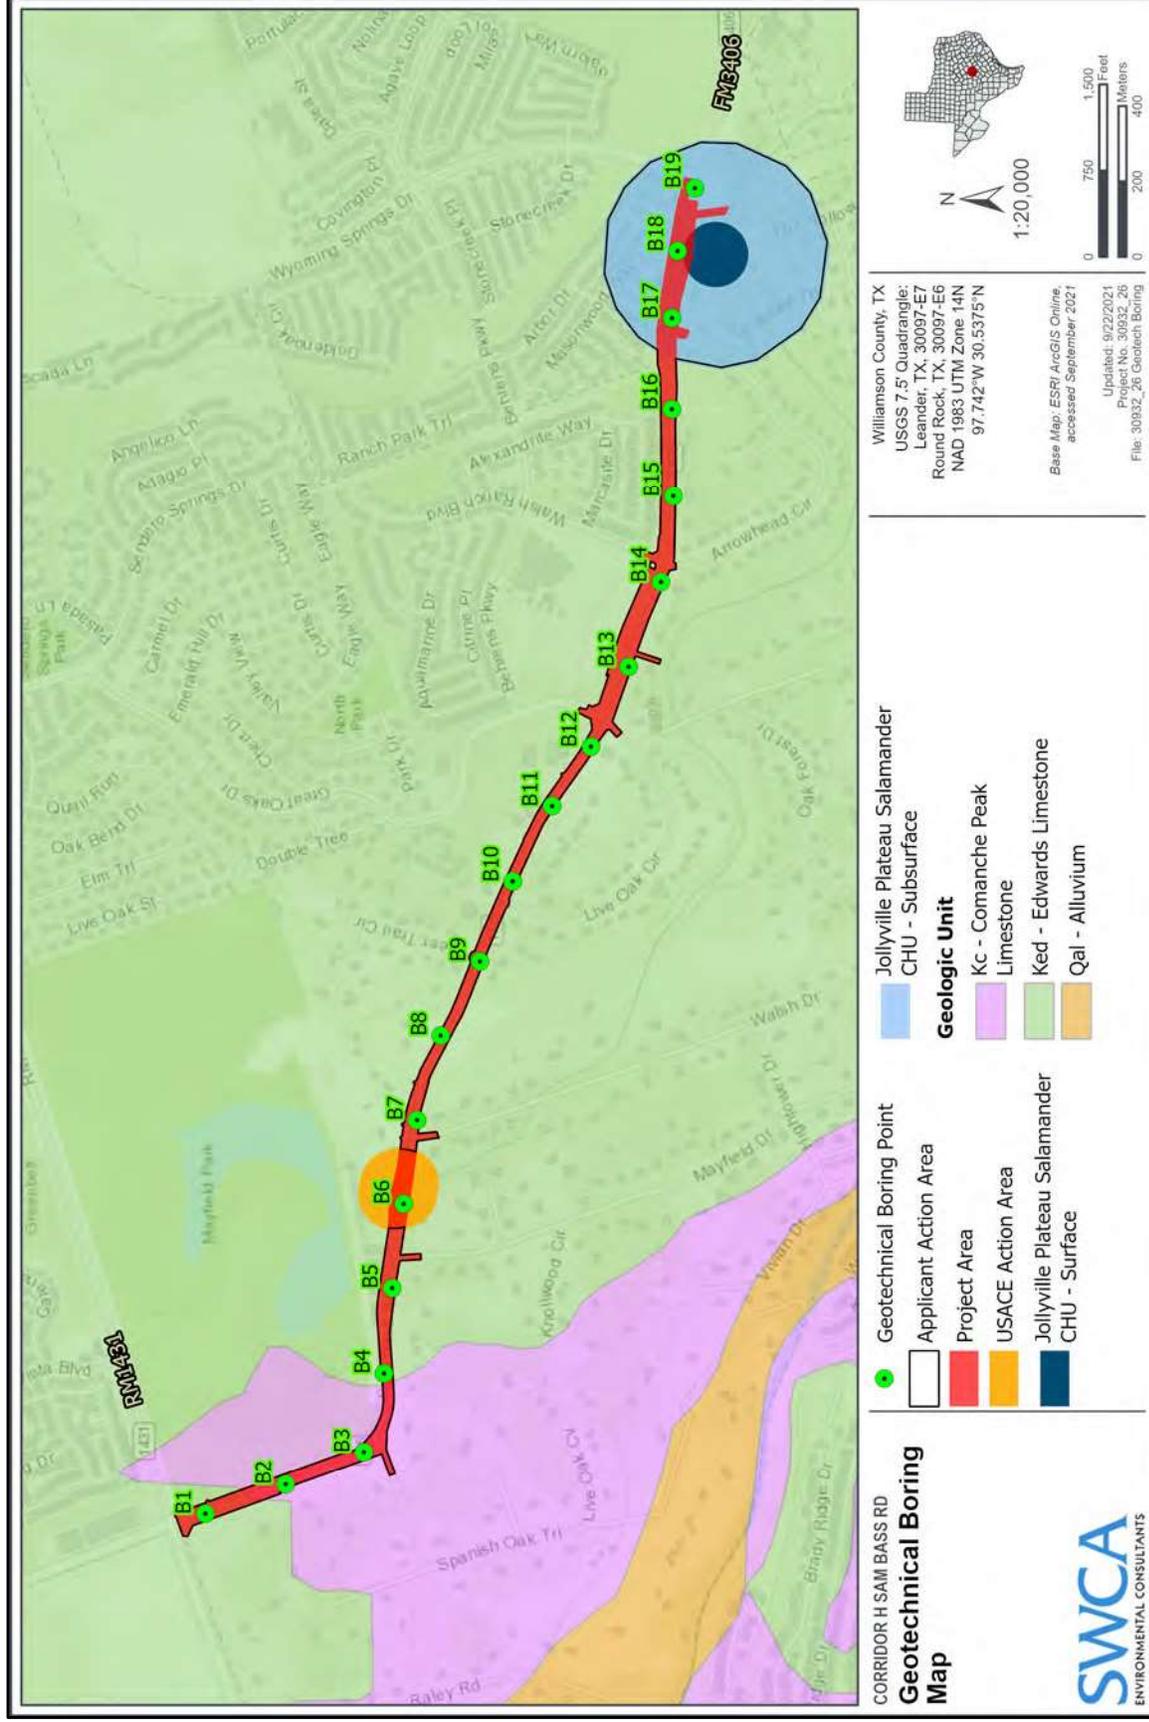
Figure 6. Locations of geotechnical borings.

The elevation of Krienke Spring is approximately 750.0 feet amsl (USGS 2018b). Raba Kistner (2019) drilled 19 geotechnical bores within the project area to evaluate subsurface conditions to 10 feet below grade (Figure 6). Raba Kistner (2019) attempted to bore to 10 feet at each location; however, some bores were unable to penetrate the underlying limestone. Therefore, the bores ranged from 5.5 to 10.0 feet below the surface.

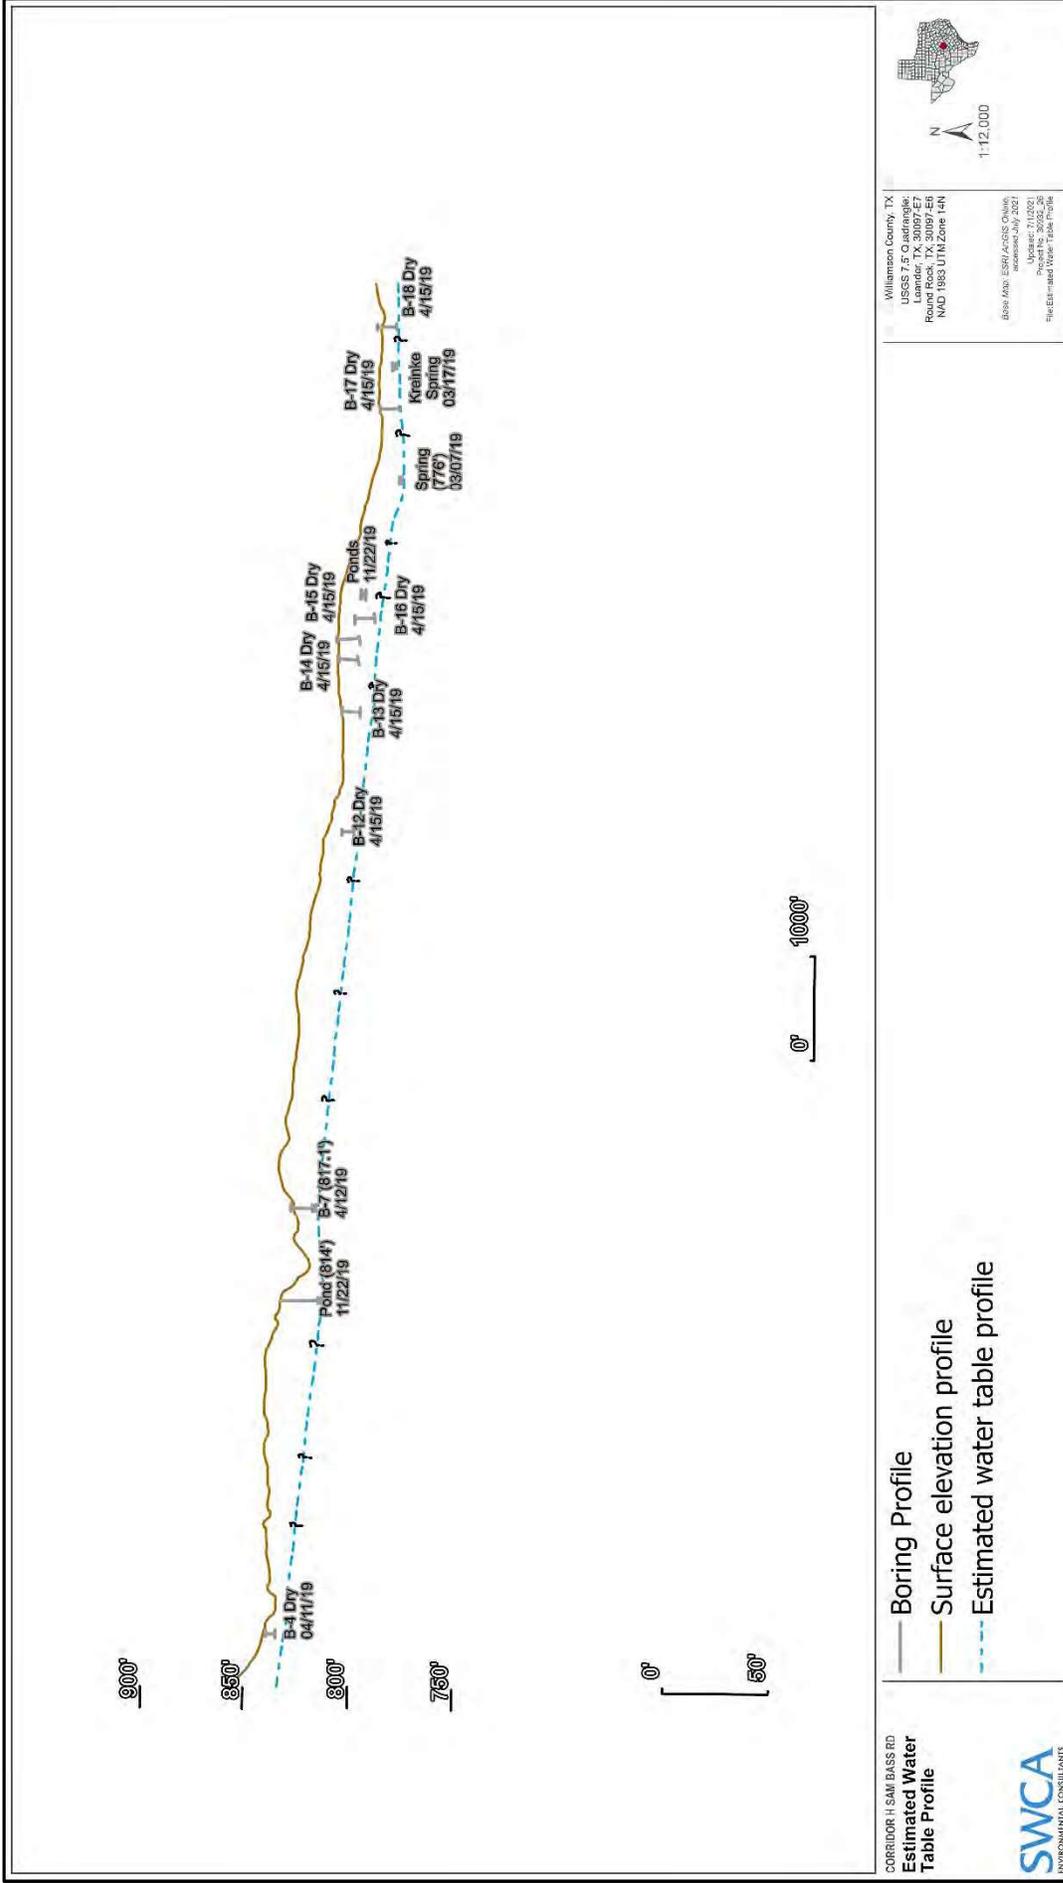
Figure 7. Estimated groundwater profile from borehole B-4 to B-18.

SWCA assumes that the underlying Edwards Aquifer travels along the contact between the Edwards and Comanche Peak Formations in some locations, but that the Edwards Aquifer also likely travel within Edwards Formation conduits in some locations. As such, estimating the location of the Edwards Aquifer in this area is difficult and likely subject to error. However, SWCA estimated Edwards Formation depth and then estimated associated depth to the Edwards Aquifer by drawing lines from the Krienke Spring perpendicular to the roadway profile and plotting a point on the profile at the elevation of the spring, where the assumed depth to the Edwards Aquifer is zero. The impoundments just south of the project area were also assumed to represent the general elevation of the Edwards Aquifer since they appear to be strongly influenced by groundwater. The elevation of the water level in the impoundments may represent the static pressure (and therefore the elevation) of the Edwards Aquifer, which would also represent a zero value for depth to water. Finally, it is possible to plot the elevations of groundwater table elevations measured in Geotech borings. We can then connect the depth of each borehole on the profile with a dashed line to represent the approximate elevation of the water table at these locations or at least estimate the approximate Edwards Aquifer depth as it travels within the subterranean matrix, likely along a bumpy path towards Krienke Spring. Figure 7 depicts the estimated depth of the Edwards Aquifer beneath the project area, which may range from 814 to 750 feet amsl or approximately 8 to 25 feet below the surface.

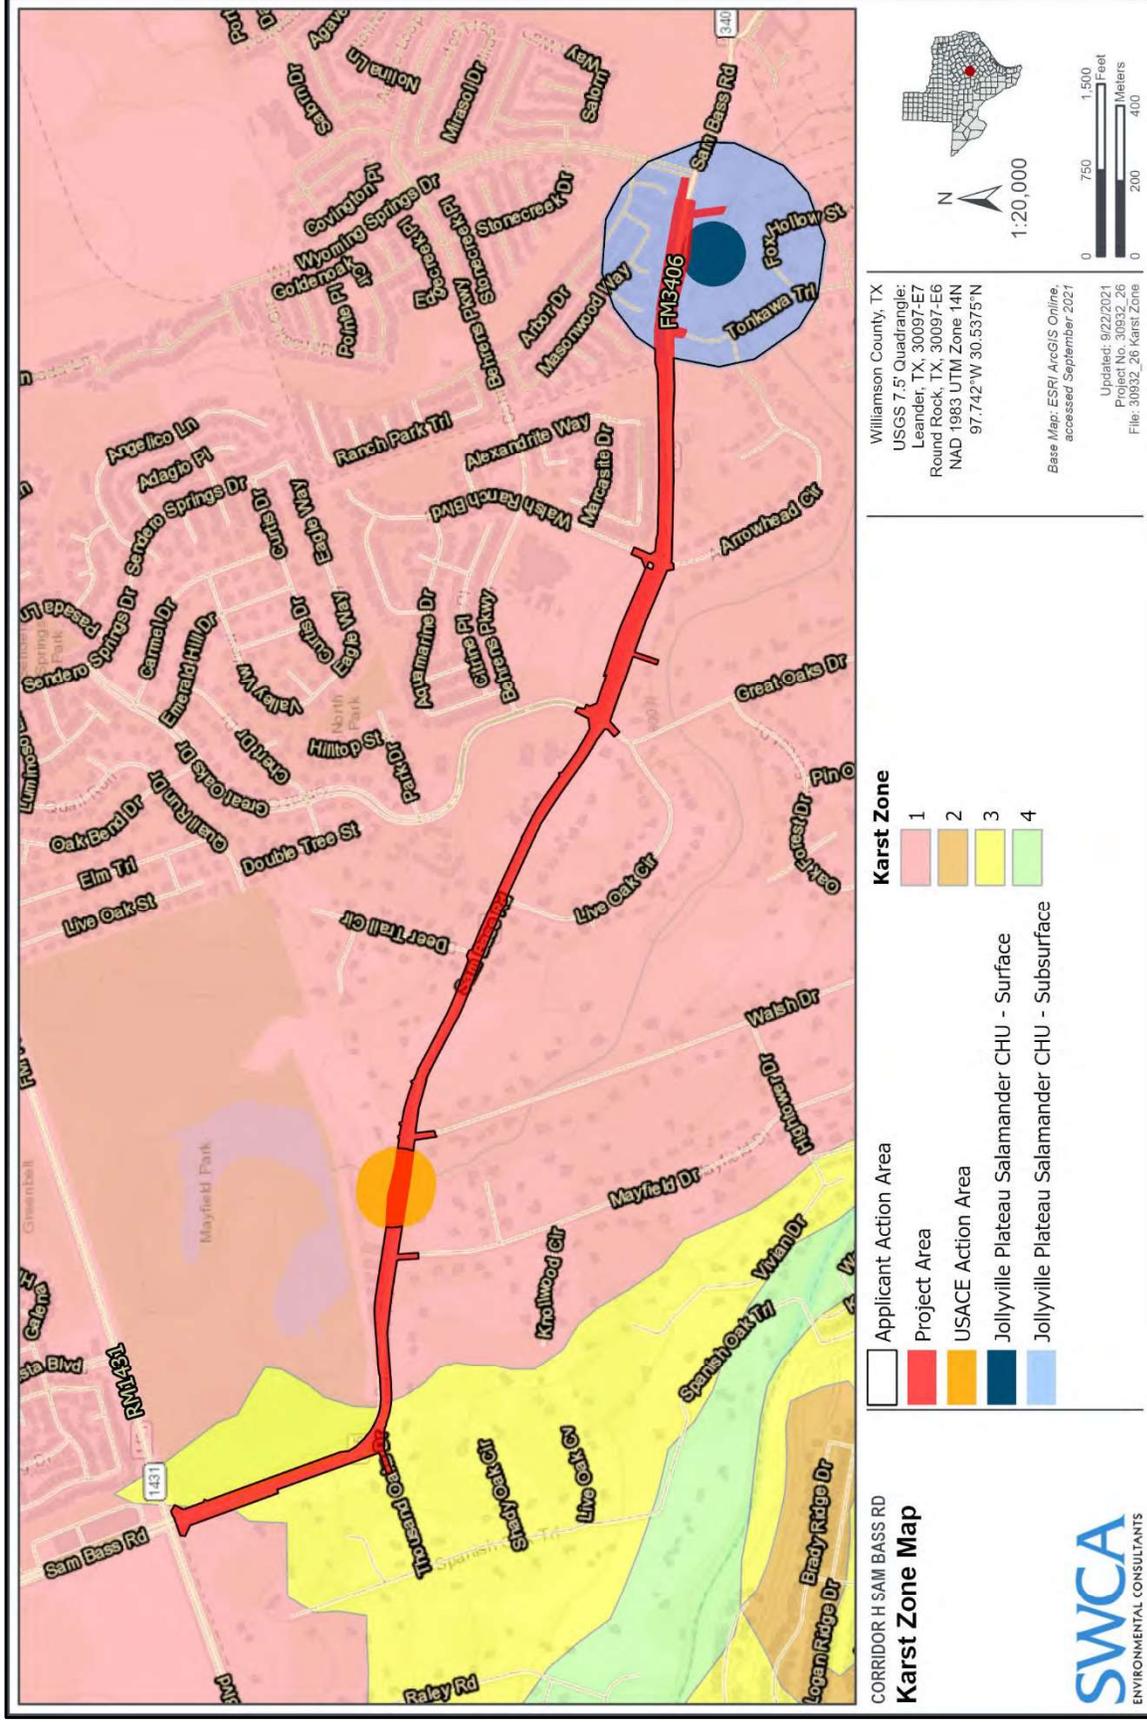
Figure 11. Mapped invertebrate karst zones (Veni and Martinez 2007).

Due to their cryptic nature and inhabitation within relatively inaccessible habitat, overall population estimates and distribution profiles are not currently available. Therefore, a population snapshot or estimate within the Action Areas is not possible. At this time, it is thought the species inhabits at least some portion of the three-dimensional karst matrix within Karst Zone 1.

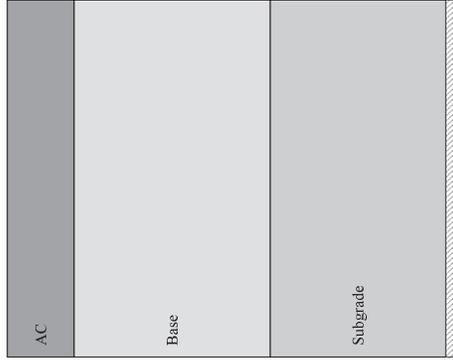
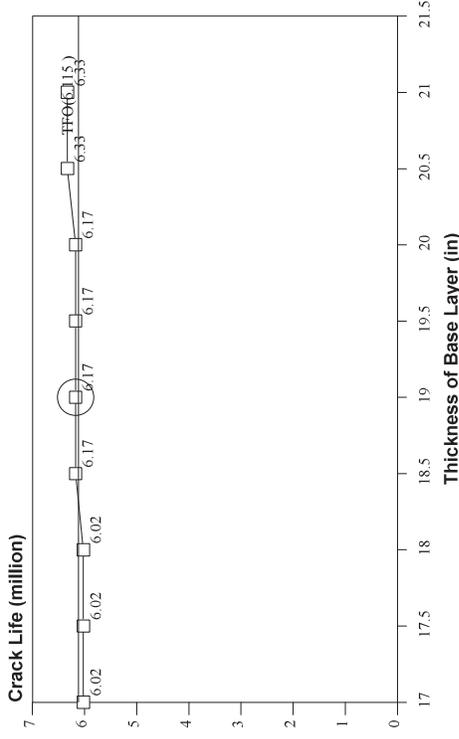
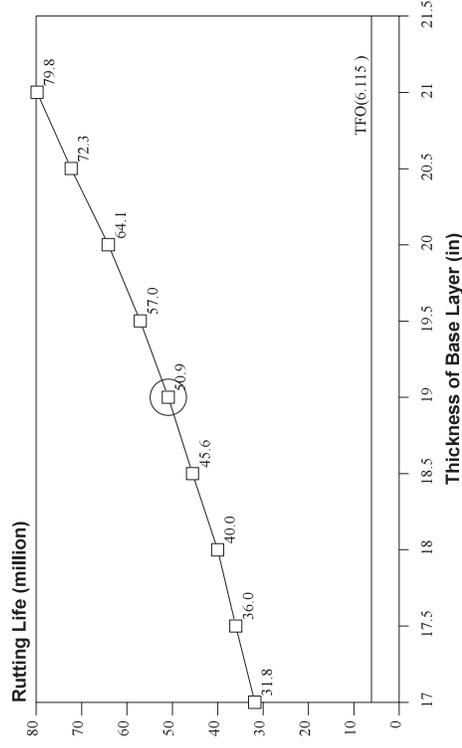
Thickness (inches)	Modulus (ksi)	Poisson's Ratio	Material Name
6.50	500.00	0.35	ASPHI CONC PVMT
19.00	40.00	0.35	FLEXIBLE BASE
200.00	13.00	0.35	SUBGRADE(200)

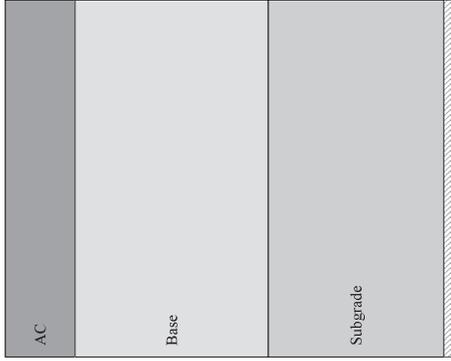
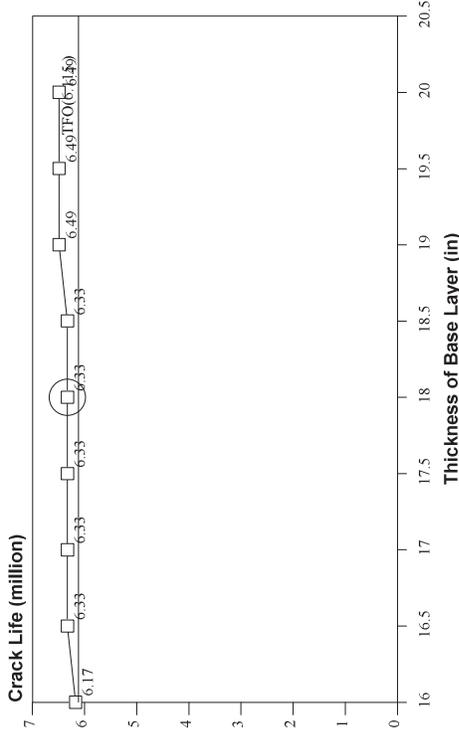
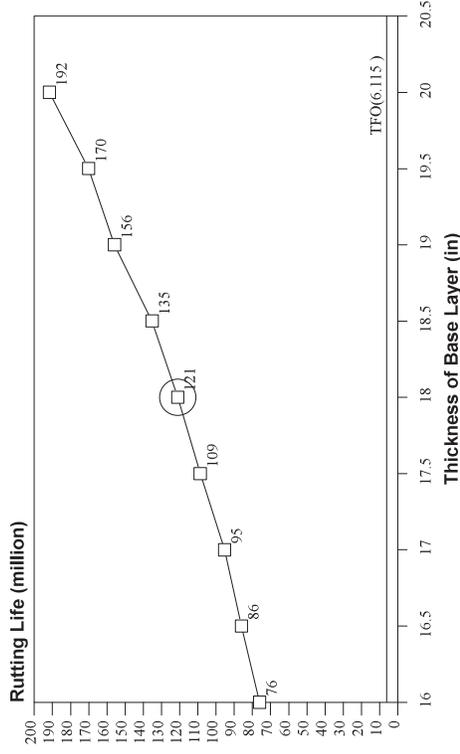
Thickness (inches)	Modulus (ksi)	Poisson's Ratio	Material Name
6.50	500.00	0.35	ASPH CONC PVMT
18.00	40.00	0.35	FLEXIBLE BASE
200.00	20.00	0.35	SUBGRADE(200)

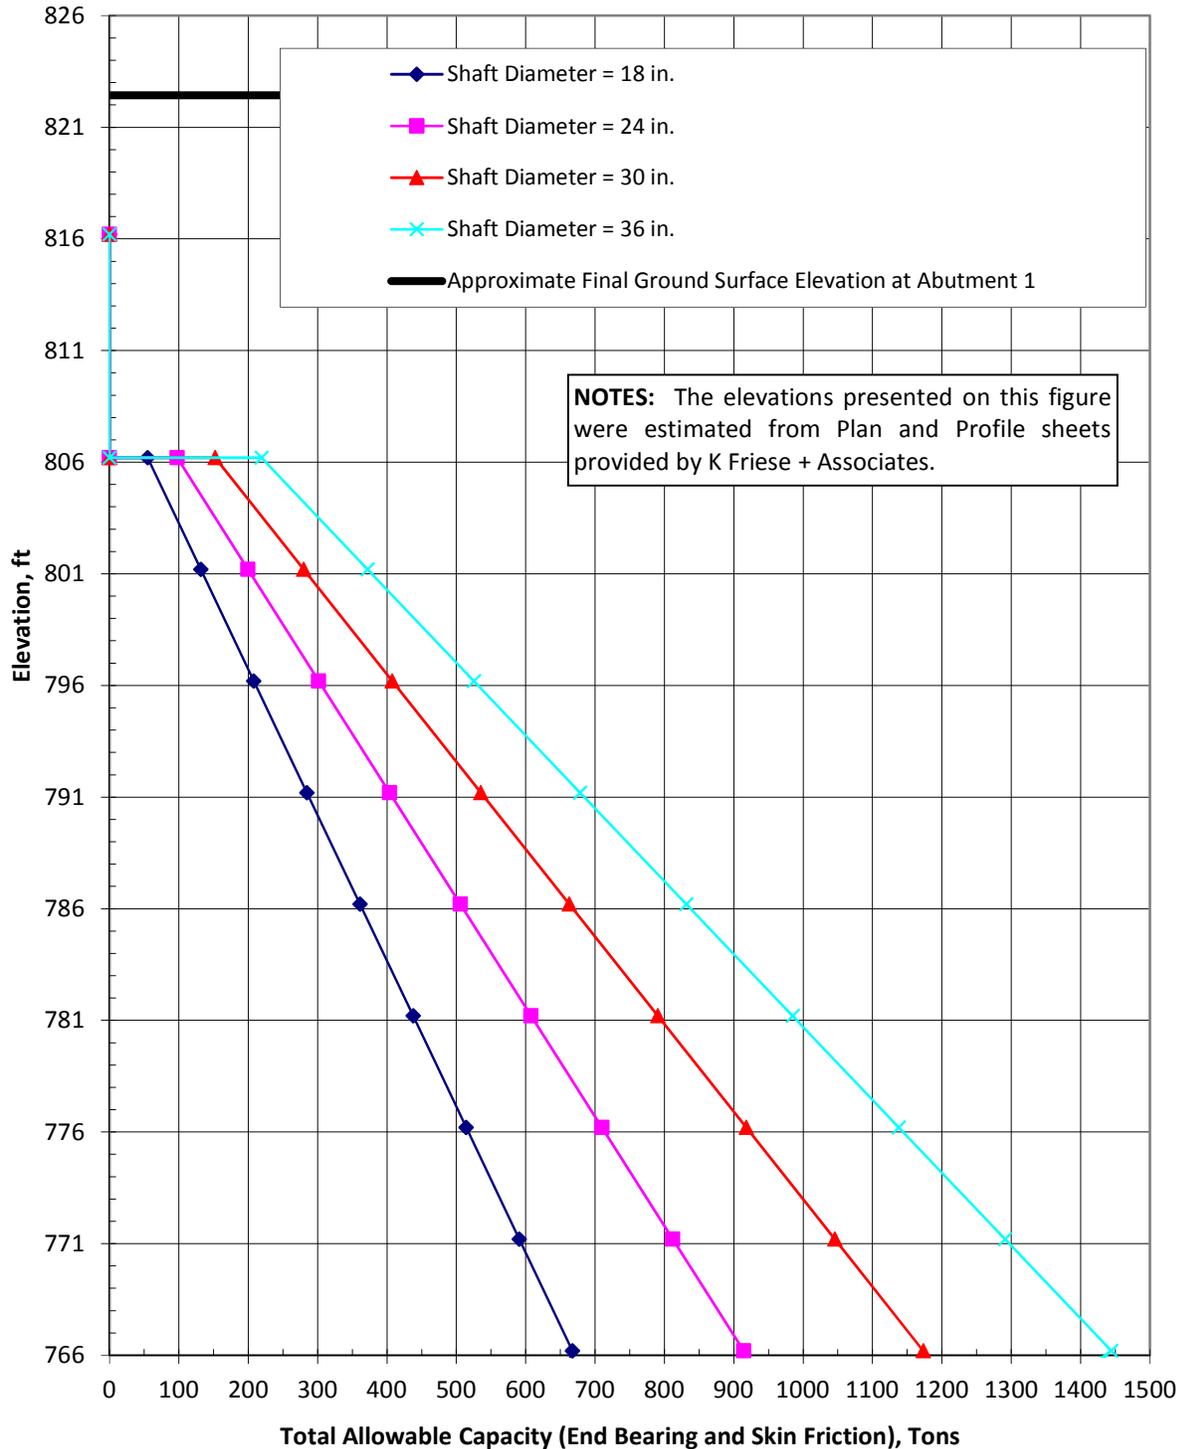
Abutment 1

DRILLED PIER AXIAL CAPACITY CURVE

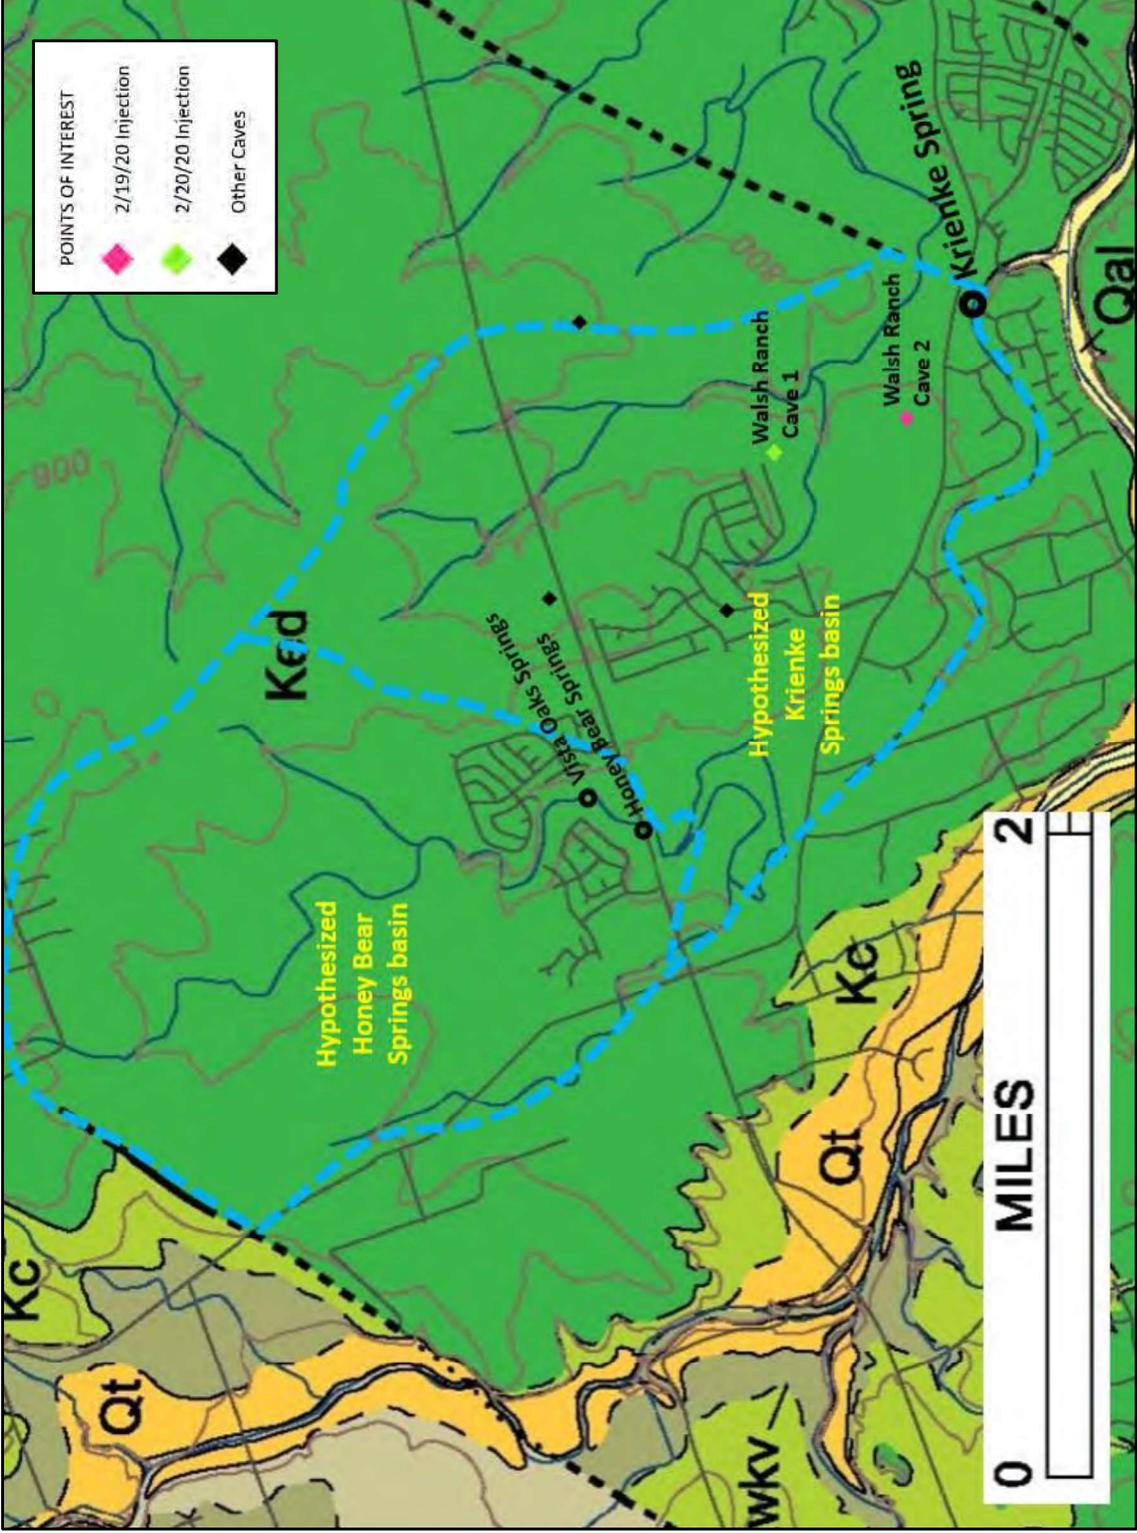
Figure 1. Presumed catchment basin for Krienke Spring south of Honey Bear and Vista Oaks Springs. Diamond shapes represent nearby caves or potential recharge features. The two closest known caves were selected for dye injection.

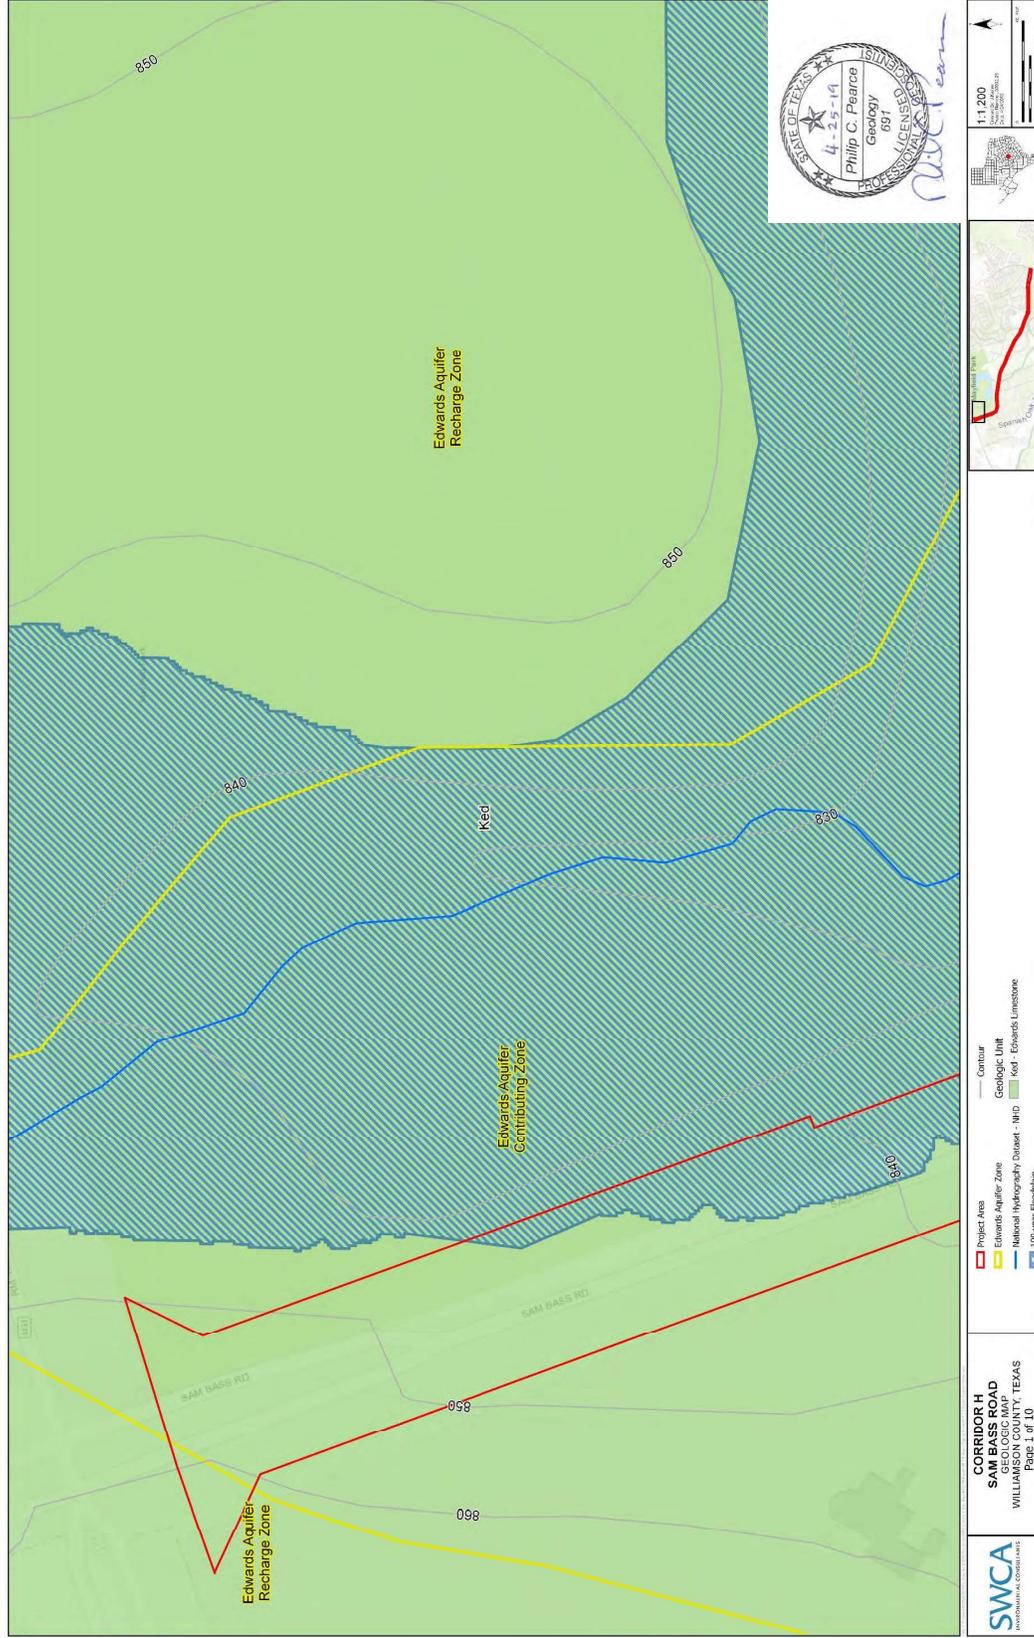
Figure 2a. Project Area geologic map (1 of 10)

Recharge into the Edwards Aquifer primarily occurs in areas where the Edwards Group and Georgetown Formation are exposed at the surface. Most recharge is from direct infiltration via precipitation and streamflow loss. Recharge occurs predominantly along secondary porosity features such as faults, fractures, and karst features (caves, solution cavities, sinkholes, etc.). Karst features are commonly formed along joints, fractures, and bedding plane surfaces in the Edwards Group and Georgetown Formation. Water that recharges the Edwards Aquifer in the vicinity of the project site commonly discharges near the contact between the Edwards Limestone and underlying Comanche Peak Formation.
