U.S. Army Corps of Engineers (USACE) Fort Worth District

Nationwide Permit (NWP) Pre-Construction Notification (PCN) Form

Williamson County Corridor H - Sam Bass Road

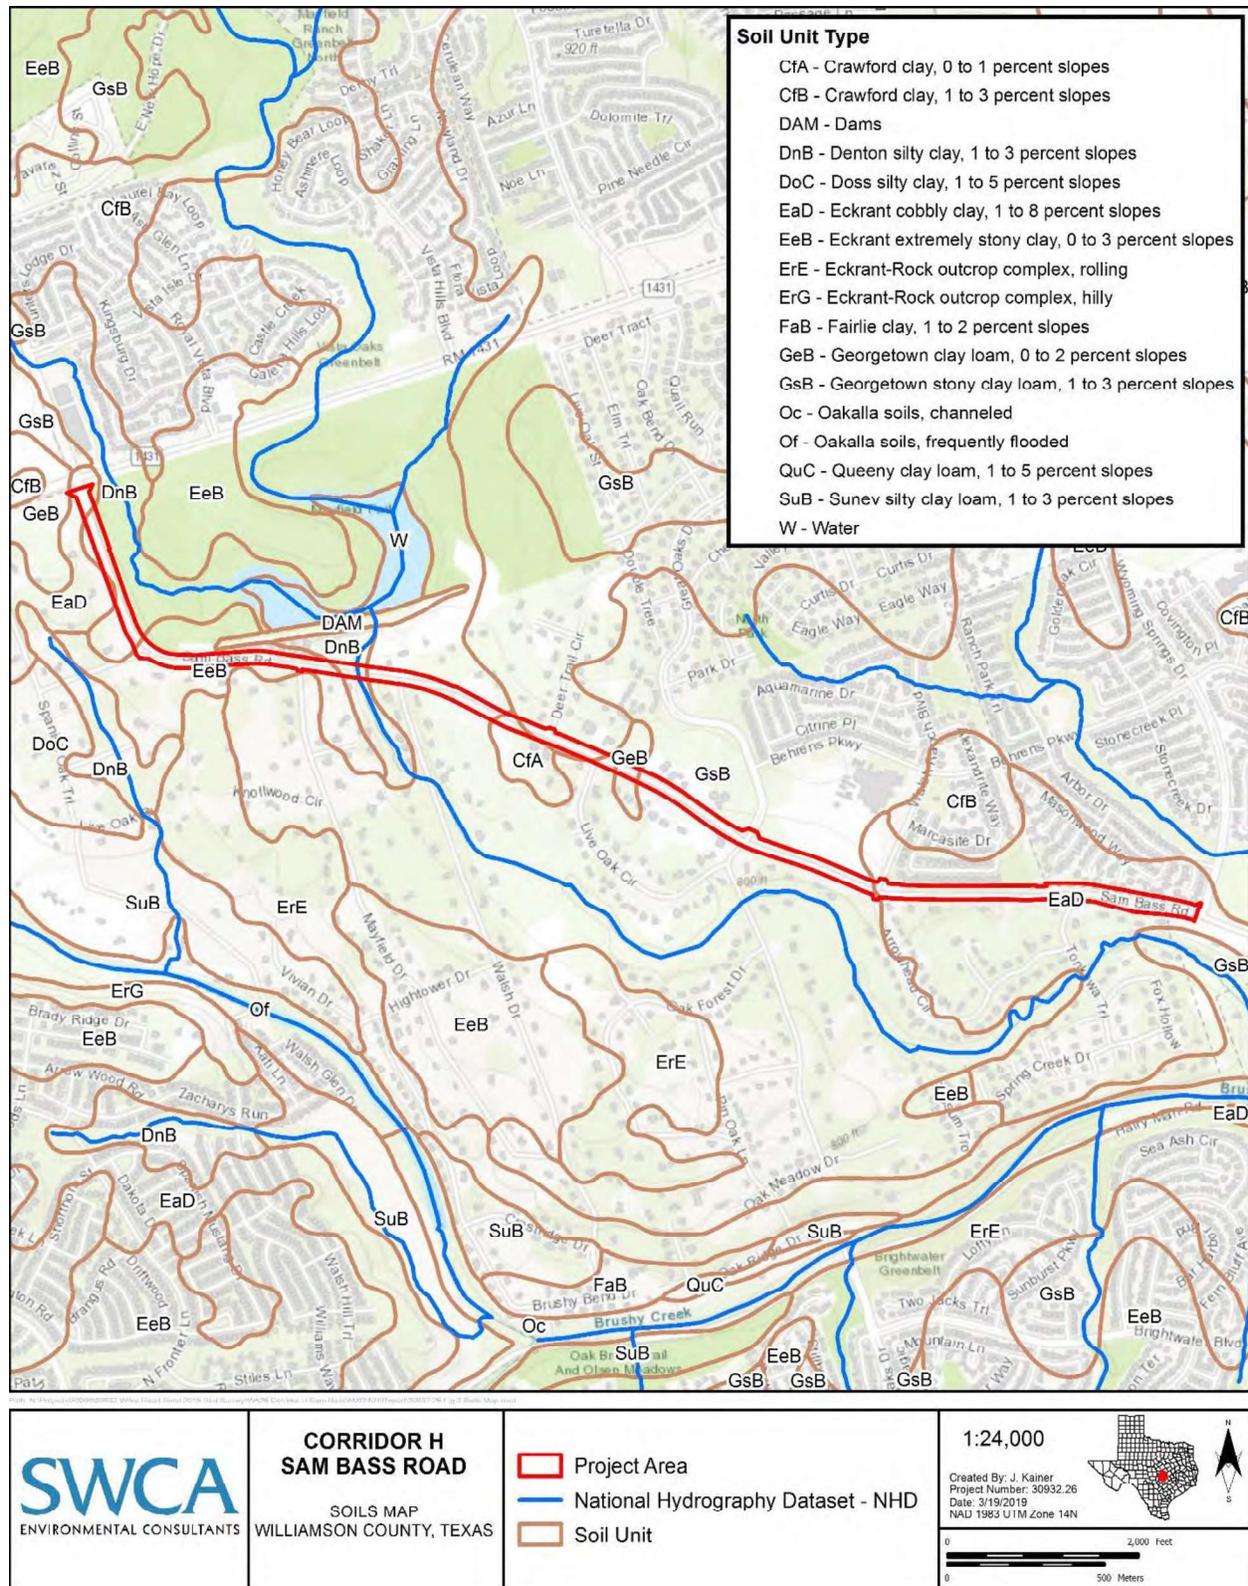
Figure 3. Project Area soils map (Natural Resources Conservation Service 2018).

* Group D – Soils had very slow infiltration rates when thoroughly wetted and exhibit the highest potential for runoff.

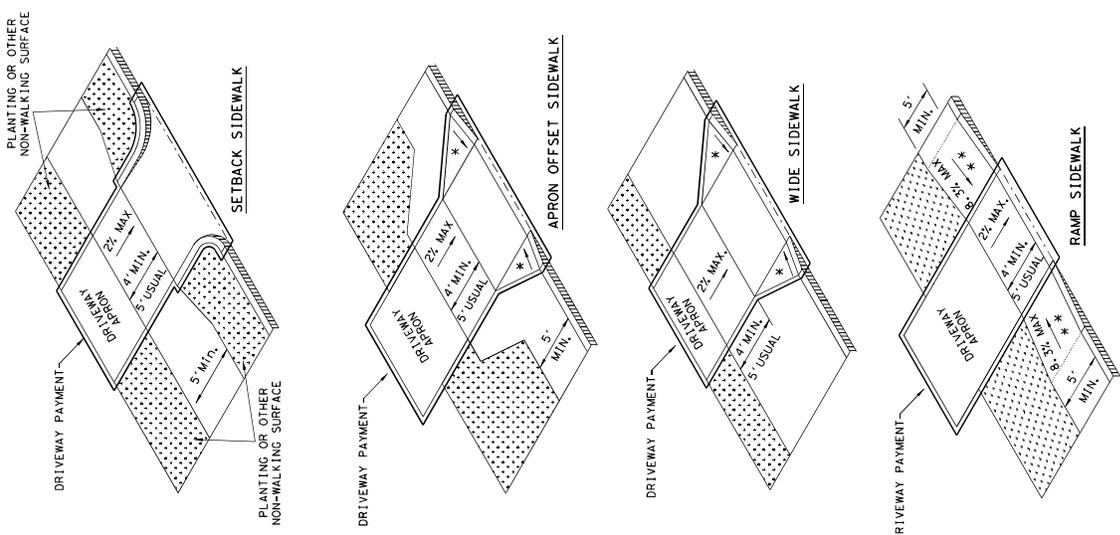
SIDEWALK TREATMENT AT DRIVEWAYS

- NOTES:
- * WHERE DRIVEWAYS CROSS THE PEDESTRIAN ROUTE, SIDES SHALL BE FLARED AT 10% MAX. SLOPE.
 - ** IF CURB HEIGHT IS GREATER THAN 6 INCHES, USE GRADE LESS THAN OR EQUAL TO 5% HANDRAIL AND DETECTABLE WARNING ARE NOT REQUIRED.
