Revised Project Proposal

Carpenter Brothers House Renovation to Historical Structure Application (REVISED)

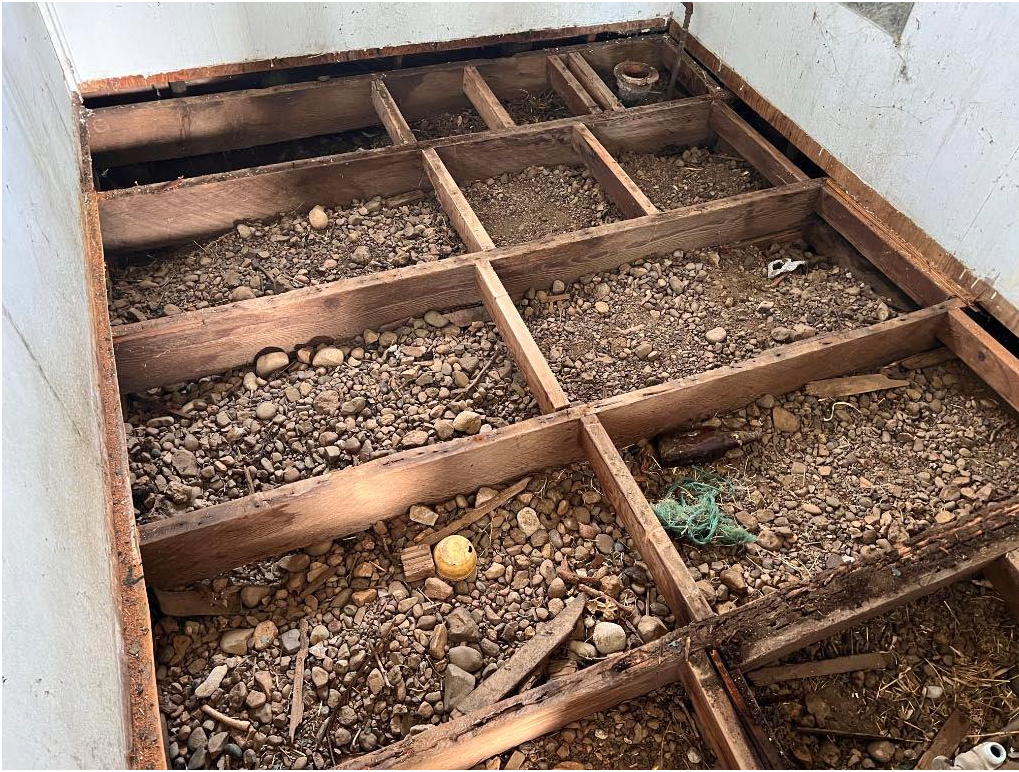
While it was clear that there was no concrete foundation, I had assumed that it was built on piers with girders and floor joists. Wrong. I removed the subfloor in the existing bathroom investigate. Figure 1 below shows the results.

1. All floor joints are 2x10 full dimensional redwood.
2. They are supported by approximately 2 inches of gravel on soil.
3. The cross braces were added during the 1960 renovation because they are 2x4 dimensional (1.5x3.5). My Dad did this, probably to stiffen the floor joists from twisting.
4. Floor joists run north/south.

Figure 1: Bathroom floor joists, overview

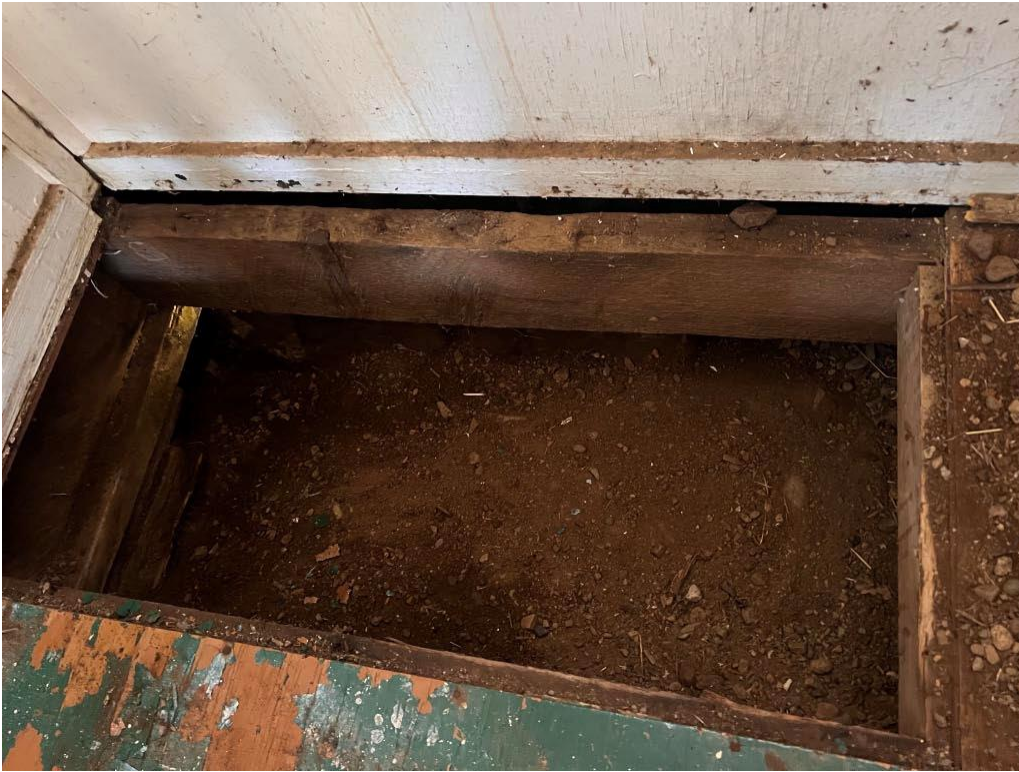
I excavated the northeast bay so I could examine the outside foundation structure. See Figure 2.

Figure 2: Excavated bay showing eastern most floor joist

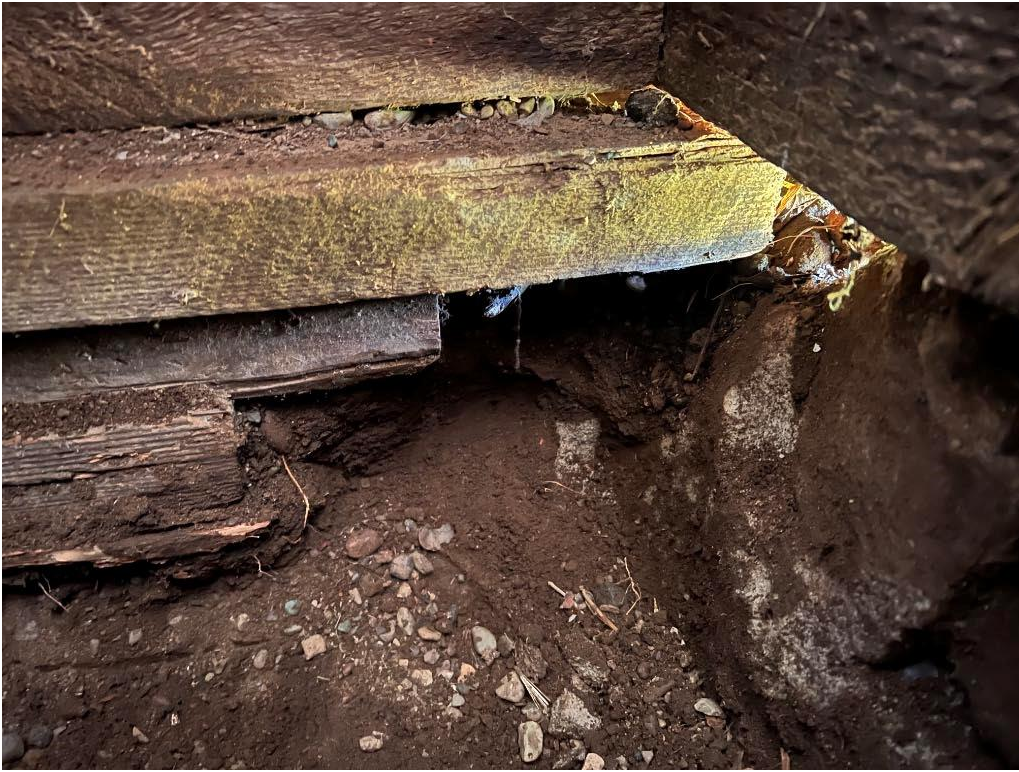
Figure 3 shows a “girder” that runs east-west under the floor joists. This is a 2x4 (full dimensional). You can see various blocks of wood supporting it on the soil. It is supported on the pier for about 1”. Note that this was all covered up by the gravel and soil fill.

Figure 3: Start of girder

What is equally disturbing is that there is direct soil to timber contact throughout. The only reason there has been less deterioration is because all timbers were redwood, which was widely (and cheaply) available during the 1850's.

However, the foundation construction and its current condition is not suitable for any modern day renovation. It is for this reason that we are now requesting a demolition permit prior to reconstruction.

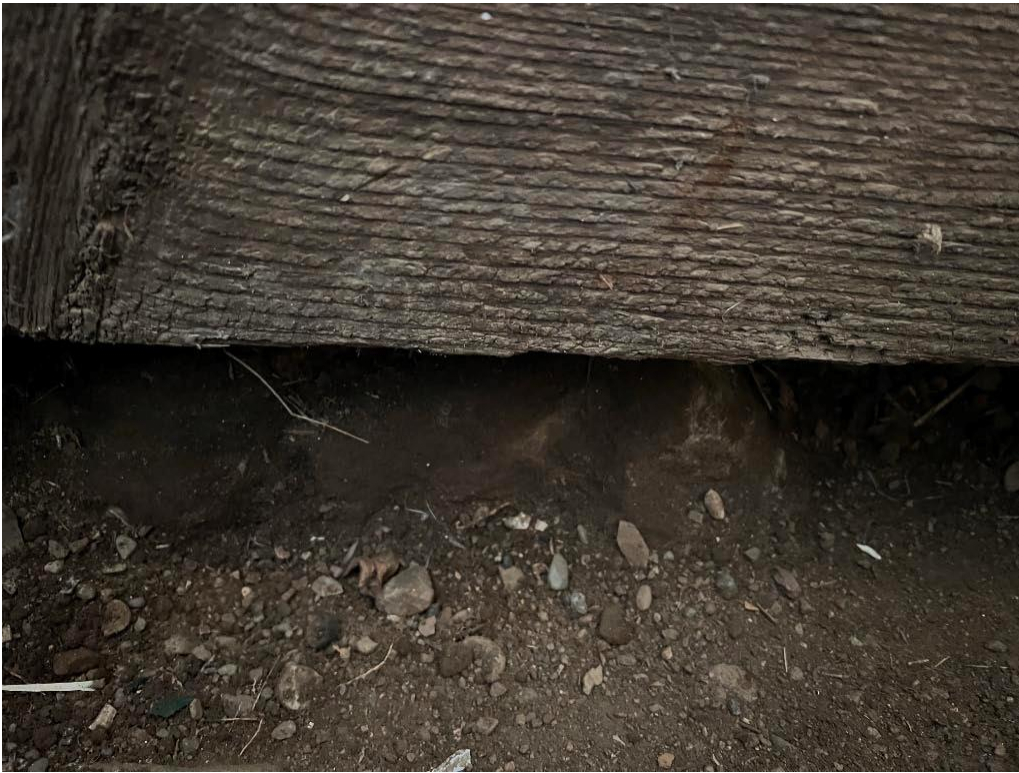
Figure 4 shows one of the “piers” supporting the outside wall sill plate. The pier is just a sandstone block placed on the soil. The pier is approximately 24 inches in length.

Figure 4: Sandstone support of eastern sill plate

There must have been a source of sandstone nearby and it was a good choice for a cottage "built on the cheap" because the Carpenter Bros could easily cut the stone to make a flat surface to support the sill plates, without having to use rock and mortar. The sandstone piers were not directly exposed to weather, but soil moisture has taken a toll. During the excavation, my shovel grazed the pier and a chip crumbled off.

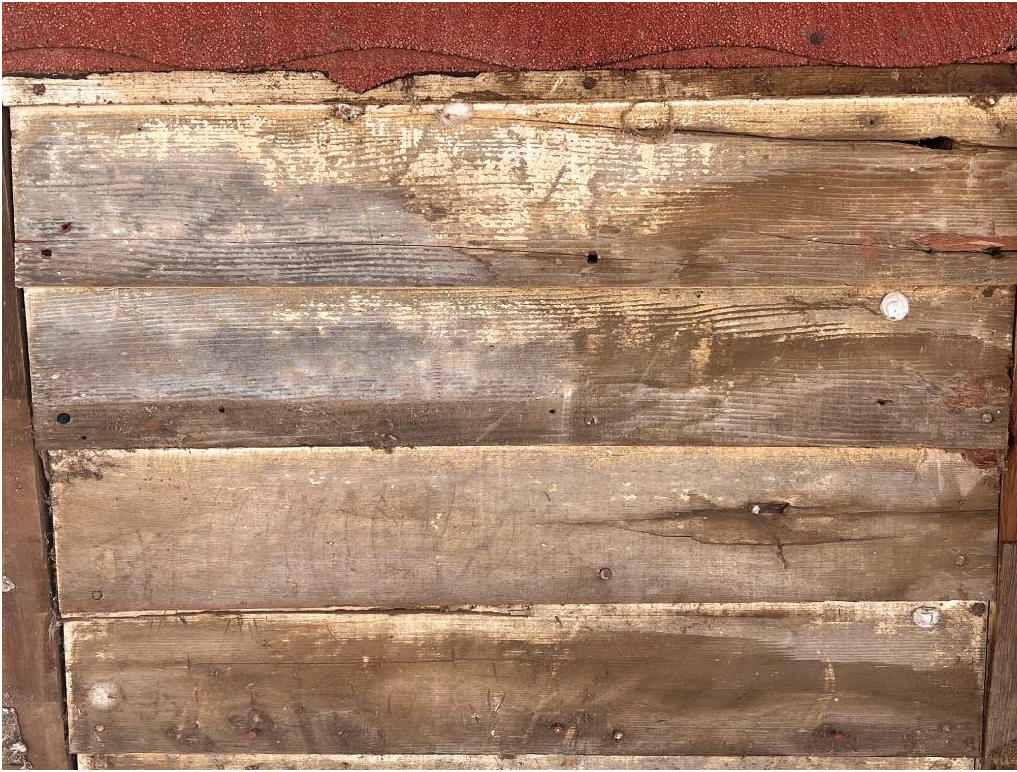
The original siding was 1/2" redwood shiplap. This was discovered when I removed the two layers of siding nailed on top of it. Figure 5 below illustrates the original shiplap. If you look closely at the boards, the raised grain is similar to the proposed Hardie Plank siding, which we intend to use for its durability and fire protection.

Figure 5: Exterior redwood shiplap siding

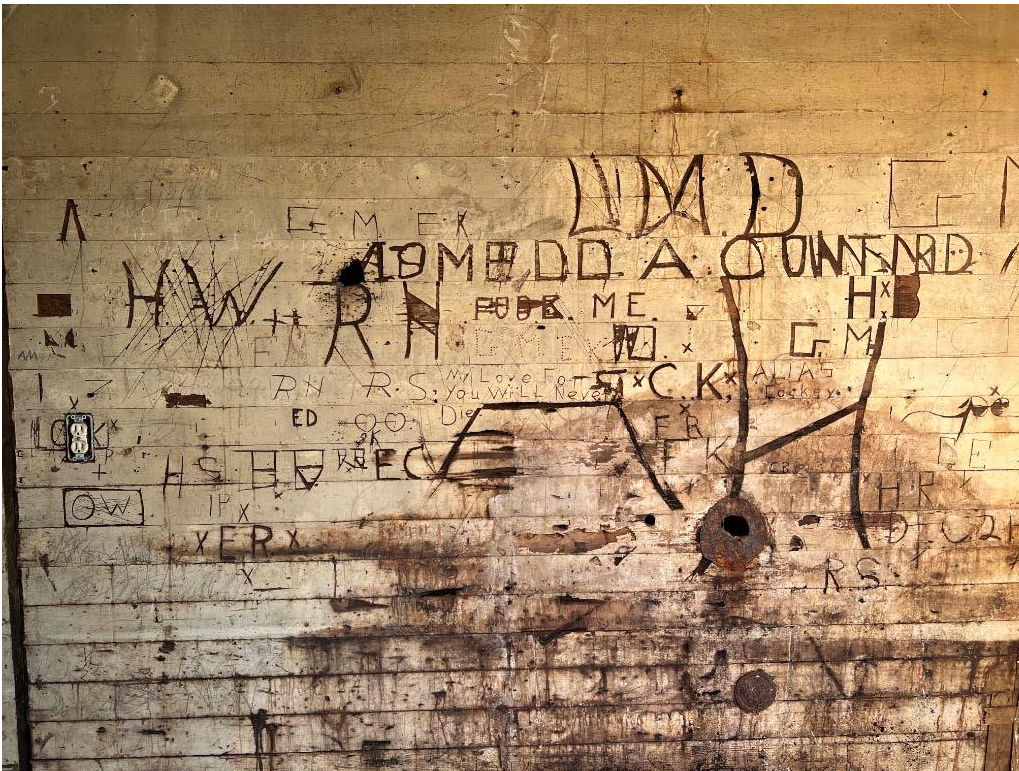
Figure 8: Love notes carved in wall

Finally, while investigating the structural elements of the house, I removed the plywood siding my Dad and I put up in 1960, and was astonished to find one wall filled with love-notes, probably by high school sweethearts around 1915. An example of this can be seen in Figure 8. Right in the middle of the Figure you can make out "RH + RS My Love For You Will Never Die"! The wall is filled with other initials and hearts and arrows. Several of the writings refer to 1915.

All this reinforces our belief that this house has had many lifecycles. Some inhabited, some not. We're not sure what we will do with these wall notes, but they impress on us that this historical cottage has a long and interesting history, worth remembering and documenting.
