From: Hannah Houraira <hourairahannah@gmail.com>
Sent: Monday, January 12, 2026 3:08 PM
To: Clerkoftheboard; Angel Barajas
Subject: County Road 41 - #35 on the agenda for January 13, 2026
Attachments: Landslide progression July 2023 - Jan 2026v2 (1).pdf

Landslide Progression and Ongoing Slope Instability
(July 2023 – January 2026)

Ongoing Landslide Progression and Infrastructure Risk (July 2023 – January 2026)

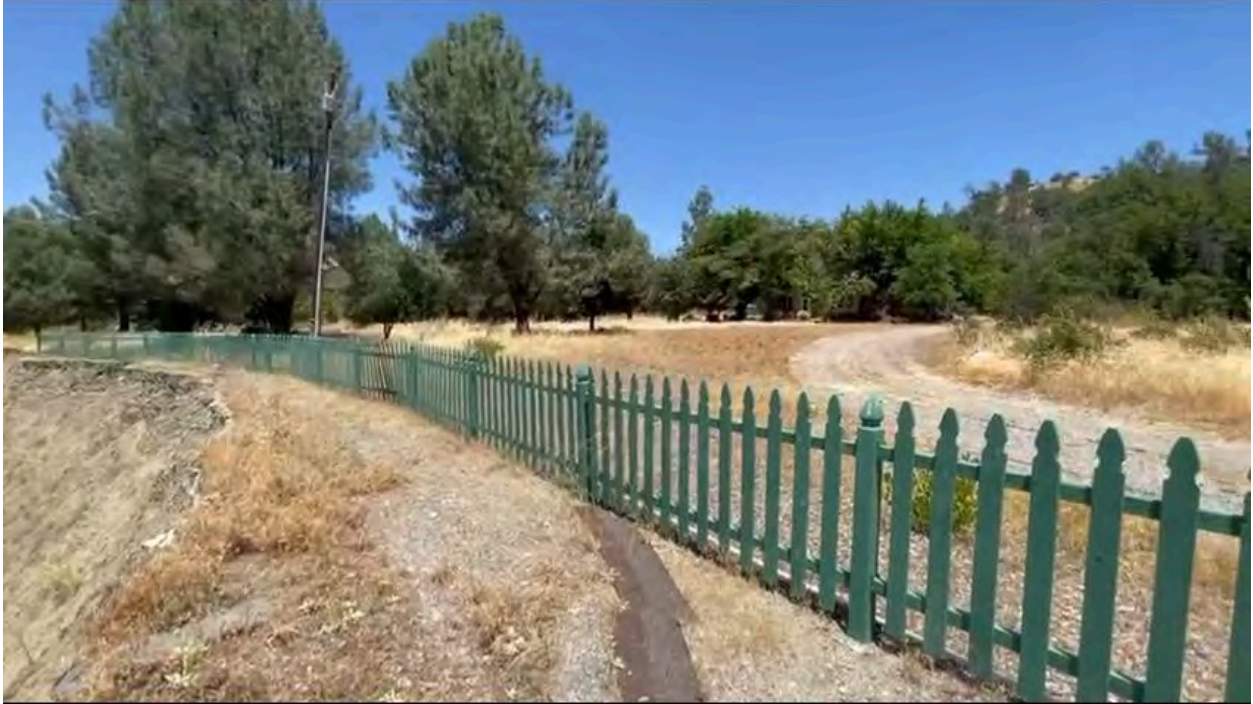
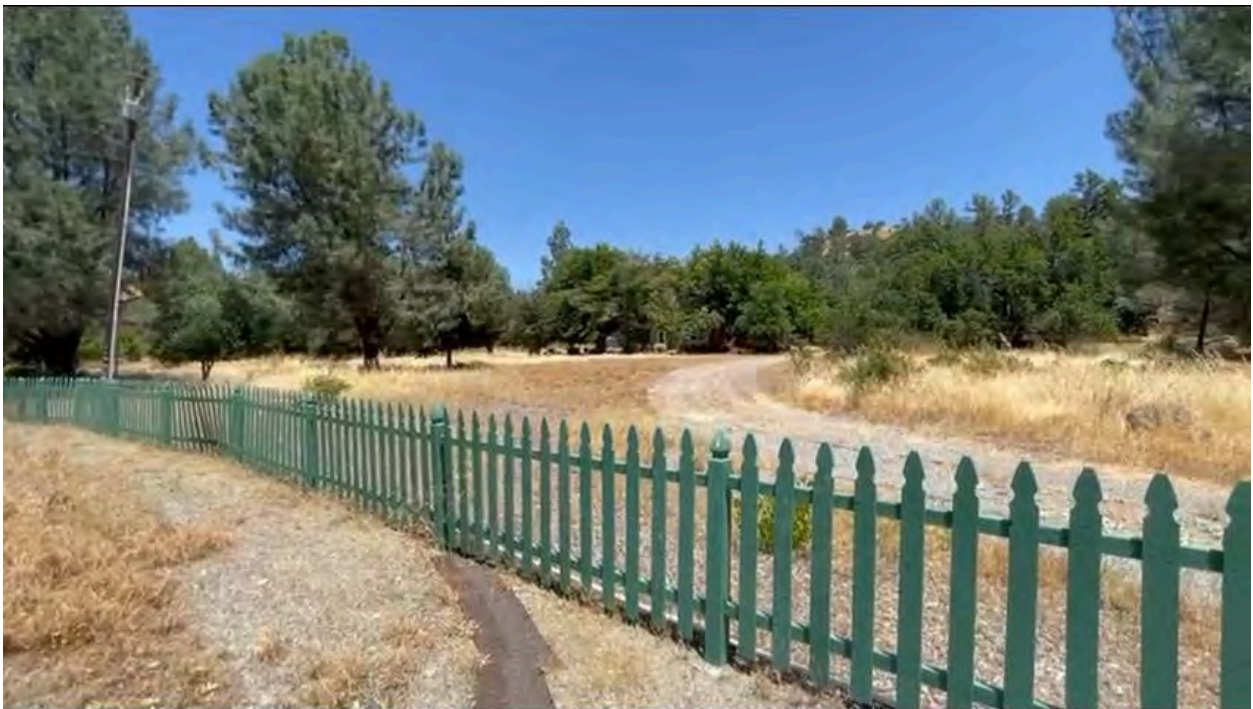
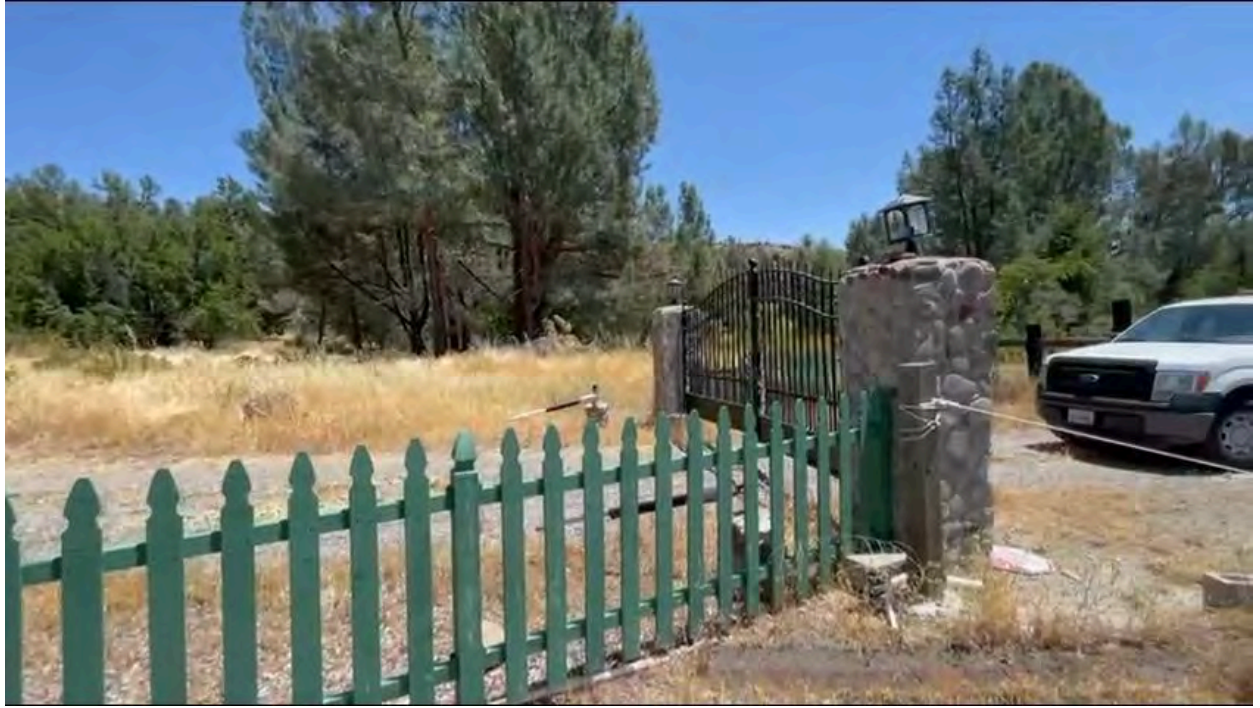
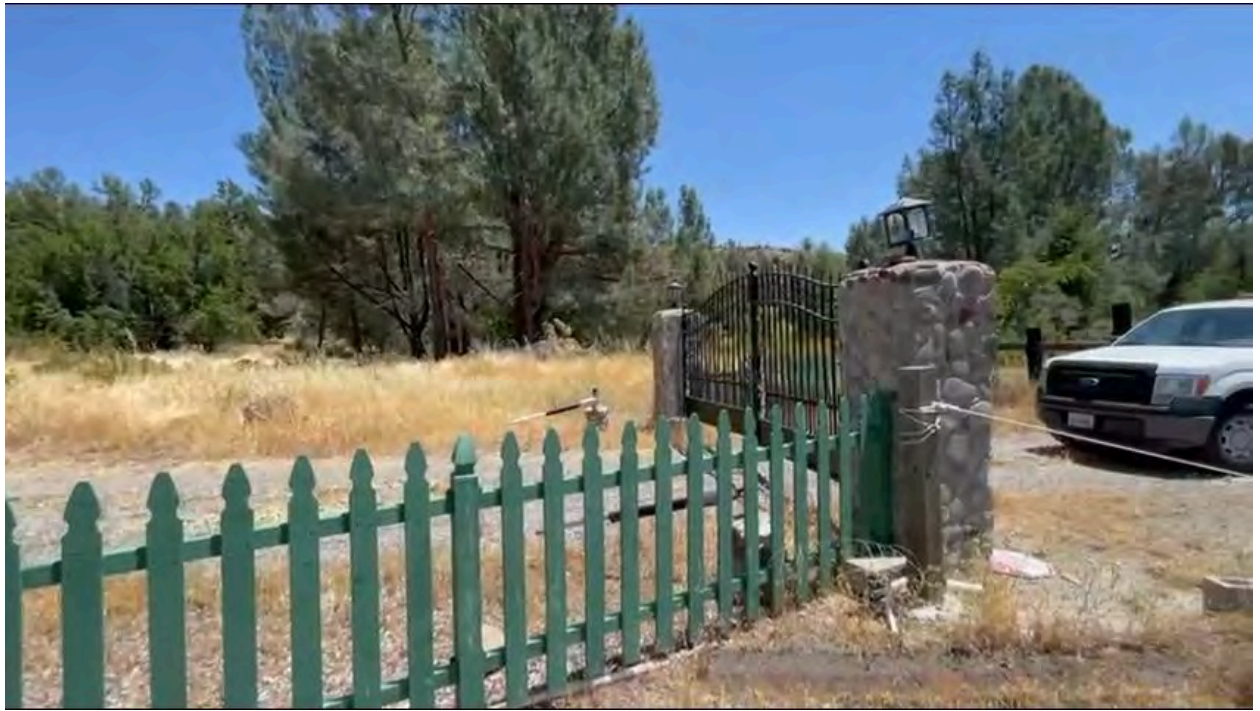
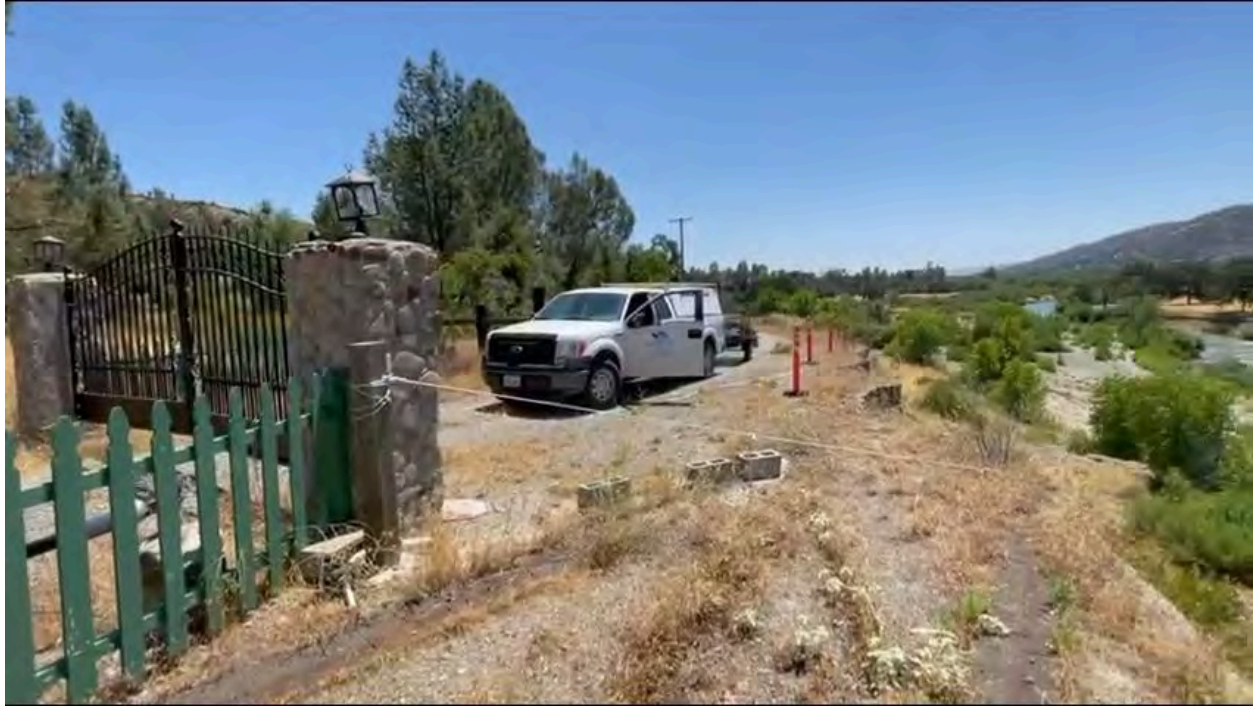
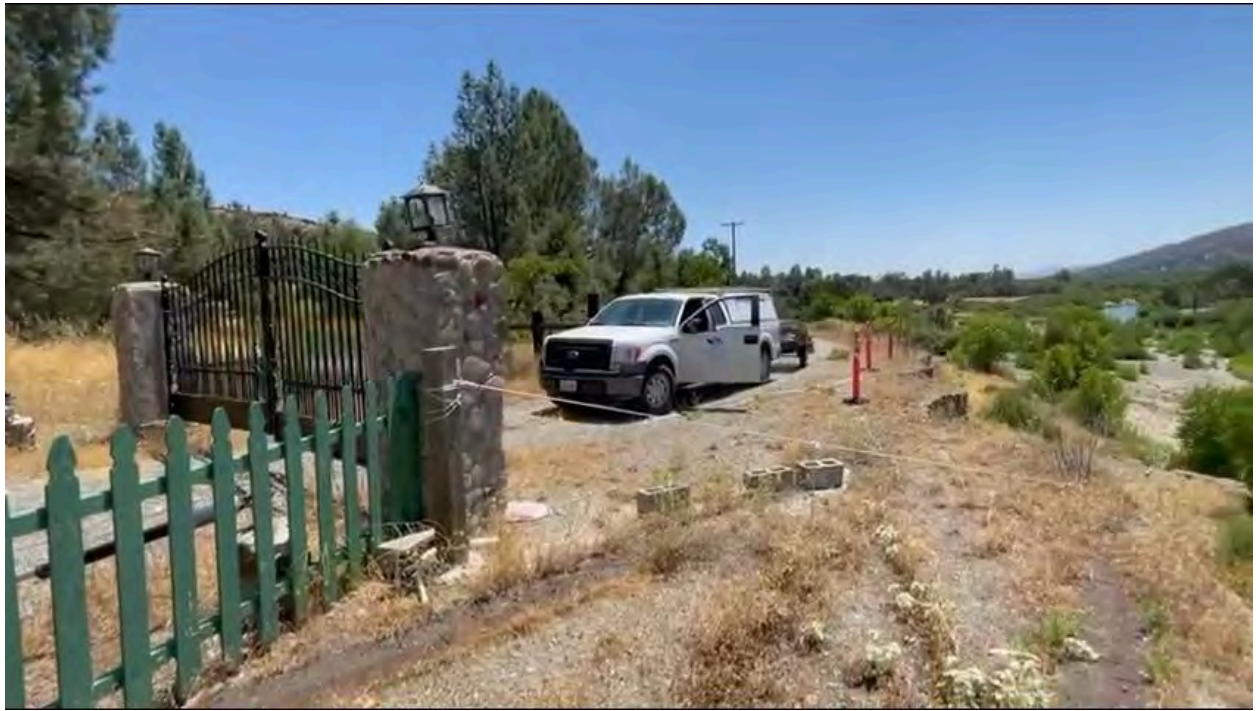
July 2023 - notice the full fence and driveway with 2 pillars and gate doors

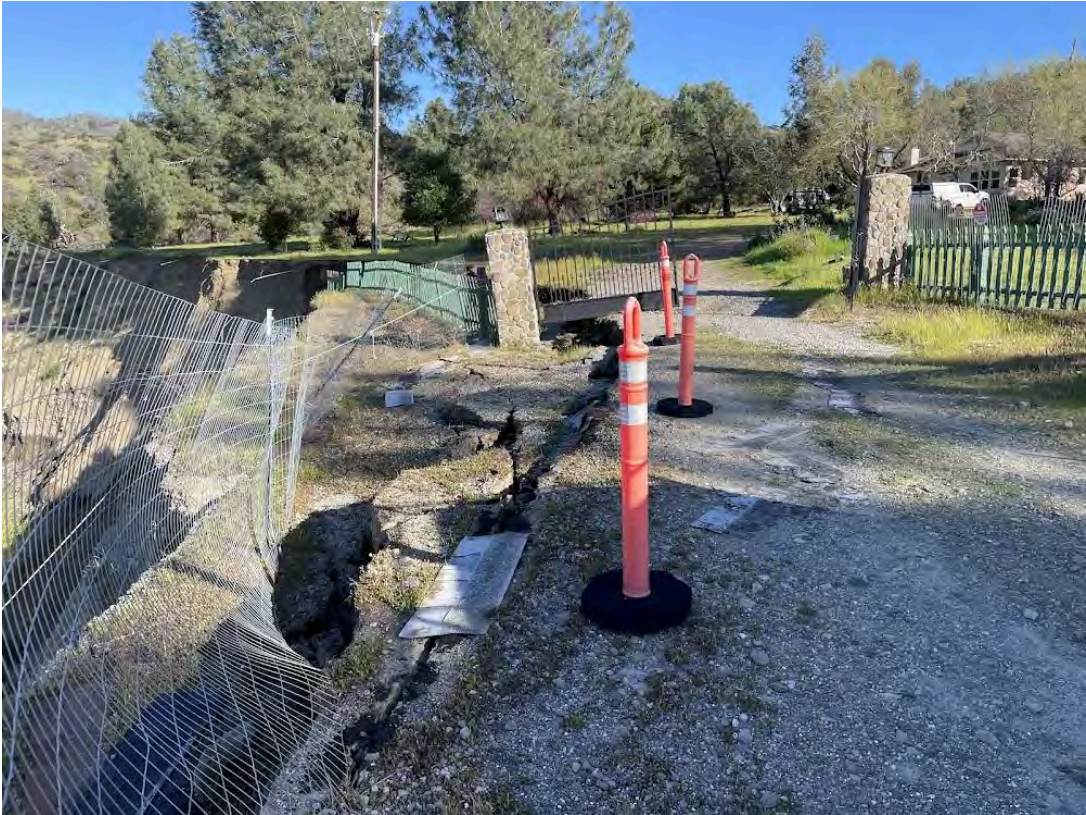
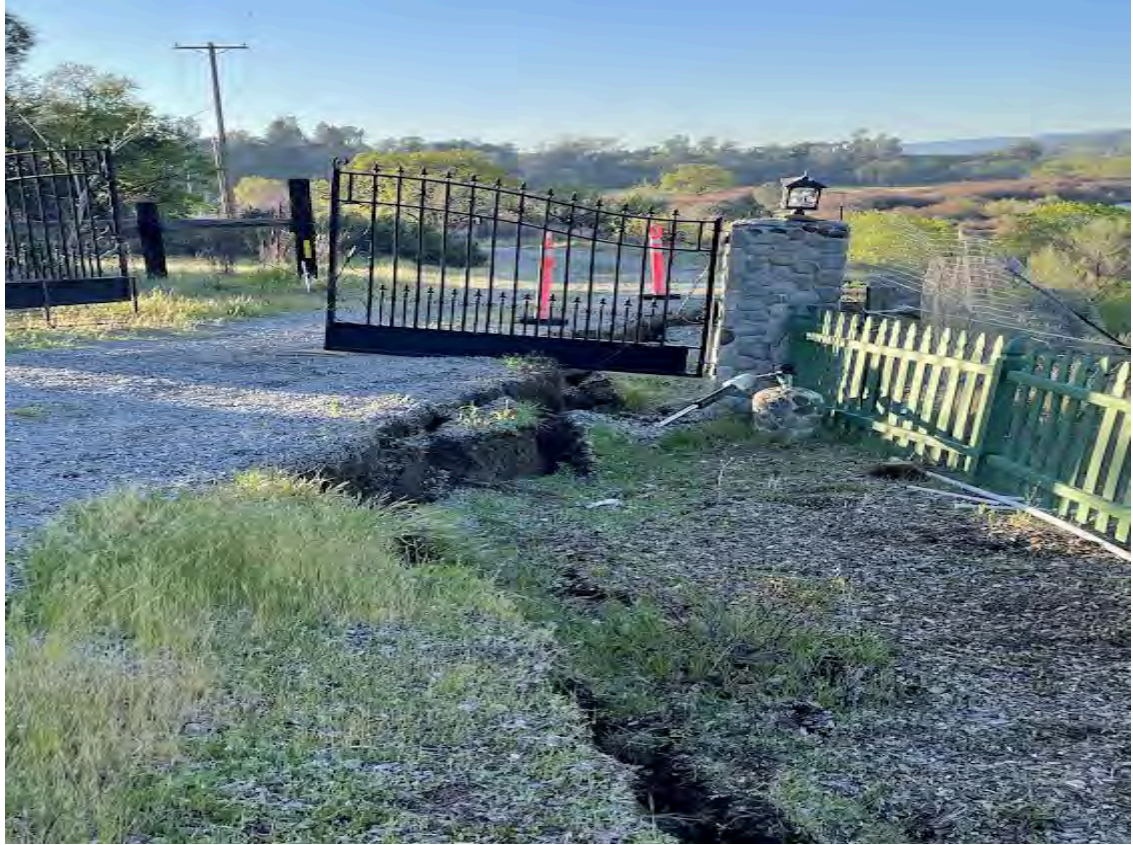
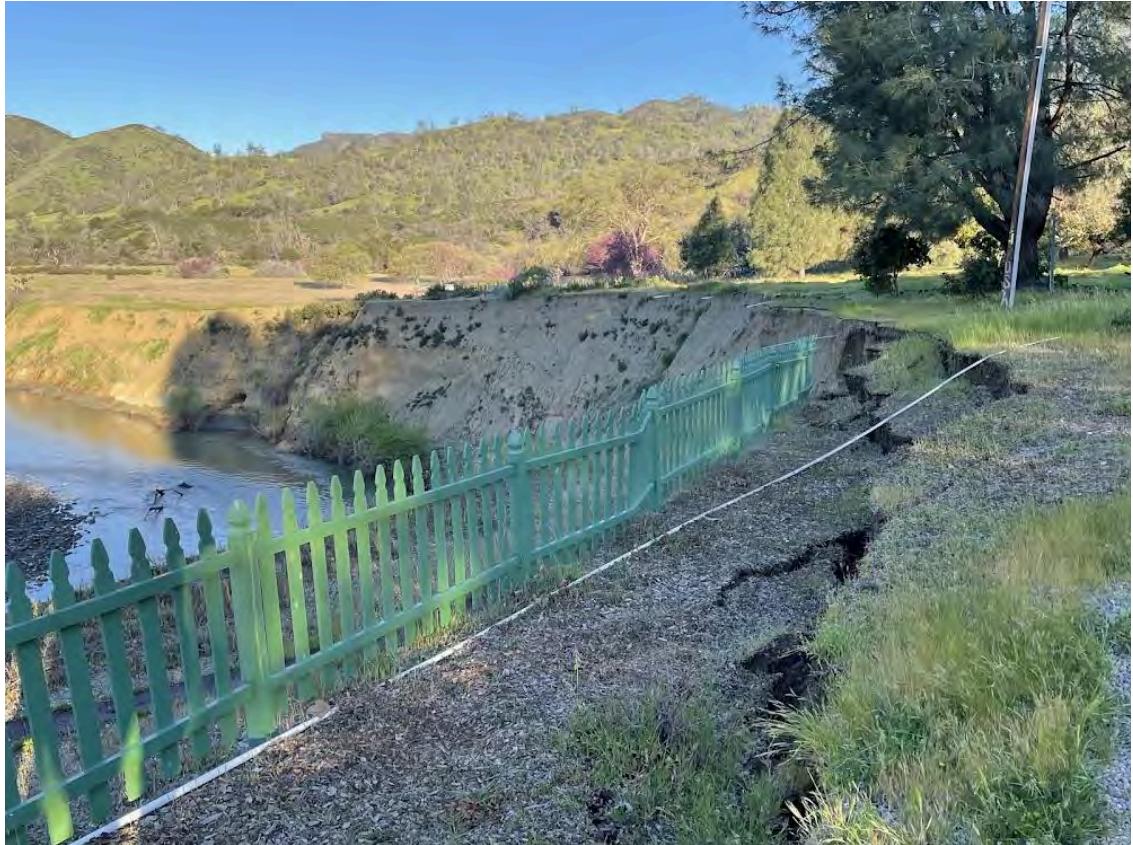
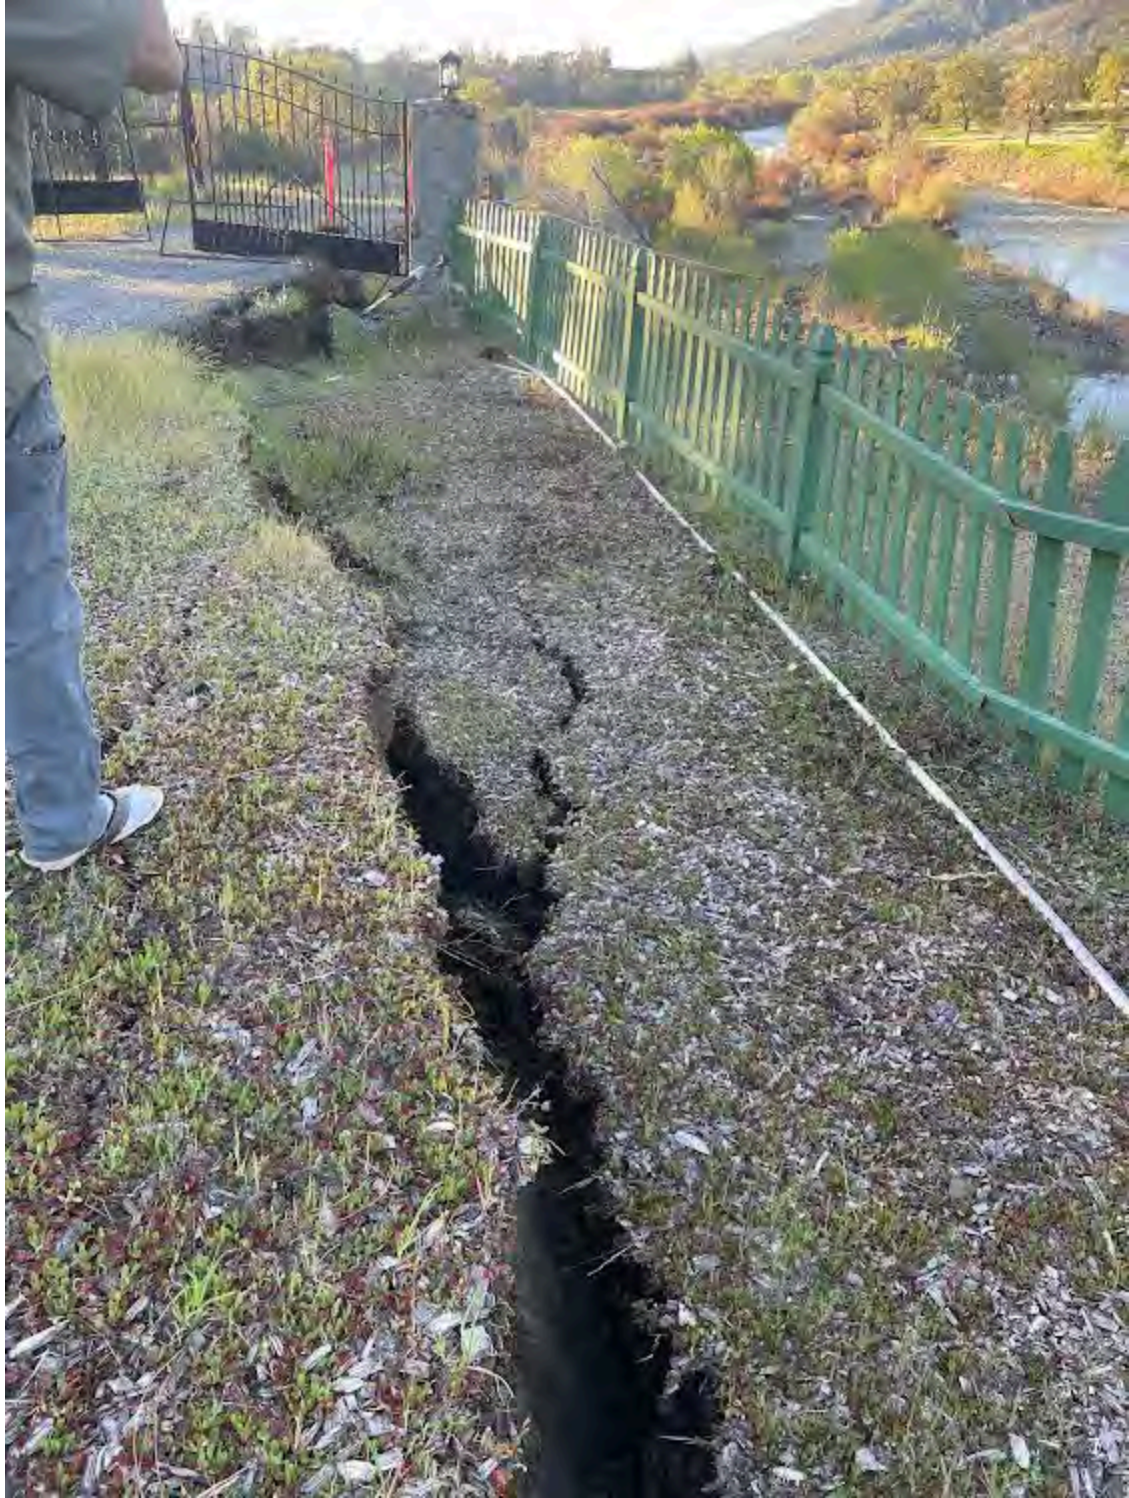
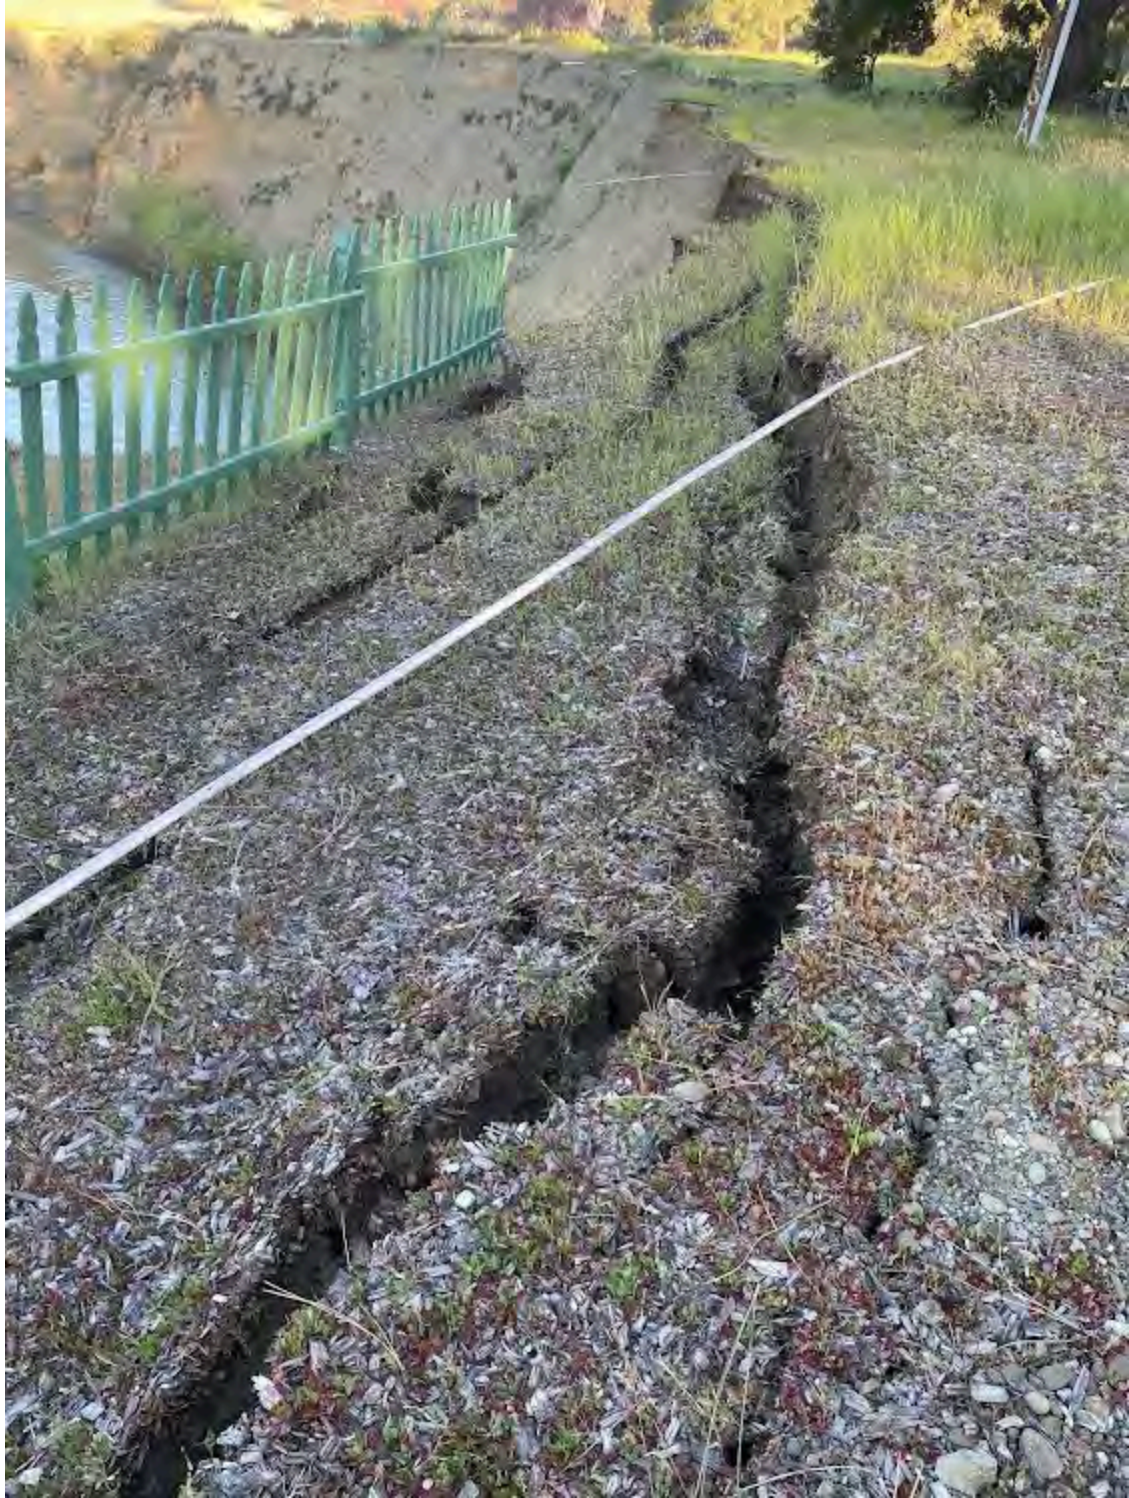
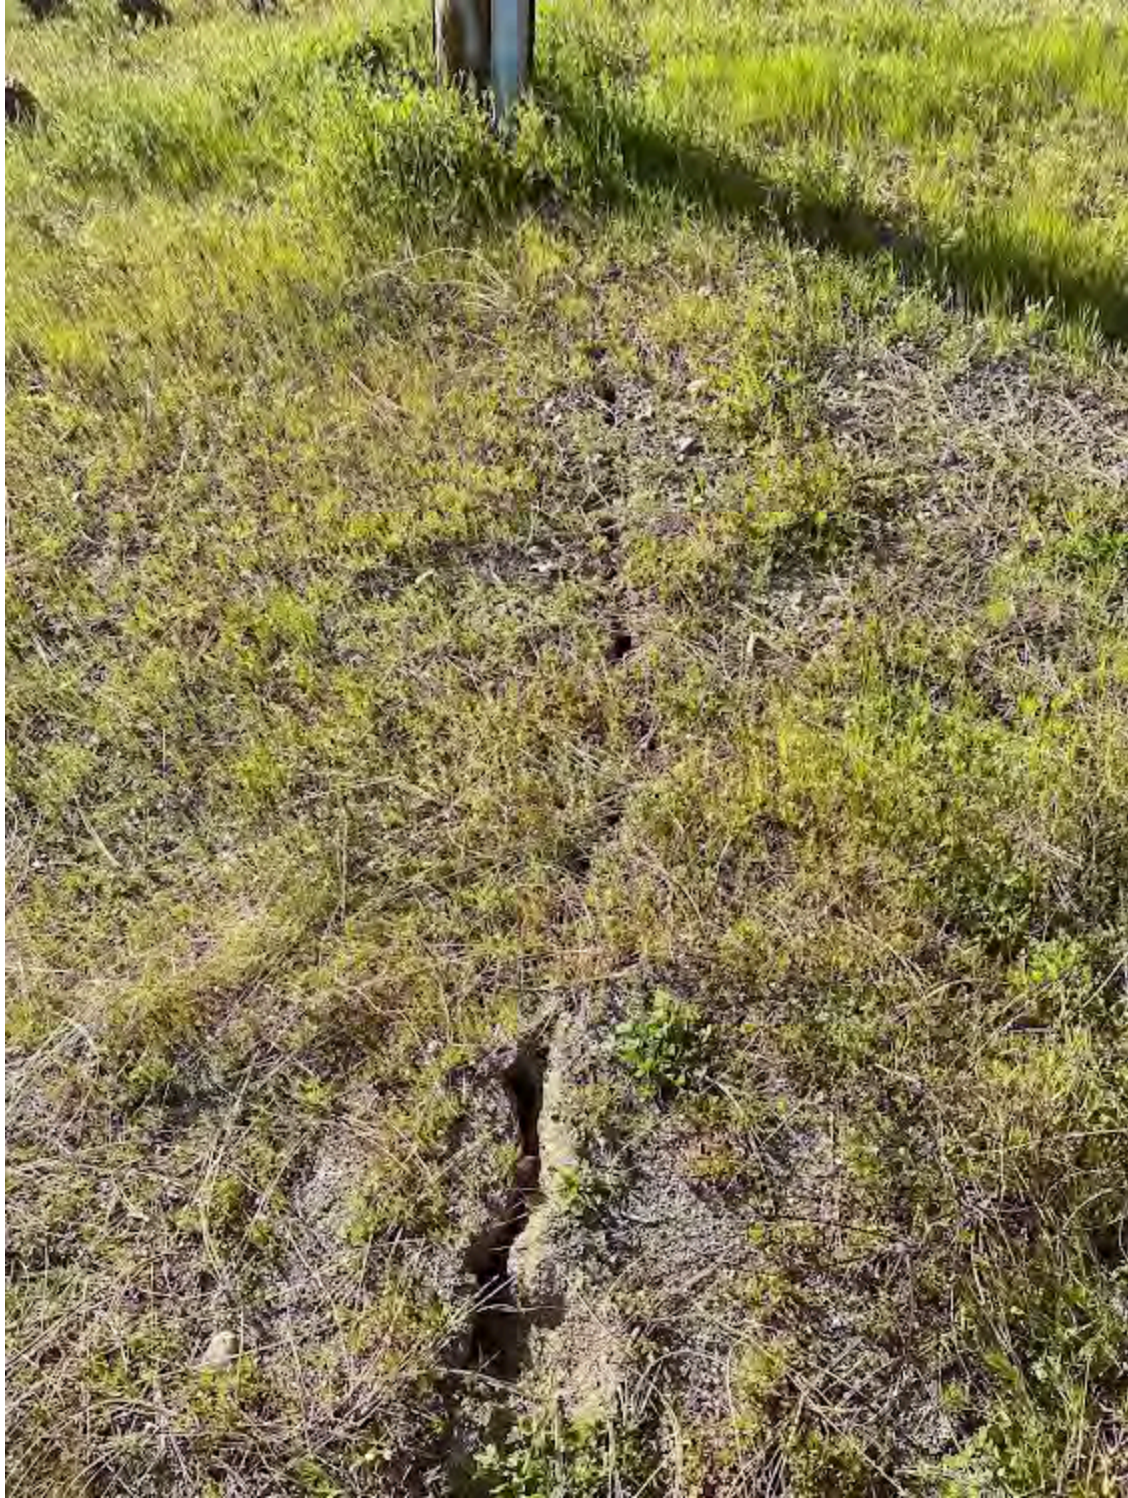
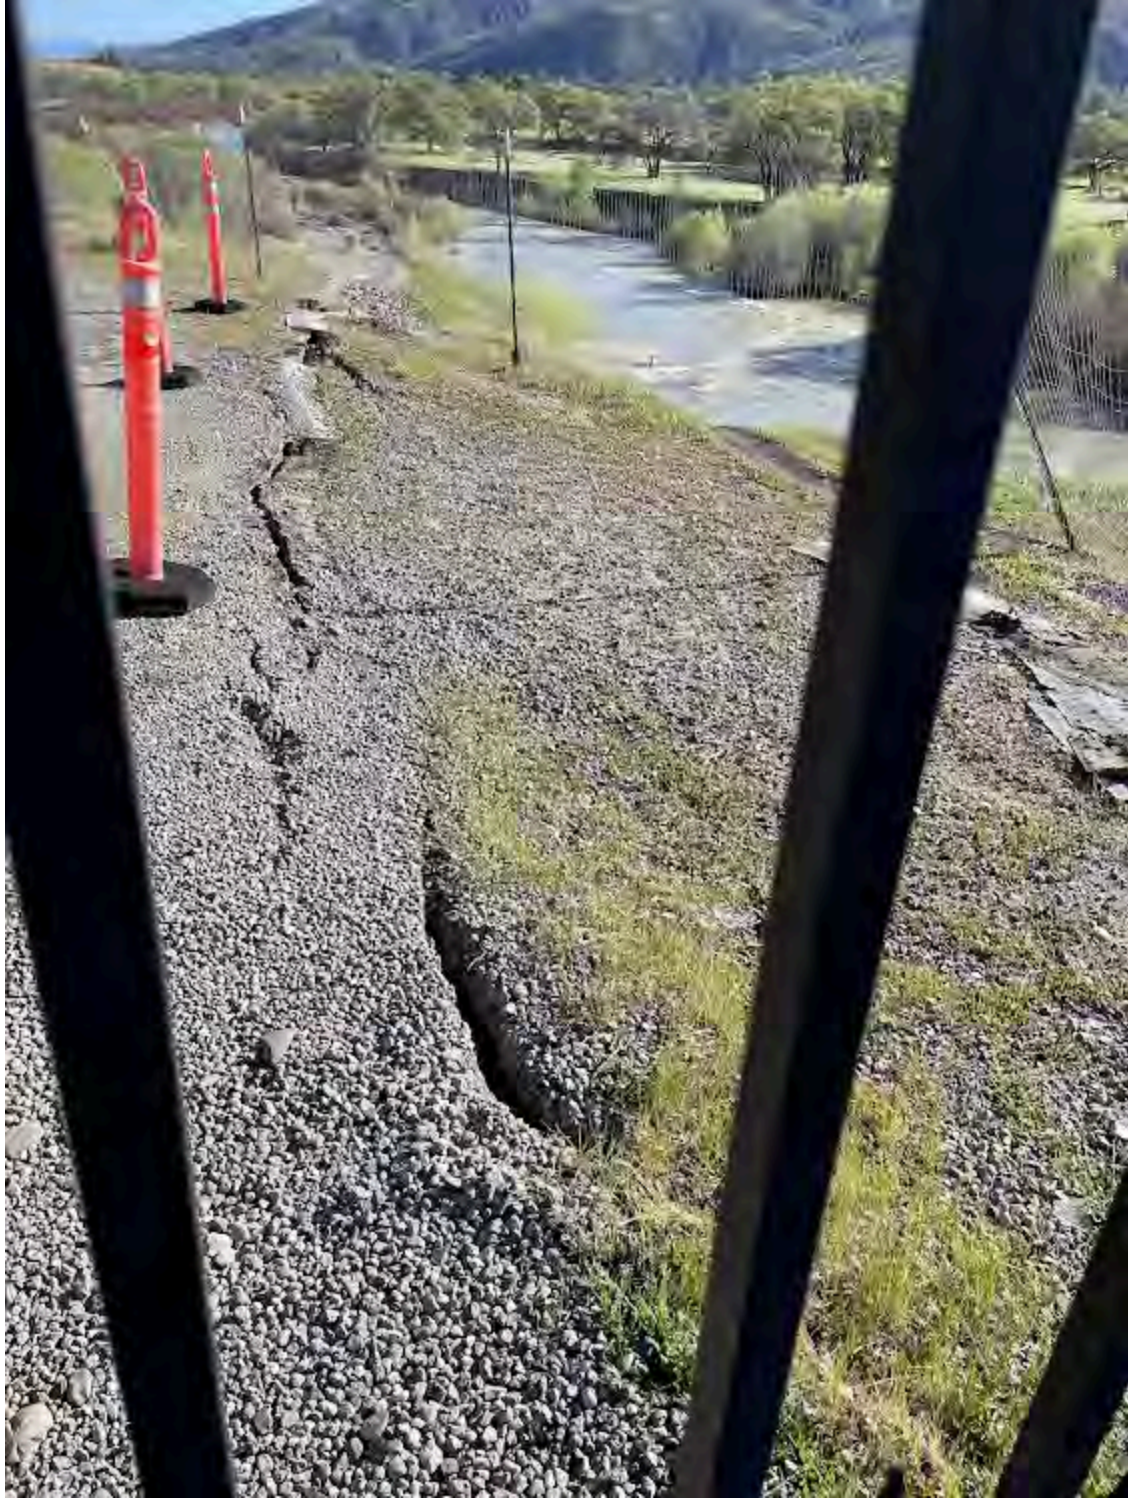
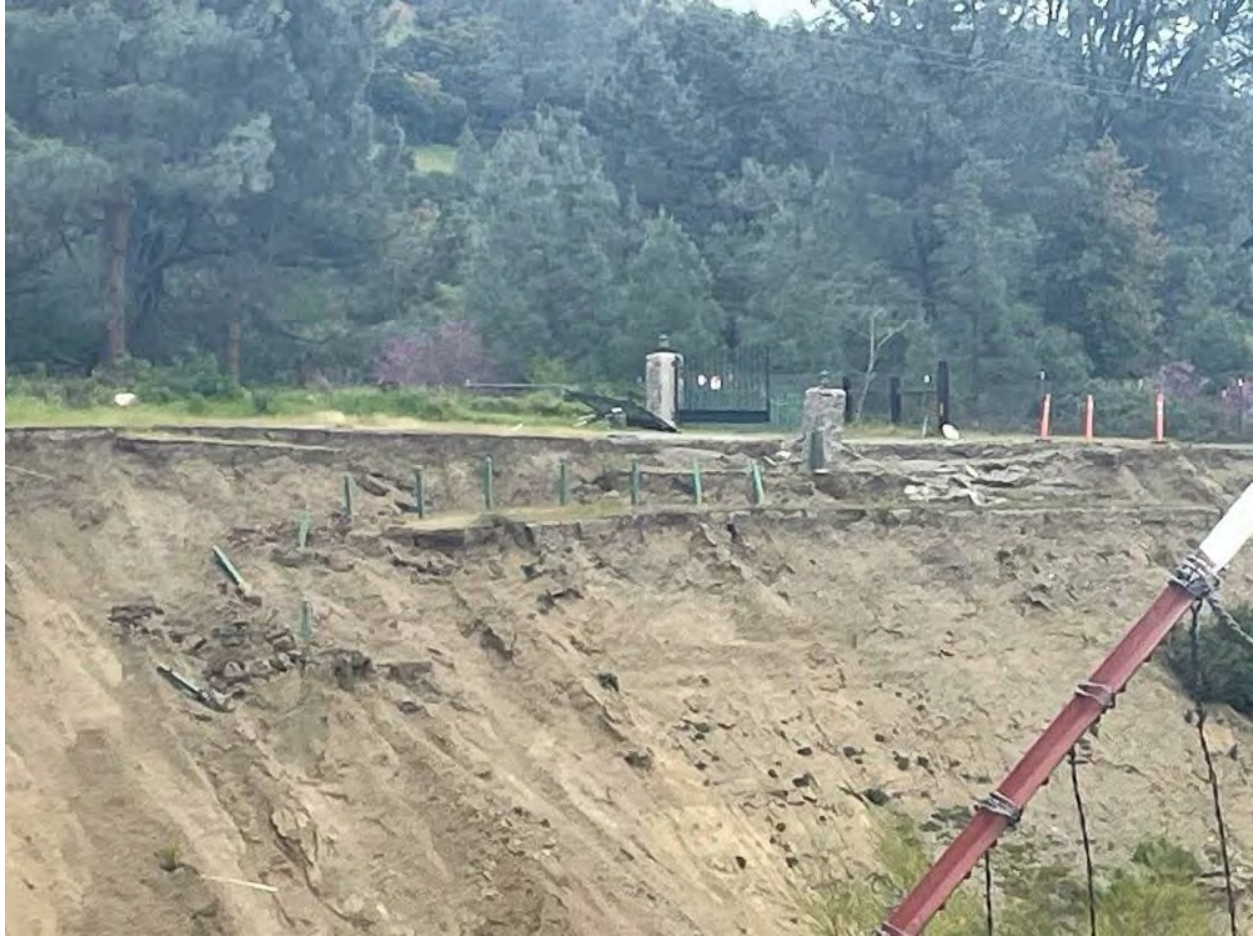
Landslide- March 2024 - Loss of fence, driveway, at least a 15 foot wide shelf along the length of the property

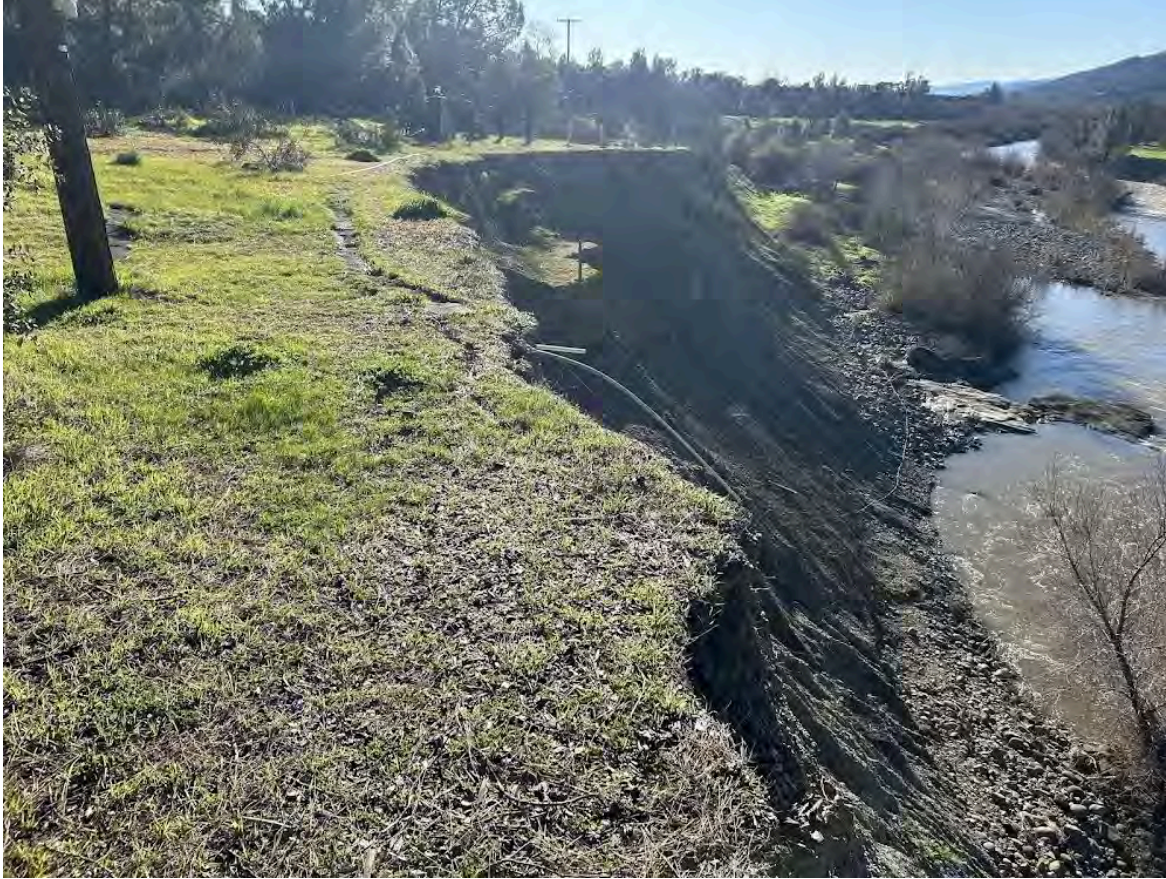
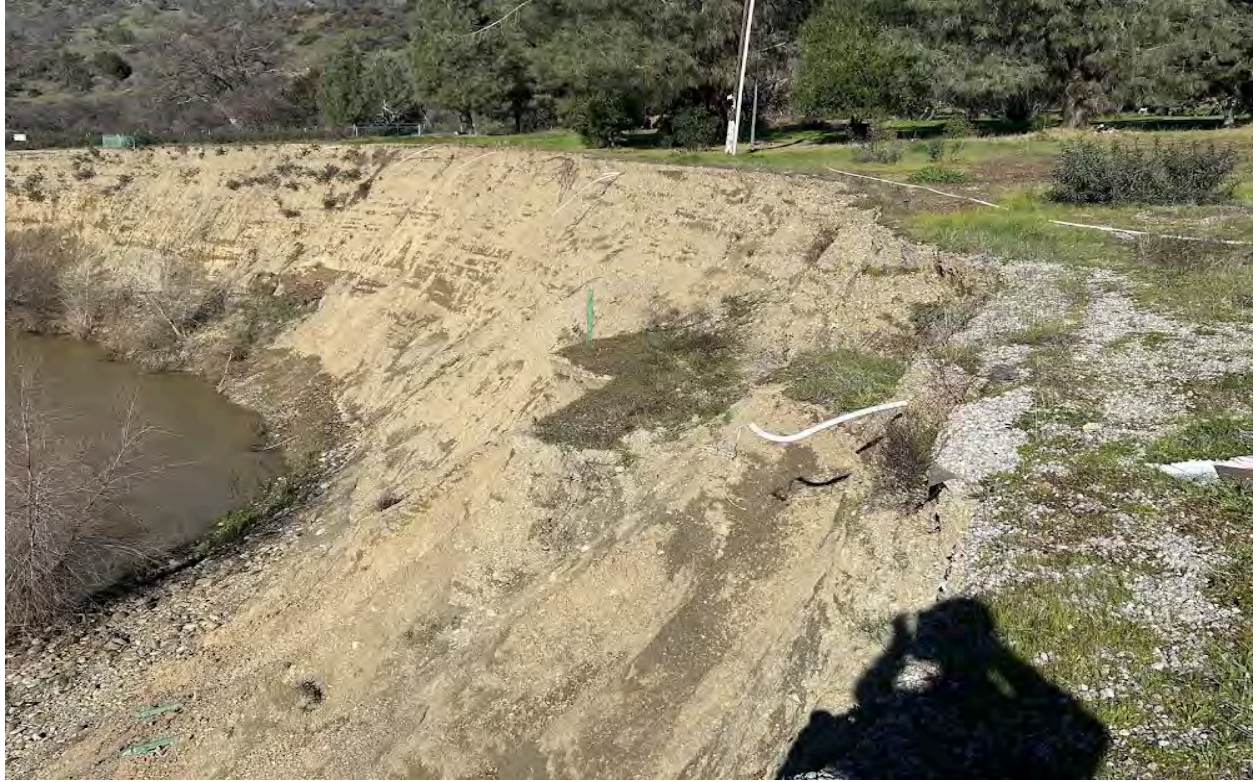
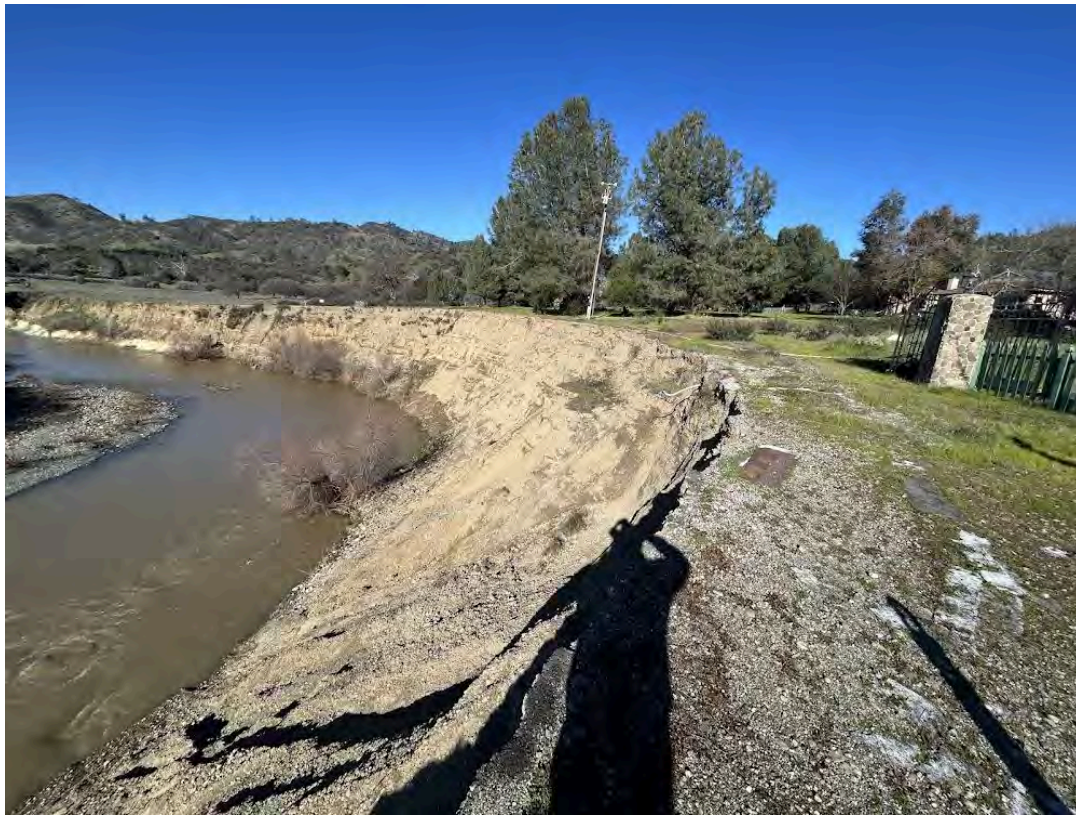
CURRENT January 2026 - shelf from the previous pictures has fallen in and there have been many additional smaller landslides since. This shelf is constantly changing and changes with every storm. Almost every rain there is some land loss.

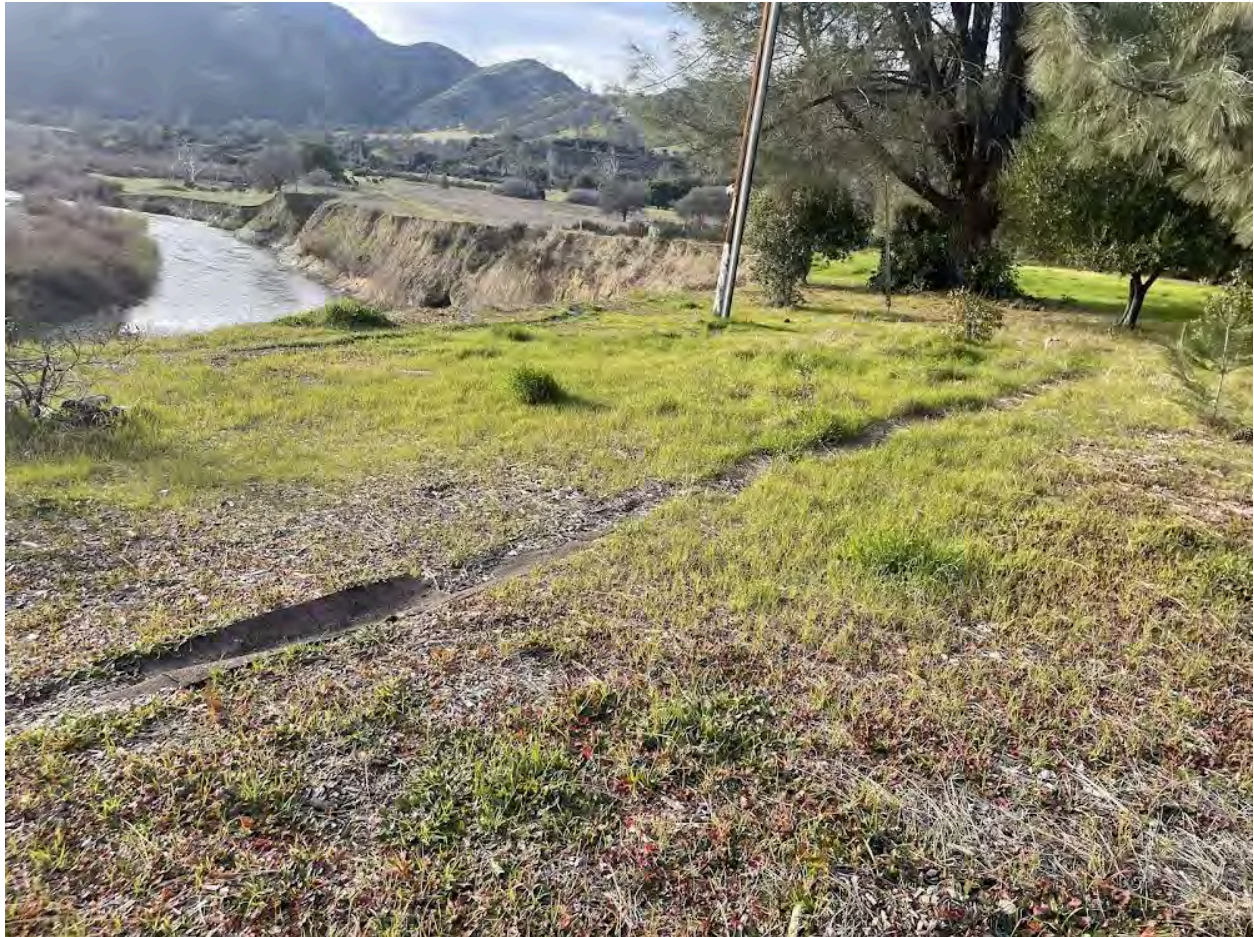
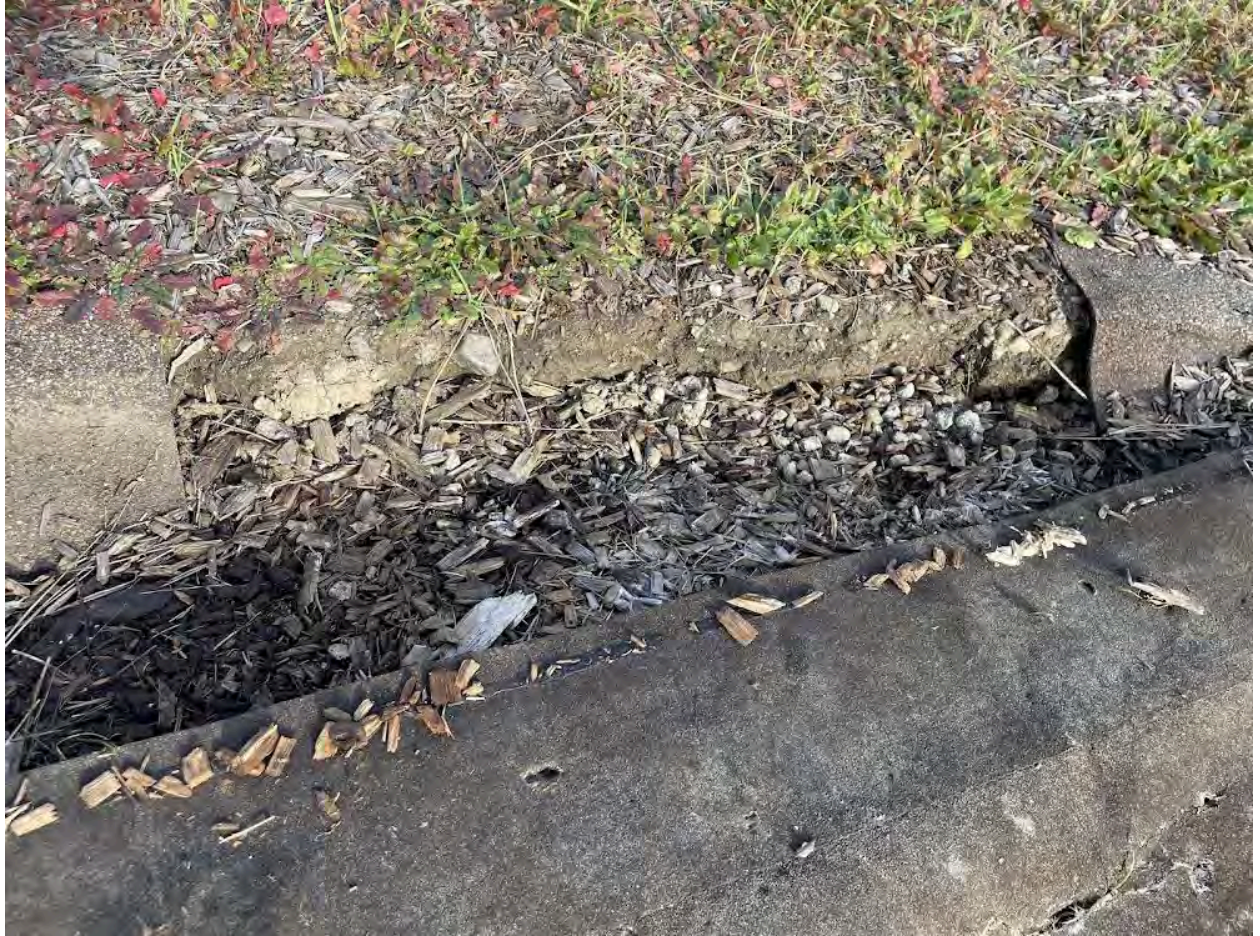
This is the next shelf already falling (about 30 feet wide) the crack is several inches wide and entire shelf is already several inches lower. You can see it is many feet farther inland from the electric pole already.
